# Wildlife Habitat Features Report Eversource Sudbury to Hudson Transmission Reliability Project Sudbury, Massachusetts

DECEMBER 2022- MAY 2023

SWCA Project No. 67849

July 2023

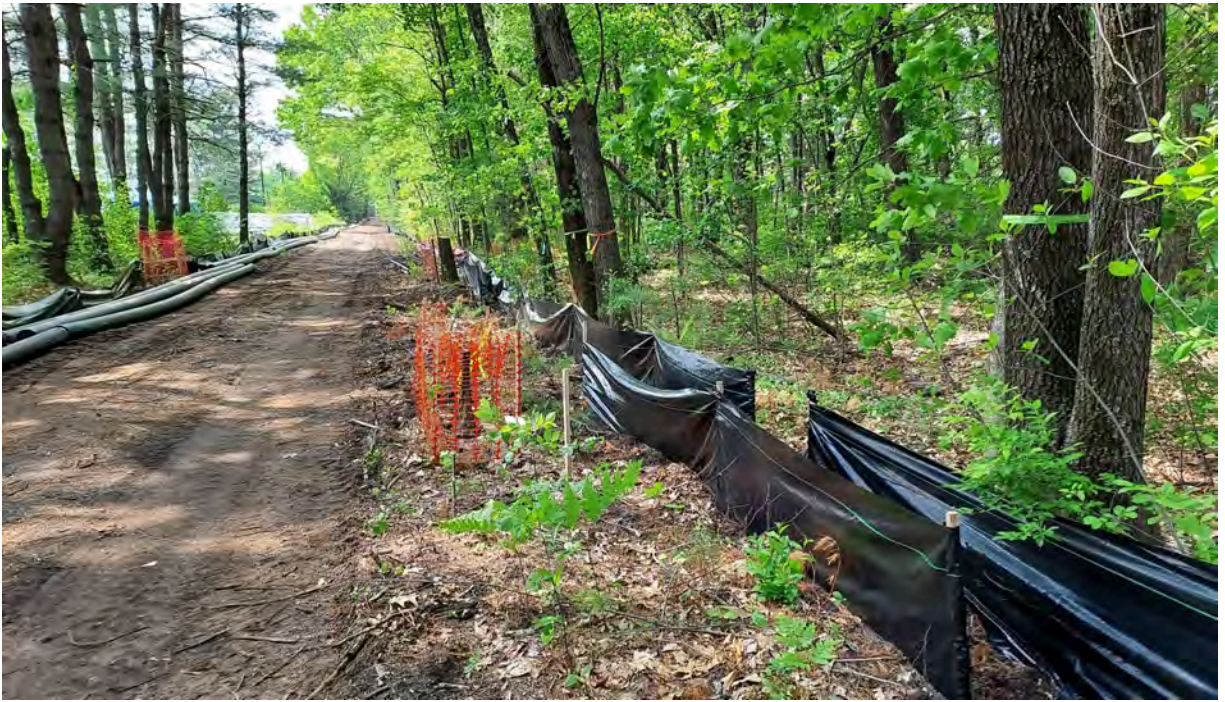
**Photo #3:** View of project area near vernal pool #11 in Segment 11. Silt fence in good condition. No sediment or debris observed in the resource area or associated buffer zone. *Facing northwest.*

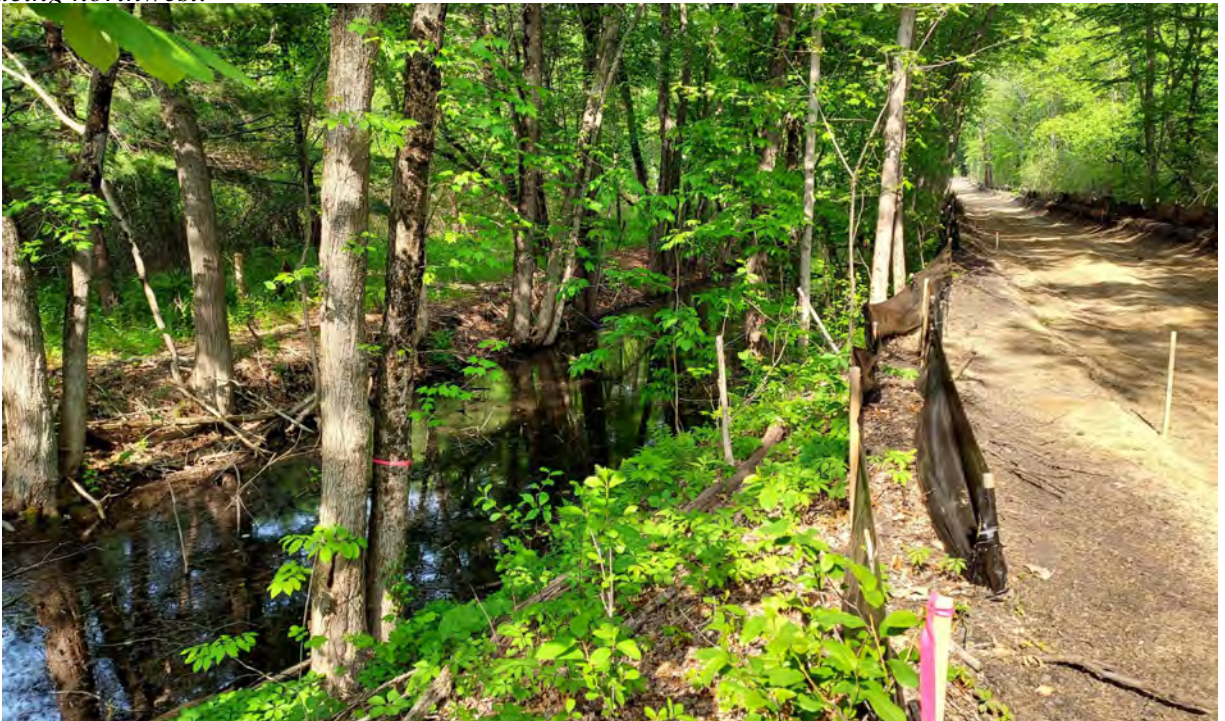
**Photo #4:** View of vernal pool #13 in Segment 14. Silt fence in good condition. No sediment or debris observed in the resource area or associated buffer zone. *Facing east.*

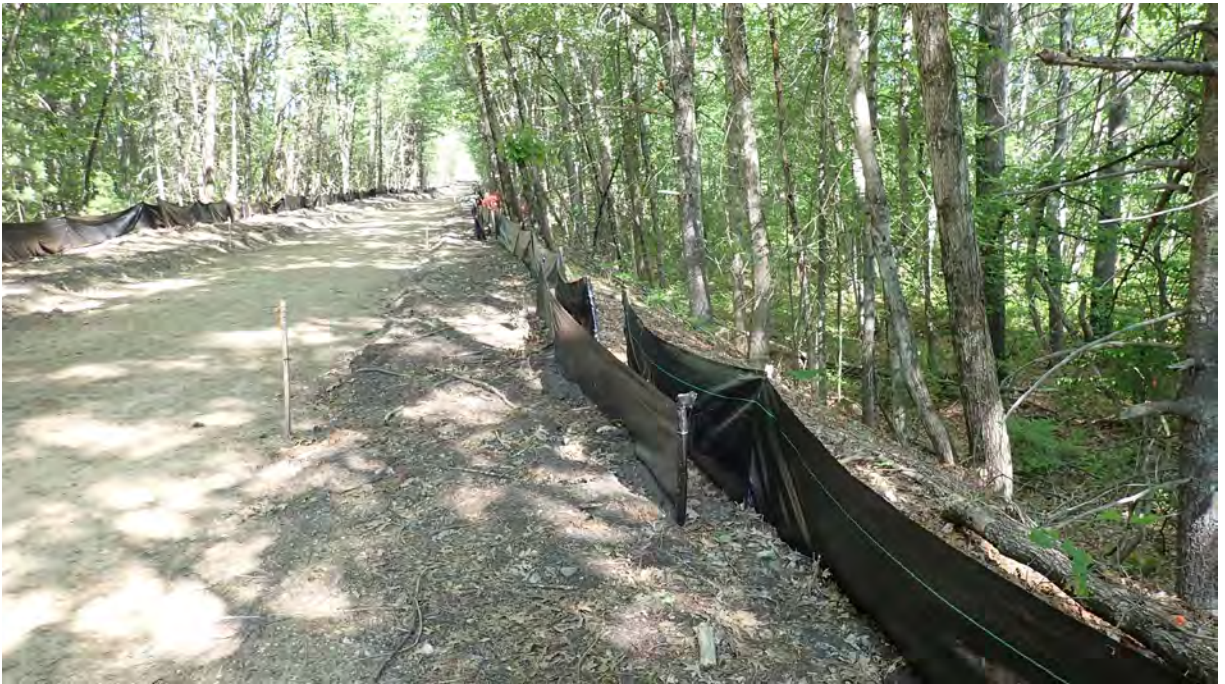
**Photo #1:** View of project area near vernal pools #7 in Segment 8. Silt fencing here, and throughout the project area, is in good condition. No sediment or debris observed within the resource area, buffer zone, or project area. *Facing northwest.*

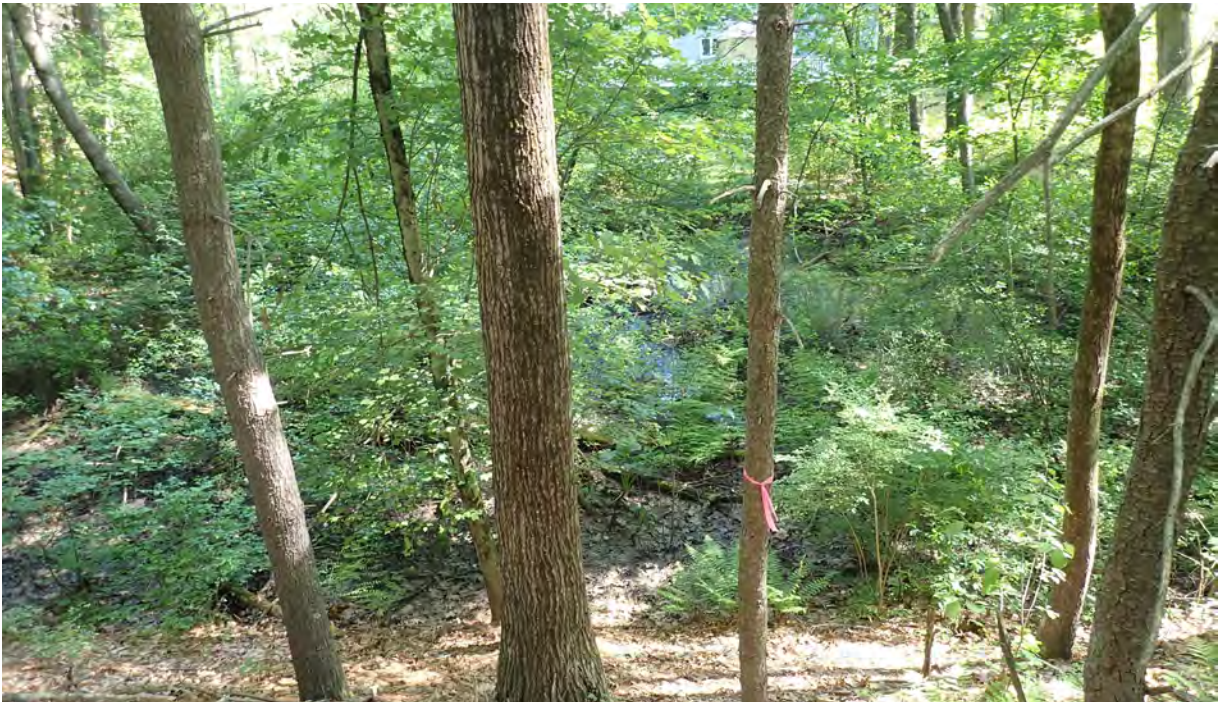
**Photo #2:** View of vernal pool #8 in Segment 10. No sediment or debris observed within the resource area or associated buffer zone. Silt fence is in good condition. *Facing north.*

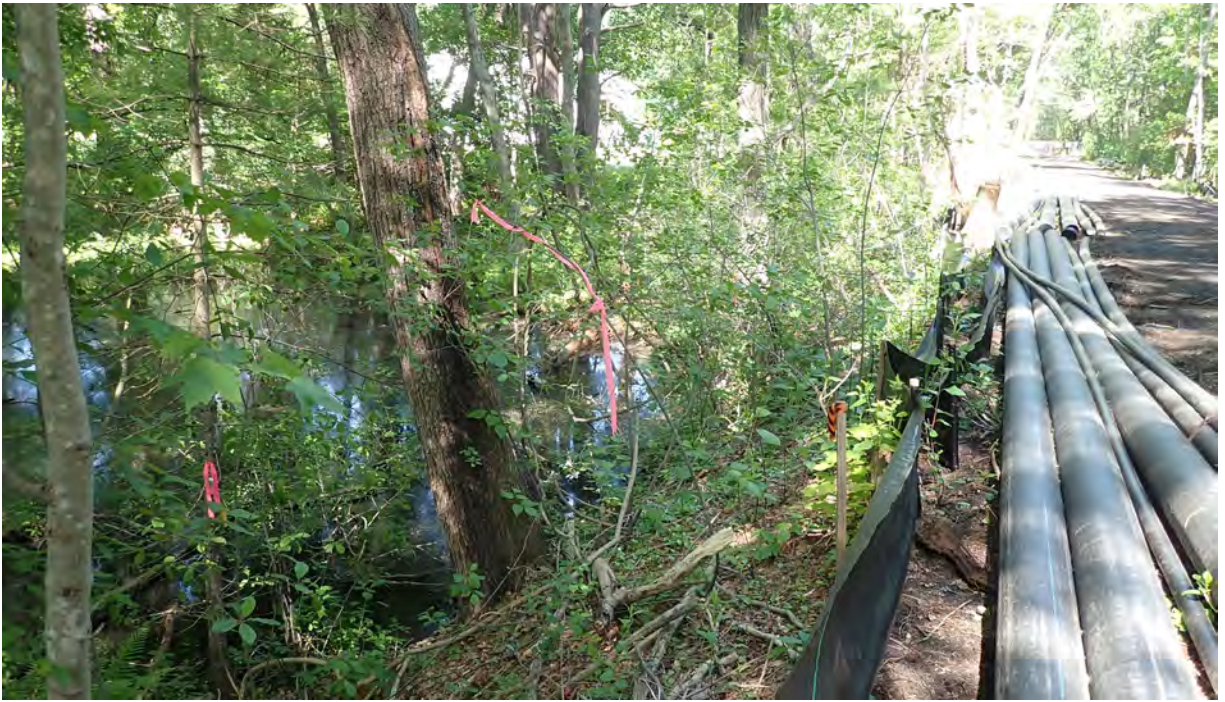
**Photo #3:** View of project area near vernal pool #10 in Segment 11. Silt fence in good condition. No sediment or debris observed in the resource area or associated buffer zone. *Facing southeast.*
