Weekly Environmental Compliance Summary

Sudbury to Hudson Transmission Reliability Project (USEPA Tracking # MAR1003UW)

Week of: October 9, 2023 to October 13, 2023

CONSTRUCTION MONITORING REPORT

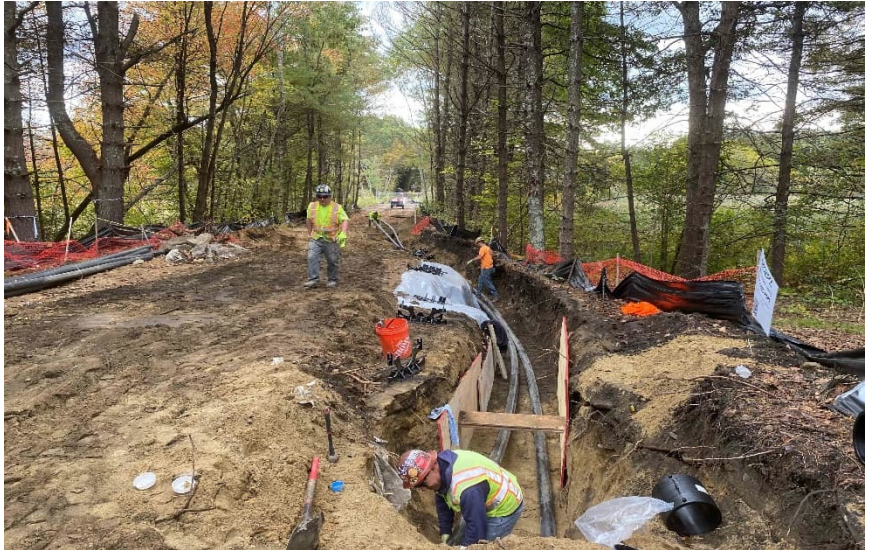
PHOTOGRAPHIC LOG	
Client Name: Eversource		Site Location: Sudbury to Hudson Transmission Reliability Project	Town: Sudbury
Photo No.: 8	Date: 10-10-23

Description: Conduit work within segment 7, existing erosion control, looking eastward.

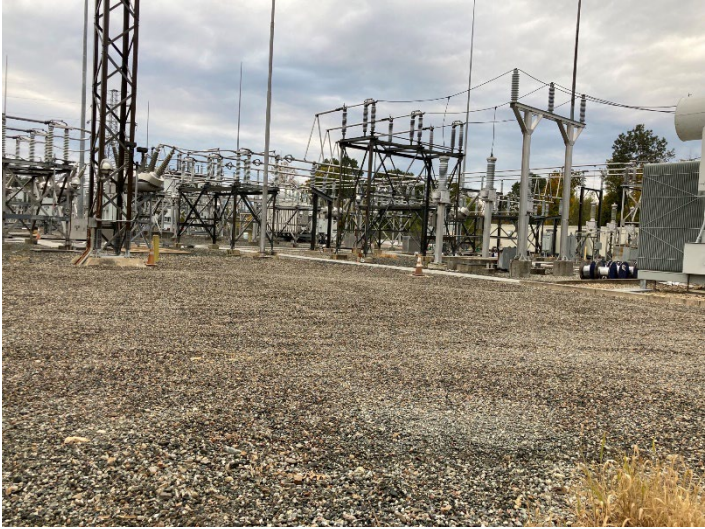
<p align="right">PHOTOGRAPHIC LOG</p>	
<p>Client Name: Eversource</p>		<p>Site Location: Sudbury to Hudson Transmission Reliability Project</p>	<p>Town: Sudbury</p>
<p>Photo No.: 1</p>	<p>Date: 10/10/2023</p>

<p>Description: View of former stockpile location at Sudbury substation. Civil construction has ceased at substation. Stockpile and all compost filter tubes have been removed. Stone has been spread for stabilization. Facing south.</p>

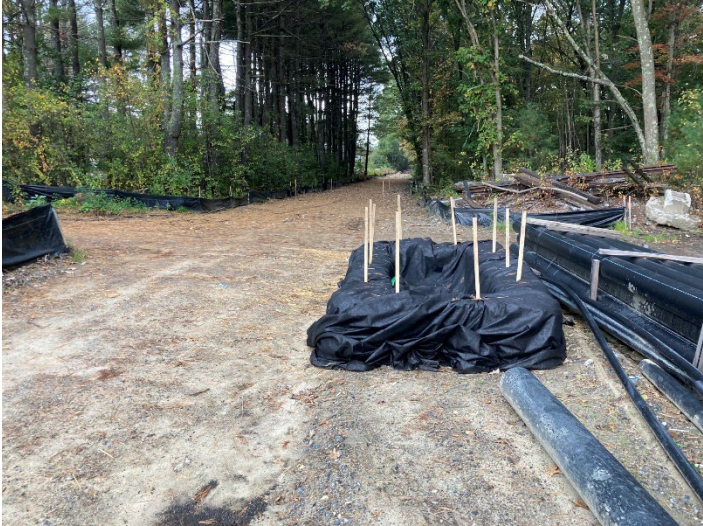
<p>PHOTOGRAPHIC LOG</p>	
<p>Client Name: Eversource</p>		<p>Site Location: Sudbury to Hudson Transmission Reliability Project</p>	<p>Town: Sudbury</p>
<p>Photo No.: 4</p>	<p>Date: 10/10/2023</p>

<p>Description: View of straw bale corral that has been set up in segment 11 for anticipated dewatering activities at Union Ave crossing. Facing west.</p>

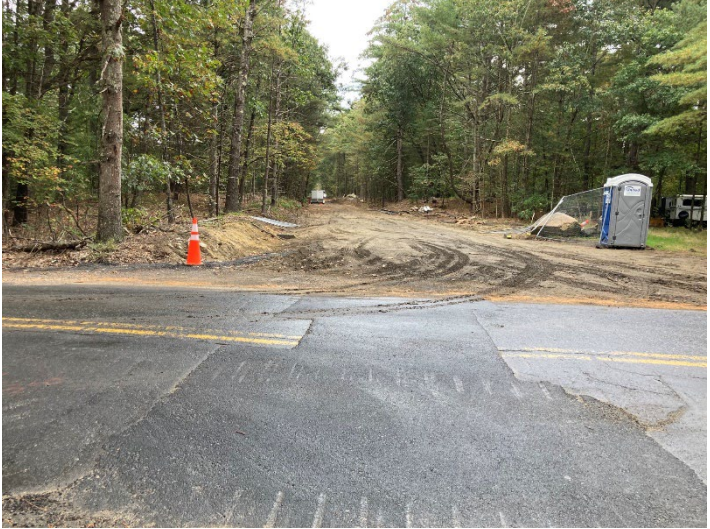
<p align="right">PHOTOGRAPHIC LOG</p>	
<p>Client Name: Eversource</p>		<p>Site Location: Sudbury to Hudson Transmission Reliability Project</p>	<p>Town: Sudbury</p>
<p>Photo No.: 6</p>	<p>Date: 10/10/2023</p>

<p>Description: View of entrance to segment 9 at Dutton Rd. Sediment tracking noted. It is recommended that the street is swept, and fresh stone is applied to construction entrance. Facing east.</p>

- Sediment tracking noted on Dutton Rd from work in segment 9. It is recommended that the street is swept, and fresh stone is applied to construction entrance.**
-
-

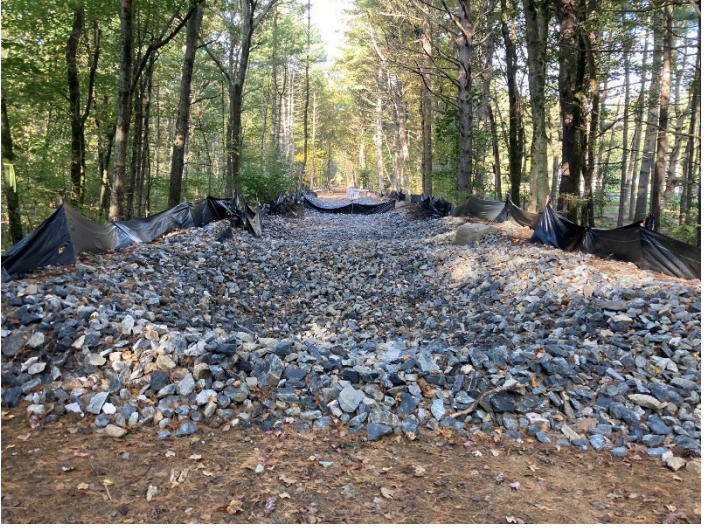
PHOTOGRAPHIC LOG	
Client Name: Eversource		Site Location: Sudbury to Hudson Transmission Reliability Project	Town: Sudbury
Photo No.: 2	Date: 10/11/2023

Description: View of area above collapsed culvert in segment 9. Facing west.

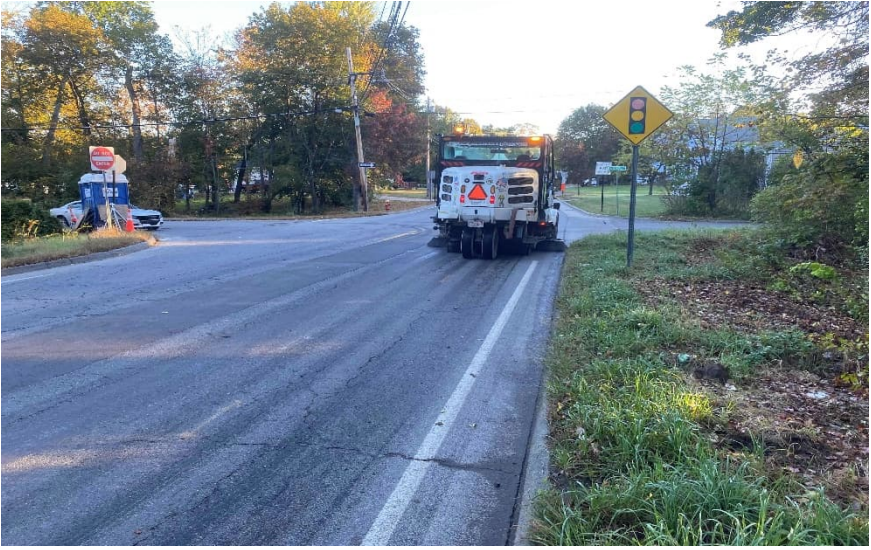
<p>PHOTOGRAPHIC LOG</p>	
<p>Client Name: Eversource</p>		<p>Site Location: Sudbury to Hudson Transmission Reliability Project</p>	<p>Town: Hudson</p>
<p>Photo No.: 1</p>	<p>Date: 10-13-23</p>

<p>Description:</p> <p>Work area within Forest Avenue, street sweeper cleaning road, looking northward.</p>

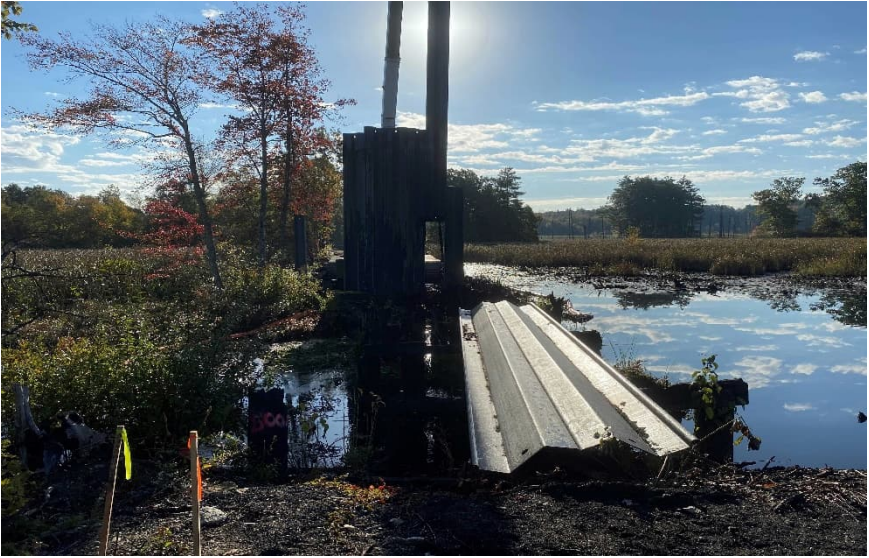
PHOTOGRAPHIC LOG	
Client Name: Eversource		Site Location: Sudbury to Hudson Transmission Reliability Project	Town: Hudson
Photo No.: 3	Date: 10-12-23

Description: Work area within segment 3, sheeting work for Bridge 130, existing erosion control, looking eastward.

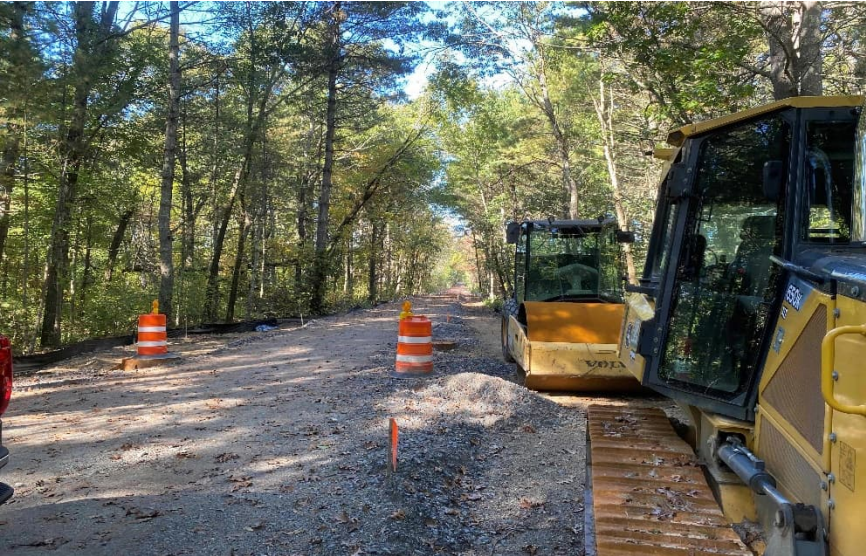
PHOTOGRAPHIC LOG	
Client Name: Eversource		Site Location: Sudbury to Hudson Transmission Reliability Project	Town: Hudson
Photo No.: 8	Date: 10-12-23

Description: Work area within segment 5, existing erosion control, looking westward.

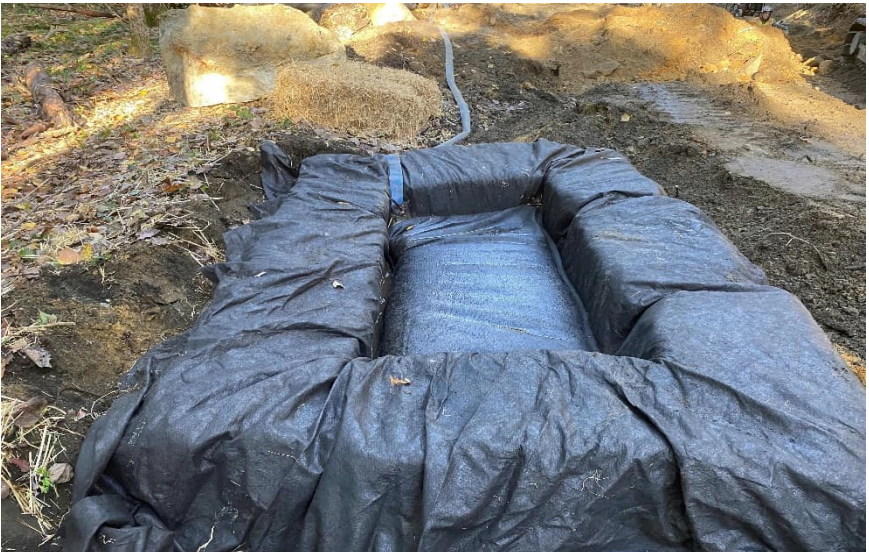
Description: Segment 9. View of discharge bag/bales, looking westward. Water discharge to bag intermittent and appeared to be slightly turbid.
