**Weekly Environmental Compliance Summary**

**Sudbury to Hudson Transmission Reliability Project (USEPA Tracking # MAR1003UW)**

Sudbury, Hudson, and Stow, MA

Week of: October 16, 2023 to October 20, 2023

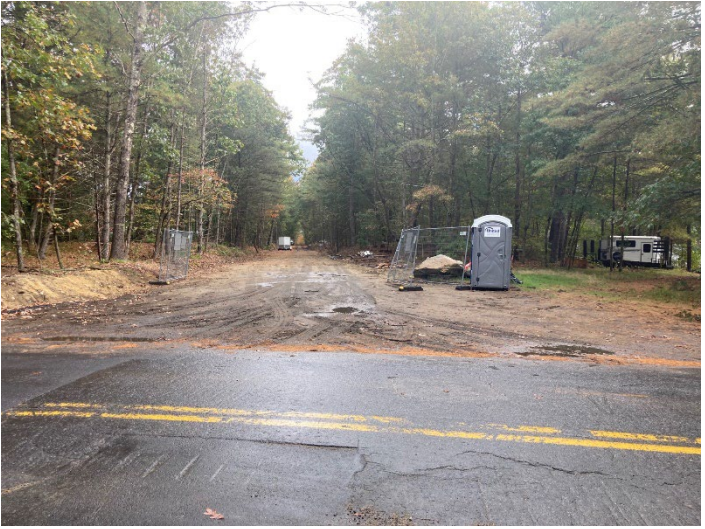
<p align="right"><b>PHOTOGRAPHIC LOG</b></p>	
<p><b>Client Name:</b> Eversource</p>		<p><b>Site Location:</b> Sudbury to Hudson Transmission Reliability Project</p>	<p><b>Town:</b> Sudbury</p>
<p><b>Photo No.:</b> 2</p>	<p><b>Date:</b> 10/16/2023</p>

<p><b>Description:</b> View of construction entrance to segment 9 at Dutton Rd. It is recommended that fresh stone is applied to entrance. Facing east.</p>

**-It is recommended that fresh stone is applied to construction entrance in segment 9 at Dutton Rd.**

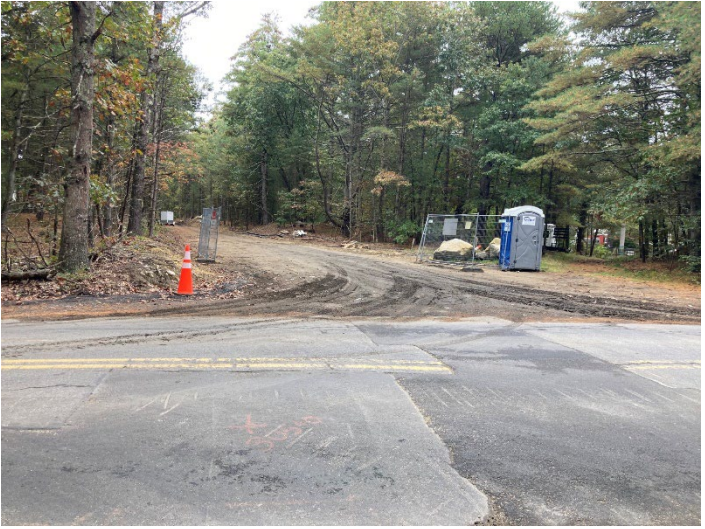
**-Sediment tracking noted on Dutton Rd from segment 9. It is recommended that fresh stone is applied to construction entrance at this location.**

<p><b>Description:</b> Sediment tracking noted on Dutton Rd from segment 9. It is recommended that fresh stone is applied to construction entrance at this location. Facing east.</p>

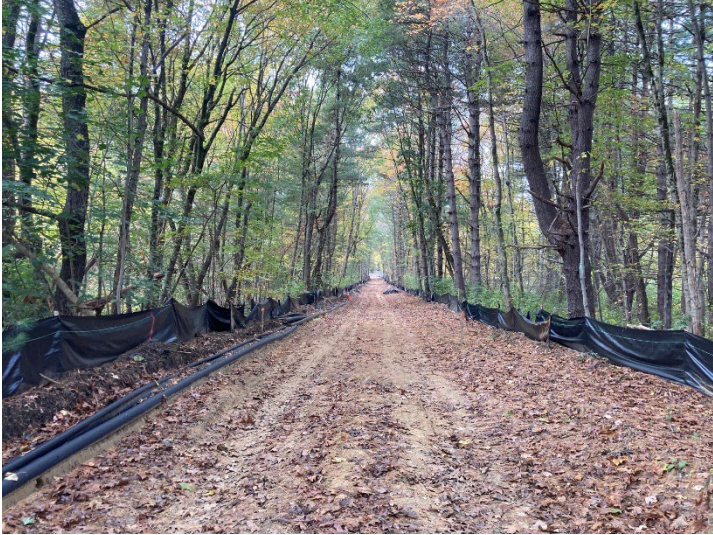
<p><b>Description:</b> View of syncopated silt fence in segment 10. Facing east.</p>

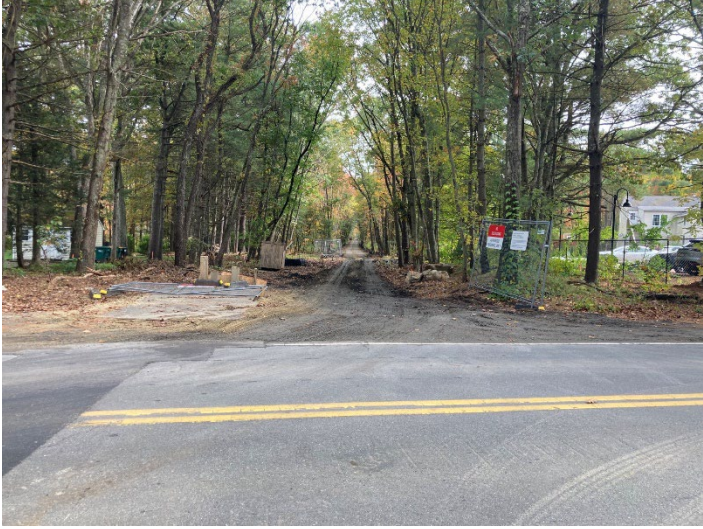
**-Sediment tracking noted on Horse Pond Rd from segment 11. It is recommended that fresh stone is applied to construction entrance at this location.**

<b>Description:</b> Sediment tracking noted on Horse Pond Rd from segment 11. It is recommended that fresh stone is applied to construction entrance at this location. Facing east.

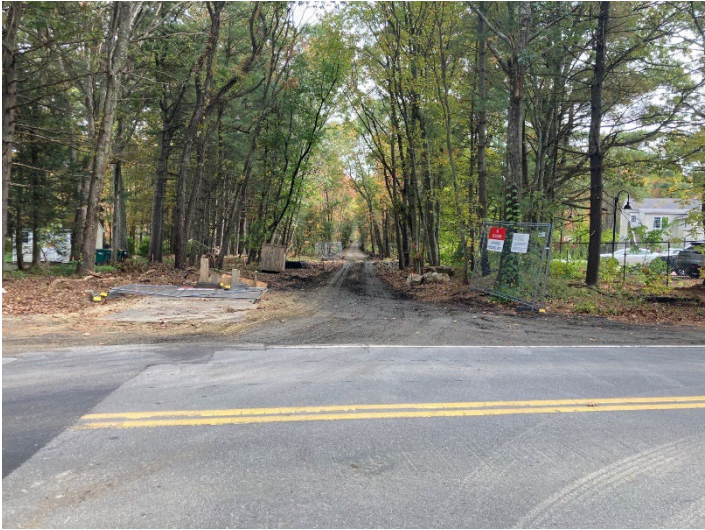
<b>Description:</b> View of entrance to segment 11 at Horse Pond Rd. It is recommended that fresh stone is applied to entrance at this location and in segment 9 at Dutton Rd. Facing east.

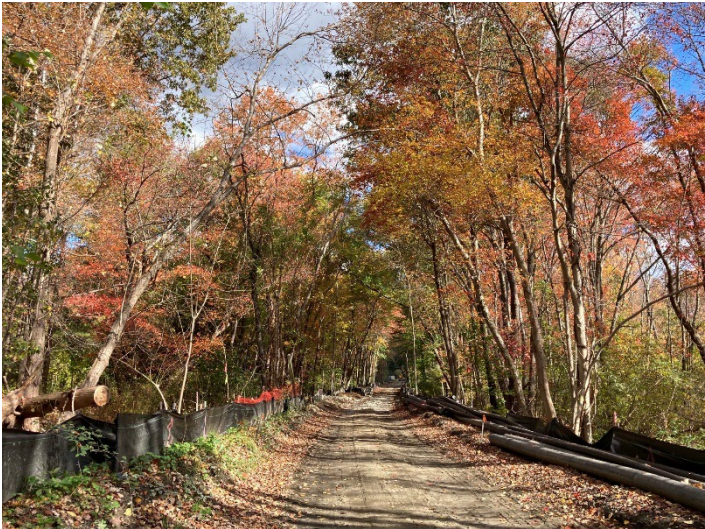
<b>Description:</b> View of syncopated silt fence in segment 14. Silt fence is in good condition and operating properly. Facing east.

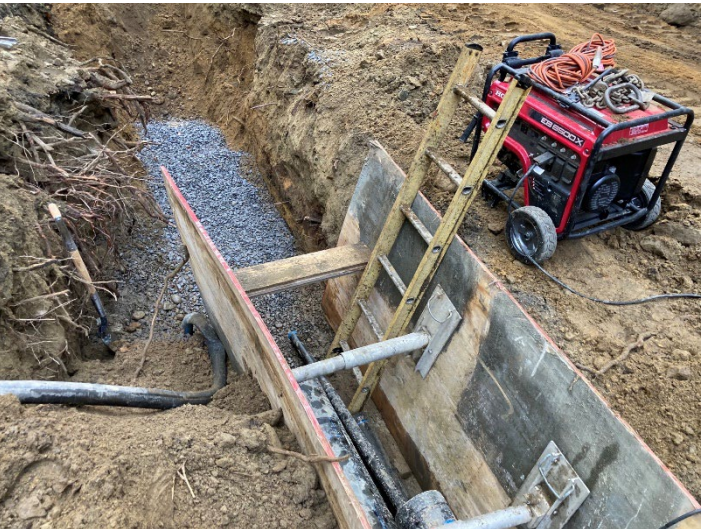
<b>Description:</b> View of pump in trench. Unable to visualize water prior to treatment. Facing east.

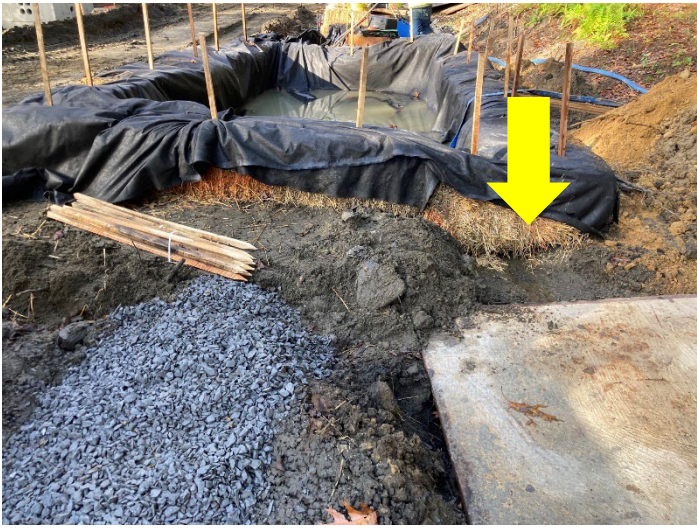
<b>Description:</b> View of discharge point from treatment corral (yellow arrow indicates discharge location). Water discharged into infiltration basin under steel plate. Discharge appeared slightly turbid. Turbidity reading was above 50 NTUs, but discharge did not appear to leave the project. Facing west.
