**Weekly Environmental Compliance Summary**

**Sudbury to Hudson Transmission Reliability Project (USEPA Tracking # MAR1003UW)**

Sudbury, Hudson, and Stow, MA

Week of: September 18, 2023 to September 22, 2023

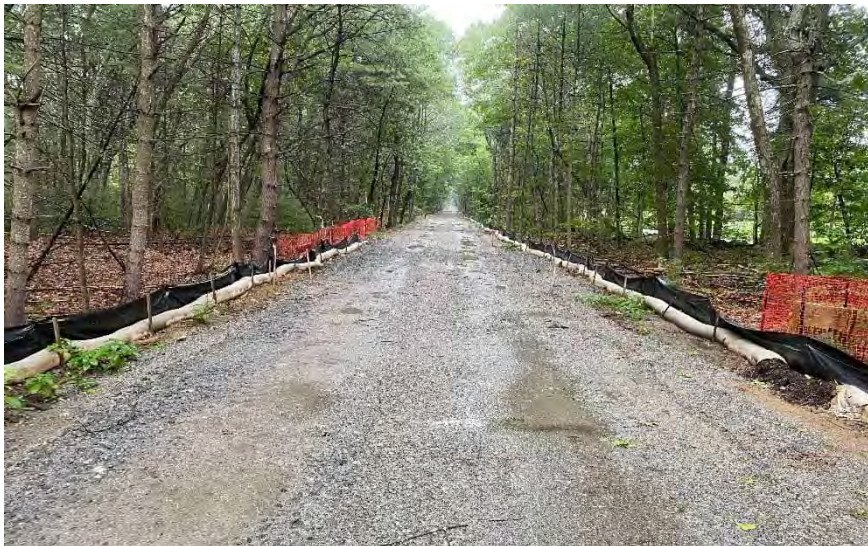
<b>PHOTOGRAPHIC LOG</b>	
Client Name: Eversource		Site Location: Sudbury to Hudson Transmission Reliability Project	
Town: Hudson			
Photo No.: 5	Date: 9-18-23		
Description:  Work area within segment 3, existing erosion control, looking eastward.

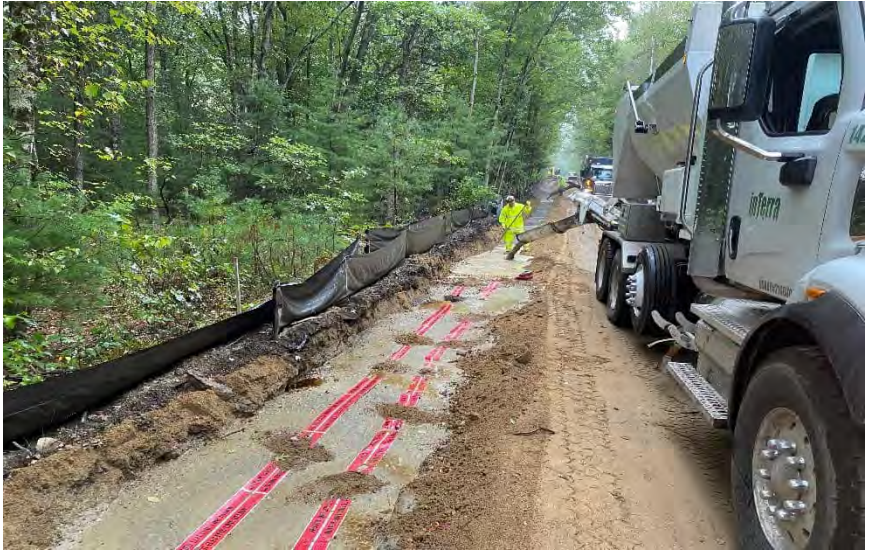
Description:  Work area within segment 6, conduit work, existing erosion control, looking eastward.

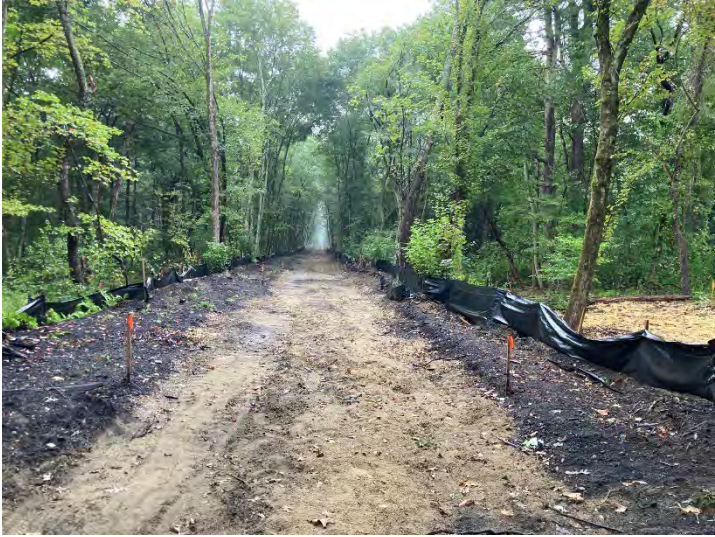
Description: View of west end of segment 11. Seed and straw have been applied to areas where invasive vegetation was removed in this area. Facing east.

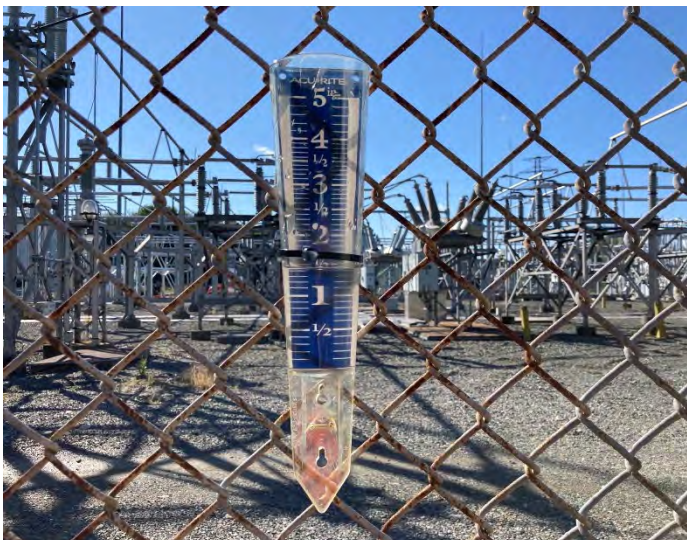
Description: View of rain gauge at Sudbury Substation. 1.50" observed in gauge at approximately 9:45am. Facing south.

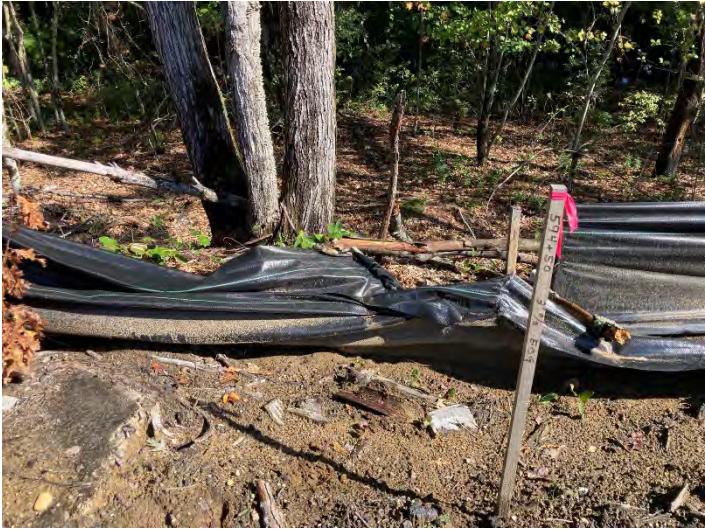
Description: View of damaged silt fence at sta. 594+50 LT in segment 11. Facing north.

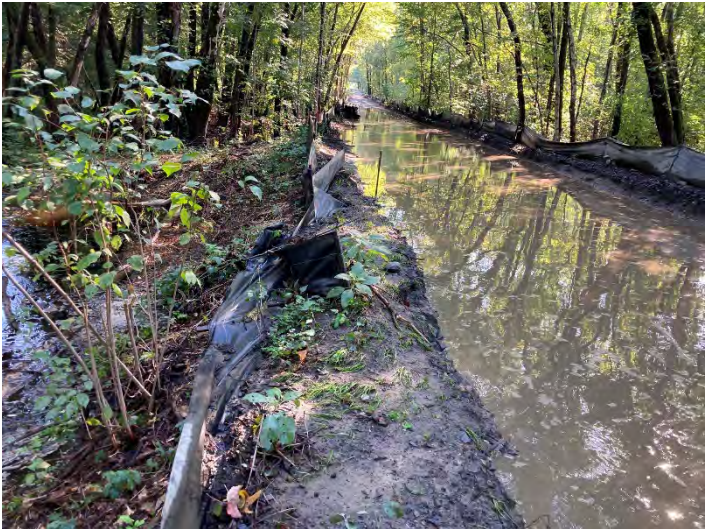
Description: View of damaged silt fence at sta. 744+50 LT in segment 14. Silt fence is in need of repair in multiple locations in this segment. Facing east.

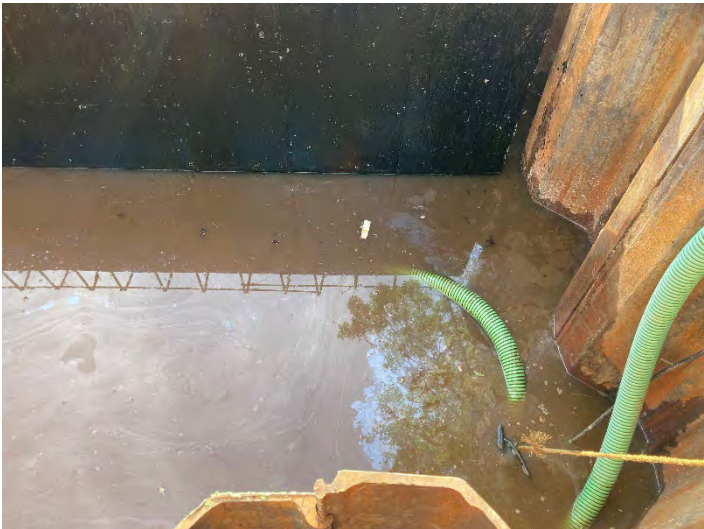
Description: View of pumping operation at Bridge 127 work at Hop Brook. Water prior to treatment appeared turbid. Possible sheen observed but appeared to be minor. Believed to be from tack coat that has been applied to abutment. No sheen was observed on water outside of sheeting/coffer dam.

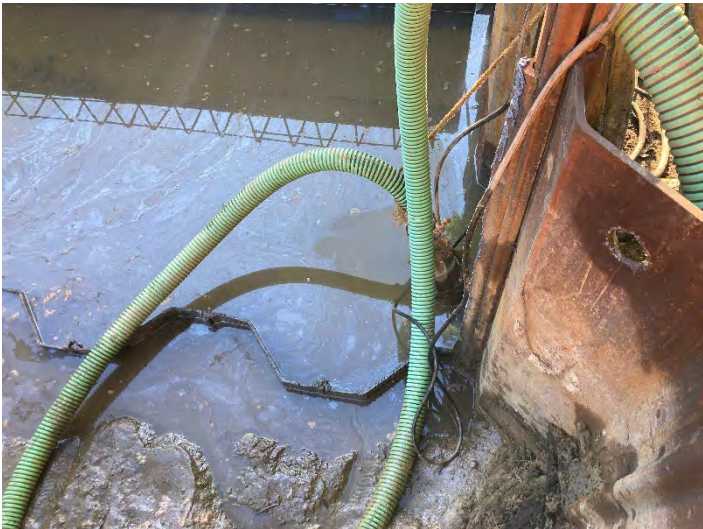
Description: View of pumping operation at Bridge 127 work at Hop Brook. Water prior to treatment appeared turbid. Possible sheen observed but appeared to be minor. Believed to be from tack coat that has been applied to abutment. No sheen was observed on water outside of sheeting/coffer dam.
