Weekly Environmental Compliance Summary

Sudbury to Hudson Transmission Reliability Project (USEPA Tracking # MAR1003UW)

Week of: September 25, 2023 to September 29, 2023

CONSTRUCTION MONITORING REPORT

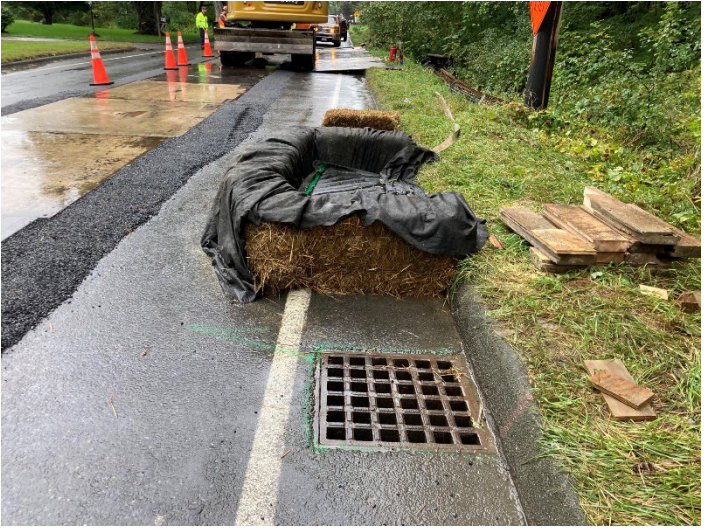
<p>PHOTOGRAPHIC LOG</p>	
<p>Client Name: Eversource</p>		<p>Site Location: Sudbury to Hudson Transmission Reliability Project</p>	<p>Town: Hudson</p>
<p>Photo No.: 2</p>	<p>Date: 9/25/2023</p>

<p>Description: View of dewatering controls near MH #4 on Forest Ave. See additional dewatering inspection report. Facing north.</p>

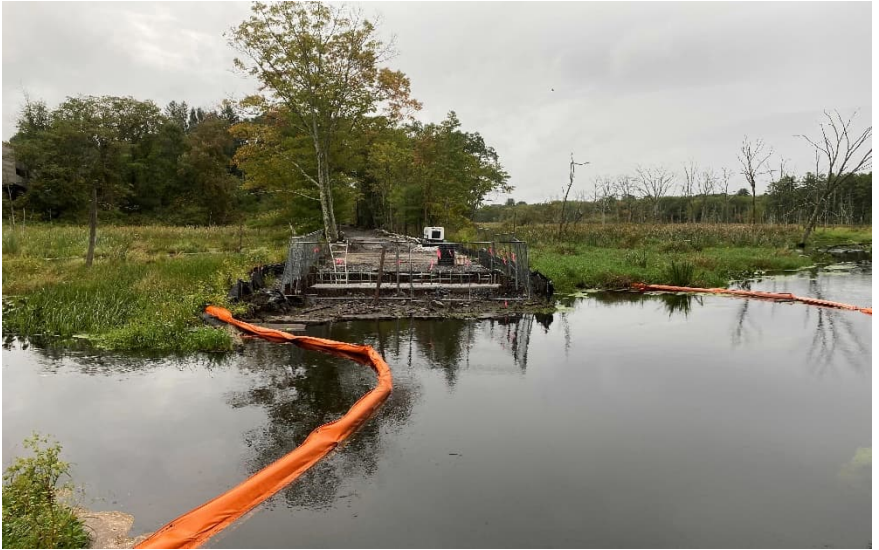
PHOTOGRAPHIC LOG	
Client Name: Eversource		Site Location: Sudbury to Hudson Transmission Reliability Project	Town: Sudbury
Photo No.: 1	Date: 9-25-23

Description: Work area looking toward segment 14 across Hop Brook, existing erosion control, looking eastward.

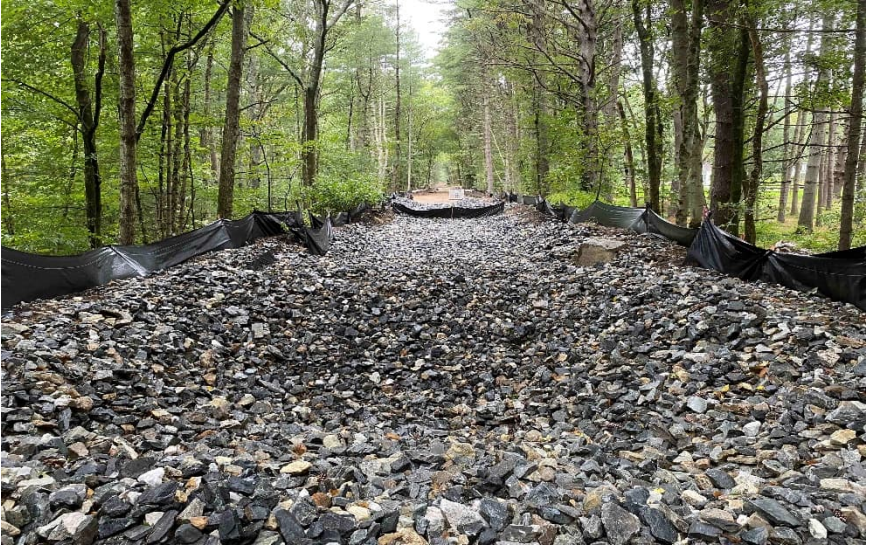
PHOTOGRAPHIC LOG	
Client Name: Eversource		Site Location: Sudbury to Hudson Transmission Reliability Project	Town: Sudbury
Photo No.: 5	Date: 9-25-23

Description: Work area within segment 9, temporary stabilization of work area, looking westward.

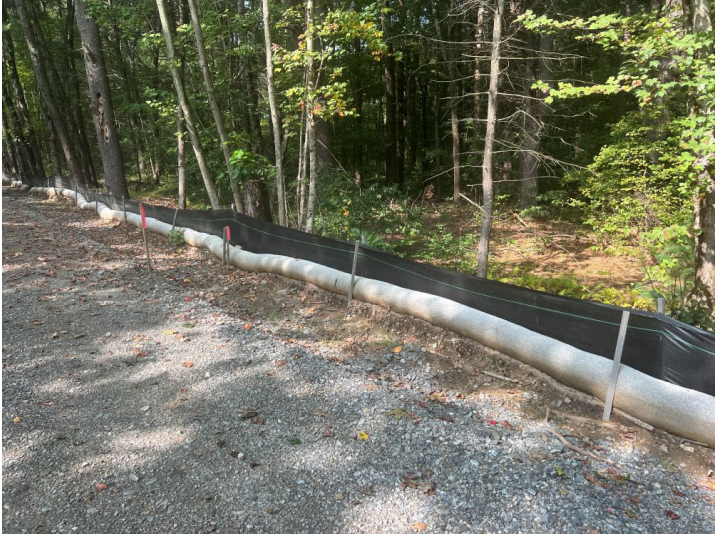
PHOTOGRAPHIC LOG	
Client Name: Eversource		Site Location: Sudbury to Hudson Transmission Reliability Project	Town: Hudson
Photo No.: 3	Date: 9/27/2023

Description: View silt fence and wattles in Segment 4. Controls are in good condition throughout Segments 1-4. Facing west.

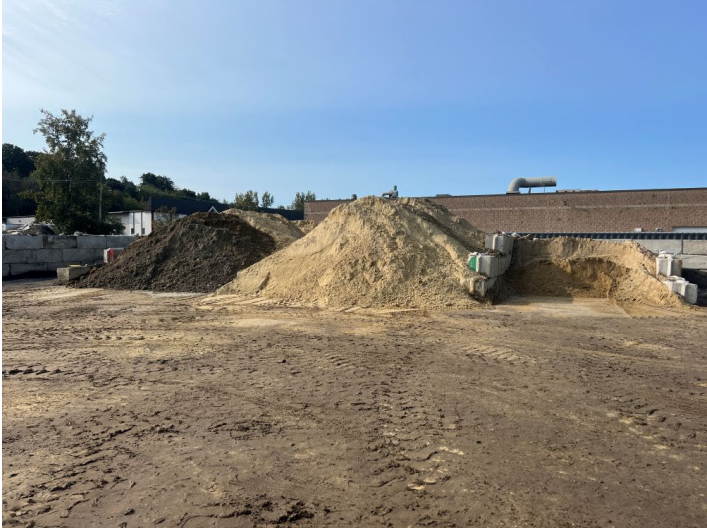
PHOTOGRAPHIC LOG	
Client Name: Eversource		Site Location: Sudbury to Hudson Transmission Reliability Project	Town: Hudson
Photo No.: 6	Date: 9/27/2023

Description: View of laydown yard on Bonazzoli Ave. Silt fence remains in good condition at the laydown yard. Facing south.

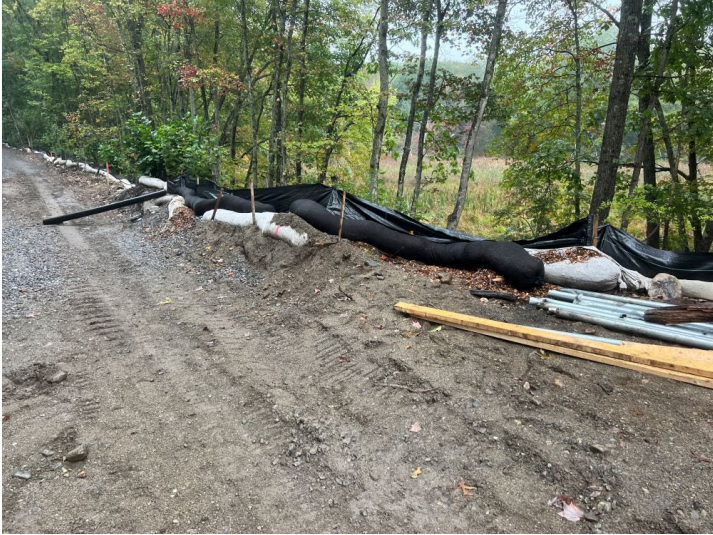
Description: View of silt fence and wattles in Segment 2. Additional wattles were added in this area. Controls are in good condition throughout Segments 1-4. Facing southwest.

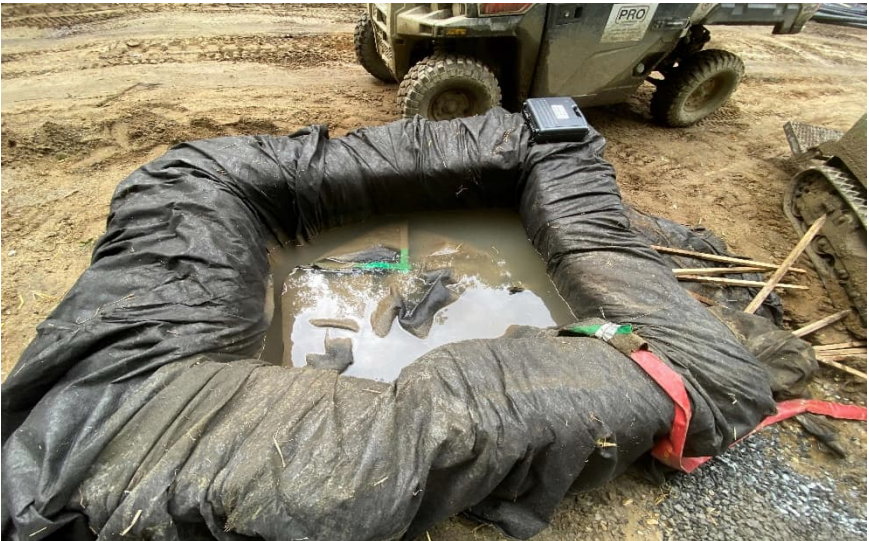
Description: Segment 6. View of discharge bag/bales, looking westward. Water discharge to bag intermittent and appeared to be slightly turbid.

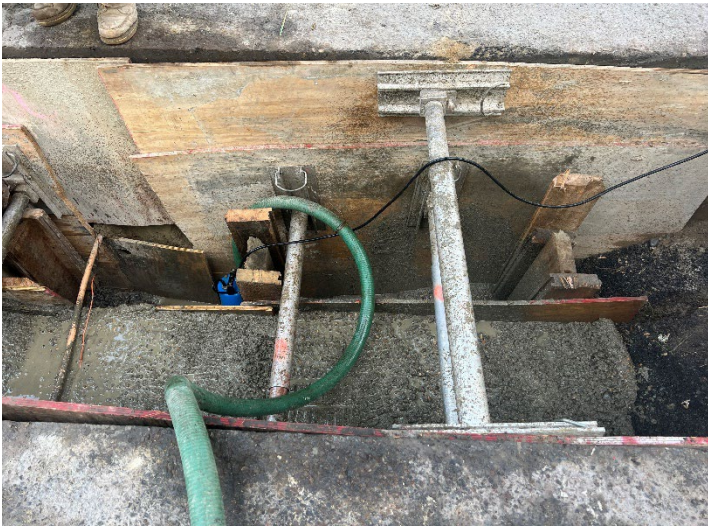
Description: View of pump in trench. Water appeared to be slightly turbid prior to treatment. Facing west.

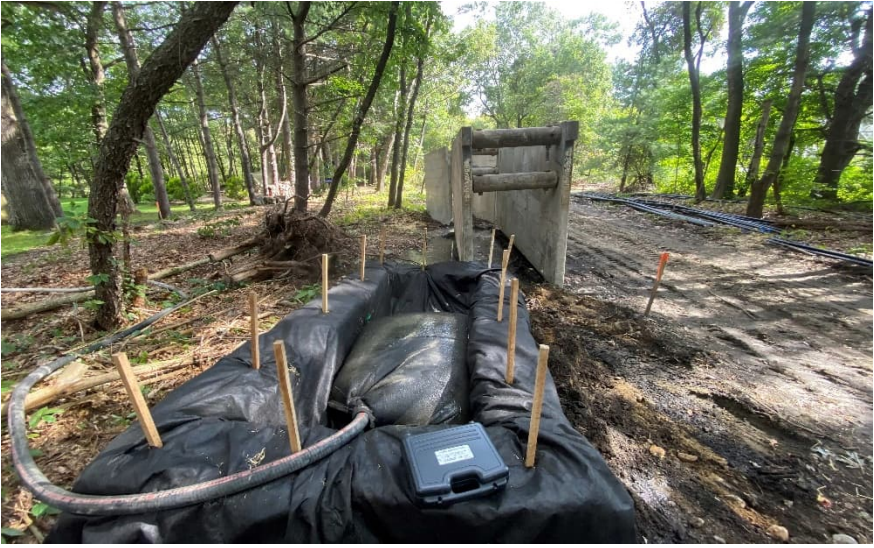
Description: Segment 11. View of discharge bag/bales, looking eastward. Water discharge to bag intermittent and appeared to be slightly turbid.
