Weekly Environmental Compliance Summary

Sudbury to Hudson Transmission Reliability Project (USEPA Tracking # MAR1003UW)

Week of: October 23, 2023 to October 27, 2023

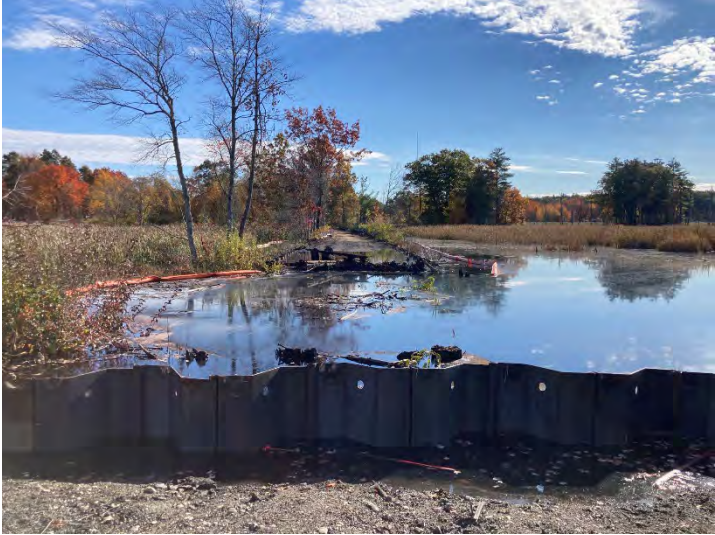
<p align="center">PHOTOGRAPHIC LOG</p>	
<p>Client Name: Eversource</p>		<p>Site Location: Sudbury to Hudson Transmission Reliability Project</p>	<p>Town: Hudson</p>
<p>Photo No.: 3</p>	<p>Date: 10/24/2023</p>

<p>Description: View of Bridge 130 from segment 2. Facing east.</p>

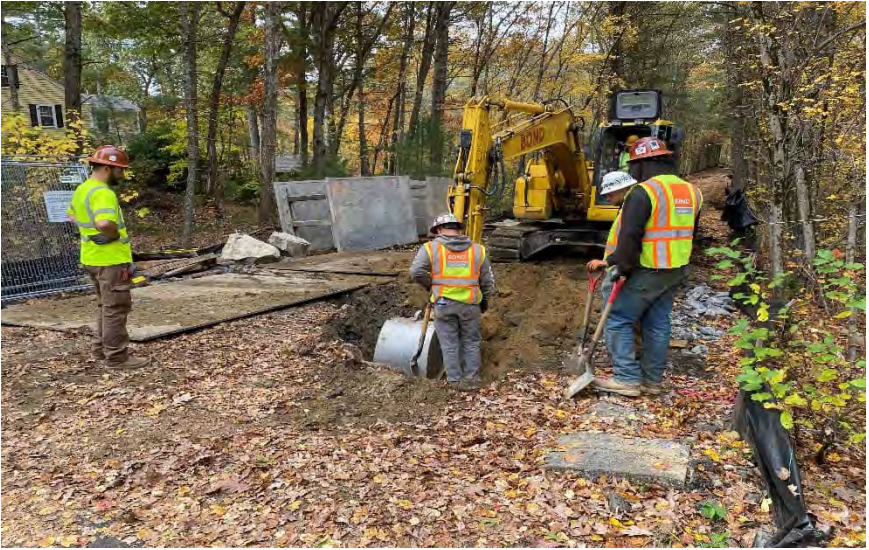
PHOTOGRAPHIC LOG	
Client Name: Eversource		Site Location: Sudbury to Hudson Transmission Reliability Project	Town: Sudbury
Photo No.: 1	Date: 10-24-23

Description: Conduit work area within segment 9, looking westward.

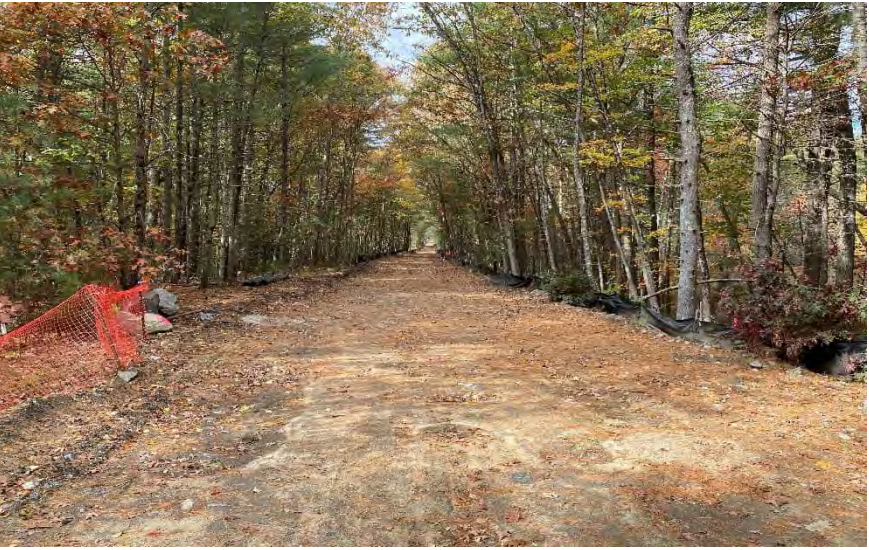
PHOTOGRAPHIC LOG	
Client Name: Eversource		Site Location: Sudbury to Hudson Transmission Reliability Project	Town: Sudbury
Photo No.: 2	Date: 10-24-23

Description: Work area within segment 8, existing erosion control, looking westward.

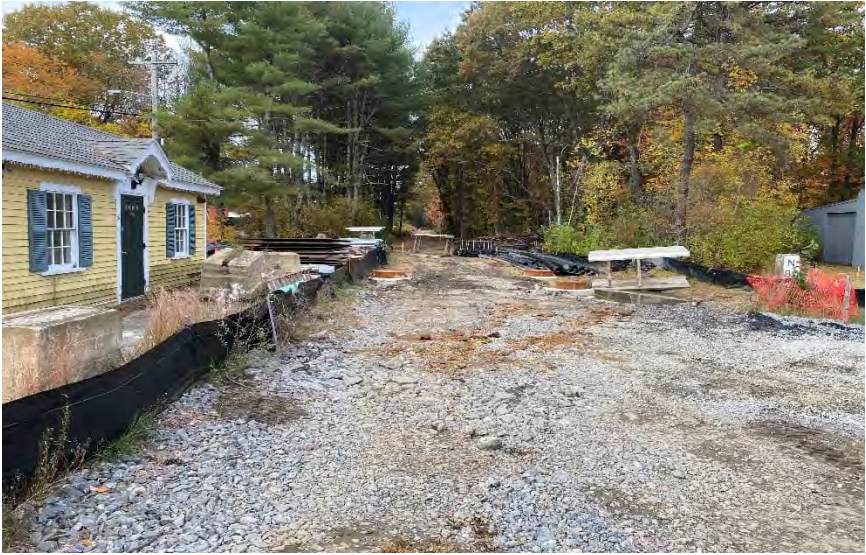
PHOTOGRAPHIC LOG	
Client Name: Eversource		Site Location: Sudbury to Hudson Transmission Reliability Project	Town: Sudbury
Photo No.: 3	Date: 10-24-23

Description: Work area within segment 11, existing erosion control, looking westward.

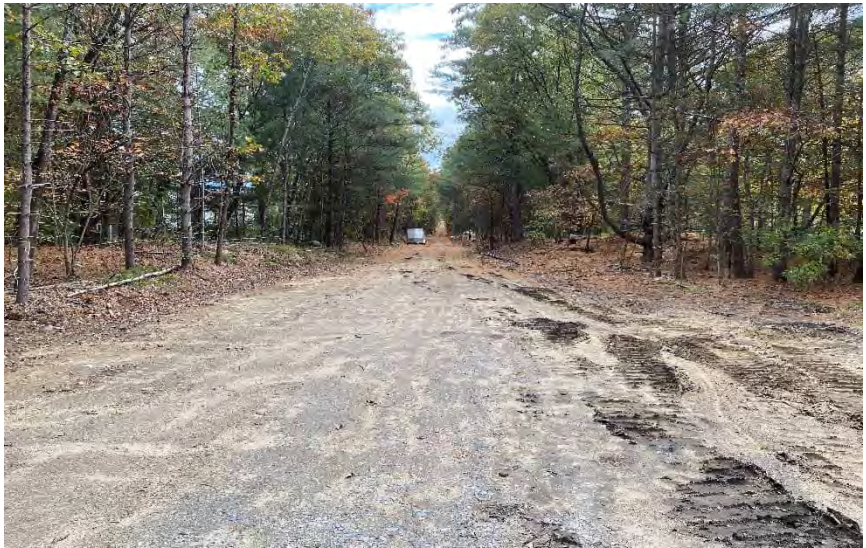
PHOTOGRAPHIC LOG	
Client Name: Eversource		Site Location: Sudbury to Hudson Transmission Reliability Project	Town: Sudbury
Photo No.: 4	Date: 10-24-23

Description: Work area within segment 9, looking eastward.

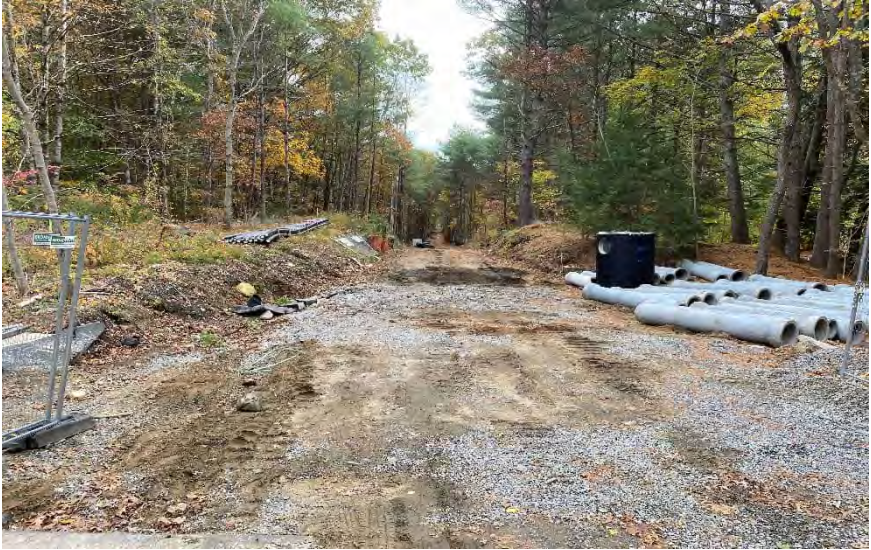
PHOTOGRAPHIC LOG	
Client Name: Eversource		Site Location: Sudbury to Hudson Transmission Reliability Project	Town: Sudbury
Photo No.: 5	Date: 10-24-23

Description: Work area within segment 10, looking eastward.

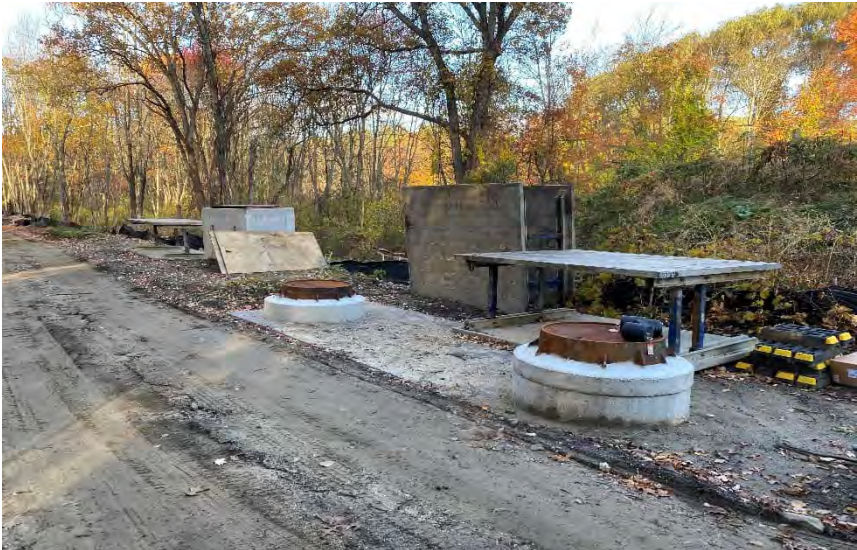
PHOTOGRAPHIC LOG	
Client Name: Eversource		Site Location: Sudbury to Hudson Transmission Reliability Project	Town: Sudbury
Photo No.: 6	Date: 10-24-23

Description: Work area within segment 14, Manhole #27, conduit work, looking westward.

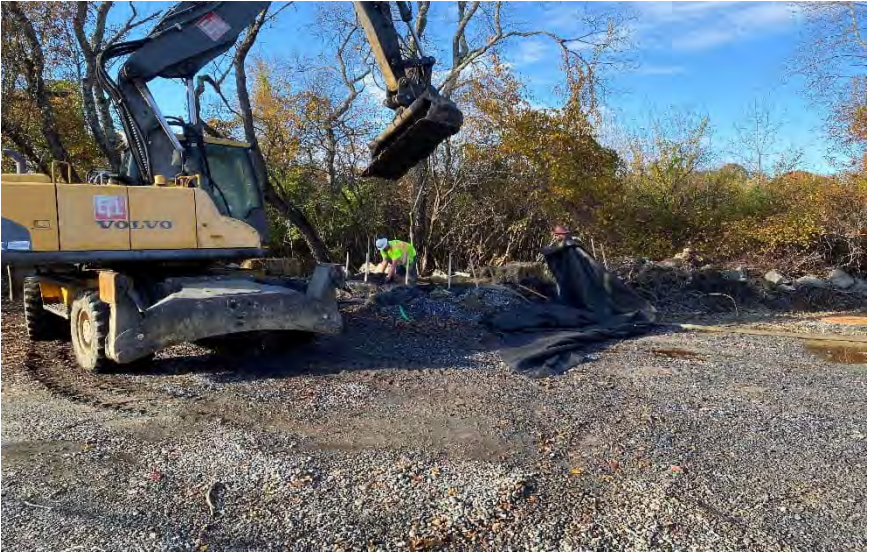
PHOTOGRAPHIC LOG	
Client Name: Eversource		Site Location: Sudbury to Hudson Transmission Reliability Project	Town: Sudbury
Photo No.: 7	Date: 10-24-23

Description: Work area near manhole #28, enhancement of dewatering setup, looking westward.

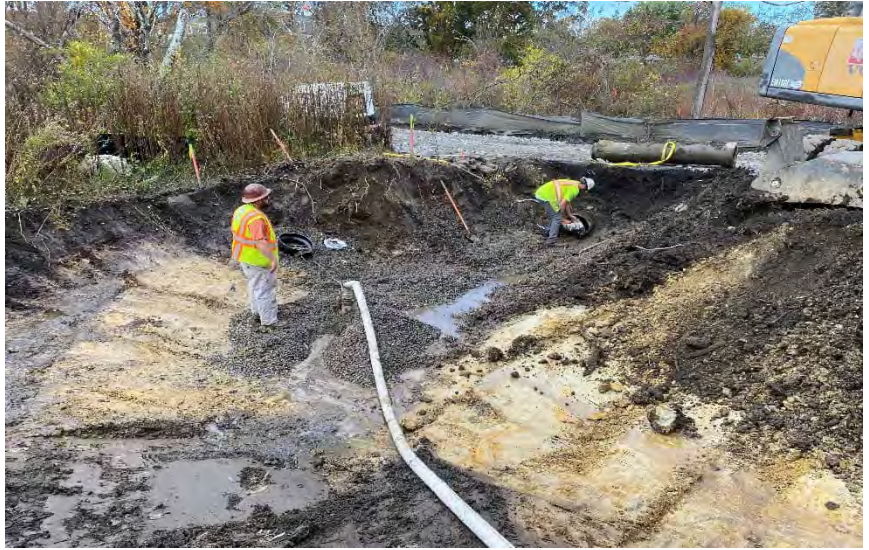
PHOTOGRAPHIC LOG	
Client Name: Eversource		Site Location: Sudbury to Hudson Transmission Reliability Project	Town: Sudbury
Photo No.: 8	Date: 10-24-23

Description: Work area within segment 14, wetland replication area, work on culvert extension, looking northward.

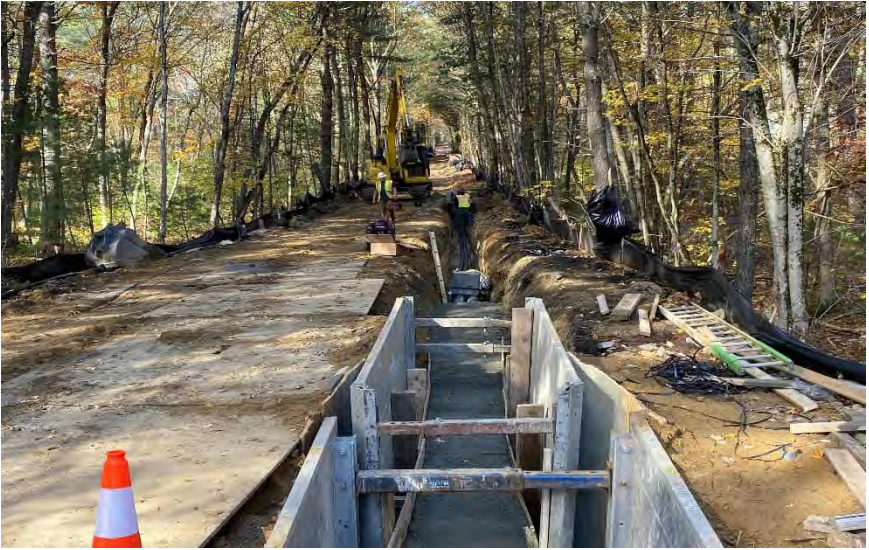
PHOTOGRAPHIC LOG	
Client Name: Eversource		Site Location: Sudbury to Hudson Transmission Reliability Project	Town: Sudbury
Photo No.: 1	Date: 10-25-23

Description: Conduit work area within segment 9, looking westward.

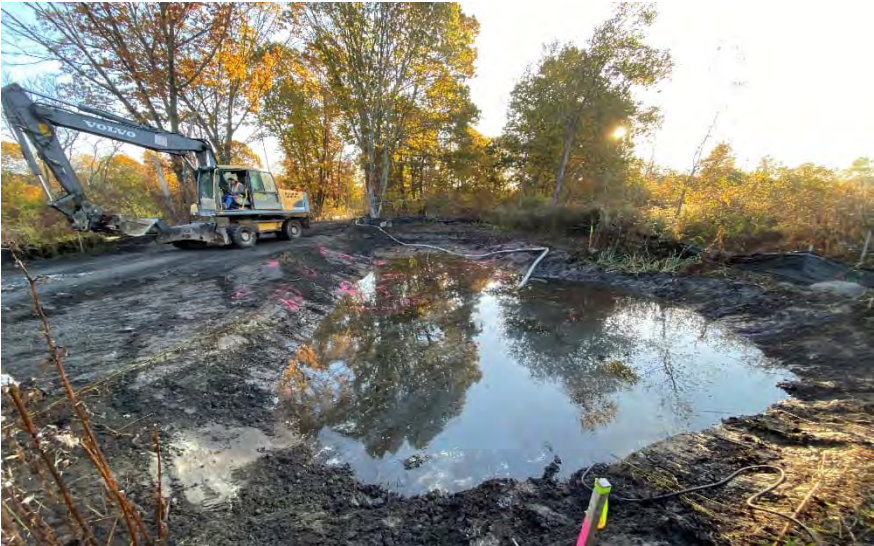
PHOTOGRAPHIC LOG	
Client Name: Eversource		Site Location: Sudbury to Hudson Transmission Reliability Project	Town: Sudbury
Photo No.: 2	Date: 10-25-23

Description: Work area within segment 14, wetland replication area, looking eastward.

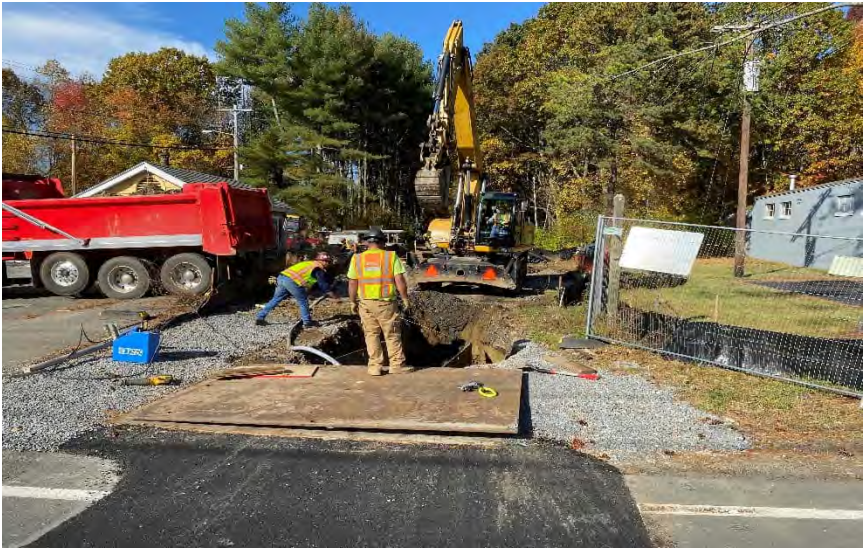
PHOTOGRAPHIC LOG	
Client Name: Eversource		Site Location: Sudbury to Hudson Transmission Reliability Project	Town: Sudbury
Photo No.: 3	Date: 10-25-23

Description: Conduit work within segment 11, existing erosion control, looking westward.

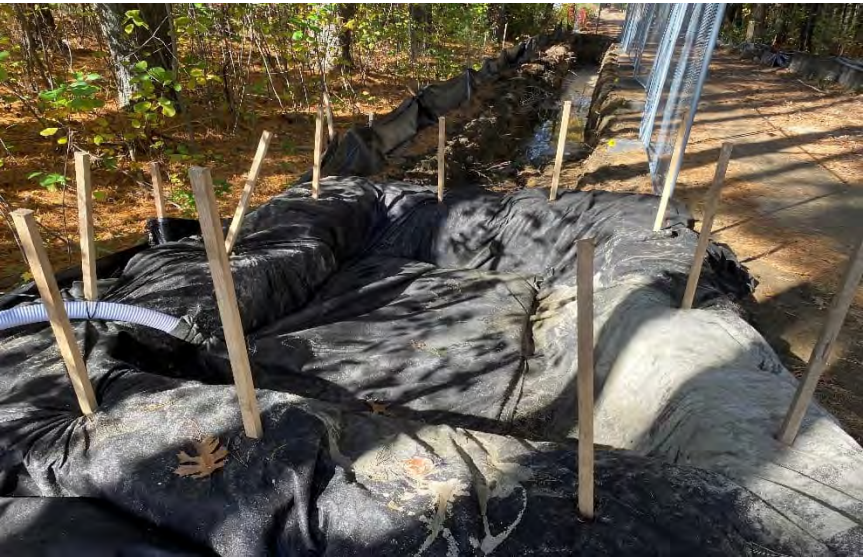
PHOTOGRAPHIC LOG	
Client Name: Eversource		Site Location: Sudbury to Hudson Transmission Reliability Project	Town: Sudbury
Photo No.: 4	Date: 10-25-23

Description: Work area within segment 11, dewatering setup, existing erosion control, looking westward.

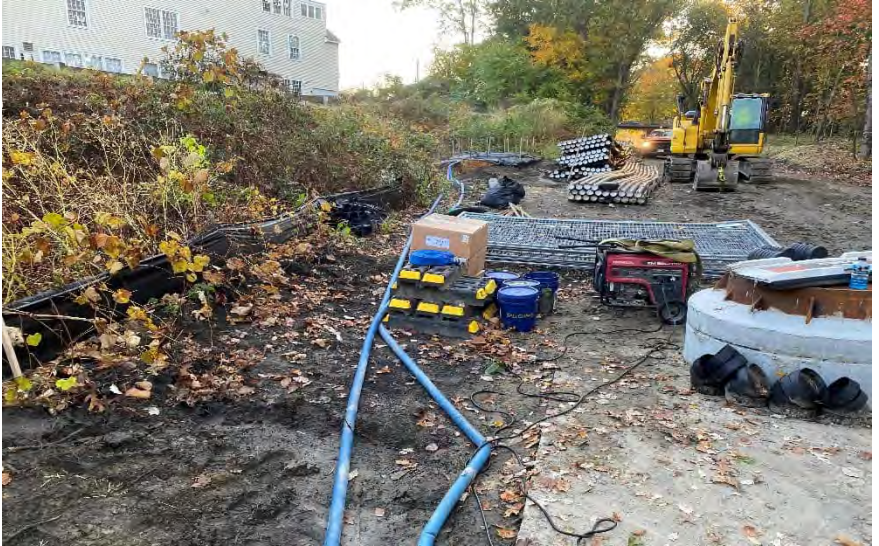
PHOTOGRAPHIC LOG	
Client Name: Eversource		Site Location: Sudbury to Hudson Transmission Reliability Project	Town: Sudbury
Photo No.: 5	Date: 10-25-23

Description: Work area within segment 14, conduit work, looking eastward.

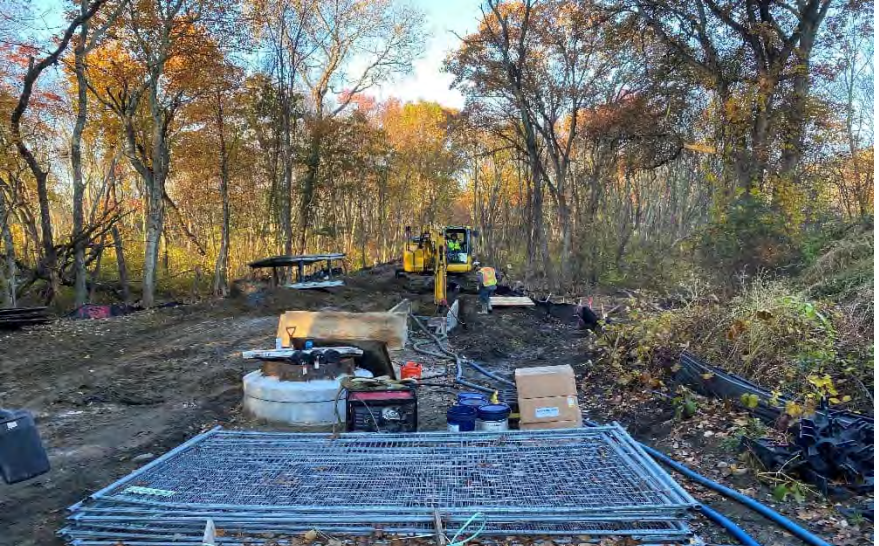
PHOTOGRAPHIC LOG	
Client Name: Eversource		Site Location: Sudbury to Hudson Transmission Reliability Project	Town: Sudbury
Photo No.: 6	Date: 10-25-23

Description: Work area within segment 14, conduit work, looking westward.

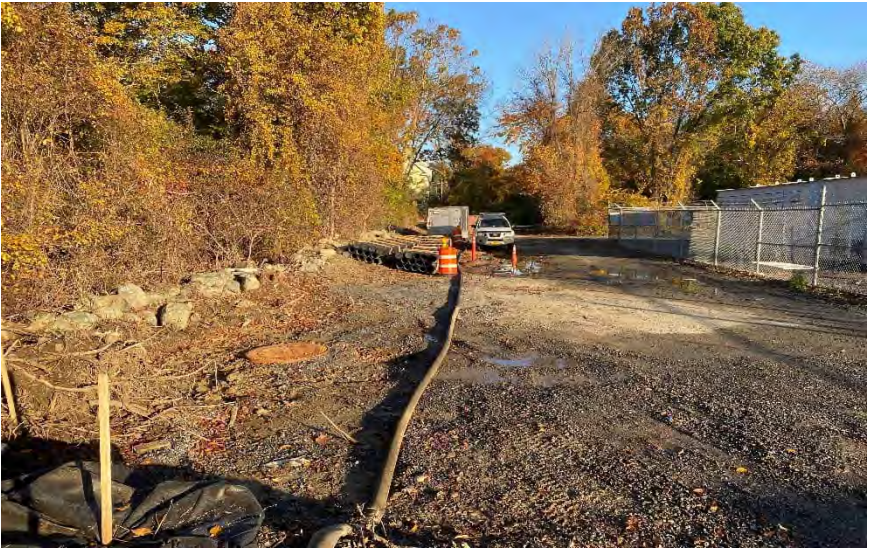
PHOTOGRAPHIC LOG	
Client Name: Eversource		Site Location: Sudbury to Hudson Transmission Reliability Project	Town: Sudbury
Photo No.: 7	Date: 10-25-23

Description: Work area near manhole #28, dewatering setup, looking northward.

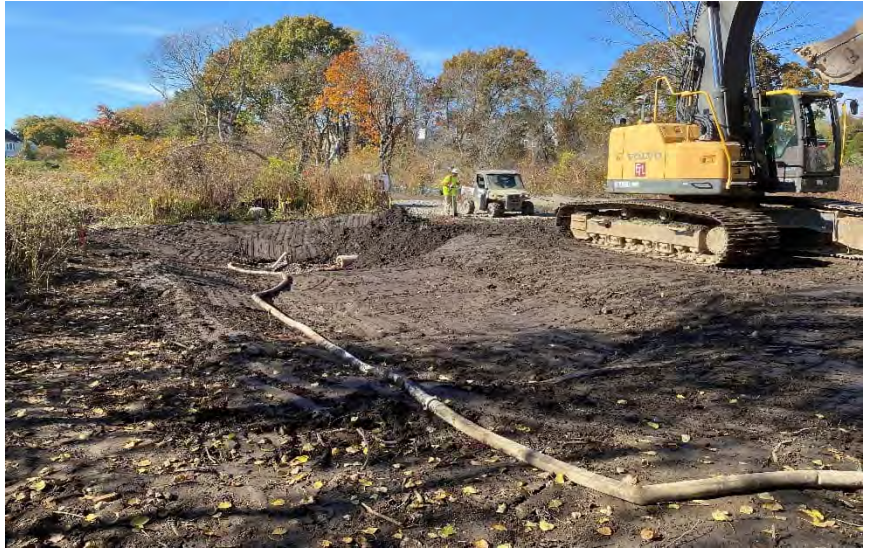
PHOTOGRAPHIC LOG	
Client Name: Eversource		Site Location: Sudbury to Hudson Transmission Reliability Project	Town: Sudbury
Photo No.: 8	Date: 10-25-23

Description: Work area within segment 14, wetland replication area, soil placement, looking westward.

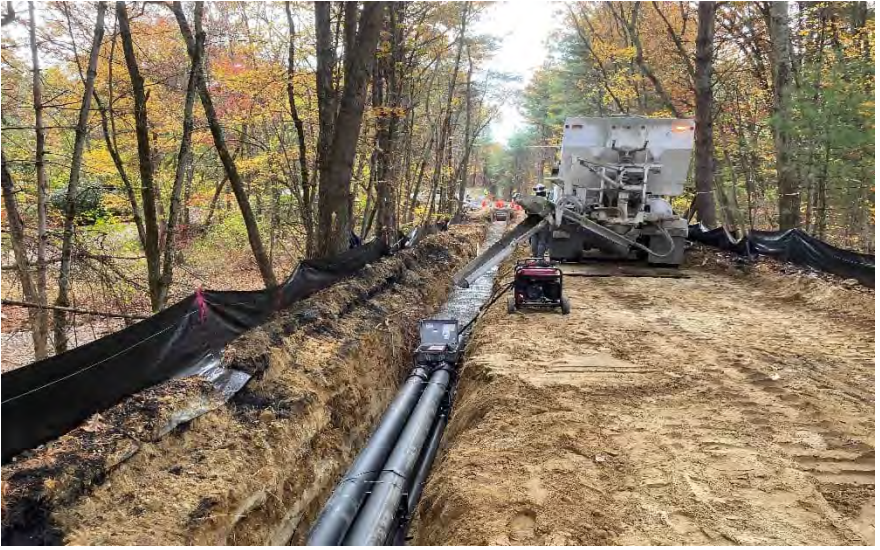
PHOTOGRAPHIC LOG	
Client Name: Eversource		Site Location: Sudbury to Hudson Transmission Reliability Project	Town: Sudbury
Photo No.: 1	Date: 10-26-23

Description: Conduit work area within segment 9, looking eastward.

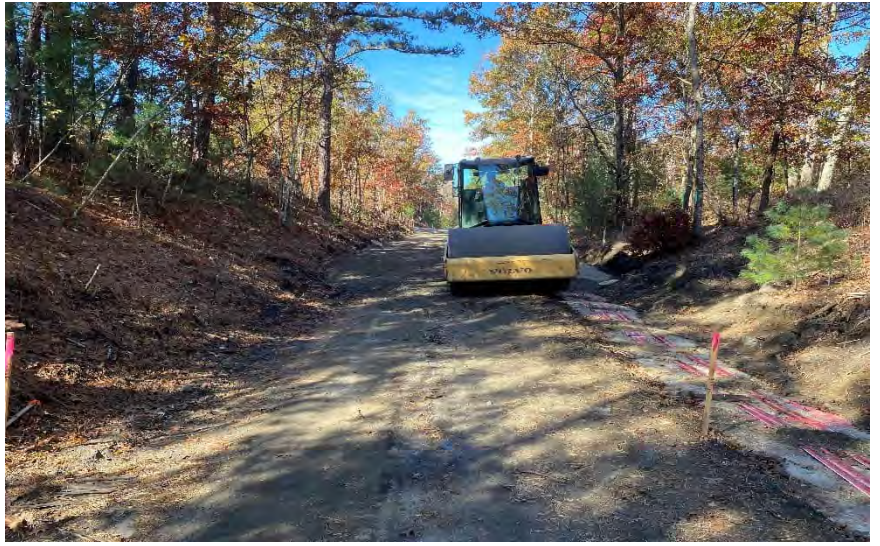
PHOTOGRAPHIC LOG	
Client Name: Eversource		Site Location: Sudbury to Hudson Transmission Reliability Project	Town: Sudbury
Photo No.: 2	Date: 10-26-23

Description: Grading within segment 7, black racer area, looking eastward.

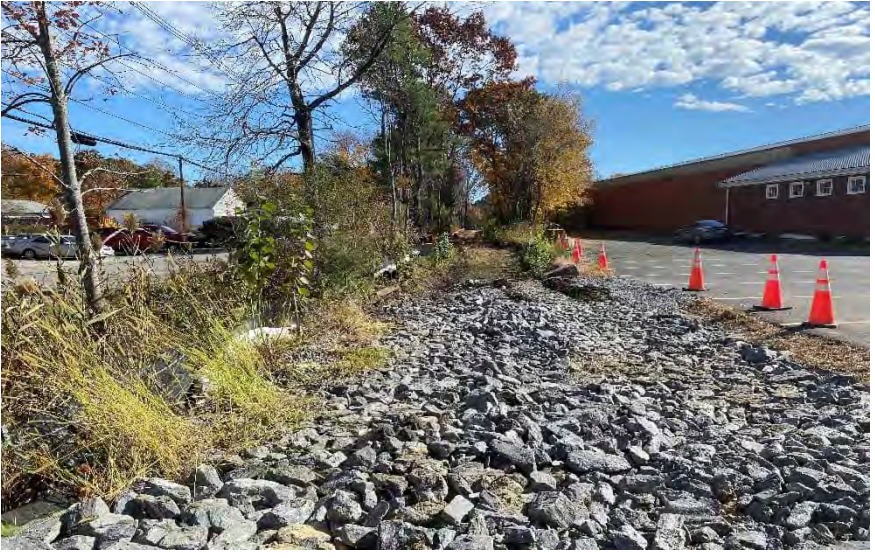
PHOTOGRAPHIC LOG	
Client Name: Eversource		Site Location: Sudbury to Hudson Transmission Reliability Project	Town: Sudbury
Photo No.: 3	Date: 10-26-23

Description: Work area within segment 12, existing erosion control, looking eastward.

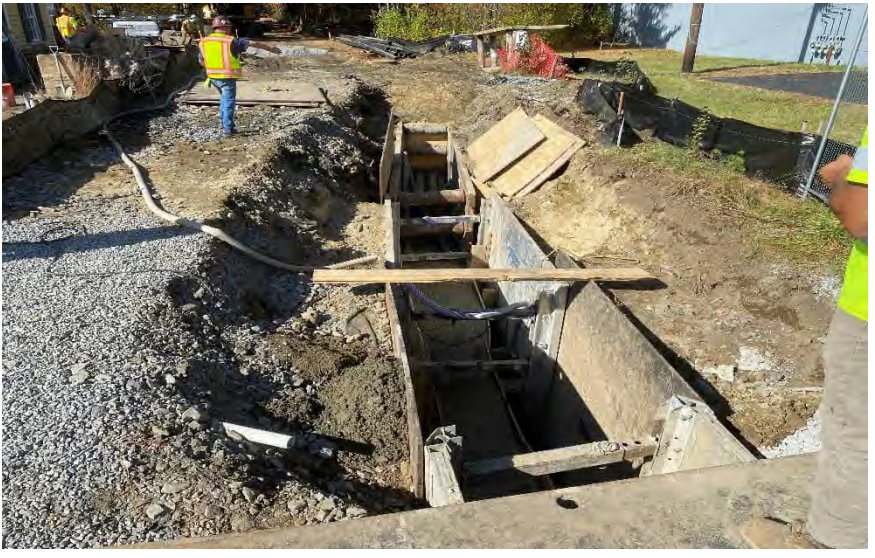
PHOTOGRAPHIC LOG	
Client Name: Eversource		Site Location: Sudbury to Hudson Transmission Reliability Project	Town: Sudbury
Photo No.: 4	Date: 10-26-23

Description: Work area within segment 11, conduit work, existing erosion control, looking westward.

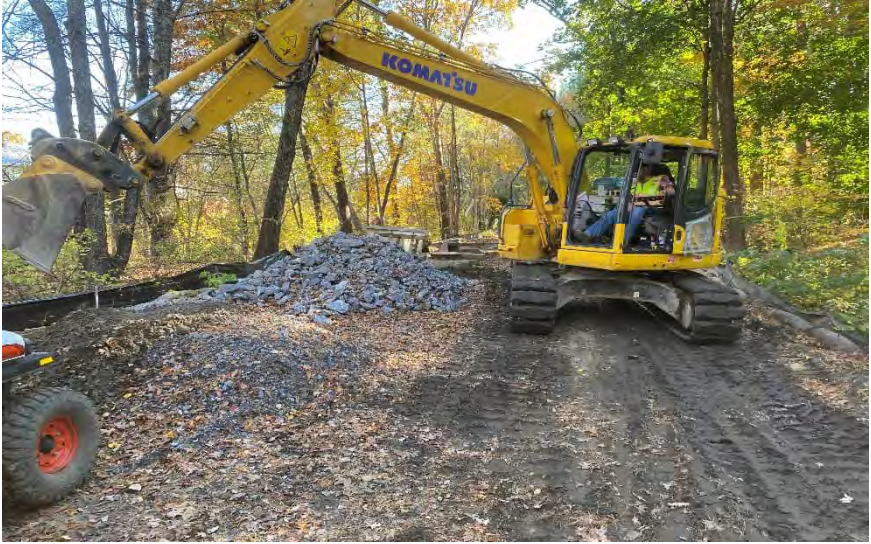
PHOTOGRAPHIC LOG	
Client Name: Eversource		Site Location: Sudbury to Hudson Transmission Reliability Project	Town: Sudbury
Photo No.: 5	Date: 10-26-23

Description: Work area within segment 13, conduit work, looking eastward.

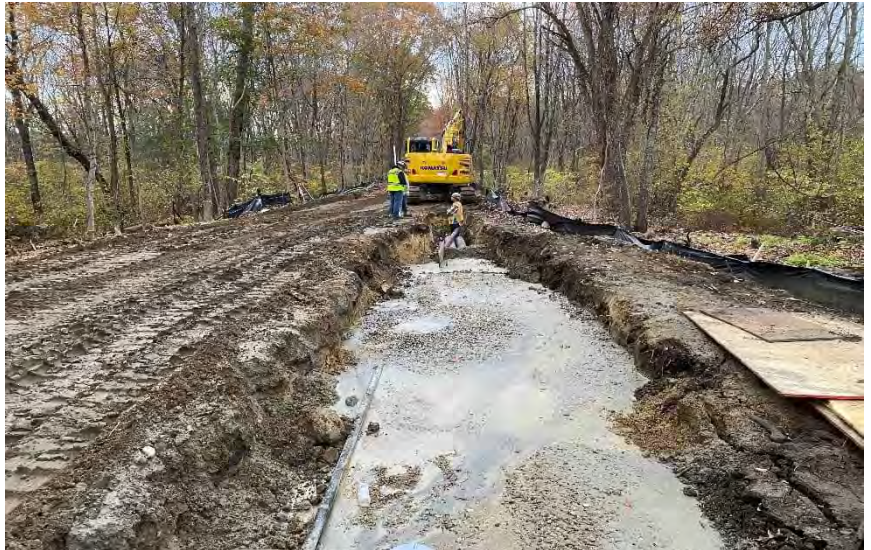
PHOTOGRAPHIC LOG	
Client Name: Eversource		Site Location: Sudbury to Hudson Transmission Reliability Project	Town: Sudbury
Photo No.: 6	Date: 10-26-23

Description: Work area within segment 14, conduit work, looking westward.

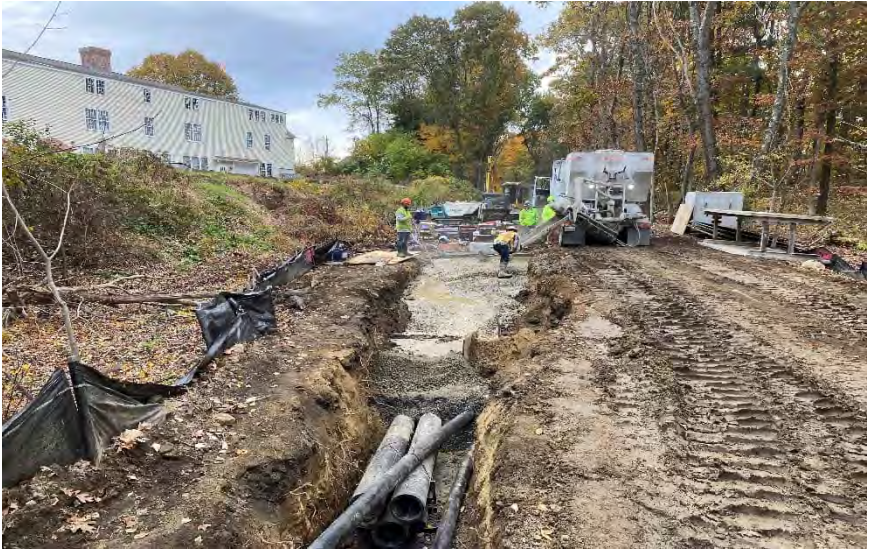
PHOTOGRAPHIC LOG	
Client Name: Eversource		Site Location: Sudbury to Hudson Transmission Reliability Project	Town: Sudbury
Photo No.: 7	Date: 10-26-23

Description: Work area within segment 14, conduit work, looking eastward.

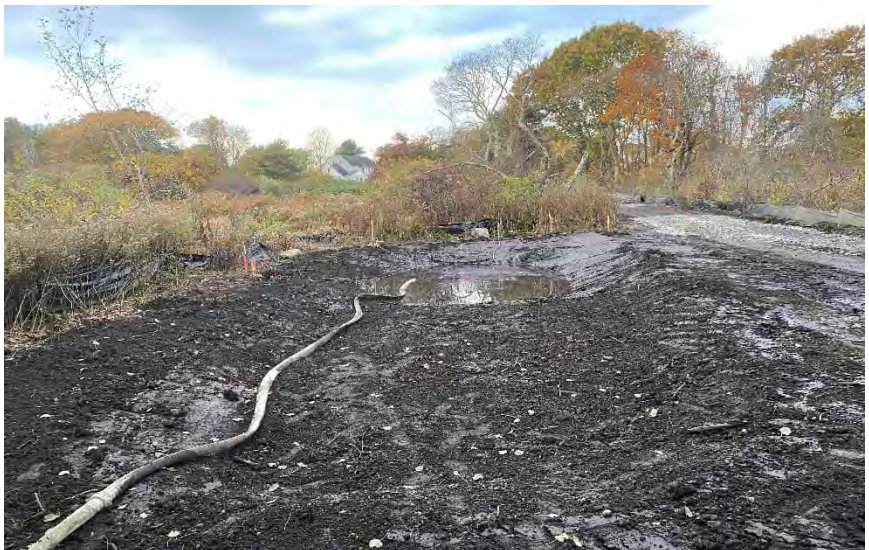
PHOTOGRAPHIC LOG	
Client Name: Eversource		Site Location: Sudbury to Hudson Transmission Reliability Project	Town: Sudbury
Photo No.: 8	Date: 10-26-23

Description: Work area within segment 14, wetland replication area, soil placement, looking westward.

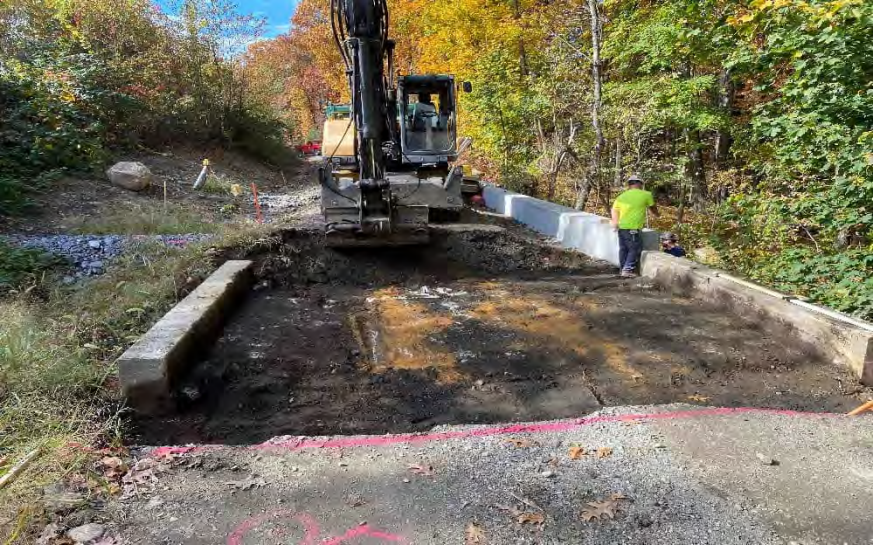
<p>PHOTOGRAPHIC LOG</p>	
<p>Client Name: Eversource</p>		<p>Site Location: Sudbury to Hudson Transmission Reliability Project</p>	<p>Town: Hudson</p>
<p>Photo No.: 2</p>	<p>Date: 10-27-23</p>

<p>Description:</p> <p>Work area within Segment 1, ET&L conducting site work, looking westward.</p>

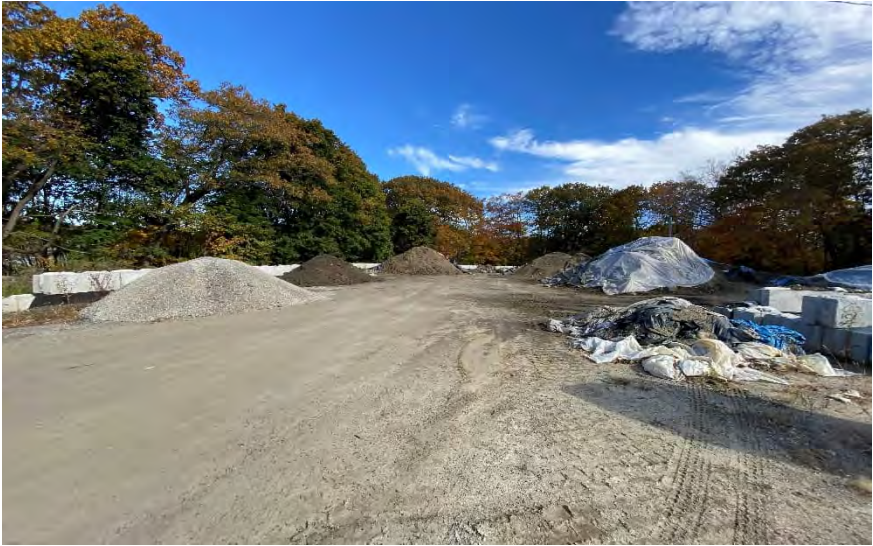
<p>PHOTOGRAPHIC LOG</p>	
<p>Client Name: Eversource</p>		<p>Site Location: Sudbury to Hudson Transmission Reliability Project</p>	<p>Town: Hudson</p>
<p>Photo No.: 3</p>	<p>Date: 10-27-23</p>

<p>Description:</p> <p>Laydown yard at Stowe Court, looking southward.</p>

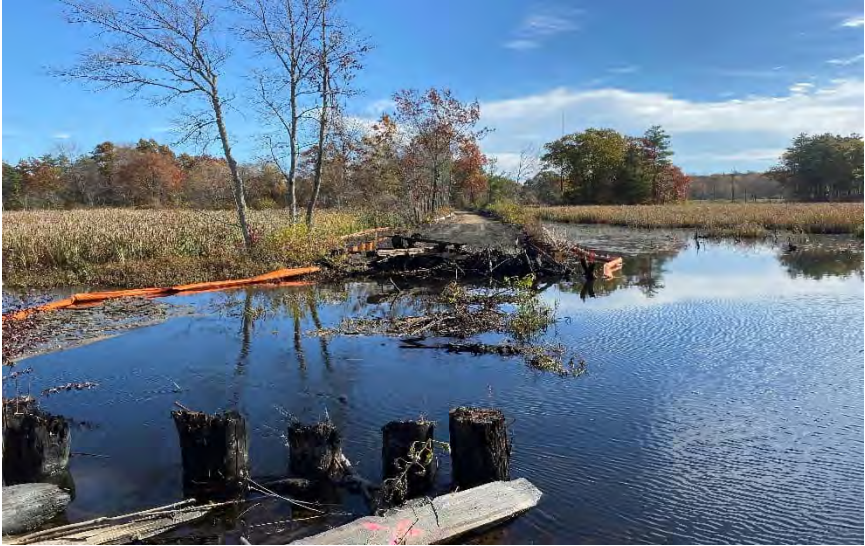
<p>PHOTOGRAPHIC LOG</p>	
<p>Client Name: Eversource</p>		<p>Site Location: Sudbury to Hudson Transmission Reliability Project</p>	<p>Town: Hudson</p>
<p>Photo No.: 4</p>	<p>Date: 10-27-23</p>

<p>Description:</p> <p>Work area over Fort Meadow Brook, Bridge 130, Segment 2 -> Segment 3, looking eastward.</p>

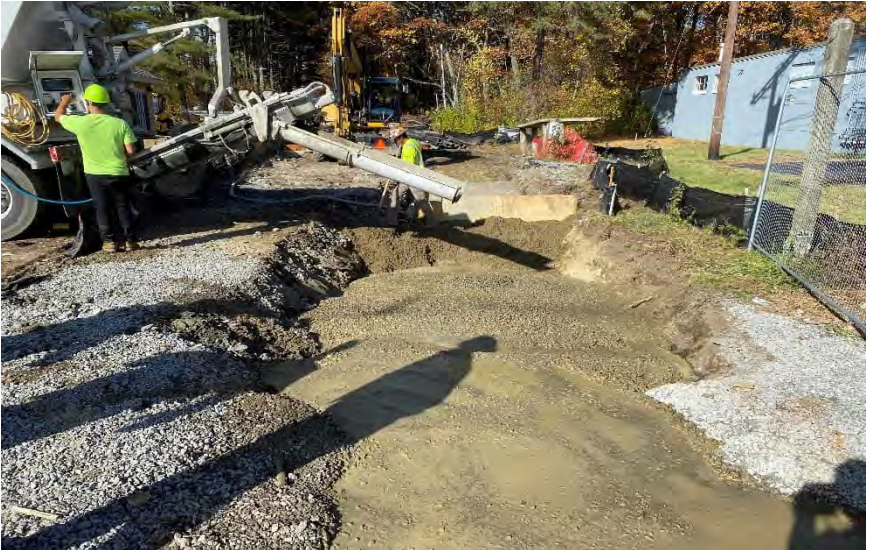
<p>PHOTOGRAPHIC LOG</p>	
<p>Client Name: Eversource</p>		<p>Site Location: Sudbury to Hudson Transmission Reliability Project</p>	<p>Town: Sudbury</p>
<p>Photo No.: 5</p>	<p>Date: 10-27-23</p>

<p>Description:</p> <p>Work area within segment 11, conduit work, existing erosion control, looking westward.</p>

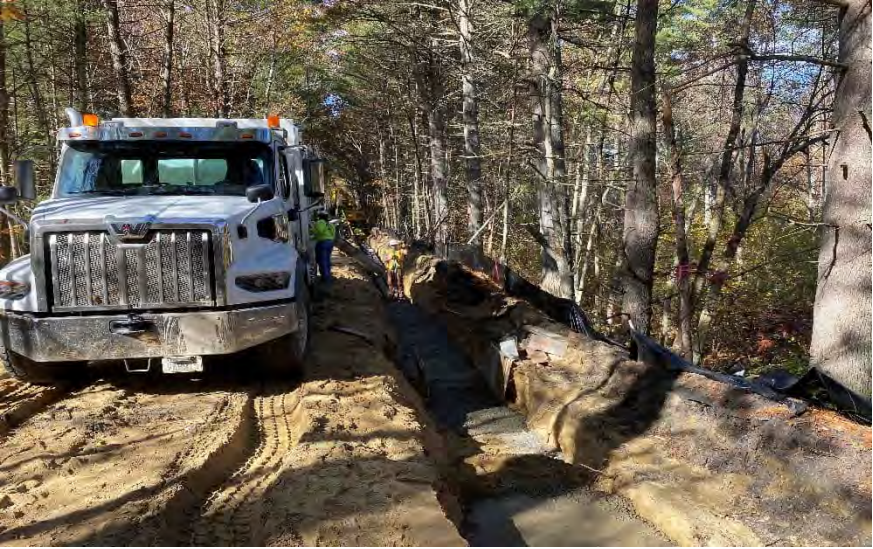
<p>Description:</p> <p>Work area within Segment 9, conduit work – placement of flowable fill, existing erosion control, looking westward.</p>

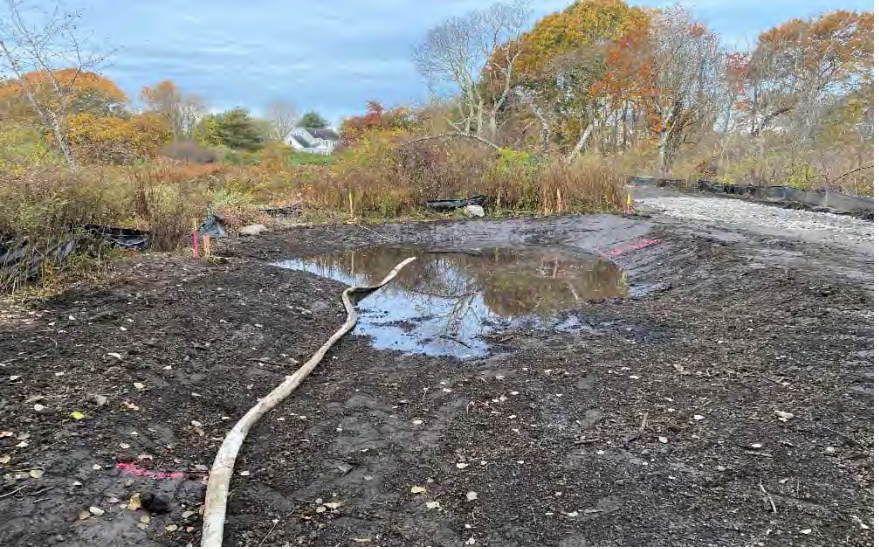
<p>Description:</p> <p>Work area within segment 14, wetland replication area, existing erosion control, looking westward.</p>

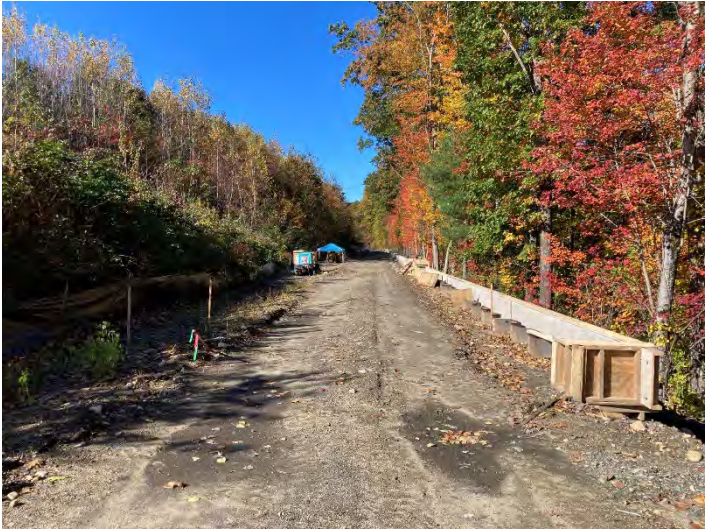
Description: View of walls 1 and 2 in segment 1. No work was observed today. Facing west.

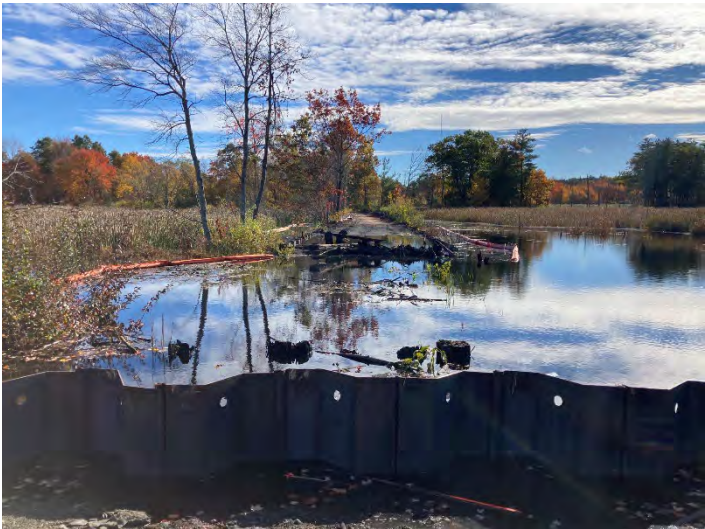
Description: View of bridge 130 from segment 2. No active work at time of inspection. High water level noted following storm event. Facing east.

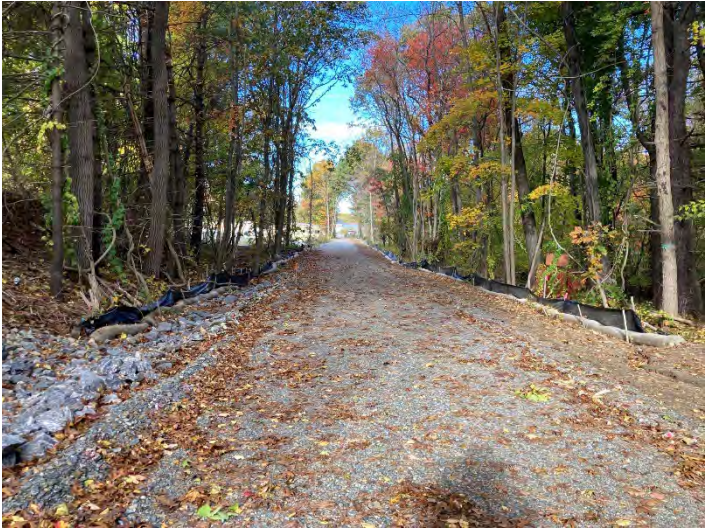
Description: View of east end of segment 3. Facing west.

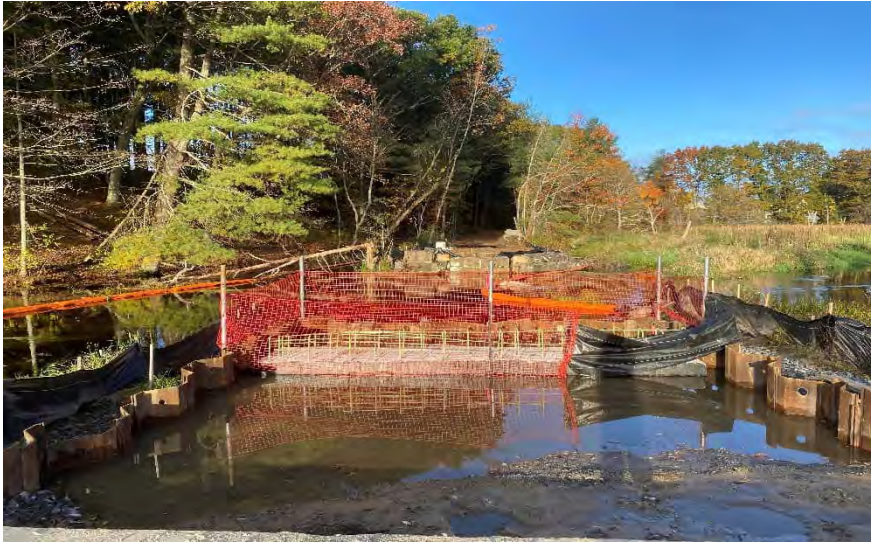
Description: Work area from segment 14 -> segment 13 (bridge 127 area), looking westward.

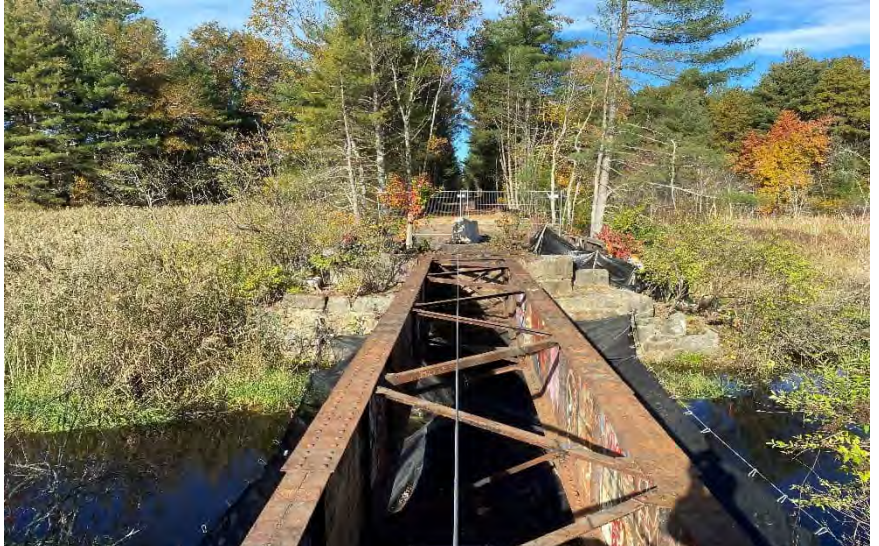
Description: Work area from segment 8 -> segment 7 (bridge 128 area), looking westward.

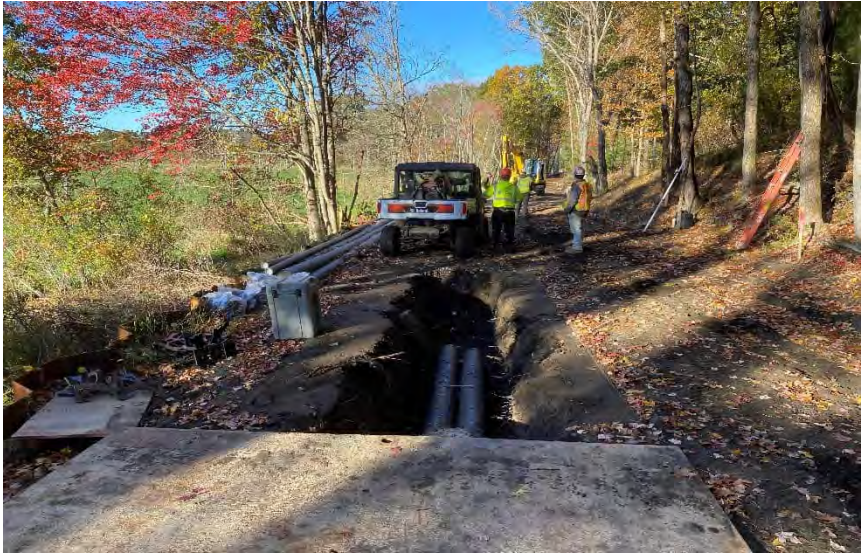
Description: Work area within segment 14, conduit work, looking westward.

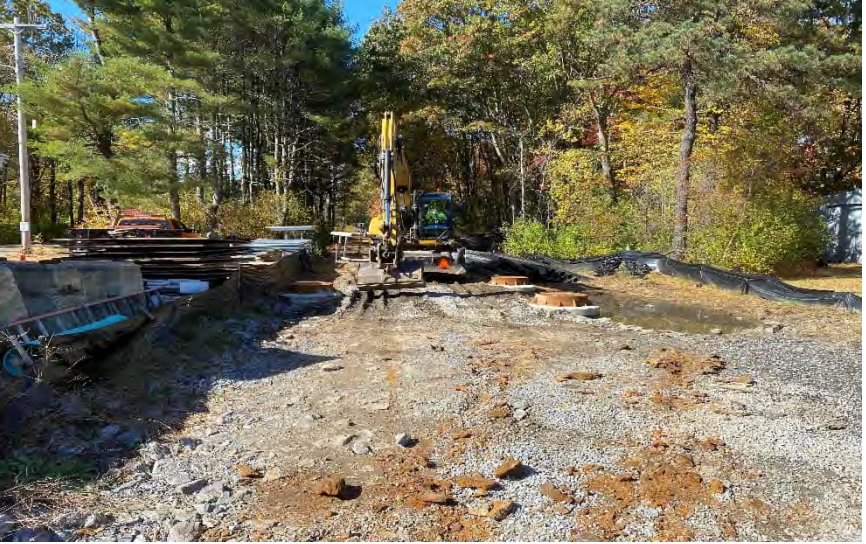
Description: Bond conducting conduit work within segment 11, looking westward.

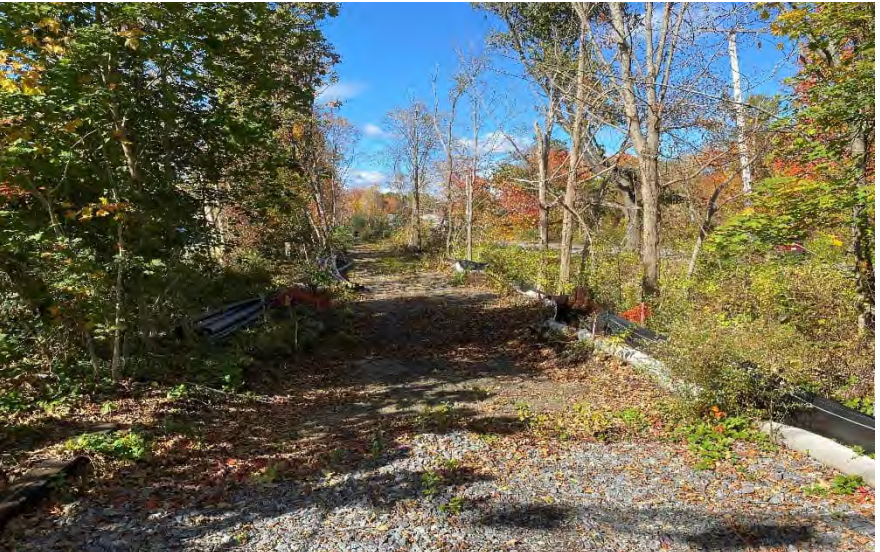
Description: Work area within segment 12, looking westward.

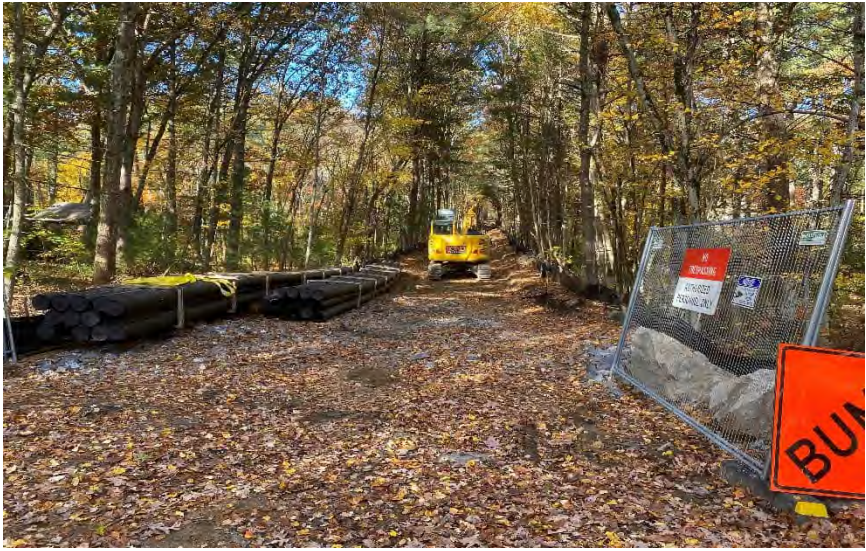
Description: Work area within segment 9, existing erosion control, looking westward.

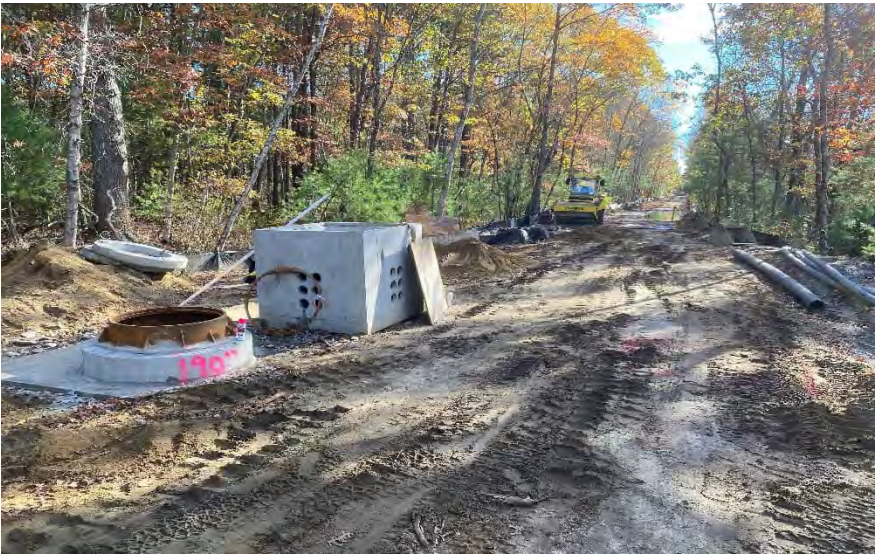
Description: Conduit work within segment 6, placement of handhole, looking eastward.

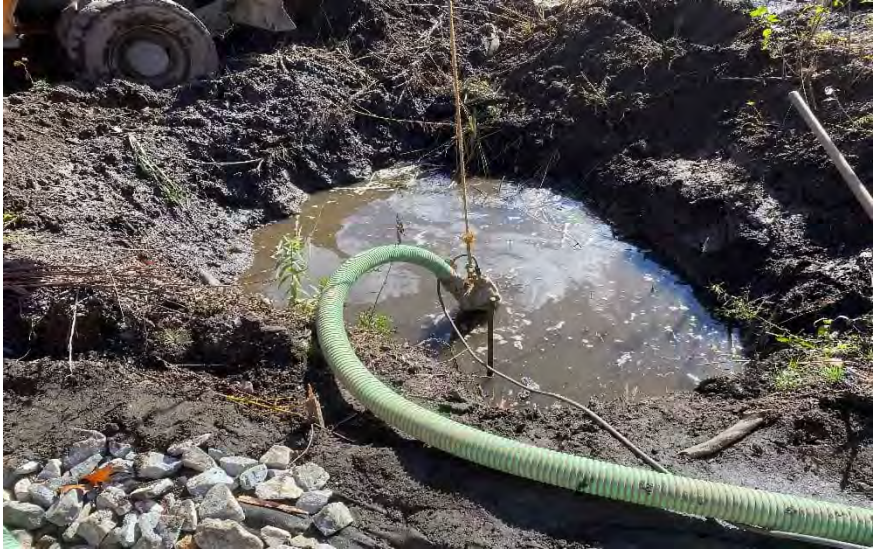
Description: View of area being pumped from Wetland Replication area within segment 14, looking eastward.

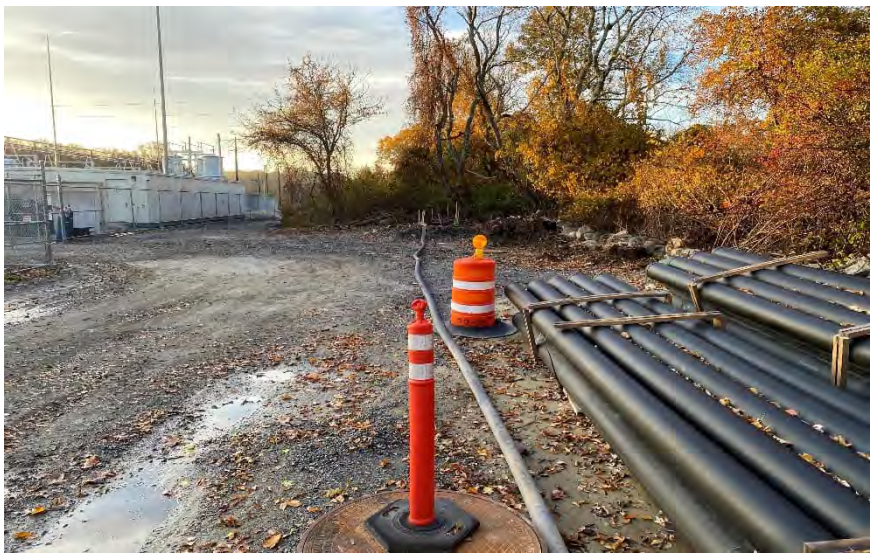
Description: Segment 14. View of dewatering operation. Looking southward.

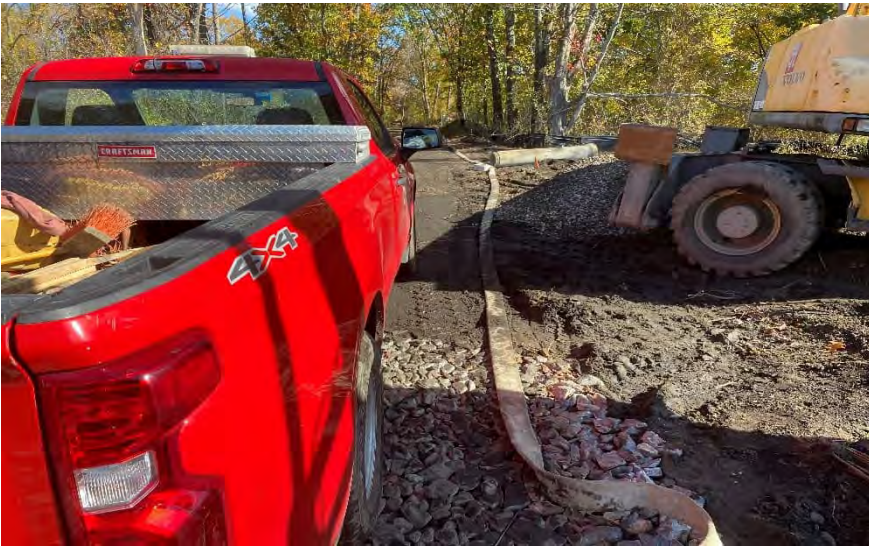
Description: Segment 14. View of dewatering operation, looking eastward.
