Weekly Environmental Compliance Summary

Sudbury to Hudson Transmission Reliability Project (USEPA Tracking # MAR1003UW)

Week of: October 23, 2023 to October 27, 2023

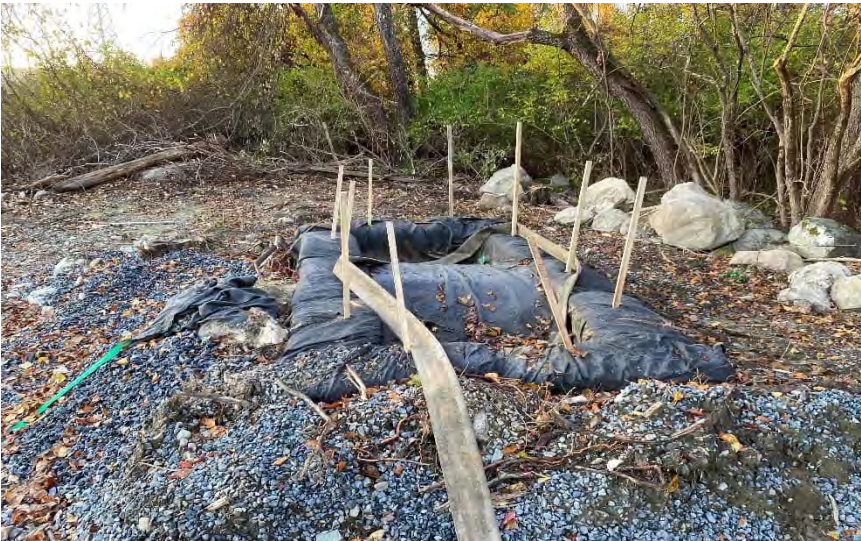
Description: Segment 14. View of discharge bag/bales, looking south. Water discharge to bag intermittent and appeared to be slightly turbid.

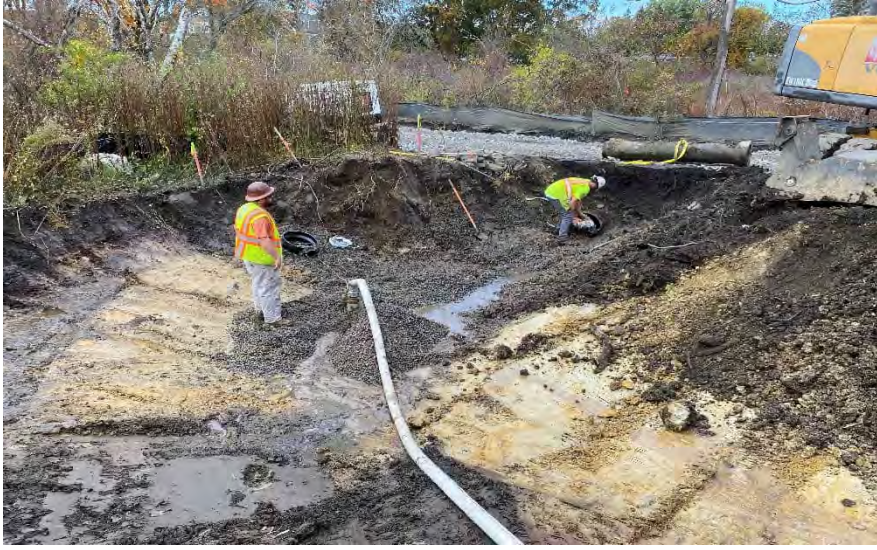
Description: View of area being pumped from Wetland Replication area within segment 14, looking northward.

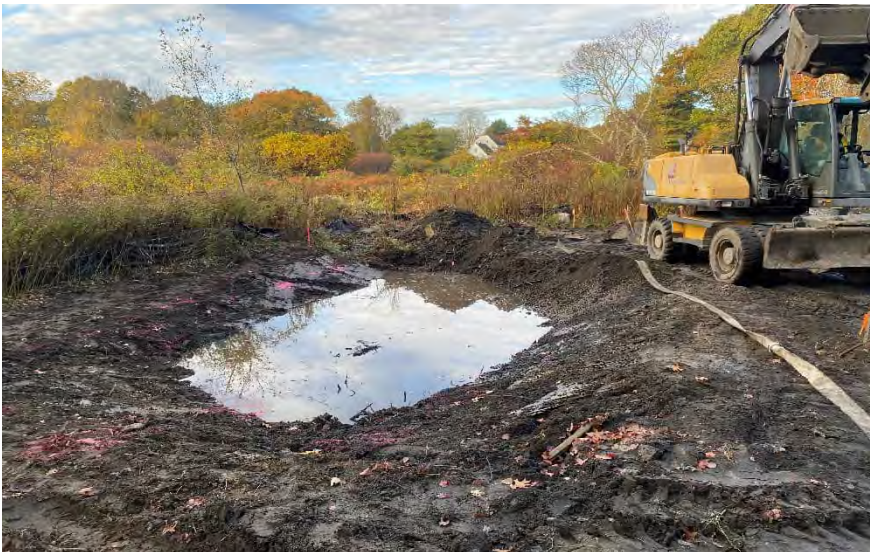
Description: Segment 14. View of dewatering operation. Looking westward.

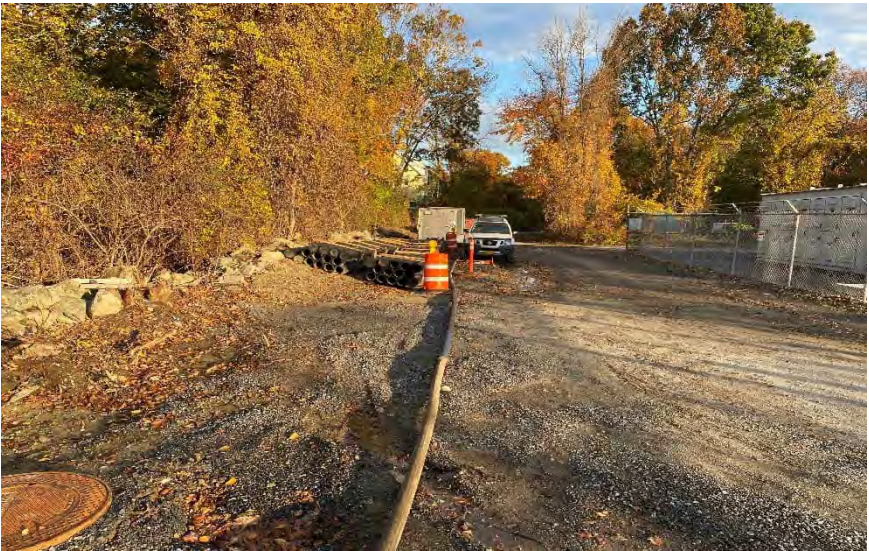
Description: Segment 14. View of dewatering operation, looking northward.

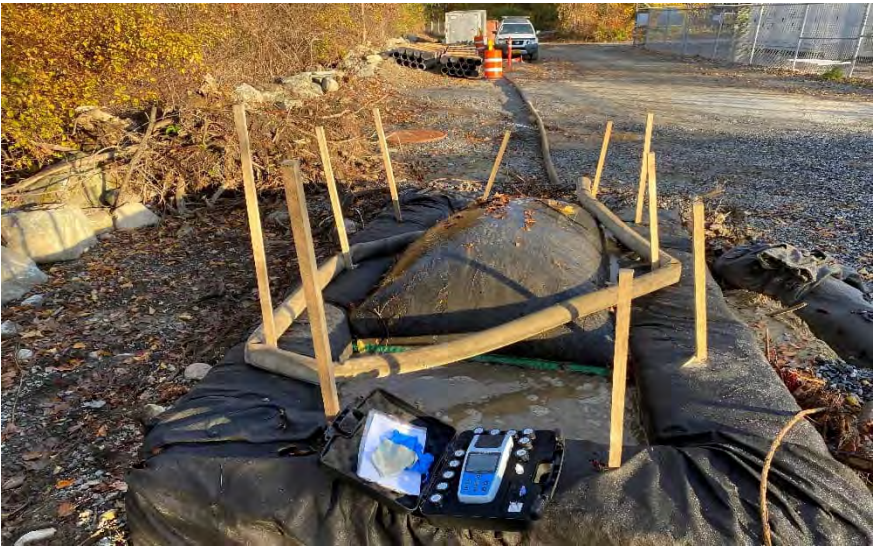
Description: Segment 14. View of discharge bag/bales, looking north. Water discharge to bag intermittent and appeared to be slightly turbid.

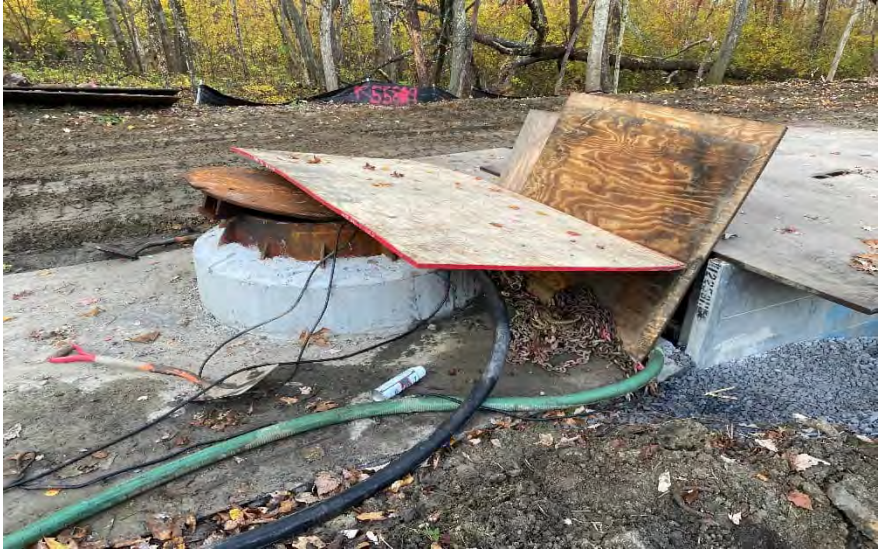
Description: View of area being pumped from manhole #27 within segment 14.

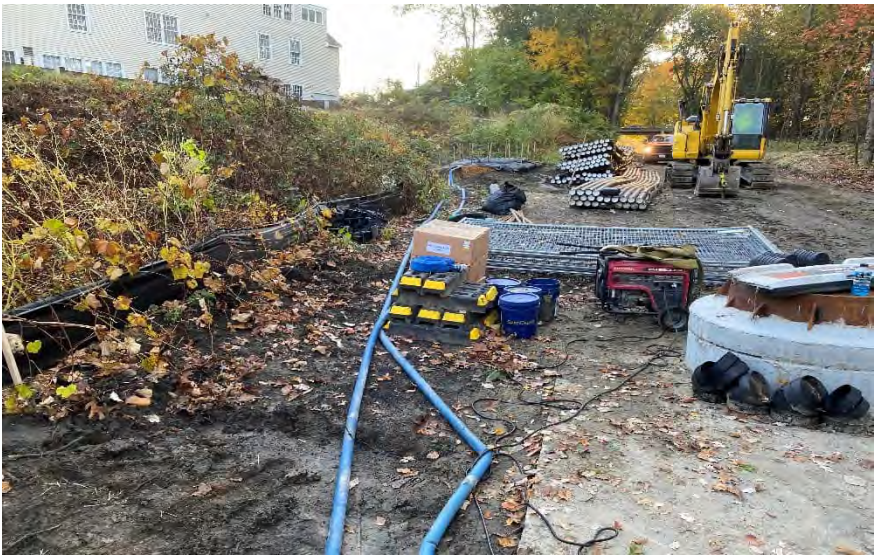
Description: Segment 14. View of dewatering operation. Looking eastward.

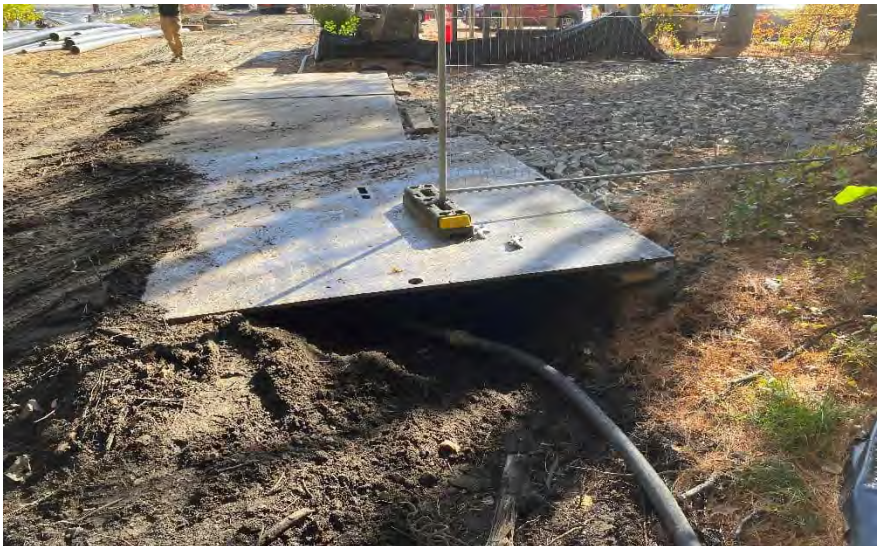
Description: View of area being pumped from manhole #24 within segment 11, looking eastward.

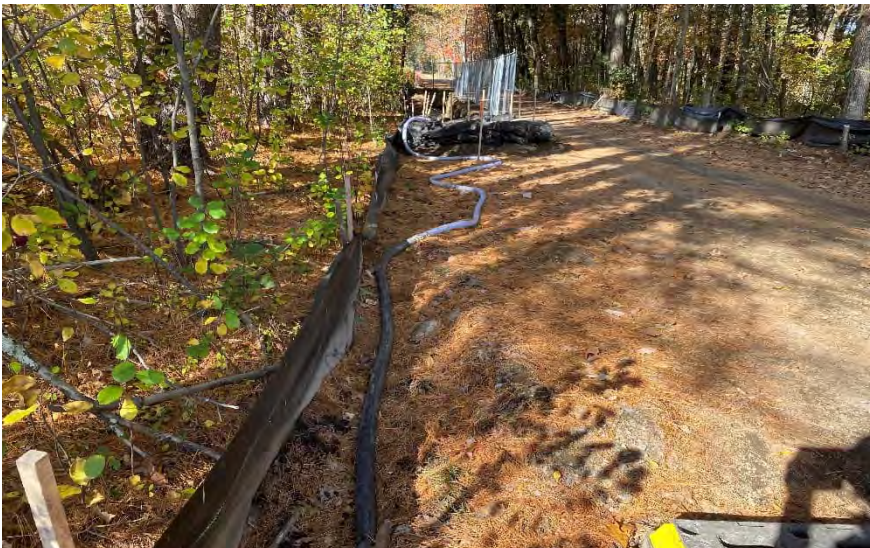
Description: Segment 11. View of dewatering operation. Looking westward.

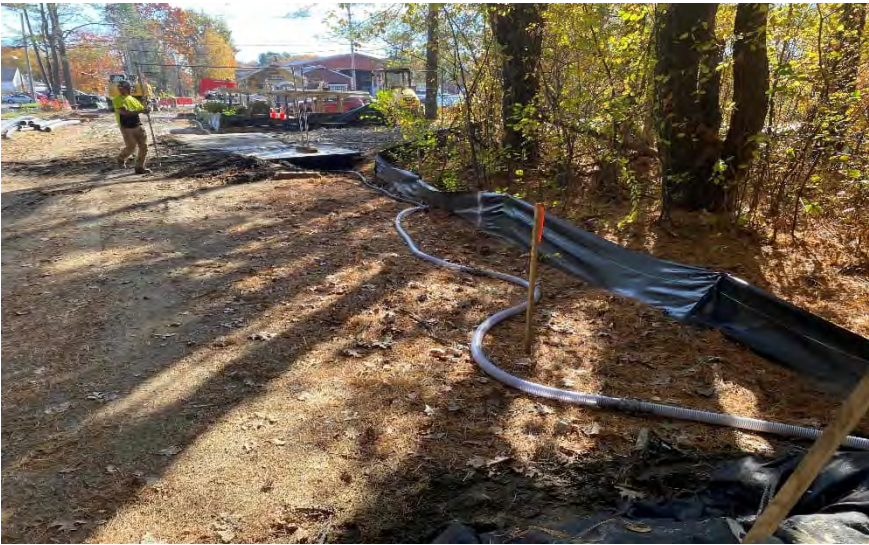
Description: Segment 11. View of dewatering operation, looking eastward.

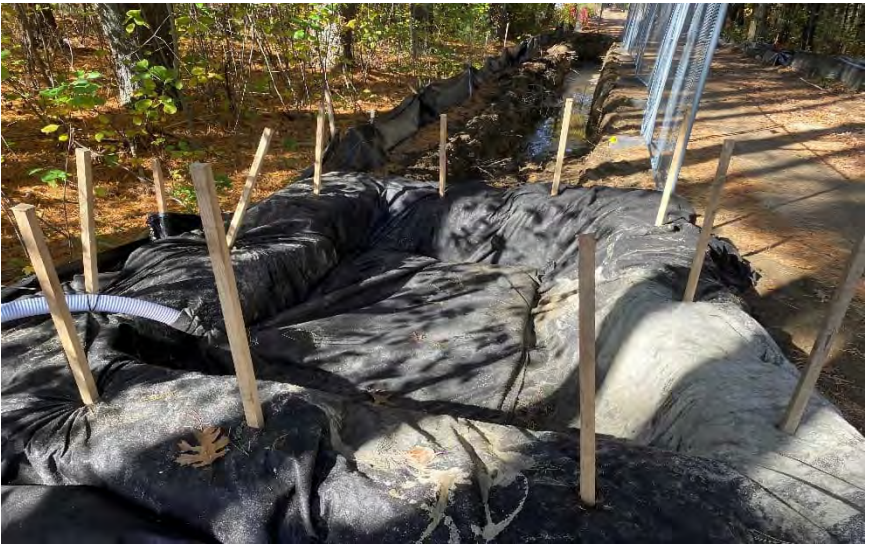
Description: Segment 11. View of discharge bag/bales, looking westward. Water discharge to bag intermittent and appeared to be slightly turbid.

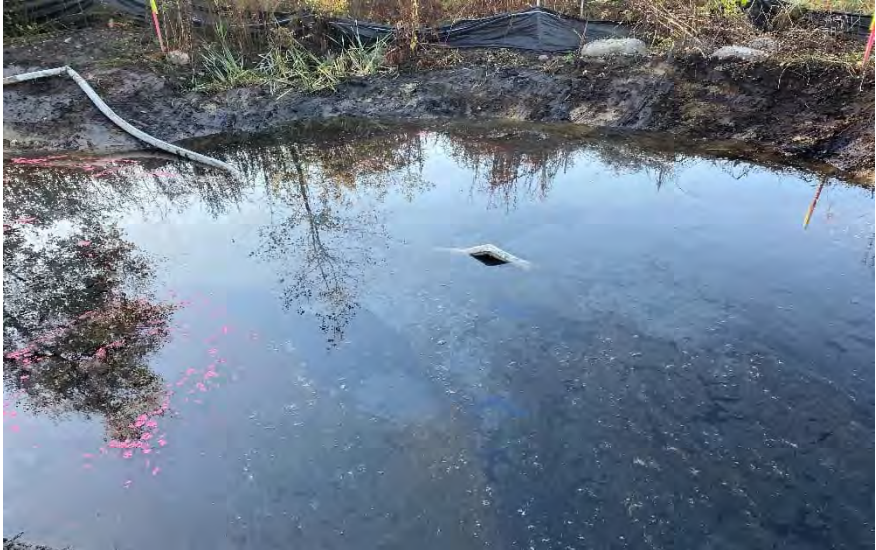
Description: View of area being pumped from Wetland Replication area within segment 14, looking southward.

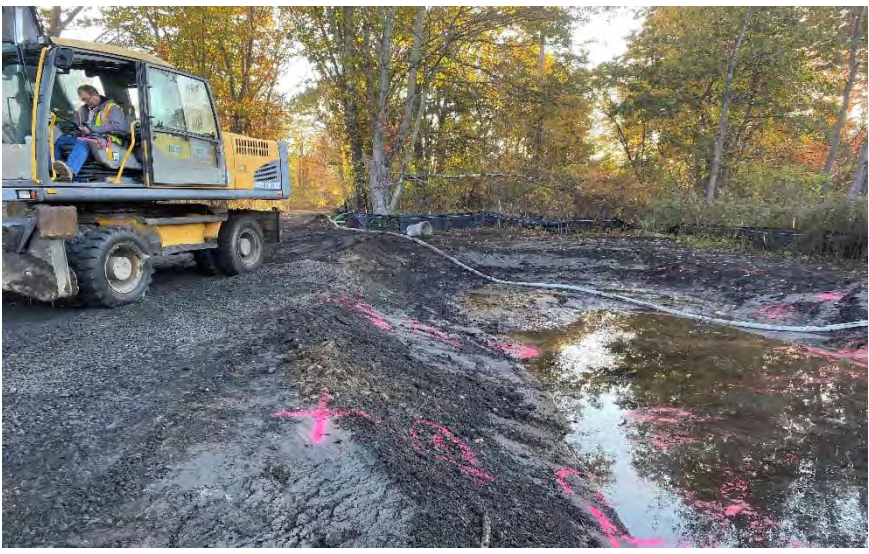
Description: Segment 14. View of dewatering operation. Looking eastward.

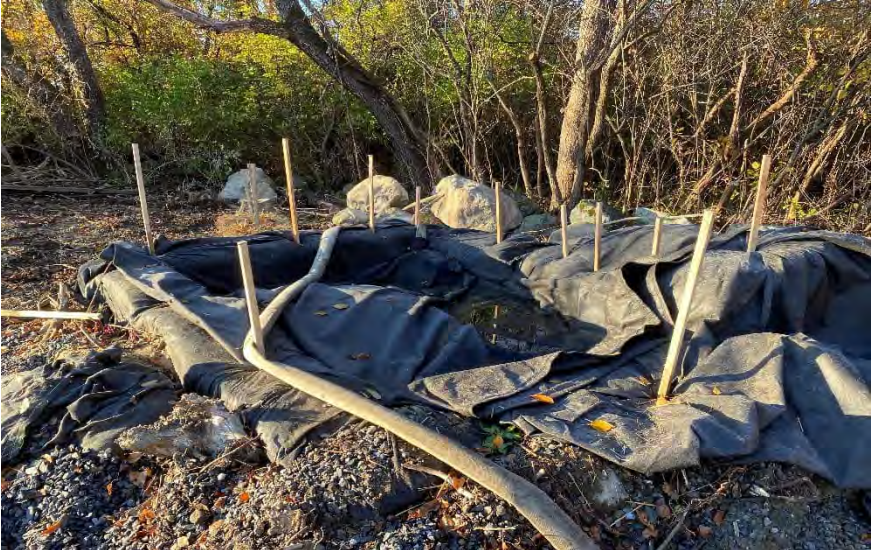
Description: Segment 14. View of discharge bag/bales, looking southward. Water discharge to bag intermittent and appeared to be slightly turbid.

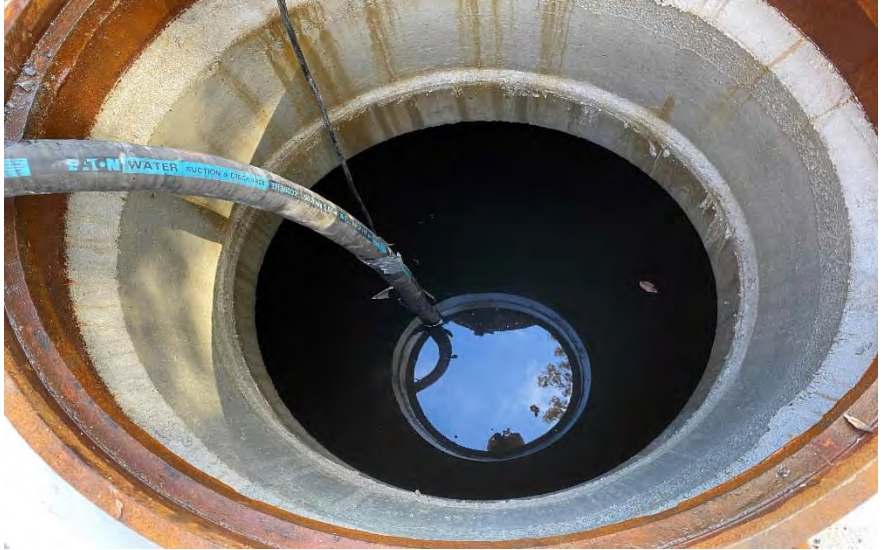
Description: View of area being pumped from manhole #27 within segment 14.

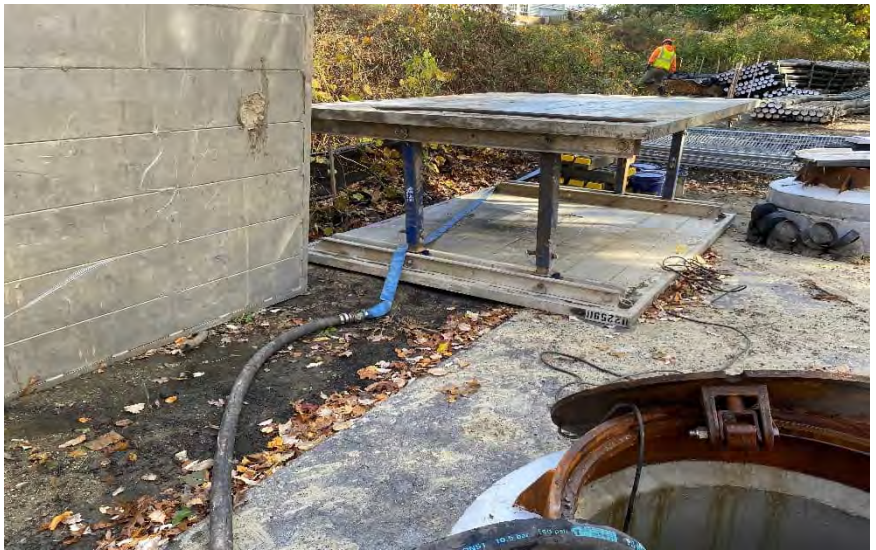
Description: Segment 14. View of dewatering operation. Looking eastward.

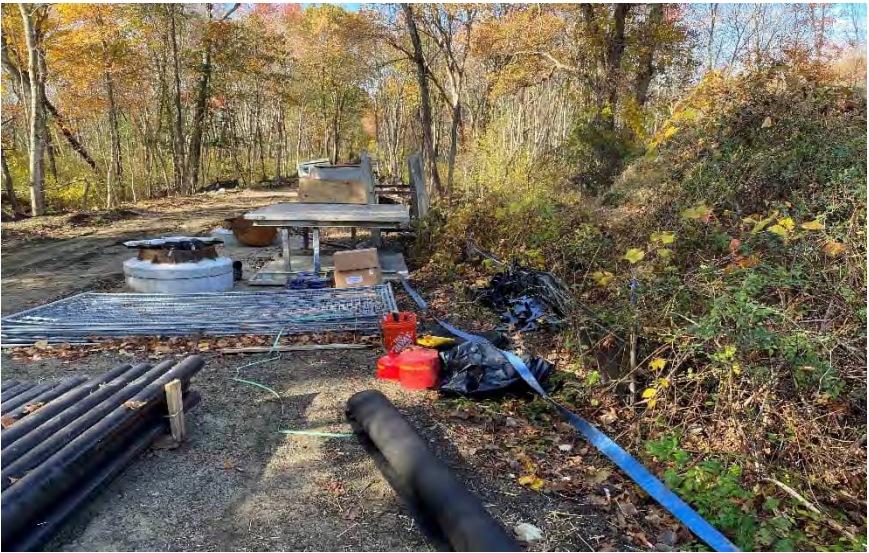
Description: Segment 14. View of dewatering operation, looking eastward.

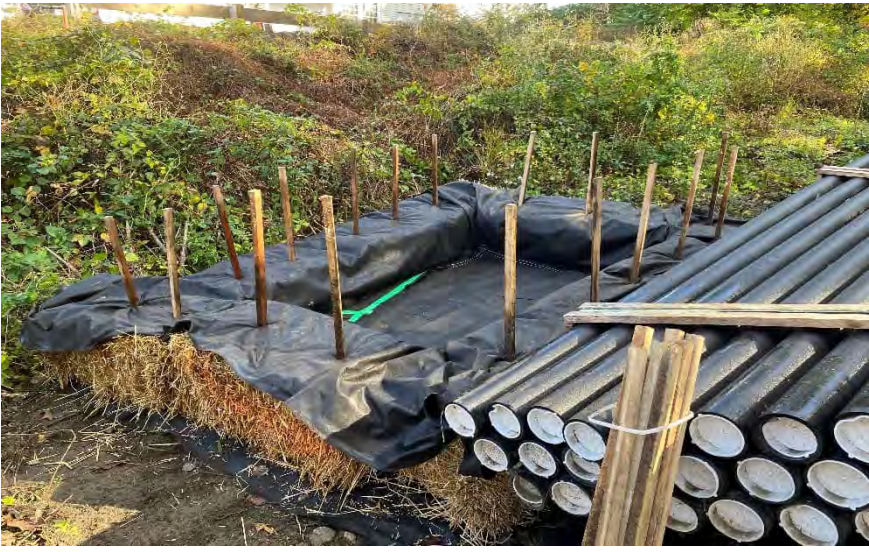
Description: Segment 14. View of discharge bag/bales, looking eastward. Water discharge to bag intermittent and appeared to be slightly turbid.

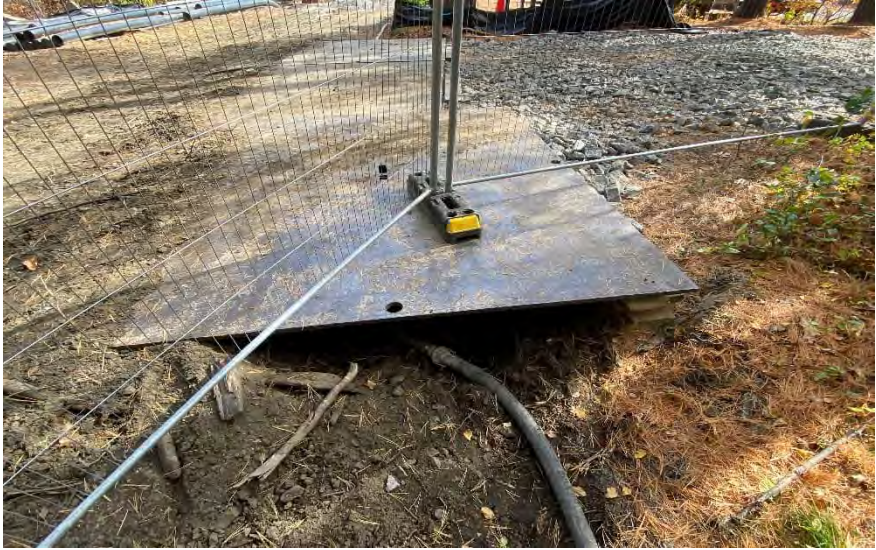
Description: View of area being pumped from manhole #24 within segment 11, looking eastward.

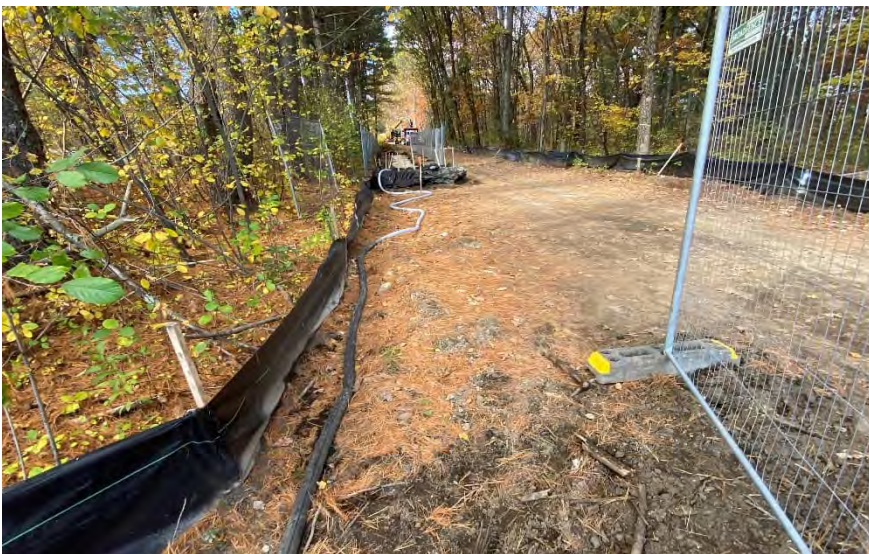
Description: Segment 11. View of dewatering operation. Looking westward.

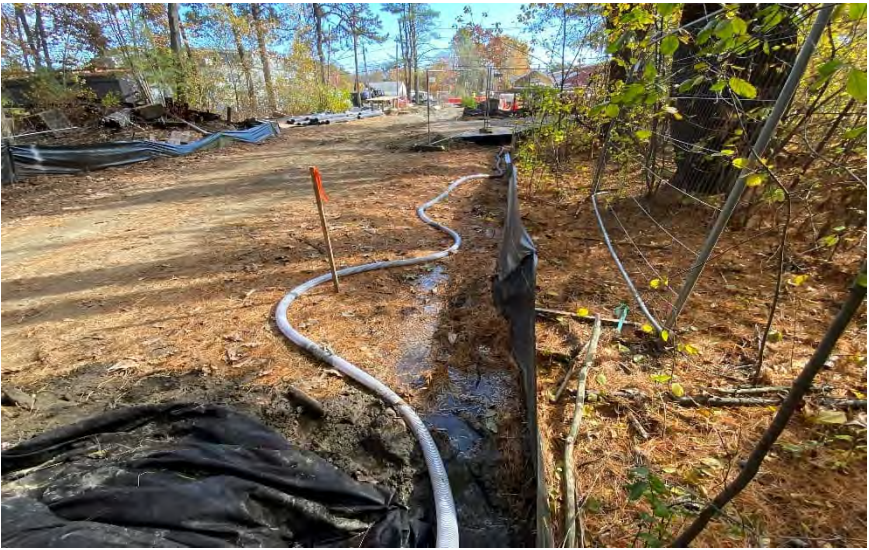
Description: Segment 11. View of dewatering operation, looking eastward.

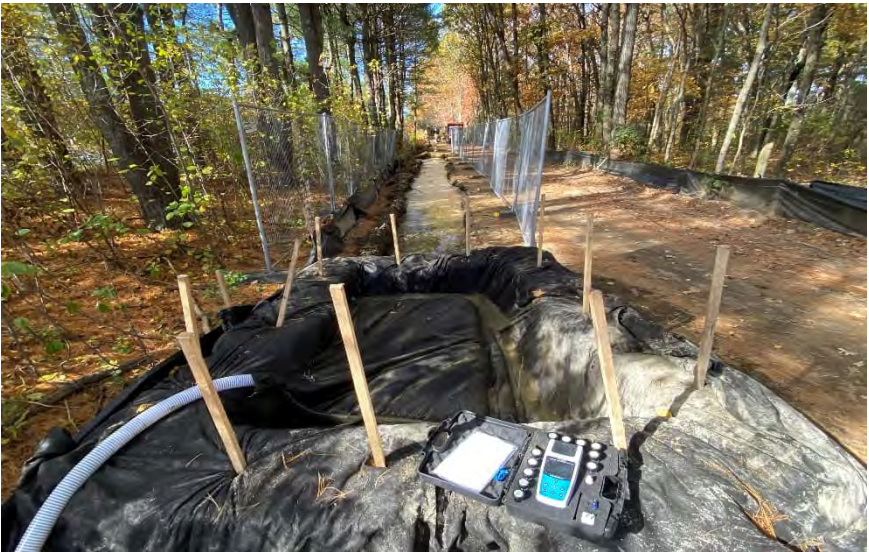
Description: Segment 11. View of discharge bag/bales, looking westward. Water discharge to bag intermittent and appeared to be slightly turbid.

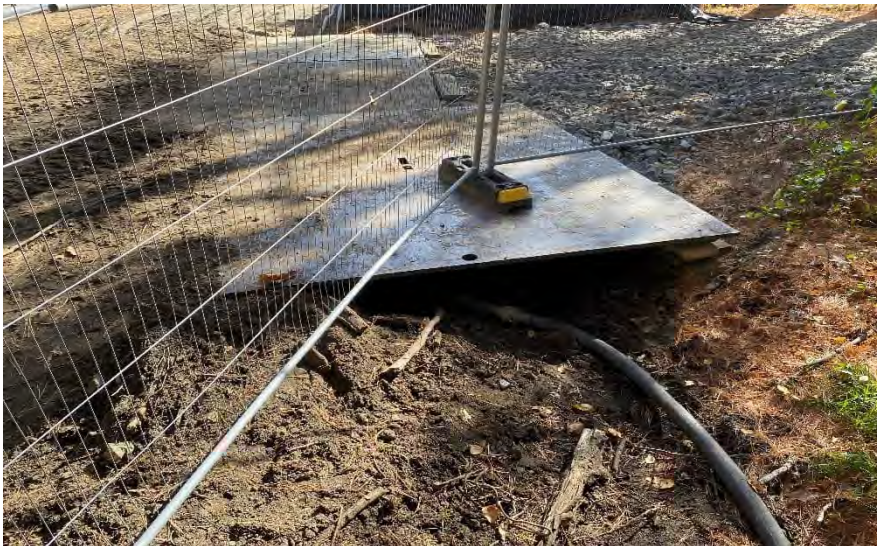
Description: View of area being pumped from manhole #24 within segment 11, looking eastward.

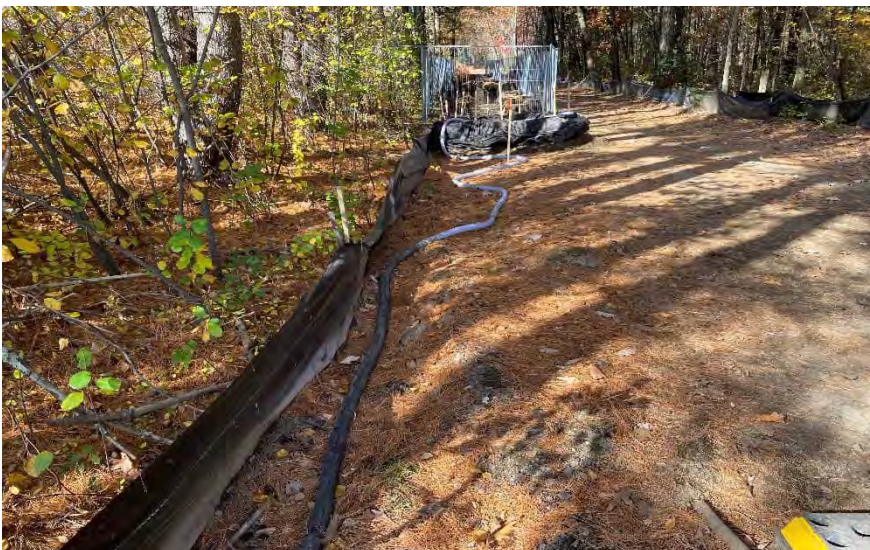
Description: Segment 11. View of dewatering operation. Looking westward.

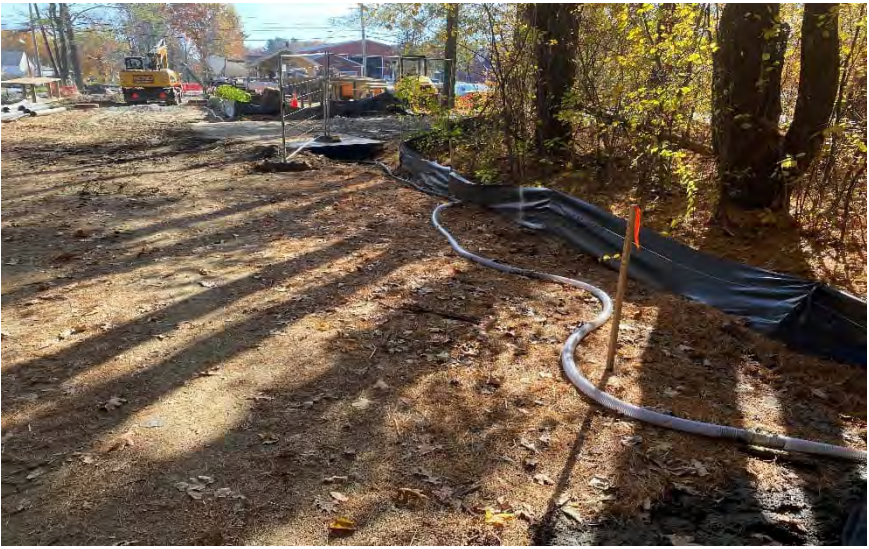
Description: Segment 11. View of dewatering operation, looking eastward.

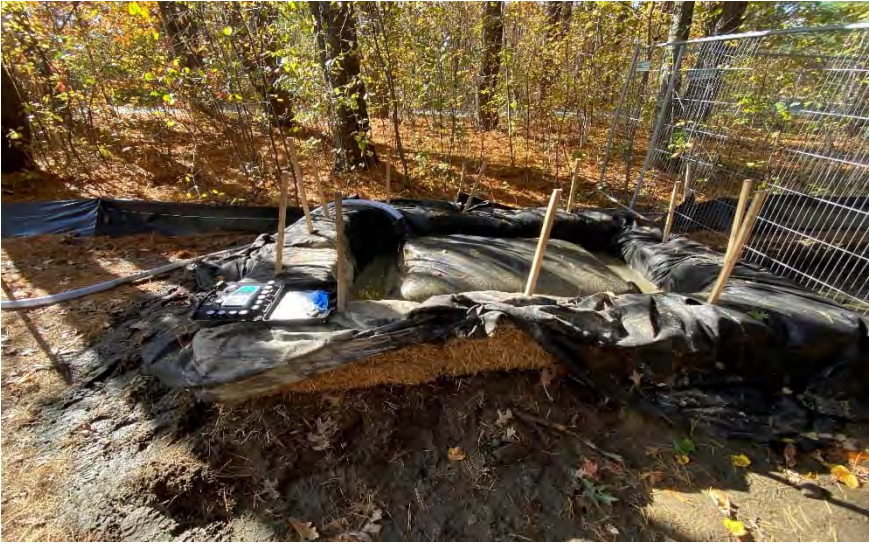
Description: Segment 11. View of discharge bag/bales, looking westward. Water discharge to bag intermittent and appeared to be slightly turbid.
