**Weekly Environmental Compliance Summary**

**Sudbury to Hudson Transmission Reliability Project (USEPA Tracking # MAR1003UW)**

Sudbury, Hudson, and Stow, MA

Week of: October 30, 2023 to November 3, 2023

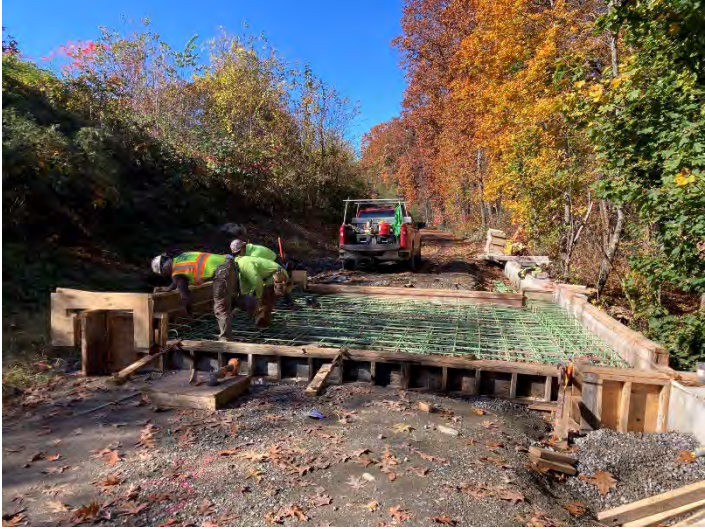
<p align="center"><b>PHOTOGRAPHIC LOG</b></p>	
<p>Client Name: Eversource</p>		<p>Site Location: Sudbury to Hudson Transmission Reliability Project</p>	<p>Town: Hudson</p>
<p>Photo No.: 1</p>	<p>Date: 10/31/2023</p>

<p>Description: View of ET&amp;L working on walls 1 and 2 and cattle crossing in segment 1. Facing west.</p>

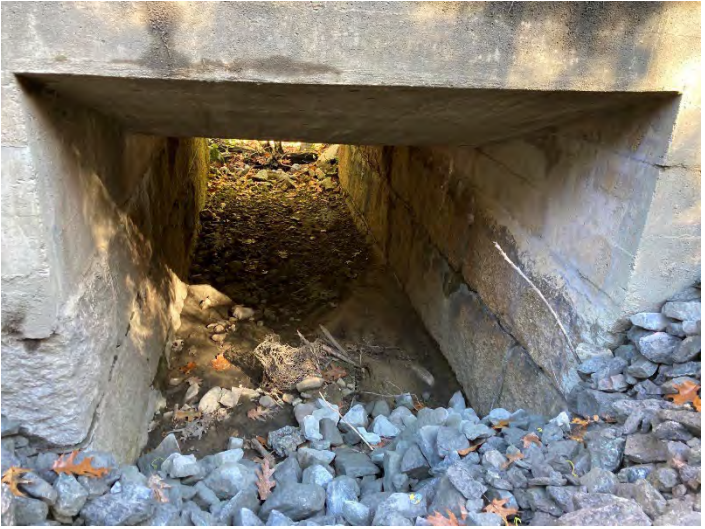
<p align="center"><b>PHOTOGRAPHIC LOG</b></p>	
<p>Client Name: Eversource</p>		<p>Site Location: Sudbury to Hudson Transmission Reliability Project</p>	<p>Town: Hudson</p>
<p>Photo No.: 2</p>	<p>Date: 10/31/2023</p>

<p>Description: View of cattle crossing tunnel in segment 1. Facing north.</p>

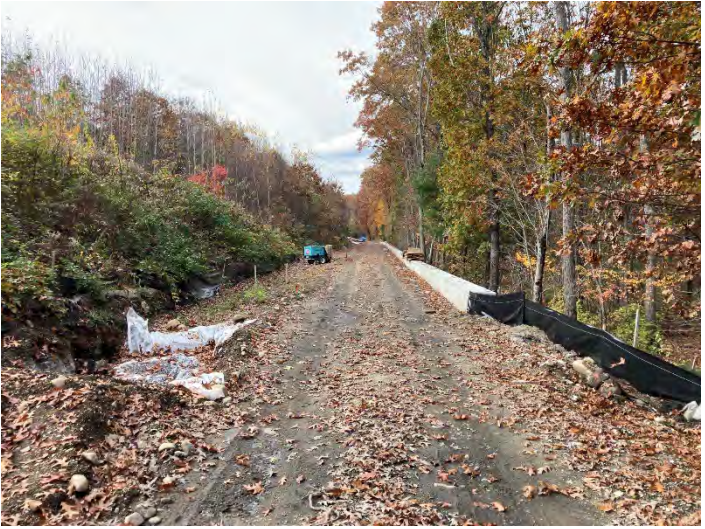
<p align="right"><b>PHOTOGRAPHIC LOG</b></p>	
<p>Client Name: Eversource</p>		<p>Site Location: Sudbury to Hudson Transmission Reliability Project</p>	<p>Town: Hudson</p>
<p>Photo No.: 2</p>	<p>Date: 11/01/2023</p>

<p><b>Description:</b> View of walls 1 and 2 in segment 1. Work on walls is now complete. Silt fence has been tied into both ends of walls. Facing west.</p>

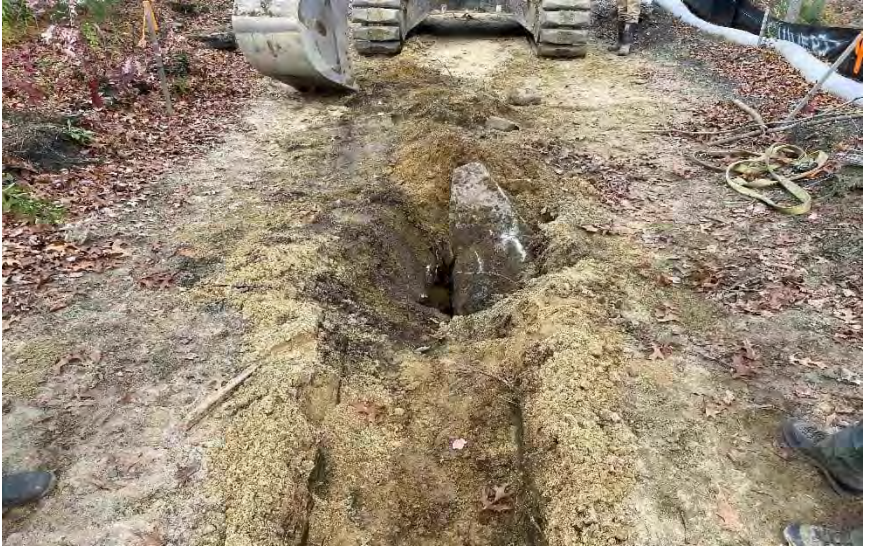
<p>PHOTOGRAPHIC LOG</p>	
<p>Client Name: Eversource</p>		<p>Site Location: Sudbury to Hudson Transmission Reliability Project</p>	<p>Town: Sudbury</p>
<p>Photo No.: 2</p>	<p>Date: 11-3-23</p>

<p>Description:</p> <p>Work area within Segment 12, initial culvert issue, looking westward.</p>

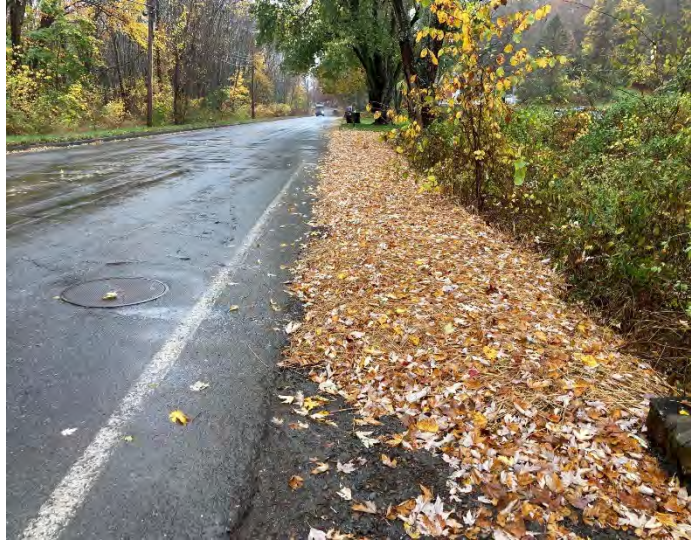
<b>Description:</b> View of Forest Ave near MH #4. Silt fence and compost filter tubes have been removed at this location now that road work is complete for the season. Loam, seed, and straw have been applied to disturbed road shoulder at 156 Forest Ave. Facing south.

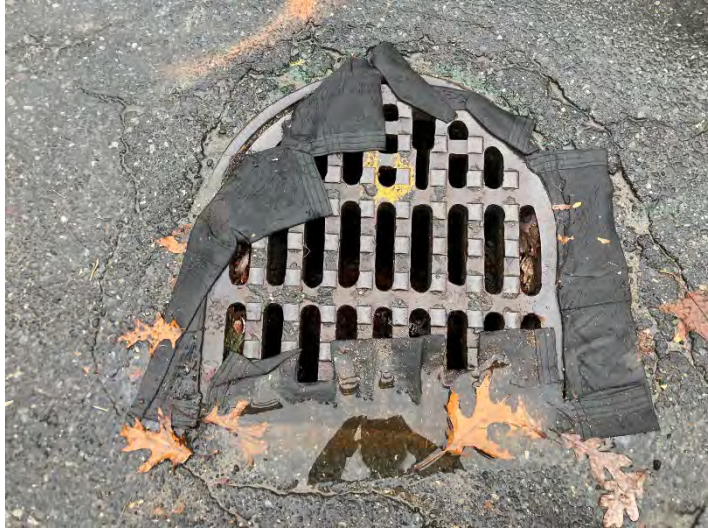
<b>Description:</b> View of silt sack inlet protection installed in storm drain near entrance to segment 1 on Wilkins St. Inlet protection is operating properly.

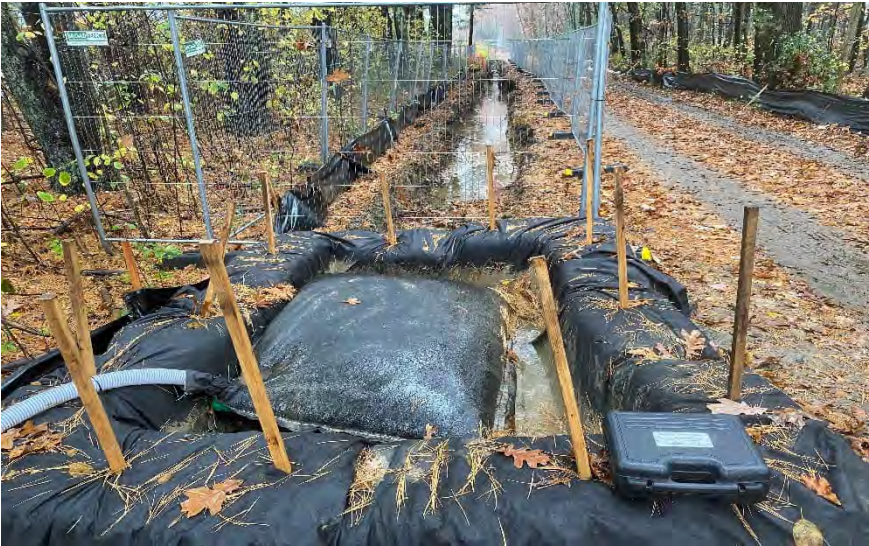
<b>Description:</b> Segment 11. View of discharge bag/bales, looking westward. Water discharge to bag intermittent and appeared to be slightly turbid.

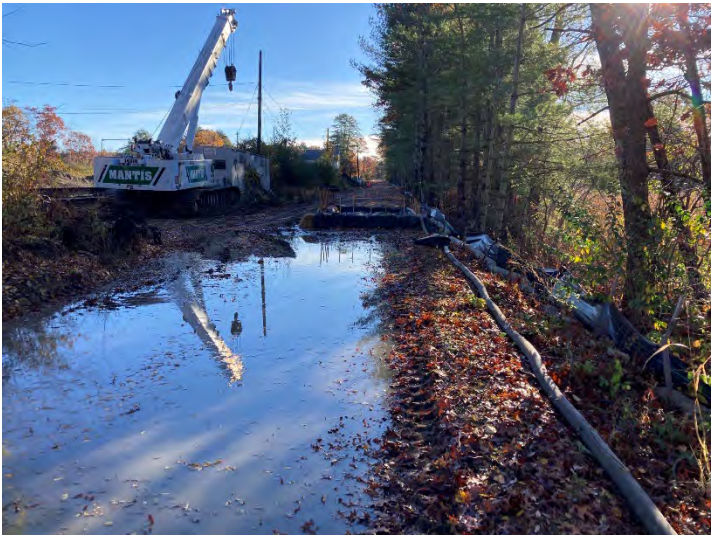
<b>Description:</b> View of discharge from controls. Discharge appeared turbid. Turbidity reading was higher than 50 NTUs, but discharge did not appear to be leaving the project. Facing east.

- Assess dewatering controls at bridge 130 in segment 3 prior to resuming pumping operation at this location. Alternative controls such as frac tank are recommended.**
- 
-

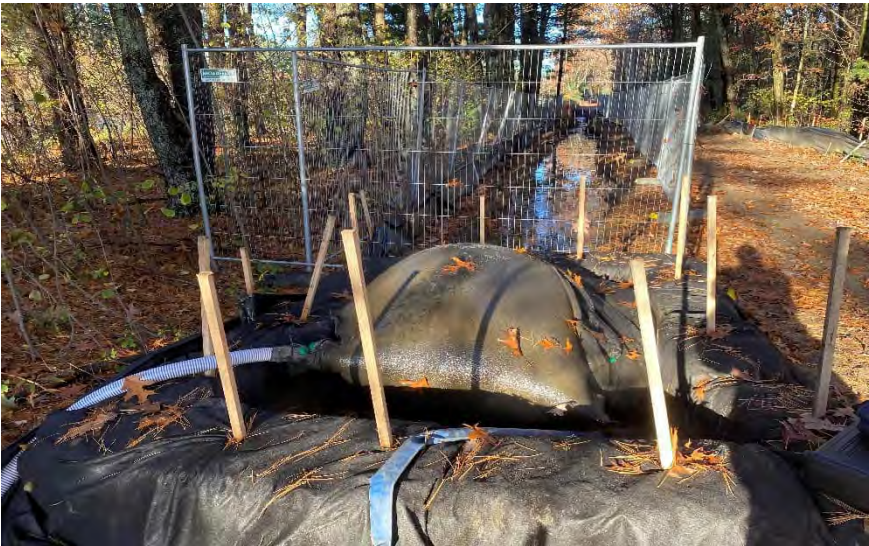
<b>Description:</b> Segment 11. View of discharge bag/bales, looking westward. Water discharge to bag intermittent and appeared to be slightly turbid.

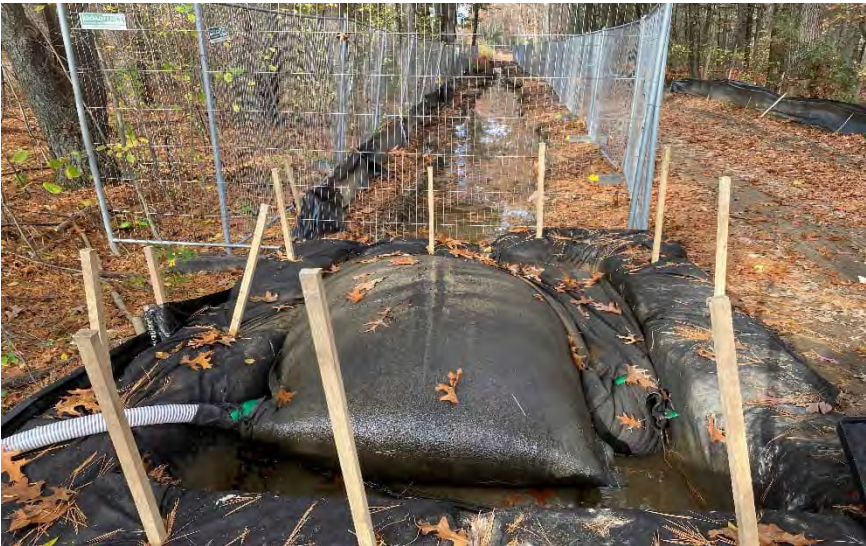
<b>Description:</b> Segment 11. View of discharge bag/bales, looking westward. Water discharge to bag intermittent and appeared to be slightly turbid.

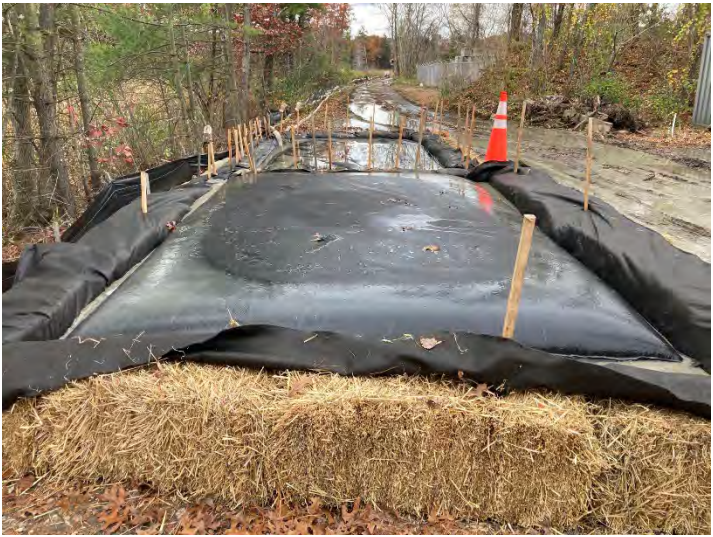
<b>Description:</b> View of dewatering controls and discharge from controls at approximately 1:30pm. Additional straw bale corral had been added to setup due to amount of water in coffer dam. Discharge appeared turbid. Turbidity reading was higher than 355 NTUs. Pump was turned off for the day at 1:35pm due to turbid discharge reaching adjacent wetlands. Facing west.

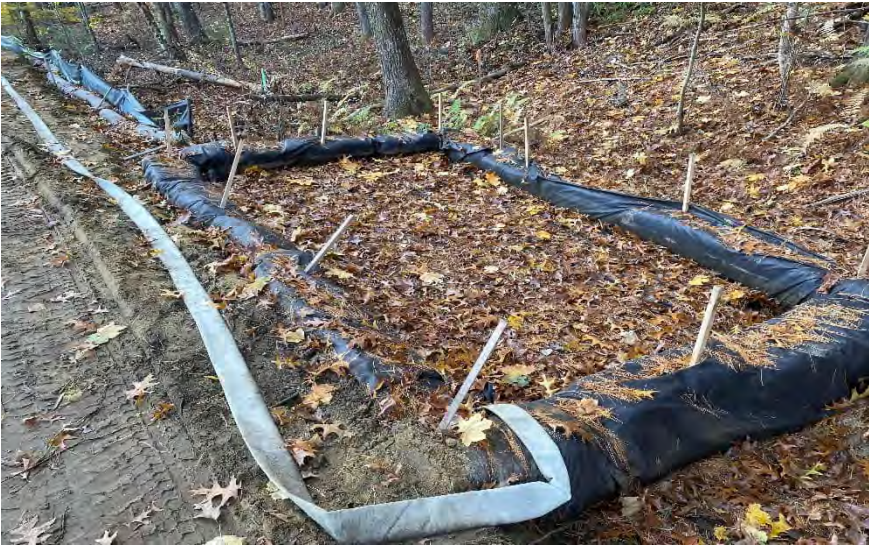
Description: Segment 13. View of discharge bag/bales, looking eastward. Water discharge to bag intermittent.
