Weekly Environmental Compliance Summary

Sudbury to Hudson Transmission Reliability Project (USEPA Tracking # MAR1003UW)

Week of: November 20, 2023 to November 24, 2023

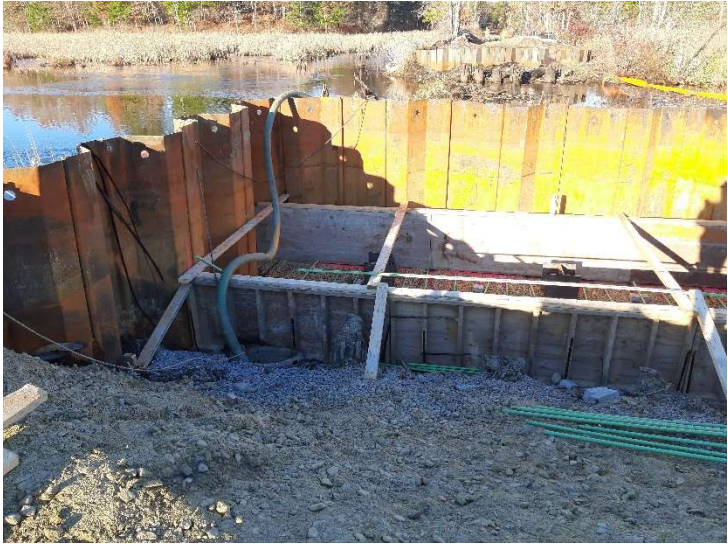
PHOTOGRAPHIC LOG	
Client Name: Eversource		Site Location: Sudbury to Hudson Transmission Reliability Project	Town: Hudson
Photo No.: 1	Date: 11-20-23

Description: Work area within segment 3 -> segment 2, bridge 130 work area, footing work. Looking westward.

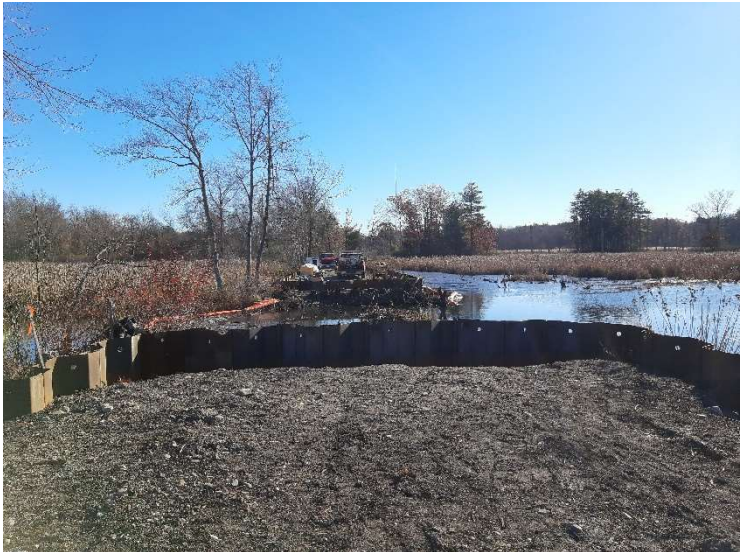
PHOTOGRAPHIC LOG	
Client Name: Eversource		Site Location: Sudbury to Hudson Transmission Reliability Project	Town: Hudson
Photo No.: 2	Date: 11-20-23

Description: Work area within segment 2 -> segment 3, bridge 130 work area, looking eastward.

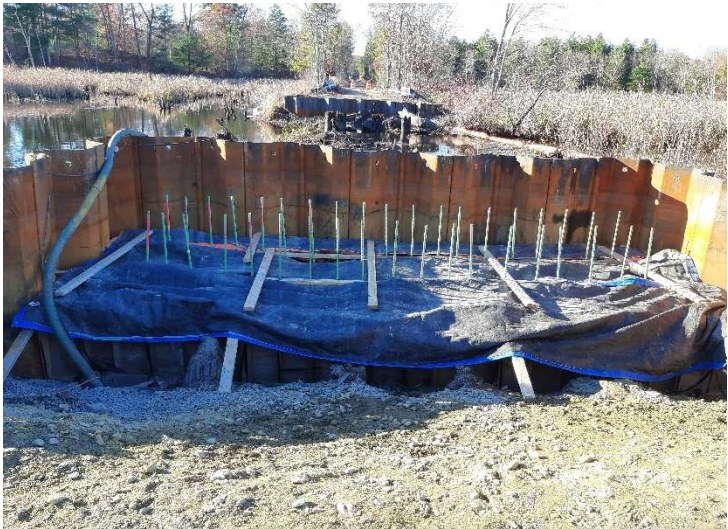
PHOTOGRAPHIC LOG	
Client Name: Eversource		Site Location: Sudbury to Hudson Transmission Reliability Project	Town: Hudson
Photo No.: 5	Date: 11-20-23

Description: Work area within segment 3 -> segment 2, bridge 130 work area, newly laid footing on segment 3 side. Looking westward.

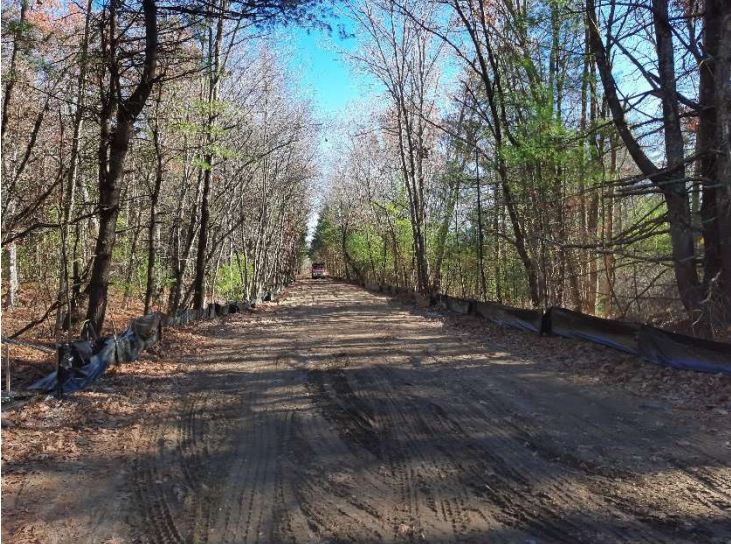
PHOTOGRAPHIC LOG	
Client Name: Eversource		Site Location: Sudbury to Hudson Transmission Reliability Project	Town: Hudson
Photo No.: 6	Date: 11-20-23

Description: Segment 6, existing erosion control, use as vehicle access to Segment 7, looking eastward.

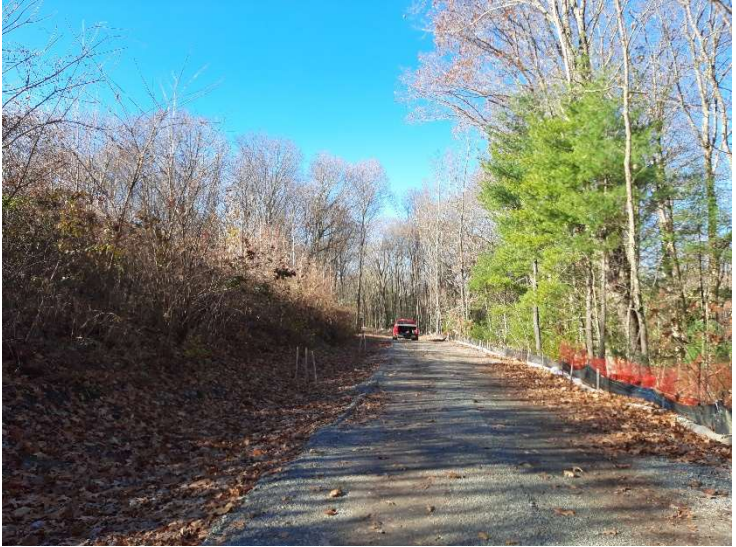
PHOTOGRAPHIC LOG	
Client Name: Eversource		Site Location: Sudbury to Hudson Transmission Reliability Project	Town: Hudson
Photo No.: 7	Date: 11-20-23

Description: Work area within segment 1, existing erosion controls, work on checking grading stakes, looking westward.

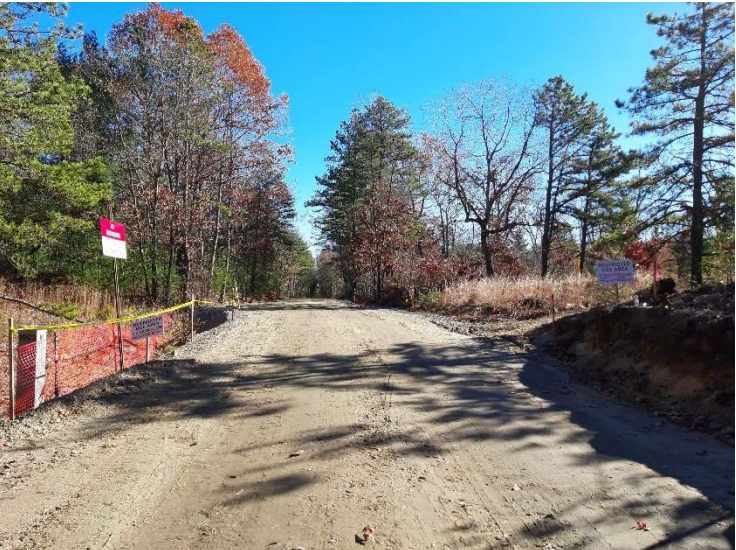
PHOTOGRAPHIC LOG	
Client Name: Eversource		Site Location: Sudbury to Hudson Transmission Reliability Project	Town: Hudson
Photo No.: 8	Date: 11-20-23

Description: Segment 6 -> 7, existing signage indicating restricted use remains in place. Segment 7 work area out of sight eastward. Looking eastward.

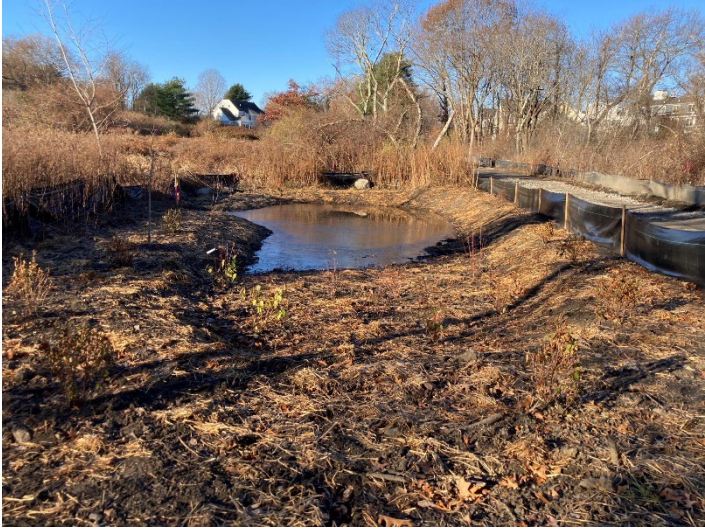
<p align="center">PHOTOGRAPHIC LOG</p>	
<p>Client Name: Eversource</p>		<p>Site Location: Sudbury to Hudson Transmission Reliability Project</p>	<p>Town: Sudbury</p>
<p>Photo No.: 1</p>	<p>Date: 11/20/2023</p>

<p>Description: View of wetland replication area at eastern end of segment 14. Facing west.</p>

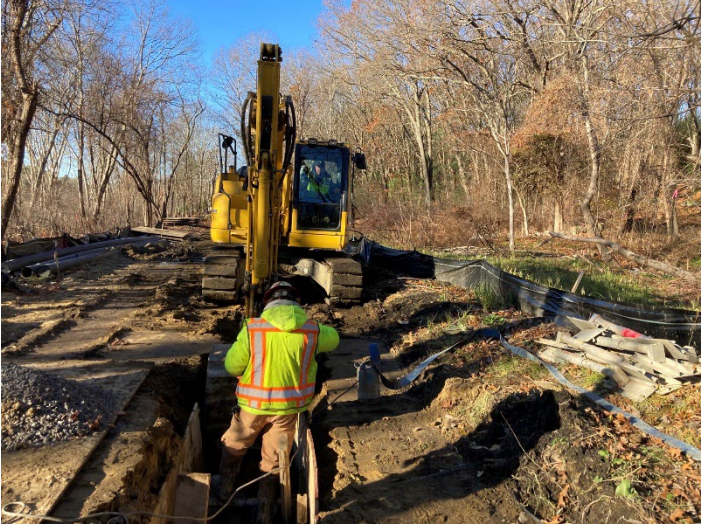
<p align="center">PHOTOGRAPHIC LOG</p>	
<p>Client Name: Eversource</p>		<p>Site Location: Sudbury to Hudson Transmission Reliability Project</p>	<p>Town: Sudbury</p>
<p>Photo No.: 2</p>	<p>Date: 11/20/2023</p>

<p>Description: View of Bond's work area and dewatering operation in segment 14. See additional dewatering inspection report. Facing west.</p>

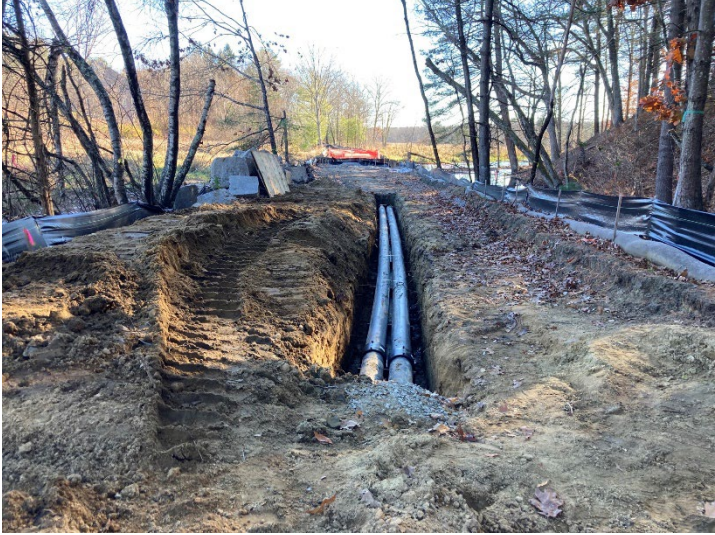
<p>PHOTOGRAPHIC LOG</p>	
<p>Client Name: Eversource</p>		<p>Site Location: Sudbury to Hudson Transmission Reliability Project</p>	<p>Town: Sudbury</p>
<p>Photo No.: 3</p>	<p>Date: 11/20/2023</p>

<p>Description: View of Bond's work area in segment 13. Facing east.</p>

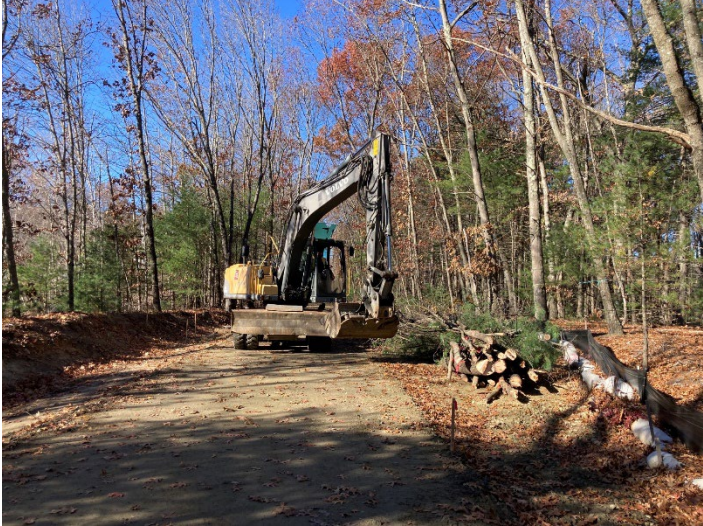
<p>PHOTOGRAPHIC LOG</p>	
<p>Client Name: Eversource</p>		<p>Site Location: Sudbury to Hudson Transmission Reliability Project</p>	<p>Town: Sudbury</p>
<p>Photo No.: 4</p>	<p>Date: 11/20/2023</p>

<p>Description: View of ET&L conducting tree removal for swale within segment 11. Facing west.</p>

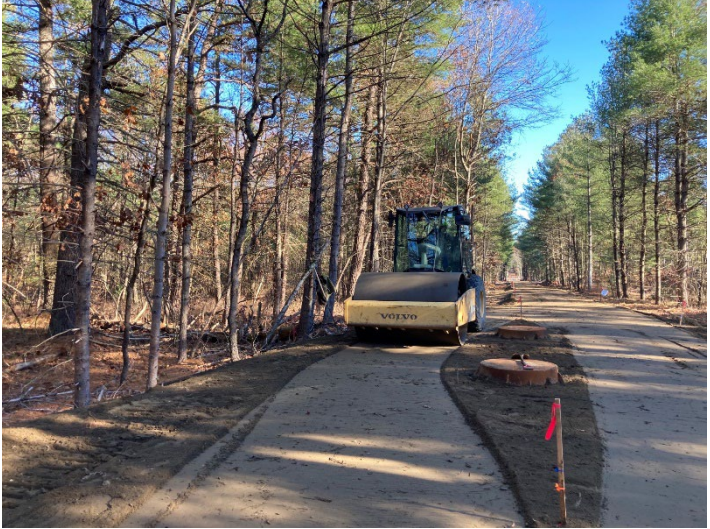
PHOTOGRAPHIC LOG	
Client Name: Eversource		Site Location: Sudbury to Hudson Transmission Reliability Project	Town: Sudbury
Photo No.: 6	Date: 11/20/2023

Description: View of ET&L working in segment 7. Facing east.

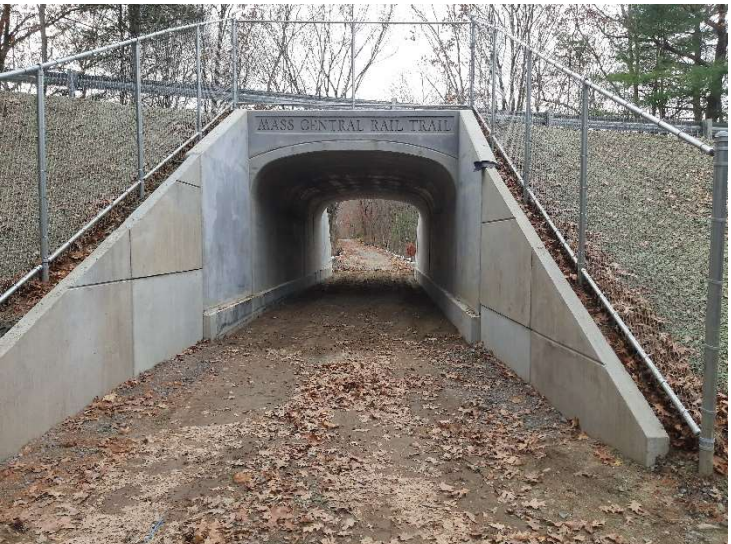
PHOTOGRAPHIC LOG	
Client Name: Eversource		Site Location: Sudbury to Hudson Transmission Reliability Project	Town: Hudson
Photo No.: 2	Date: 11-21-23

Description: Segment 1, location of newly installed French drains under Chestnut Street flyover. Looking westward.

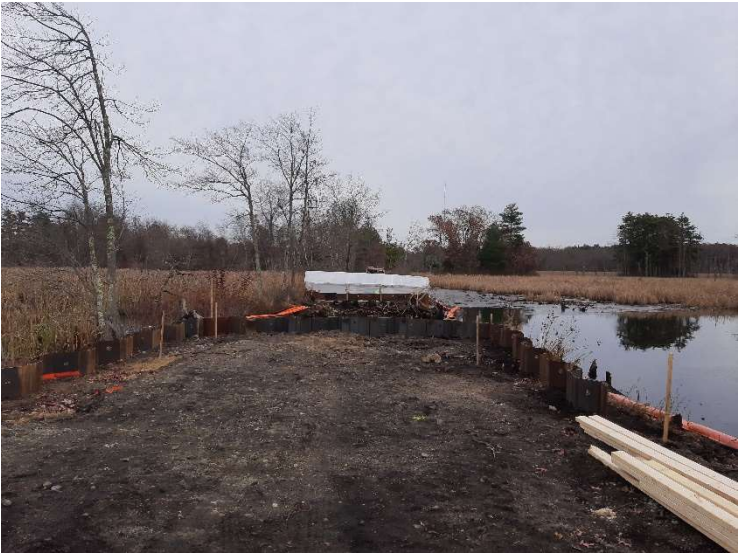
PHOTOGRAPHIC LOG	
Client Name: Eversource		Site Location: Sudbury to Hudson Transmission Reliability Project	Town: Hudson
Photo No.: 3	Date: 11-21-23

Description: Work area within segment 2 -> segment 3, bridge 130 work area, with newly placed stakes, looking eastward.

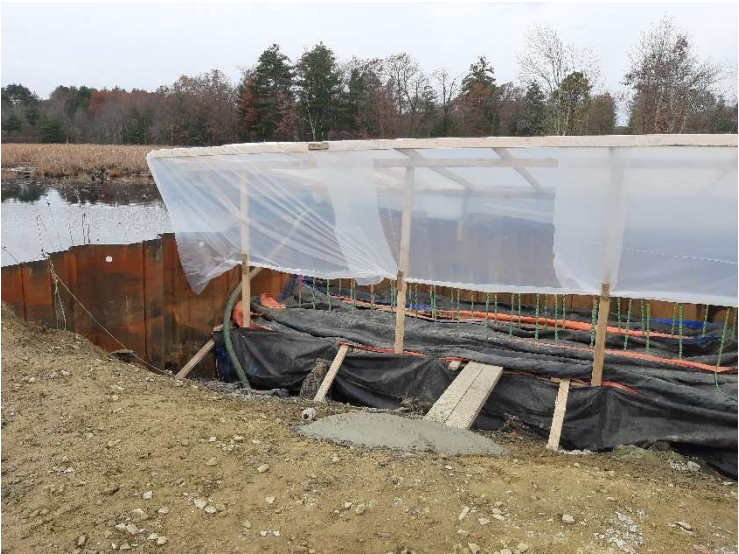
PHOTOGRAPHIC LOG	
Client Name: Eversource		Site Location: Sudbury to Hudson Transmission Reliability Project	Town: Hudson
Photo No.: 4	Date: 11-21-23

Description: Work area within Segment 3 -> Segment 2, bridge 130, footing work and newly established protection for anticipated precipitation. Looking westward.

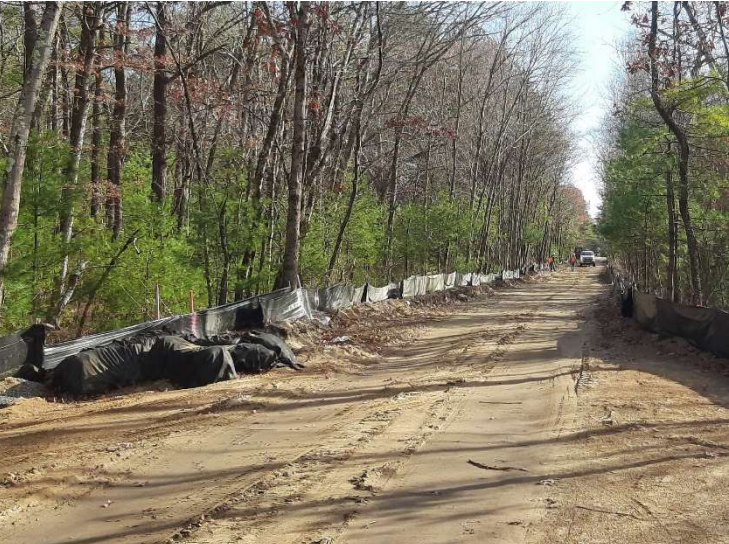
PHOTOGRAPHIC LOG	
Client Name: Eversource		Site Location: Sudbury to Hudson Transmission Reliability Project	Town: Hudson
Photo No.: 6	Date: 11-21-23

Description: Segment 6, existing erosion controls, invasive species check, looking eastward.

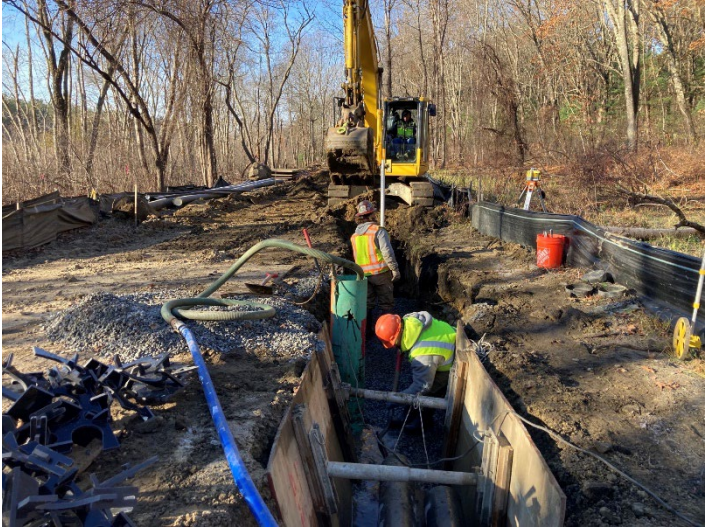
<p align="right">PHOTOGRAPHIC LOG</p>	
<p>Client Name: Eversource</p>		<p>Site Location: Sudbury to Hudson Transmission Reliability Project</p>	<p>Town: Sudbury</p>
<p>Photo No.: 1</p>	<p>Date: 11/21/2023</p>

<p>Description: View of Bond's work area and dewatering operation in segment 14. See additional dewatering inspection report. Facing west.</p>

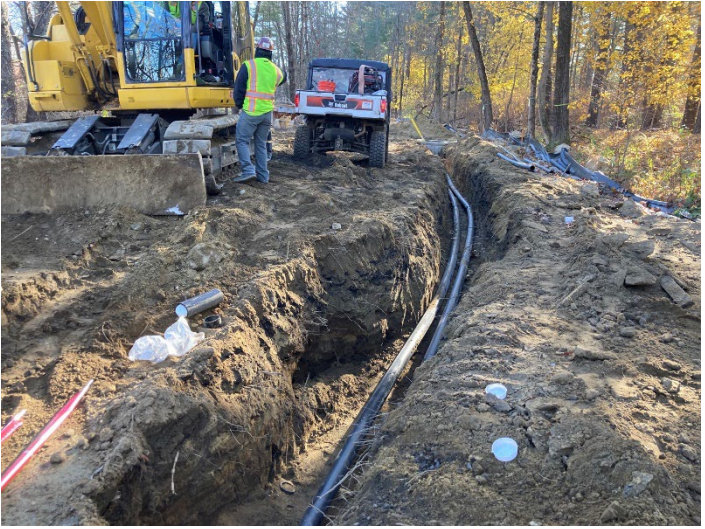
<p align="right">PHOTOGRAPHIC LOG</p>	
<p>Client Name: Eversource</p>		<p>Site Location: Sudbury to Hudson Transmission Reliability Project</p>	<p>Town: Sudbury</p>
<p>Photo No.: 2</p>	<p>Date: 11/21/2023</p>

<p>Description: View of Bond's work area in segment 13. Facing east.</p>

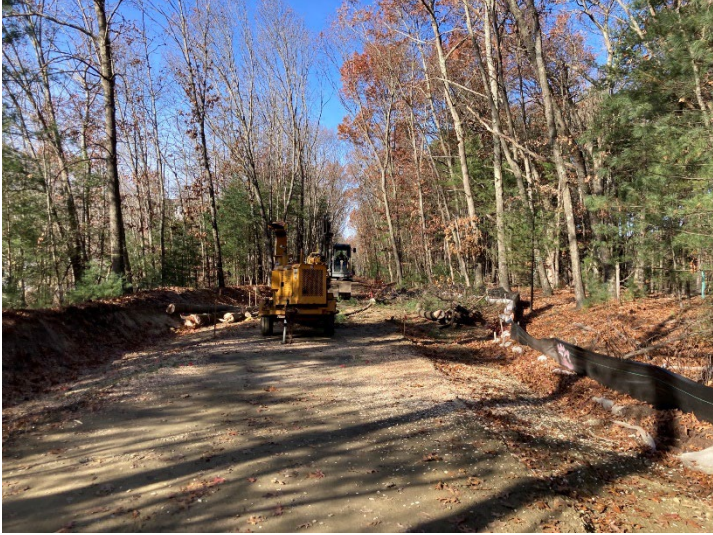
Description: View of ET&L conducting tree removal for swale within segment 11. Facing west.

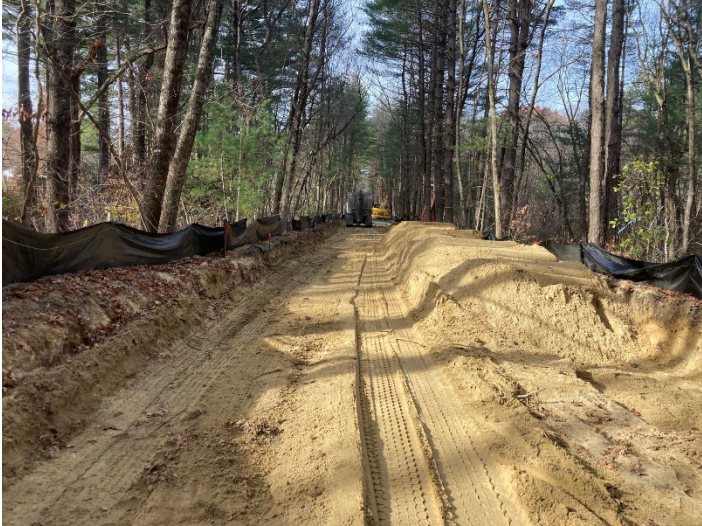
Identify presence of stockpiles and document when placed and when removed (week maximum for stockpiles)
Stockpiles noted within ROW in segment 10.

Description: View of stockpiles noted in segment 10. Facing west.

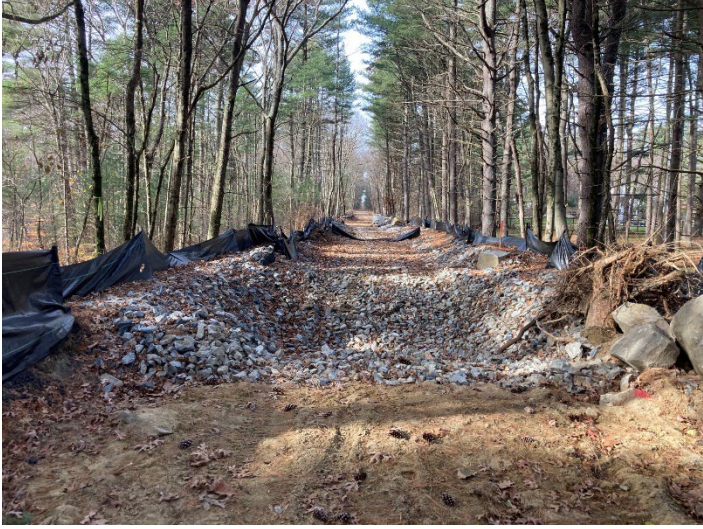
Description: View of area above collapsed culvert in segment 9. Facing west.

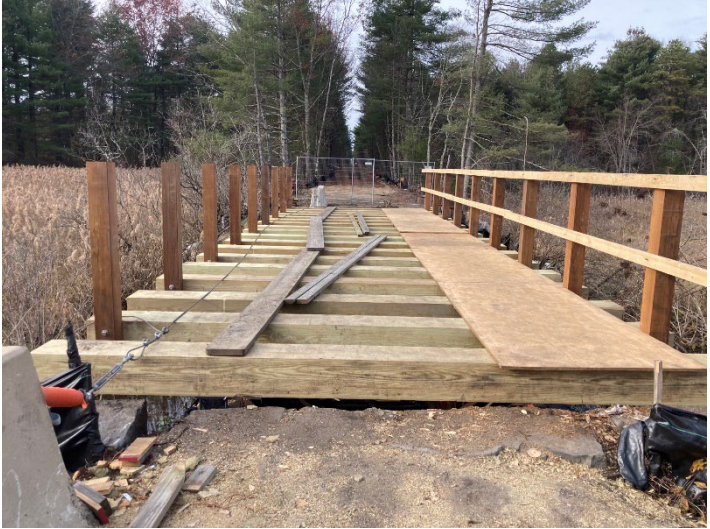
Description: View of Bridge 128. No work observed today. Facing west.

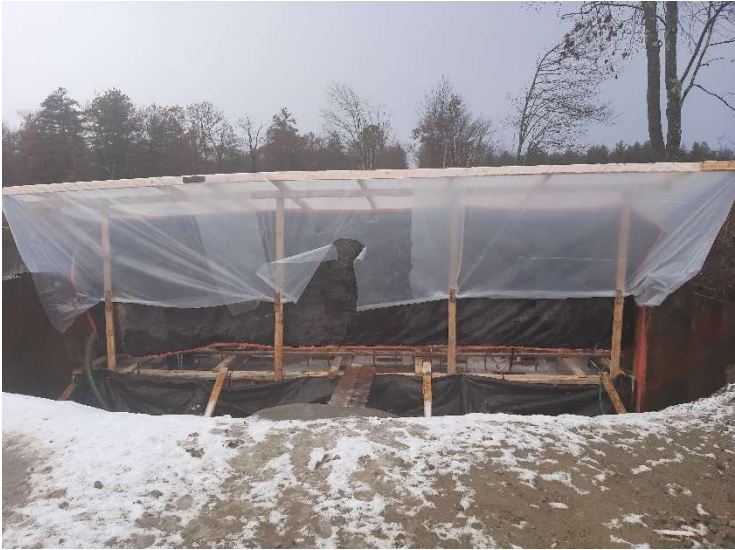
Description: Work area from segment 3 -> segment 2 (bridge 130 area), looking westward. Work area covered to protect from elements. Looking westward.

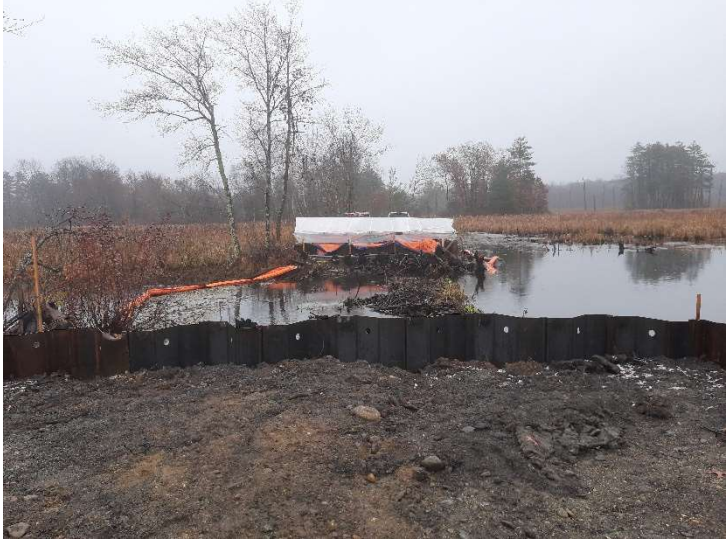
Description: Work area from segment 2 -> segment 3 (bridge 130 area), looking westward. Work area in Segment 3 covered to protect from elements. Looking eastward.

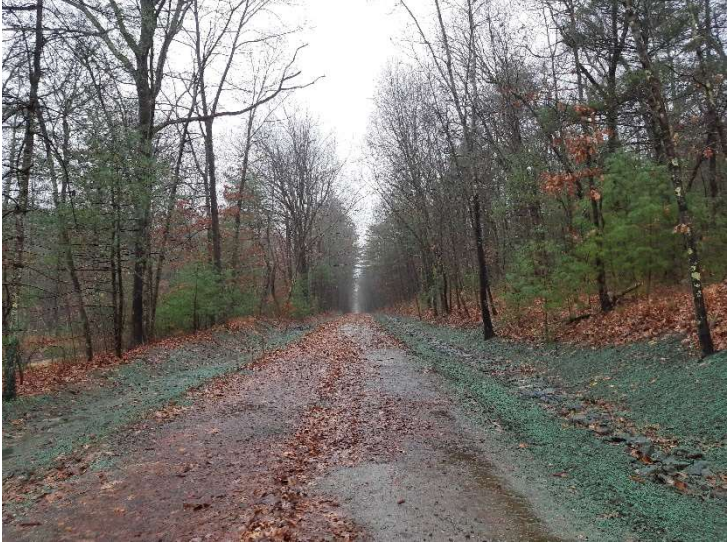
Description: Segment 5, recently laid hydroseed atop stone & loam of swale, looking westward.

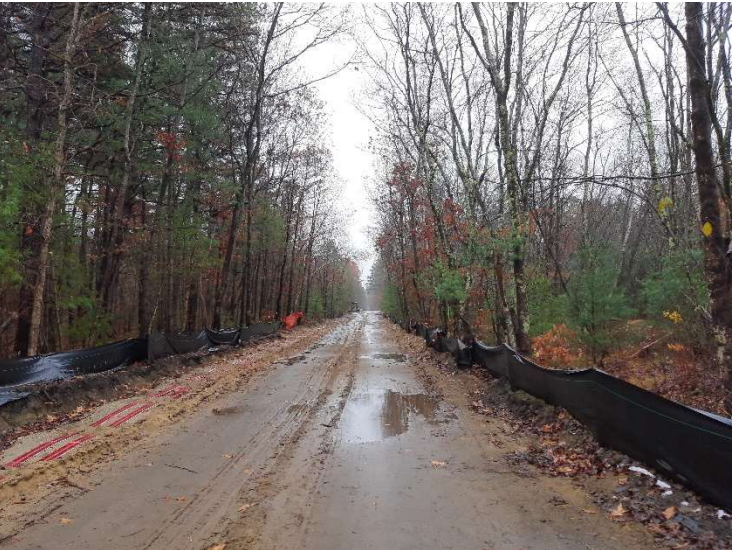
Description: Segment 6 looking eastward, near town line. Existing erosion controls.

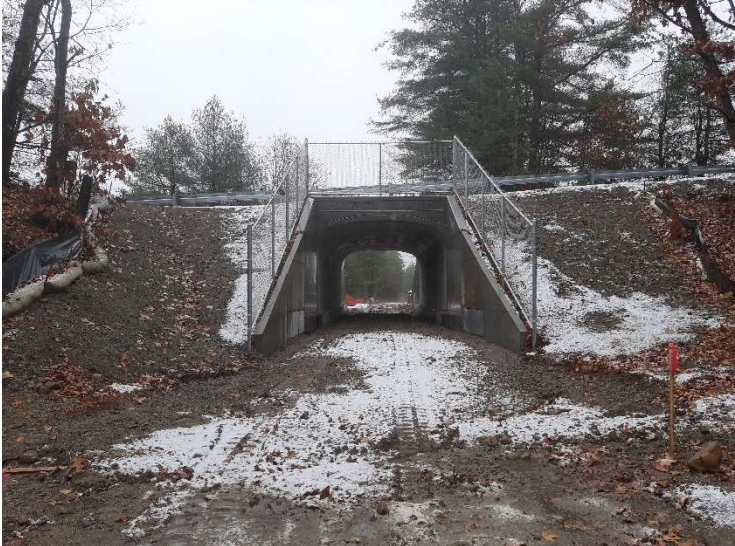
Description: Yesterday's work area within segment 1, location of installation of French drains under Chestnut Street flyover, looking eastward.

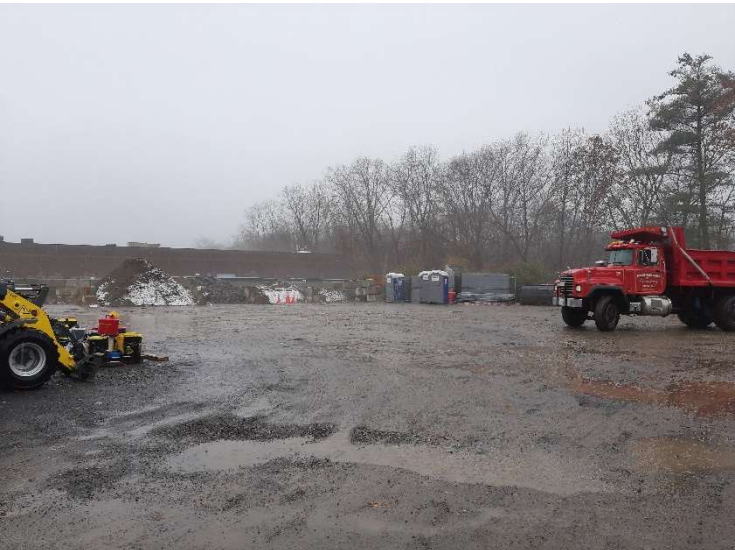
Description: Bonazzoli laydown yard, material loadout, looking southwestward.

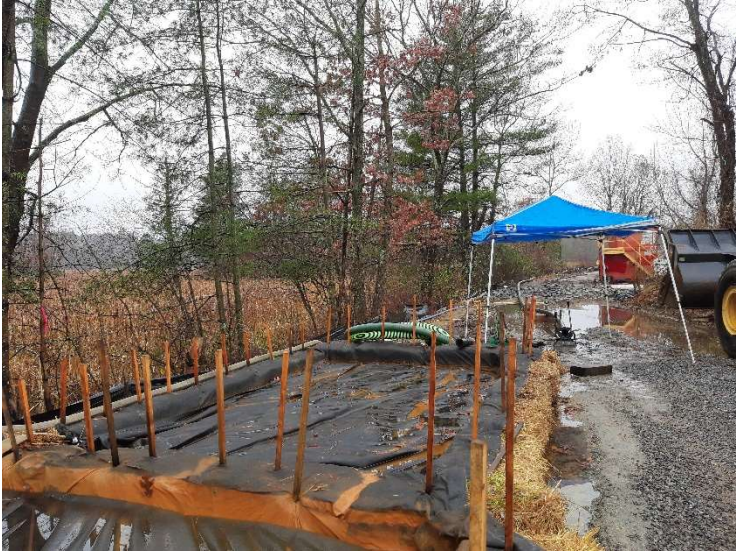
Description: Work area within segment 3, near bridge 130. Fusing tubing in preparation for dewatering from Segment 2 side of bridge 130 to Segment 3 side.

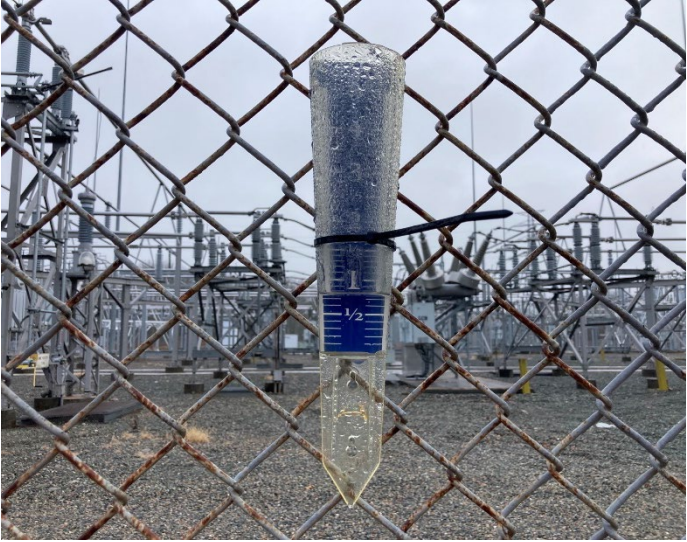
Description: View of rain gauge at Sudbury Substation. 0.75" observed in gauge at 2:15pm. Facing south.

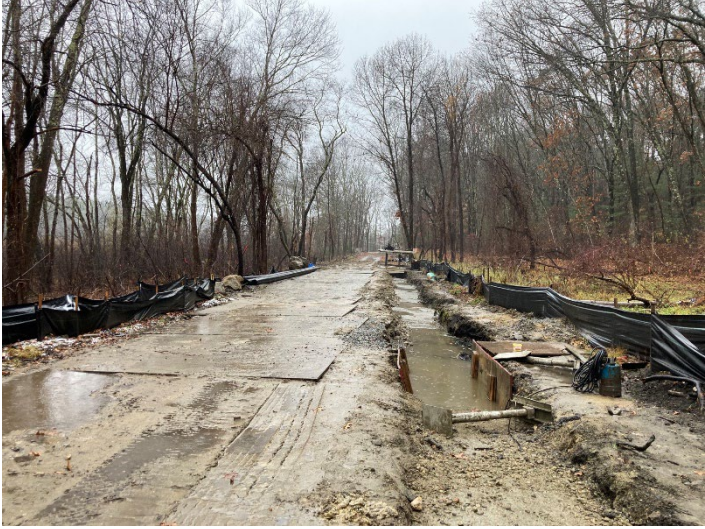
Description: View of Bond's work area in segment 14. No dewatering occurred today. Facing west.

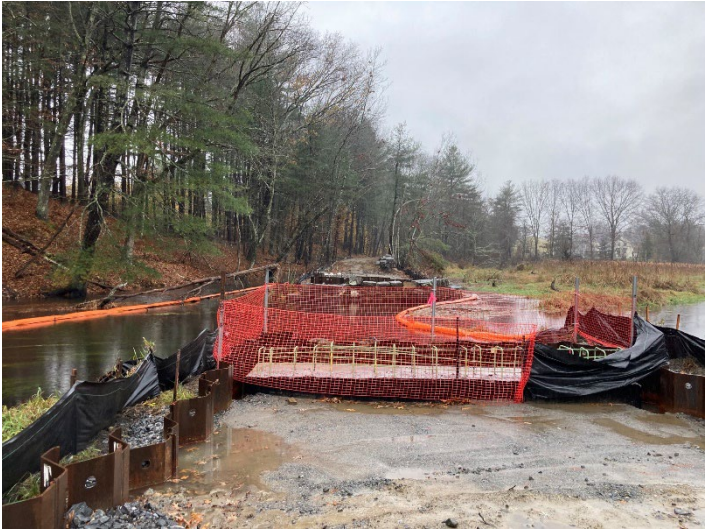
Description: View of bridge 127. Facing west.

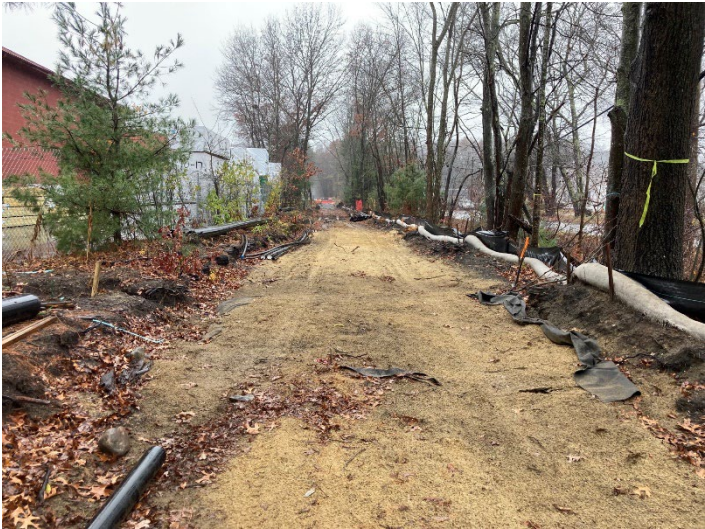
Description: View of culvert area and Type B E&S controls in segment 12. Facing west.

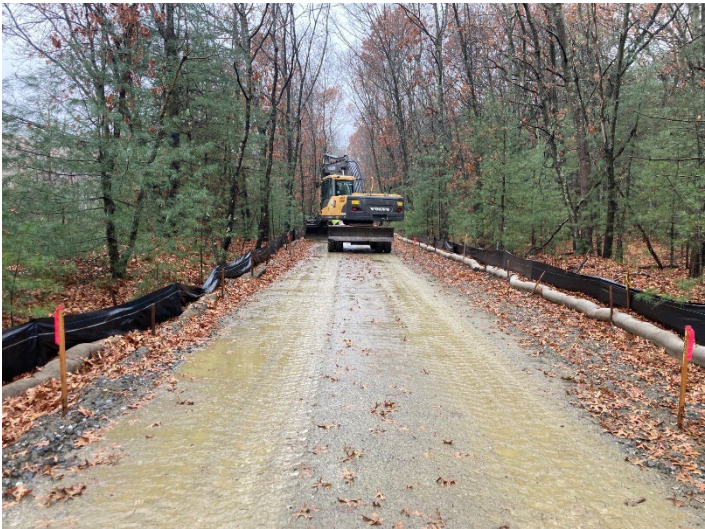
Description: View of ET&L conducting site work and Type B E&S controls in segment 11. Facing east.

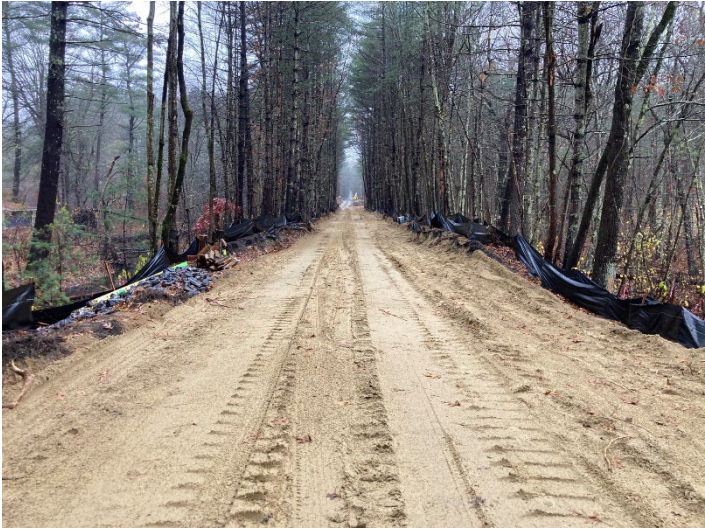
Description: View of Dudley Brook culvert area in segment 10. Facing west.

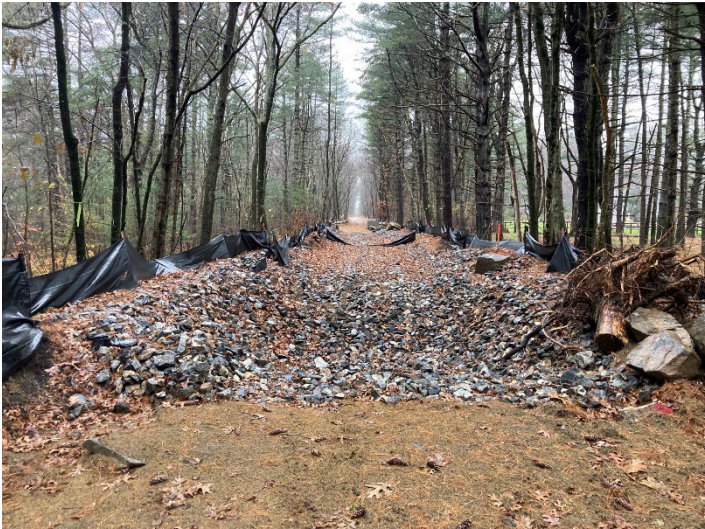
Description: View of collapsed culvert area in segment 9. Facing west.

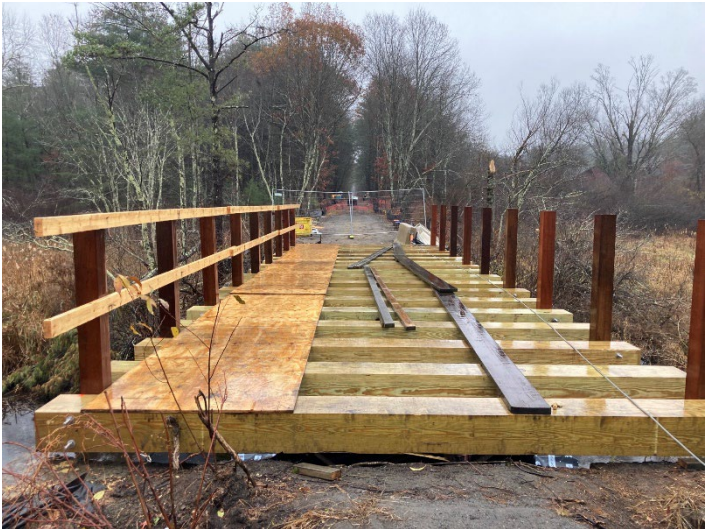
Description: View of Bridge 128. Facing east.

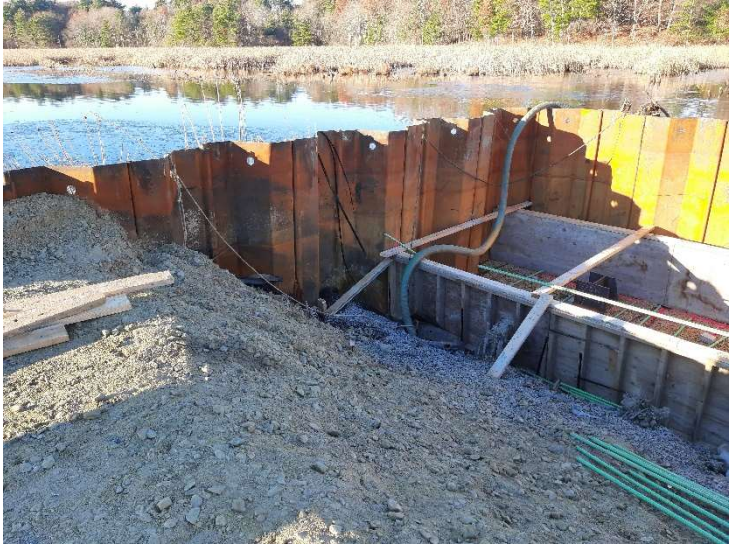
Description: View of area being pumped (i.e., cofferdam within segment 3 off Fort Meadow Brook), looking westward.

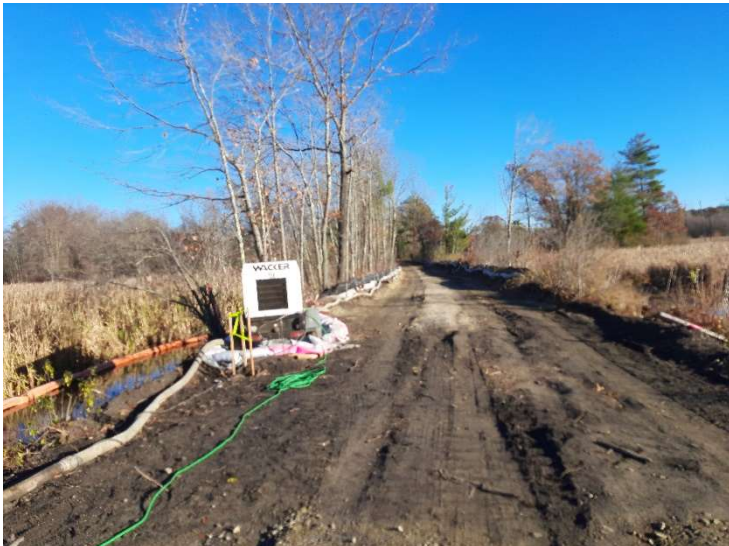
Description: Segment 3. View of dewatering operation. Looking eastward.

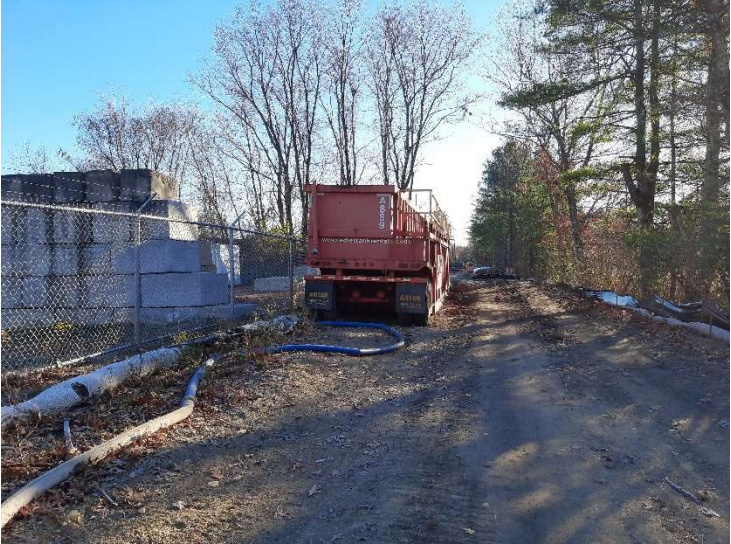
Description: Segment 3. View of discharge dewatering operation, looking eastward. Hosing bypasses frack tank, frack tank not in use.

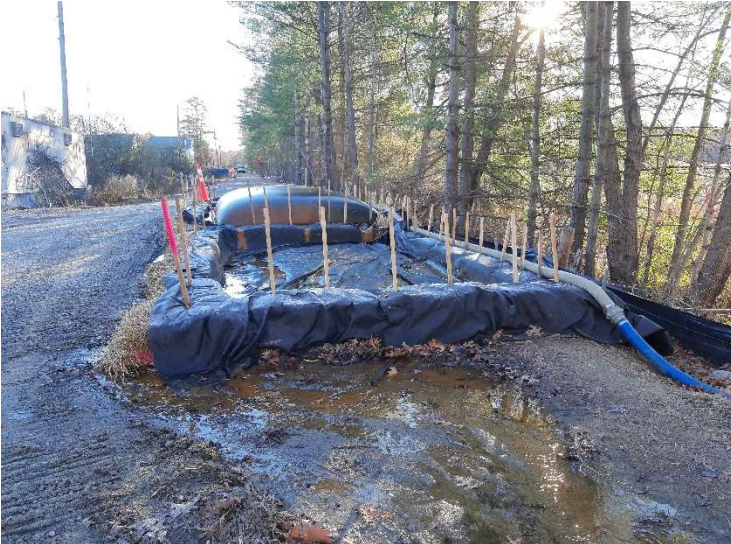
Description: Segment 3. View of discharge from bag/bales to adjacent work area, looking eastward. Water discharge to bag intermittent. Discharge from corral to work area (foreground).

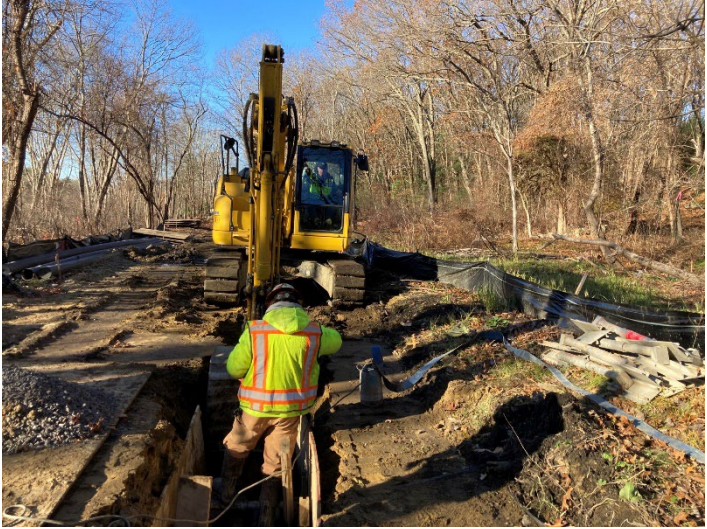
Description: View of Bond working in trench in segment 14. Facing west.

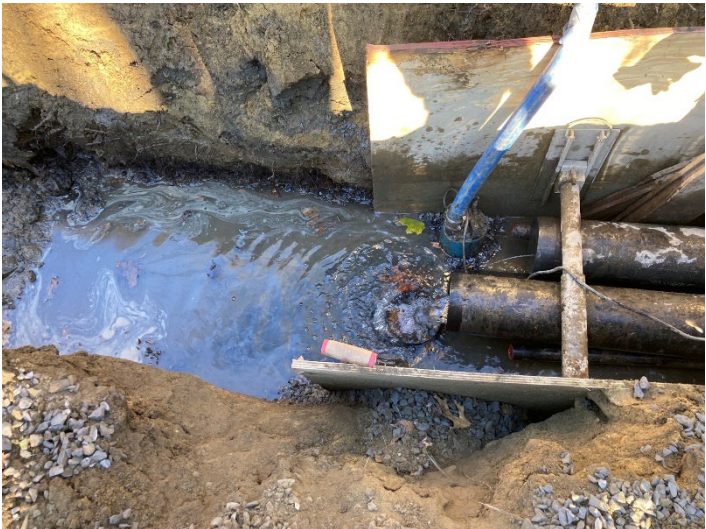
Description: View of pump in trench. Water appeared turbid prior to treatment.

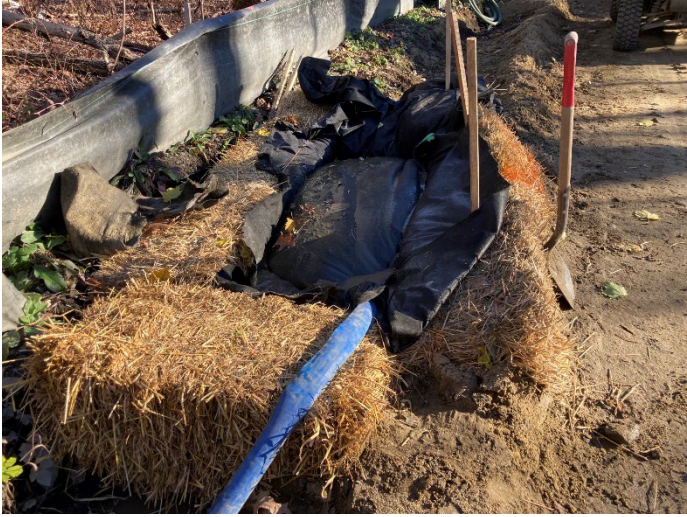
Photo No.: 3	Date: 11/20/2023		
Description: View of dewatering controls (straw bale corral with filter fabric and silt bag). Facing east.

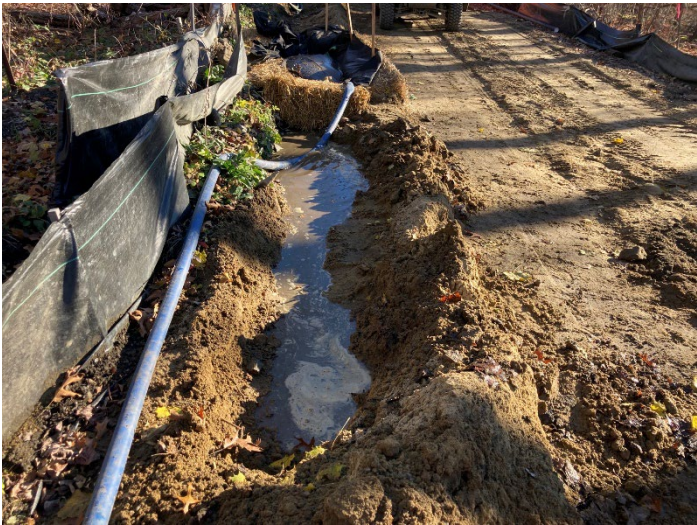
Photo No.: 4	Date: 11/20/2023		
Description: Additional view of dewatering controls (straw bale corral with filter fabric and silt bag) and discharge from corral. Discharge was directed into infiltration swales on both sides of corral. Turbidity reading was higher than 50 NTUs, but discharge did not appear to be leaving the site. Facing east.

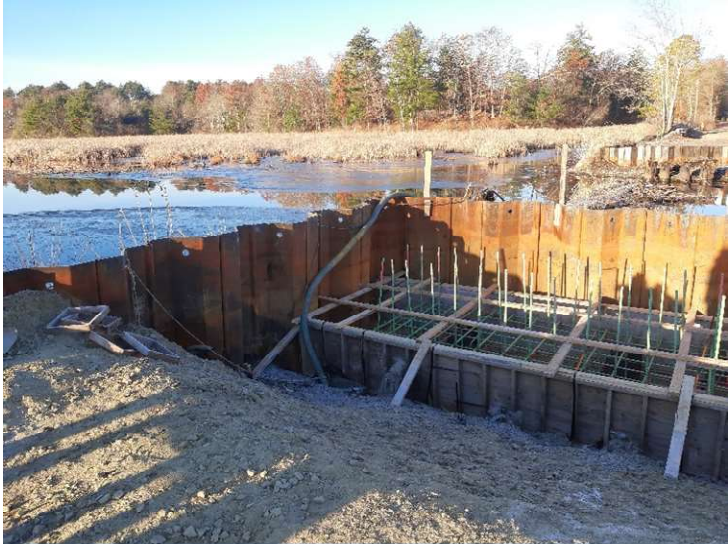
Description: View of area being pumped (i.e., cofferdam within segment 3 off Fort Meadow Brook), looking westward.

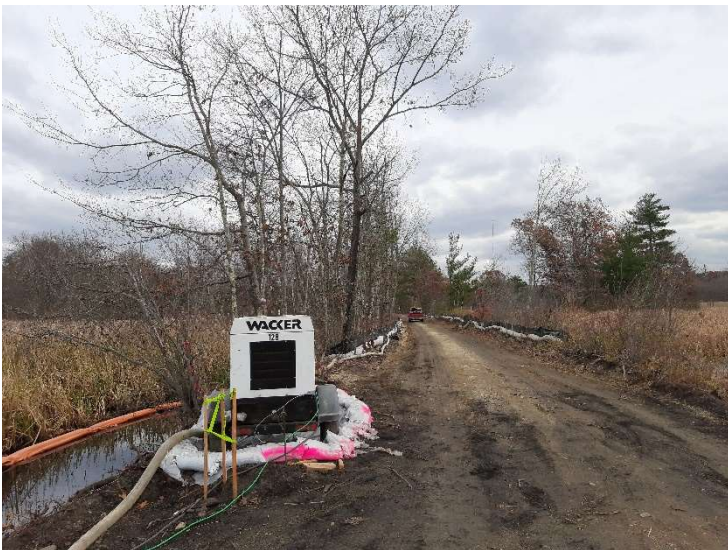
Description: Segment 3. View of dewatering operation. Looking eastward.

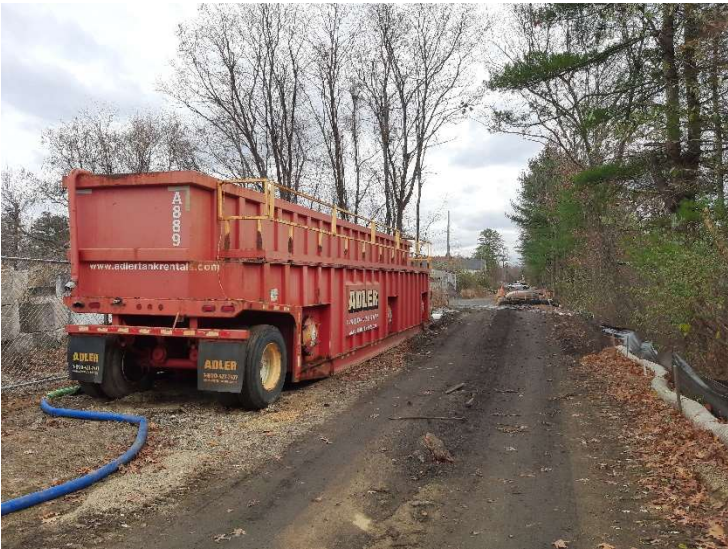
Photo No.: 3	Date: 11/21/2023		
Description: Segment 3. View of discharge dewatering operation, looking eastward. Hosing bypasses frack tank, frack tank not in use.

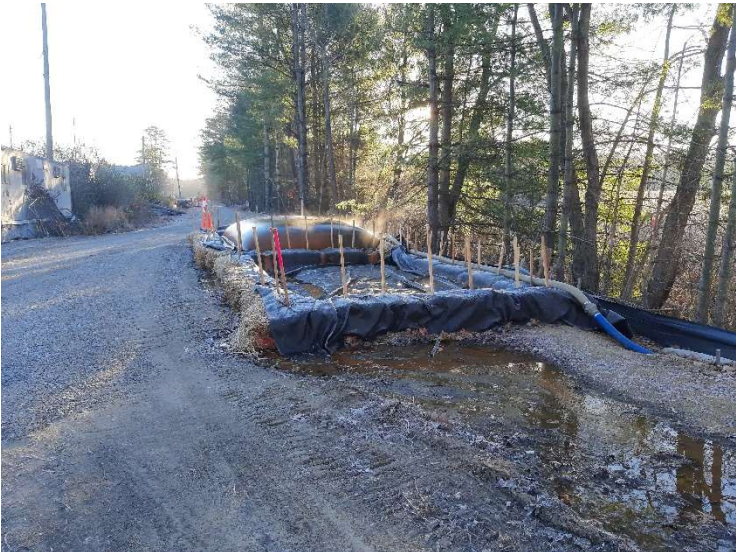
Photo No.: 4	Date: 11/21/2023		
Description: Segment 3. View of discharge from bag/bales to adjacent work area, looking eastward. Water discharge to bag intermittent. Discharge from corral to work area (foreground). Bag to be replaced at end of work day.

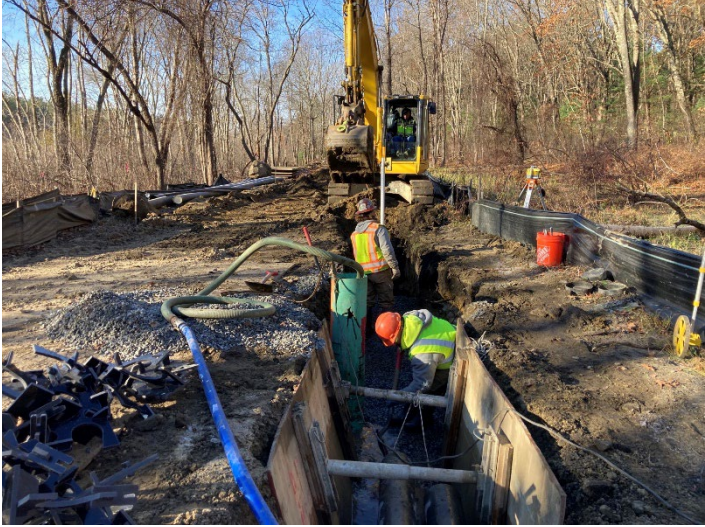
Description: View of Bond working in trench in segment 14. Facing west.

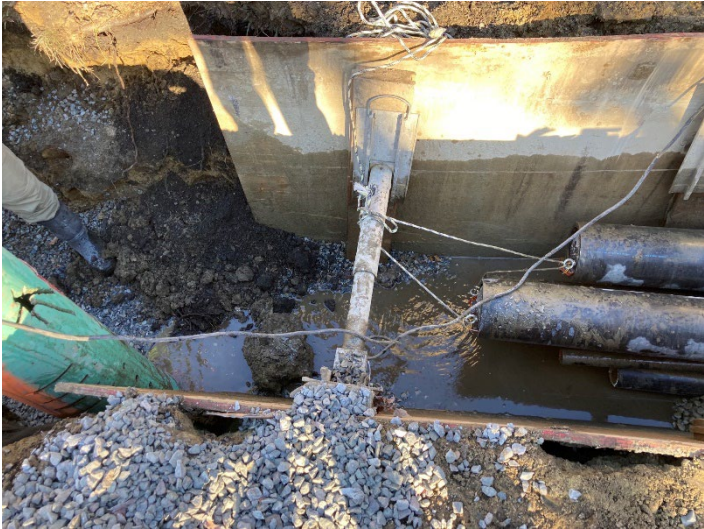
Description: View of pump in trench. Water appeared turbid prior to treatment.

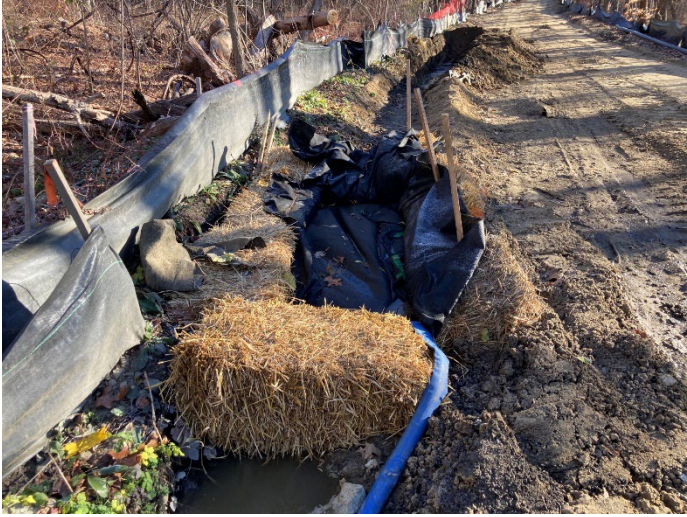
Description: View of dewatering controls (straw bale corral with filter fabric and silt bag). Facing east.

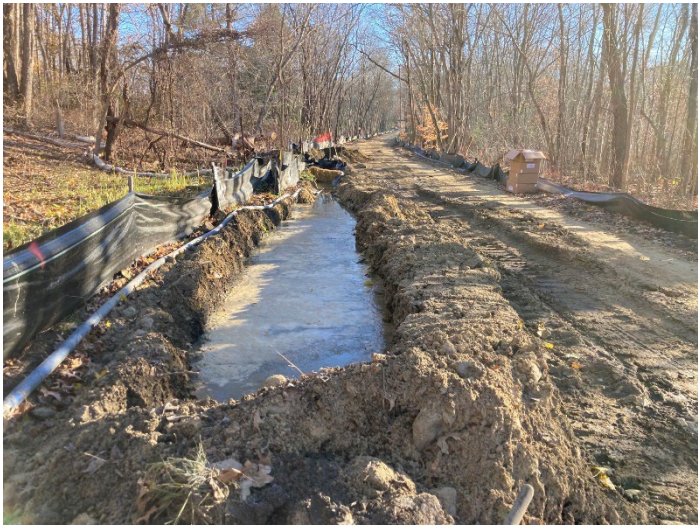
Description: View of discharge from corral. Discharge was directed into infiltration swales on both sides of corral. Turbidity reading was higher than 50 NTUs, but discharge did not appear to be leaving the site. Facing east.

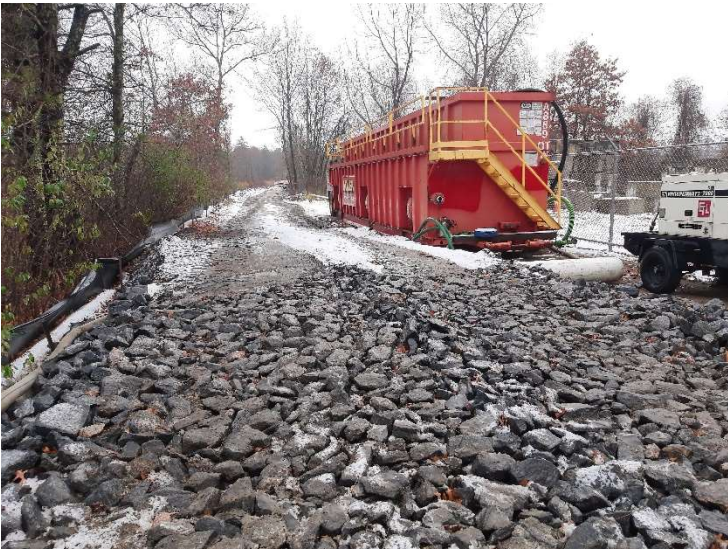
Description: Segment 3. View of discharge dewatering operation, looking westward. Hosing bypasses frack tank, frack tank not in use.
