Weekly Environmental Compliance Summary

Sudbury to Hudson Transmission Reliability Project (USEPA Tracking # MAR1003UW)

Week of: November 20, 2023 to November 24, 2023

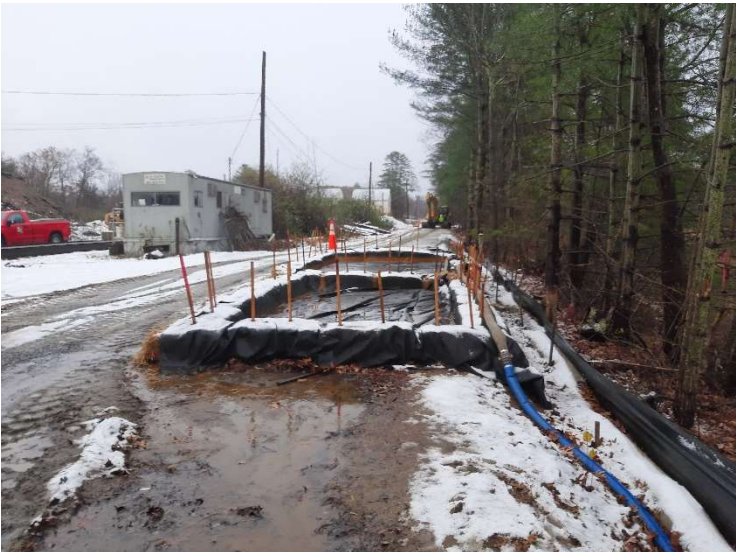
Description: Segment 3. View of discharge from bag/bales to adjacent work area, looking eastward. Water discharge to forward bag, intermittent. Discharge from corral to work area (foreground)..

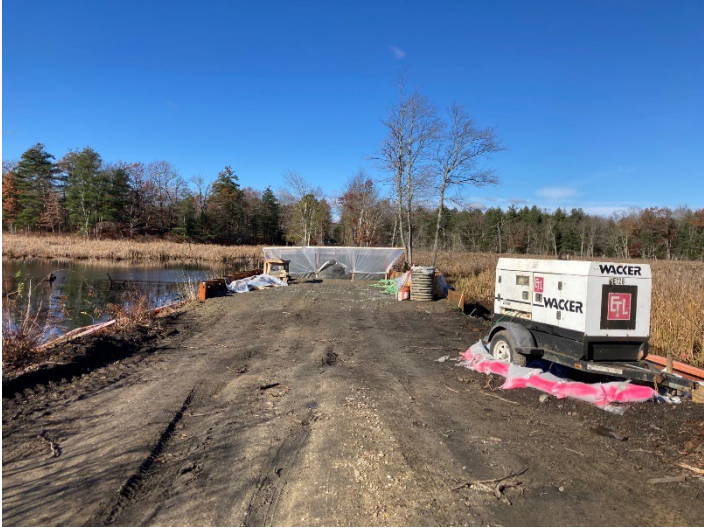
Description: View of work area and pumping operation at bridge 130 in segment 3. Facing west.

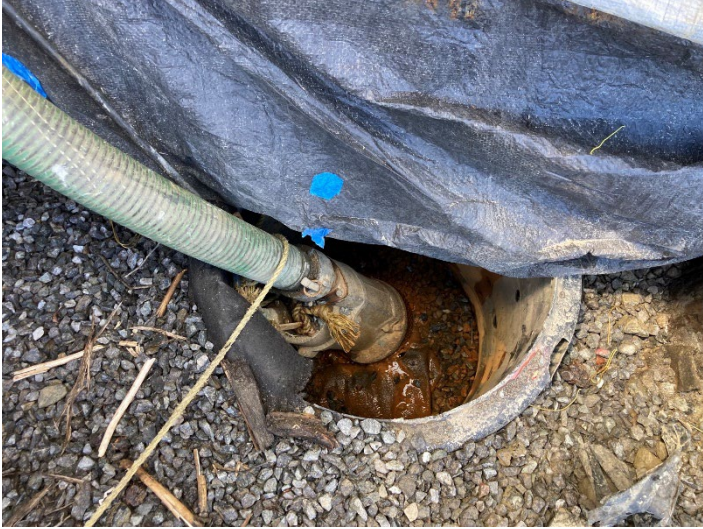
Description: View of pump. Water appeared mostly clear prior to treatment. Oxidizing bacteria observed in water.

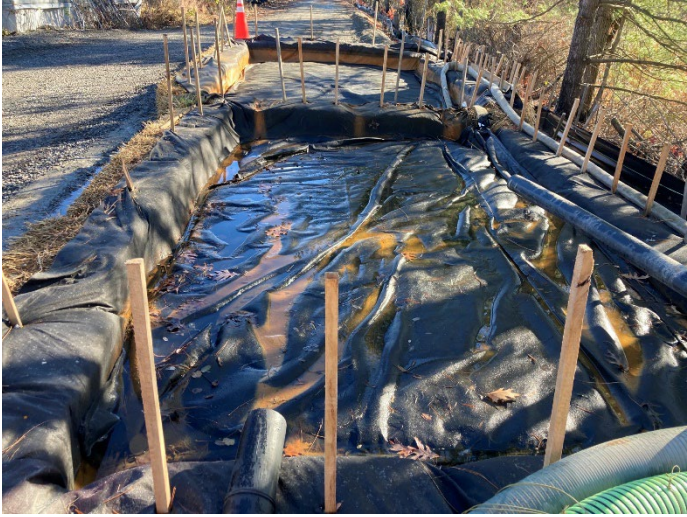
Description: View of dewatering controls (straw bale corral with filter fabric, stone, and silt bag). Facing east.

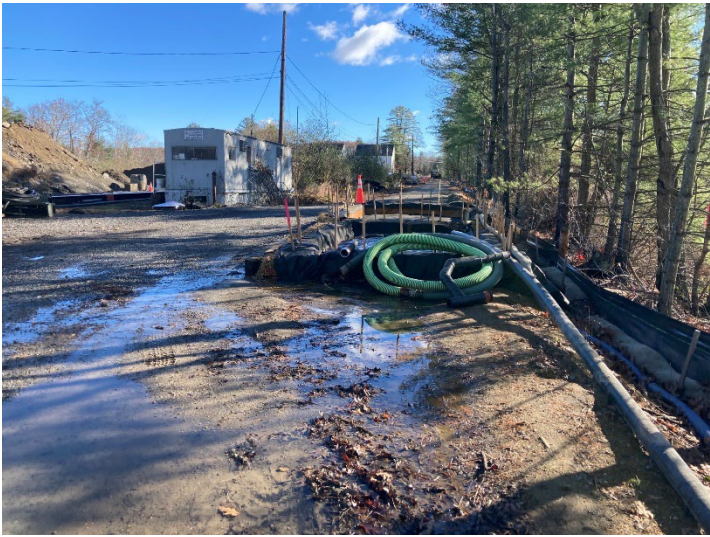
Description: View of discharge from controls. Discharge appeared mostly clear. Turbidity reading was below 50 NTUs. Discharge did not appear to be leaving the project at time of inspection. Facing east.

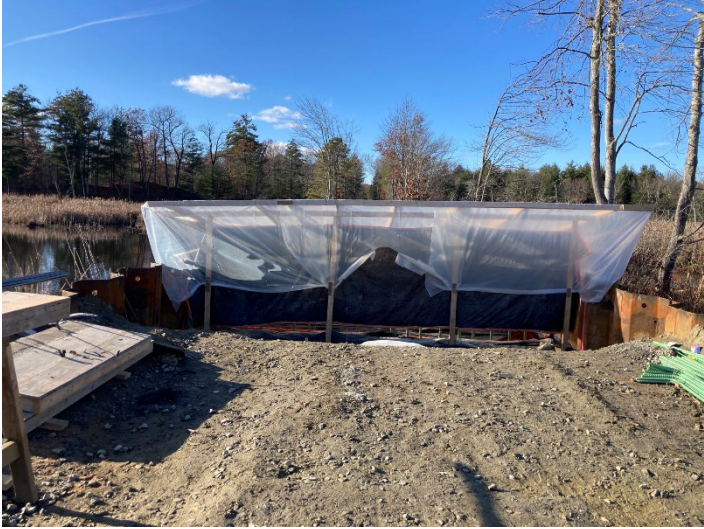
Description: View of work area and pumping operation at bridge 130 in segment 3. Facing west.

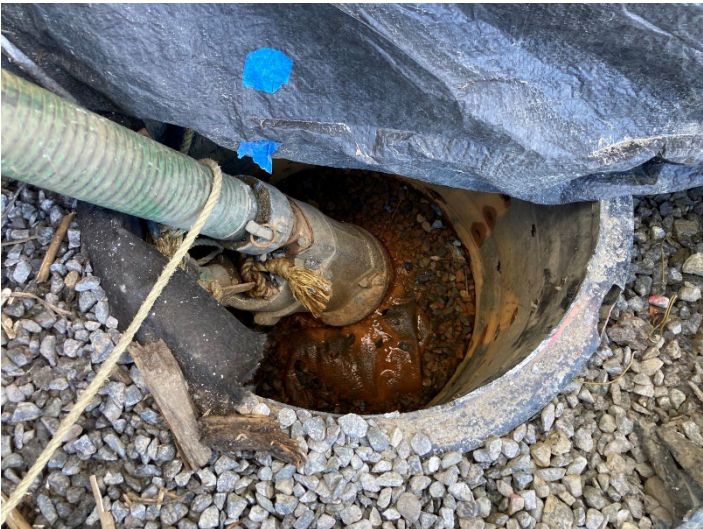
Description: View of pump. Water appeared mostly clear prior to treatment. Oxidizing bacteria observed in water.

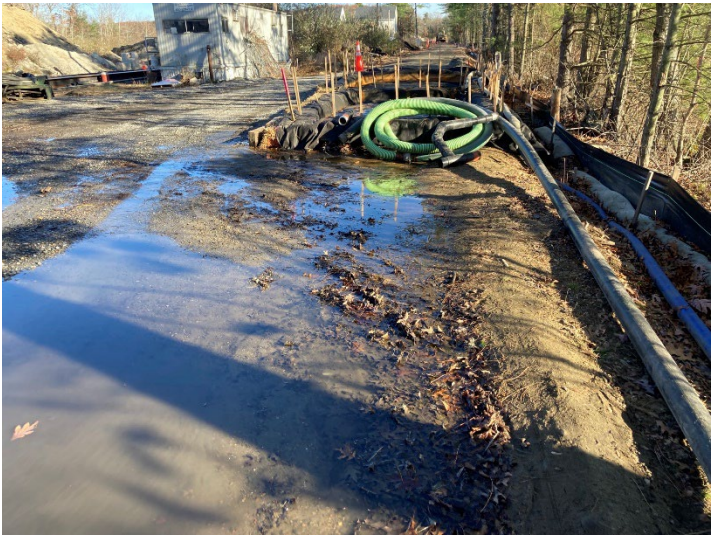
Description: View of discharge from controls. Discharge appeared mostly clear. Turbidity reading was below 50 NTUs. Discharge did not appear to be leaving the project at time of inspection. Facing east.

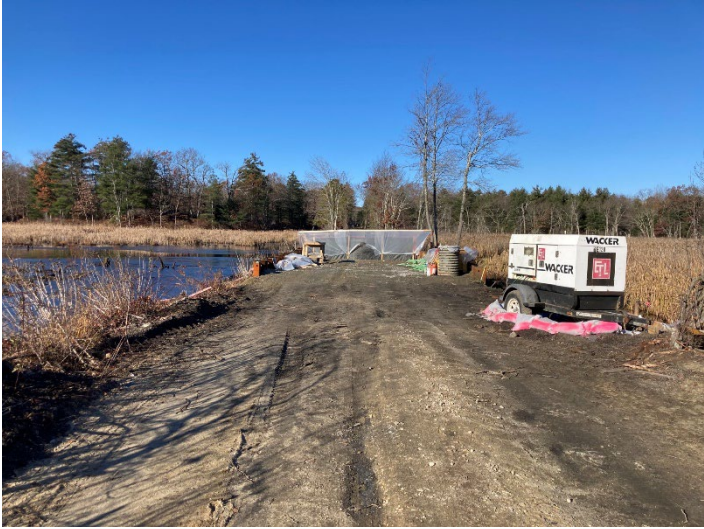
Description: View of work area and pumping operation at bridge 130 in segment 3. Facing west.

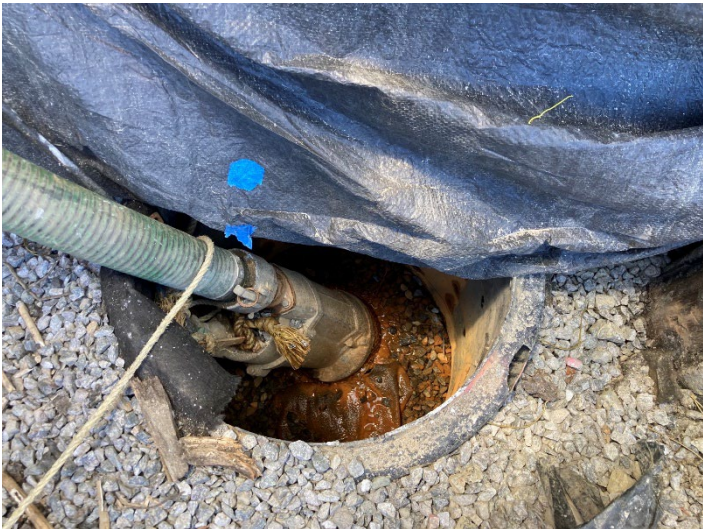
Description: View of pump. Water appeared mostly clear prior to treatment. Oxidizing bacteria observed in water.

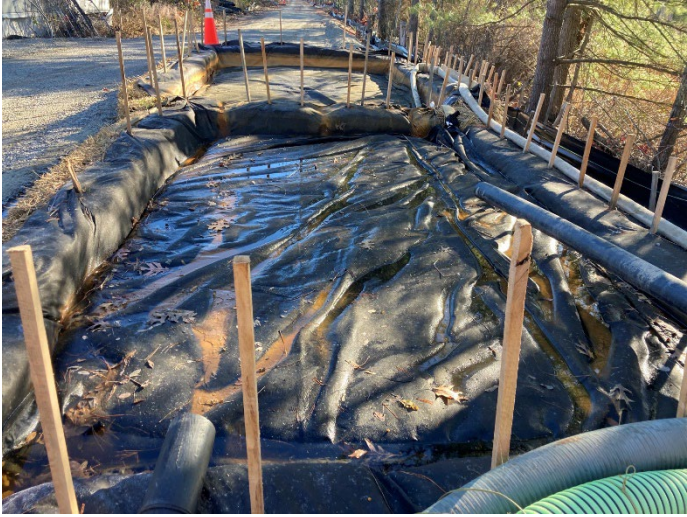
Description: View of dewatering controls (straw bale corral with filter fabric, stone, and silt bag). Facing east.

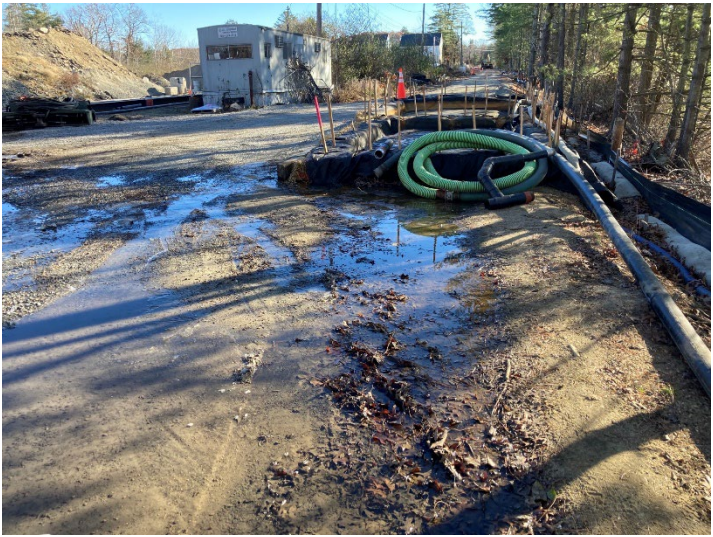
Description: View of discharge from controls. Discharge appeared mostly clear. Turbidity reading was below 50 NTUs. Discharge did not appear to be leaving the project at time of inspection. Facing east.

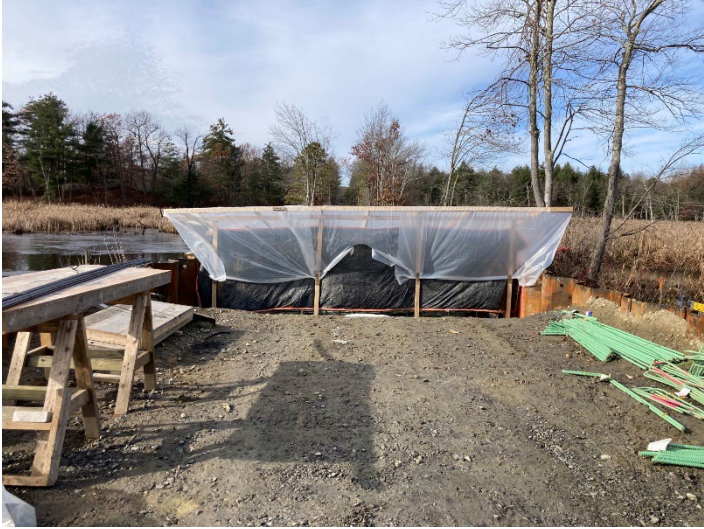
Description: View of work area and pumping operation at bridge 130 in segment 3. Facing west.

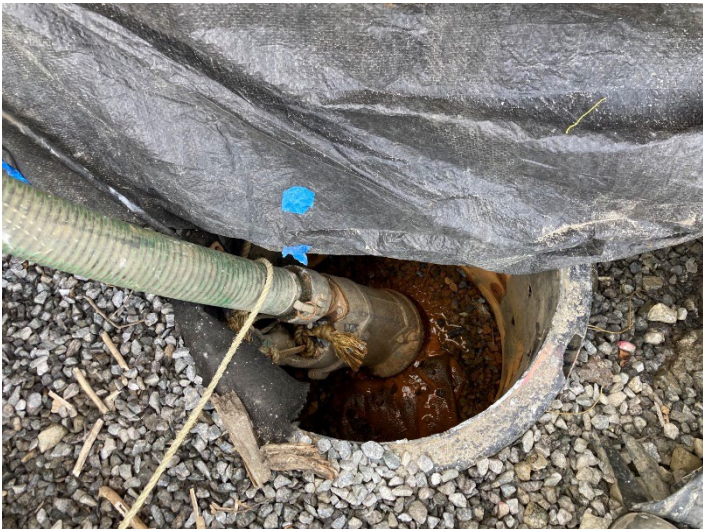
Description: View of pump. Water appeared mostly clear prior to treatment. Oxidizing bacteria observed in water.

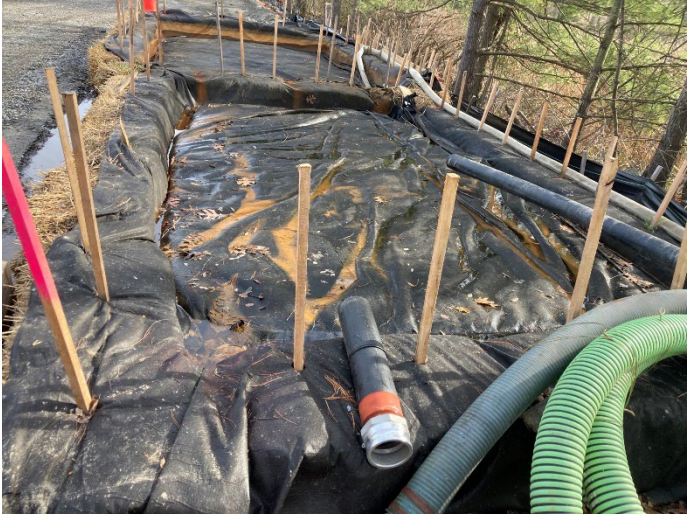
Description: View of dewatering controls (straw bale corral with filter fabric, stone, and silt bag). Facing east.

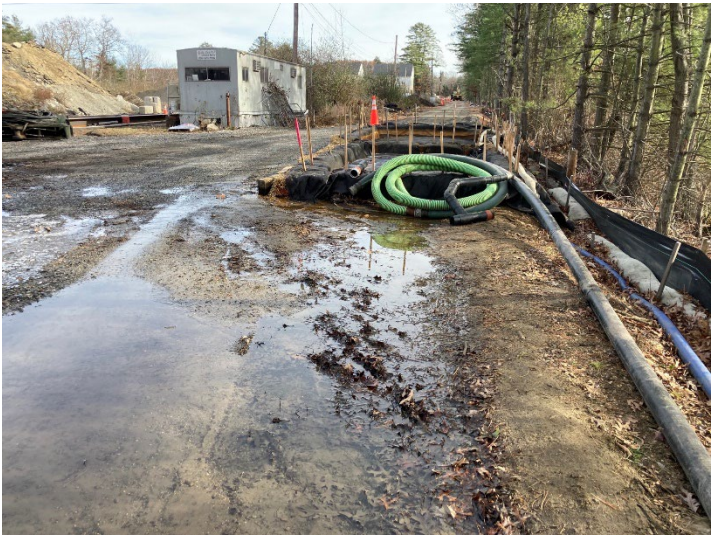
Description: View of discharge from controls. Discharge appeared mostly clear. Turbidity reading was below 50 NTUs. Discharge did not appear to be leaving the project at time of inspection. Facing east.
