Assessment of Trees in Buffer Zone

Anthony Moro
38 Robert Frost Road
Sudbury, MA 01776

Revised November 7, 2023

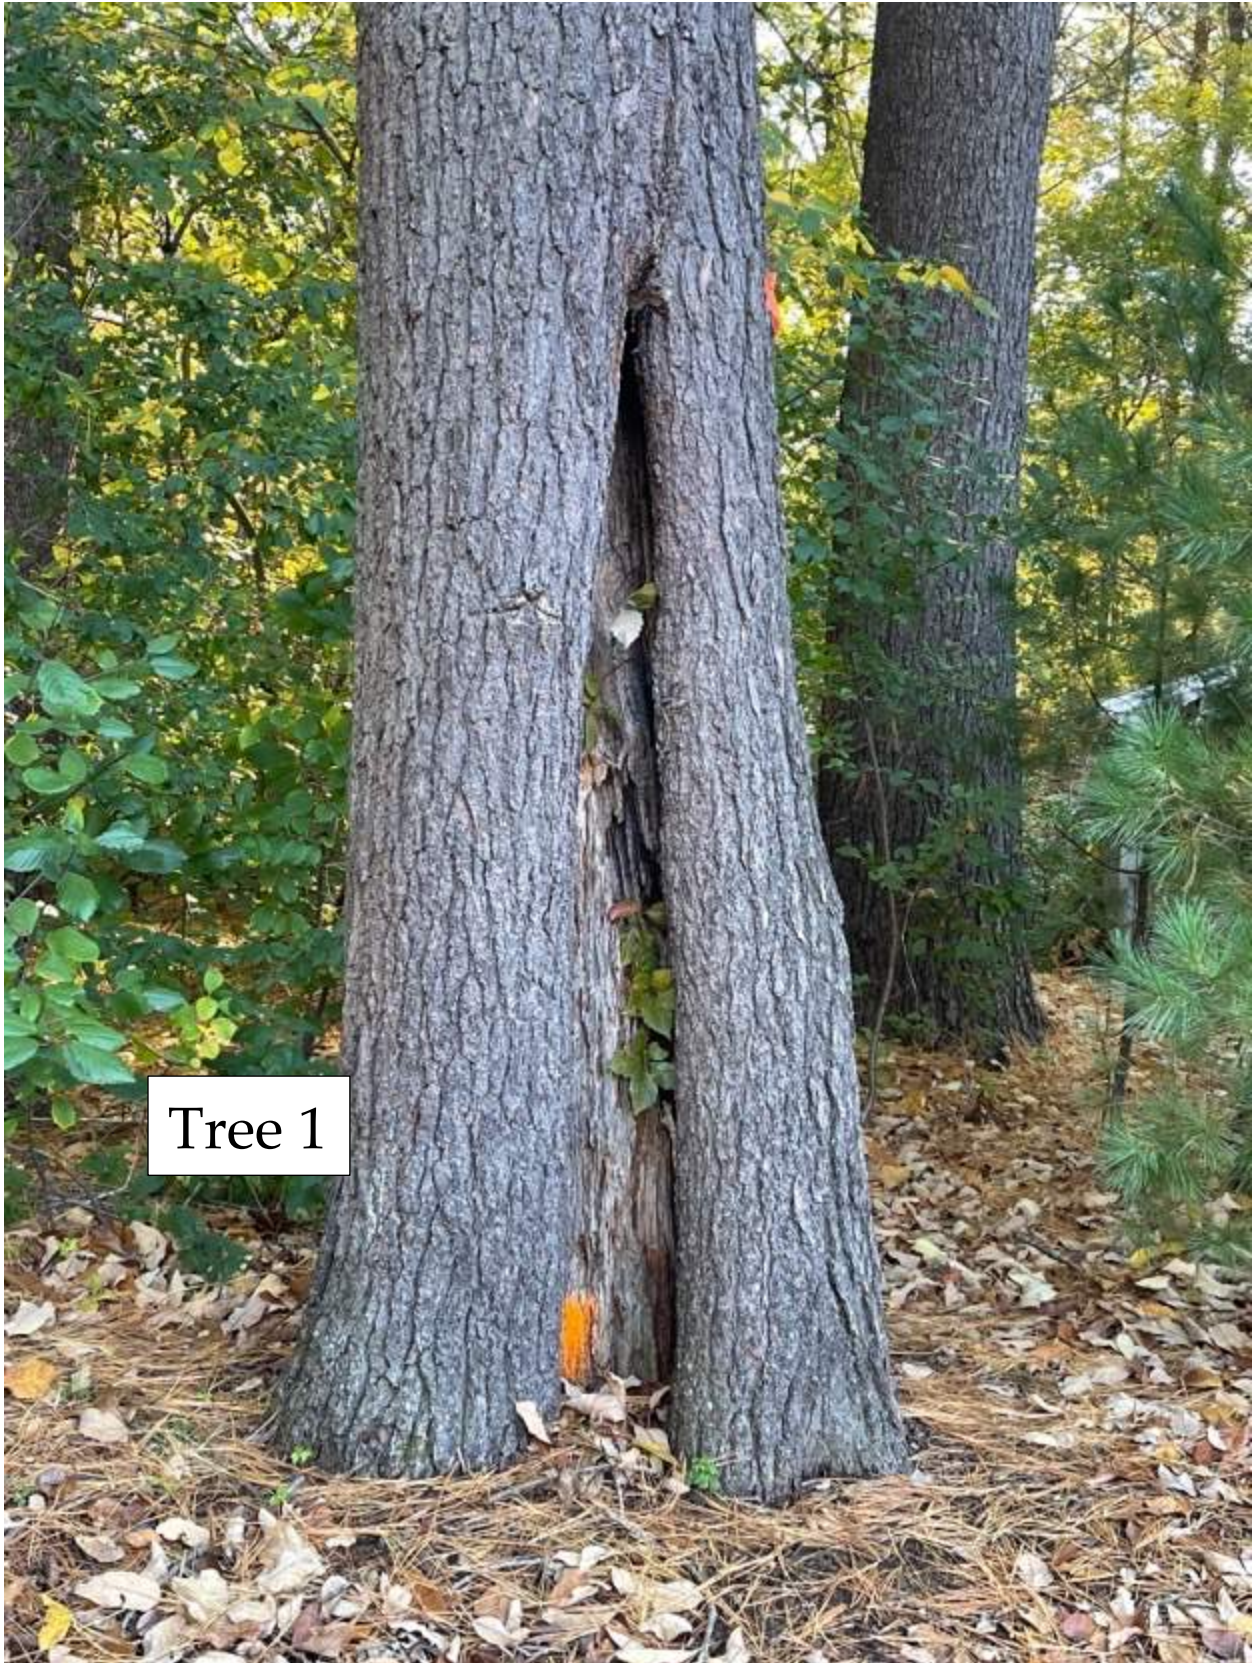
Tree 1

Tree #1 has a large cavity at the base of the trunk and a poor live crown ration (“LCR”).

Trees #1, #3, #24 & #25 currently pose a high-risk to the site and should be removed at earliest convenience.

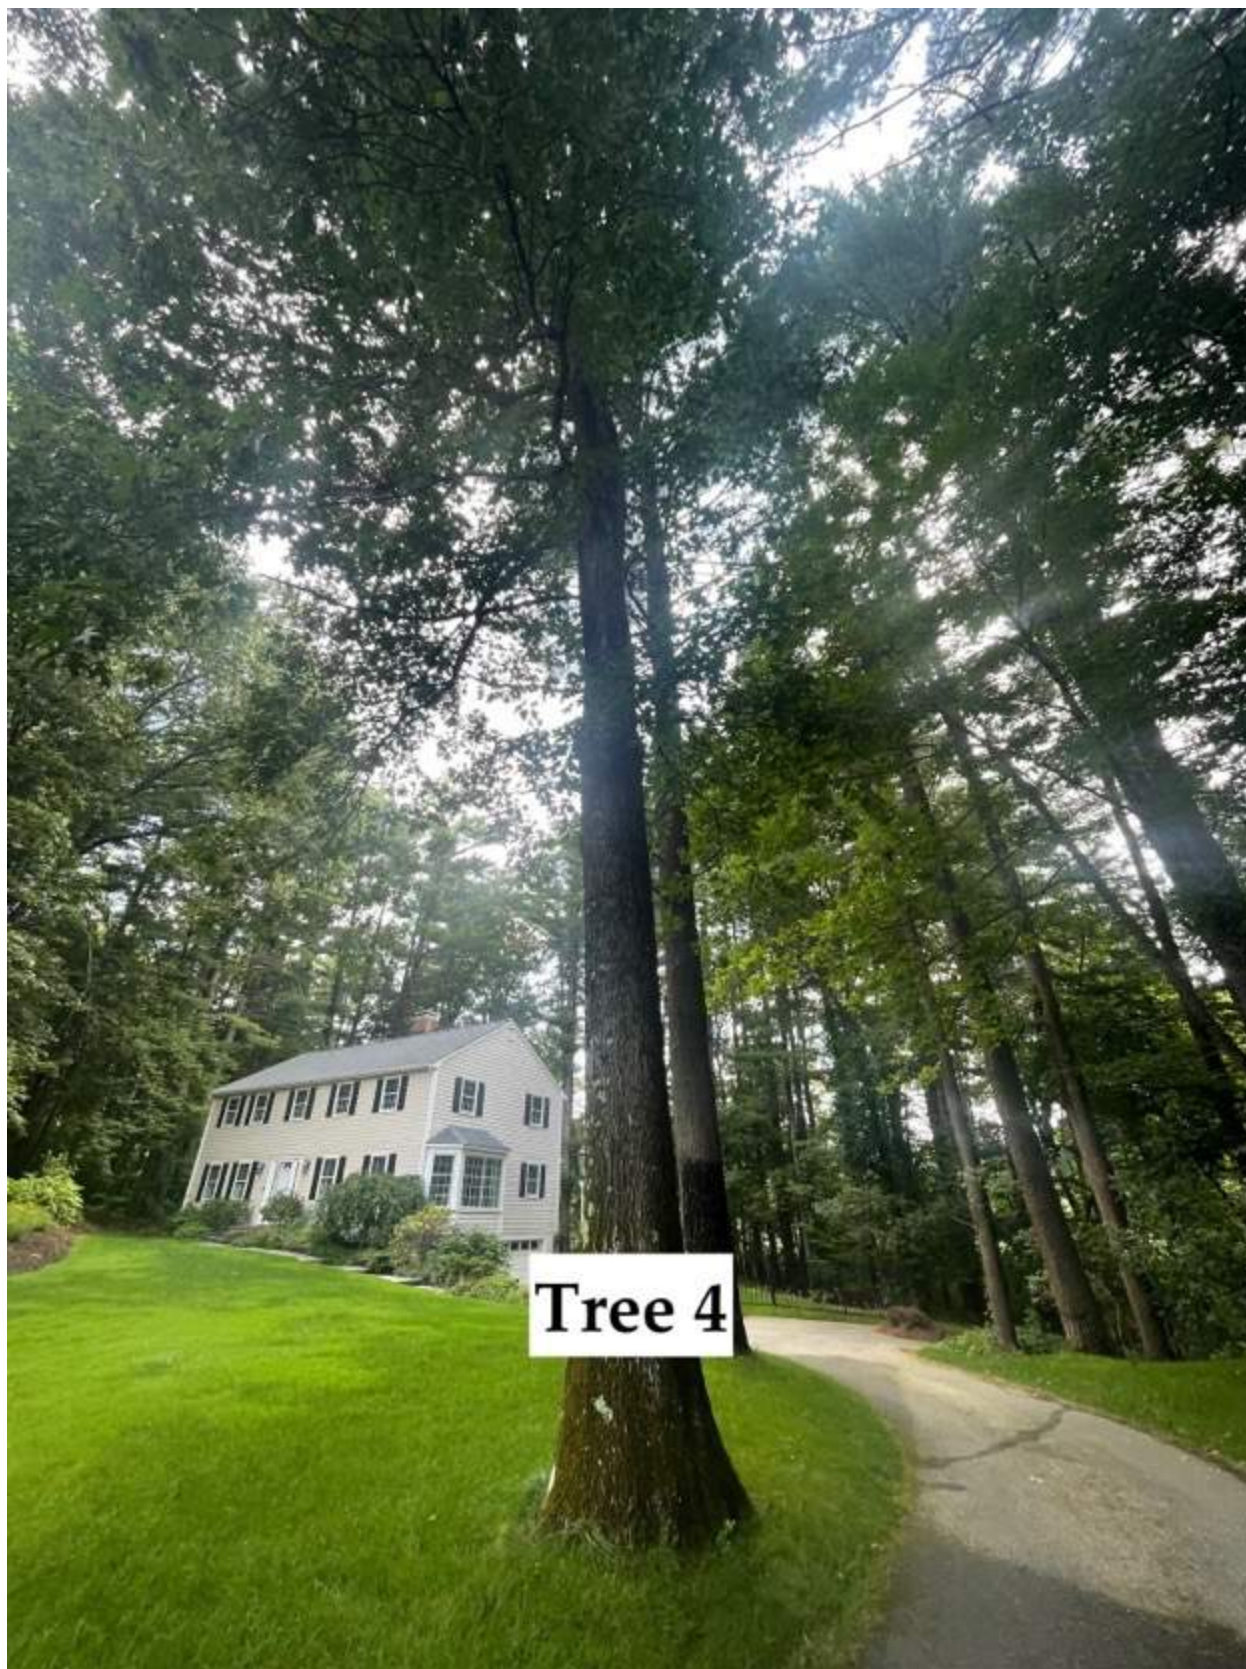
Tree 4

Tree #4 has some impact from the driveway and due to its size failure is a concern.

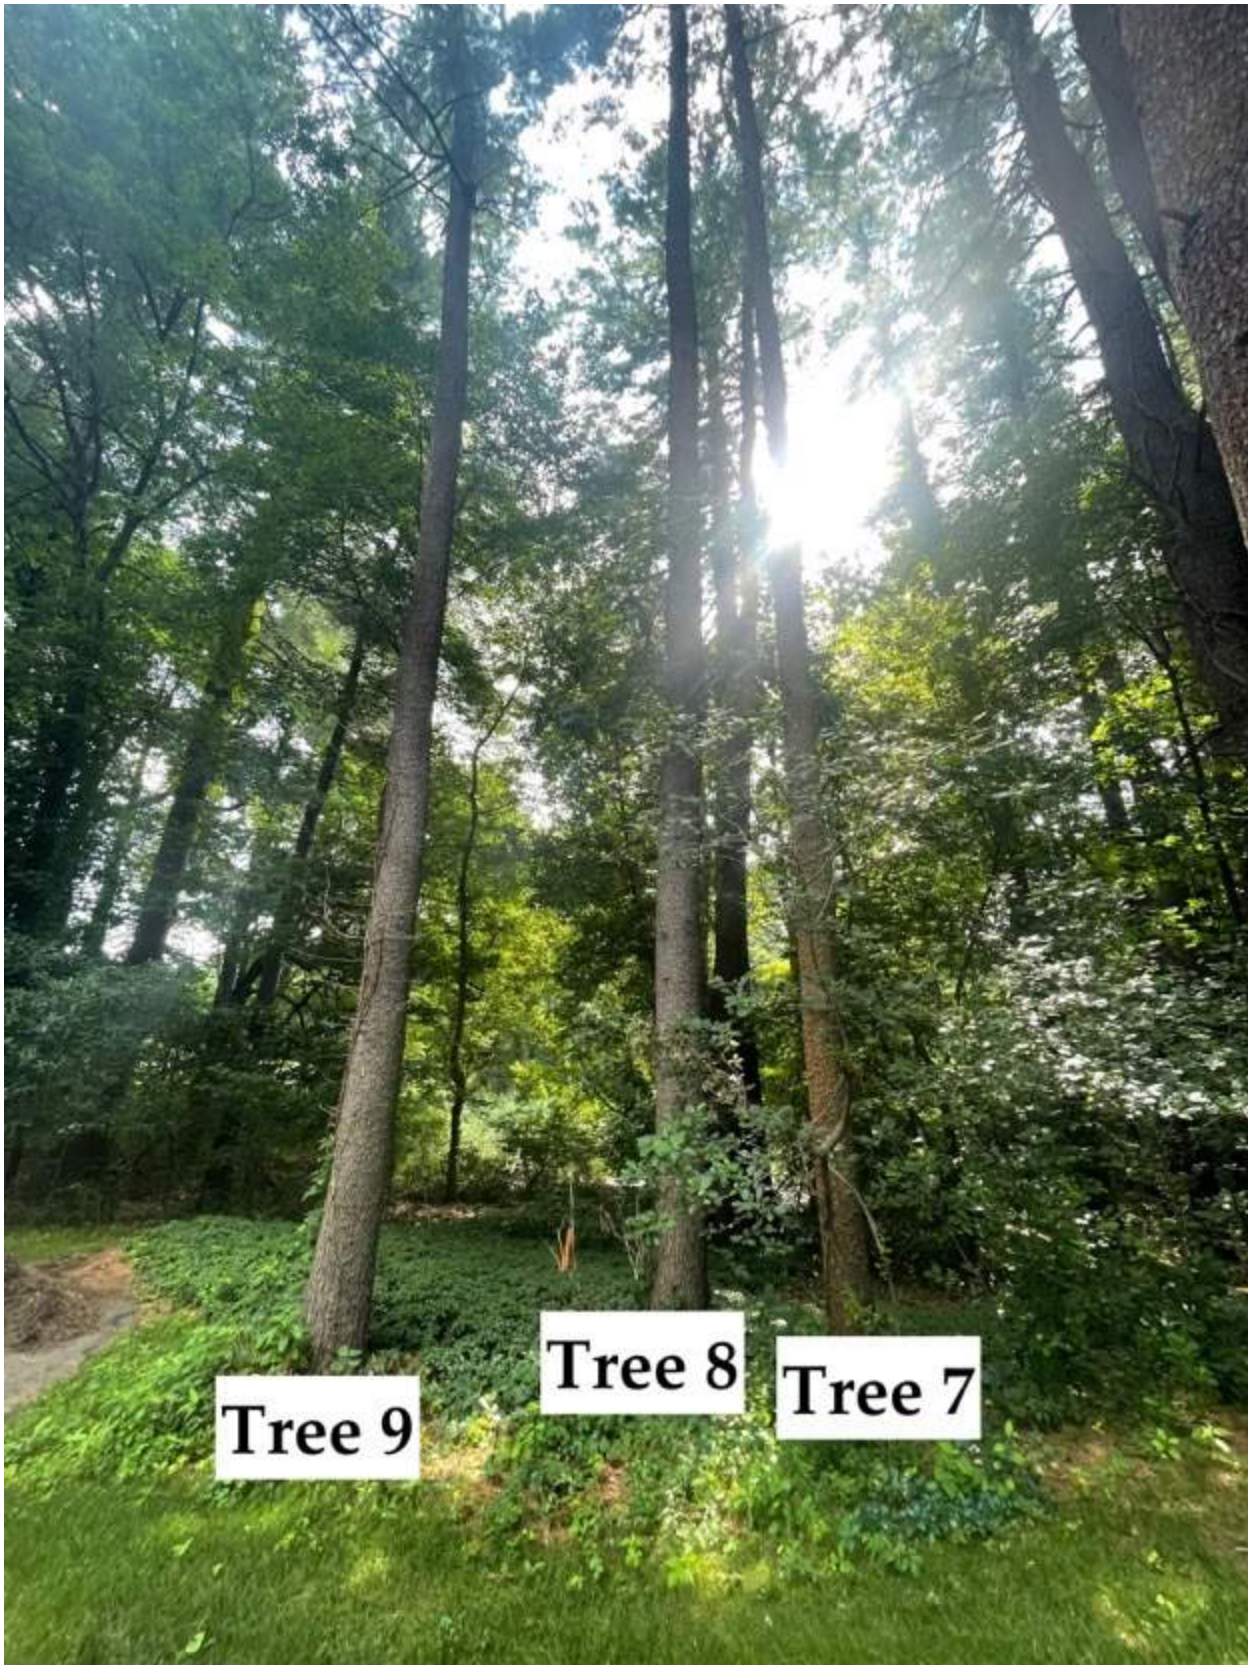
Tree 9

Tree #7 has a poor LCR and poor trunk taper.

Tree #8 has a poor LCR and poor trunk taper.

Tree #9 has a poor LCR and poor trunk taper.

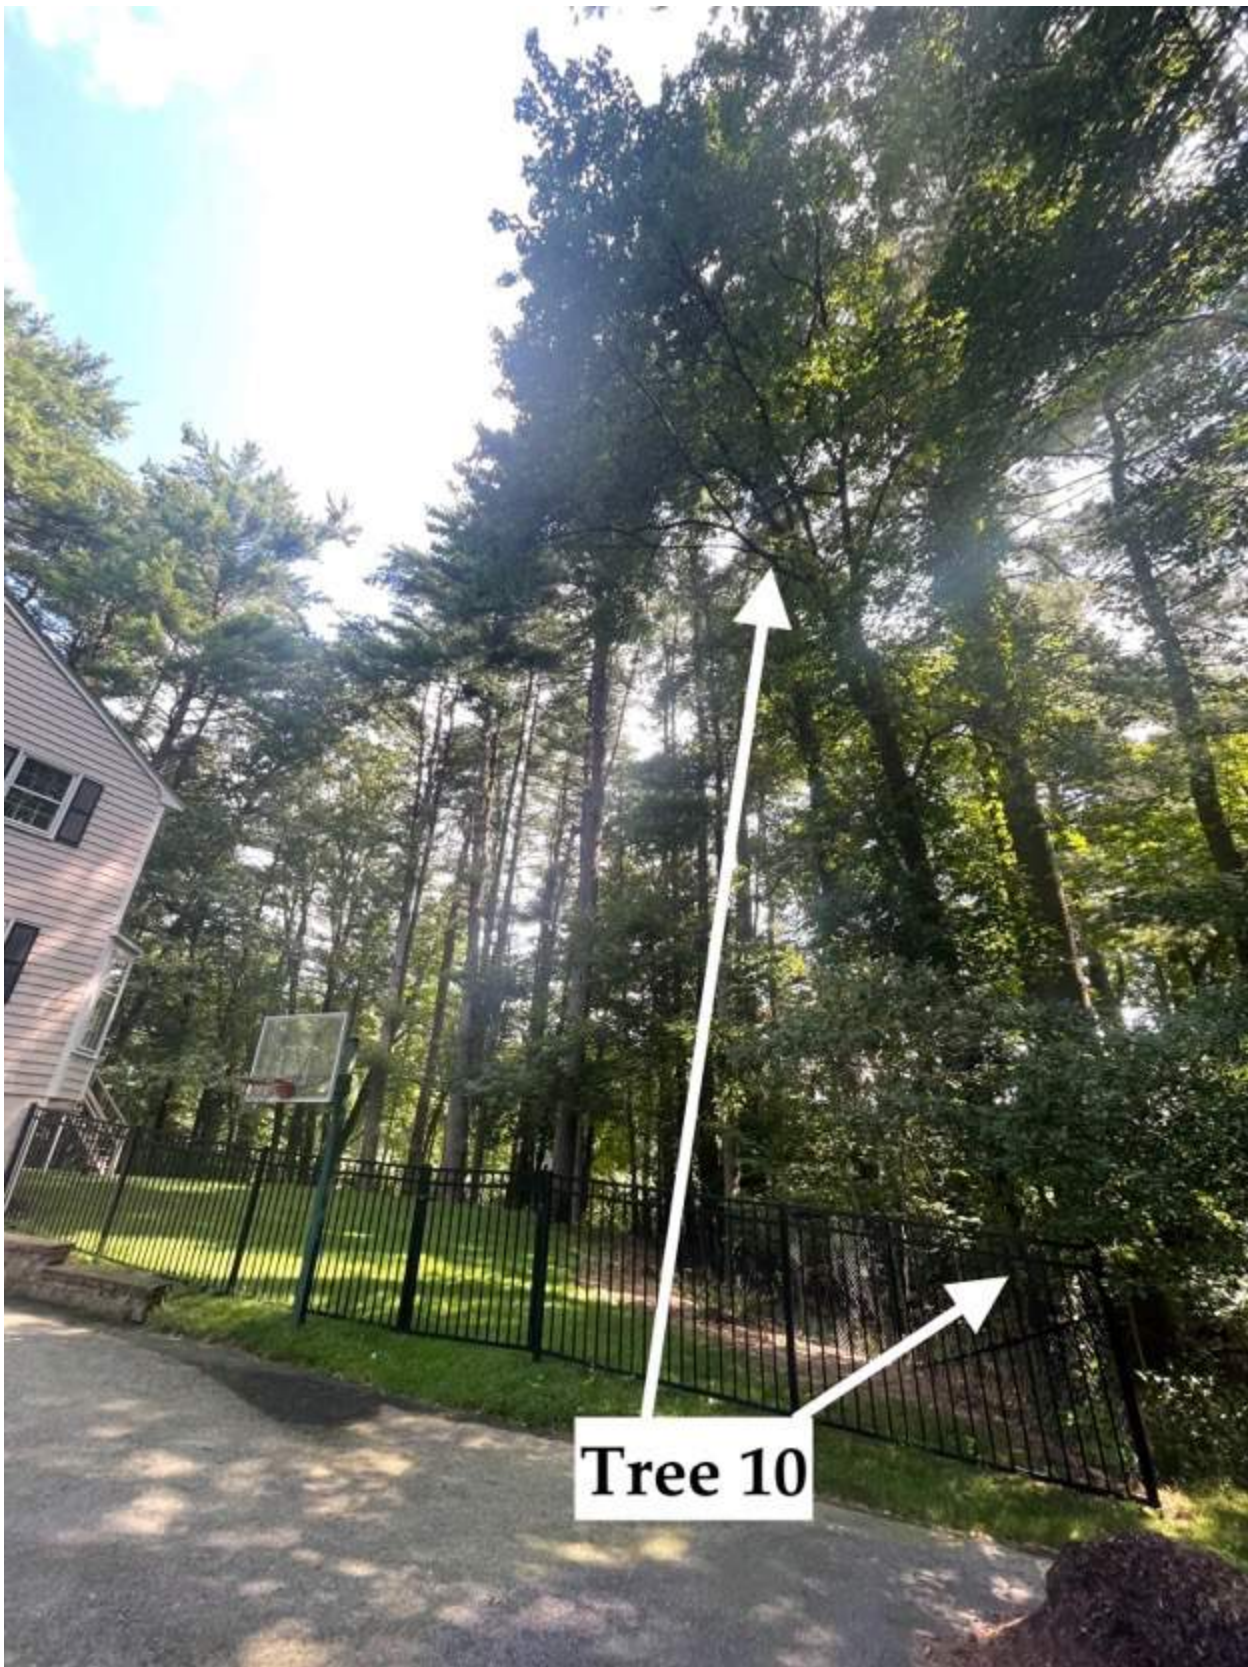
Tree 10

Tree #10 has a significant lean over the property. **If pruning is performed to eliminate the lean over the driveway, not enough viable live material will remain to sustain the tree and it will decline and die.**

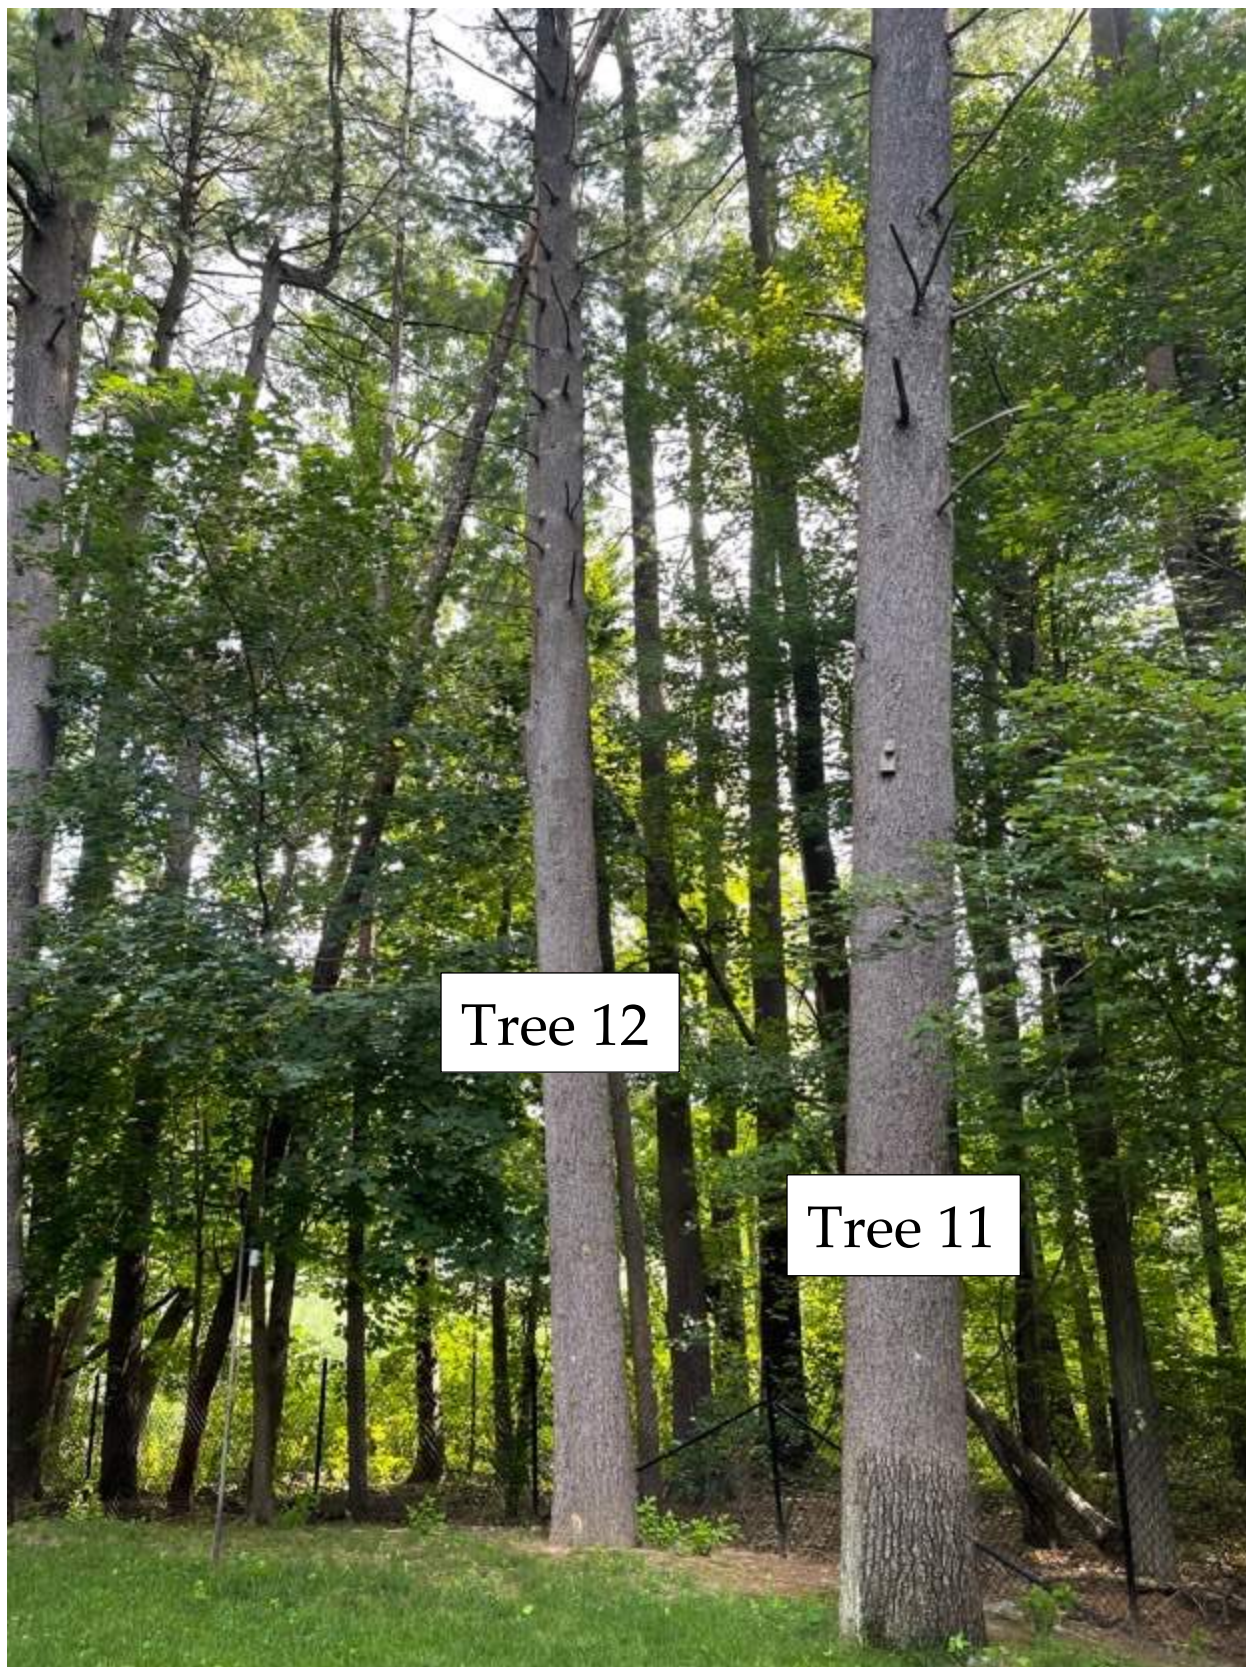
Tree 12

Tree #11 has had its root collar buried during a previous regrading of the rear yard.

Tree #12 has had its root collar buried during a previous regrading of the rear yard.
