Weekly Environmental Compliance Summary

Sudbury to Hudson Transmission Reliability Project (USEPA Tracking # MAR1003UW)

Sudbury, Hudson, and Stow, MA

Week of: November 27, 2023 to December 1, 2023

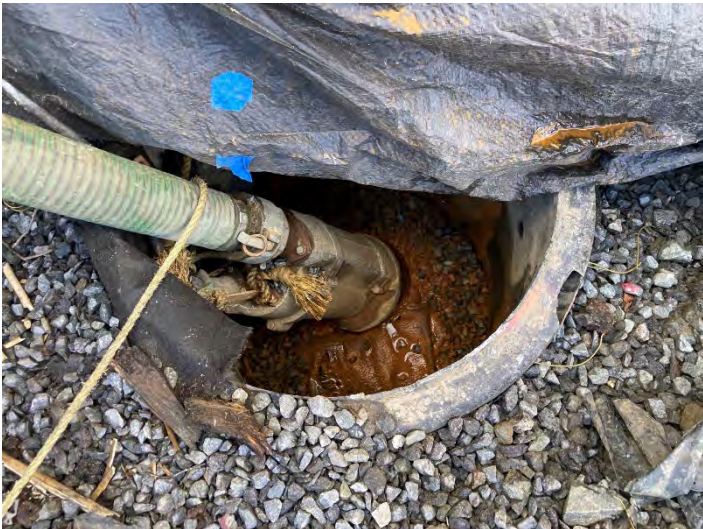
| Description: View of pump. Water appeared mostly clear prior to treatment. Oxidizing bacteria observed in water. | | | |

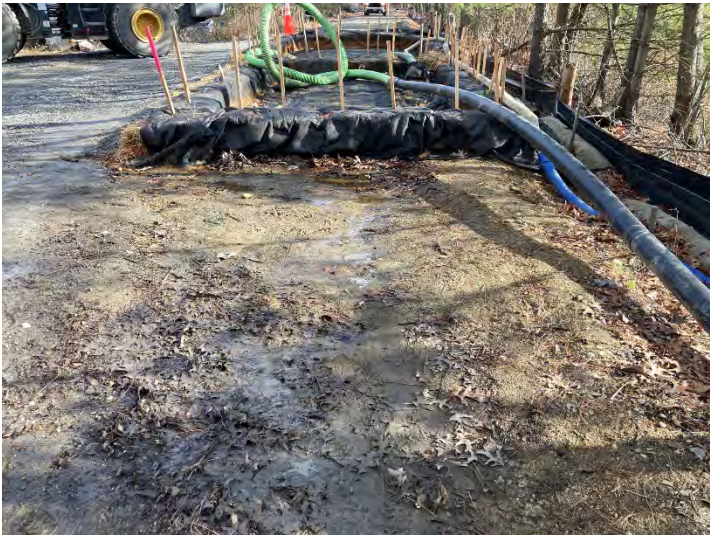
| Description: View of discharge from controls. Discharge appeared mostly clear. Turbidity reading was below 50 NTUs. Discharge did not appear to be leaving the project at time of inspection. Facing east. | | | |

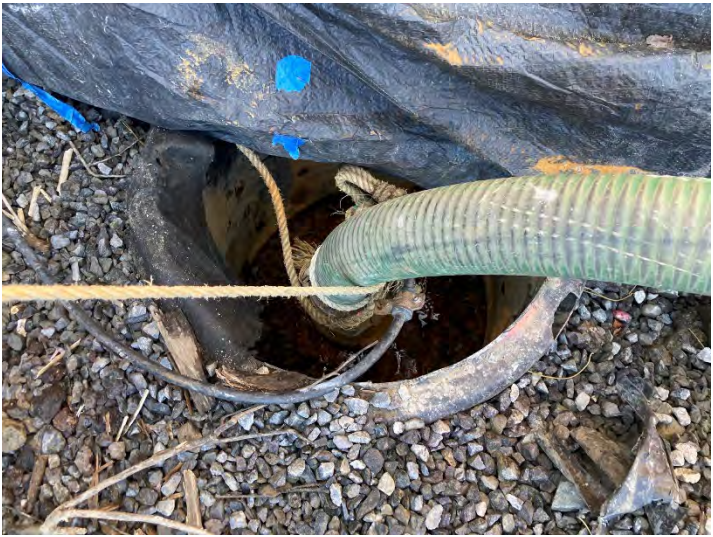
| Description: View of pump in segment 3. Water appeared mostly clear prior to treatment. Oxidizing bacteria observed in water. | | | |

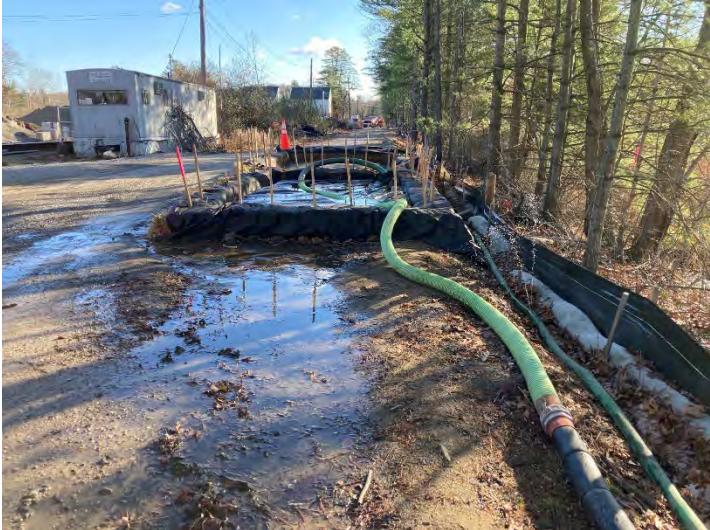
| Description: View of discharge from controls. Discharge appeared mostly clear. Turbidity reading was below 50 NTUs. Discharge did not appear to be leaving the project at time of inspection. Facing east. | | | |

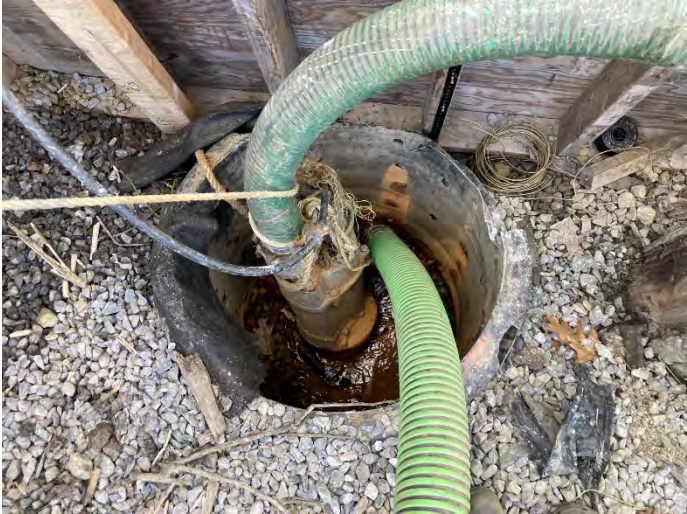
| Description: View of pump in segment 3. Water appeared mostly clear prior to treatment. Oxidizing bacteria observed in water. | | | |

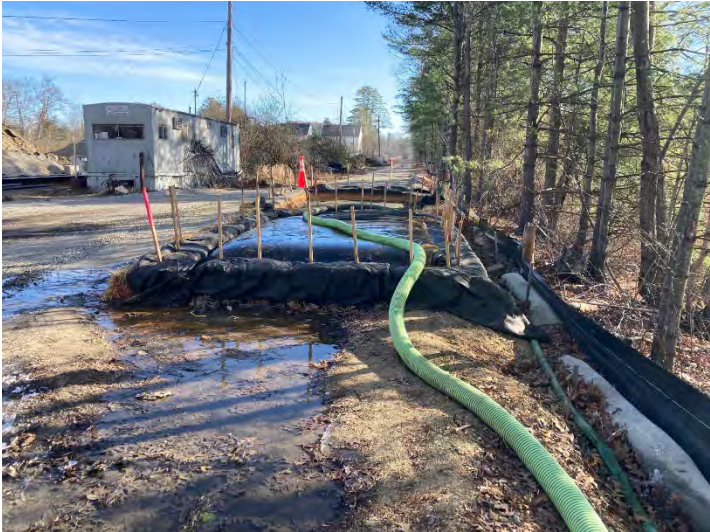
| Description: View of discharge from controls. Discharge appeared mostly clear. Turbidity reading was below 50 NTUs. Discharge did not appear to be leaving the project at time of inspection. Facing east. | | | |

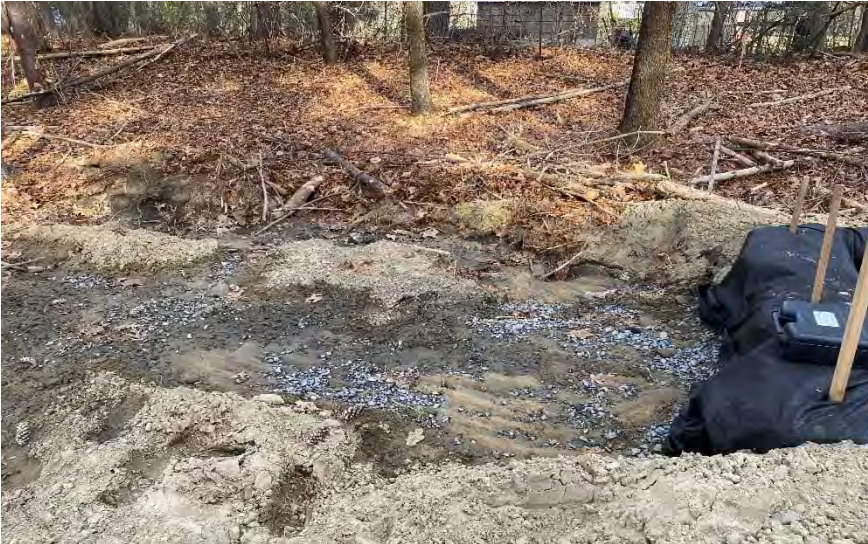
| Description: Manhole #21. View of discharge bag/bales, looking westward. Water discharge to bag intermittent and flow from corral to adjacent work area. | | | |

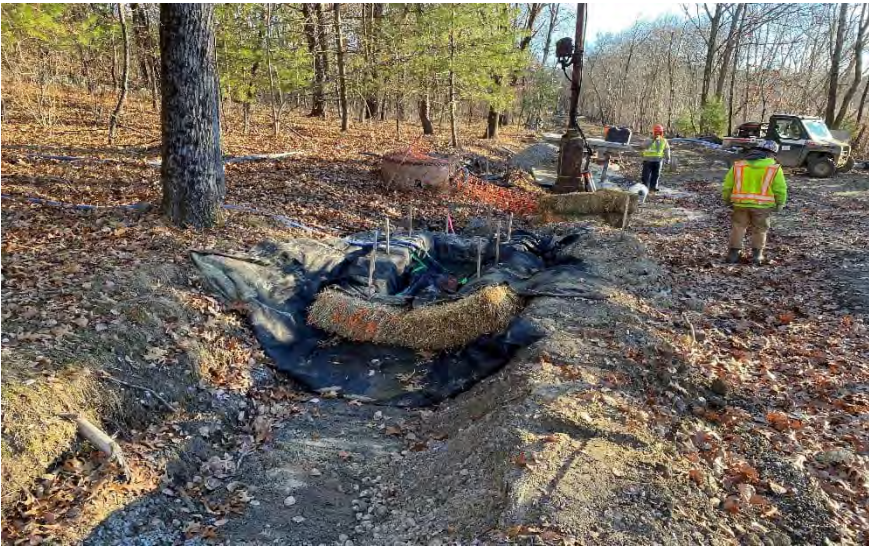
| Description: Manhole #26. View of discharge bag/bales, looking eastward. Water discharge to bag intermittent and flow from corral to adjacent work area trench. | | | |

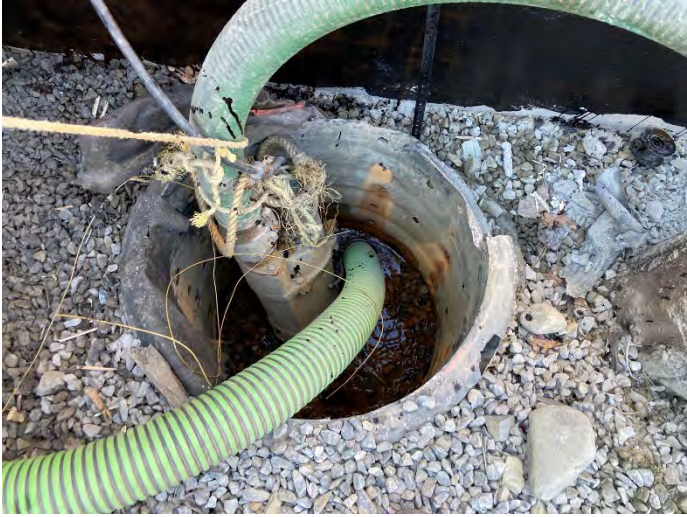
| Description: View of pump in segment 3. Water appeared mostly clear prior to treatment. Oxidizing bacteria observed in water. | | | |

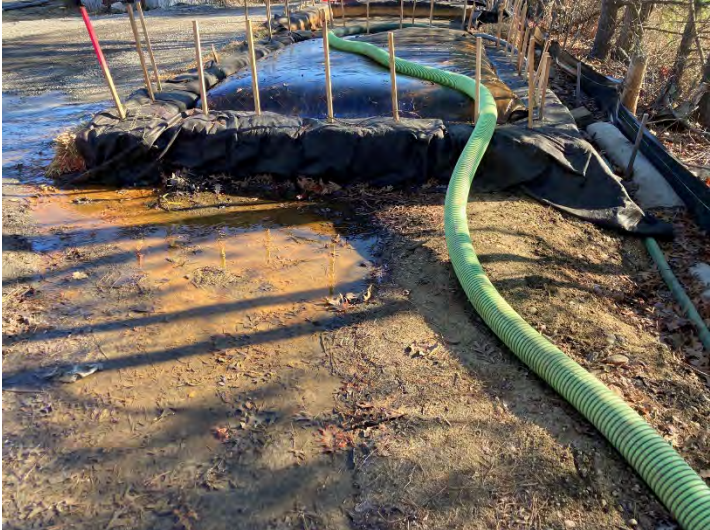
| Description: View of discharge from controls. Discharge appeared mostly clear. Turbidity reading was below 50 NTUs. Discharge did not appear to be leaving the project at time of inspection. Facing east. | | | |

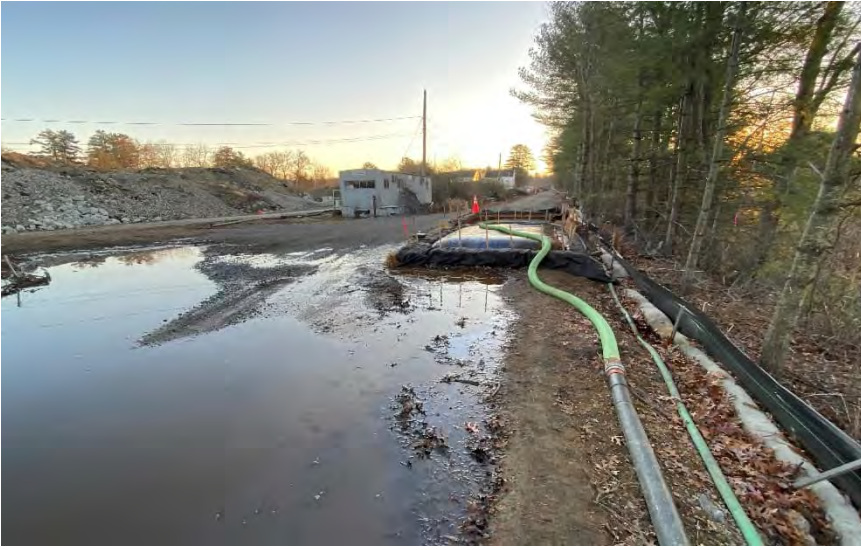
| Description: Segment 3. View of discharge from bag/bales to adjacent work area, looking eastward. Water discharge to bag intermittent and appeared to be slightly turbid. Discharge from corral to work area (foreground). | | | |

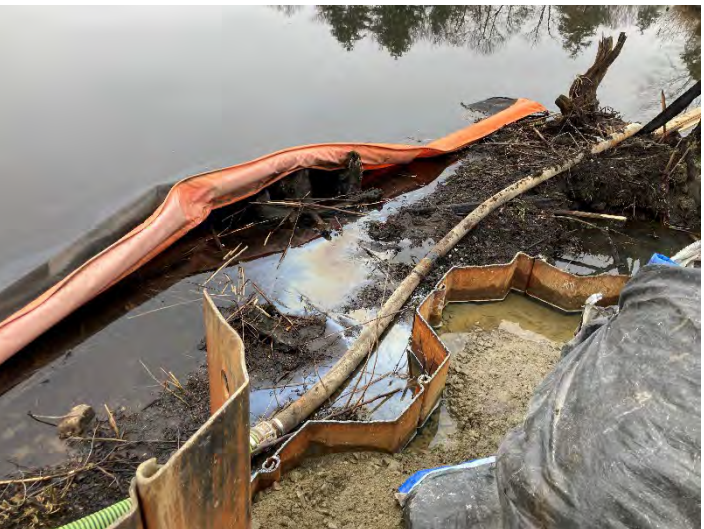
| Description: Sheen noted in Fort Meadow Brook at bridge 130 on segment 3 side. It is believed that sheen is being caused by naturally occurring oxidizing bacteria. Facing southwest. | | | |

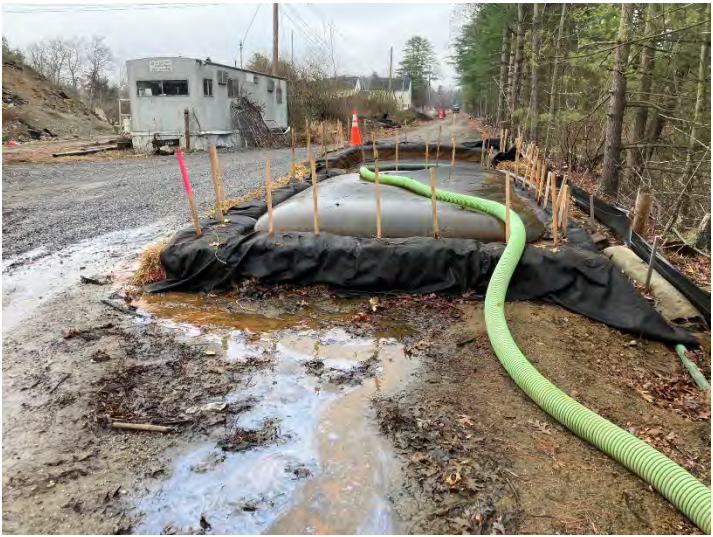
| Description: View of discharge from controls. Sheen noted at discharge but believed to be from naturally occurring oxidizing bacteria. Discharge appeared mostly clear below sheen. Turbidity reading was below 50 NTUs. Discharge did not appear to be leaving the project at time of inspection. Facing east. | | | |
