**Weekly Environmental Compliance Summary**

**Sudbury to Hudson Transmission Reliability Project (USEPA Tracking # MAR1003UW)**

Sudbury, Hudson, and Stow, MA

Week of: December 4, 2023 to December 8, 2023

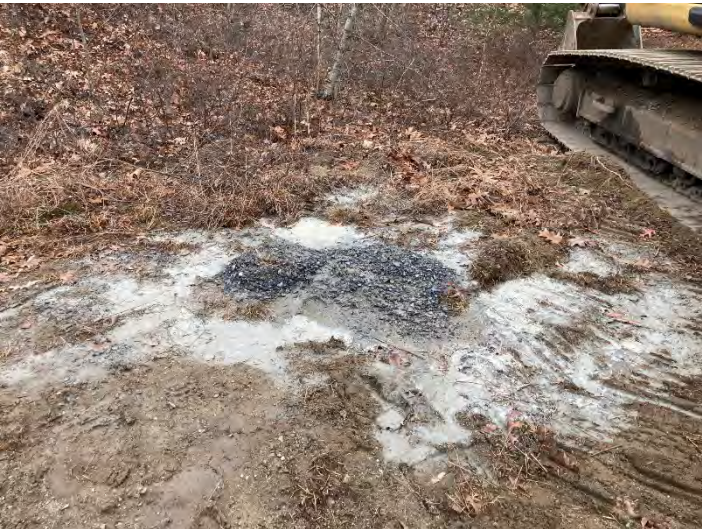
<b>PHOTOGRAPHIC LOG</b>	
Client Name: Eversource		Site Location: Sudbury to Hudson Transmission Reliability Project	Town: Hudson
Photo No.: 4	Date: 12/05/2023

<b>Description:</b> Fresh concrete leavings noted on ground along Water Supply Road near segment 2. Please ensure all concrete trucks washout into lined pit if washout onsite is needed. Facing northeast.

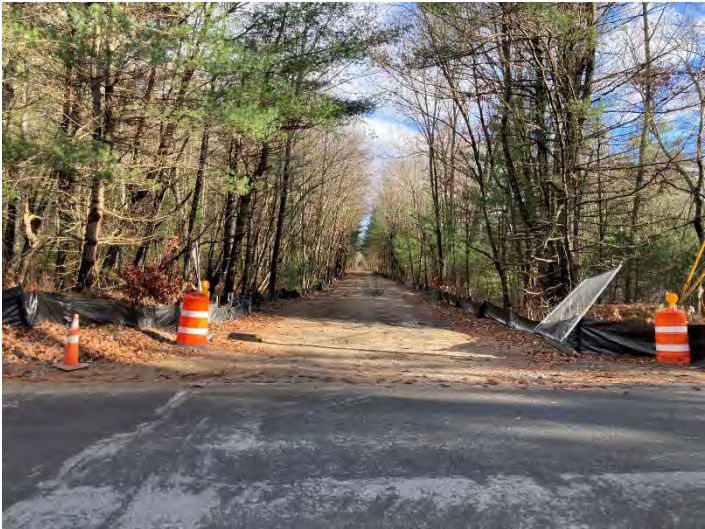
Description: View of construction entrance to segment 6 at White Pond Rd. It is recommended that fresh stone is applied to entrance pad. No sediment tracked noted at this time. Facing east.

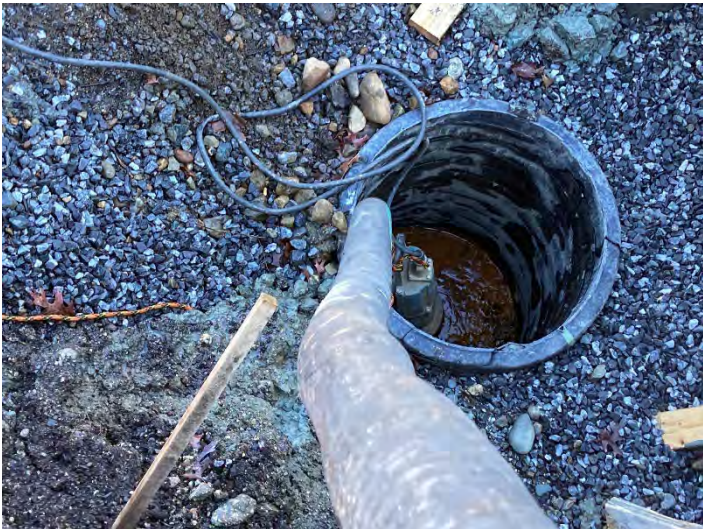
Description: View of pump. Water appeared mostly clear prior to treatment. Oxidizing bacteria noted.

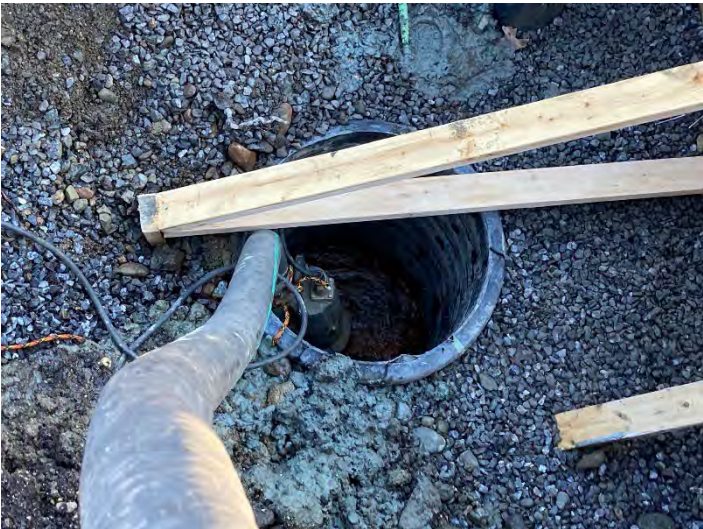
Description: View of pump. Water appeared mostly clear prior to treatment. Oxidizing bacteria noted.

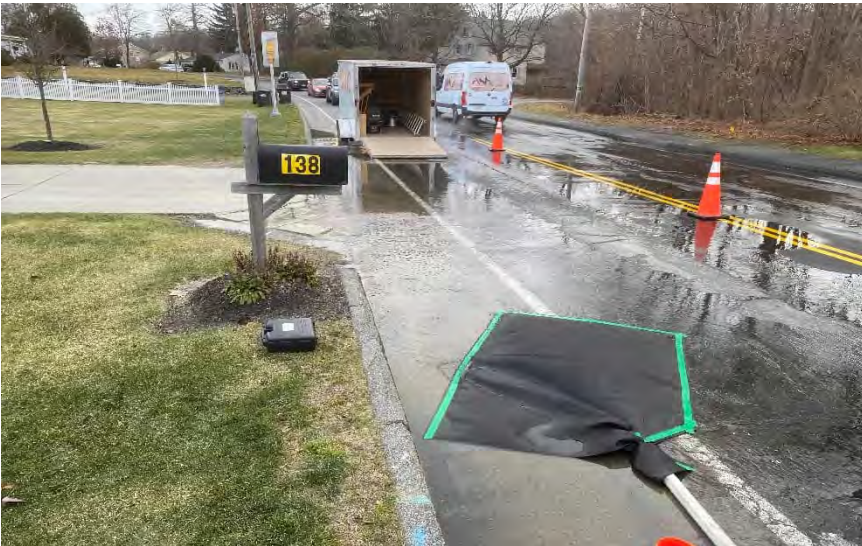
Description: Manhole #3. View of discharge from bag to adjacent catch basin within Forest Avenue. Water discharge to bag appeared to be only slightly turbid.

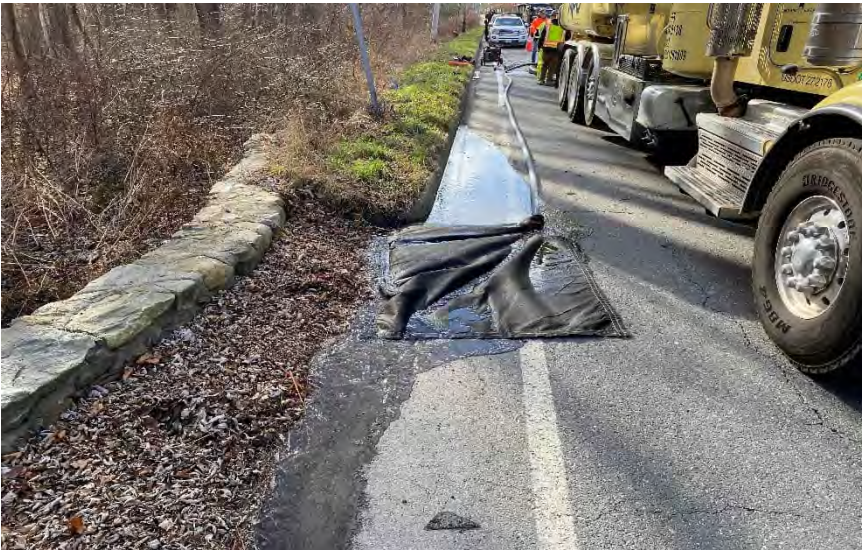
Description: Manhole #4. View of discharge from bag to adjacent stream area off Forest Avenue, looking southward. Water discharge to bag appeared to be only slightly turbid.

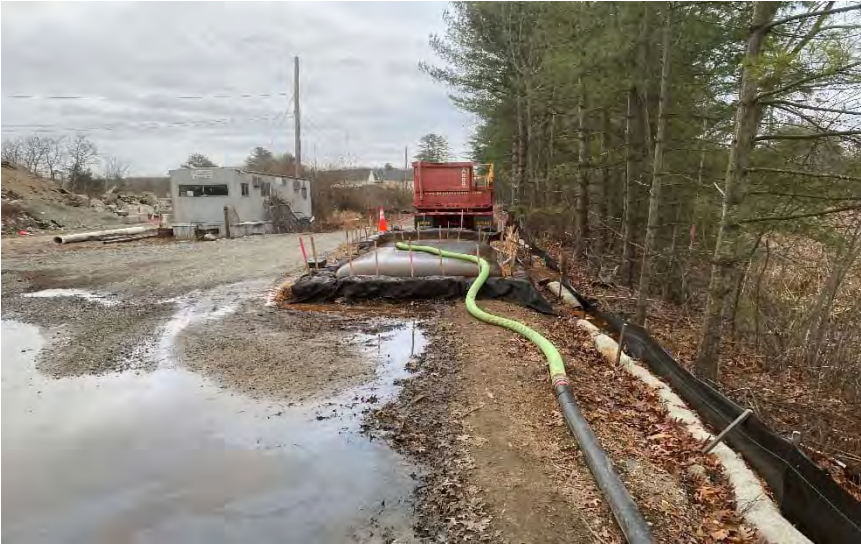
<b>Description:</b> Segment 3. View of discharge from bag/bales to adjacent work area, looking eastward. Water discharge to bag intermittent and appeared to be slightly turbid. Discharge from corral to work area (foreground).

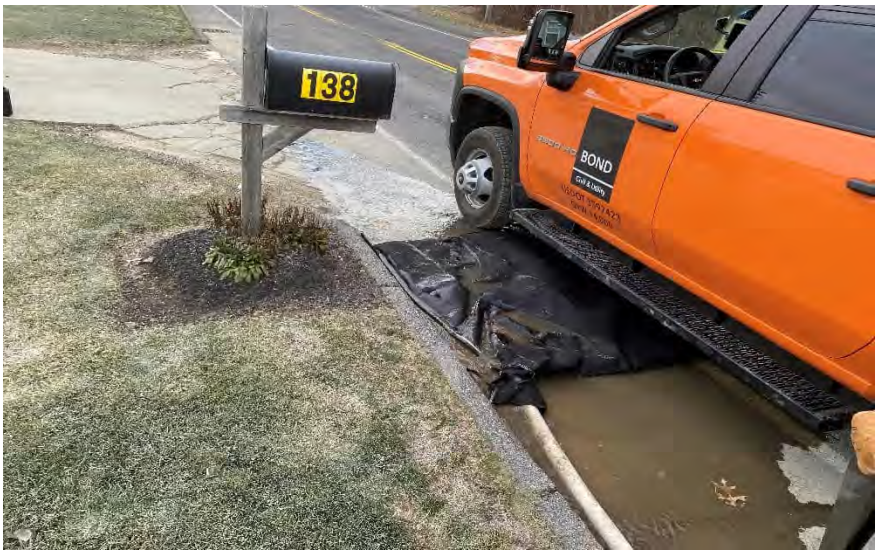
<b>Description:</b> Manhole #3. View of discharge from bag to adjacent catch basin within Forest Avenue. Water discharge to bag appeared to be slightly turbid.

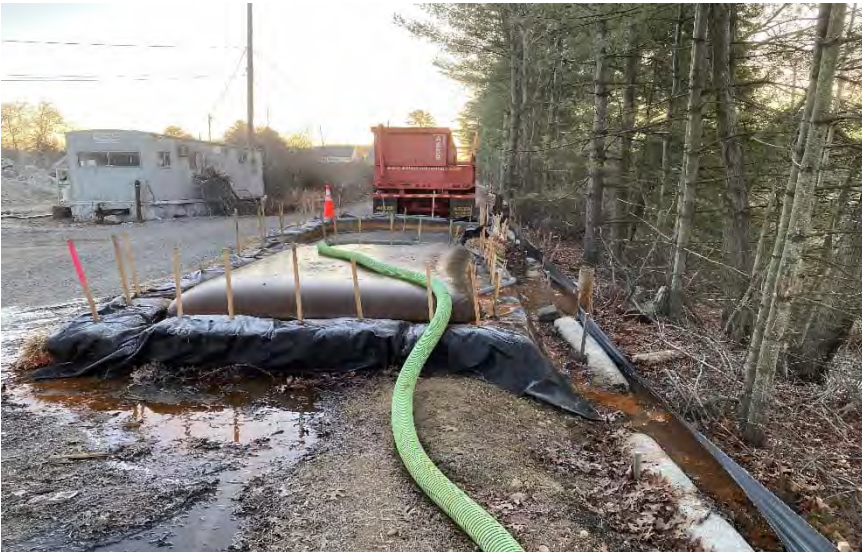
<b>Description:</b> Segment 3. View of discharge from bag/bales to adjacent work area, looking eastward. Water discharge to bag intermittent and appeared to be slightly turbid. Discharge from corral to work area (foreground).

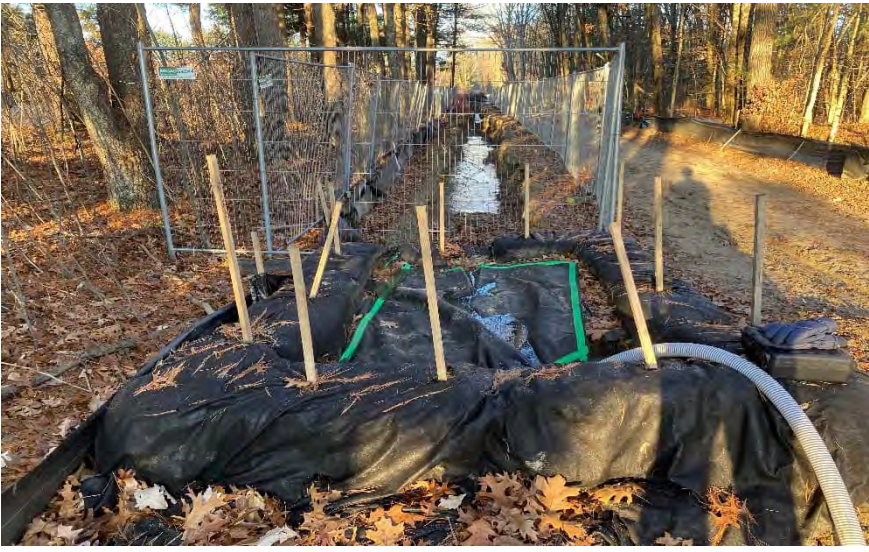
<b>Description:</b> Segment 11. View of discharge bag/bales, looking westward. Water discharge to bag intermittent and appeared to be slightly turbid. Discharge from corral to trench west of corral.

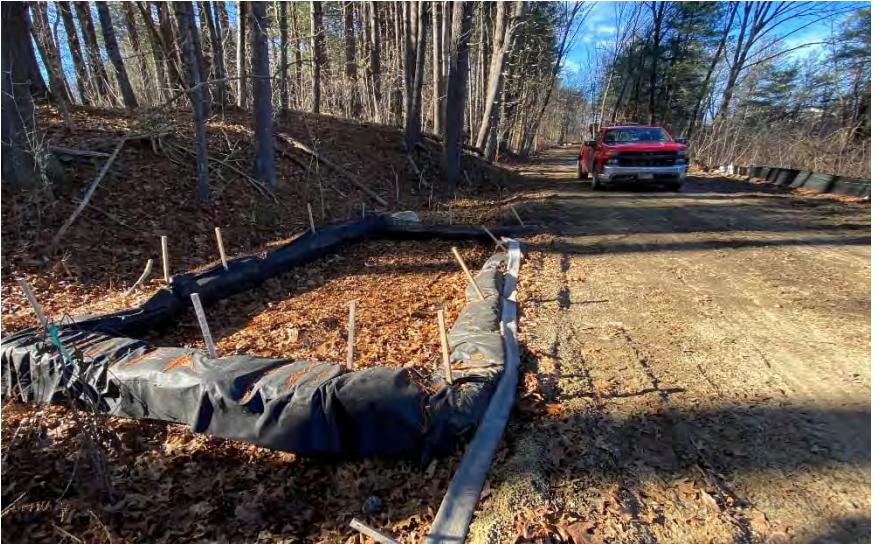
<b>Description:</b> Segment 13. View of discharge bag/bales, looking westward. Water discharge to bag intermittent and appeared to be slightly turbid. Discharge from corral to work area (foreground).

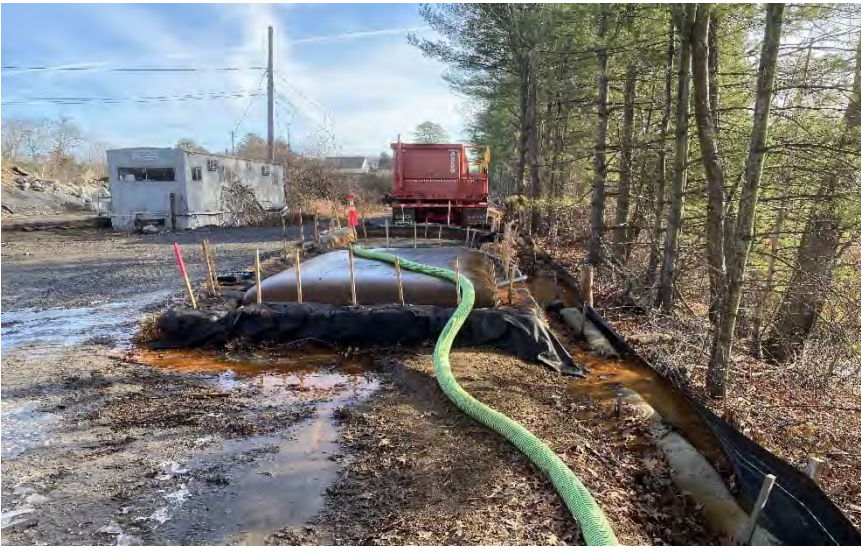
<b>Description:</b> Segment 3. View of discharge from bag/bales to adjacent work area, looking eastward. Water discharge to bag intermittent and appeared to be slightly turbid. Discharge from corral to work area (foreground).
