Weekly Environmental Compliance Summary

Sudbury to Hudson Transmission Reliability Project (USEPA Tracking # MAR1003UW)

Week of: December 11, 2023 to December 15, 2023

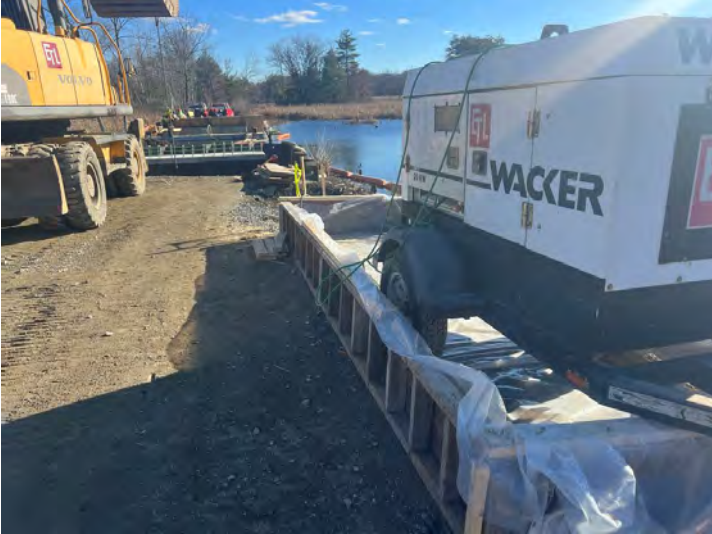
PHOTOGRAPHIC LOG	
Client Name: Eversource		Site Location: Sudbury to Hudson Transmission Reliability Project	Town: Hudson
Photo No.: 3	Date: 12/12/2023

Description: View of work at bridge 130 in segment 2. See additional dewatering inspection report. Facing east.

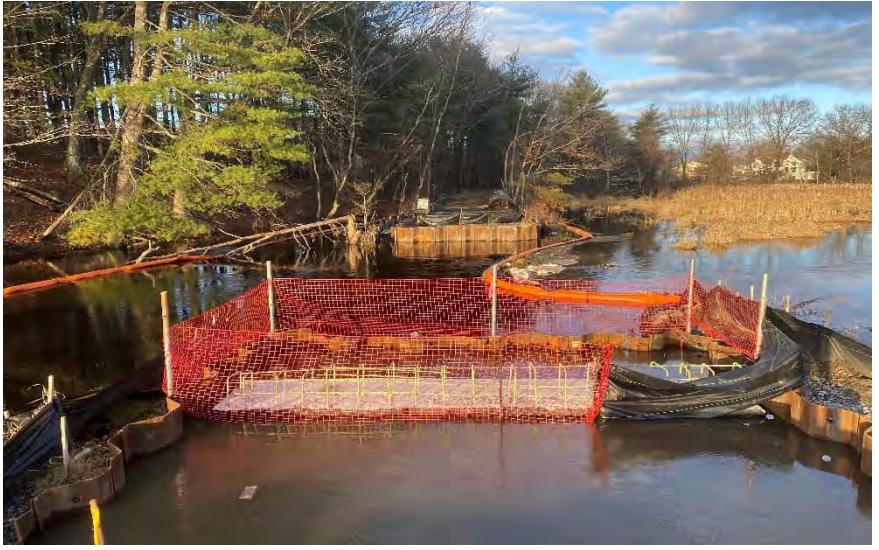
<p>PHOTOGRAPHIC LOG</p>	
<p>Client Name: Eversource</p>		<p>Site Location: Sudbury to Hudson Transmission Reliability Project</p>	<p>Town: Sudbury</p>
<p>Photo No.: 1</p>	<p>Date: 12-12-23</p>

<p>Description:</p> <p>Work area from segment 14 over Hop Brook toward segment 13 (bridge 127 expanse), existing erosion control, looking westward.</p>

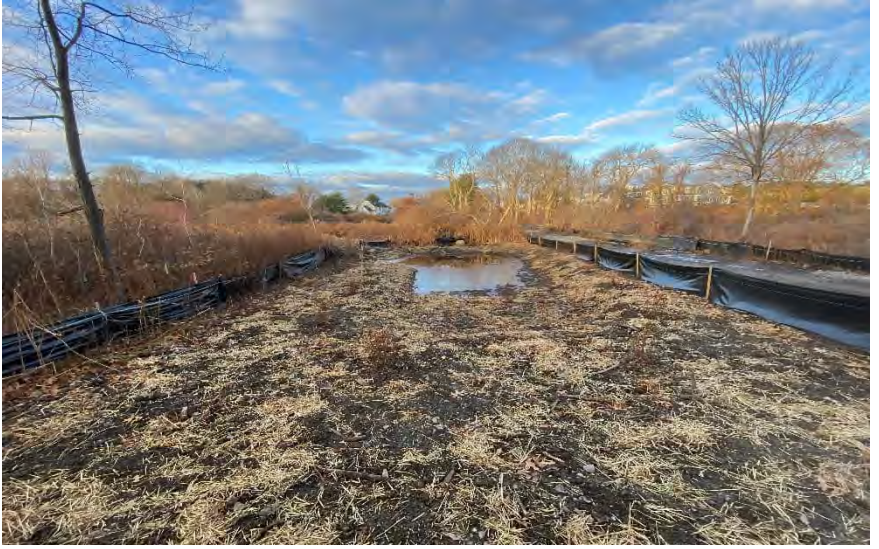
<p>PHOTOGRAPHIC LOG</p>	
<p>Client Name: Eversource</p>		<p>Site Location: Sudbury to Hudson Transmission Reliability Project</p>	<p>Town: Sudbury</p>
<p>Photo No.: 2</p>	<p>Date: 12-12-23</p>

<p>Description:</p> <p>Wetland replication area, within Segment 14, looking westward.</p>

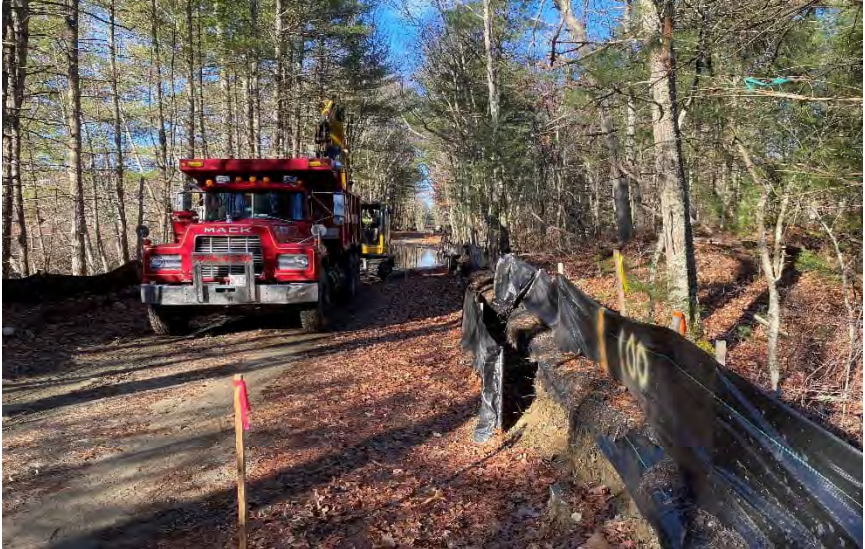
<p>PHOTOGRAPHIC LOG</p>	
<p>Client Name: Eversource</p>		<p>Site Location: Sudbury to Hudson Transmission Reliability Project</p>	<p>Town: Sudbury</p>
<p>Photo No.: 4</p>	<p>Date: 12-12-23</p>

<p>Description:</p> <p>Work area within Segment 8, site work – adding stone to flooded area, existing erosion control, looking westward.</p>

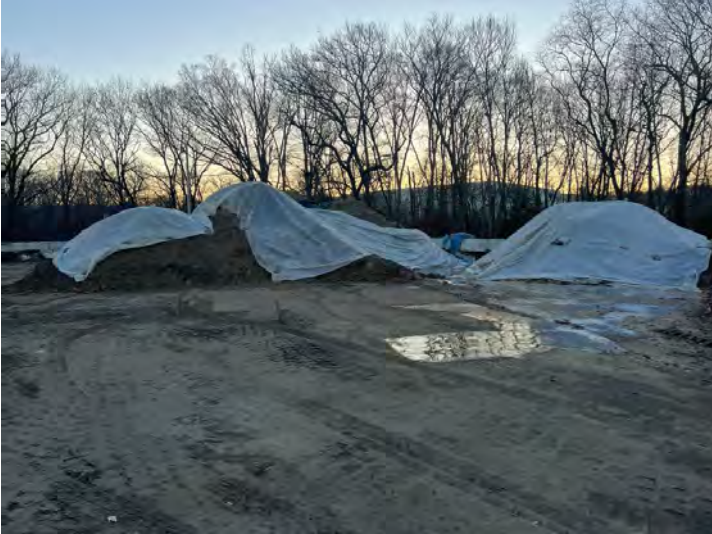
PHOTOGRAPHIC LOG	
Client Name: Eversource		Site Location: Sudbury to Hudson Transmission Reliability Project	Town: Hudson
Photo No.: 3	Date: 12/14/2023

Description: View of Stowe laydown yard. Sediment stockpiles were covered with plastic lining. Facing northeast.

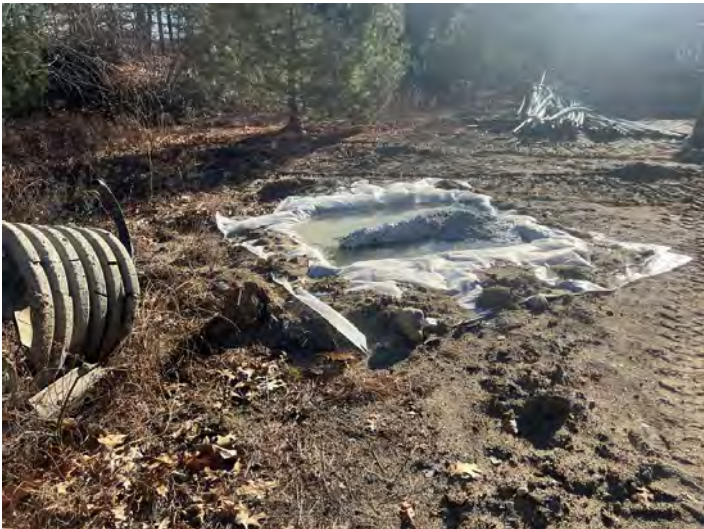
PHOTOGRAPHIC LOG	
Client Name: Eversource		Site Location: Sudbury to Hudson Transmission Reliability Project	Town: Hudson
Photo No.: 4	Date: 12/14/2023

Description: View of concrete washout area in Segment 2. Plastic lining is in good condition. No concrete observed outside of the plastic lining. Facing northeast.

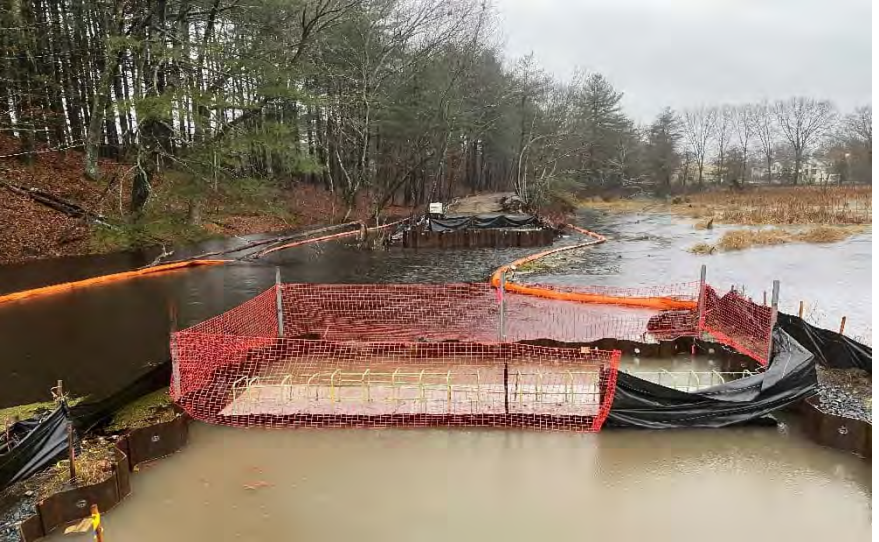
Description: Work area from segment 14 over Hop Brook toward segment 13, area flooded, existing erosion control, looking westward.

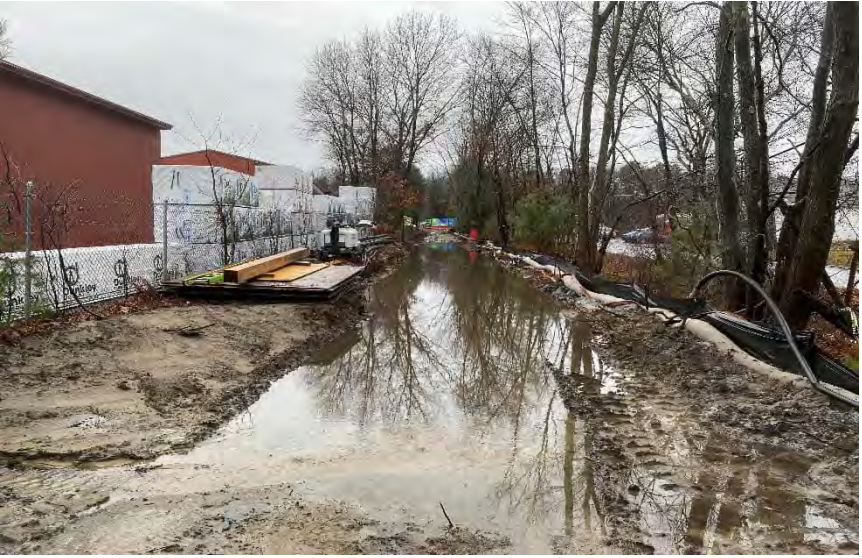
Description: Work area within segment 12, existing erosion control, work area flooded, looking westward.

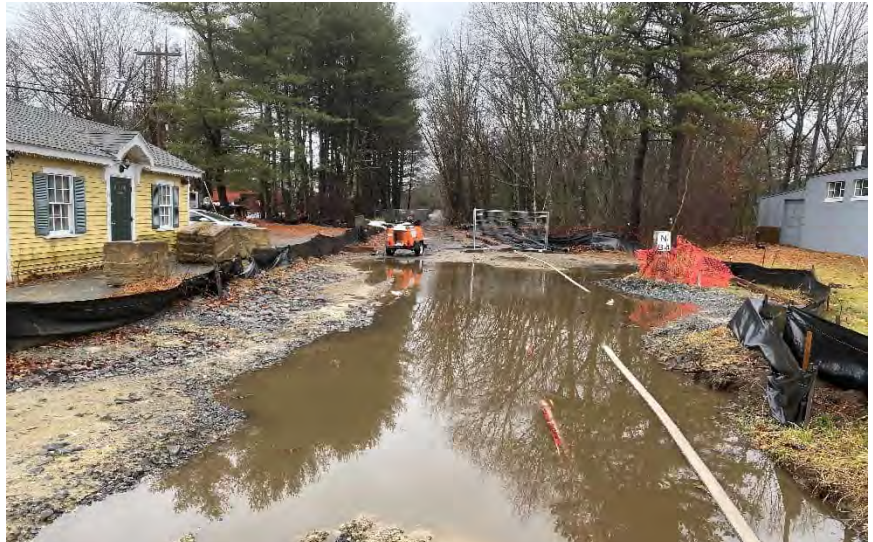
Description: Work area within segment 11, existing erosion control, area flooded, looking westward.

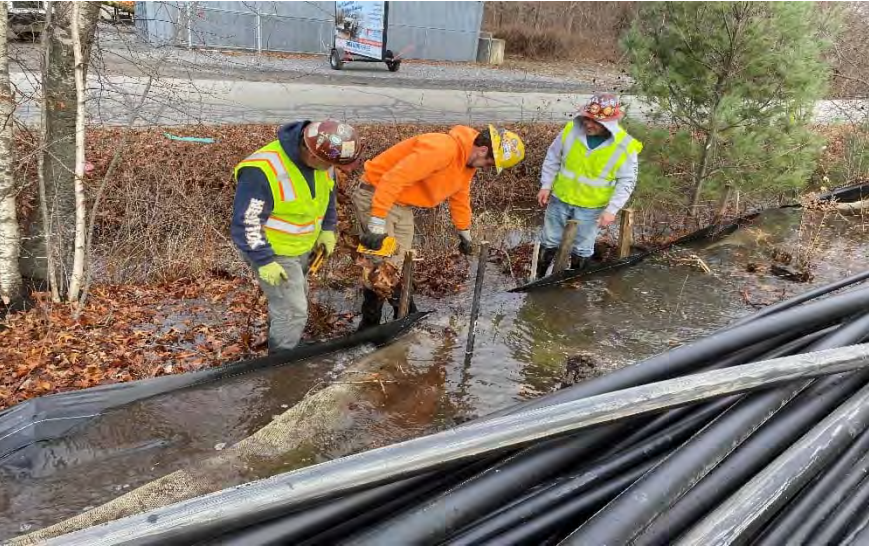
Description: Work area within segment 12, repair of downed erosion control (due to overwhelming water from adjacent property), looking eastward.

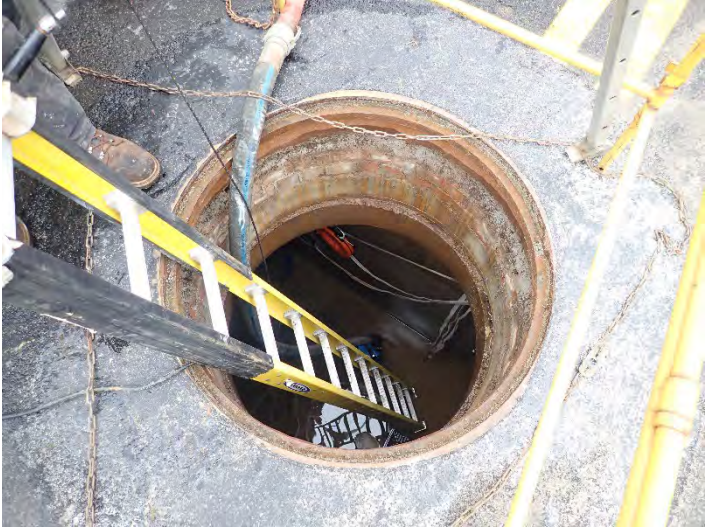
Description: View of water prior to treatment at MH#3. Water appeared turbid. Facing northeast.

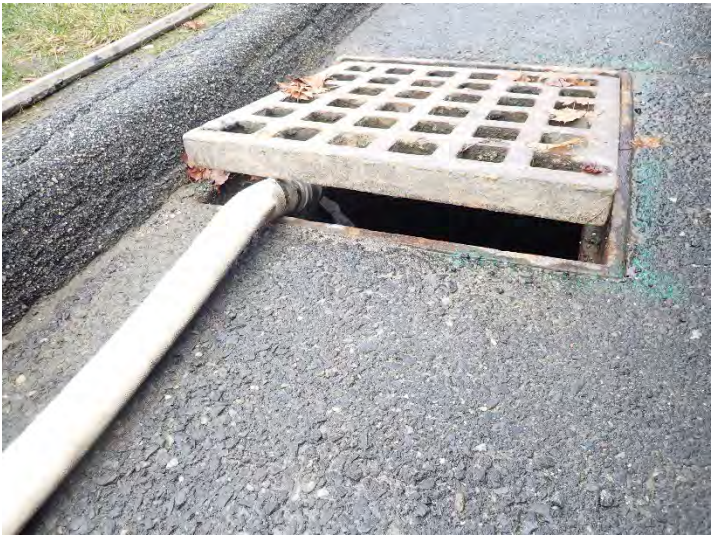
Description: View of discharge from the hose. Discharge appeared turbid. Turbidity reading was on average 240 NTUs at 12:40pm. Facing northeast.

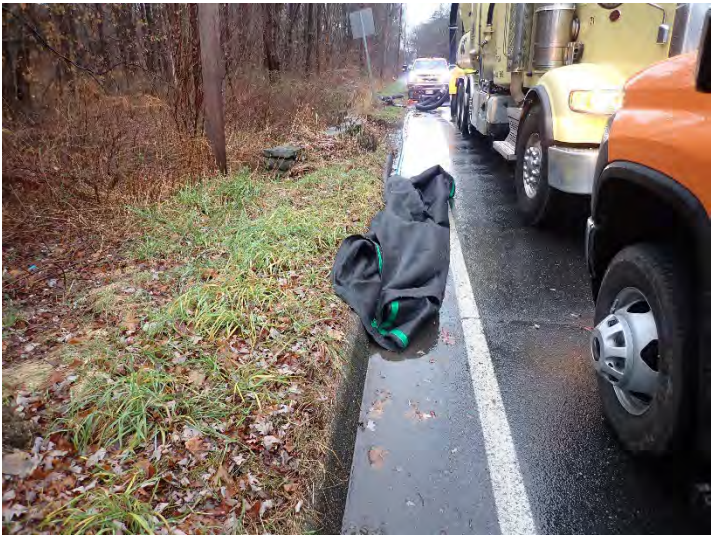
Description: View of discharge from the filter bag. Active rain at the time of dewatering. Discharge appeared clear. Turbidity reading was on average 4 NTUs at 8:40am. Discharge did not appear to be leaving the project. Facing northeast.

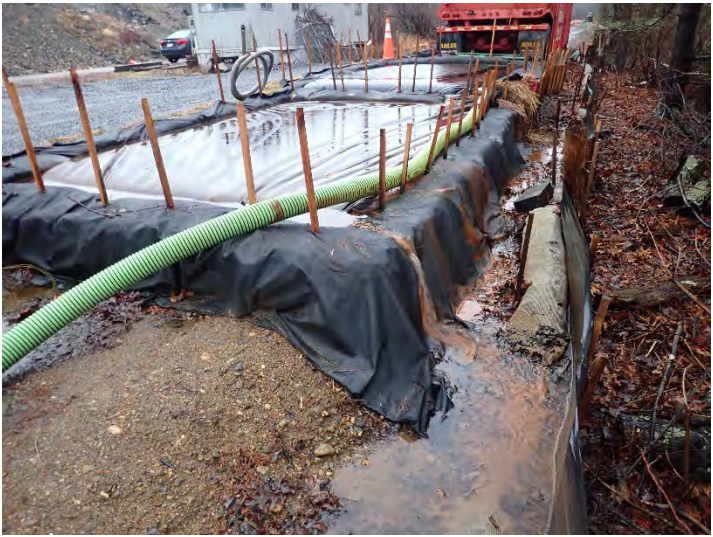
Description: View of discharge from controls. Discharge appeared clear. Turbidity reading was on average 22 NTUs at 7:45am. Facing west.

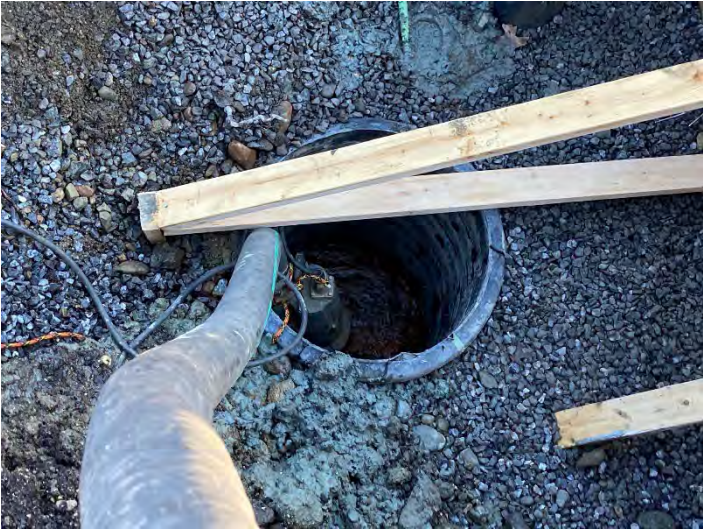
Description: View of pump. Water appeared mostly clear prior to treatment. Oxidizing bacteria noted.

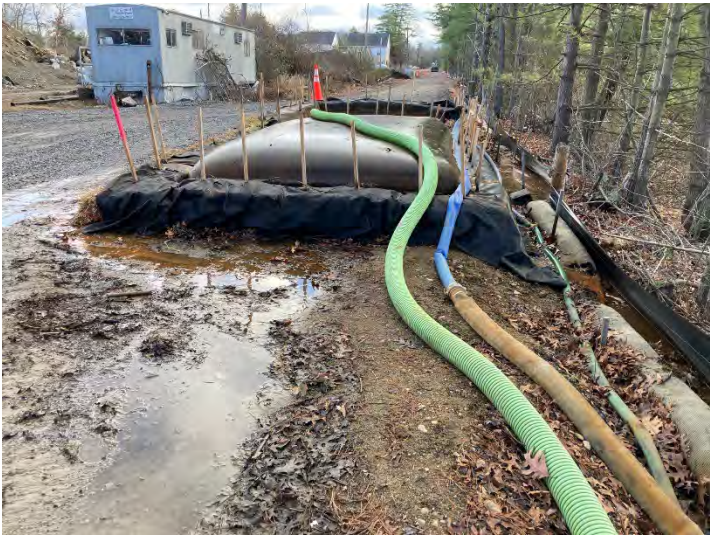
Description: View of discharge from controls. Discharge appeared mostly clear. Turbidity reading was below 50 NTUs. Discharge appeared to be leaving the project at time of inspection. Facing east.

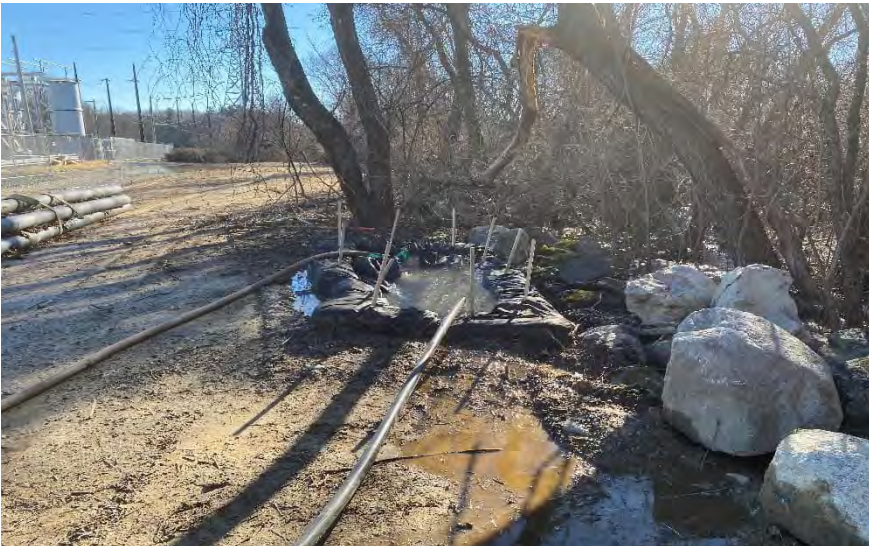
Description: Manhole #28. View of discharge bag/bales, looking southward. Water from corral discharged to adjacent wooded area (upper middle right).

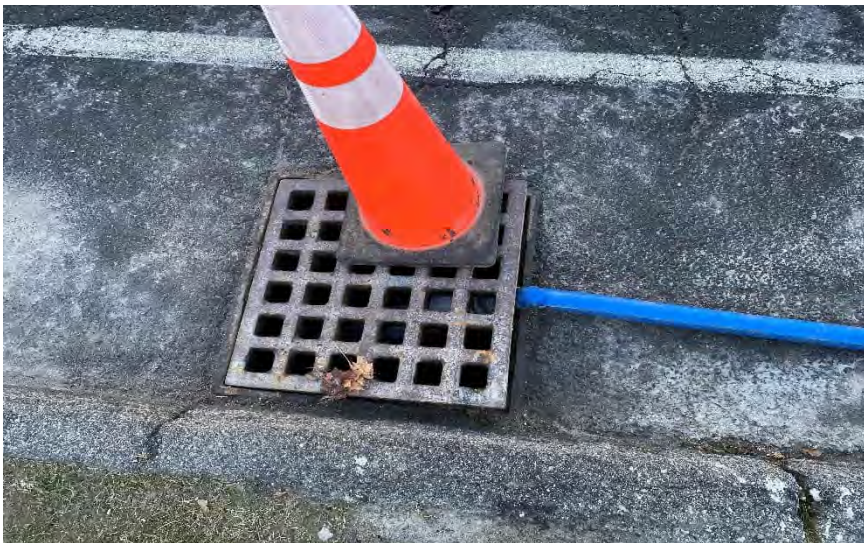
Description: Manhole #3. View of discharge from manhole to adjacent catch basin within Forest Avenue. Water discharge to basin appeared to be clear.

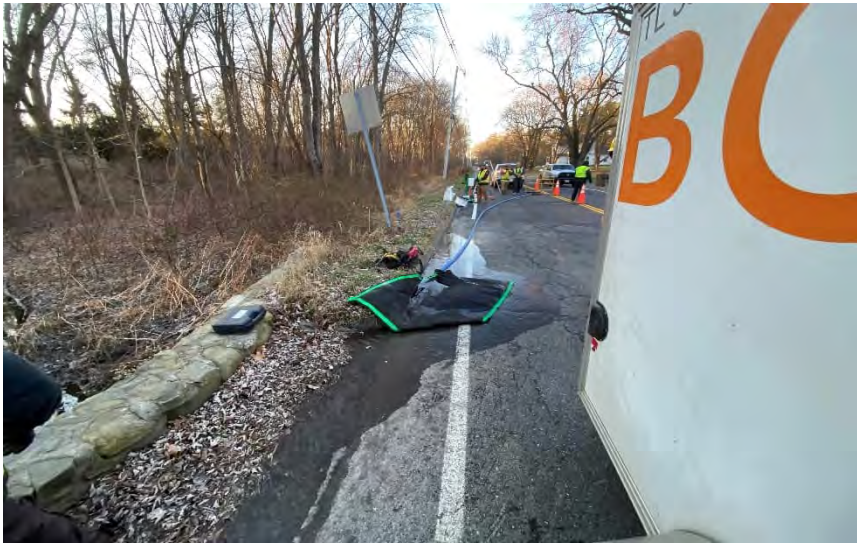
Description: Manhole #4. View of discharge dewatering operation, looking southward. Dewatering to bag discharging to adjacent stream.

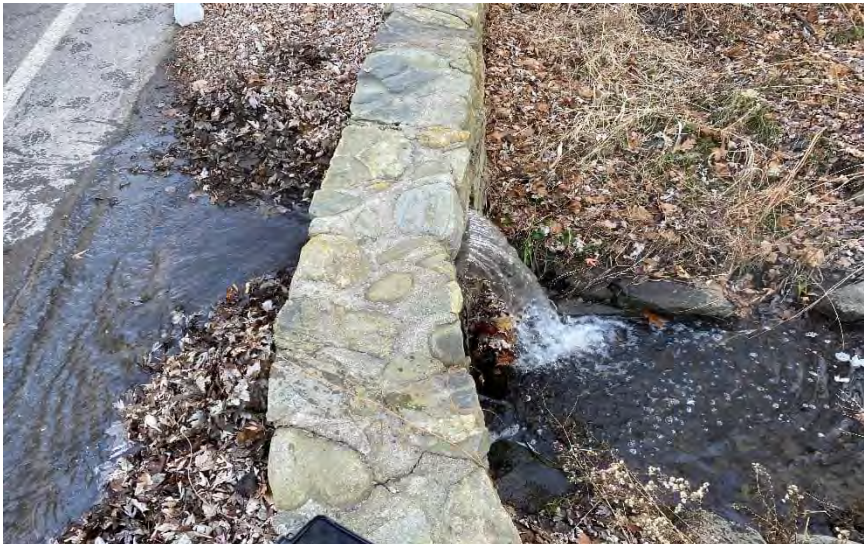
Description: Manhole #4. View of discharge from bag to adjacent stream area off Forest Avenue, looking northward. Water discharge to bag appeared to be clear.

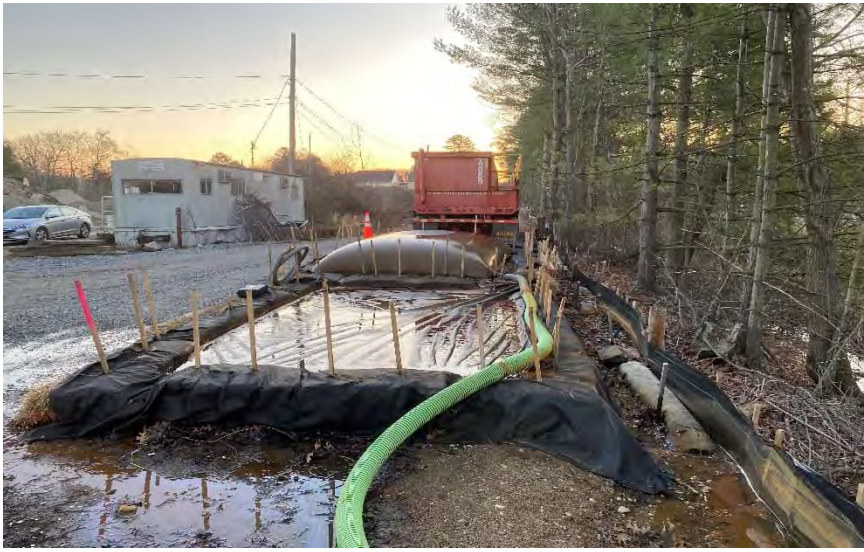
Description: Segment 3. View of discharge from bag/bales to adjacent work area, looking eastward. Water discharge to bag intermittent and appeared to be slightly turbid. Discharge from corral to work area (foreground).

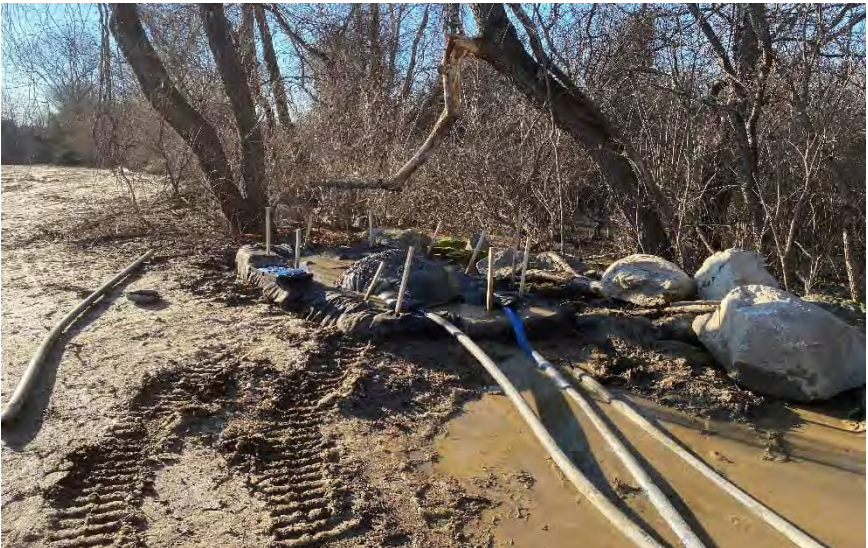
Description: Manhole #28. View of discharge bag/bales, looking southward. Water from corral discharged to adjacent wooded area (upper middle right).

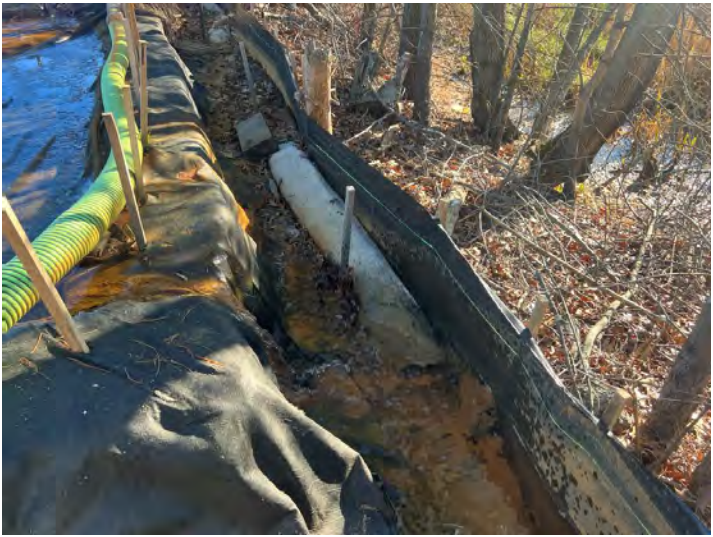
Description: View of discharge from controls. Discharge appeared mostly clear. Turbidity reading was below 50 NTUs. Discharge appeared to be leaving the project at time of inspection. Facing east.

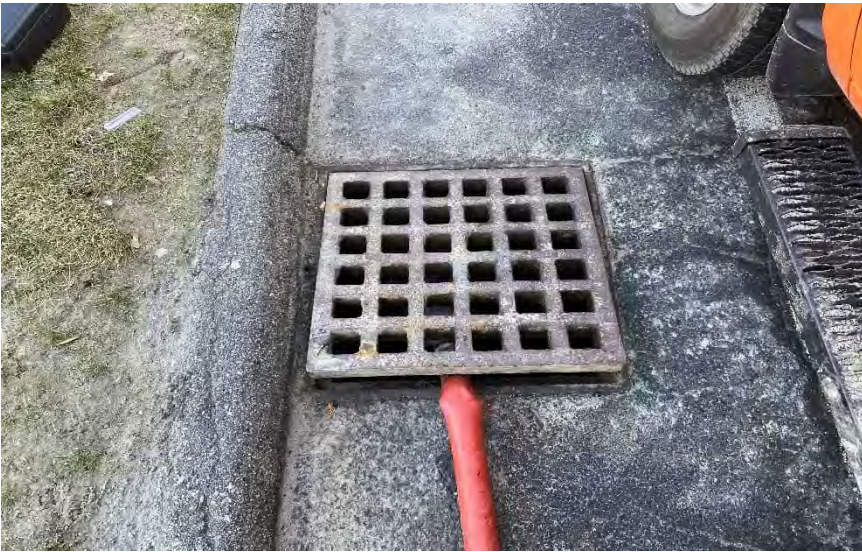
Description: Manhole #3. View of discharge from manhole to adjacent catch basin within Forest Avenue. Water discharge to basin appeared to be clear.

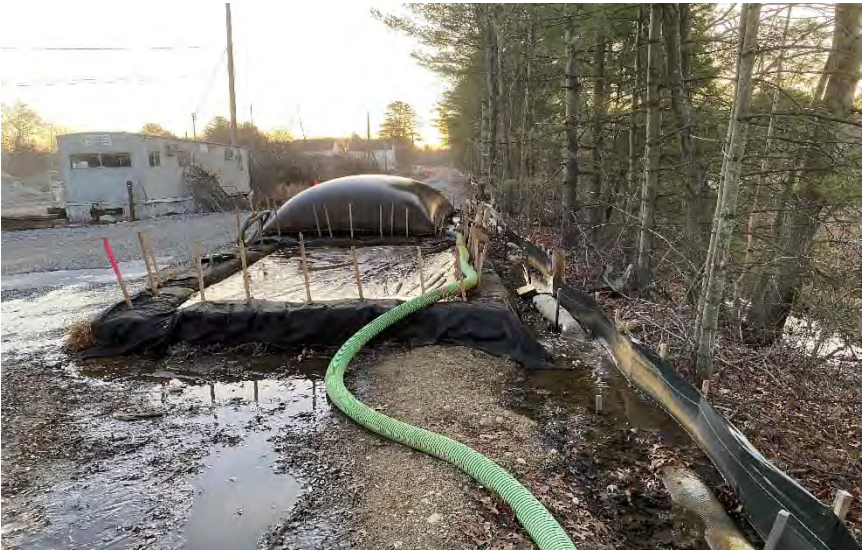
Description: Segment 3. View of discharge from bag/bales to adjacent work area, looking eastward. Water discharge to bag intermittent and appeared to be slightly turbid. Discharge from corral to work area (foreground).
