Weekly Environmental Compliance Summary

Sudbury to Hudson Transmission Reliability Project (USEPA Tracking # MAR1003UW)

Week of: January 1, 2024 to January 5, 2024

CONSTRUCTION MONITORING REPORT

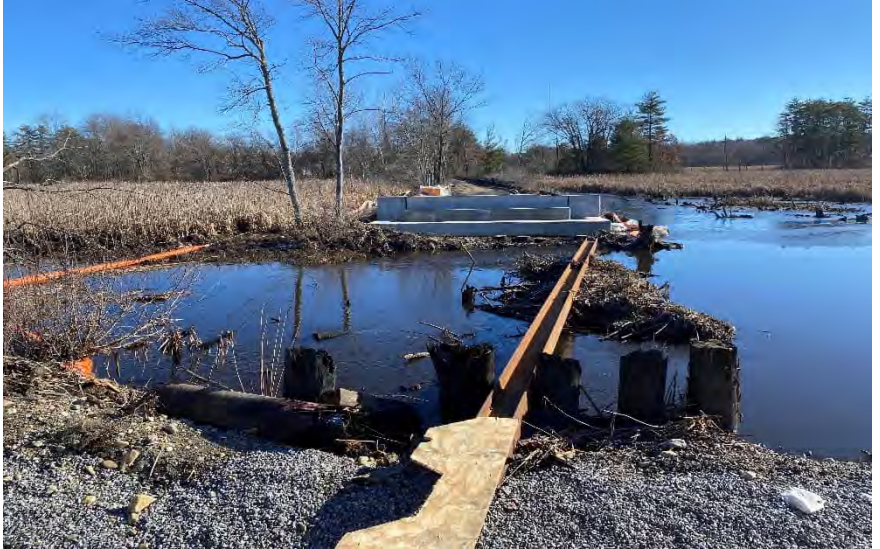
<p>PHOTOGRAPHIC LOG</p>	
<p>Client Name: Eversource</p>		<p>Site Location: Sudbury to Hudson Transmission Reliability Project</p>	<p>Town: Hudson</p>
<p>Photo No.: 2</p>	<p>Date: 1-2-24</p>

<p>Description:</p> <p>Bridge 130 work area from segment 2 toward segment 3 across Fort Meadow Brook, existing erosion control (floating silt curtain), looking eastward.</p>

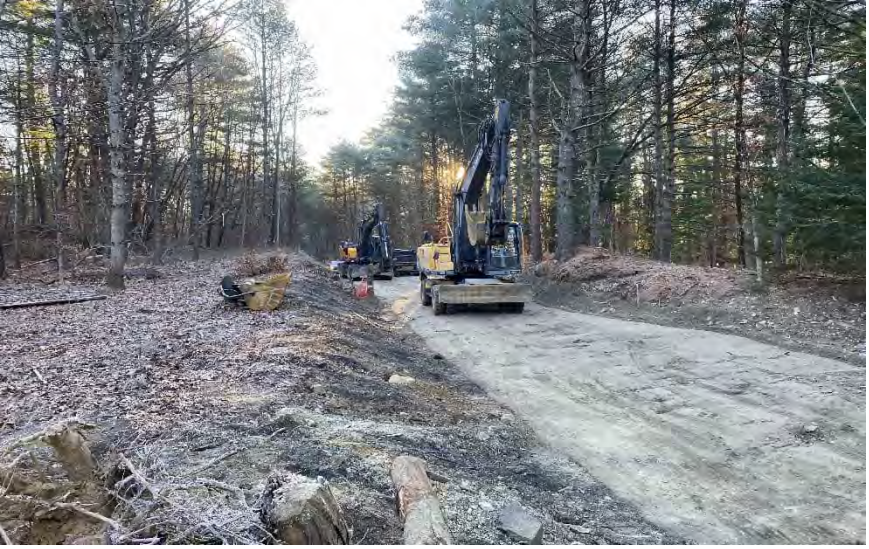
<p>PHOTOGRAPHIC LOG</p>	
<p>Client Name: Eversource</p>		<p>Site Location: Sudbury to Hudson Transmission Reliability Project</p>	<p>Town: Sudbury</p>
<p>Photo No.: 6</p>	<p>Date: 1-2-24</p>

<p>Description:</p> <p>Work area within segment 10, grading work, existing erosion control, looking eastward.</p>

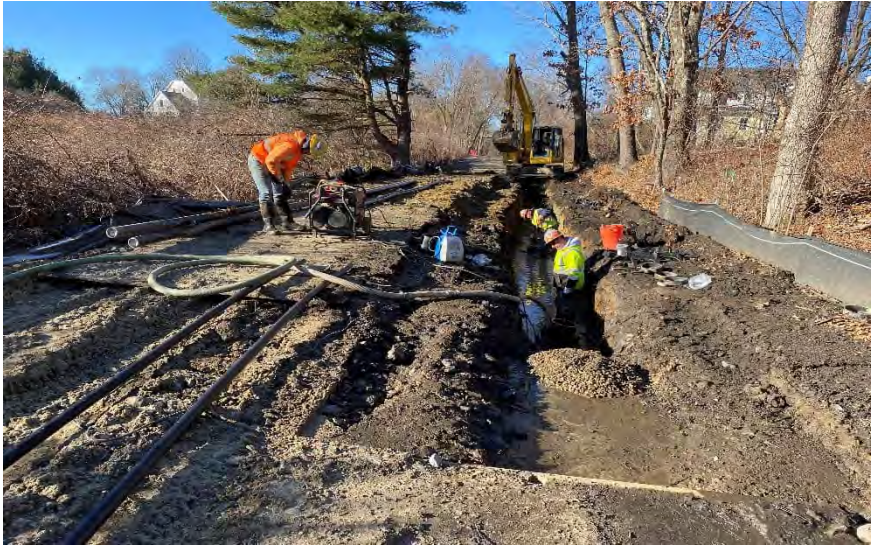
<p>PHOTOGRAPHIC LOG</p>	
<p>Client Name: Eversource</p>		<p>Site Location: Sudbury to Hudson Transmission Reliability Project</p>	<p>Town: Sudbury</p>
<p>Photo No.: 7</p>	<p>Date: 1-2-24</p>

<p>Description:</p> <p>Work area within Segment 14, conduit work, existing erosion control, looking westward.</p>

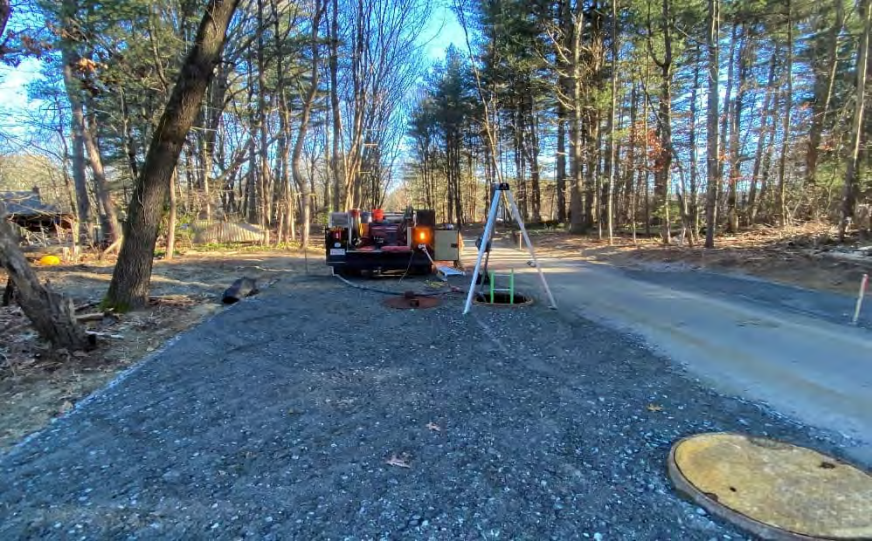
<p>PHOTOGRAPHIC LOG</p>	
<p>Client Name: Eversource</p>		<p>Site Location: Sudbury to Hudson Transmission Reliability Project</p>	<p>Town: Sudbury</p>
<p>Photo No.: 8</p>	<p>Date: 1-2-24</p>

<p>Description:</p> <p>Work area within segment 10, proofing at manhole #21, looking eastward.</p>

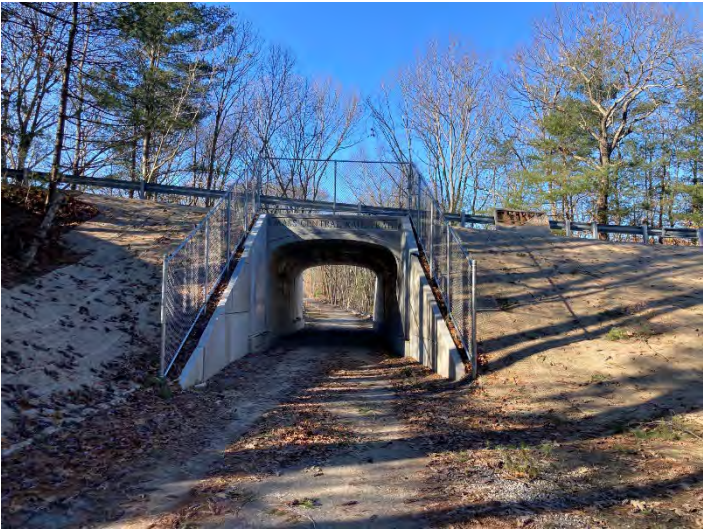
<p>PHOTOGRAPHIC LOG</p>	
<p>Client Name: Eversource</p>		<p>Site Location: Sudbury to Hudson Transmission Reliability Project</p>	<p>Town: Hudson</p>
<p>Photo No.: 1</p>	<p>Date: 1/03/2024</p>

<p>Description: View of Chestnut St tunnel. Facing west.</p>

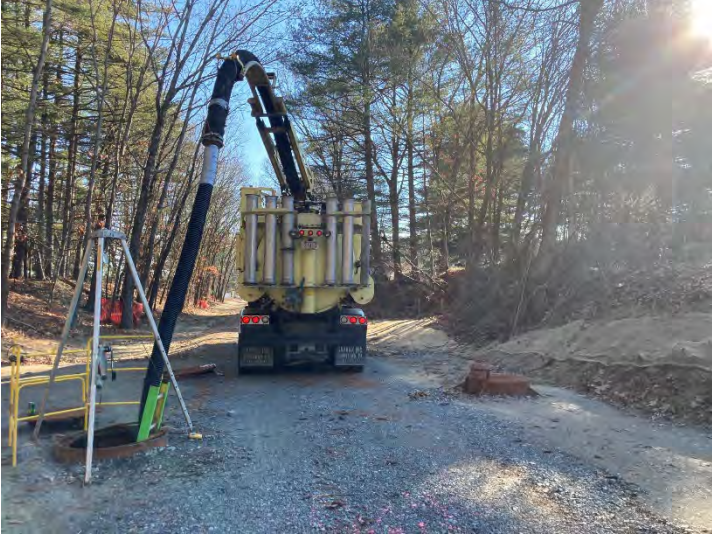
<p>PHOTOGRAPHIC LOG</p>	
<p>Client Name: Eversource</p>		<p>Site Location: Sudbury to Hudson Transmission Reliability Project</p>	<p>Town: Hudson</p>
<p>Photo No.: 3</p>	<p>Date: 1/03/2024</p>

<p>Description: View of Bond working at MH #9 in segment 3. Facing east.</p>

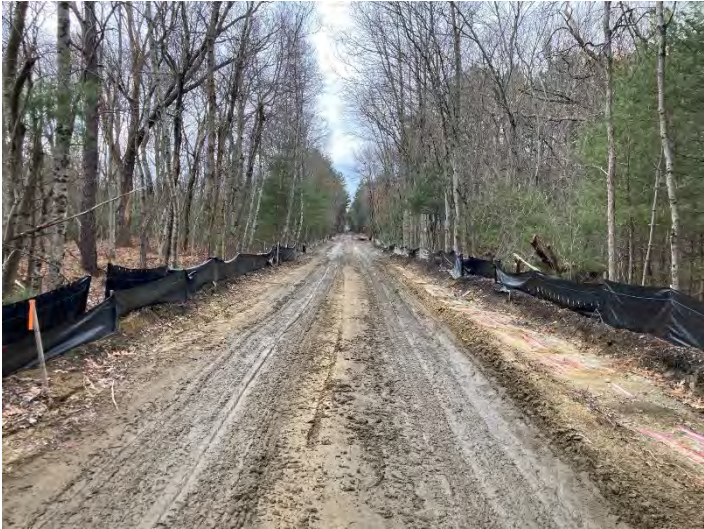
<p>PHOTOGRAPHIC LOG</p>	
<p>Client Name: Eversource</p>		<p>Site Location: Sudbury to Hudson Transmission Reliability Project</p>	<p>Town: Hudson</p>
<p>Photo No.: 5</p>	<p>Date: 1/03/2024</p>

<p>Description: View of E&S controls in segment 6. Facing west.</p>

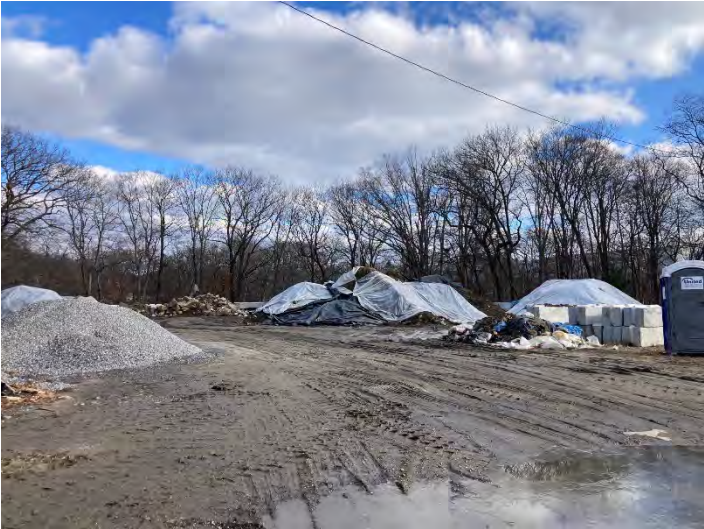
<p>PHOTOGRAPHIC LOG</p>	
<p>Client Name: Eversource</p>		<p>Site Location: Sudbury to Hudson Transmission Reliability Project</p>	<p>Town: Hudson</p>
<p>Photo No.: 6</p>	<p>Date: 1/03/2024</p>

<p>Description: View of Stowe Ct laydown yard. Facing northeast.</p>

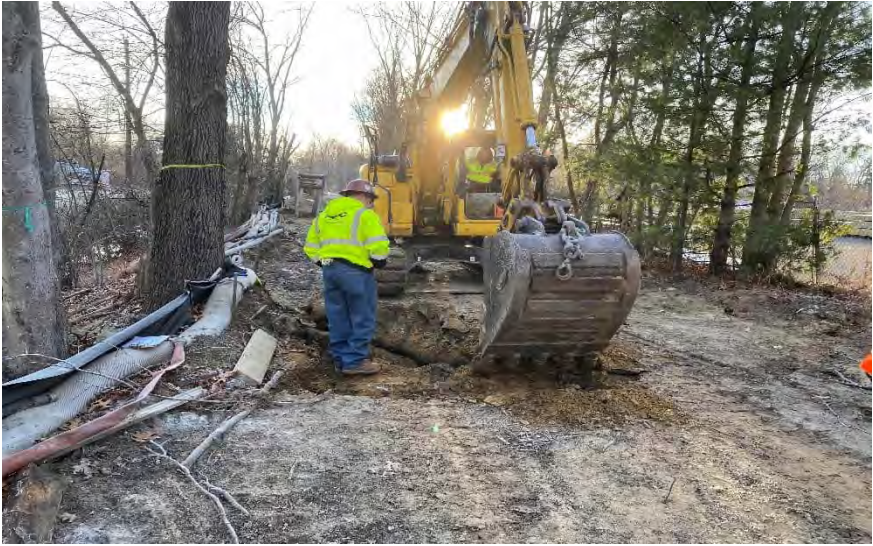
<p>PHOTOGRAPHIC LOG</p>	
<p>Client Name: Eversource</p>		<p>Site Location: Sudbury to Hudson Transmission Reliability Project</p>	<p>Town: Sudbury</p>
<p>Photo No.: 1</p>	<p>Date: 1-3-24</p>

<p>Description:</p> <p>Work area within segment 12, culvert replacement, existing erosion control, looking eastward.</p>

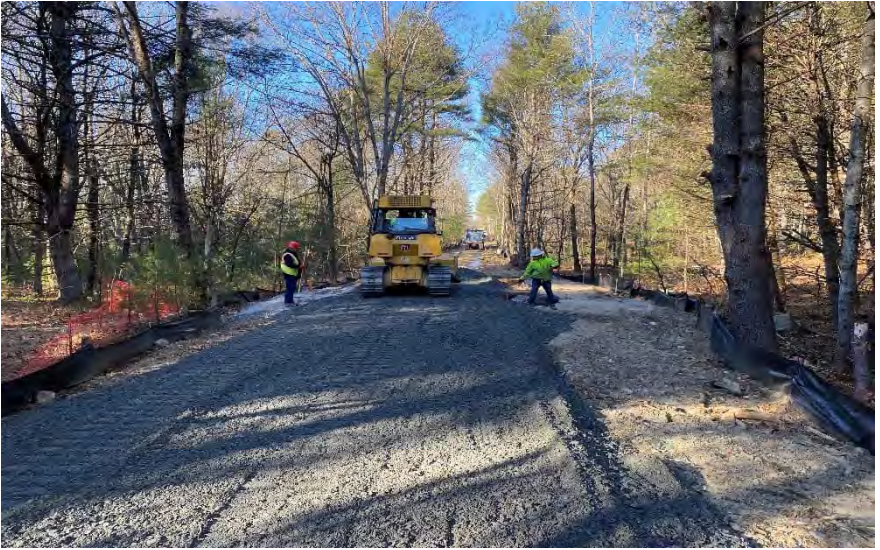
<p>PHOTOGRAPHIC LOG</p>	
<p>Client Name: Eversource</p>		<p>Site Location: Sudbury to Hudson Transmission Reliability Project</p>	<p>Town: Sudbury</p>
<p>Photo No.: 3</p>	<p>Date: 1-3-24</p>

<p>Description:</p> <p>Work area within Segment 7, grading work, existing erosion control, looking westward.</p>

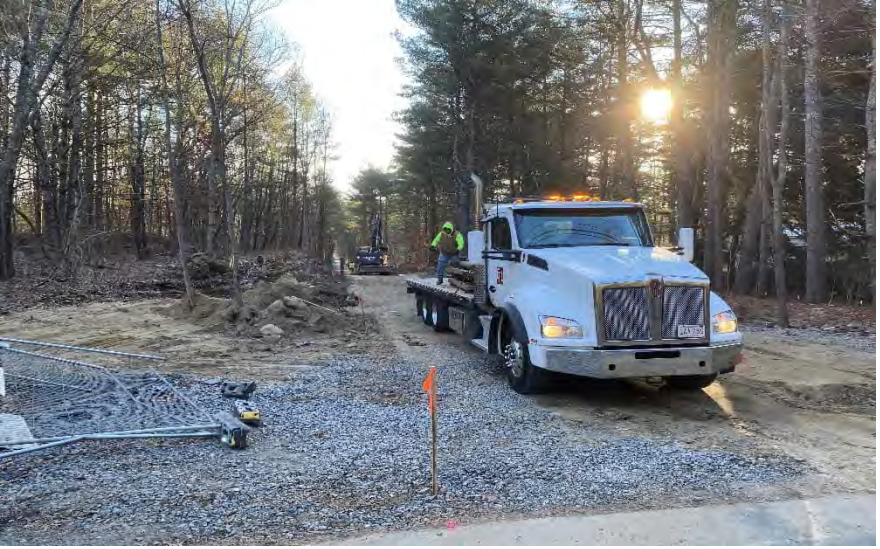
<p>PHOTOGRAPHIC LOG</p>	
<p>Client Name: Eversource</p>		<p>Site Location: Sudbury to Hudson Transmission Reliability Project</p>	<p>Town: Sudbury</p>
<p>Photo No.: 4</p>	<p>Date: 1-3-24</p>

<p>Description:</p> <p>Work area within Segment 10, work on new drainage structure, existing erosion control, looking eastward.</p>

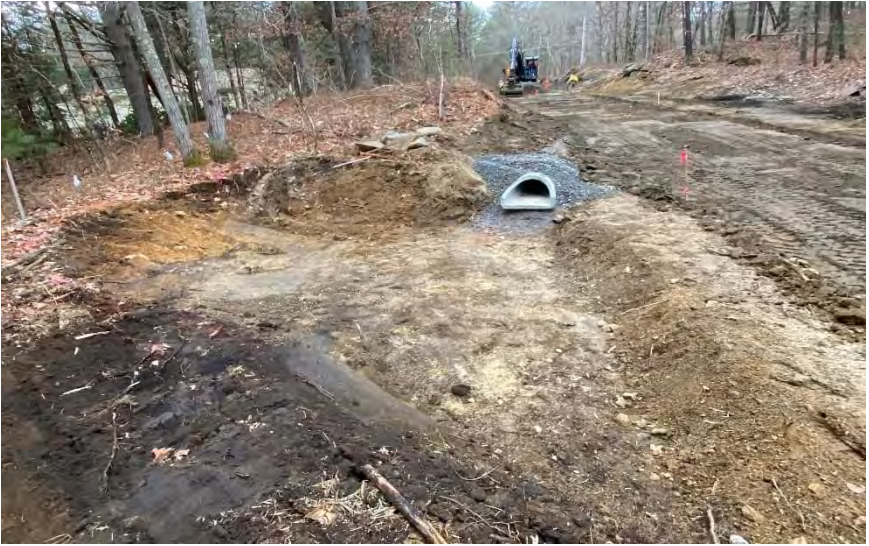
<p align="center">PHOTOGRAPHIC LOG</p>	
<p>Client Name: Eversource</p>		<p>Site Location: Sudbury to Hudson Transmission Reliability Project</p>	<p>Town: Sudbury</p>
<p>Photo No.: 5</p>	<p>Date: 1-3-24</p>

<p>Description:</p> <p>Work area within Segment 10 (off Peakham Road), new drainage structure placed, looking westward.</p>

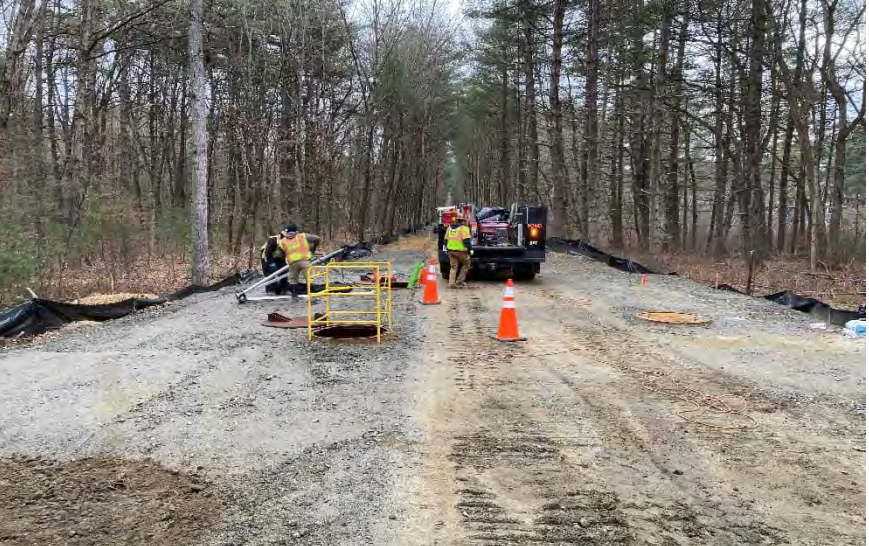
<p align="center">PHOTOGRAPHIC LOG</p>	
<p>Client Name: Eversource</p>		<p>Site Location: Sudbury to Hudson Transmission Reliability Project</p>	<p>Town: Sudbury</p>
<p>Photo No.: 6</p>	<p>Date: 1-3-24</p>

<p>Description:</p> <p>Work area within Segment 10, proofing work at manhole # 21, existing erosion control, looking eastward.</p>

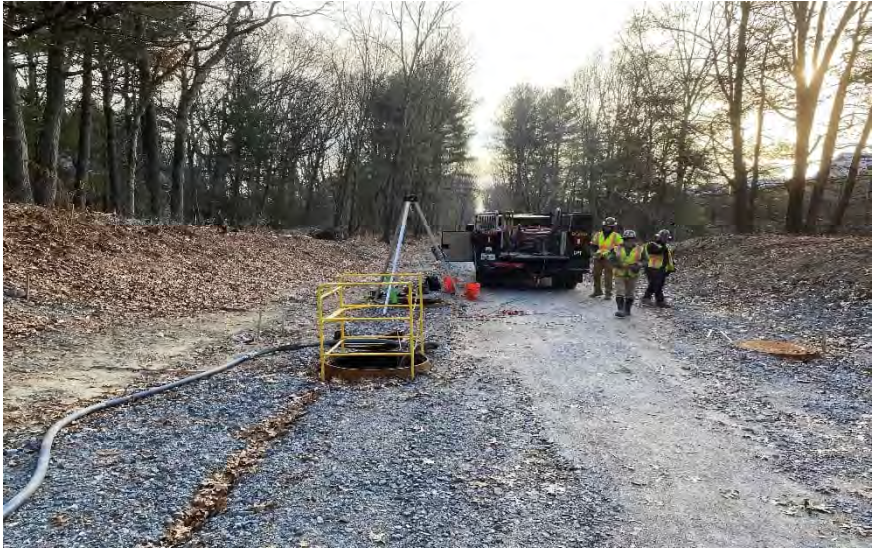
<p align="center">PHOTOGRAPHIC LOG</p>	
<p>Client Name: Eversource</p>		<p>Site Location: Sudbury to Hudson Transmission Reliability Project</p>	<p>Town: Sudbury</p>
<p>Photo No.: 7</p>	<p>Date: 1-3-24</p>

<p>Description:</p> <p>Work area within Segment 11, proofing work at manhole # 22, looking eastward.</p>

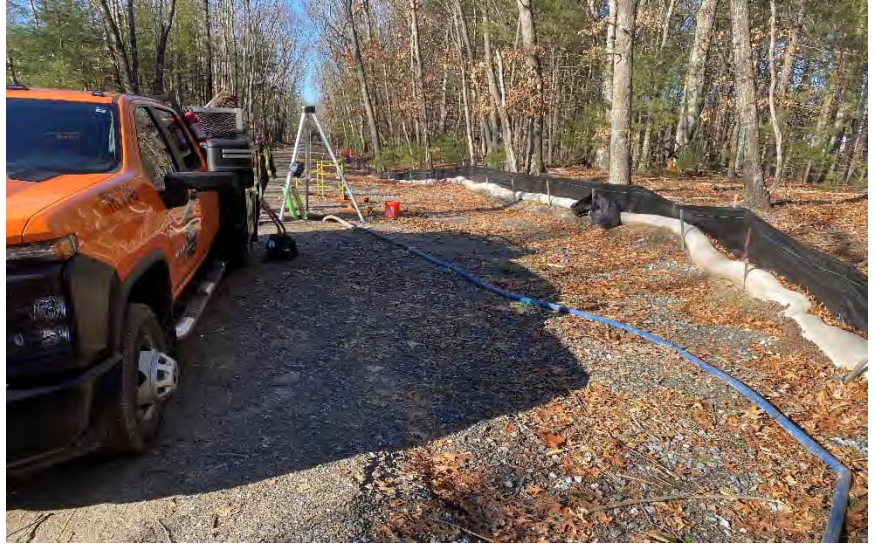
<p align="center">PHOTOGRAPHIC LOG</p>	
<p>Client Name: Eversource</p>		<p>Site Location: Sudbury to Hudson Transmission Reliability Project</p>	<p>Town: Sudbury</p>
<p>Photo No.: 8</p>	<p>Date: 1-3-24</p>

<p>Description:</p> <p>Work area within Segment 11, proofing work at manhole # 23, existing erosion control, looking westward.</p>

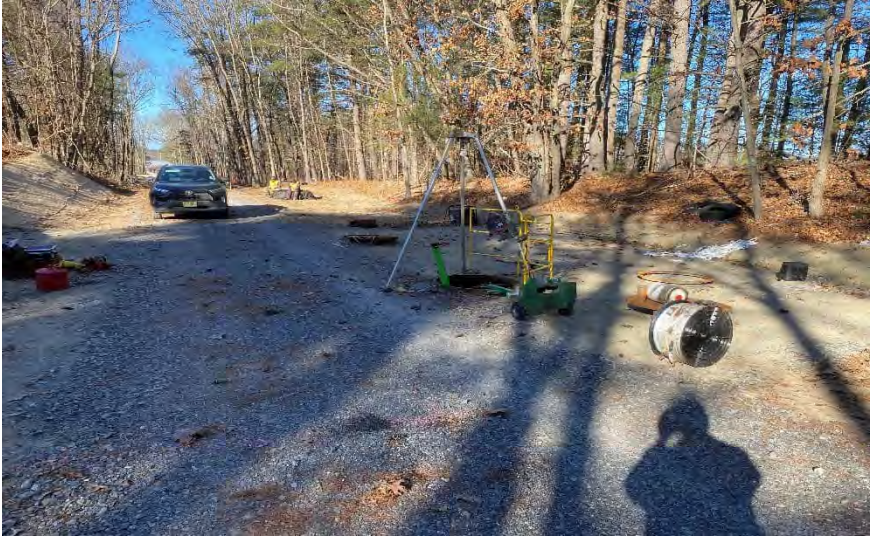
<p>PHOTOGRAPHIC LOG</p>	
<p>Client Name: Eversource</p>		<p>Site Location: Sudbury to Hudson Transmission Reliability Project</p>	<p>Town: Hudson</p>
<p>Photo No.: 2</p>	<p>Date: 1-5-24</p>

<p>Description:</p> <p>Bond conducting proofing work at manhole #9 (segment 3), looking westward.</p>

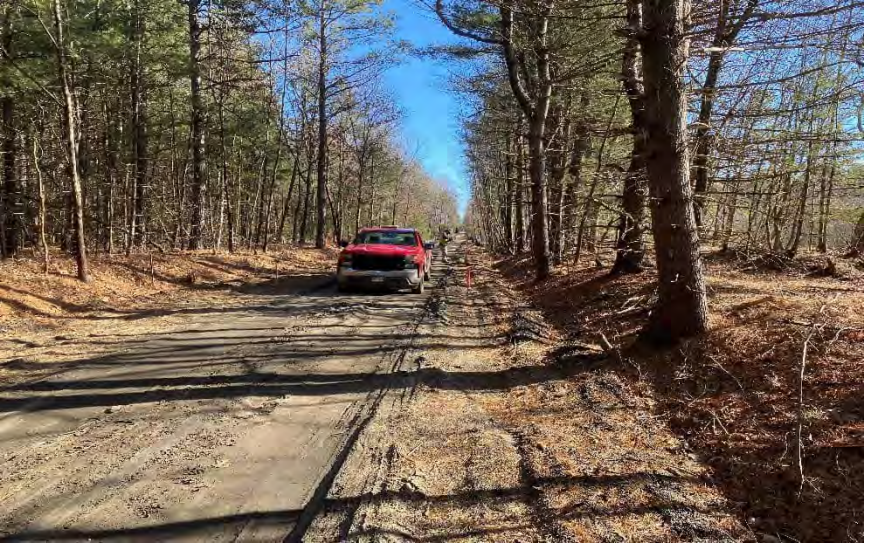
<p>PHOTOGRAPHIC LOG</p>	
<p>Client Name: Eversource</p>		<p>Site Location: Sudbury to Hudson Transmission Reliability Project</p>	<p>Town: Hudson</p>
<p>Photo No.: 4</p>	<p>Date: 1-5-24</p>

<p>Description:</p> <p>Work area within segment 6, survey work prior to grading, looking eastward.</p>

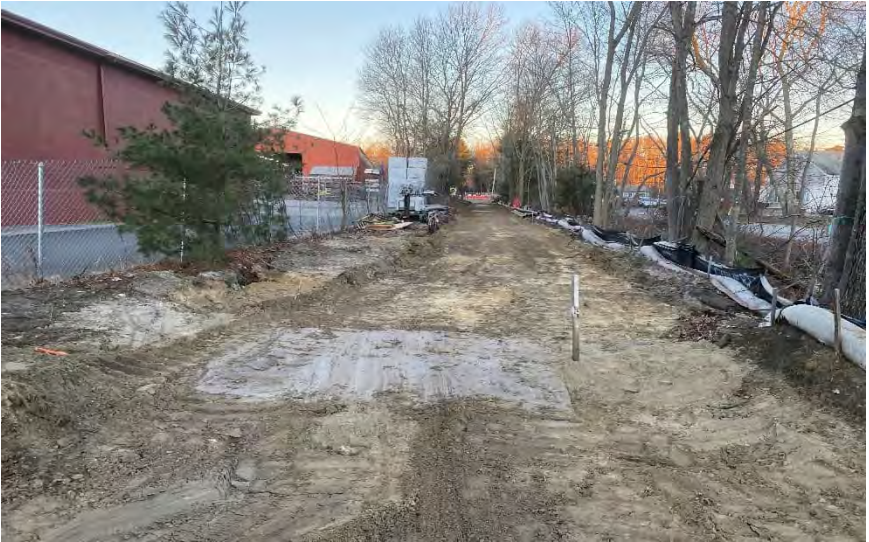
<p>PHOTOGRAPHIC LOG</p>	
<p>Client Name: Eversource</p>		<p>Site Location: Sudbury to Hudson Transmission Reliability Project</p>	<p>Town: Sudbury</p>
<p>Photo No.: 7</p>	<p>Date: 1-5-24</p>

<p>Description:</p> <p>Work area within Segment 12, culvert replacement area, existing erosion control, looking westward.</p>

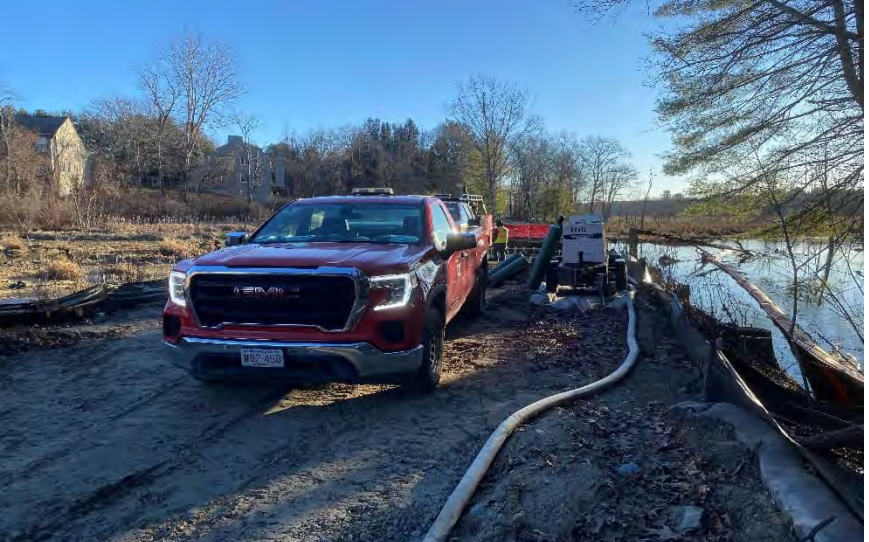
<p>PHOTOGRAPHIC LOG</p>	
<p>Client Name: Eversource</p>		<p>Site Location: Sudbury to Hudson Transmission Reliability Project</p>	<p>Town: Sudbury</p>
<p>Photo No.: 8</p>	<p>Date: 1-5-24</p>

<p>Description:</p> <p>Bridge 127 work area looking eastward from segment 13 across Hop Brook toward segment 14, sheeting cutting, looking eastward.</p>

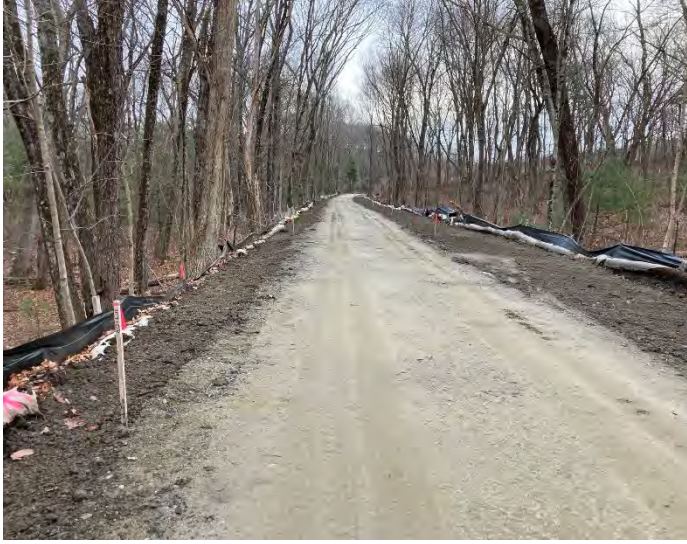
-Loam has been applied to shoulders throughout segment 1 and E&S controls are almost buried in some locations (notably Sta. #109, Sta. #116+50, and Sta. #130). It is recommended that loam is stabilized and that E&S controls are repaired as needed.

Description: View of Sta. #109 in segment 1. Loam has been applied to shoulders throughout this segment and E&S controls are almost buried in some locations. It is recommended that loam is stabilized and that E&S controls are repaired as needed. Facing east.

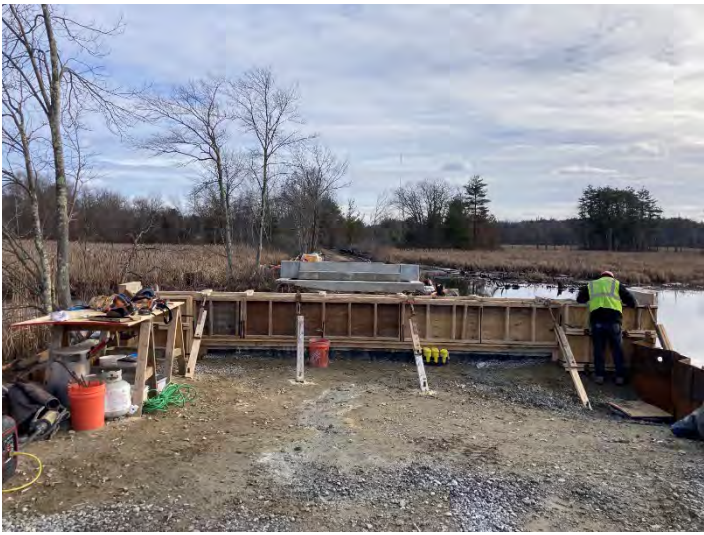
Description: View of work area at bridge 130 in segment 2. Facing east.

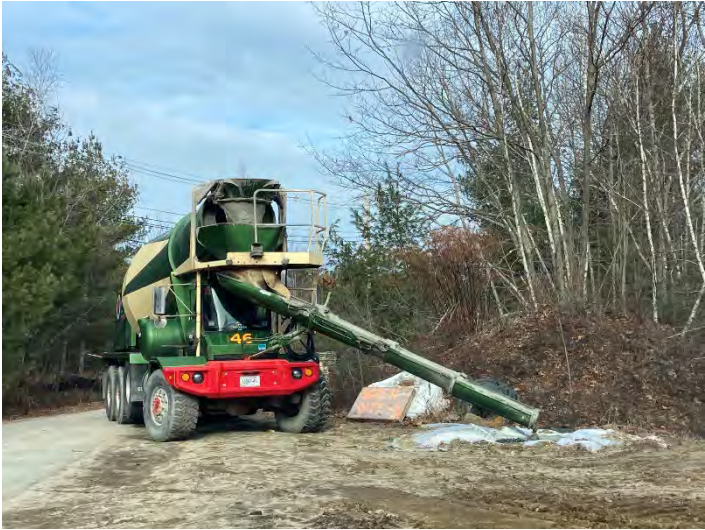
Description: View of concrete truck utilizing concrete washout pit in segment 2. Facing north.

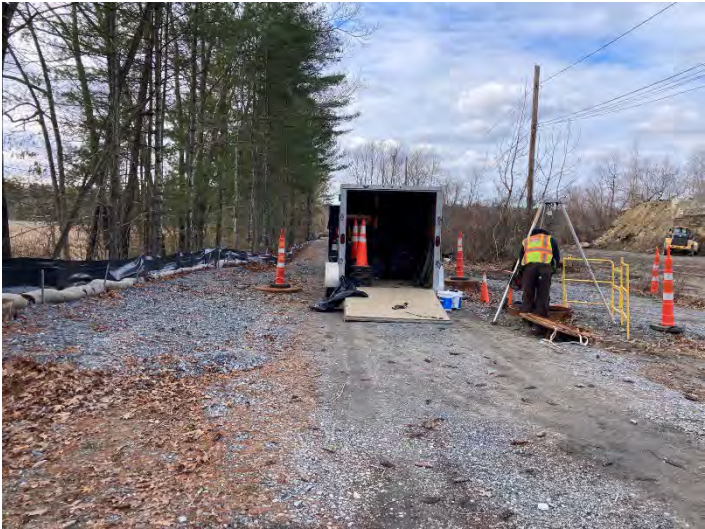
Description: View of Bond working at MH #8 in segment 3. Facing west.

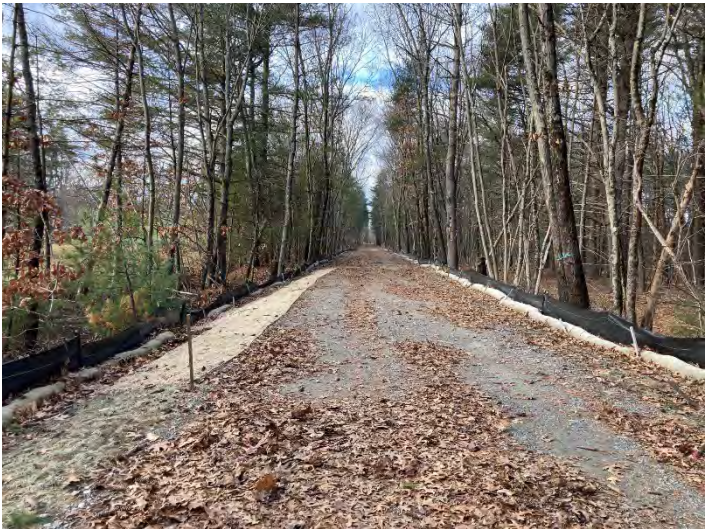
Description: View of E&S controls and matting in segment 4. Facing west.

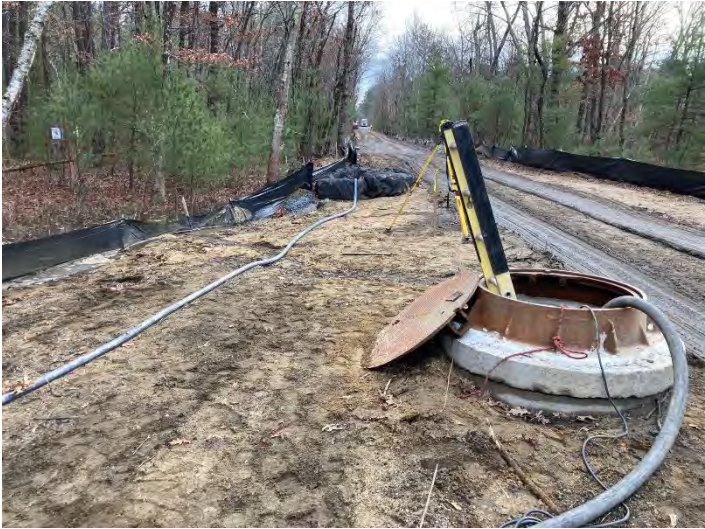
Description: View of pumping operation at MH #14 in segment 6. See additional dewatering inspection report. Facing east.

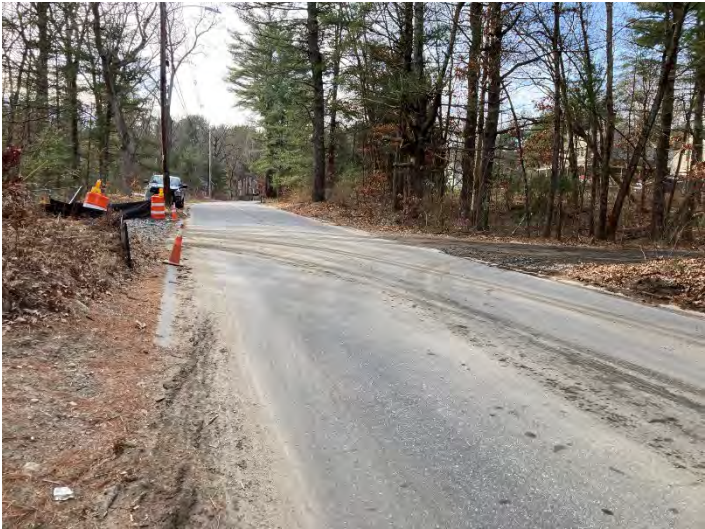
3. Sediment tracking/street sweeping	<input checked="" type="checkbox"/> Yes <input type="checkbox"/> No	1	<input type="checkbox"/> Yes <input checked="" type="checkbox"/> No	1/04/2024	Sediment tracking noted on White Pond Rd (segments 5 & 6). Continue to sweep streets as needed.

Description: View of White Pond Rd between segments 5 and 6. Sediment tracking noted on roadway. Continue to sweep streets as needed. Facing south.

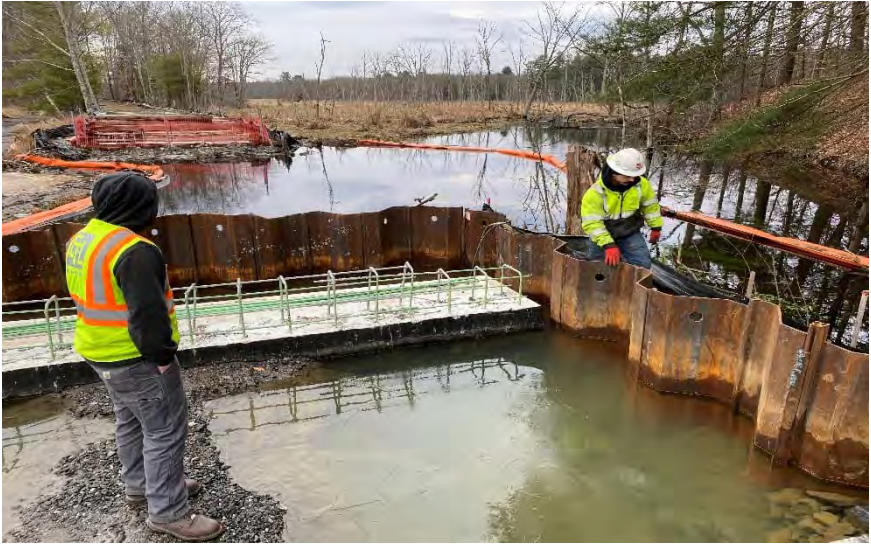
Description: Work area within segment 13, Bridge 127 work area, looking eastward.

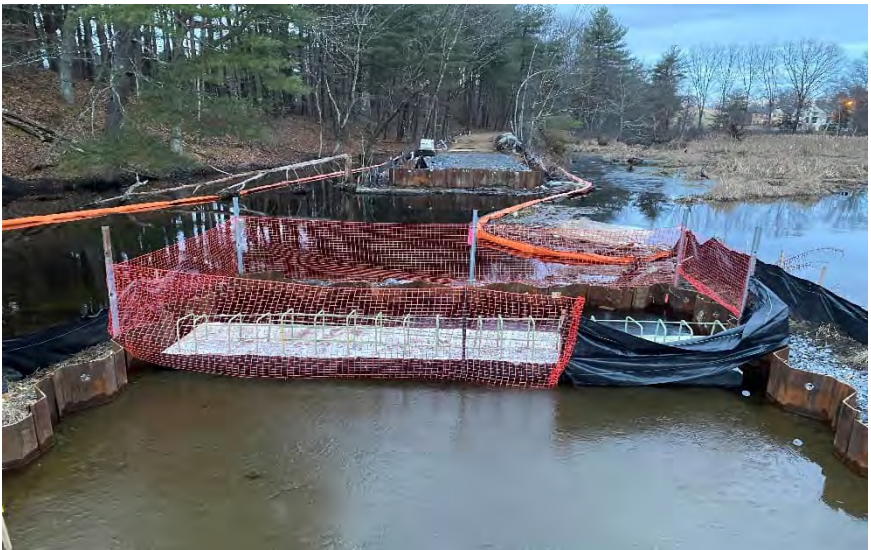
Description: Work area from segment 14 over Hop Brook toward segment 13, existing erosion control, looking westward.

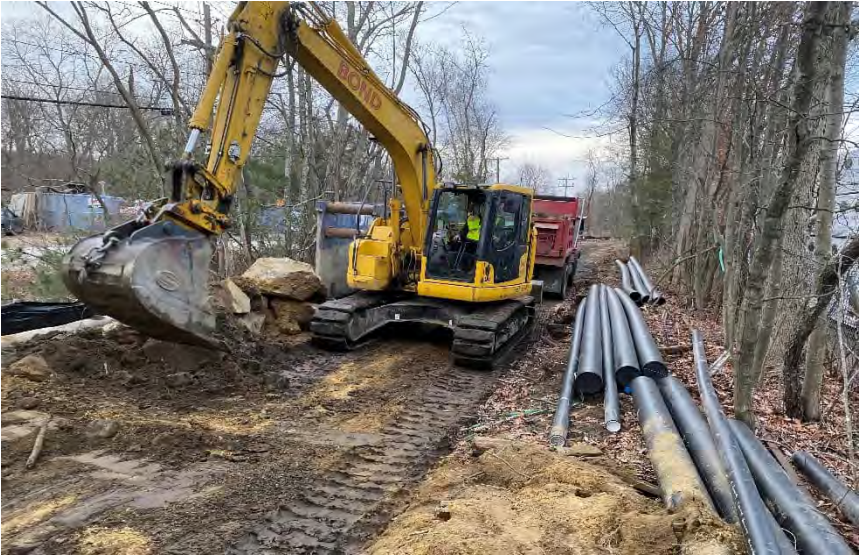
Description: Work area within segment 12, existing erosion control, looking westward.

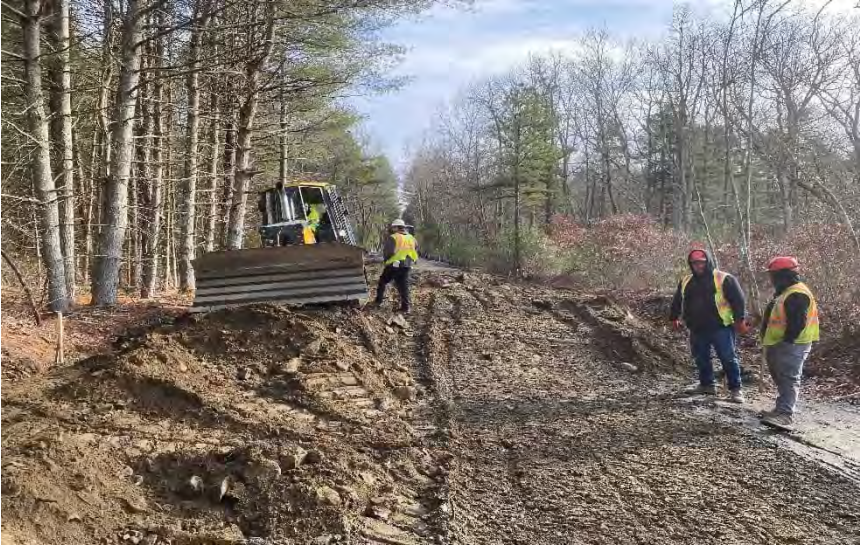
Description: Work area, grading work, within segment 7, looking eastward.

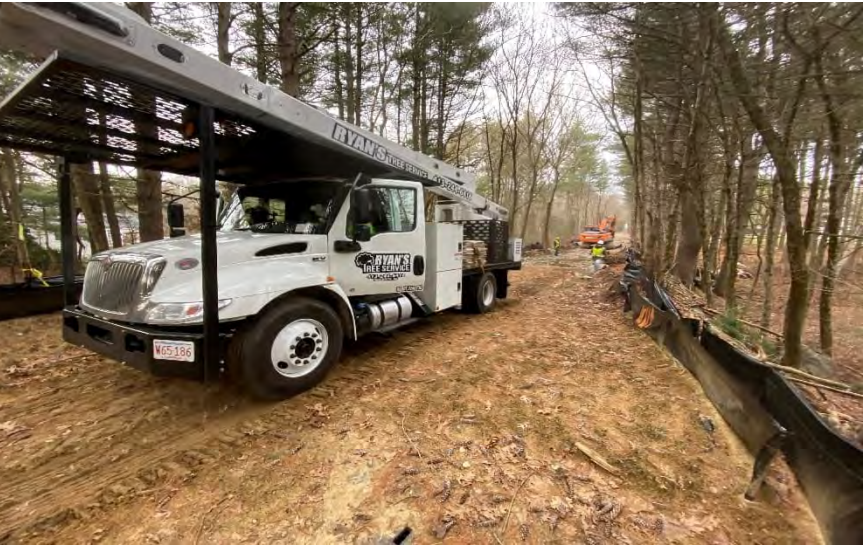
Description: Work area within segment 9, tree removal prior to culvert repair work, existing erosion control, looking westward.

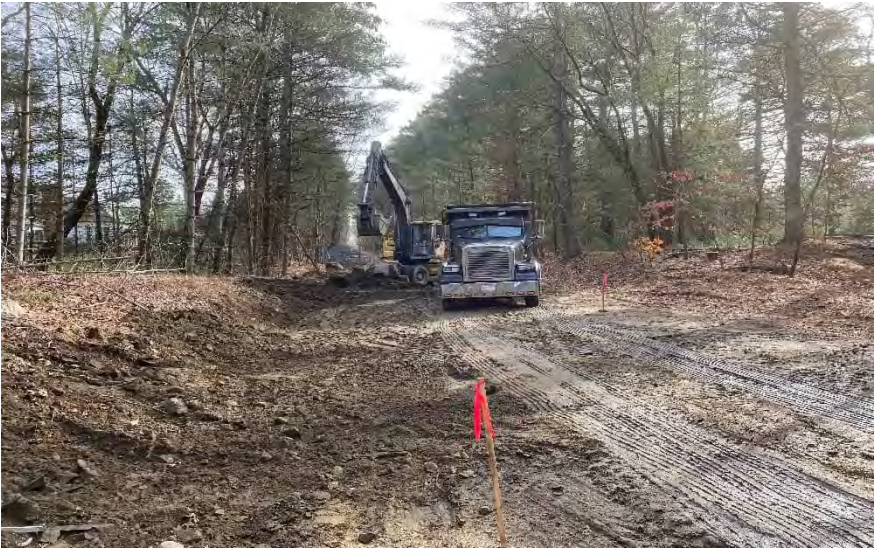
Description: Work area within segment 10, removal of soil stockpiles, looking eastward.

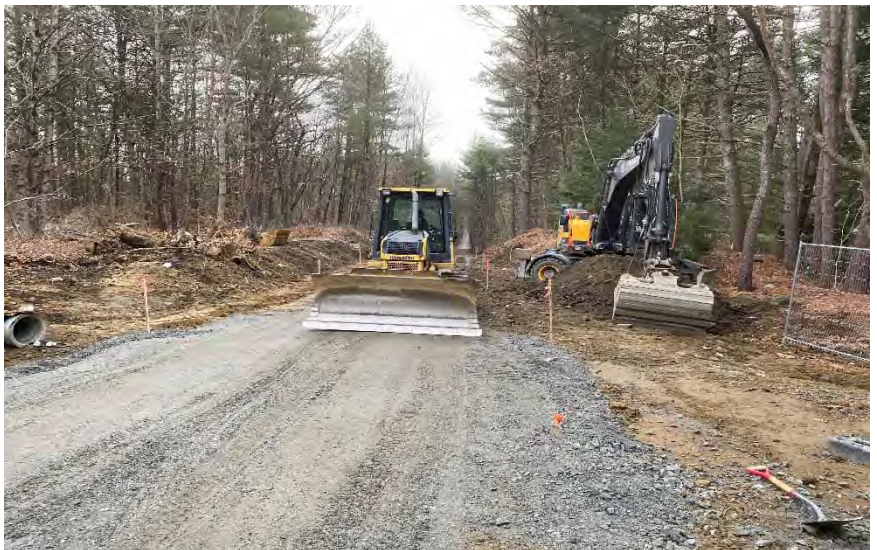
Description: Work area within segment 10, grading work, looking eastward.

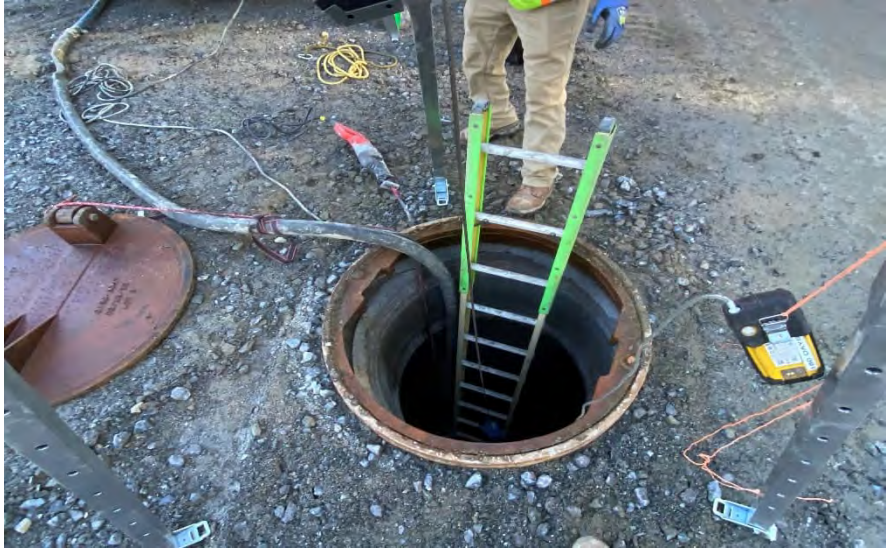
Description: View of pumping from manhole #21 segment 10, looking eastward.

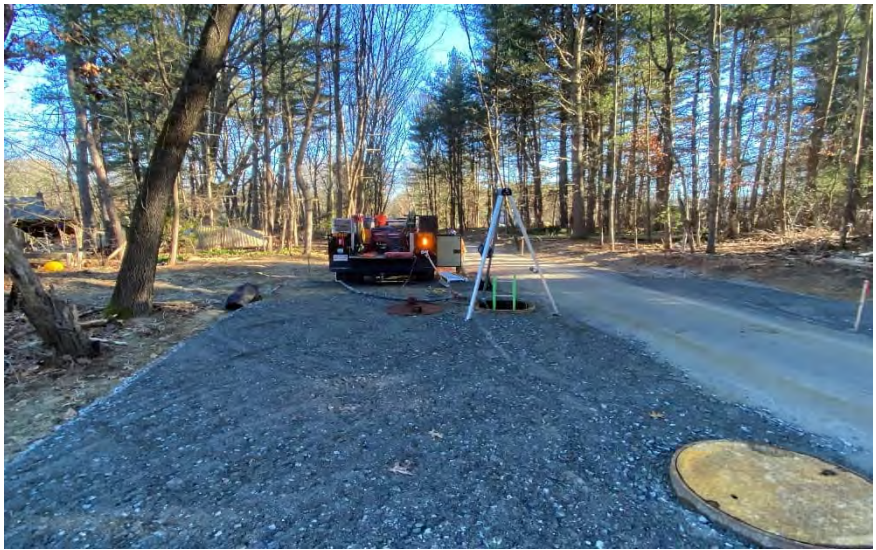
Description: Manhole #21. View of dewatering operation. Looking eastward.

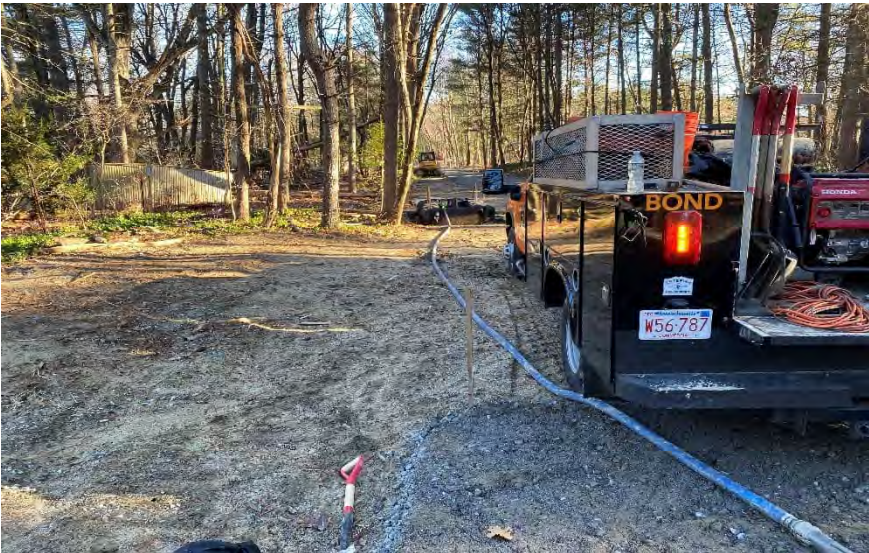
Description: Manhole #21. View of dewatering operation, looking eastward.

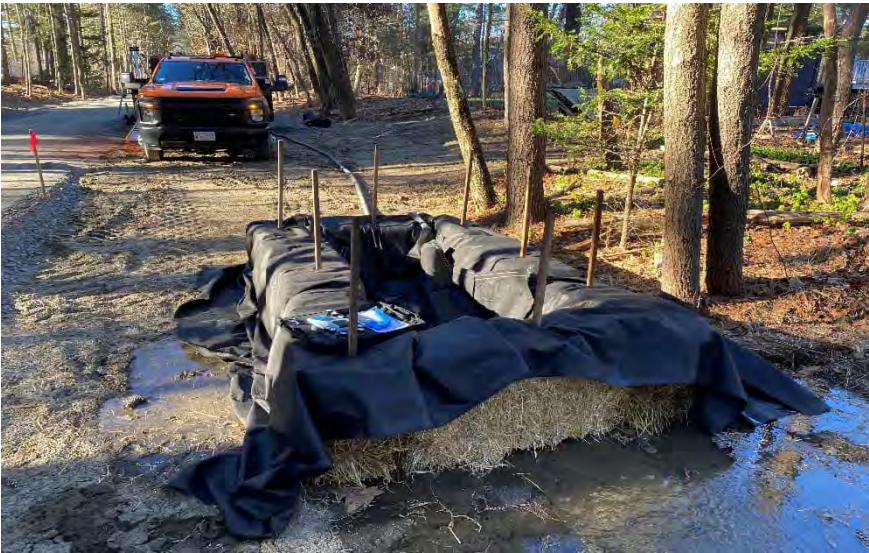
Description: Manhole #21. View of discharge bag, looking westward. Water from bag/corral discharged to adjacent work area, water appeared clear, looking westward.

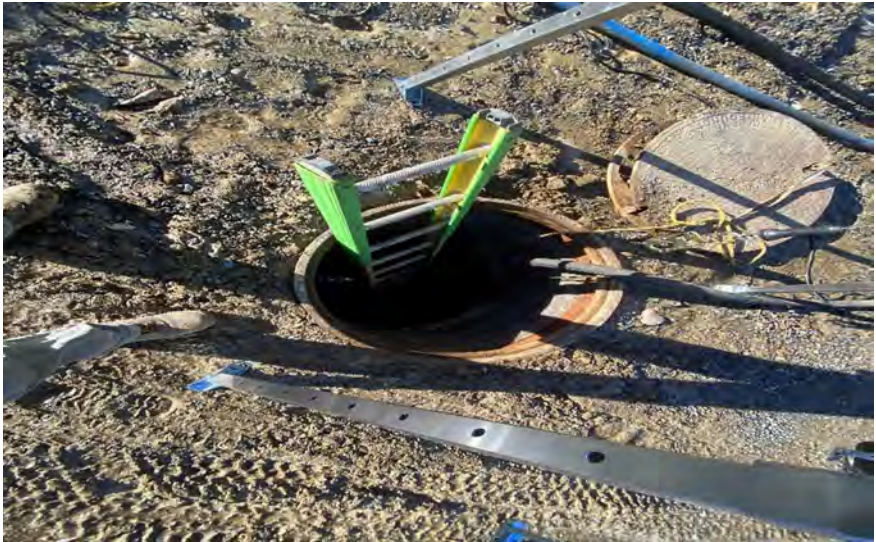
Description: View of area being pumped from manhole #28 outside segment 14, looking eastward.

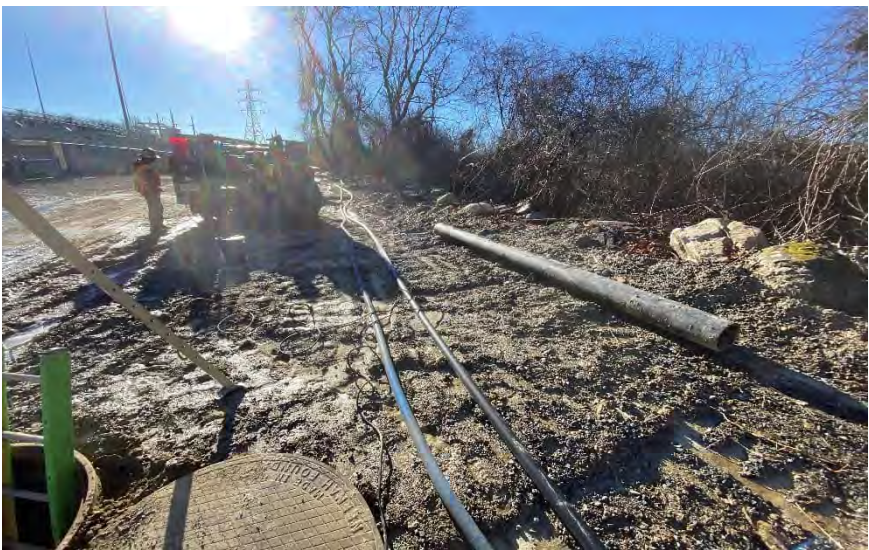
Description: Manhole #28. View of dewatering operation. Looking southward.

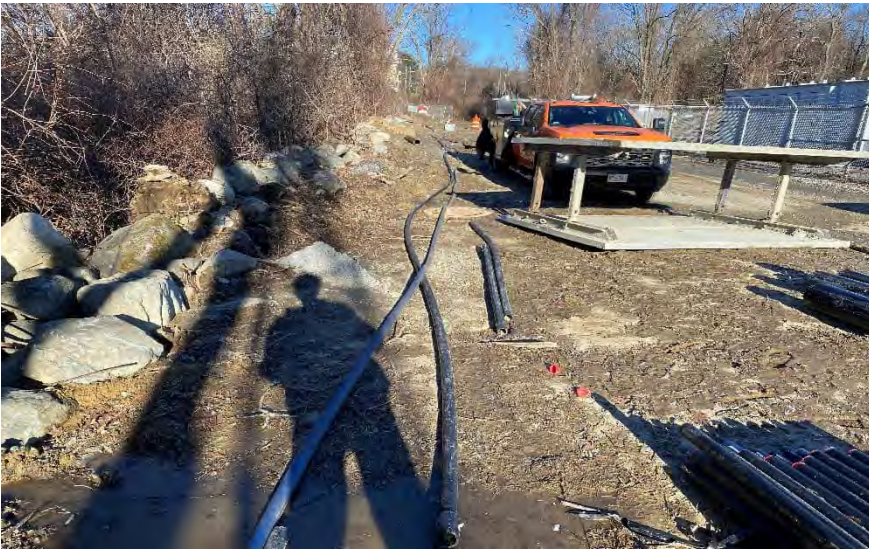
Description: Manhole #28. View of dewatering operation, looking northward.

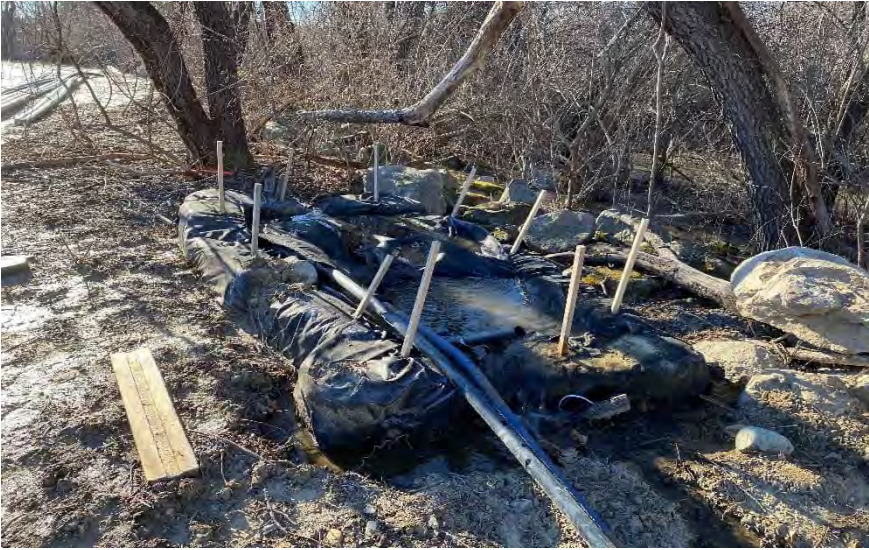
Description: Manhole #28. View of discharge corral/bag, looking southward. Water from bag discharged to adjacent wooded area to the west. Water appeared clear, looking southward.

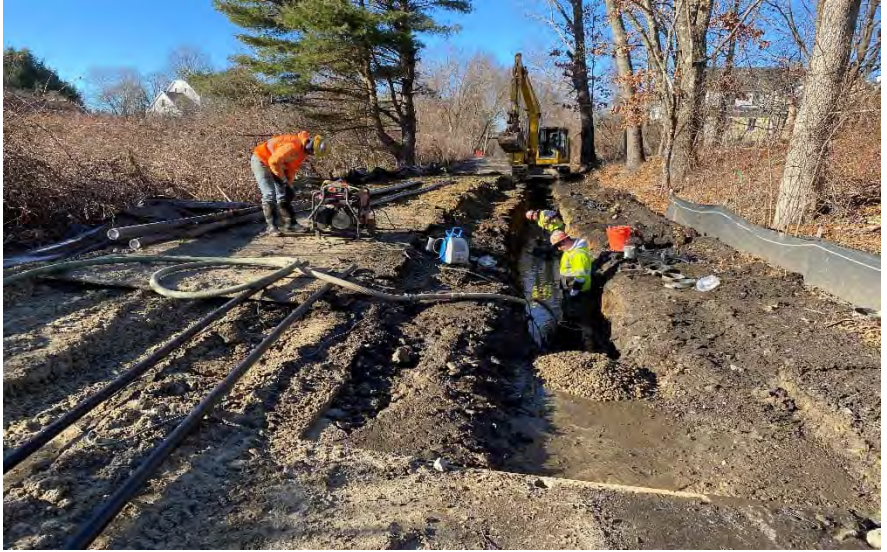
Description: View of area being pumped from segment 14 trench, looking westward.

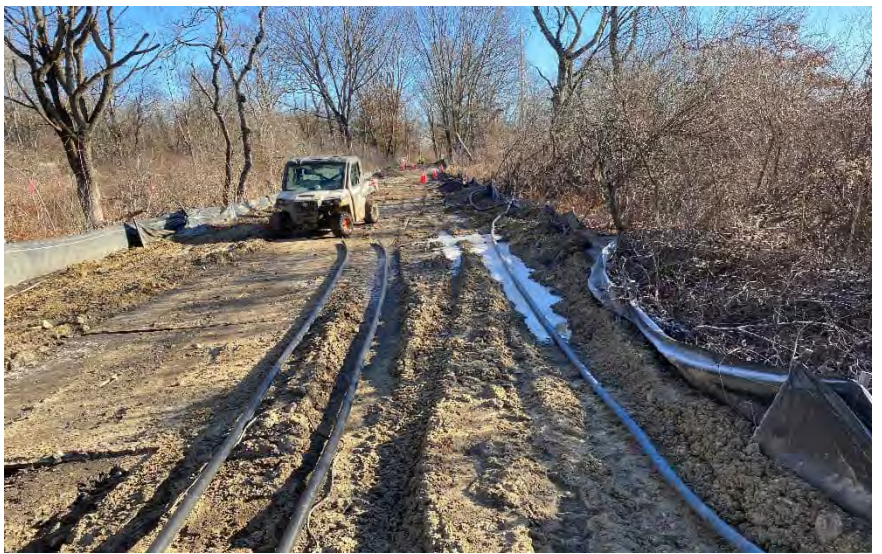
Description: Segment 14. View of dewatering operation in trench. Looking eastward.

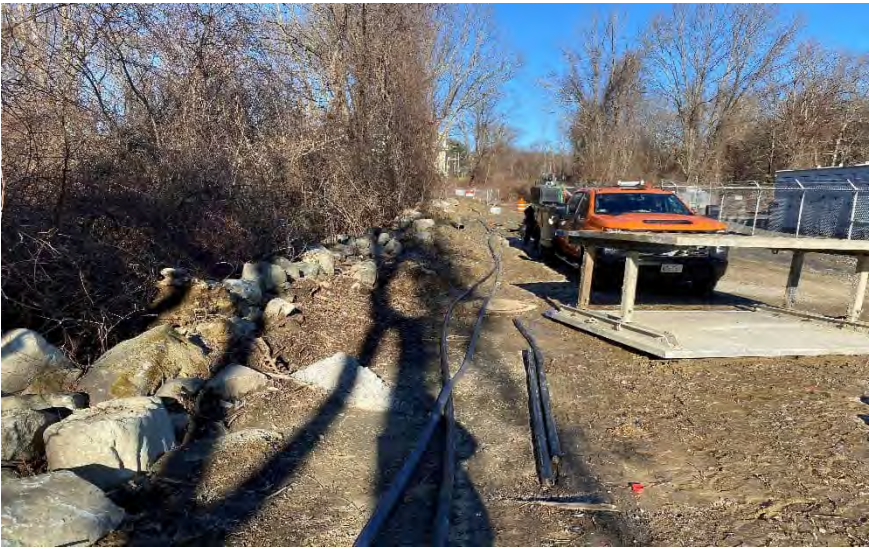
Description: Segment 14. View of dewatering operation, looking northward.

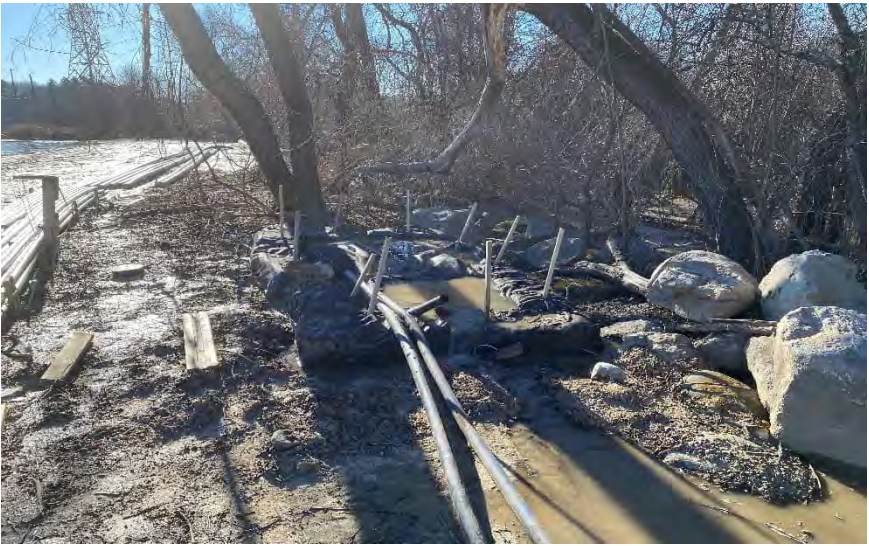
Description: Segment 14. View of discharge to corral/bag, looking southward. Water ultimately discharged to wooded area adjacent to the work area & appeared turbid, looking southward.
