Weekly Environmental Compliance Summary

Sudbury to Hudson Transmission Reliability Project (USEPA Tracking # MAR1003UW)

Week of: January 1, 2024 to January 5, 2024

CONSTRUCTION MONITORING REPORT

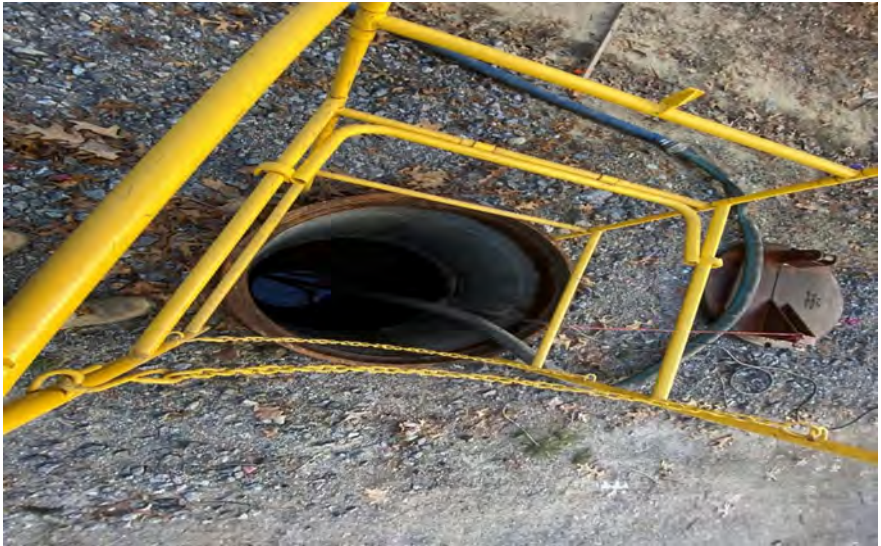
Description: View of pumping from manhole #22 segment 11.

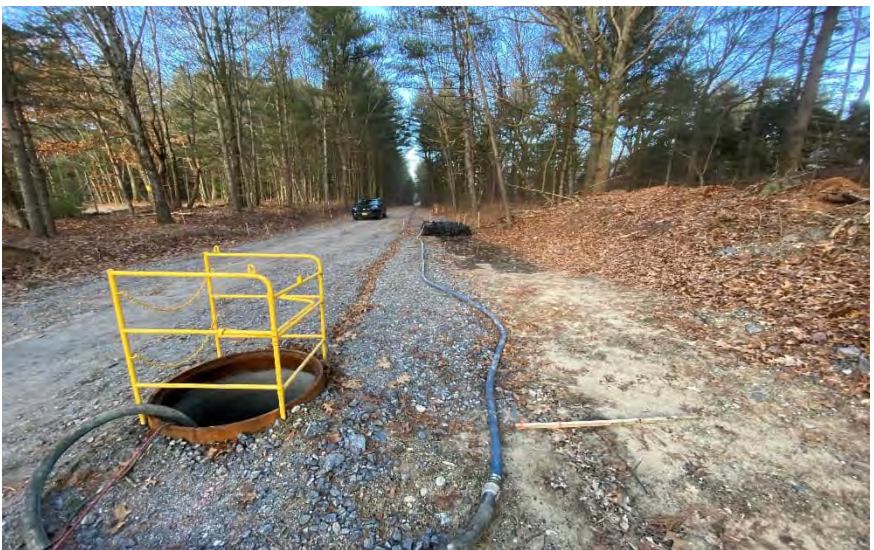
Description: Manhole #22. View of dewatering operation. Looking westward.

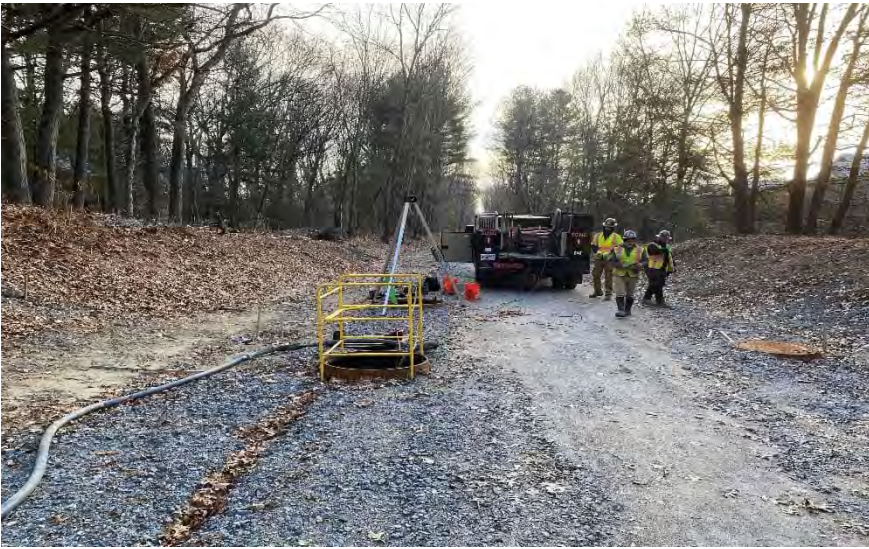
Description: Manhole #22. View of dewatering operation, looking eastward.

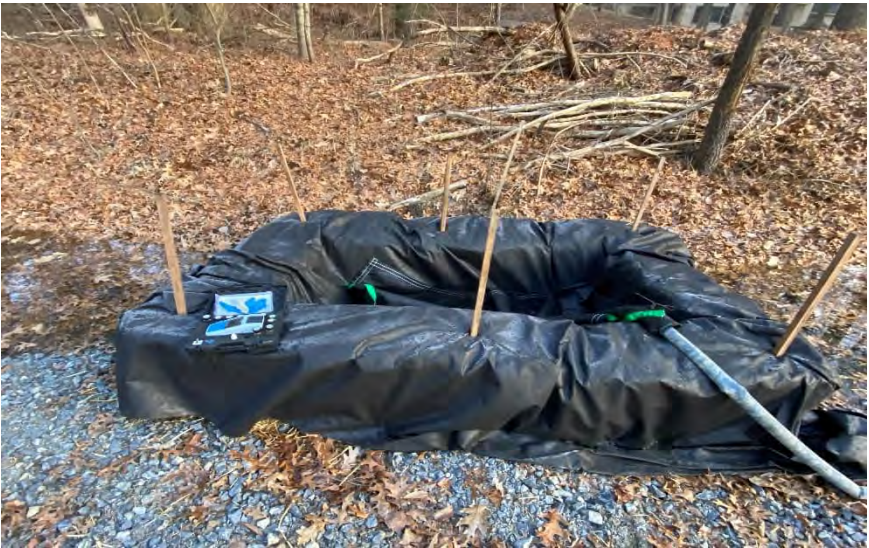
Description: Manhole #22. View of discharge bag, looking northward. Water from bag/corral discharged to adjacent work area, water appeared clear, looking northward.

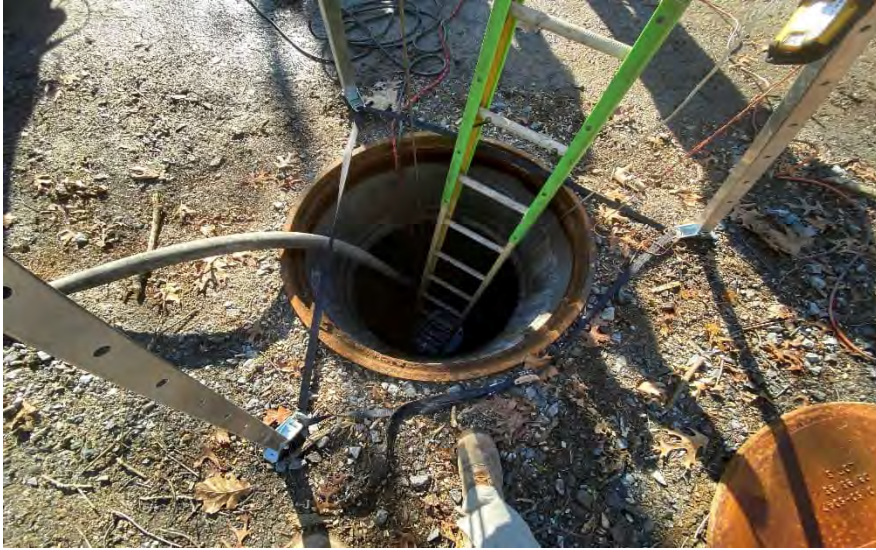
Description: View of area being pumped from manhole #23 within segment 11.

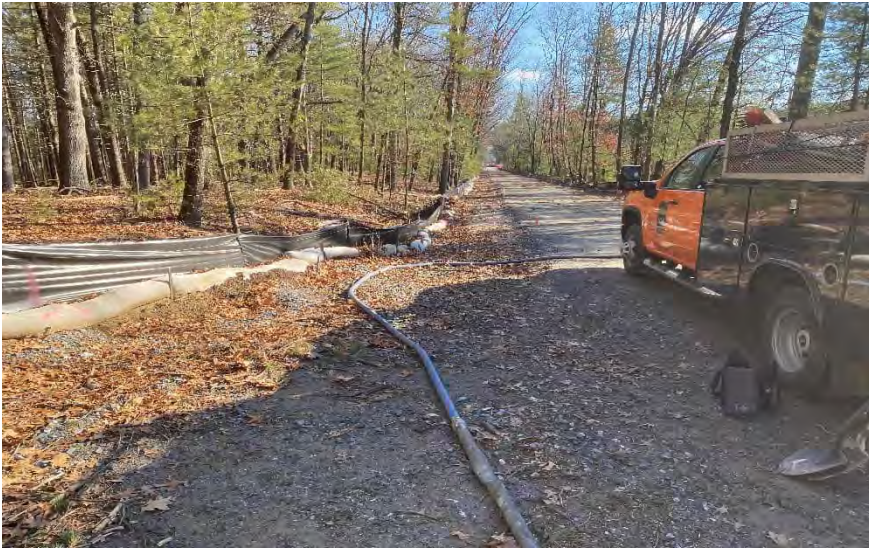
Description: Manhole #23. View of dewatering operation. Looking eastward.

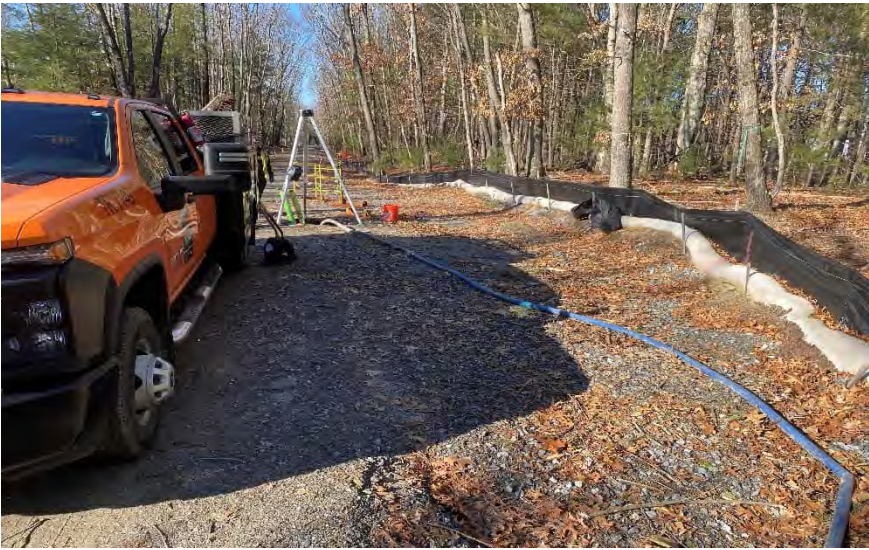
Description: Manhole #23. View of dewatering operation, looking westward.

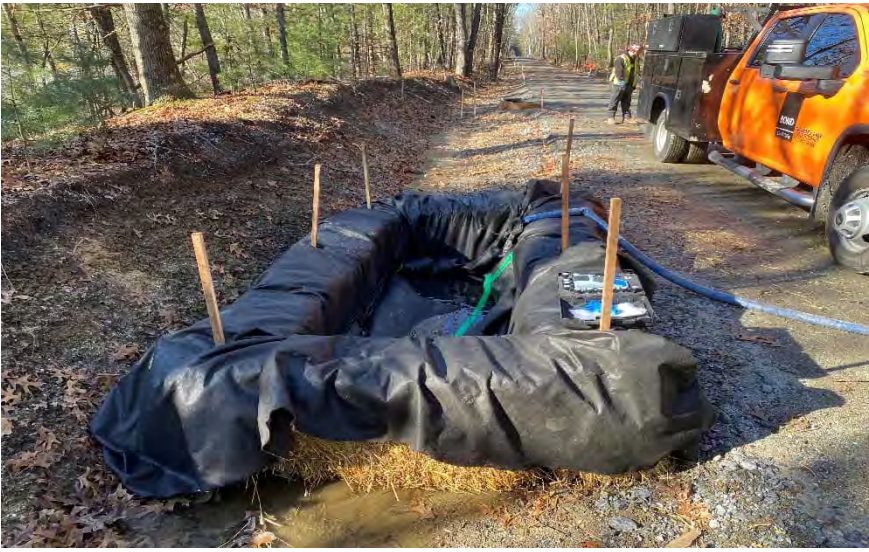
Description: Manhole #23. View of discharge corral/bag, looking westward. Water from bag discharged to adjacent wooded area to the west. Water appeared clear, looking westward.

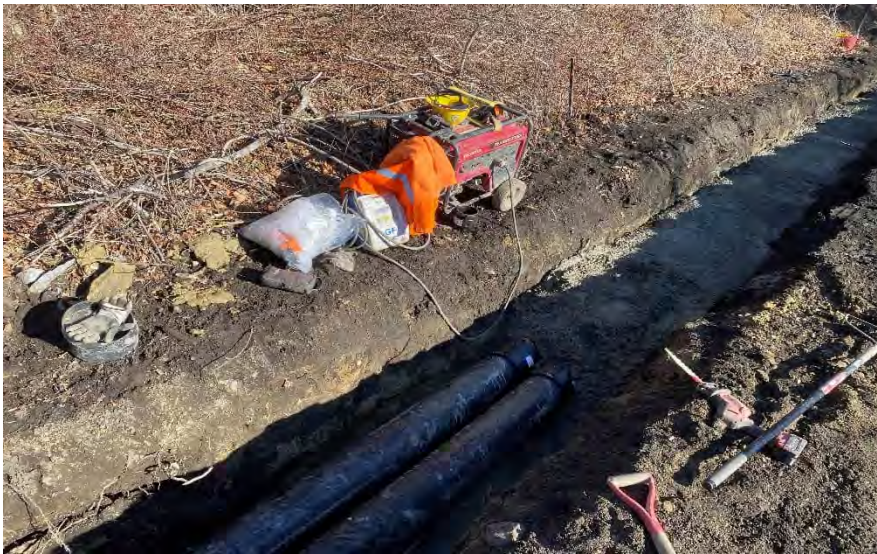
Description: View of area being pumped from segment 14 trench, looking eastward.

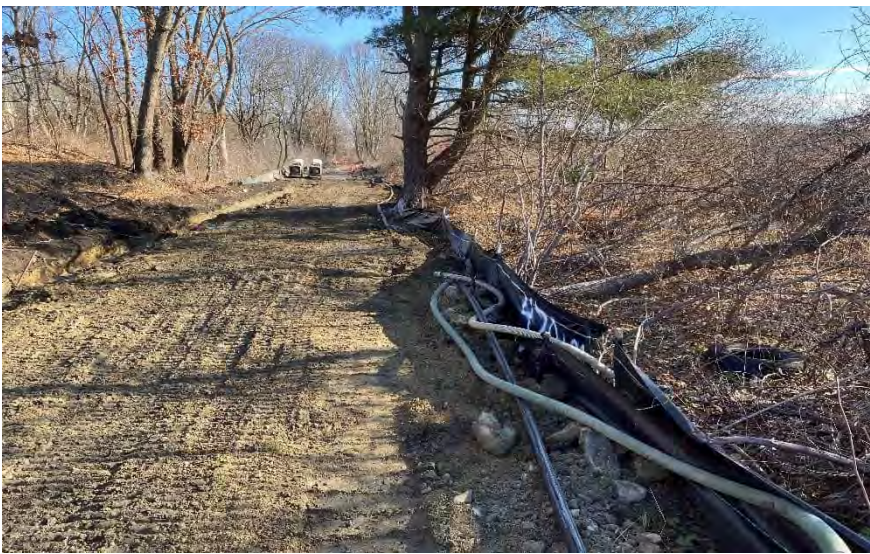
Description: Segment 14. View of dewatering operation in trench. Looking eastward.

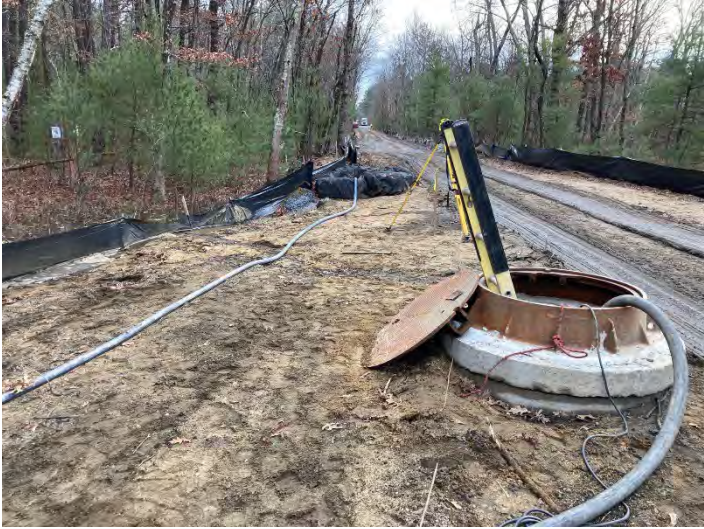
Description: View of pumping operation at MH #14 in segment 6. Facing east.

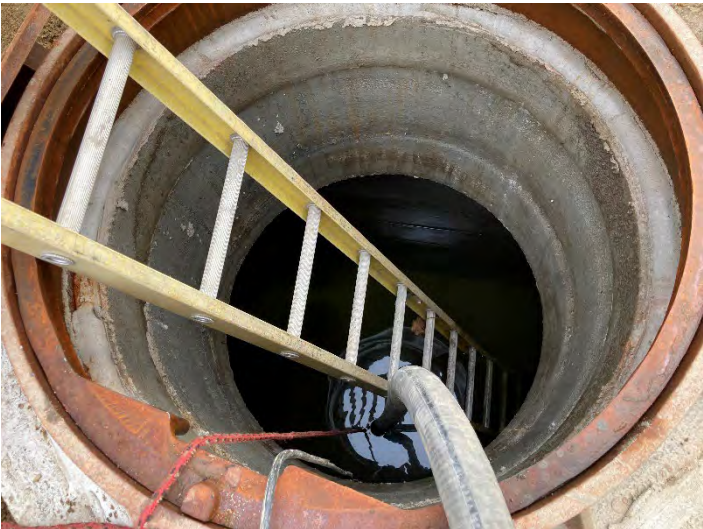
Description: View of pump in MH #14. Water appeared mostly clear prior to treatment.

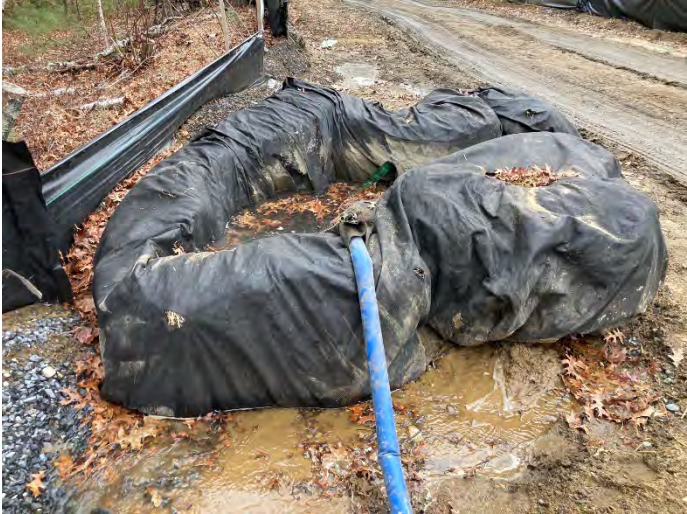
Description: View of dewatering controls (straw bale corral with filter fabric and silt bag). Facing east.

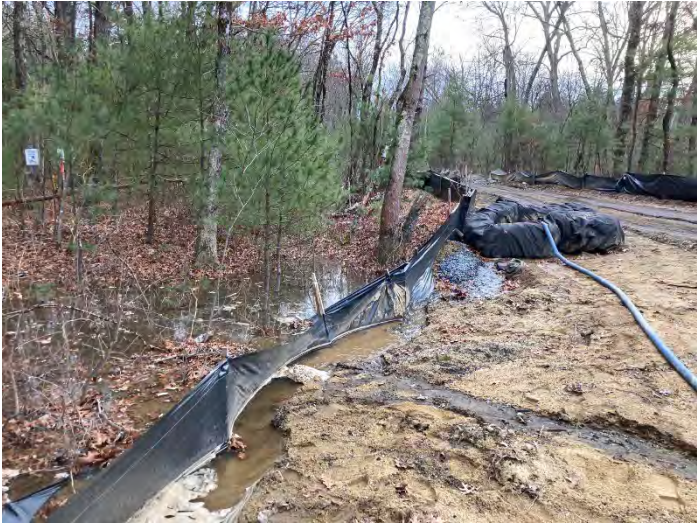
Description: View of dewatering controls (straw bale corral with filter fabric and silt bag) and discharge from project. Discharge appeared mostly clear, but turbidity reading was higher than 50 NTUs. Facing east.

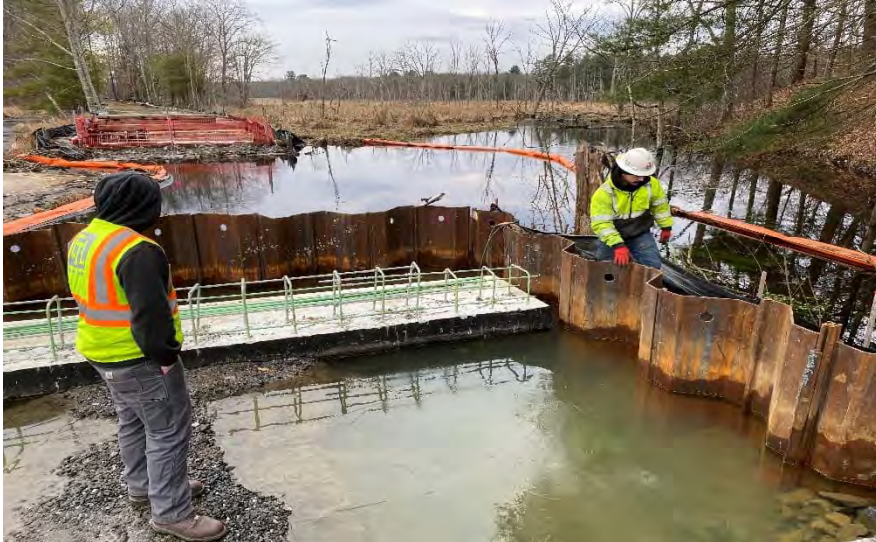
Description: View of area being pumped from segment 13 at bridge 127.

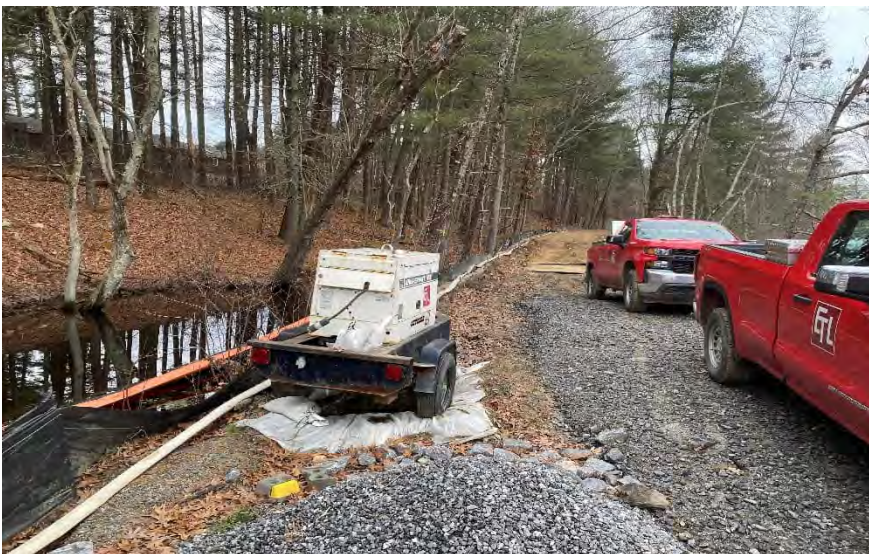
Description: Segment 13. View of dewatering operation. Looking westward.

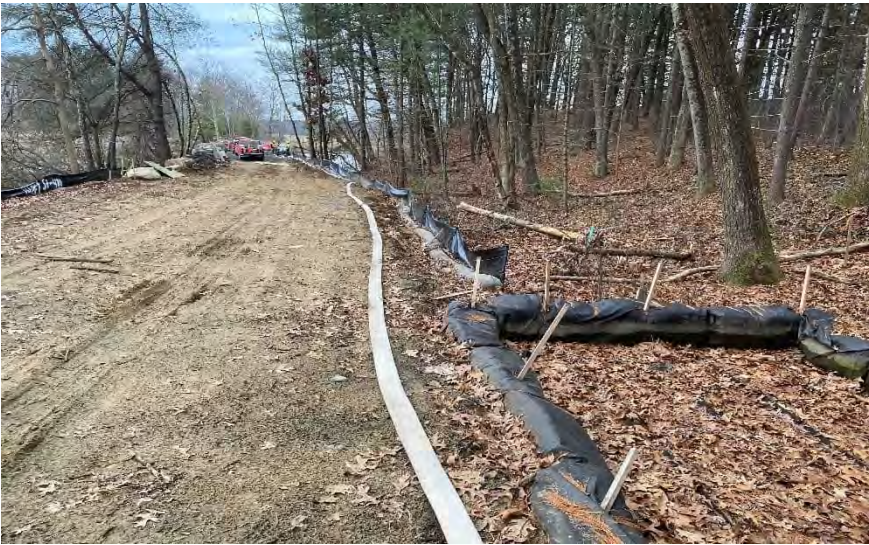
Description: Segment 13. View of dewatering operation, looking eastward.

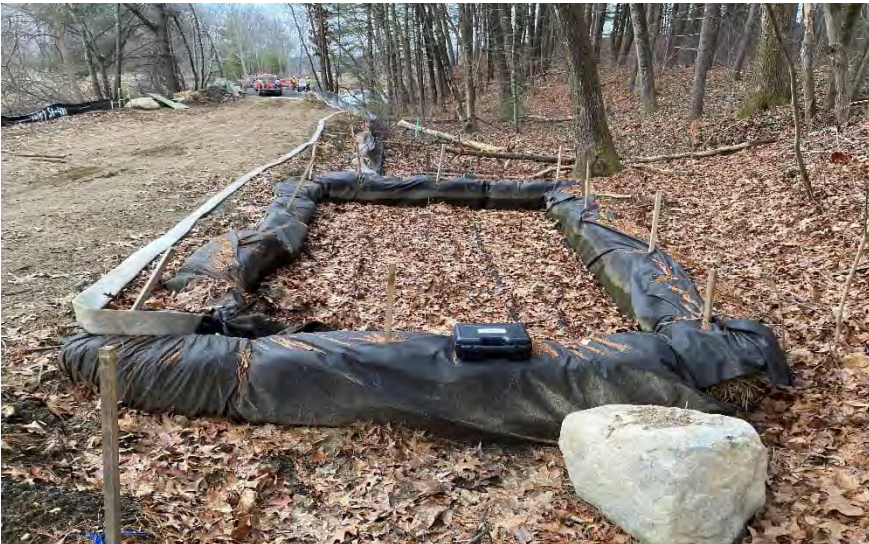
Description: Segment 13. View of discharge corral/bag, looking eastward. Water from bag discharged to adjacent work area to the east. Water appeared clear, looking eastward.

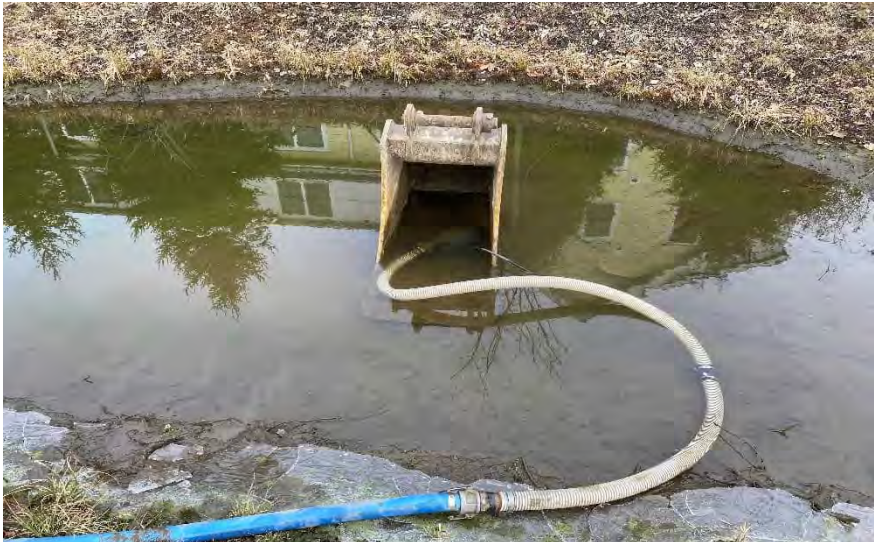
Description: View of area being pumped from segment 14 detention area, looking northward.

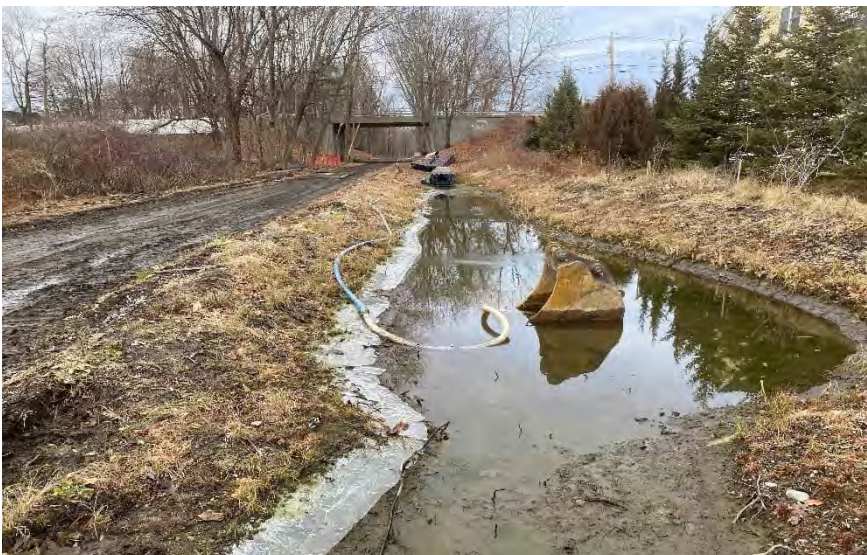
Description: Segment 14. View of dewatering operation in detention area. Looking westward.

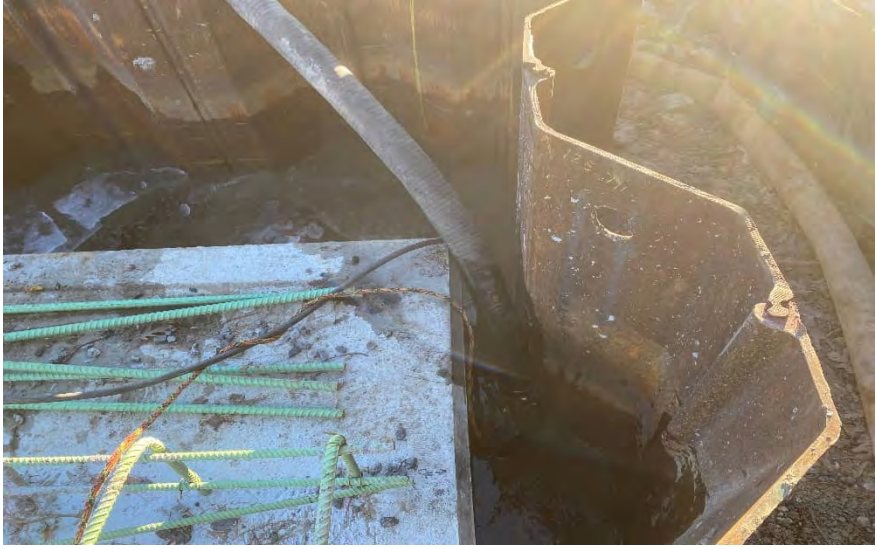
Description: View of area being pumped from segment 13 at bridge 127.

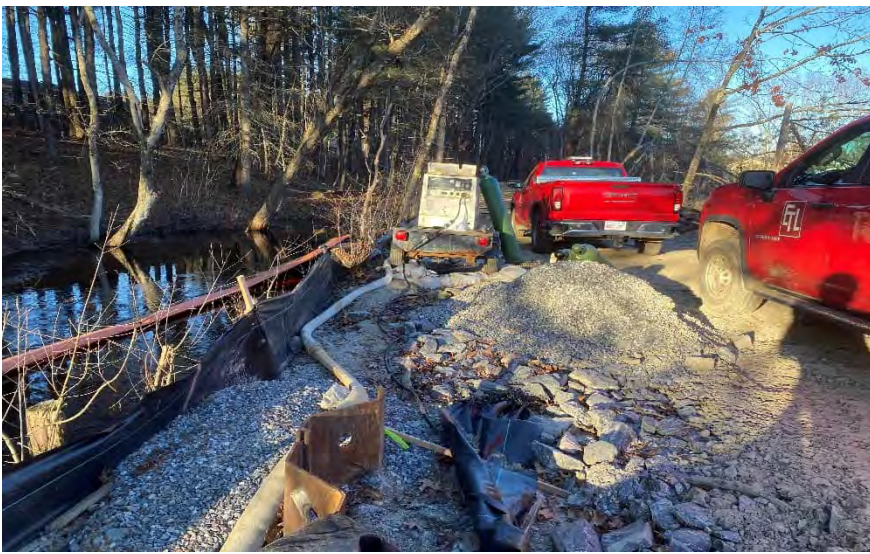
Description: Segment 13. View of dewatering operation. Looking westward.

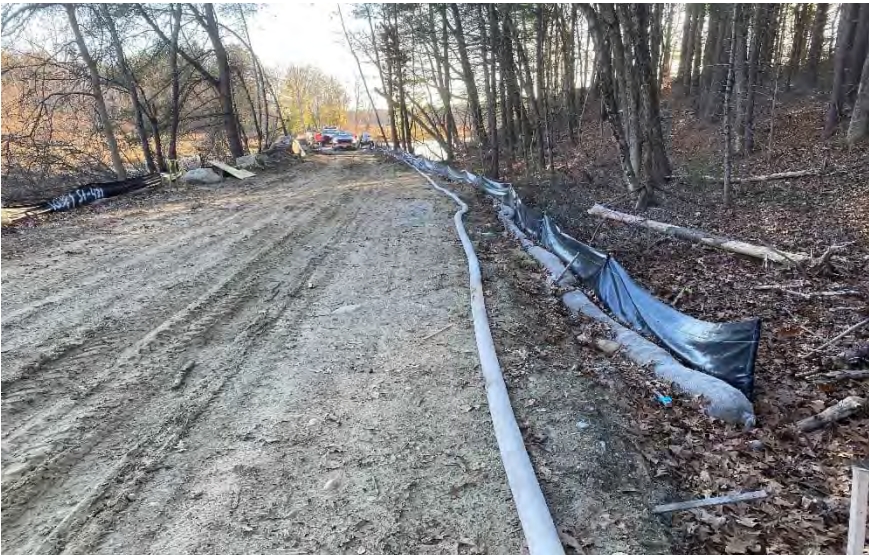
Description: Segment 13. View of dewatering operation, looking eastward.

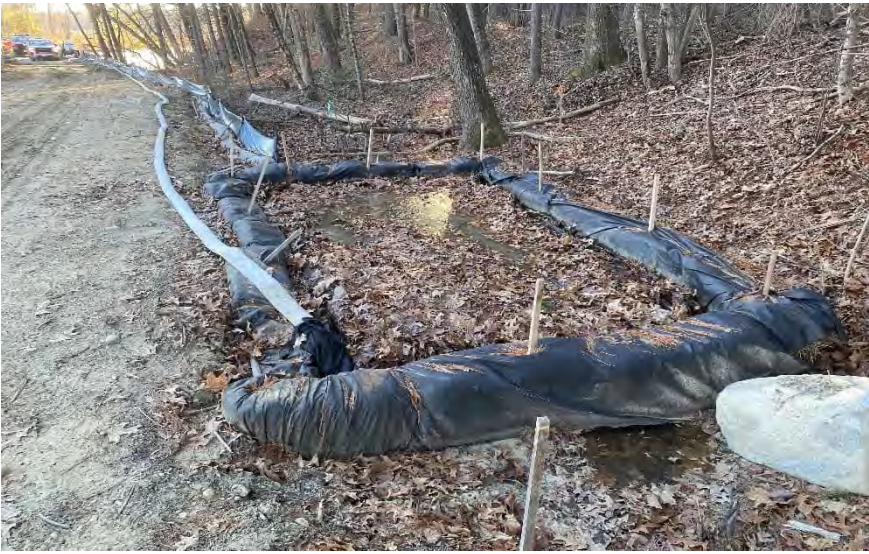
Description: Segment 13. View of discharge corral/bag, looking eastward. Water from bag discharged to adjacent work area to the east. Water appeared clear, looking eastward.
