Weekly Environmental Compliance Summary

Sudbury to Hudson Transmission Reliability Project (USEPA Tracking # MAR1003UW)

Week of: January 8, 2024 to January 12, 2024

**CONSTRUCTION MONITORING REPORT
Sudbury to Hudson Transmission Project**

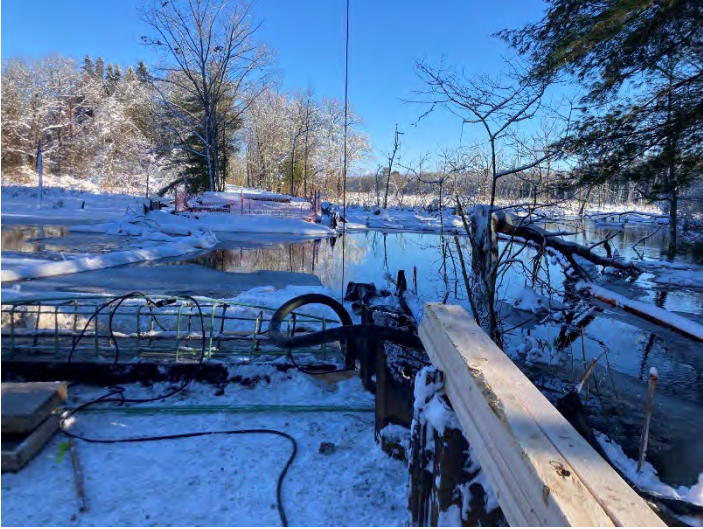
<p>PHOTOGRAPHIC LOG</p>	
<p>Client Name: Eversource</p>		<p>Site Location: Sudbury to Hudson Transmission Reliability Project</p>	<p>Town: Sudbury</p>
<p>Photo No.: 1</p>	<p>Date: 1/08/2024</p>

<p>Description: View of pumping and work area at Bridge 127. Facing east.</p>

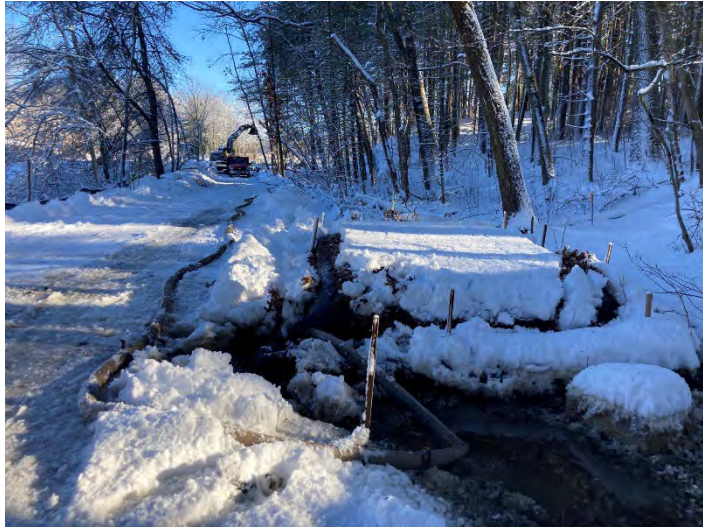
<p>PHOTOGRAPHIC LOG</p>	
<p>Client Name: Eversource</p>		<p>Site Location: Sudbury to Hudson Transmission Reliability Project</p>	<p>Town: Sudbury</p>
<p>Photo No.: 2</p>	<p>Date: 1/08/2024</p>

<p>Description: View of dewatering controls in segment 13. See additional dewatering inspection report. Facing east.</p>

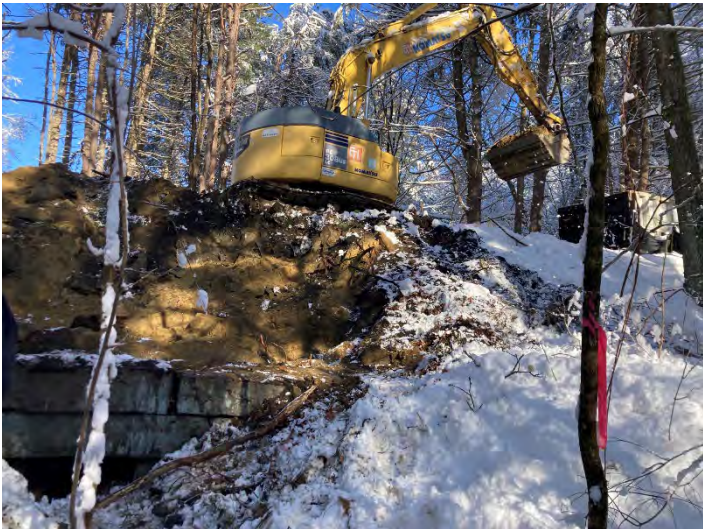
PHOTOGRAPHIC LOG	
Client Name: Eversource		Site Location: Sudbury to Hudson Transmission Reliability Project	Town: Sudbury
Photo No.: 4	Date: 1/08/2024

Description: View of excavation for culvert repair in segment 9. Facing north.

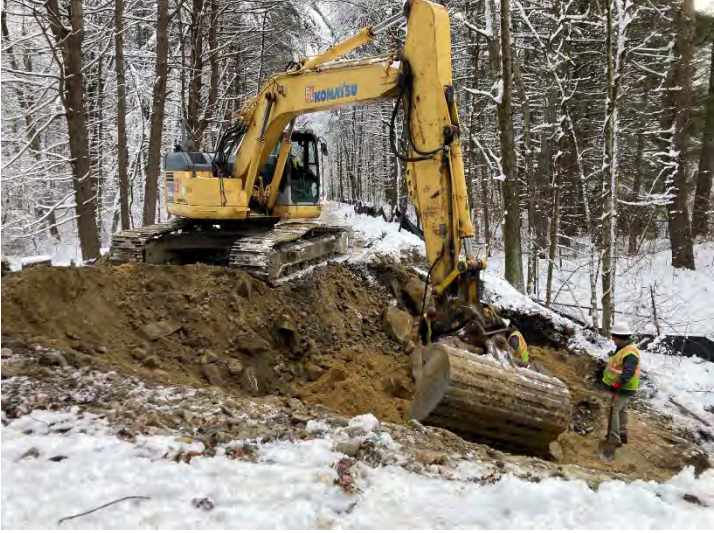
PHOTOGRAPHIC LOG	
Client Name: Eversource		Site Location: Sudbury to Hudson Transmission Reliability Project	Town: Sudbury
Photo No.: 3	Date: 1/09/2024

Description: View of ET&L excavating for culvert repair in segment 9. Facing east.

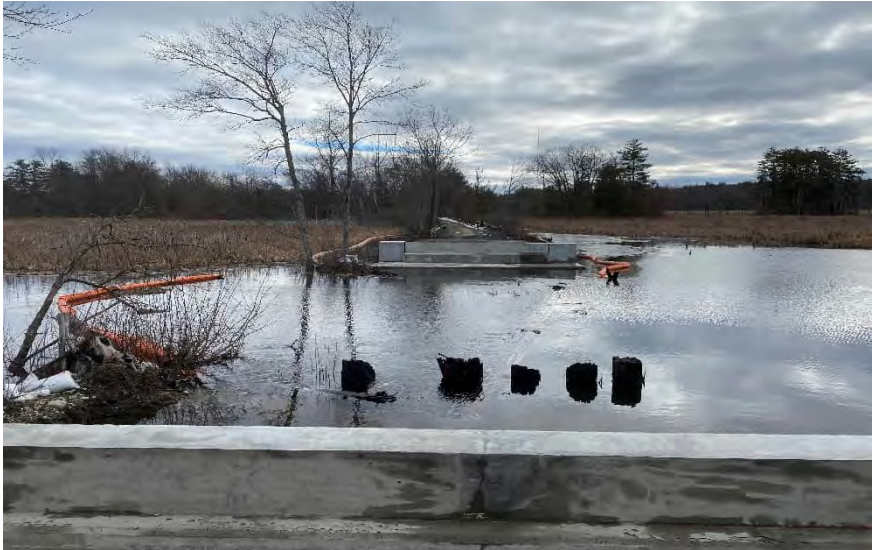
<p>PHOTOGRAPHIC LOG</p>	
<p>Client Name: Eversource</p>		<p>Site Location: Sudbury to Hudson Transmission Reliability Project</p>	<p>Town: Hudson</p>
<p>Photo No.: 1</p>	<p>Date: 1-11-24</p>

<p>Description:</p> <p>Bridge 130 work area from segment 2 toward segment 3 across Fort Meadow Brook, existing erosion control (floating silt curtain), looking eastward.</p>

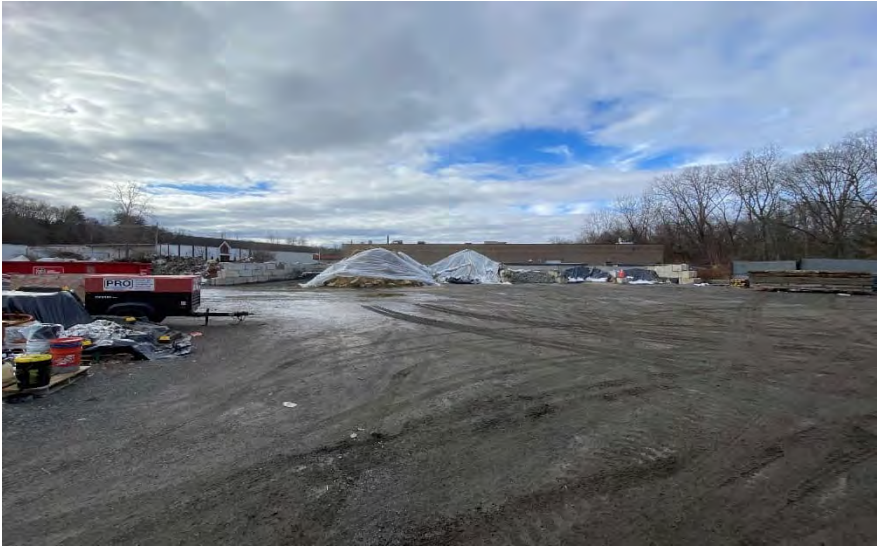
<p>PHOTOGRAPHIC LOG</p>	
<p>Client Name: Eversource</p>		<p>Site Location: Sudbury to Hudson Transmission Reliability Project</p>	<p>Town: Hudson</p>
<p>Photo No.: 3</p>	<p>Date: 1-11-24</p>

<p>Description:</p> <p>Bonazzoli laydown yard, covered spoil piles, looking westward.</p>

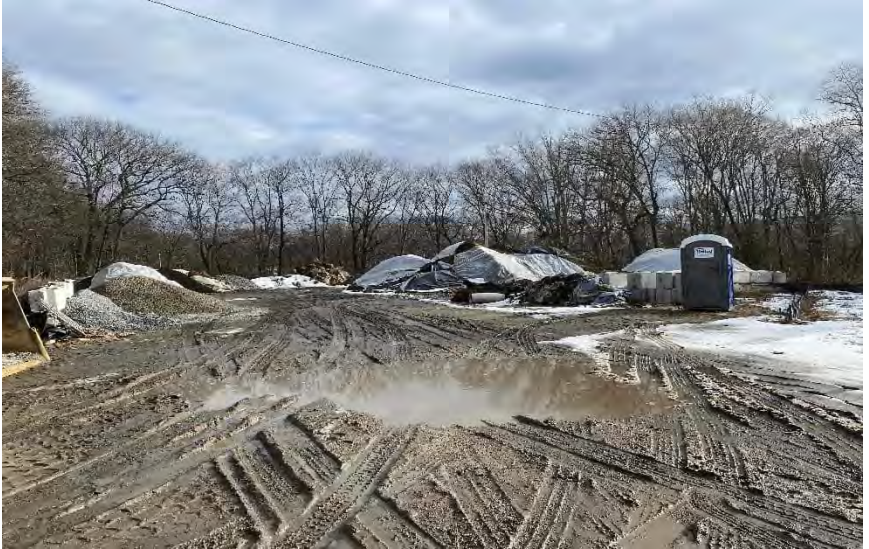
<p>PHOTOGRAPHIC LOG</p>	
<p>Client Name: Eversource</p>		<p>Site Location: Sudbury to Hudson Transmission Reliability Project</p>	<p>Town: Hudson</p>
<p>Photo No.: 4</p>	<p>Date: 1-11-24</p>

<p>Description:</p> <p>Stowe Court laydown yard, covered spoil piles, looking southward.</p>

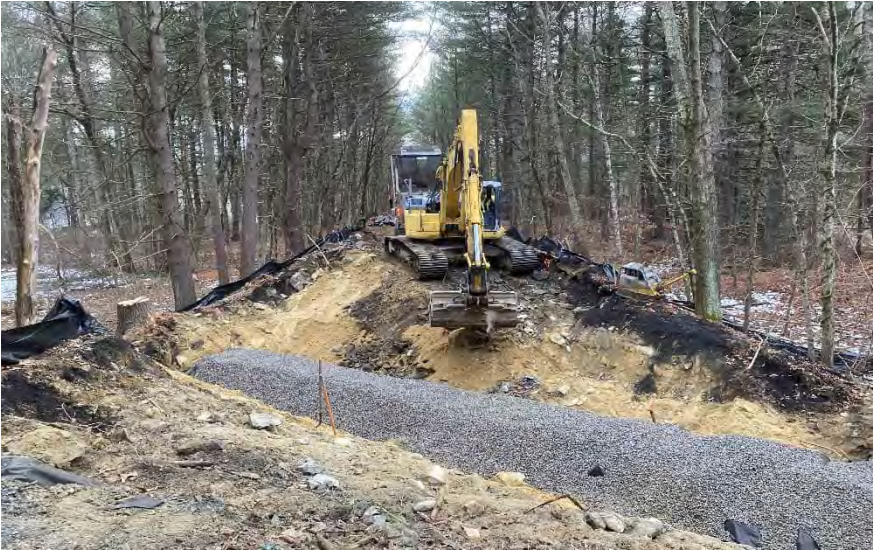
<p>PHOTOGRAPHIC LOG</p>	
<p>Client Name: Eversource</p>		<p>Site Location: Sudbury to Hudson Transmission Reliability Project</p>	<p>Town: Sudbury</p>
<p>Photo No.: 5</p>	<p>Date: 1-11-24</p>

<p>Description:</p> <p>Work area within segment 9, culvert rehabilitation, existing erosion control, looking eastward.</p>

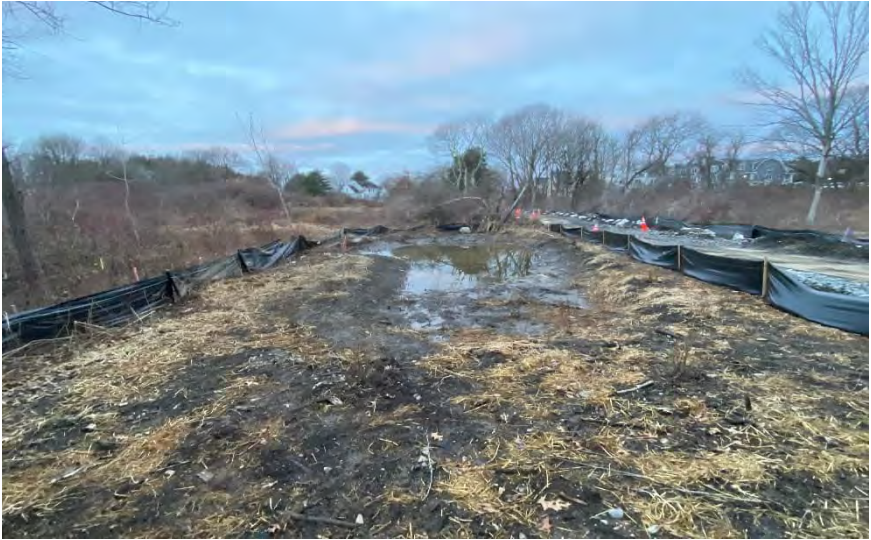
<p>PHOTOGRAPHIC LOG</p>	
<p>Client Name: Eversource</p>		<p>Site Location: Sudbury to Hudson Transmission Reliability Project</p>	<p>Town: Sudbury</p>
<p>Photo No.: 7</p>	<p>Date: 1-11-24</p>

<p>Description:</p> <p>Wetland replication area within Segment 14, existing erosion control, looking westward.</p>

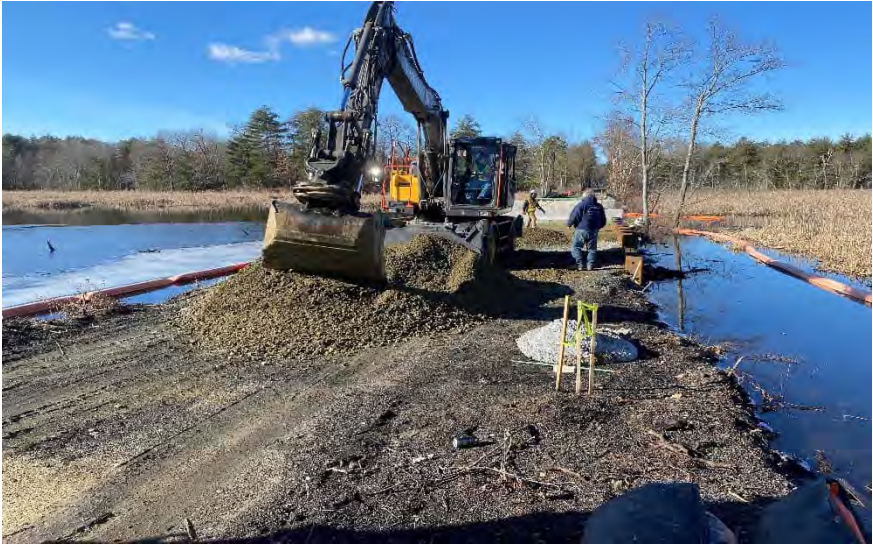
<p>PHOTOGRAPHIC LOG</p>	
<p>Client Name: Eversource</p>		<p>Site Location: Sudbury to Hudson Transmission Reliability Project</p>	<p>Town: Hudson</p>
<p>Photo No.: 1</p>	<p>Date: 1-12-24</p>

<p>Description:</p> <p>Bridge 130 work area from segment 3 toward segment 2 across Fort Meadow Brook, existing erosion control (floating silt curtain), looking westward.</p>

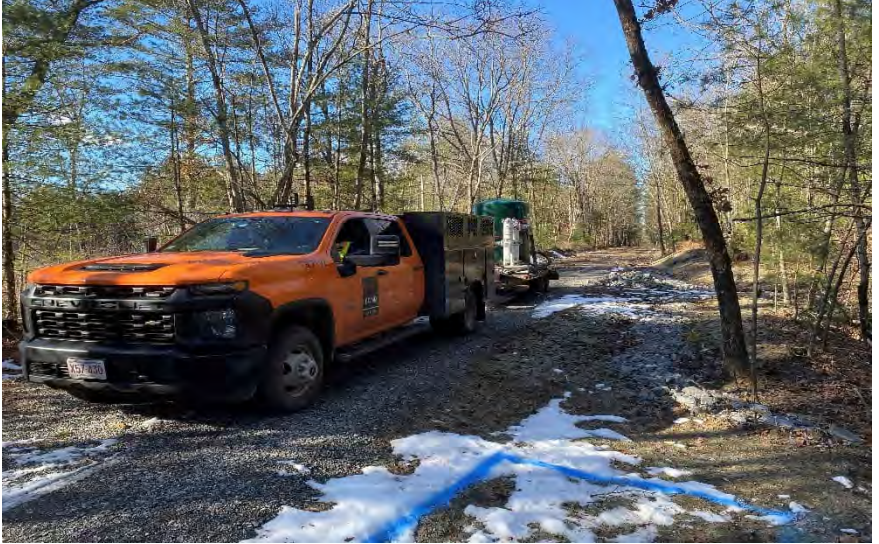
<p>PHOTOGRAPHIC LOG</p>	
<p>Client Name: Eversource</p>		<p>Site Location: Sudbury to Hudson Transmission Reliability Project</p>	<p>Town: Hudson</p>
<p>Photo No.: 3</p>	<p>Date: 1-12-24</p>

<p>Description:</p> <p>Bond setting up dewatering system (frac tank/filtration) within segment 5 at manhole #12, looking westward.</p>

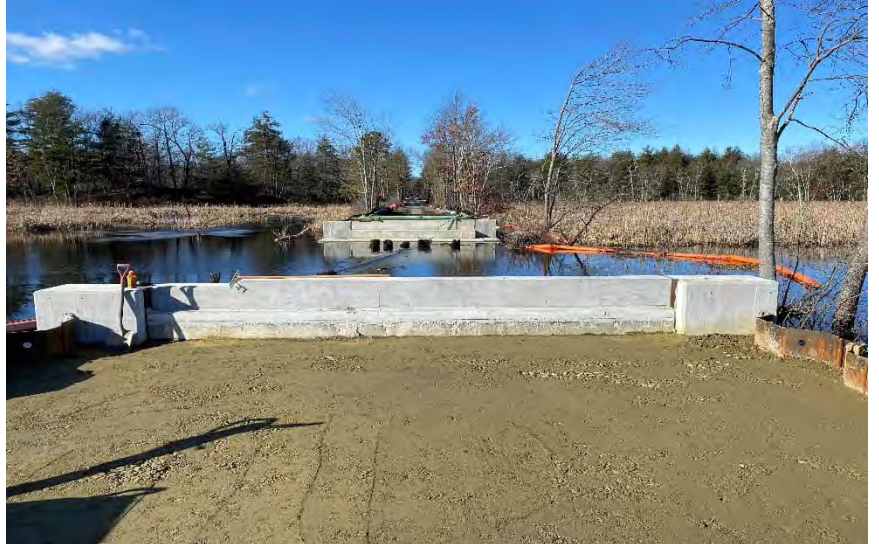
<p>PHOTOGRAPHIC LOG</p>	
<p>Client Name: Eversource</p>		<p>Site Location: Sudbury to Hudson Transmission Reliability Project</p>	<p>Town: Hudson</p>
<p>Photo No.: 4</p>	<p>Date: 1-12-24</p>

<p>Description:</p> <p>Work area within segment 3 looking westward over Fort Meadow Brook toward segment 2, existing erosion control (floating silt curtains), looking westward.</p>

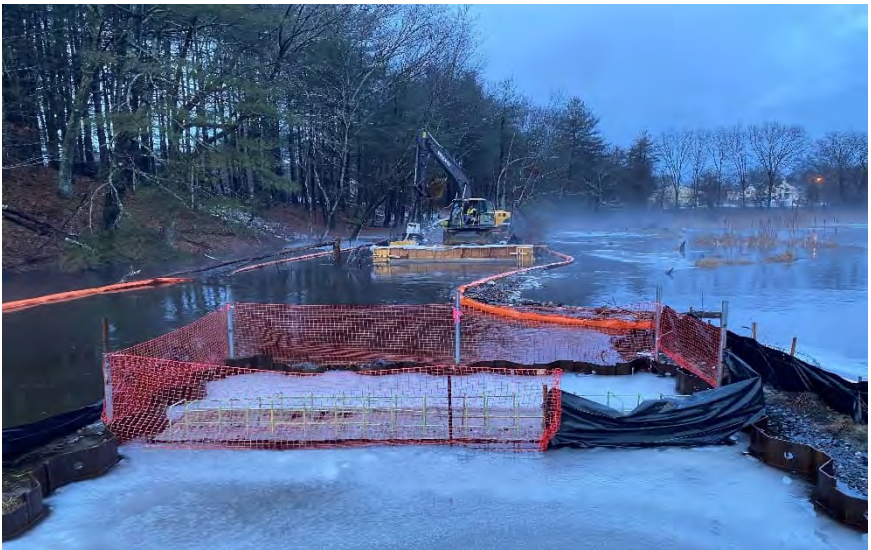
Description: Work area from segment 14 over Hop Brook toward segment 13, high water, existing erosion control, looking westward.

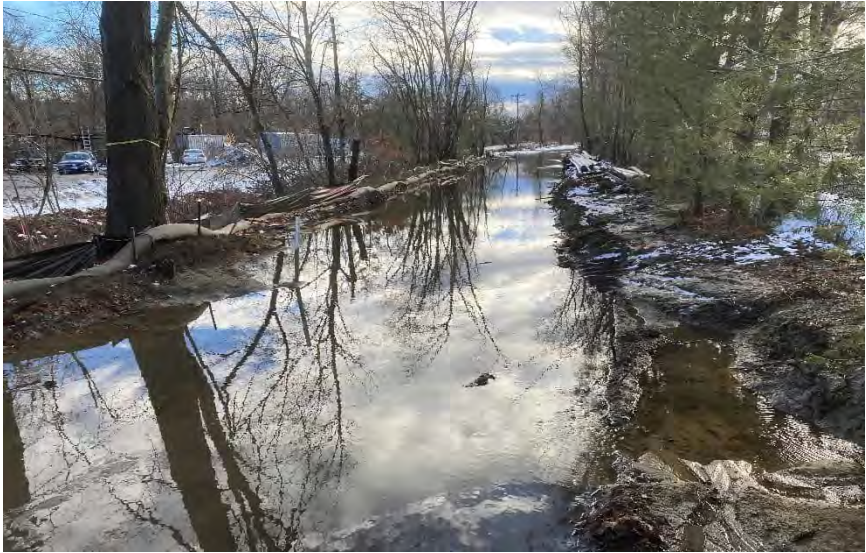
Description: Work area within segment 12, existing erosion control, area flooded over previously replaced culvert, looking eastward.

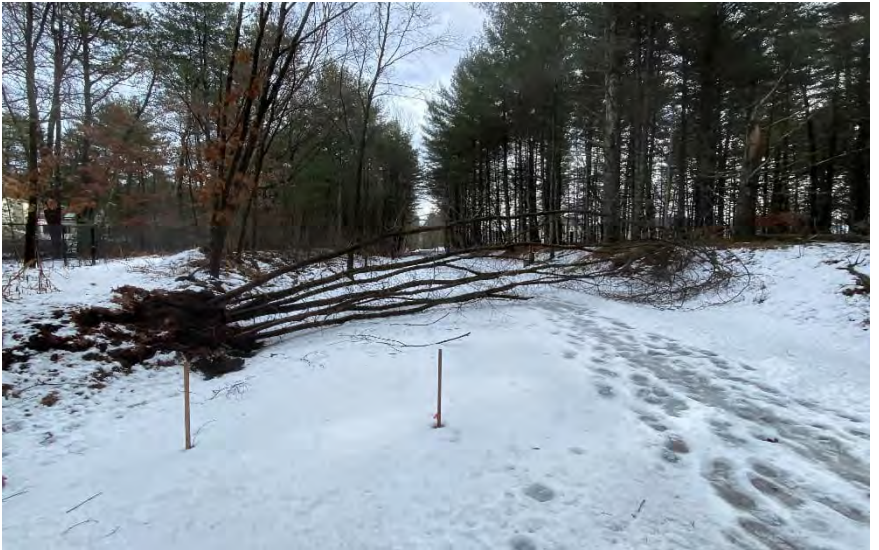
Description: Work area within segment 10, fallen tree from storm to be removed, existing erosion control, looking eastward.

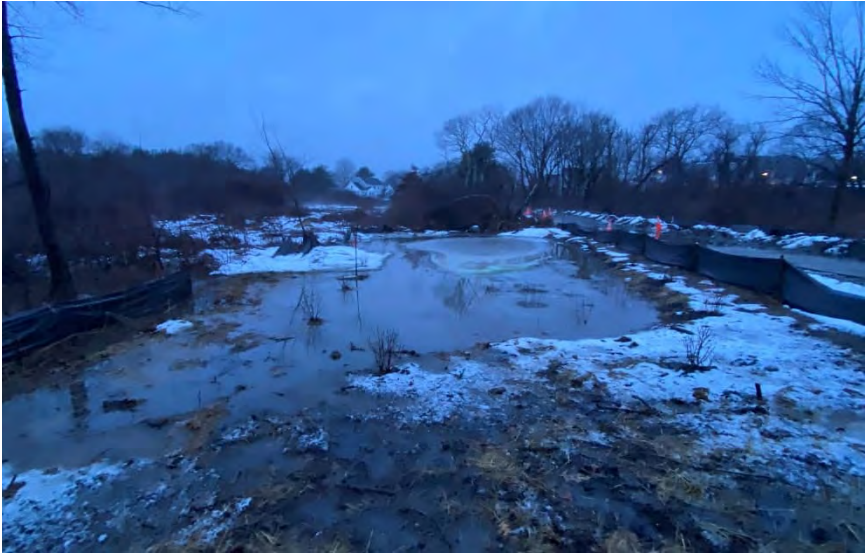
Description: Work area within segment 14, wetland replication area, flooded, looking westward.

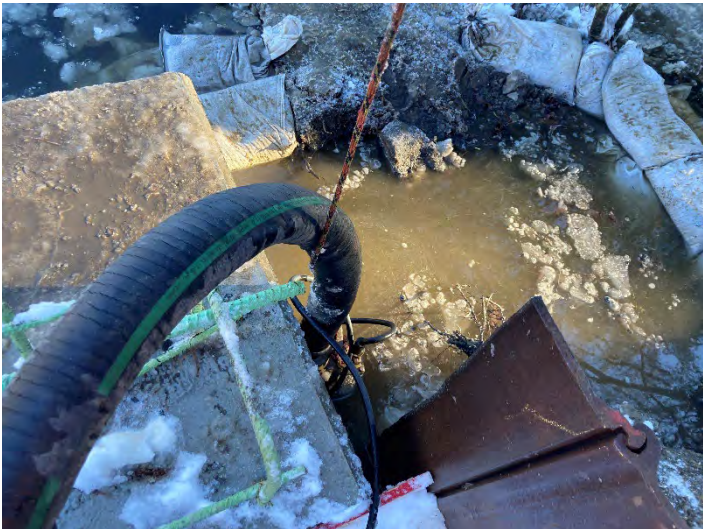
Description: View of pumping operation at Bridge 127 work at Hop Brook. Water prior to treatment appeared turbid.

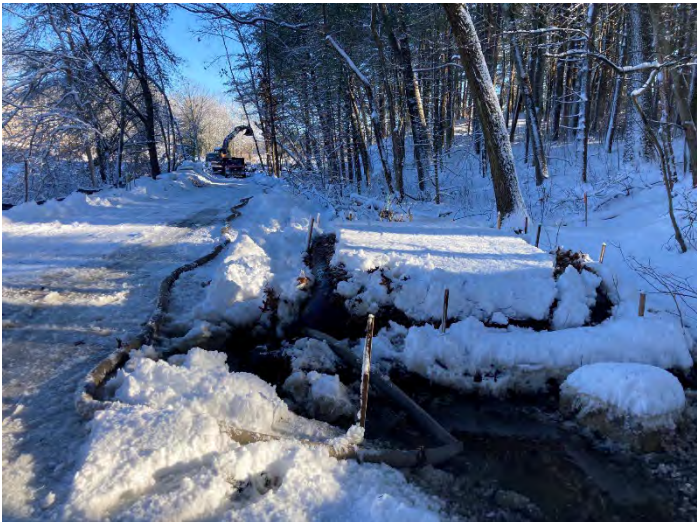
Description: Additional view of dewatering controls (straw bale corral with filter fabric, stone, and silt bag) and discharge from corral. Discharge appeared slightly turbid. Turbidity reading was higher than 50 NTUs but did not appear to be reaching wetlands. Facing east.

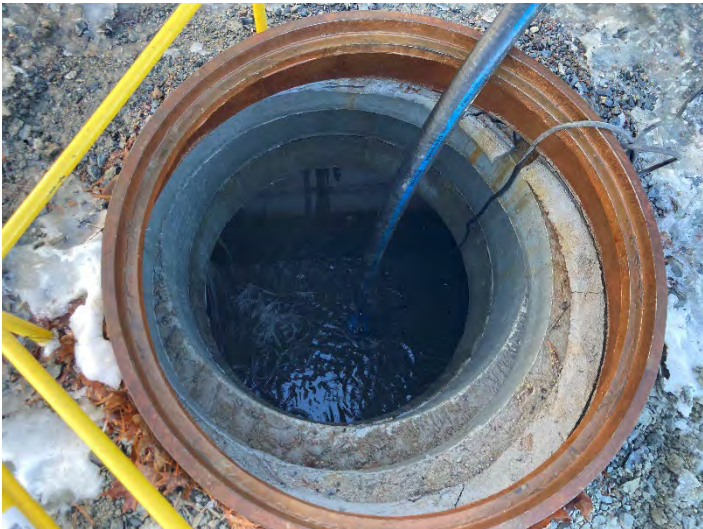
Description: View of pump in MH #8. Water appeared mostly clear prior to treatment.

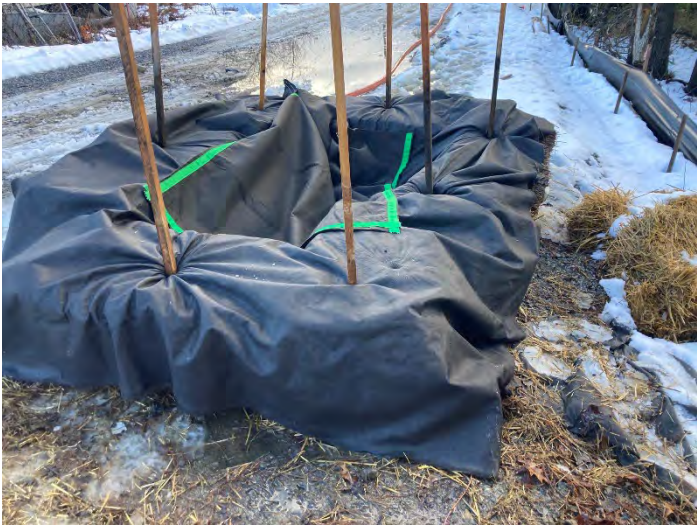
Description: Additional view of dewatering controls (straw bale corral with filter fabric and silt bag) and discharge from corral. Discharge appeared mostly clear, but turbidity reading was higher than 50 NTUs. Facing east.

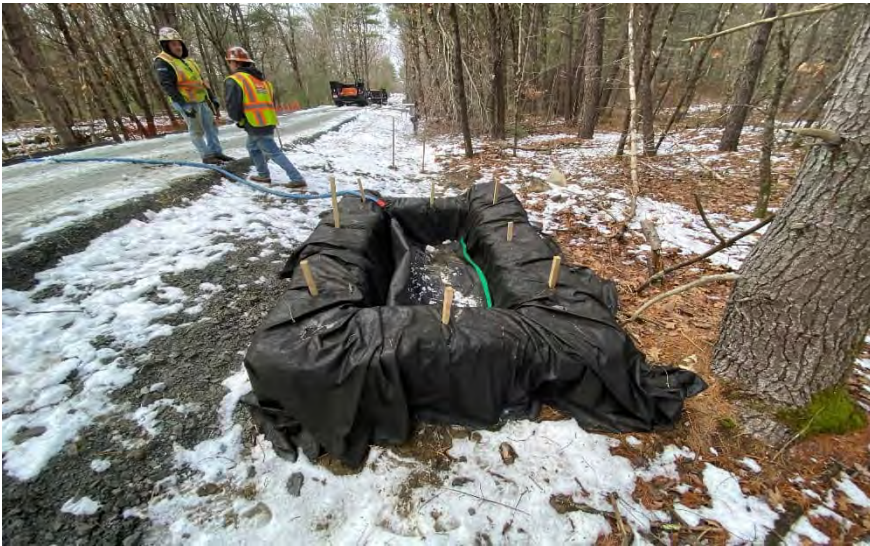
Description: Manhole #15. View of discharge bag, looking westward. Water from bag/corral discharged to adjacent work area, water appeared clear, looking westward.

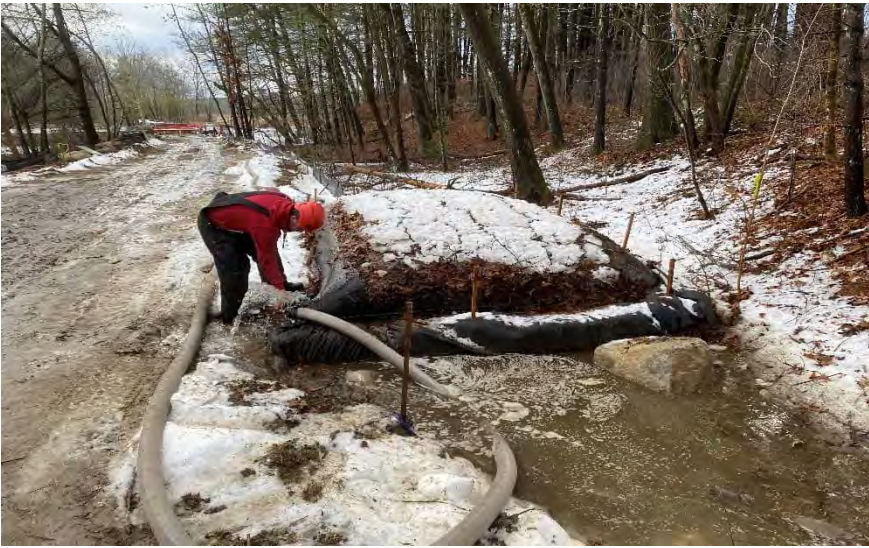
Description: Segment 13. View of discharge corral/bag, looking eastward. Water from bag discharged to adjacent work area to the east. Water appeared slightly turbid, looking eastward.

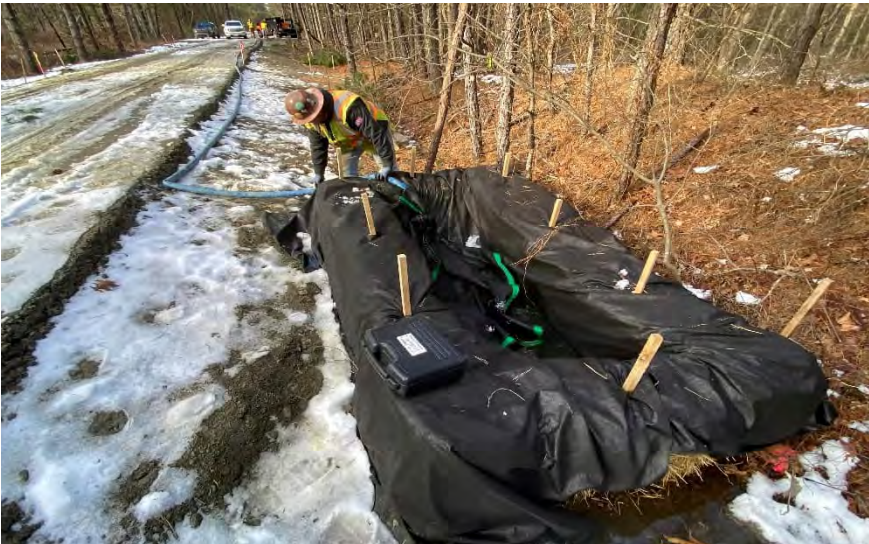
Description: Manhole #16. View of discharge bag, looking westward. Water from bag/corral discharged to adjacent work area, water appeared clear, looking westward.

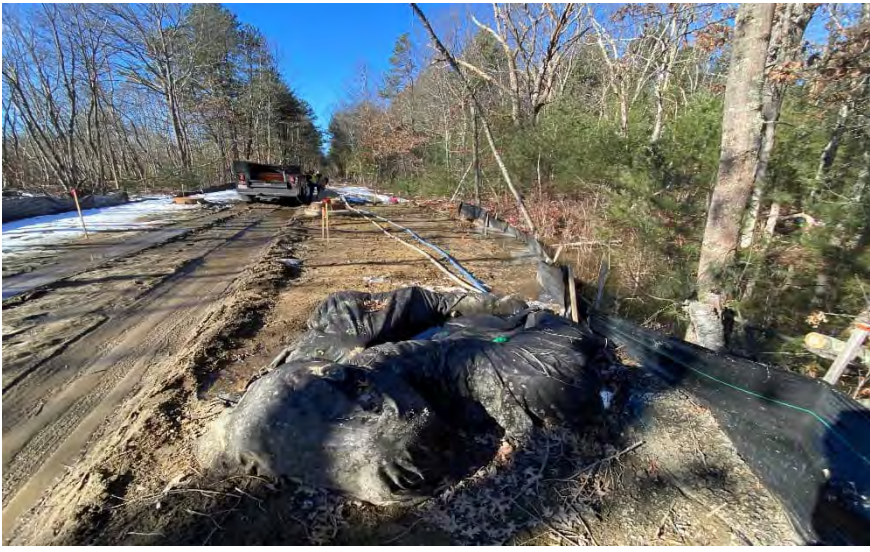
Description: Manhole #14. View of discharge bag, looking westward. Water from bag/corral discharged to adjacent work area, water appeared clear, looking westward.

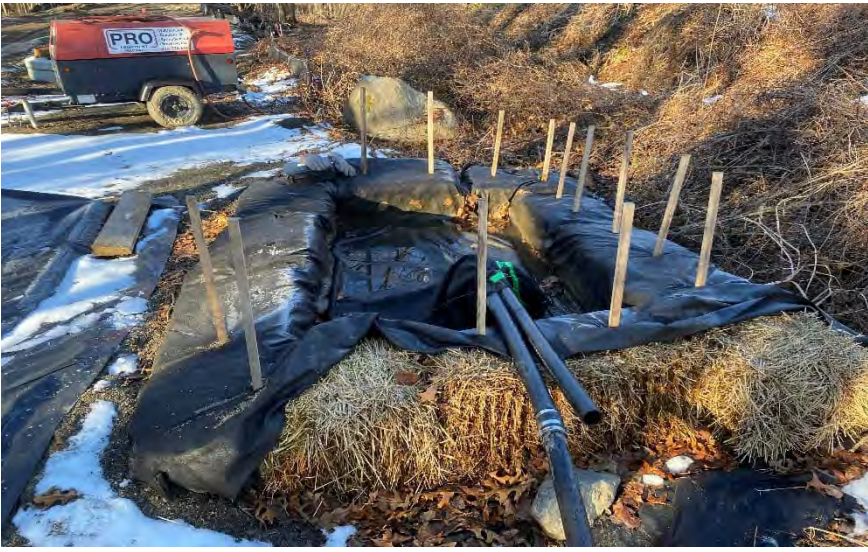
Description: Segment 14. View of discharge corral/bag, looking westward. Water from bag discharged to adjacent work area to the east. Water appeared slightly turbid, looking westward.
