Weekly Environmental Compliance Summary

Sudbury to Hudson Transmission Reliability Project (USEPA Tracking # MAR1003UW)

Sudbury, Hudson, and Stow, MA

Week of: January 15, 2024 to January 19, 2024

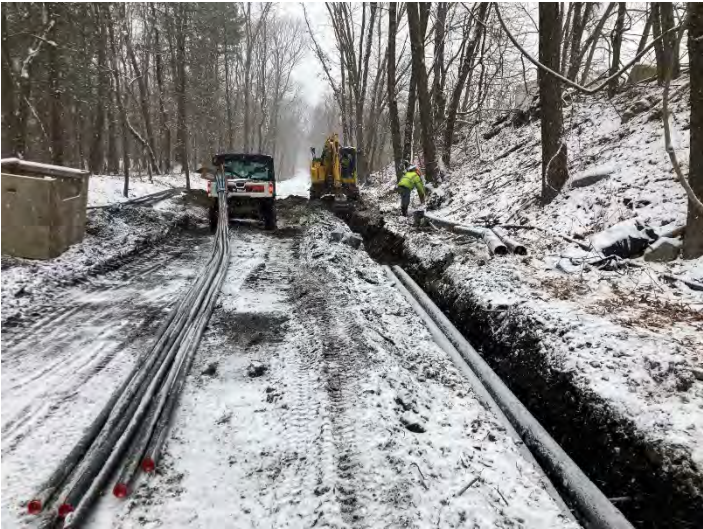
PHOTOGRAPHIC LOG	
Client Name: Eversource		Site Location: Sudbury to Hudson Transmission Reliability Project	Town: Sudbury
Photo No.: 1	Date: 1/16/2024

Description: View of Bond installing conduit in segment 14. See additional dewatering inspection report. Facing west.

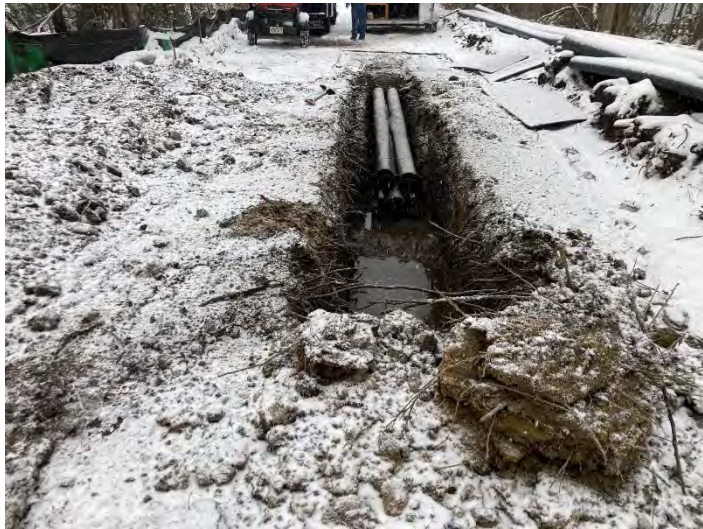
PHOTOGRAPHIC LOG	
Client Name: Eversource		Site Location: Sudbury to Hudson Transmission Reliability Project	Town: Sudbury
Photo No.: 2	Date: 1/16/2024

Description: View of Bond's work area in segment 12. Facing east.

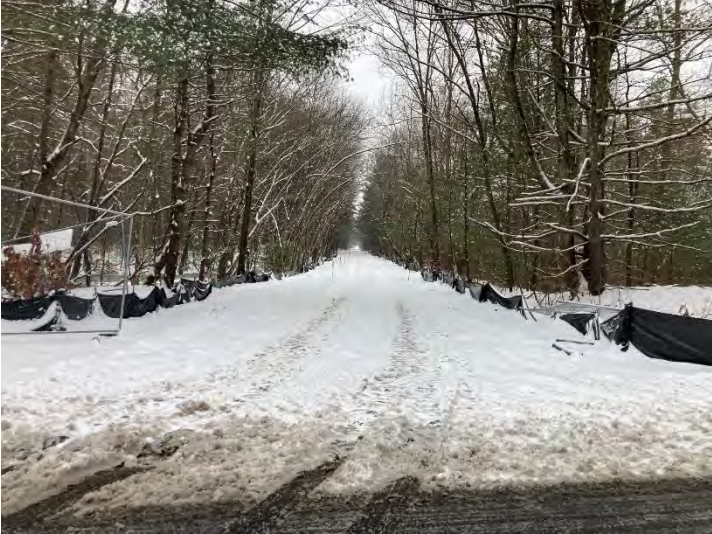
PHOTOGRAPHIC LOG	
Client Name: Eversource		Site Location: Sudbury to Hudson Transmission Reliability Project	Town: Sudbury
Photo No.: 3	Date: 1/16/2024

Description: View of entrance to segment 6 at White Pond Rd. Facing east.

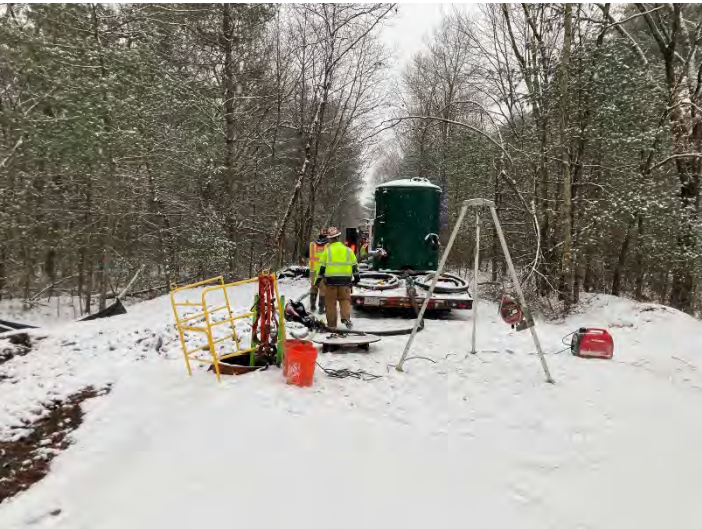
PHOTOGRAPHIC LOG	
Client Name: Eversource		Site Location: Sudbury to Hudson Transmission Reliability Project	Town: Hudson
Photo No.: 4	Date: 1/16/2024

Description: View of Bond working at MH #12 in segment 5. See additional dewatering inspection report. Facing east.

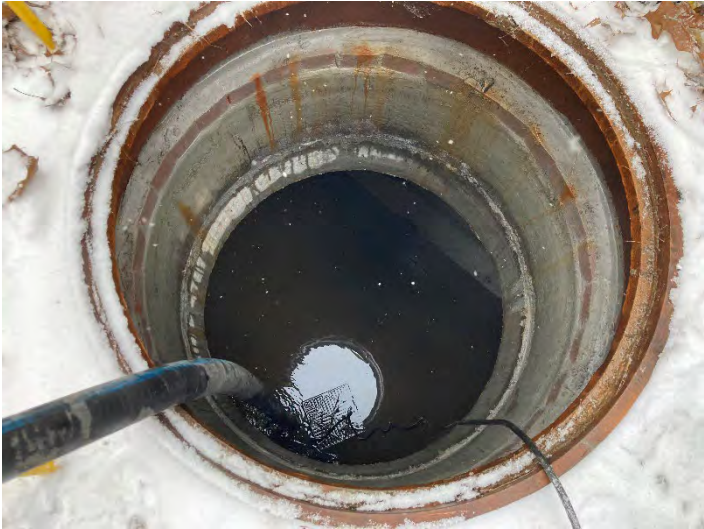
PHOTOGRAPHIC LOG	
Client Name: Eversource		Site Location: Sudbury to Hudson Transmission Reliability Project	Town: Hudson
Photo No.: 5	Date: 1/16/2024

Description: View of pumping operation at MH #13 in segment 5. See additional dewatering inspection report.

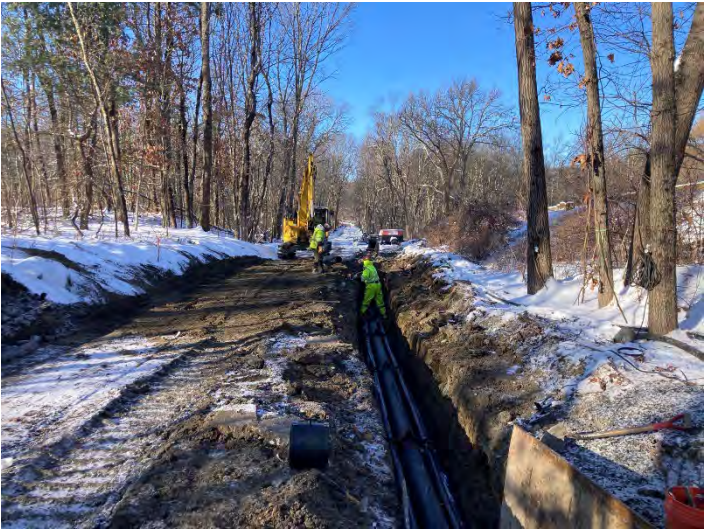
PHOTOGRAPHIC LOG	
Client Name: Eversource		Site Location: Sudbury to Hudson Transmission Reliability Project	Town: Sudbury
Photo No.: 1	Date: 1/17/2024

Description: View of Bond installing conduit in segment 14. No dewatering needed today. Facing west.

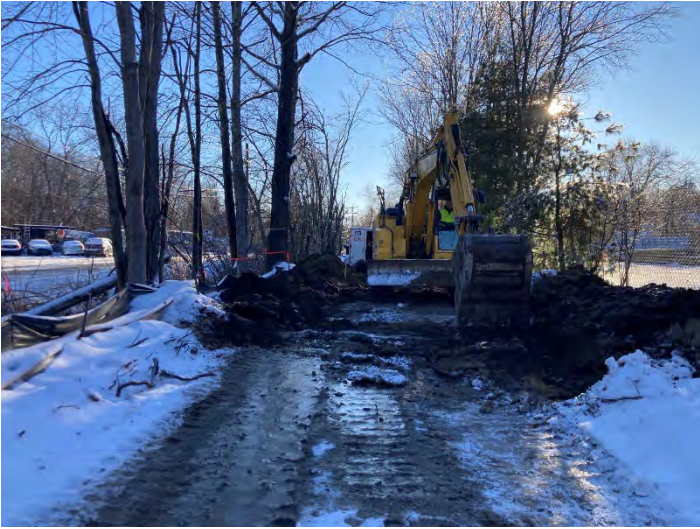
PHOTOGRAPHIC LOG	
Client Name: Eversource		Site Location: Sudbury to Hudson Transmission Reliability Project	Town: Sudbury
Photo No.: 2	Date: 1/17/2024

Description: View of Bond installing conduit in segment 12. Facing east.

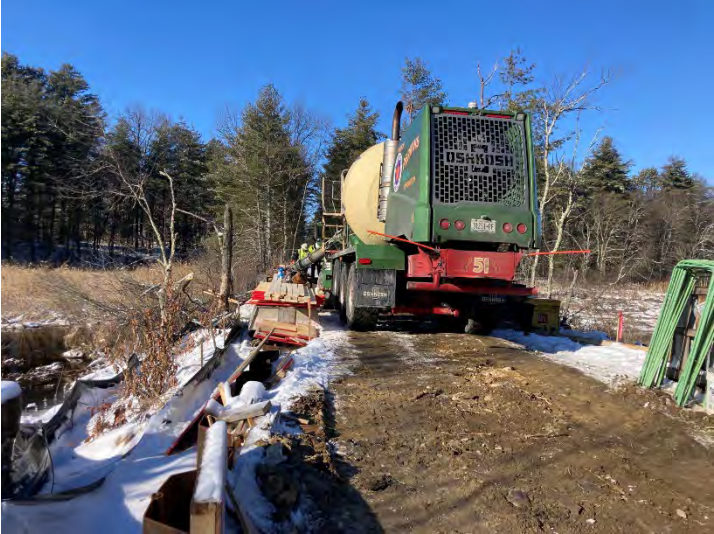
PHOTOGRAPHIC LOG	
Client Name: Eversource		Site Location: Sudbury to Hudson Transmission Reliability Project	
Town: Sudbury			
Photo No.: 3	Date: 1/17/2024

Description: View of ET&L working at Bridge 128 in segment 8. Facing west.

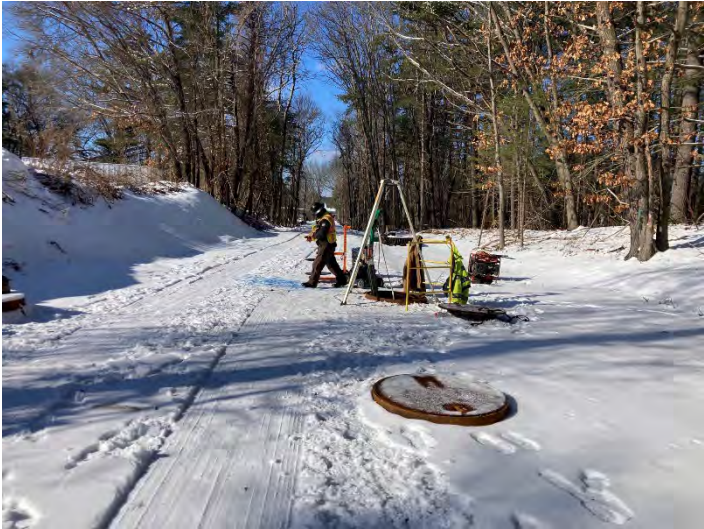
PHOTOGRAPHIC LOG	
Client Name: Eversource		Site Location: Sudbury to Hudson Transmission Reliability Project	
Town: Hudson			
Photo No.: 4	Date: 1/17/2024

Description: View of Bond working at MH #9 in segment 3. Facing west.

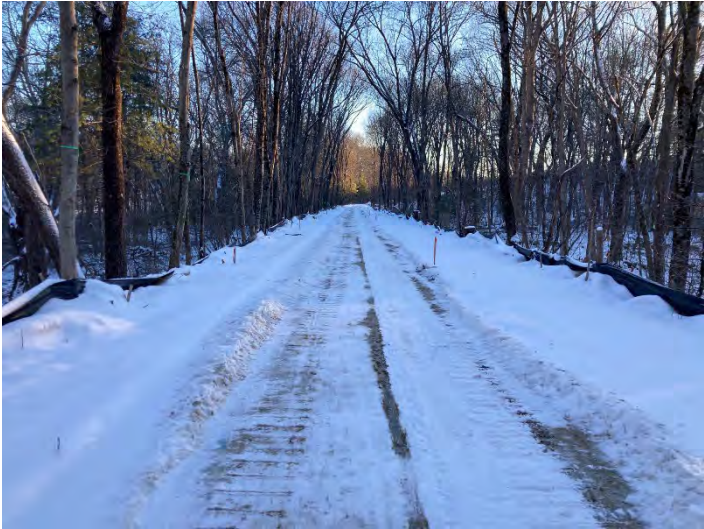
PHOTOGRAPHIC LOG	
Client Name: Eversource		Site Location: Sudbury to Hudson Transmission Reliability Project	Town: Hudson
Photo No.: 5	Date: 1/17/2024

Description: View of segment 1. Facing east.

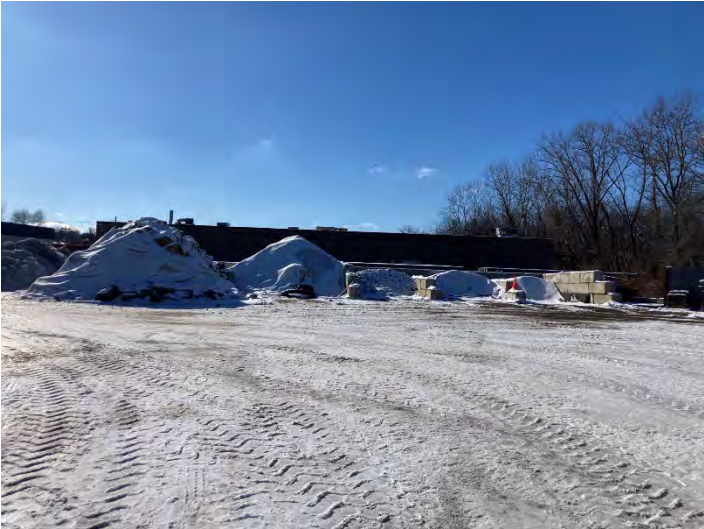
PHOTOGRAPHIC LOG	
Client Name: Eversource		Site Location: Sudbury to Hudson Transmission Reliability Project	Town: Hudson
Photo No.: 6	Date: 1/17/2024

Description: View of Bonazzoli laydown yard. Facing west.

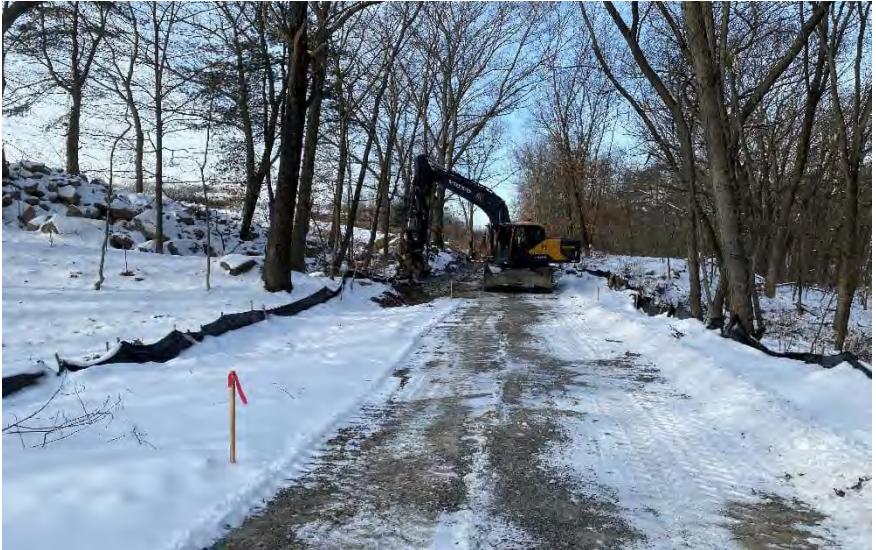
PHOTOGRAPHIC LOG	
Client Name: Eversource		Site Location: Sudbury to Hudson Transmission Reliability Project	
Photo No.: 1		Date: 1-18-24	
Description: ET&L adding rock lined swale within work area of segment #1, looking westward.

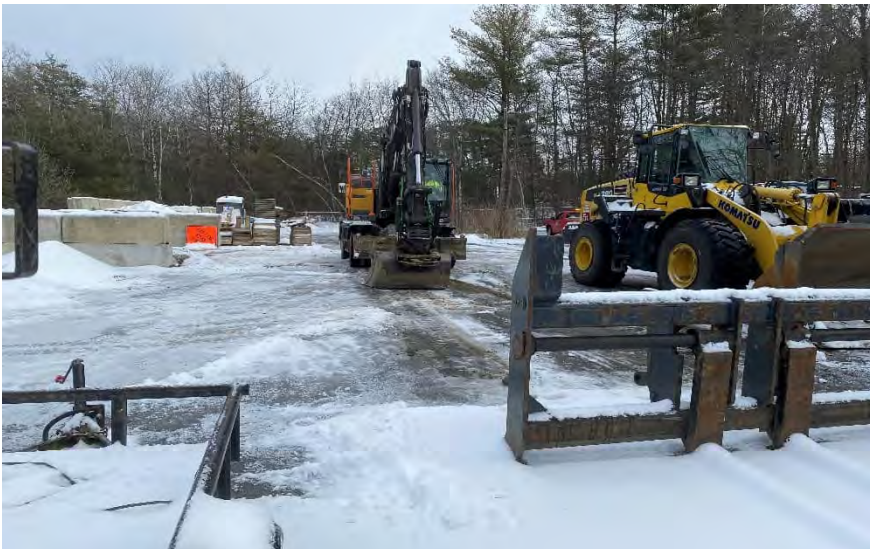
PHOTOGRAPHIC LOG	
Client Name: Eversource		Site Location: Sudbury to Hudson Transmission Reliability Project	
Photo No.: 2		Date: 1-18-24	
Description: ET&L conducting site work within Main Street laydown yard, looking eastward.

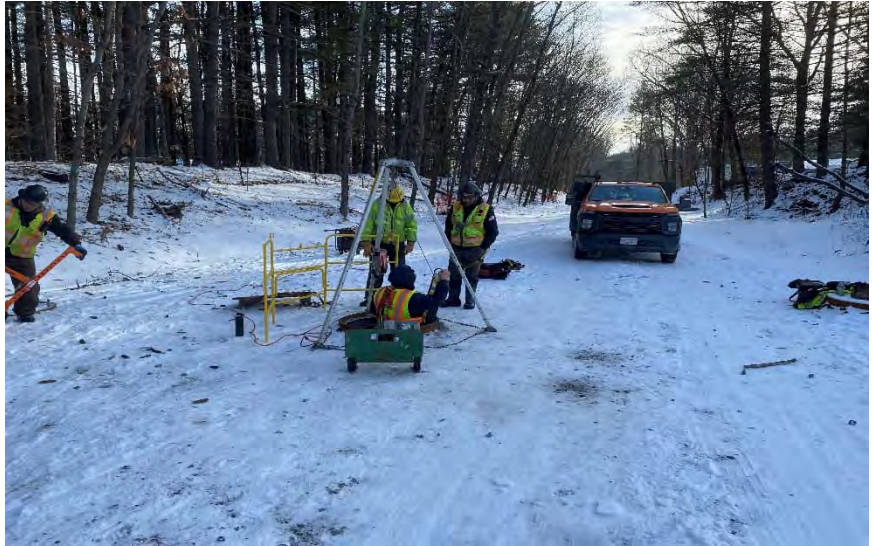
PHOTOGRAPHIC LOG	
Client Name: Eversource		Site Location: Sudbury to Hudson Transmission Reliability Project	
Photo No.: 3		Town: Hudson	
Date: 1-18-24

Description: Bond conducting proofing work within segment 3 at manhole #9, looking eastward.

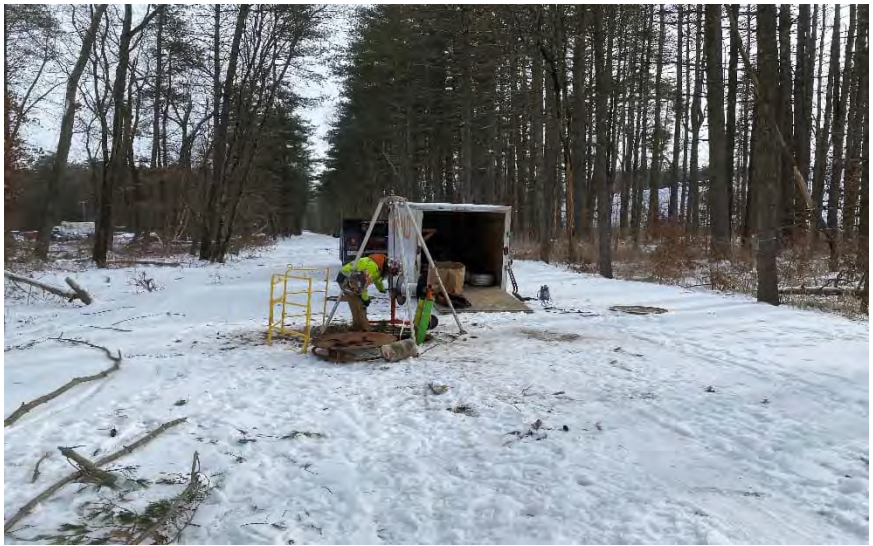
PHOTOGRAPHIC LOG	
Client Name: Eversource		Site Location: Sudbury to Hudson Transmission Reliability Project	
Photo No.: 4		Town: Hudson	
Date: 1-18-24

Description: Bond conducting proofing work within segment 4 at manhole #10, looking eastward.

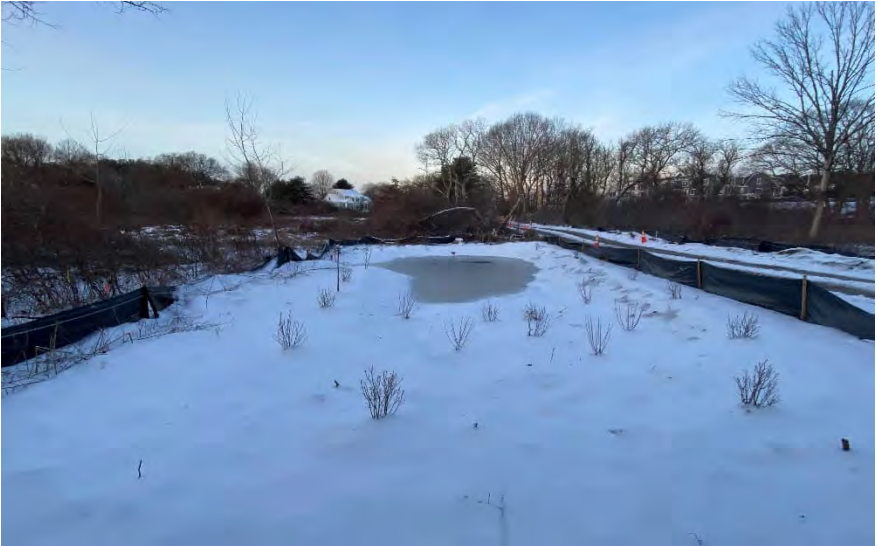
PHOTOGRAPHIC LOG	
Client Name: Eversource		Site Location: Sudbury to Hudson Transmission Reliability Project	
Photo No.: 5		Date: 1-18-24	
Description: Wetland replication area, approximately 2-3" of snow on-site, looking westward.

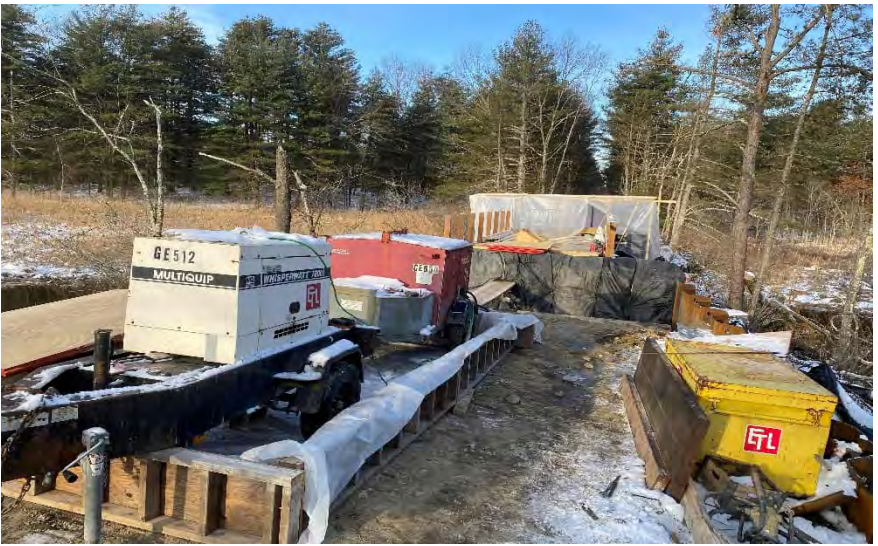
PHOTOGRAPHIC LOG	
Client Name: Eversource		Site Location: Sudbury to Hudson Transmission Reliability Project	
Photo No.: 6		Date: 1-18-24	
Description: Work area within segment 8, bridge 128 work, curing concrete, looking westward.

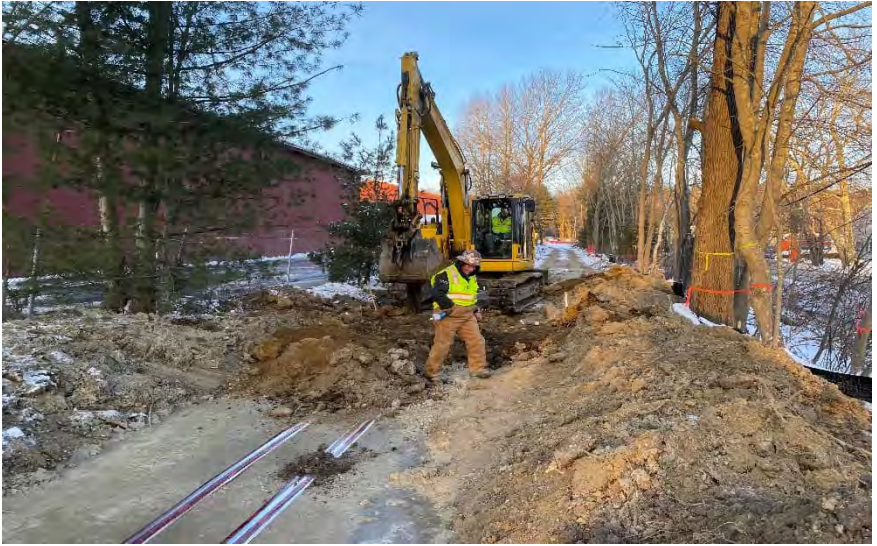
PHOTOGRAPHIC LOG	
Client Name: Eversource		Site Location: Sudbury to Hudson Transmission Reliability Project	
Photo No.: 7		Date: 1-18-24	
Description: Work area within segment 12, conduit work, looking westward.

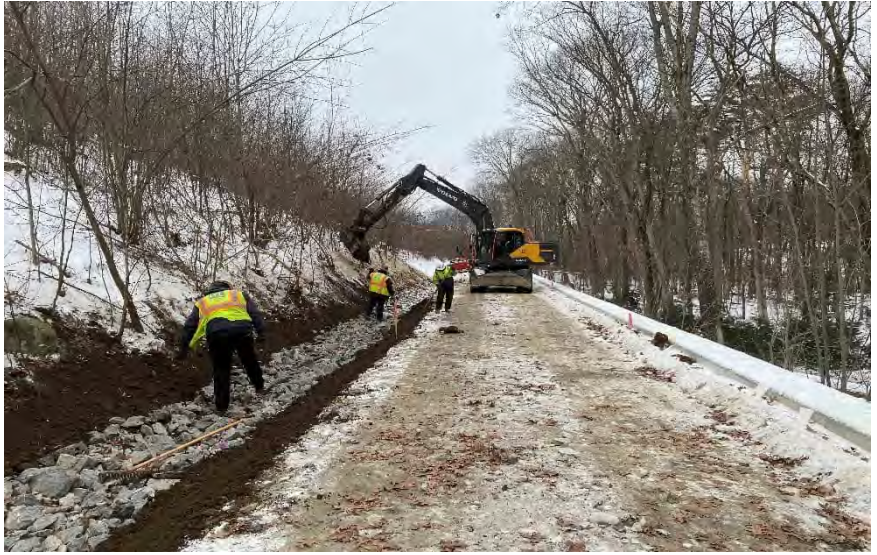
PHOTOGRAPHIC LOG	
Client Name: Eversource		Site Location: Sudbury to Hudson Transmission Reliability Project	
Town: Hudson			
Photo No.: 1	Date: 1-19-24

Description: ET&L adding loam adjacent to a recently installed rock lined swale within work area of segment 1, looking westward.

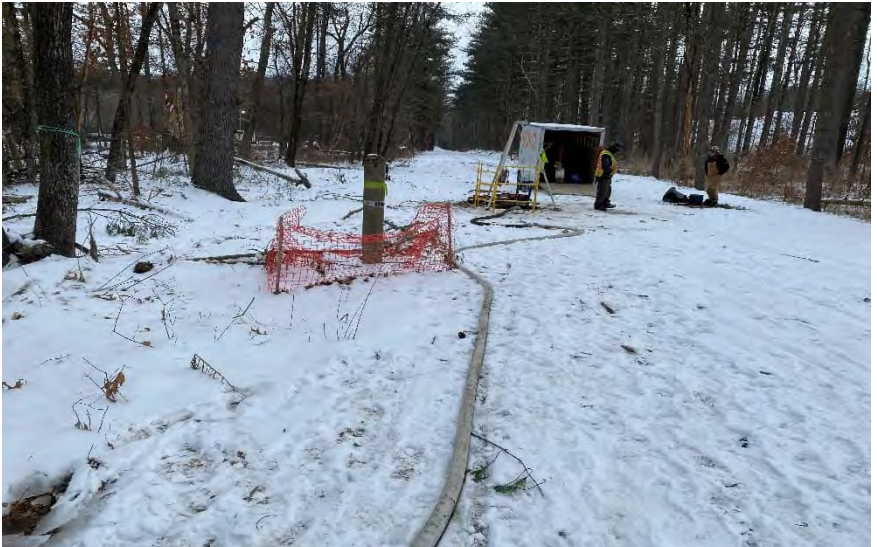
PHOTOGRAPHIC LOG	
Client Name: Eversource		Site Location: Sudbury to Hudson Transmission Reliability Project	
Town: Hudson			
Photo No.: 2	Date: 1-19-24

Description: Bond conducting proofing work within segment 4 at manhole #10, looking eastward.

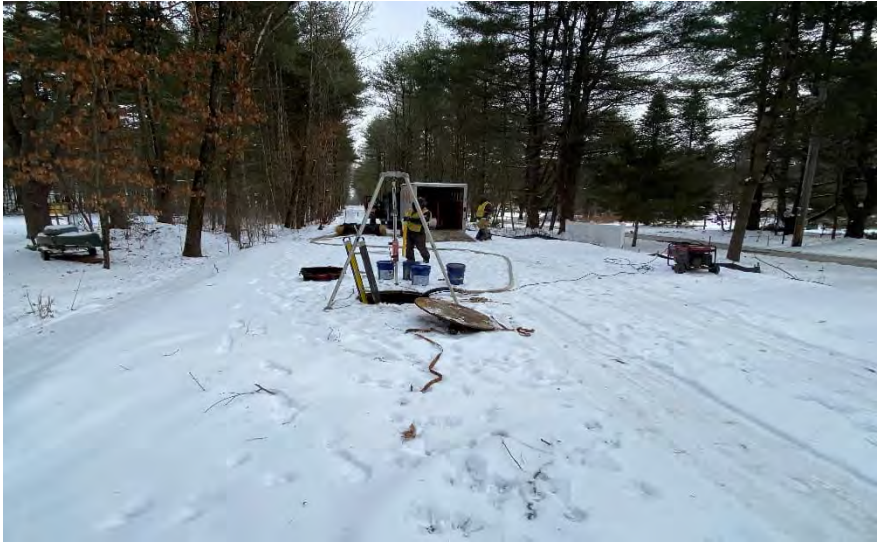
PHOTOGRAPHIC LOG	
Client Name: Eversource		Site Location: Sudbury to Hudson Transmission Reliability Project	
Photo No.: 3		Town: Hudson	
Date: 1-19-24

Description: Bond conducting proofing work within segment 5 at manhole #11, looking eastward.

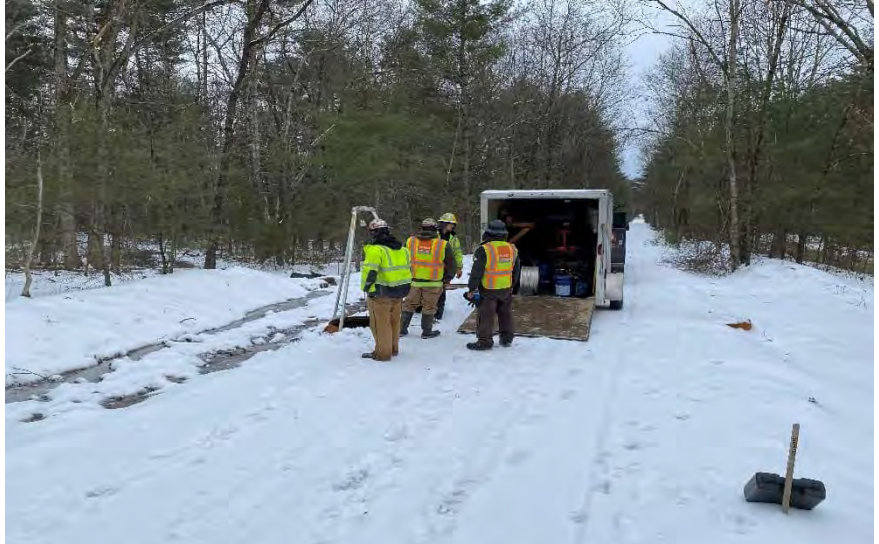
PHOTOGRAPHIC LOG	
Client Name: Eversource		Site Location: Sudbury to Hudson Transmission Reliability Project	
Photo No.: 4		Town: Hudson	
Date: 1-19-24

Description: Bond conducting proofing work within segment 5 at manhole #12, looking eastward.

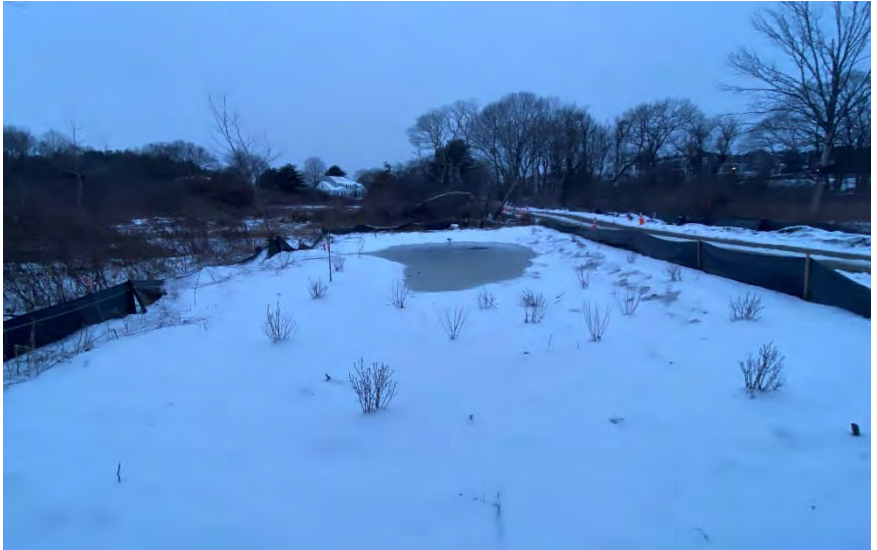
PHOTOGRAPHIC LOG	
Client Name: Eversource		Site Location: Sudbury to Hudson Transmission Reliability Project	
Photo No.: 5		Date: 1-19-24	
Description: Wetland replication area, approximately 2-3" of snow on-site, looking westward.

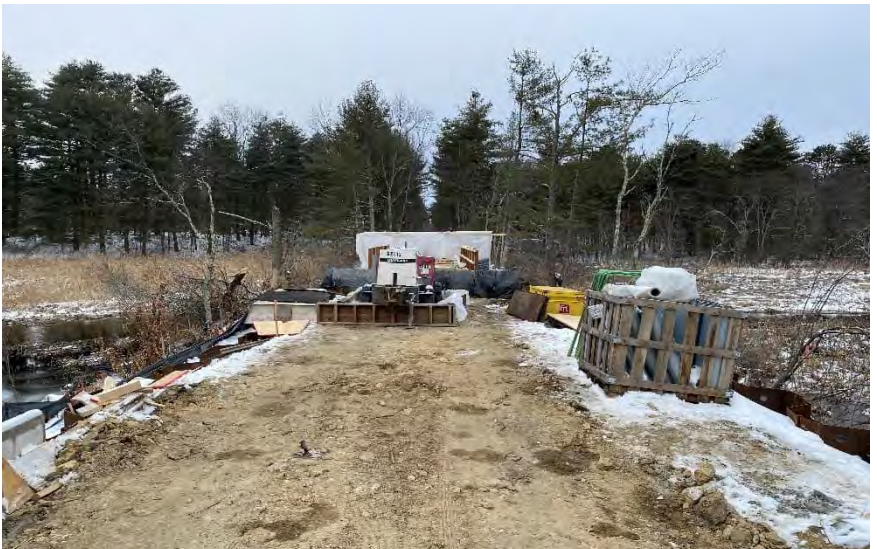
PHOTOGRAPHIC LOG	
Client Name: Eversource		Site Location: Sudbury to Hudson Transmission Reliability Project	
Photo No.: 6		Date: 1-19-24	
Description: Work area within segment 8, bridge 128 work, curing concrete, looking westward.

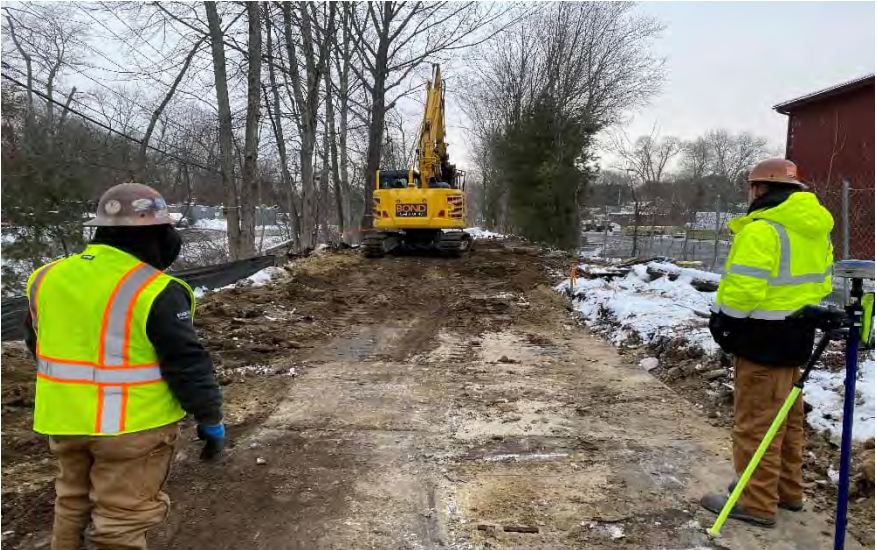
PHOTOGRAPHIC LOG	
Client Name: Eversource		Site Location: Sudbury to Hudson Transmission Reliability Project	
Town: Sudbury			
Photo No.: 7	Date: 1-19-24

Description: Work area within segment 12, conduit work, looking eastward.

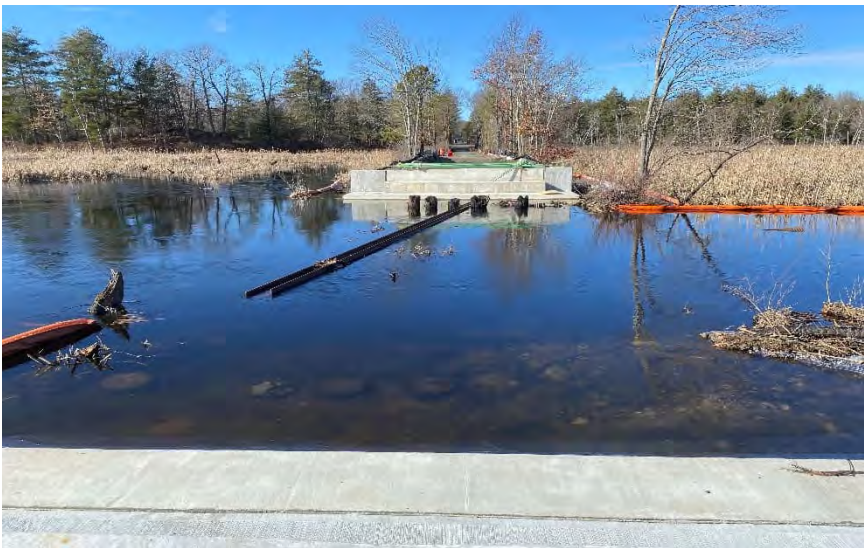
PHOTOGRAPHIC LOG	
Client Name: Eversource		Site Location: Sudbury to Hudson Transmission Reliability Project	
Town: Hudson			
Photo No.: 1	Date: 1-15-24

Description: Work area from segment 3 across Fort Meadow Brook toward segment 2 (bridge 130 area), looking westward.

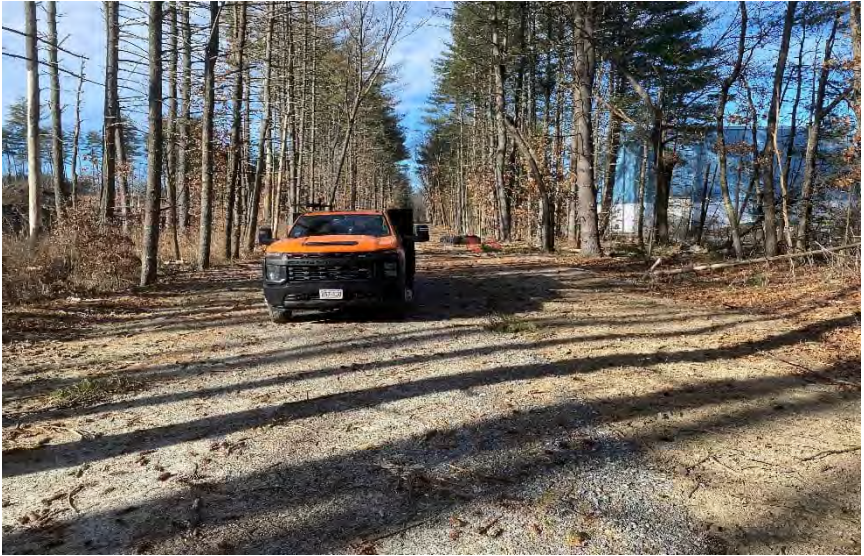
PHOTOGRAPHIC LOG	
Client Name: Eversource		Site Location: Sudbury to Hudson Transmission Reliability Project	
Town: Hudson			
Photo No.: 3	Date: 1-15-24

Description: Survey work at manhole #10, segment 4, looking westward.

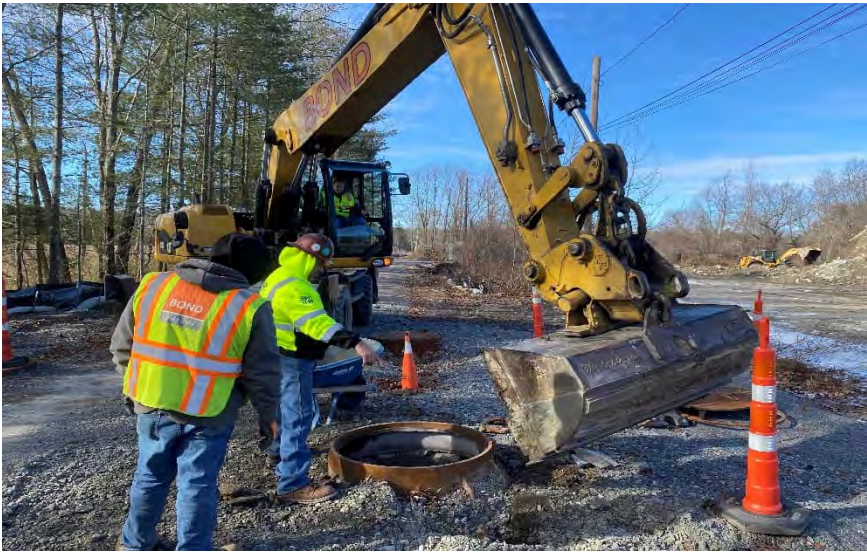
PHOTOGRAPHIC LOG	
Client Name: Eversource		Site Location: Sudbury to Hudson Transmission Reliability Project	
Town: Hudson			
Photo No.: 4	Date: 1-15-24

Description: Proofing at manhole #8, segment 3, looking westward.

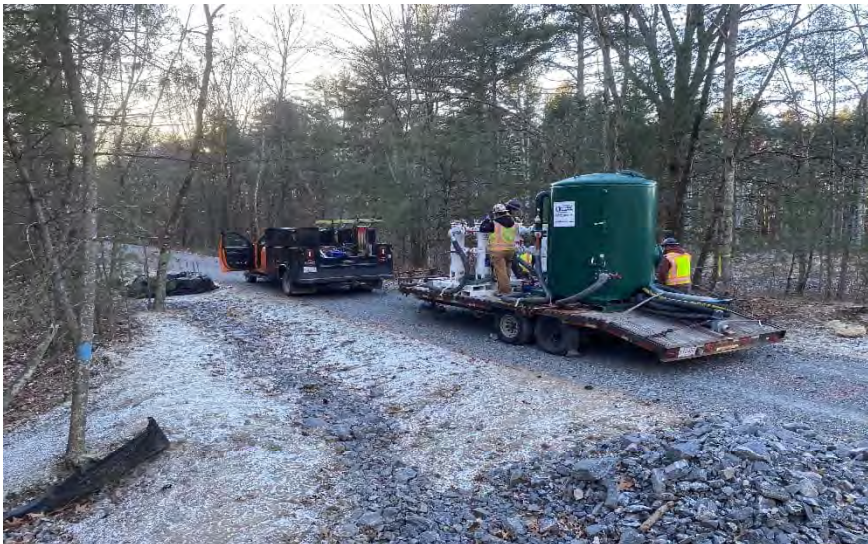
PHOTOGRAPHIC LOG	
Client Name: Eversource		Site Location: Sudbury to Hudson Transmission Reliability Project	
Town: Hudson			
Photo No.: 5	Date: 1-15-24

Description: Work area within segment 5, manhole #12 area, looking westward.

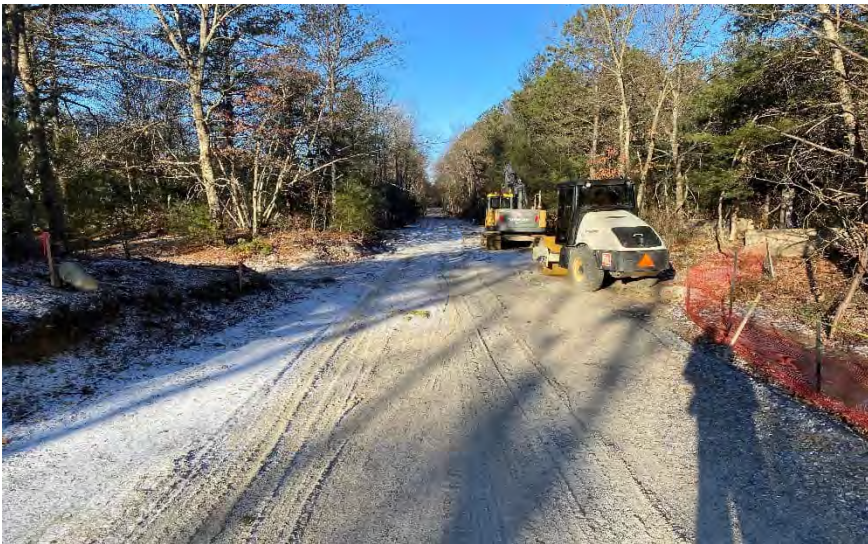
Description: Work area within segment 6, looking westward.

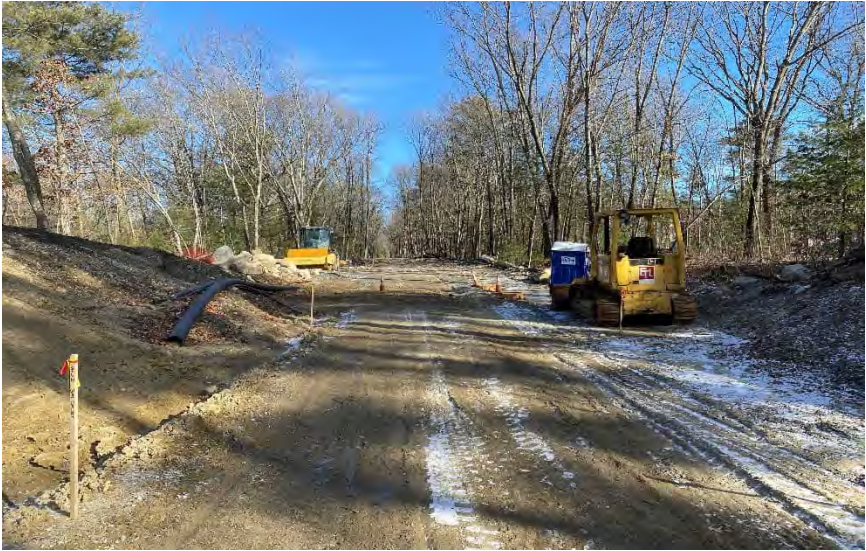
Description: Work area within segment 1, manhole #5, looking eastward.

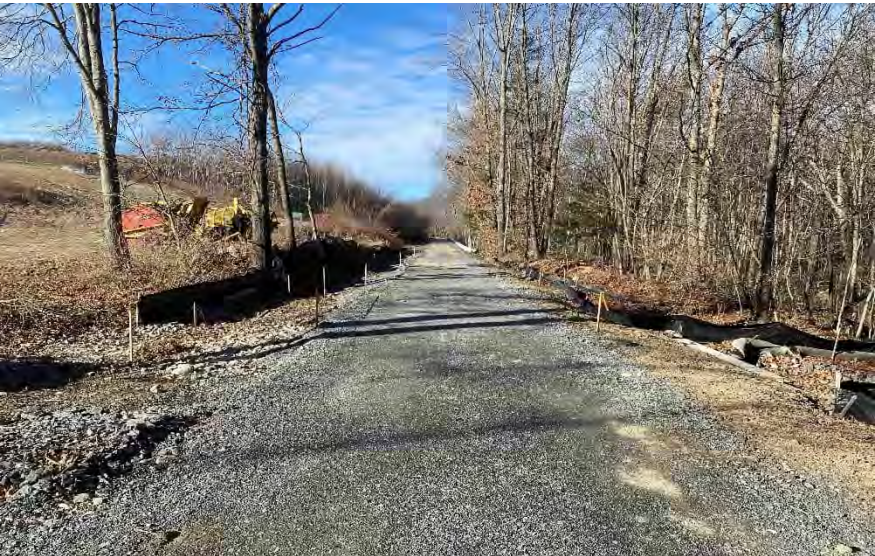
Description: Work area within segment 1, existing erosion control, looking westward.

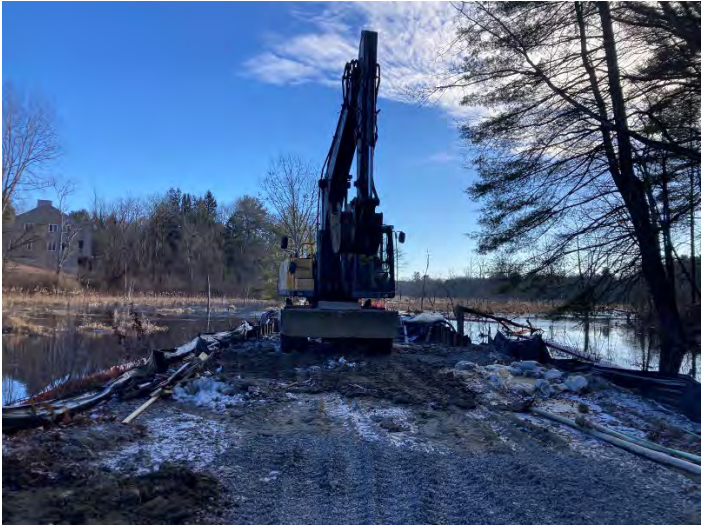
Description: View of ET&L working at Bridge 127 in segment 13. Facing east.

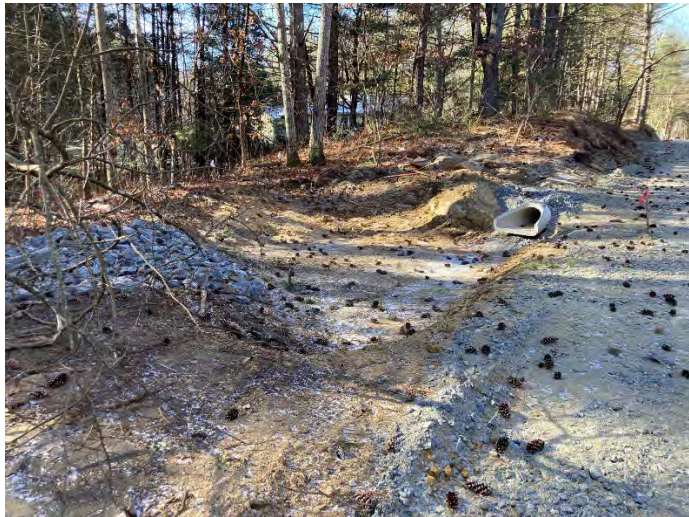
Description: View of newly installed storm drainage structure (FES/Drainage Structure 10) in segment 10. Facing southwest.

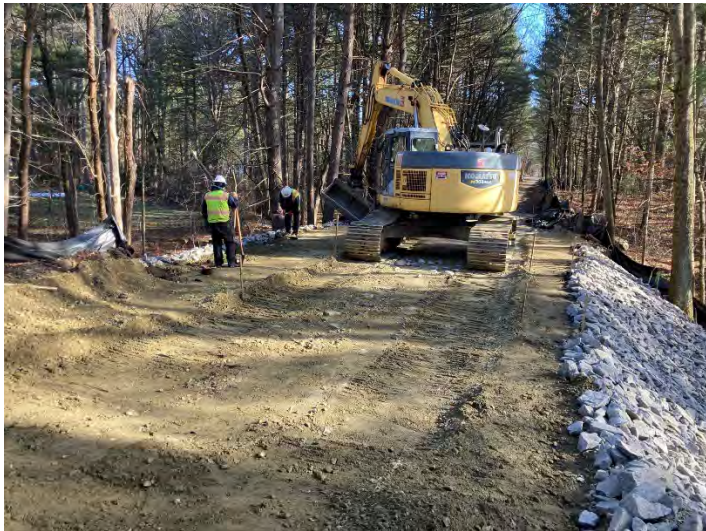
Description: View of culvert remediation work area in segment 9. Facing east.

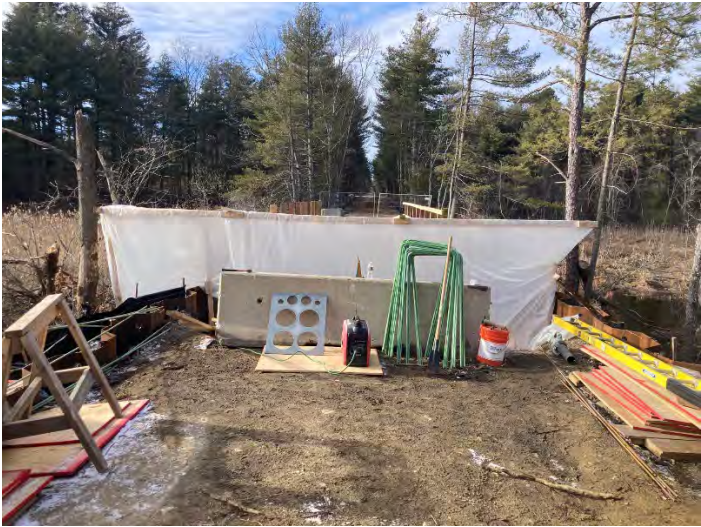
Description: View of work area at Bridge 128 in segment 8. Facing west.

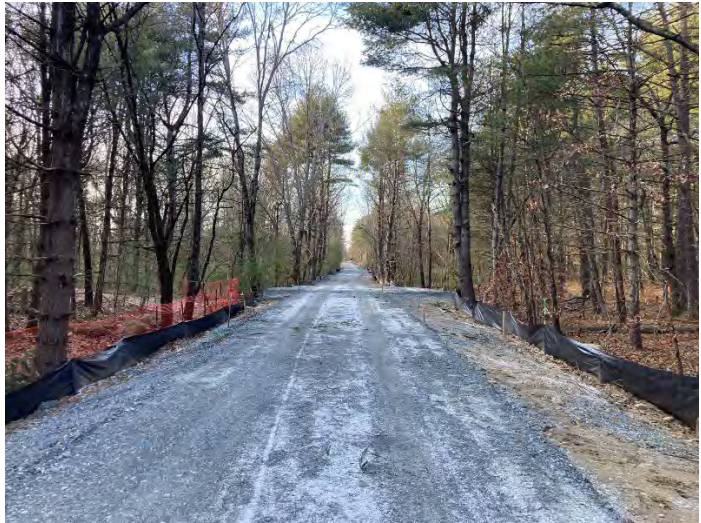
Description: View of E&S controls in segment 7. Facing west.

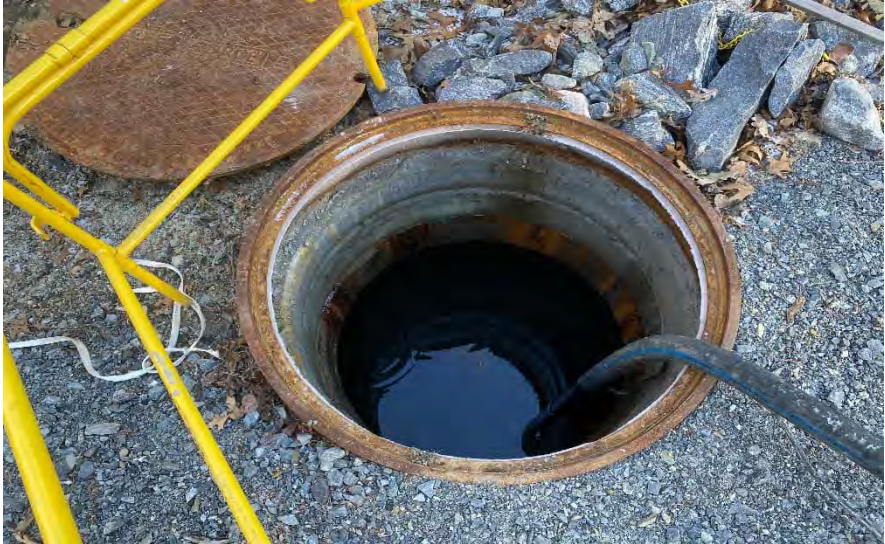
Description: View of pumping from manhole #12 segment 5.

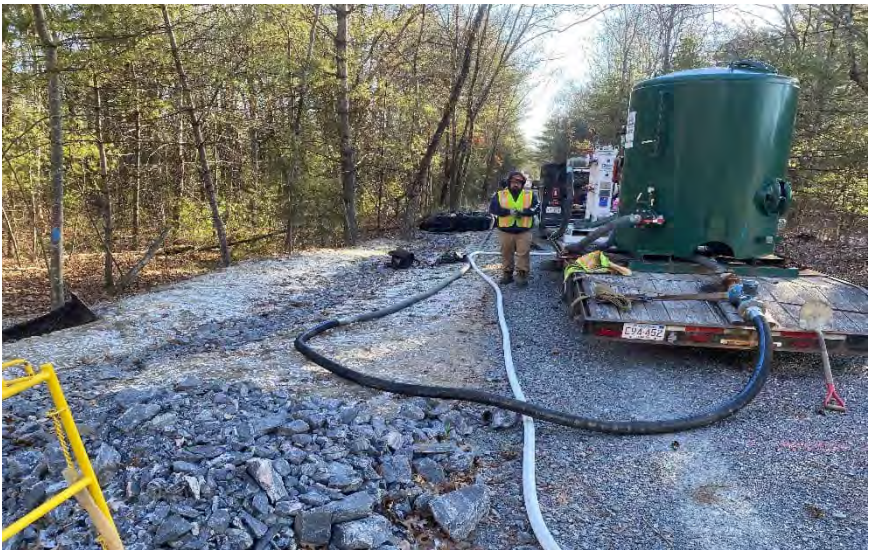
Description: Manhole #12. View of dewatering operation. Looking eastward.

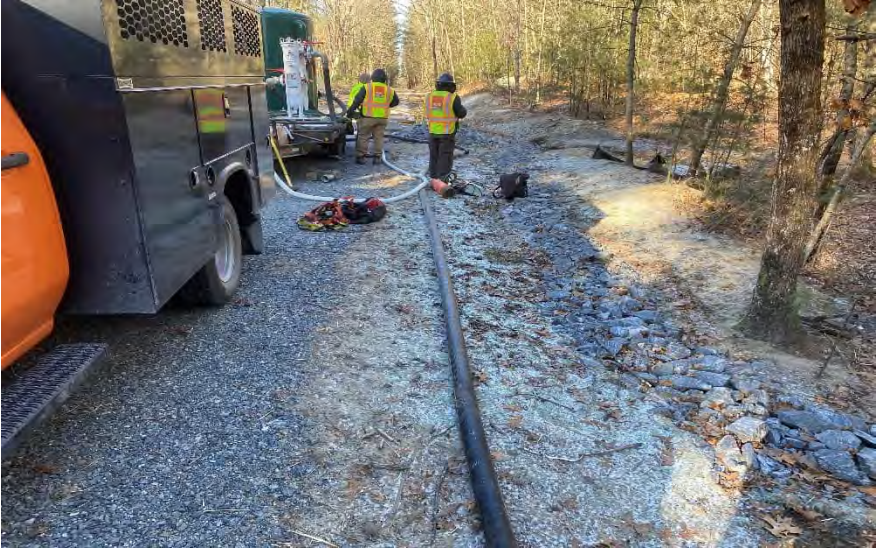
Description: Manhole #12. View of dewatering operation, looking westward.

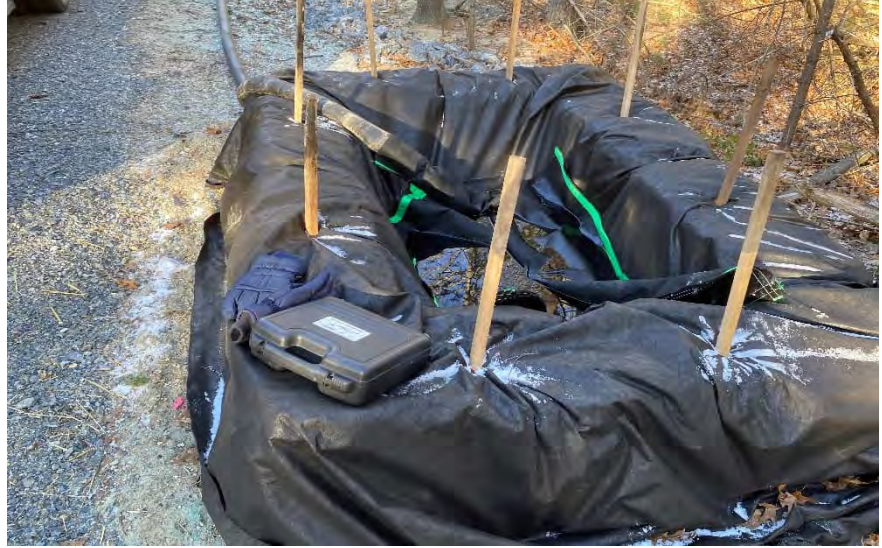
Description: Manhole #12. View of discharge bag, looking westward. Water from bag/corral discharged to adjacent work area, water appeared clear, looking westward.

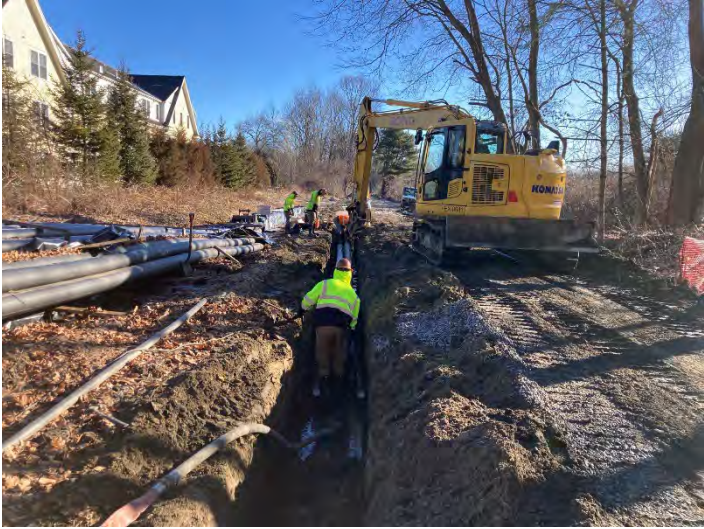
Description: View of Bond working in trench in segment 14. Facing east.

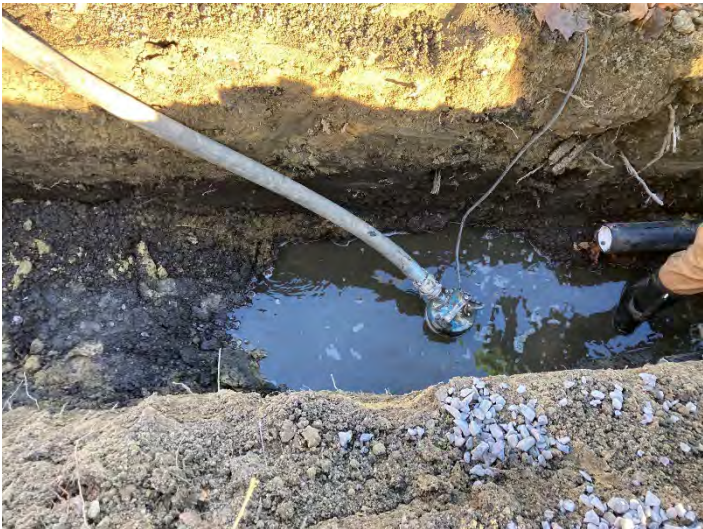
Description: View of pump in trench. Water appeared turbid prior to treatment.

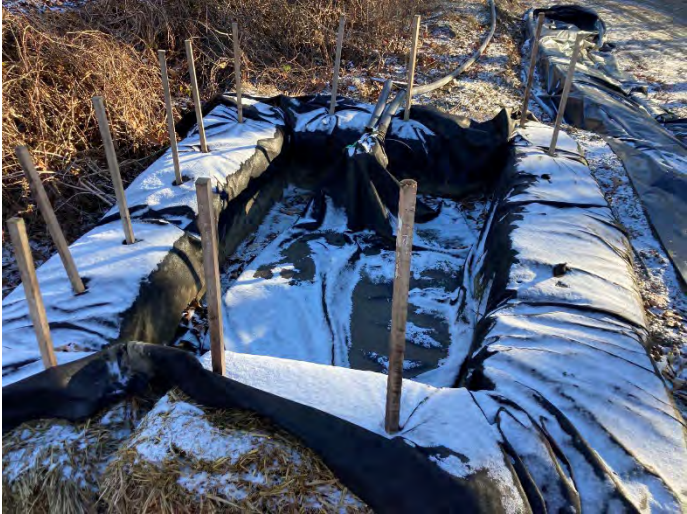
Description: View of dewatering controls (straw bale corral with filter fabric and silt bag). Facing east.

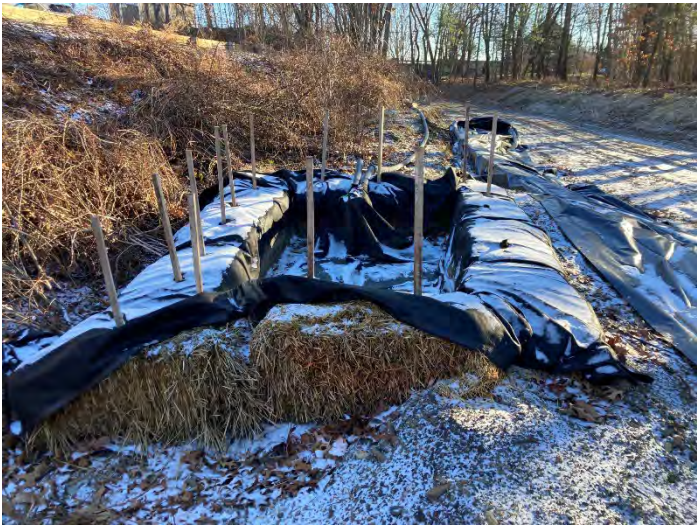
Description: Additional view of dewatering controls (straw bale corral with filter fabric and silt bag). No discharge observed in or around corral, so no turbidity sample was collected. Facing east.

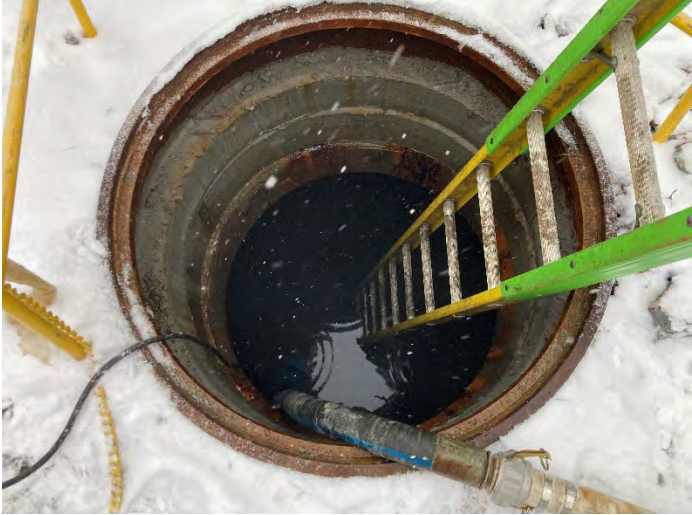
Description: View of pump in MH #12. Water appeared mostly clear prior to treatment.

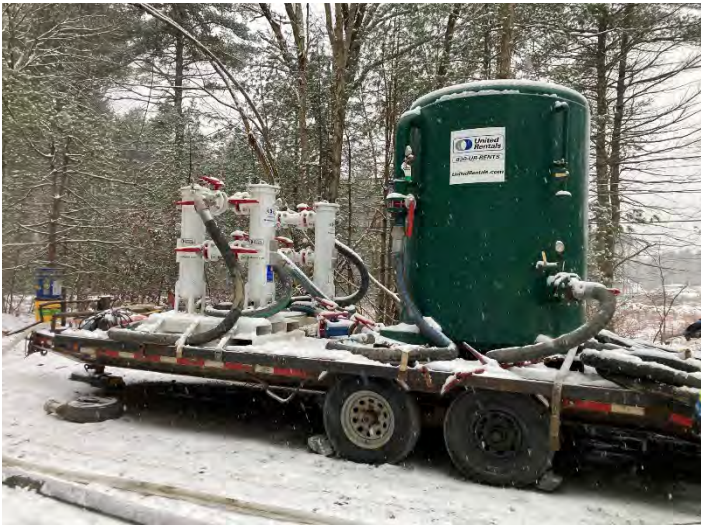
Description: View of filtration system being used in this area due to PFAS. Facing south.

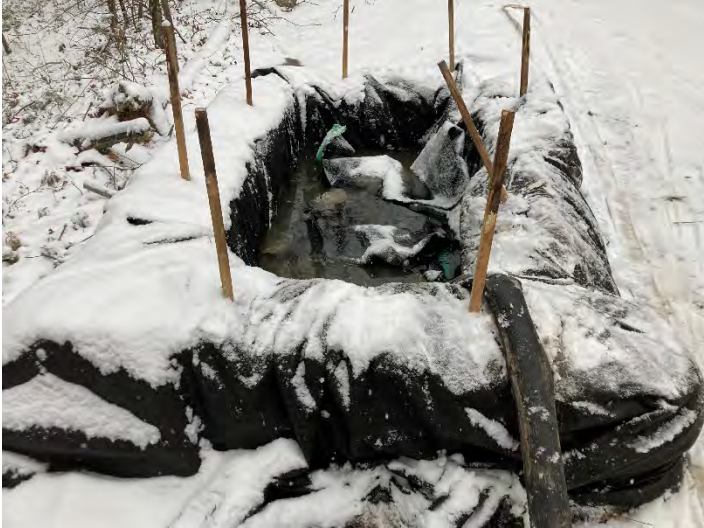
Description: View of dewatering controls (straw bale corral with filter fabric and silt bag). Facing east.
