Weekly Environmental Compliance Summary

Sudbury to Hudson Transmission Reliability Project (USEPA Tracking # MAR1003UW)

Sudbury, Hudson, and Stow, MA

Week of: January 15, 2024 to January 19, 2024

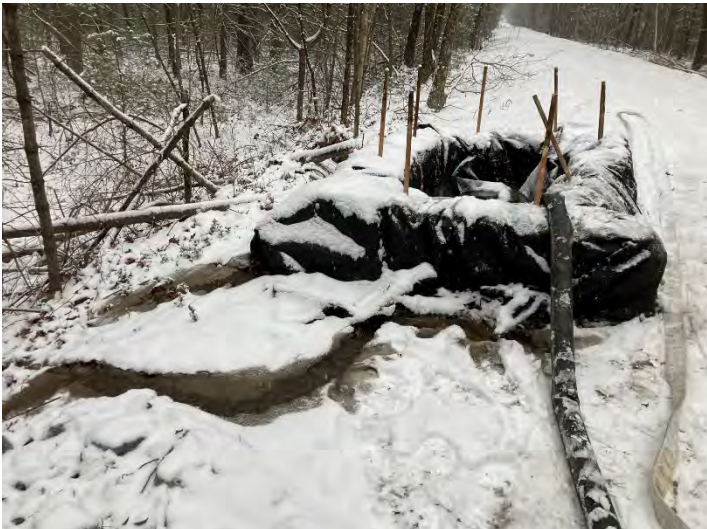
Description: View of dewatering controls (straw bale corral with filter fabric and silt bag) and discharge from project. Discharge appeared mostly clear. Turbidity reading was higher than 50 NTUs but did not reach resource areas. Facing east.

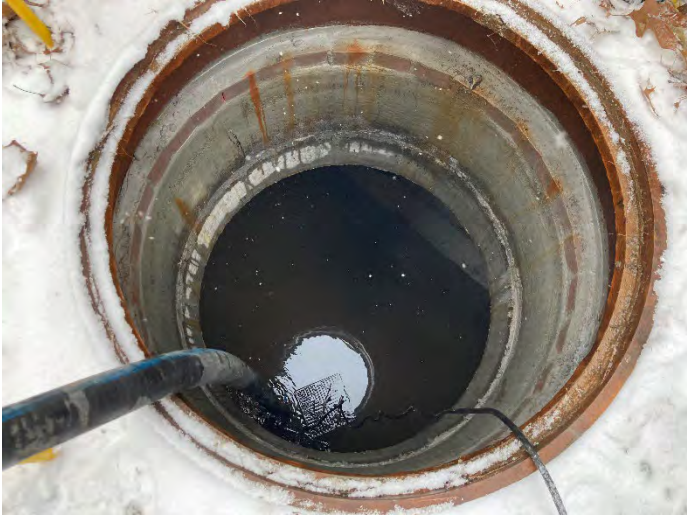
Description: View of pump in MH #13. Water appeared mostly clear prior to treatment.

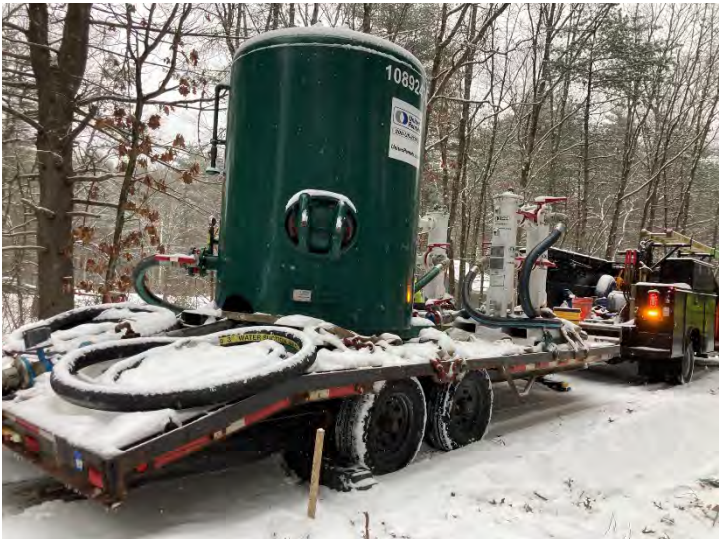
Description: View of filtration system being used in this area due to PFAS. Facing southeast.

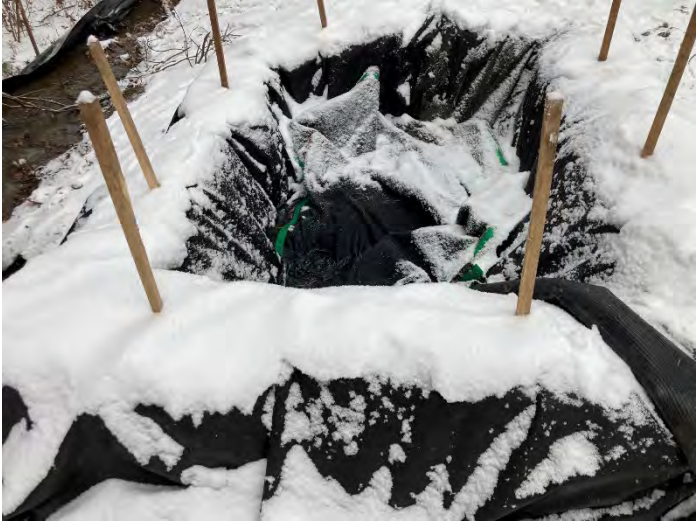
Description: View of dewatering controls (straw bale corral with filter fabric and silt bag). Facing east.

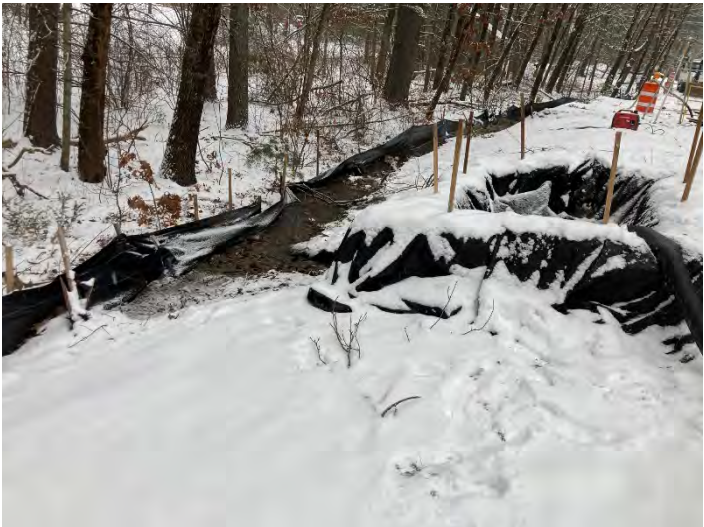
Description: View of dewatering controls (straw bale corral with filter fabric and silt bag) and discharge from project. Discharge appeared mostly clear, but turbidity reading was higher than 50 NTUs. Facing east.

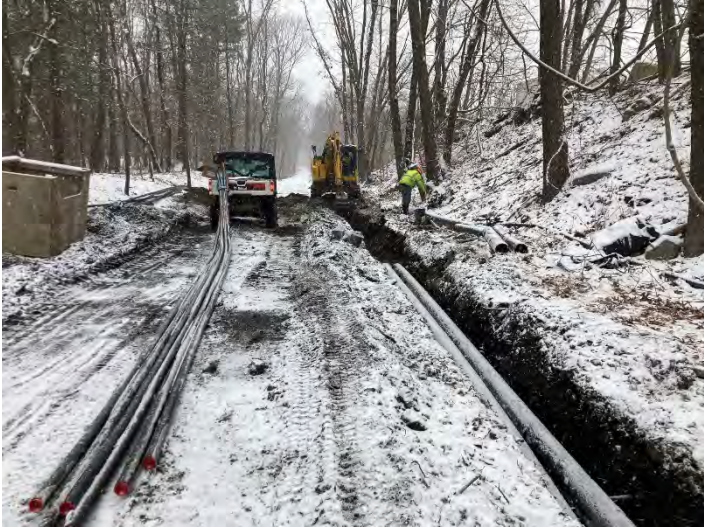
Description: View of Bond working in trench in segment 14. Facing west.

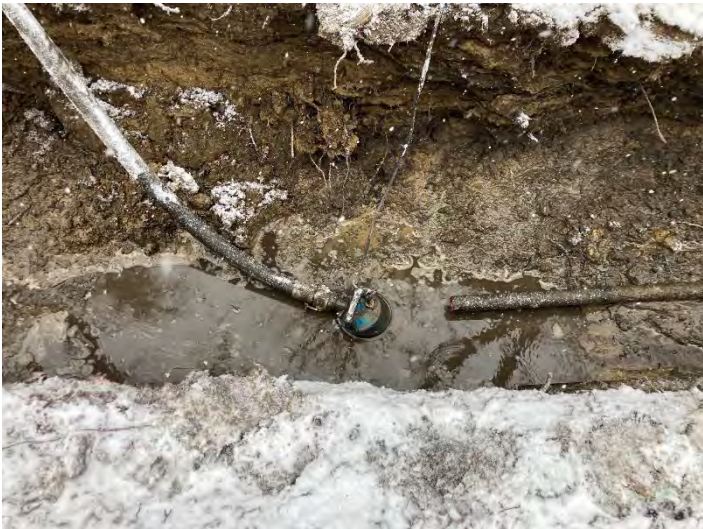
Description: View of pump in trench. Water appeared turbid prior to treatment.

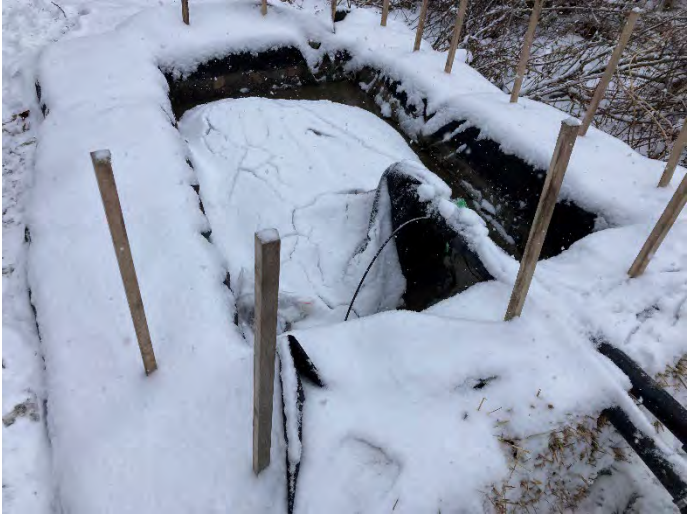
Description: View of dewatering controls (straw bale corral with filter fabric and silt bag). Facing west.

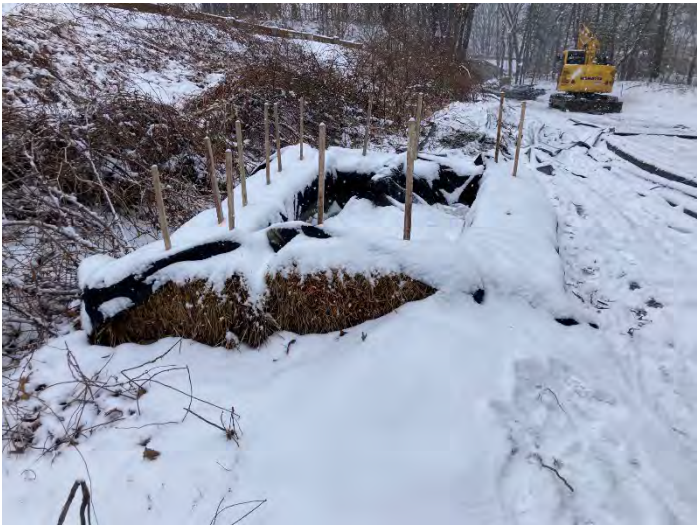
Description: Additional view of dewatering controls (straw bale corral with filter fabric and silt bag). Turbidity reading was higher than 50 NTUs, but water appeared to be contained within corral at time of inspection. Facing east.

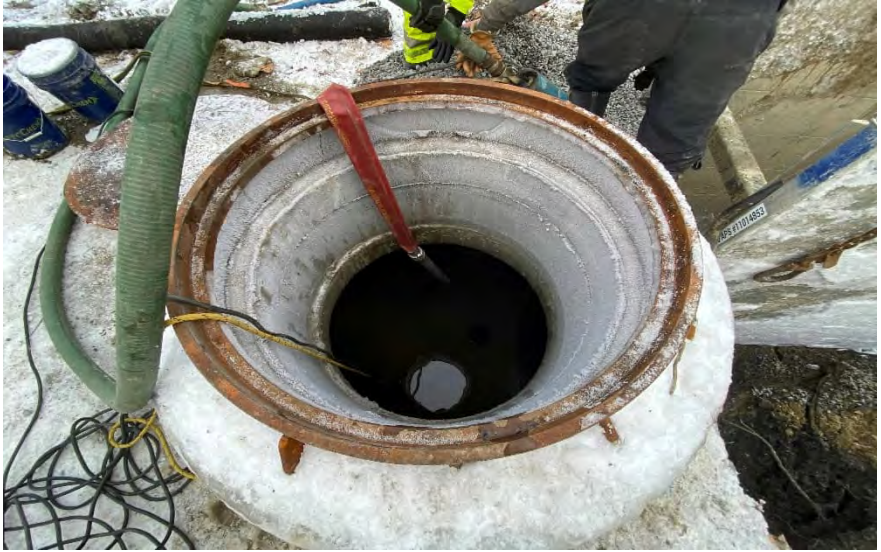
Description: View of area being pumped from segment 14-manhole #27, trench work.

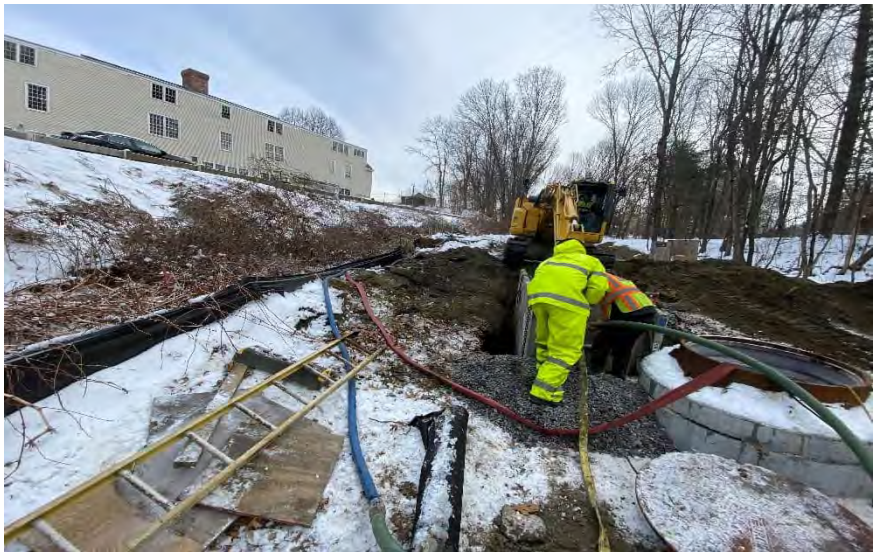
Description: Segment 14. View of dewatering operation. Looking eastward.

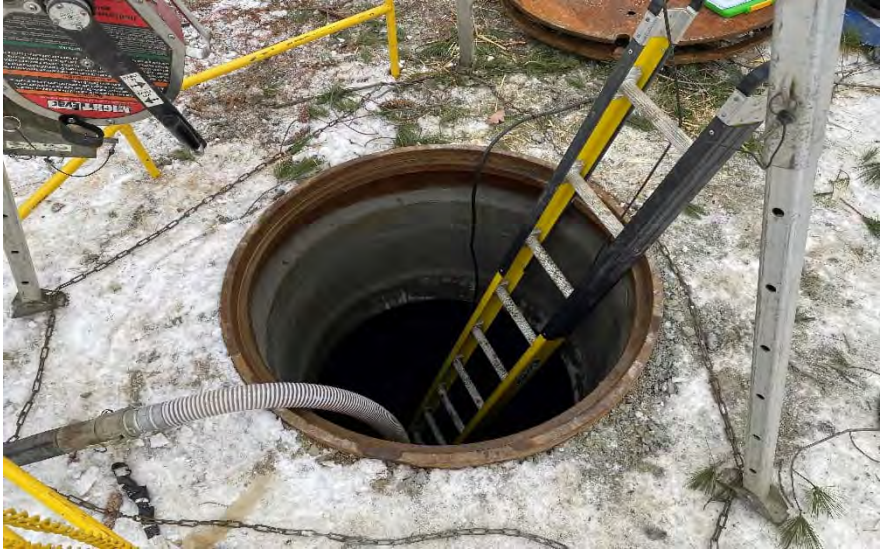
Description: View of pumping from manhole #10 segment 4.

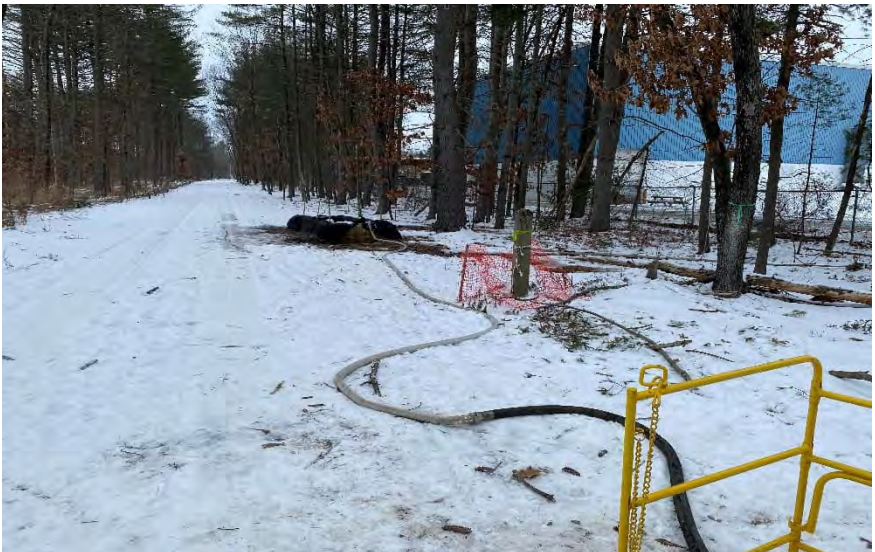
Description: Manhole #10. View of dewatering operation. Looking westward.

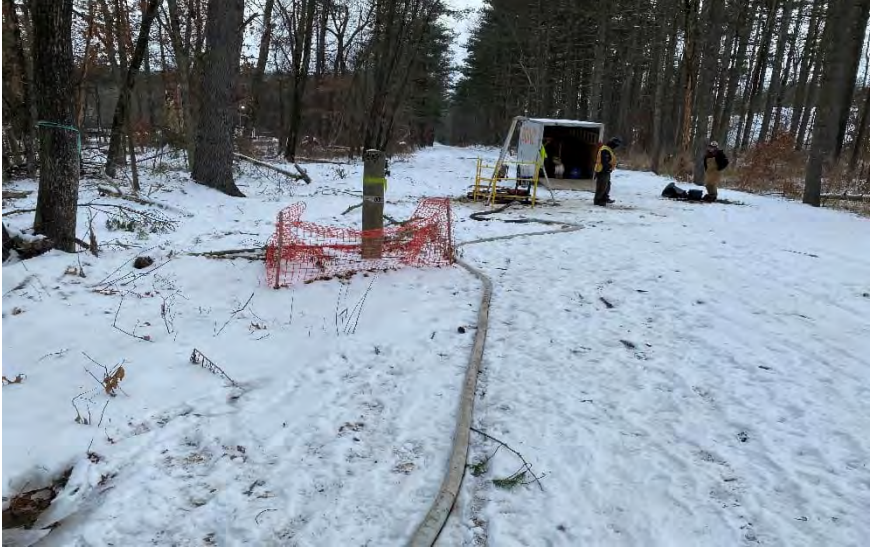
Description: Manhole #10. View of dewatering operation, looking eastward.

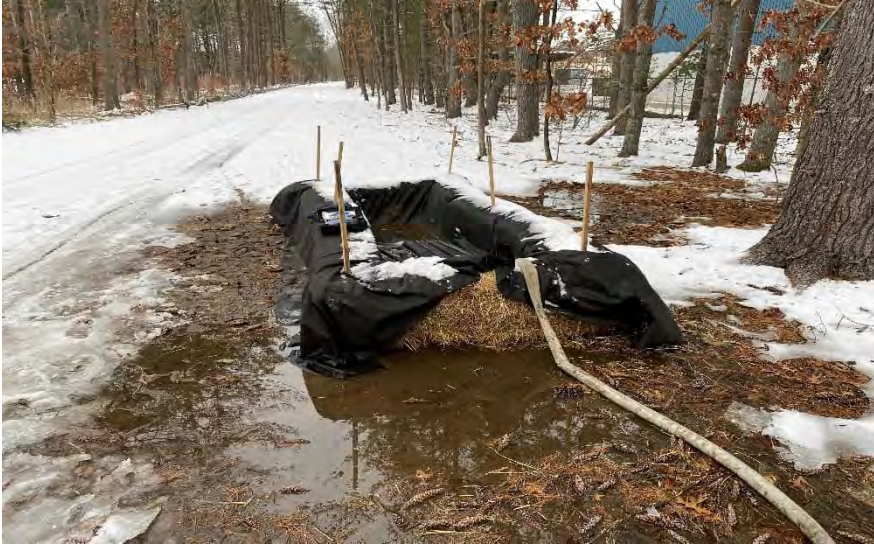
Description: Manhole #10. View of discharge bag, looking westward. Water from bag/corral discharged to adjacent work area, water appeared clear, looking westward.

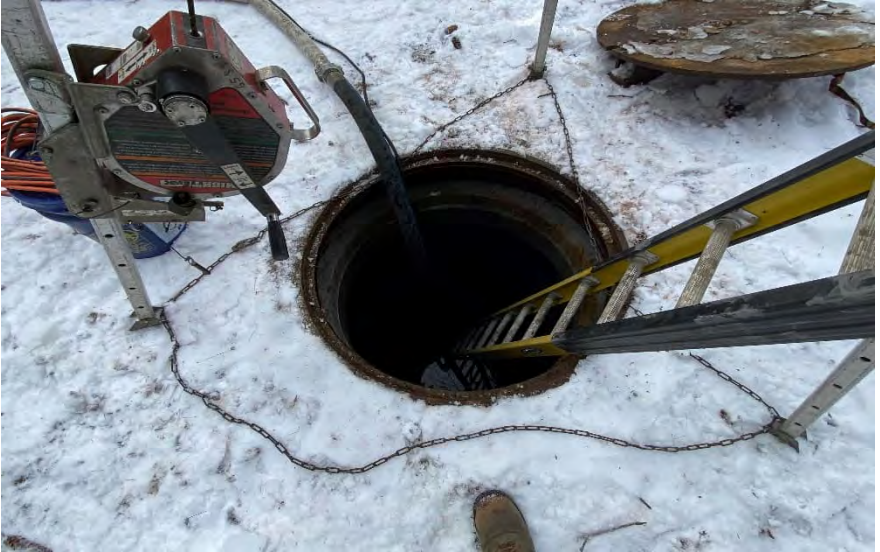
Description: View of pumping from manhole #11 segment 5.

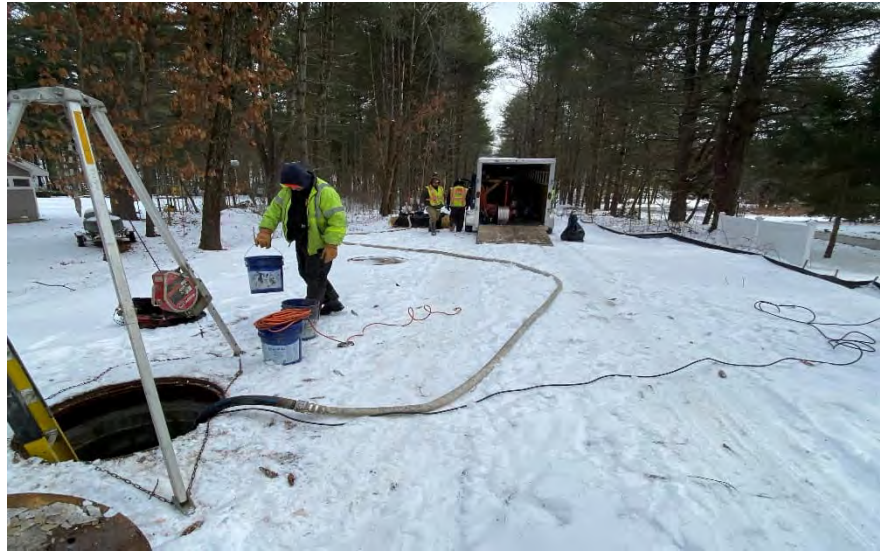
Description: Manhole #11. View of dewatering operation. Looking eastward.

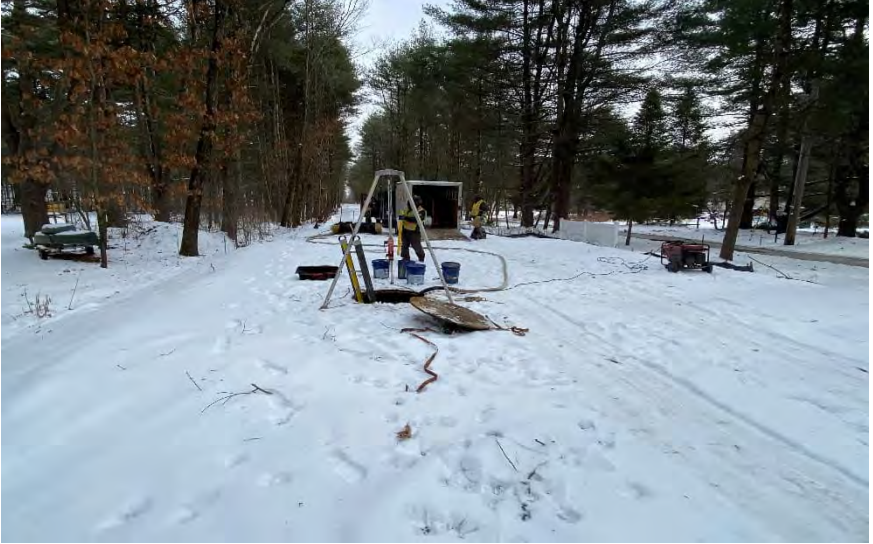
Description: Manhole #11. View of dewatering operation, looking eastward.

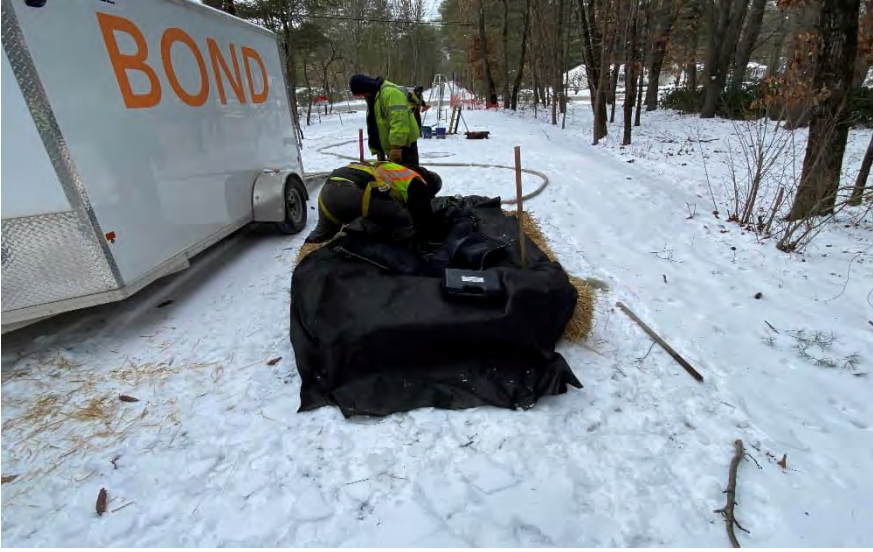
Description: Manhole #11. View of discharge bag, looking westward. Water from bag/corral discharged to adjacent work area, water appeared clear, looking westward.
