Weekly Environmental Compliance Summary

Sudbury to Hudson Transmission Reliability Project (USEPA Tracking # MAR1003UW)

Week of: December 18, 2023 to December 22, 2023

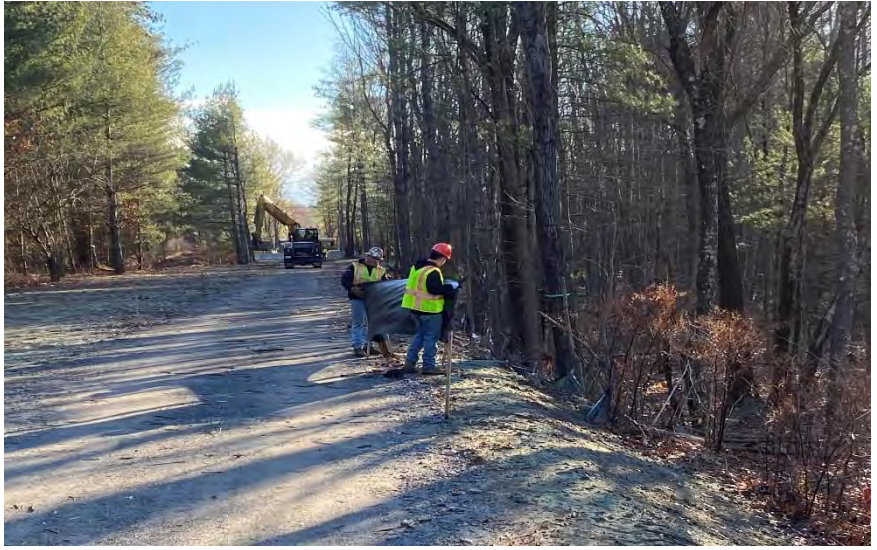
PHOTOGRAPHIC LOG	
Client Name: Eversource		Site Location: Sudbury to Hudson Transmission Reliability Project	
Photo No.: 5		Date: 12-19-23	
Description: Work area within Segment 2, Bond repairing damaged erosion controls, looking eastward.

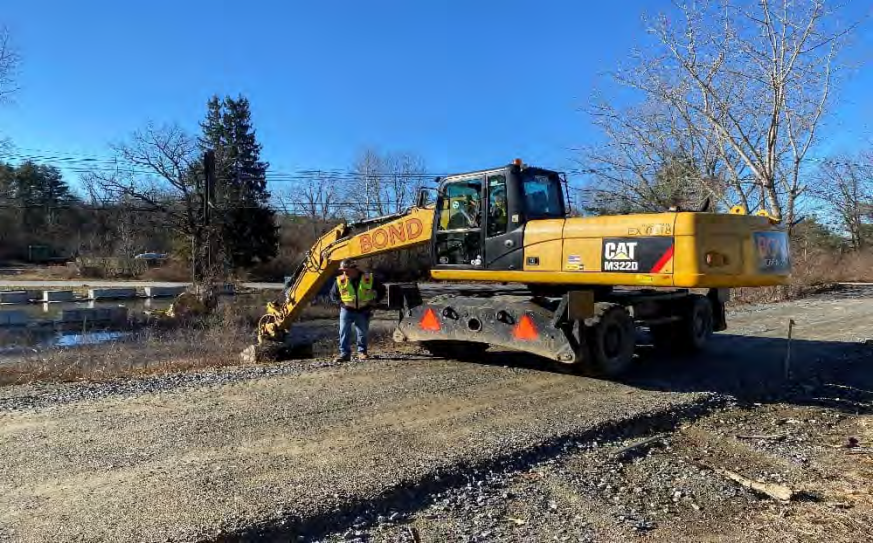
PHOTOGRAPHIC LOG	
Client Name: Eversource		Site Location: Sudbury to Hudson Transmission Reliability Project	
Photo No.: 6		Date: 12-19-23	
Description: Work area within Segment 3, Bond repairing erosion on side slope, looking westward.

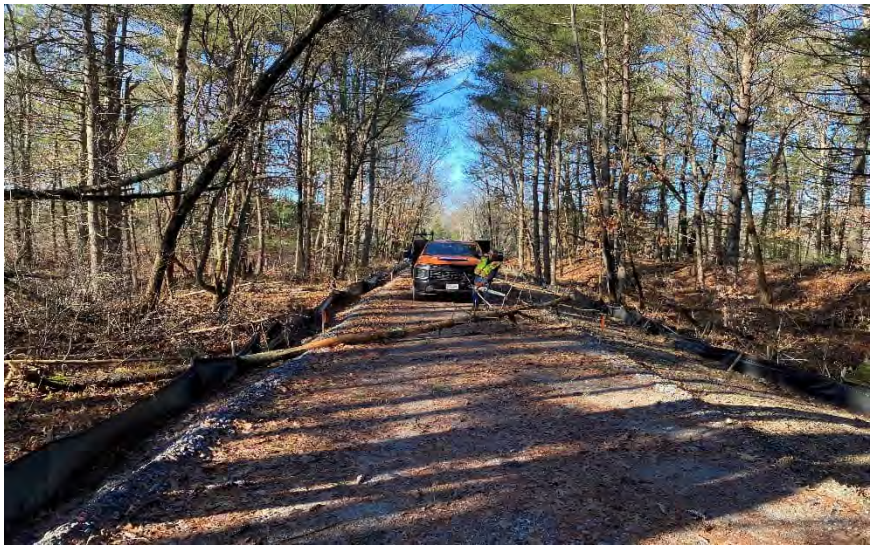
PHOTOGRAPHIC LOG	
Client Name: Eversource		Site Location: Sudbury to Hudson Transmission Reliability Project	
Photo No.: 8		Date: 12-19-23	
Description: Work area within segment 5, removal of fallen tree & repair of damaged erosion control, looking westward.

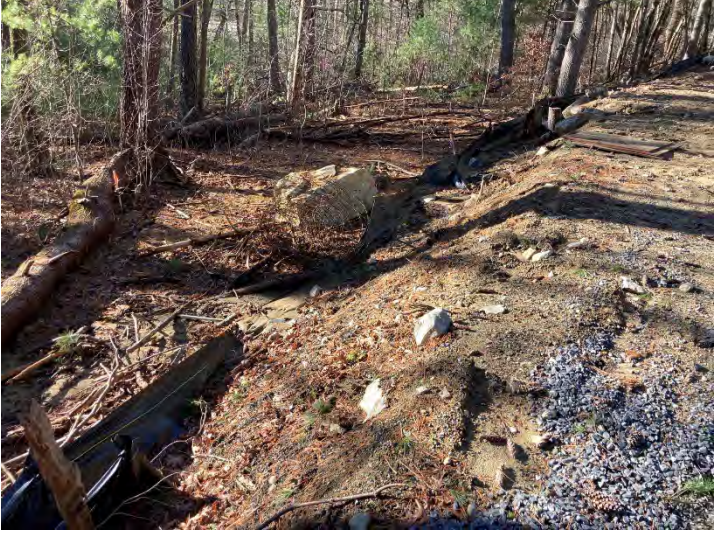
PHOTOGRAPHIC LOG	
Client Name: Eversource		Site Location: Sudbury to Hudson Transmission Reliability Project	
Town: Sudbury			
Photo No.: 3	Date: 12/19/2023

-During heavy rains, stormwater overtopped silt fence near manhole in segment 9 and discharged from project. Sediment deposited beyond silt fence but did not reach any jurisdictional areas. Silt fence repair and sediment removal are needed.

Description: View of silt fence repair needed where stormwater discharge occurred near manhole in segment 9. Sediment has deposited beyond silt fence but did not reach jurisdictional areas. Facing southwest.

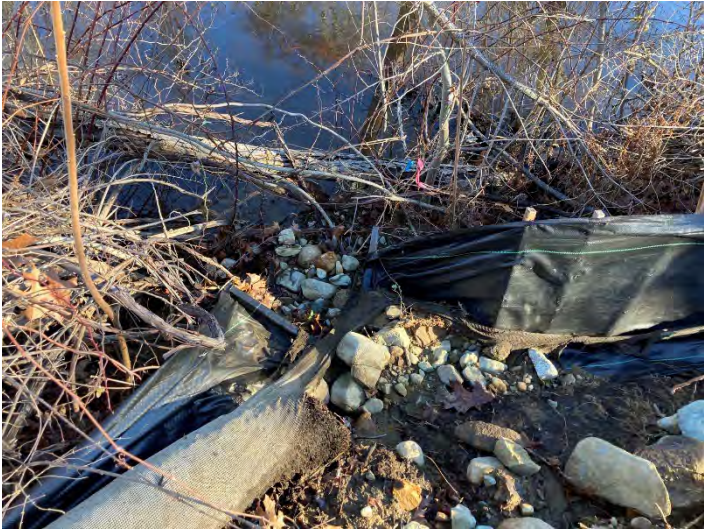
-During heavy rains, stormwater overtopped silt fence in segment 12 and discharged from project. Small amount of sediment was deposited into tributary adjacent to project. Silt fence repair and sediment removal are needed. Lori Capone (Sudbury CC) was notified and gave permission for sediment clean up to proceed.

PHOTOGRAPHIC LOG	
Client Name: Eversource		Site Location: Sudbury to Hudson Transmission Reliability Project	
Photo No.: 5		Date: 12/19/2023	
Description: View of damaged silt fence where stormwater discharge occurred in segment 12. Small amount of sediment deposited into tributary adjacent to project. Facing north.

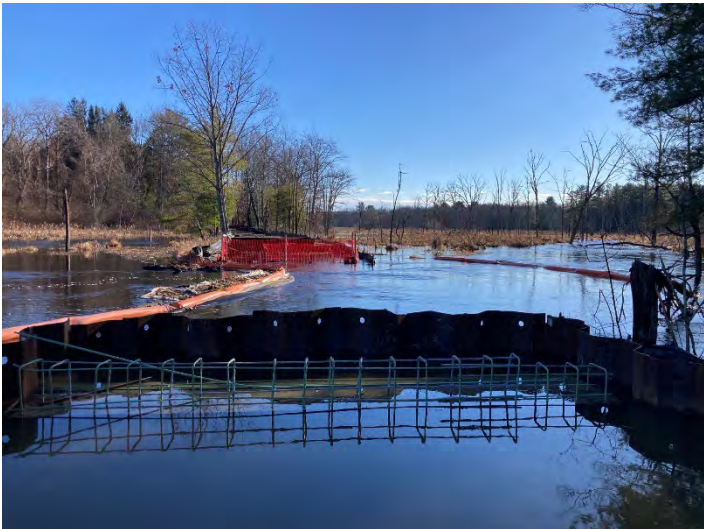
PHOTOGRAPHIC LOG	
Client Name: Eversource		Site Location: Sudbury to Hudson Transmission Reliability Project	
Photo No.: 6		Date: 12/19/2023	
Description: View of Bridge 127. Water levels are high following heavy rains. Turbidity curtain may need to be adjusted once water levels recede. Facing east.

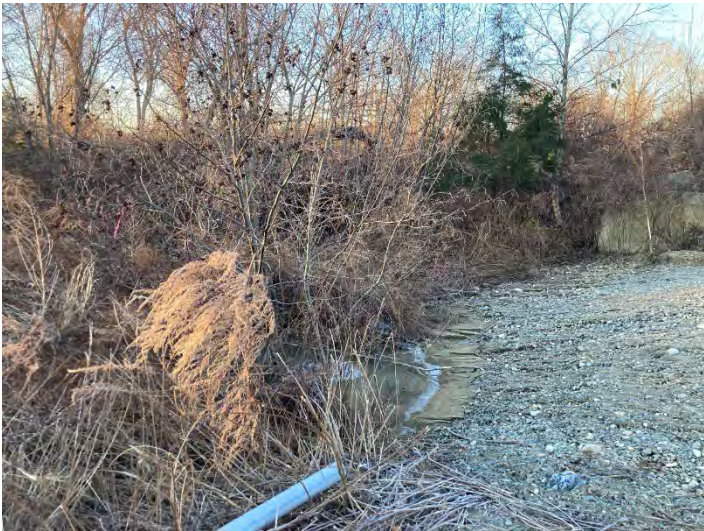
-Erosion noted near entrance to Sudbury Substation. It is recommended that erosion controls are installed in this area to prevent impact to nearby wetlands.

PHOTOGRAPHIC LOG	
Client Name: Eversource		Site Location: Sudbury to Hudson Transmission Reliability Project	
Photo No.: 6 Date: 12/20/2023		Town: Sudbury	
Description: View of erosion near entrance to Sudbury Substation. It is recommended that erosion controls are installed in this area to prevent impact to nearby wetlands. Facing west.

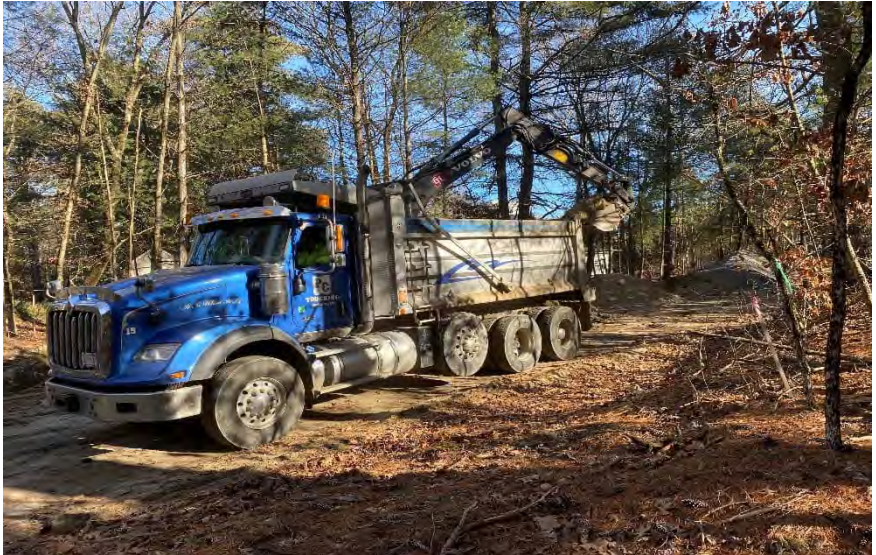
Spoil piles, noted earlier this week (12-18-23) within segment 9, removed today. Please see photo 5 below.

PHOTOGRAPHIC LOG	
Client Name: Eversource		Site Location: Sudbury to Hudson Transmission Reliability Project	
Photo No.: 5		Date: 12-22-23	
Description: Work area within segment 9, spoil pile removal, looking eastward.

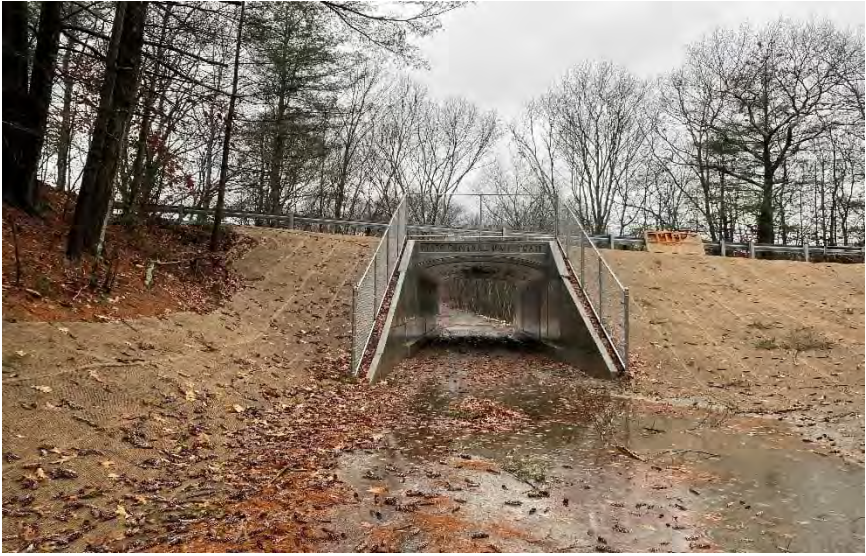
Description: Chestnut Street crossing segments 1/2, flooded, looking westward.

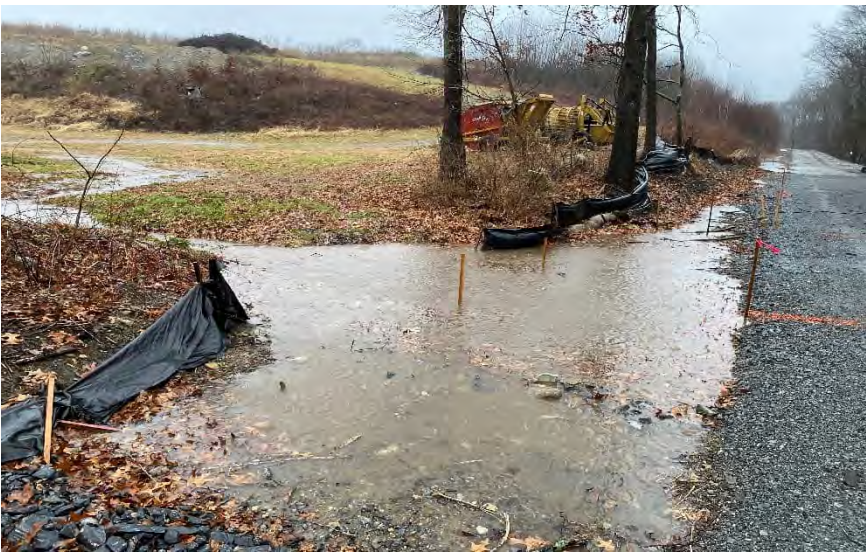
Description: Work area within segment 1, catch basin flooded with water overflowing onto work area further east, looking westward.

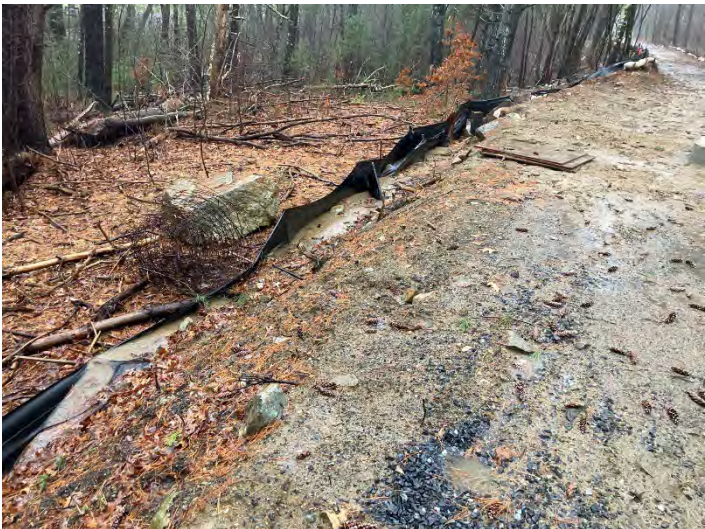
Description: View of stormwater discharge and damaged silt fence near manhole in segment 9. Facing southwest.

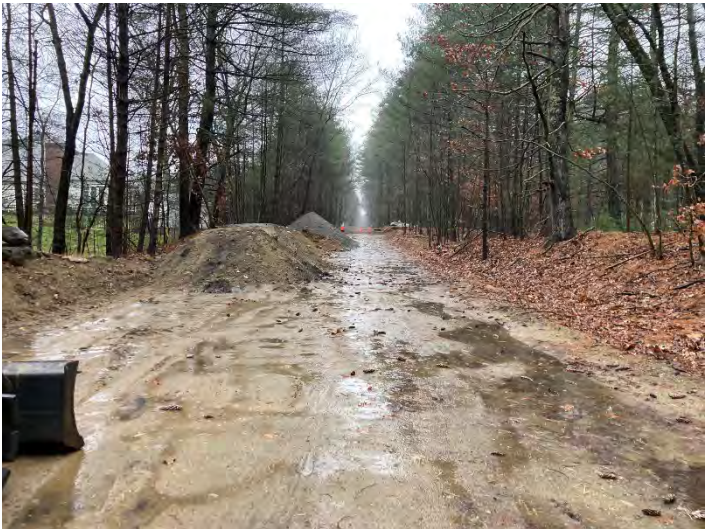
Description: View of stockpiles noted at west end of segment 9. Facing east.

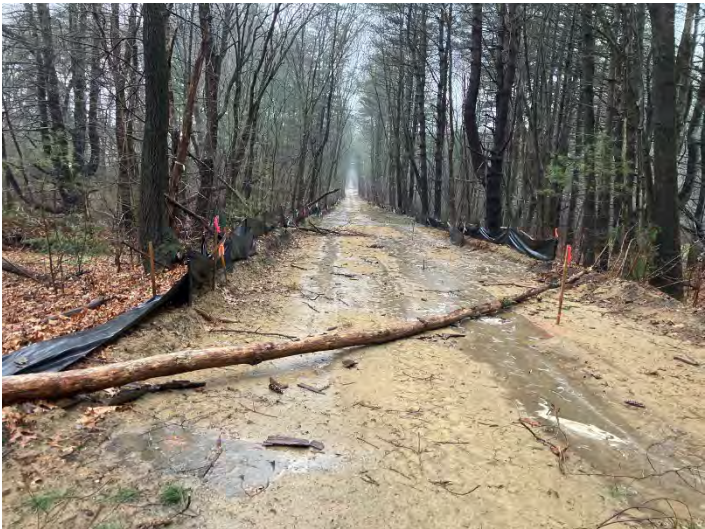
Description: View of fallen tree and damaged silt fence in segment 10. Facing west.

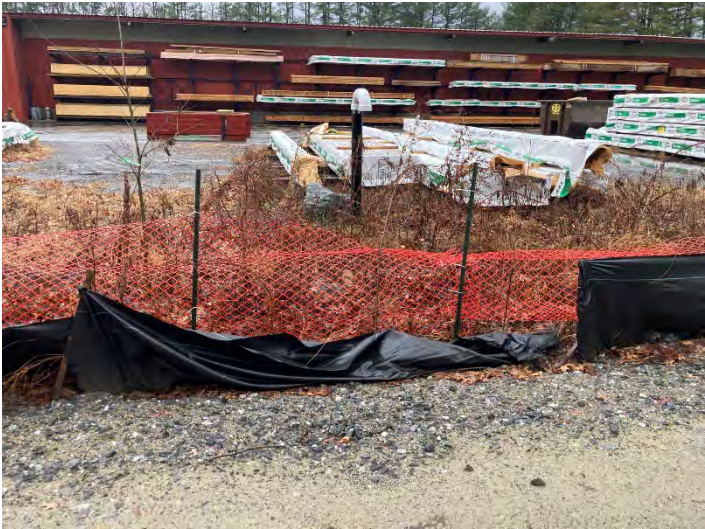
Description: View of damaged silt fence in segment 11. Facing south.

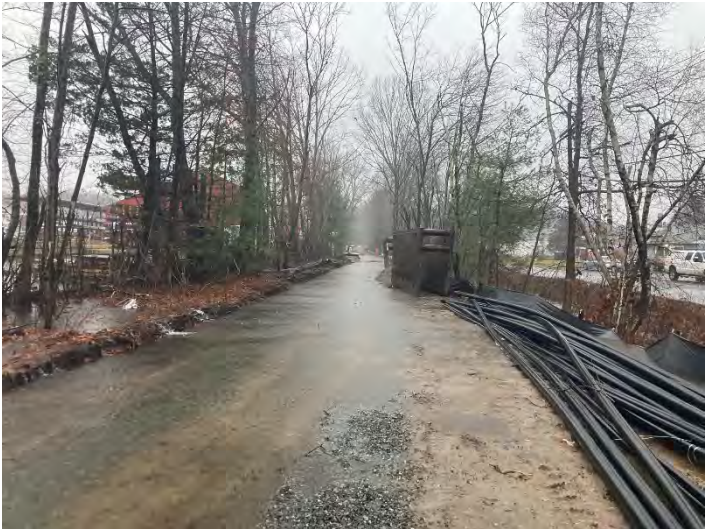
Description: View of stormwater discharge in segment 12. Facing west.

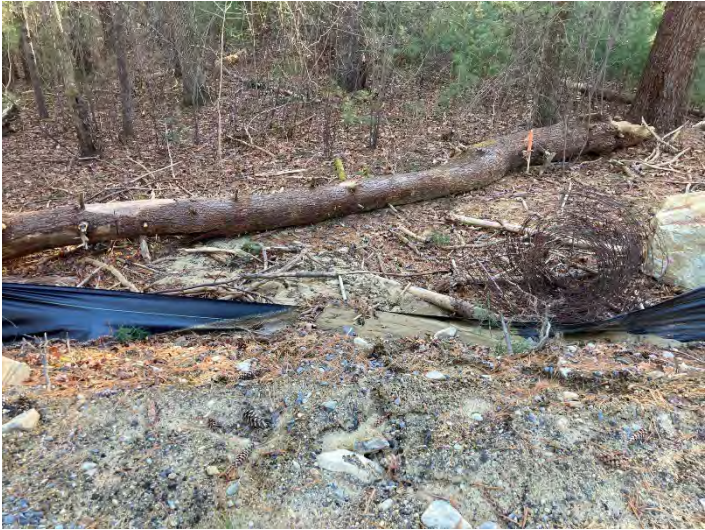
Description: View of damaged silt fence and deposited sediment near manhole in segment 9. Facing south.

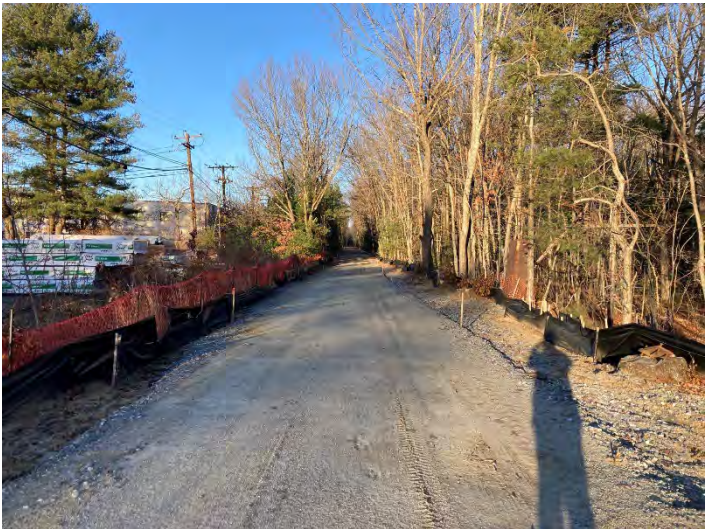
Description: View of repaired silt fence in segment 11. Facing west.

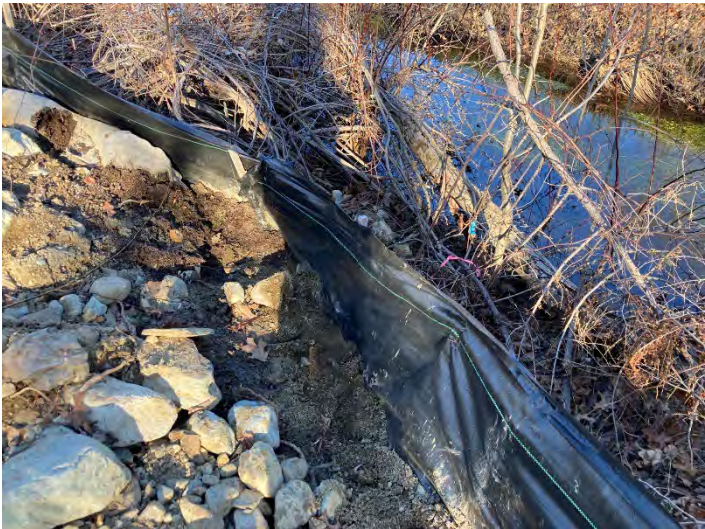
Description: View of repaired silt fence in segment 12. Facing northwest.

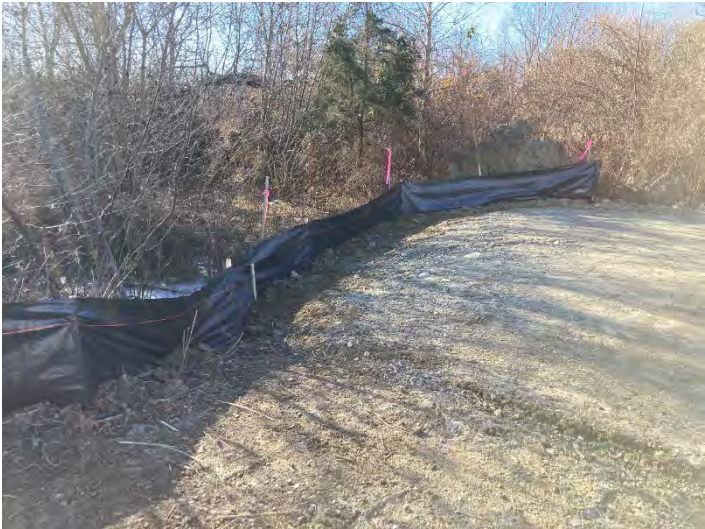
Description: Silt fence has been installed along exposed soils near entrance to Sudbury Substation. Facing west.

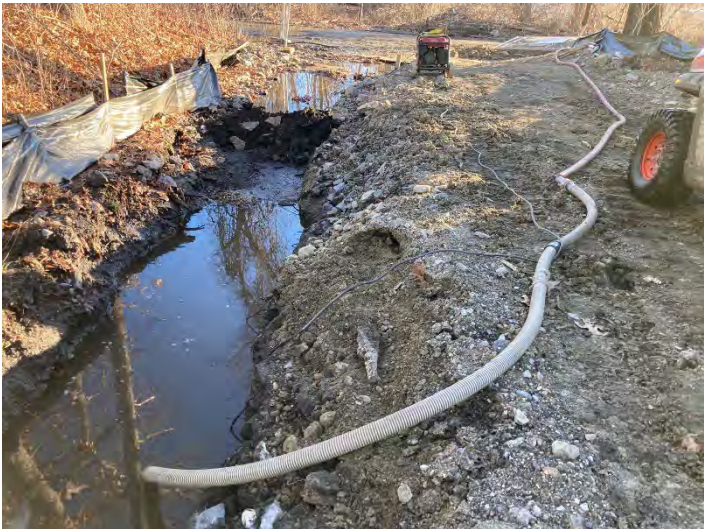
Description: View of pump in trench. Water appeared turbid prior to treatment. Facing east.

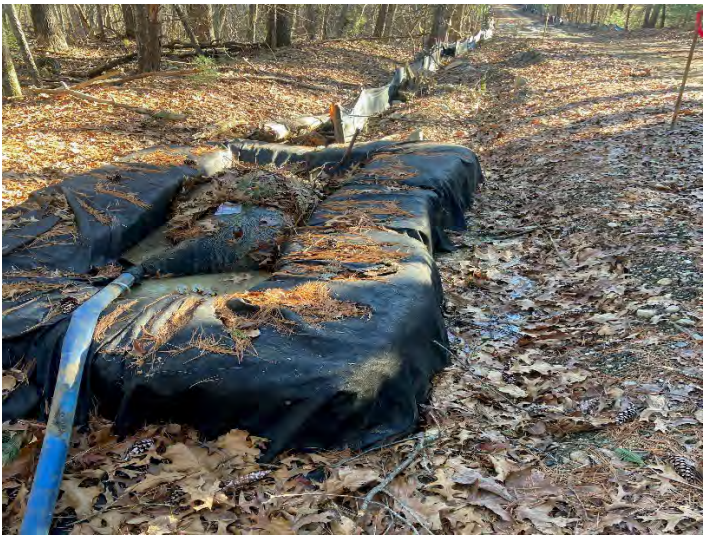
Description: View of dewatering controls (straw bale corral with filter fabric and silt bag). Only a small amount of water was leaving the corral at time of inspection and water did not appear to leave project boundaries. Facing east.
