Weekly Environmental Compliance Summary

Sudbury to Hudson Transmission Reliability Project (USEPA Tracking # MAR1003UW)

Week of: December 25, 2023 to December 29, 2023

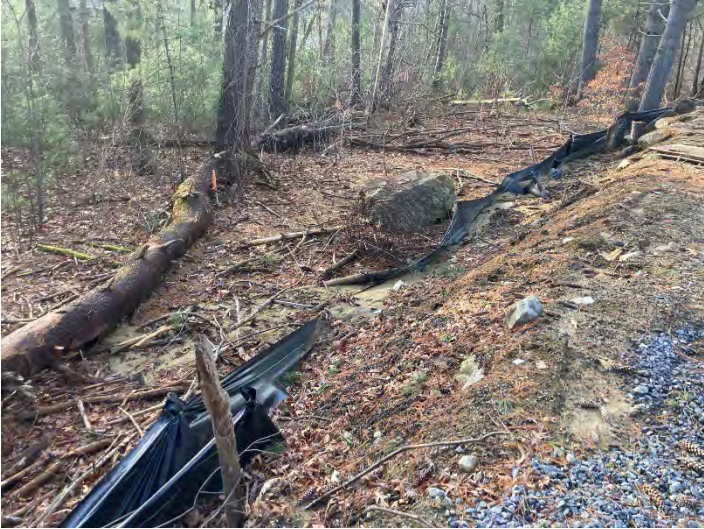
| <p>Photo No.: 6</p> | <p>Date: 12/26/2023</p> | | |

-Sediment is present beyond limit of work in segment 9. Silt fence repair and sediment removal are needed.

| <p>Description: View of damaged silt fence and sedimentation near manhole in segment 9. Facing southwest.</p> | | | |

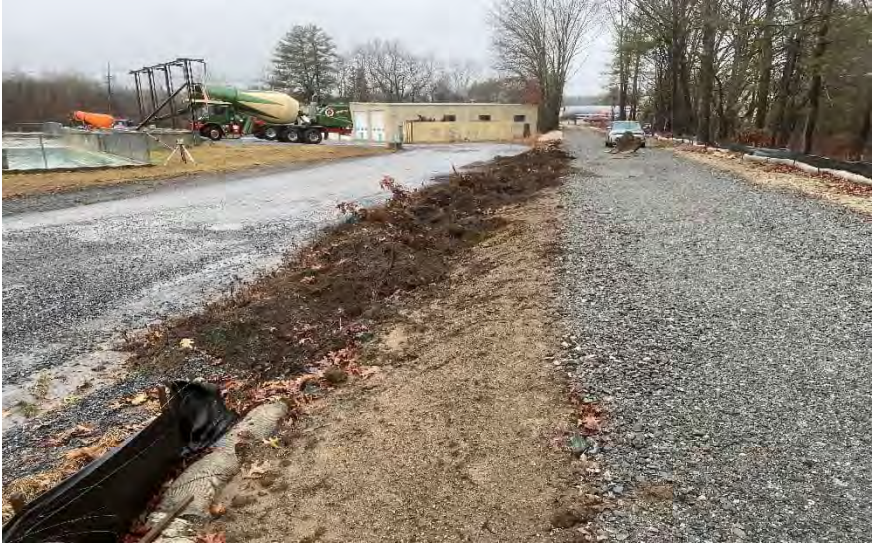
| <p>Photo No.: 8</p> | <p>Date: 12-29-23</p> | | |

| <p>Description:</p> <p>Work area within Segment 3, landowner (Perkins) removed approximately 150' of previously installed erosion control (silt fencing & compost filter tubes), looking westward.</p> | | | |

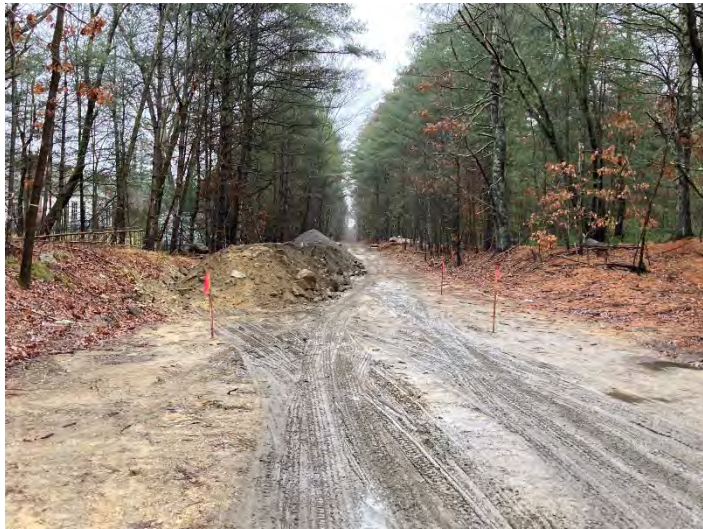
| <p>Photo No.: 2</p> | <p>Date: 12/29/2023</p> | | |

Identify presence of stockpiles and document when placed and when removed (week maximum for stockpiles)
Stockpiles noted within ROW at west end of segment 9.

| <p>Description: View of stockpiles noted at west end of segment 9. Facing east.</p> | | | |

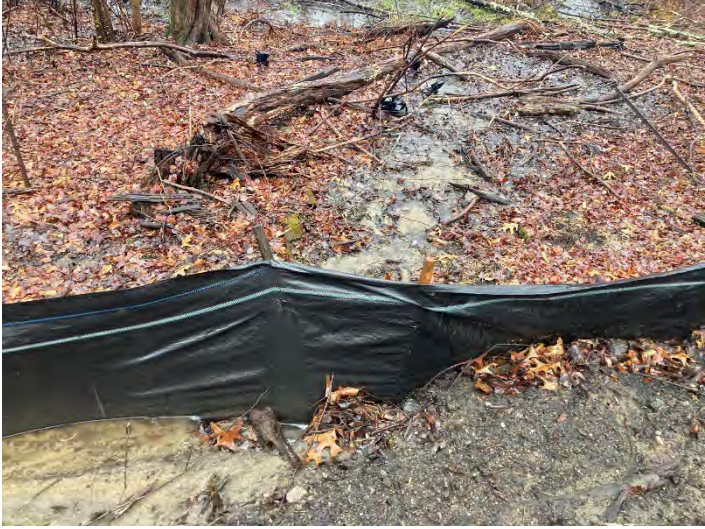
| Photo No.: 2 | Date: 12-28-2023 | | |

| Description: View of stormwater discharge occurring in segment 14. Skim layer of sediment appears to have deposited beyond silt fence but has not reached wetlands. Facing south. | | | |

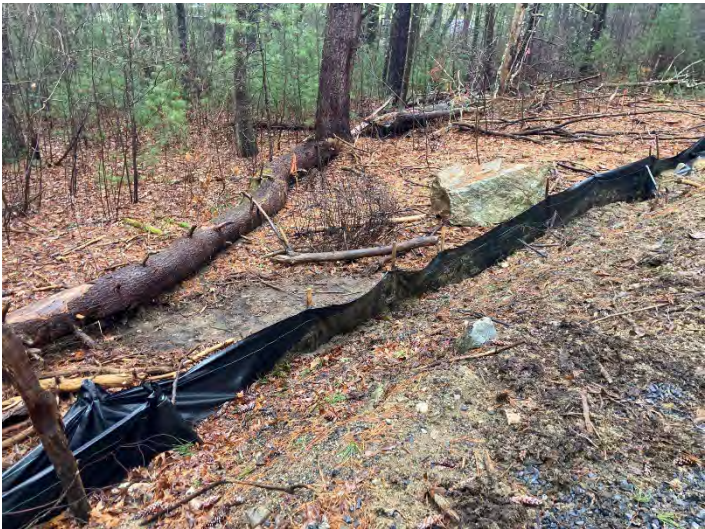
| Photo No.: 5 | Date: 12-28-2023 | | |

| Description: View of silt fence repair and sediment removal that occurred near manhole in segment 9. Facing southwest. | | | |

-Silt fence repair and sediment removal in segment 9 has been completed.

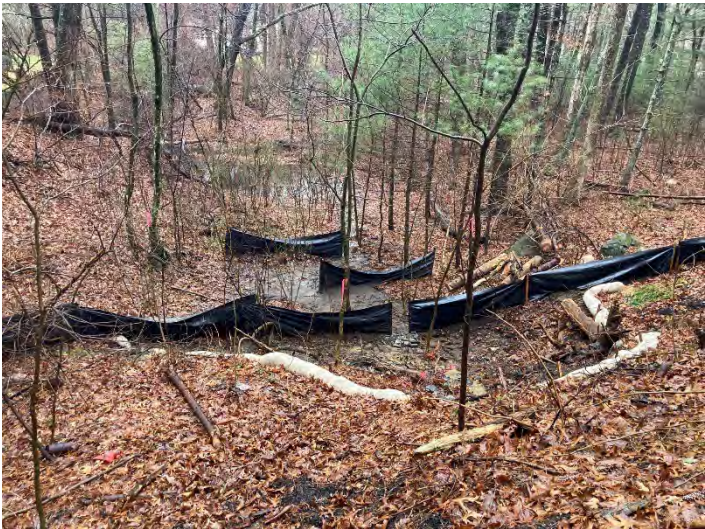
| Photo No.: 6 | Date: 12-28-2023 | | |

| Description: View of wetlands below damaged culvert in segment 9. Sediment that had previously deposited in wetlands has been removed. Additional silt fence has been installed in preparation for culvert repair work. Facing southwest. | | | |

-Additional silt fence has been installed at damaged culvert in segment 9 in preparation for repair work.

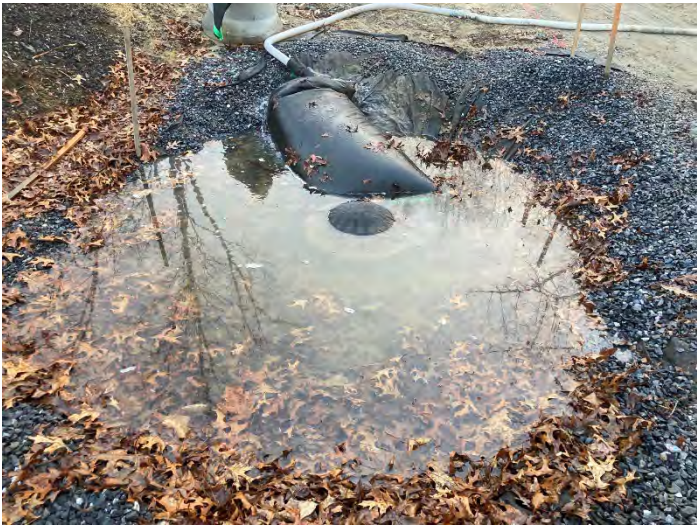
| Photo No.: 4 | Date: 12/26/2023 | | |

| Description: Additional view of filter bag and discharge. Dewatering water sent to filter bag before being discharged into catch basin within segment 1. Water appeared mostly clear. Turbidity reading was higher than 50 NTUs. Facing east. | | | |

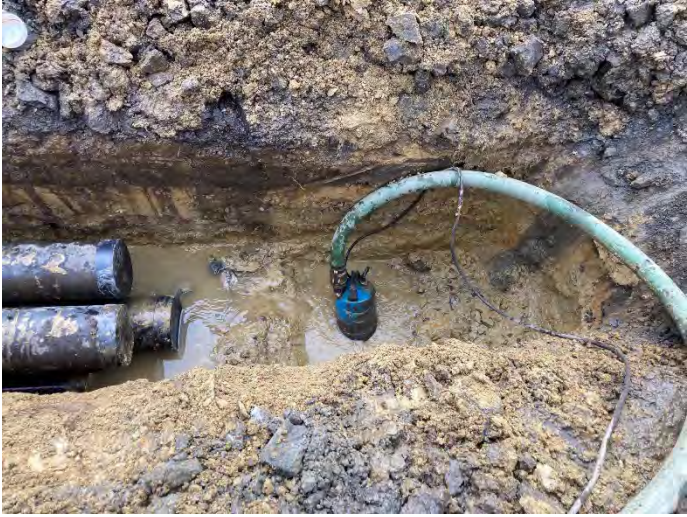
| Photo No.: 3 | Date: 12/26/2023 | | |

| Description: View of pump in trench. Water appeared turbid prior to treatment. | | | |

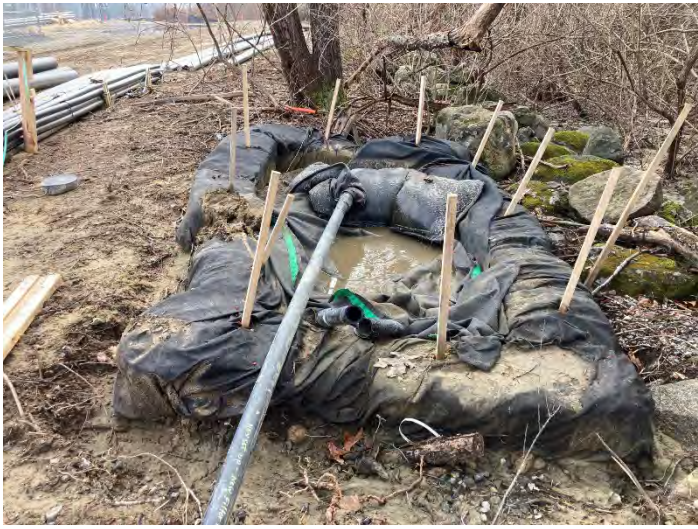
| Photo No.: 4 | Date: 12/26/2023 | | |

| Description: View of dewatering controls (straw bale corral with filter fabric and silt bag). Water was contained within the corral at time of inspection. Turbidity reading was higher than 50 NTUs. Facing south. | | | |

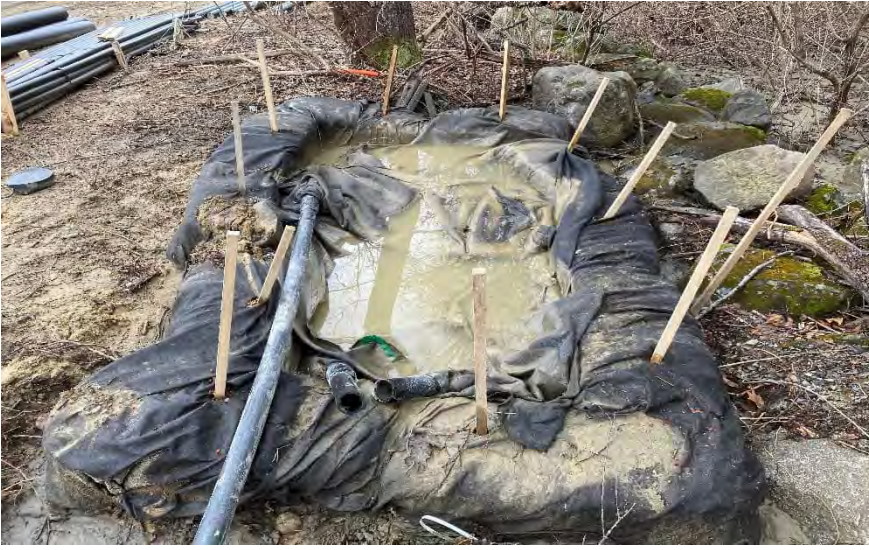
| Photo No.: 4 | Date: 12/27/2023 | | |

| Description: Segment 14. View of discharge to corral/bag, looking southward. Water ultimately discharged to wooded area adjacent to the work area & appeared turbid, looking southward. | | | |

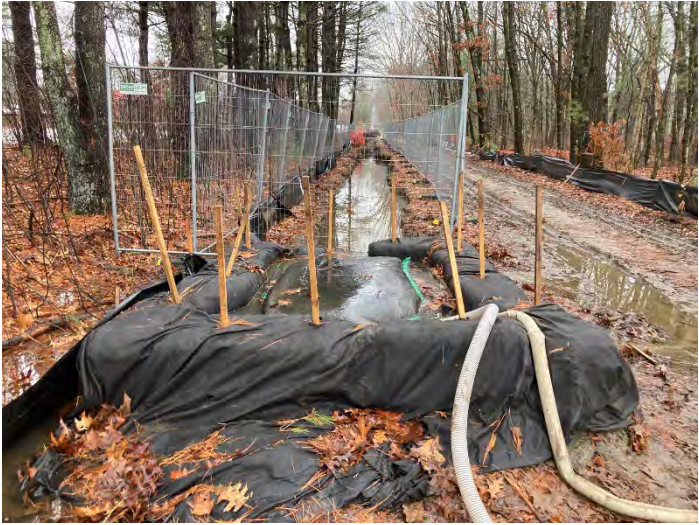
| Photo No.: 4 | Date: 12/29/2023 | | |

| Description: View of dewatering controls (straw bale corral with filter fabric and silt bag) and discharge from corral. Discharge was mostly contained within trench west of corral. Turbidity reading was below 50 NTUs. Facing west. | | | |
