Weekly Environmental Compliance Summary

Sudbury to Hudson Transmission Reliability Project (USEPA Tracking # MAR1003UW)

Week of: January 22, 2024 to January 26, 2024

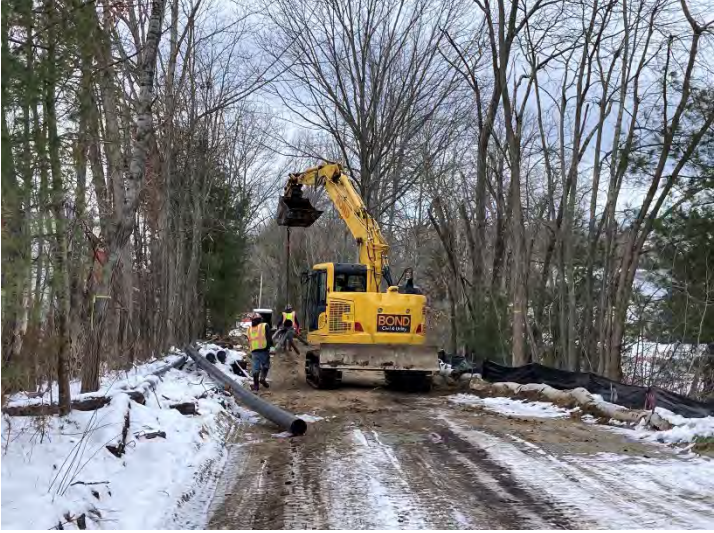
PHOTOGRAPHIC LOG	
Client Name: Eversource		Site Location: Sudbury to Hudson Transmission Reliability Project	Town: Sudbury
Photo No.: 3	Date: 1/23/2024

Description: View of Bond installing conduit in segment 12. Facing west.

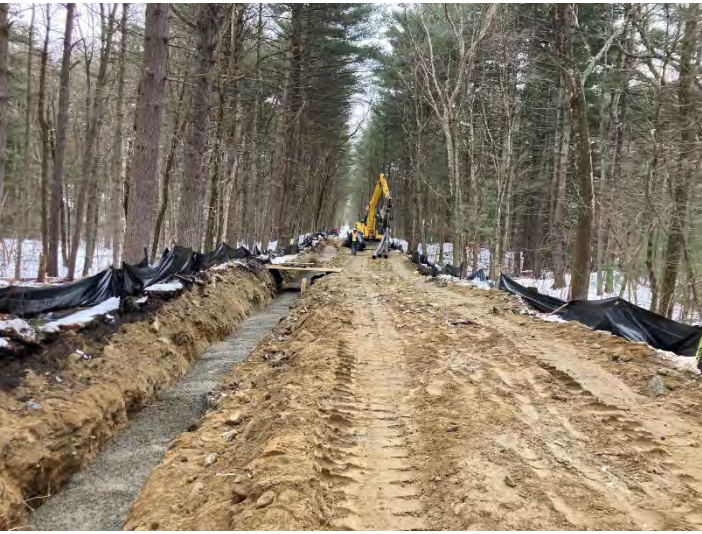
PHOTOGRAPHIC LOG	
Client Name: Eversource		Site Location: Sudbury to Hudson Transmission Reliability Project	Town: Sudbury
Photo No.: 4	Date: 1/23/2024

Description: View of Bond installing ductbank over culvert in segment 9. Facing east.

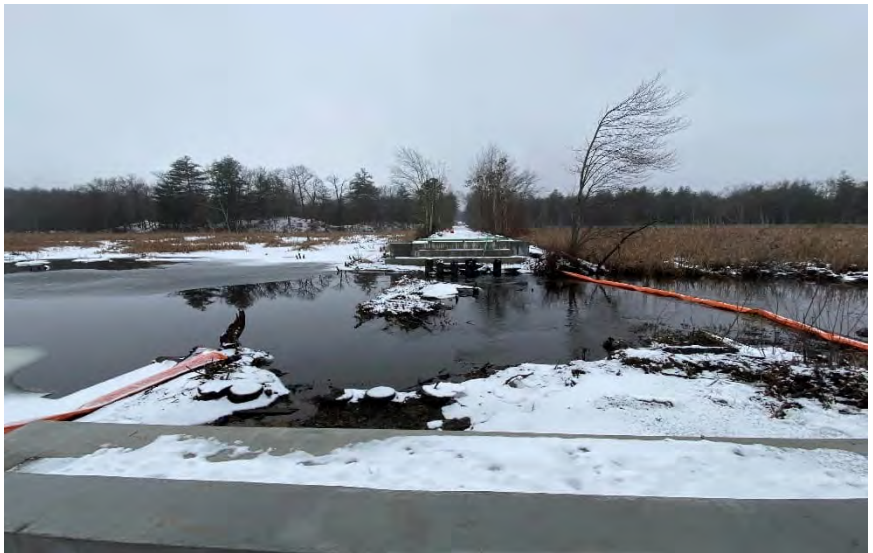
<p>PHOTOGRAPHIC LOG</p>	
<p>Client Name: Eversource</p>		<p>Site Location: Sudbury to Hudson Transmission Reliability Project</p>	<p>Town: Hudson</p>
<p>Photo No.: 4</p>	<p>Date: 1-24-24</p>

<p>Description:</p> <p>Work area over Fort Meadow Brook segment 3 looking toward segment 2 at bridge 130 area, existing erosion control (floating silt curtain), looking westward.</p>

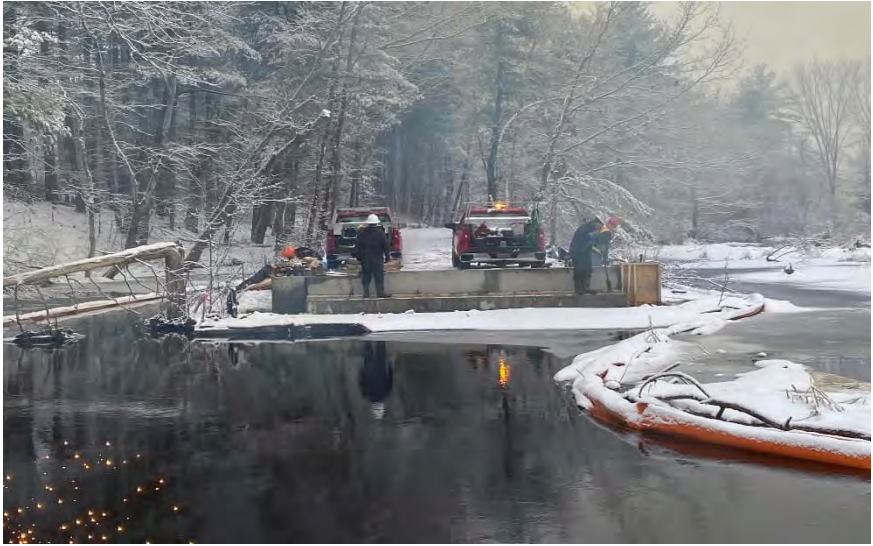
<p>PHOTOGRAPHIC LOG</p>	
<p>Client Name: Eversource</p>		<p>Site Location: Sudbury to Hudson Transmission Reliability Project</p>	<p>Town: Sudbury</p>
<p>Photo No.: 5</p>	<p>Date: 1-24-24</p>

<p>Description:</p> <p>Work area across Hop Brook looking from segment 14 toward segment 13, existing erosion control (floating silt curtain), looking westward.</p>

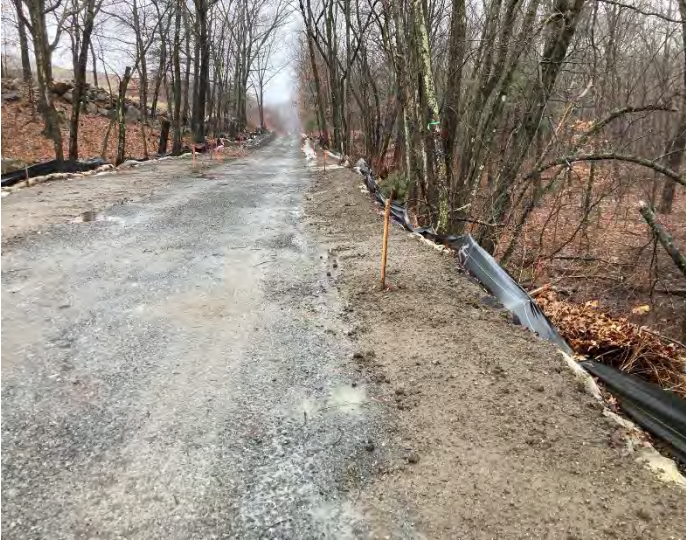
Description: View of Sta. #130 in segment 1. Loam has been applied to shoulders throughout segment 1 and E&S controls are almost buried or overwhelmed in some locations. It is recommended that loam is stabilized and that E&S controls are repaired as needed. Facing west.

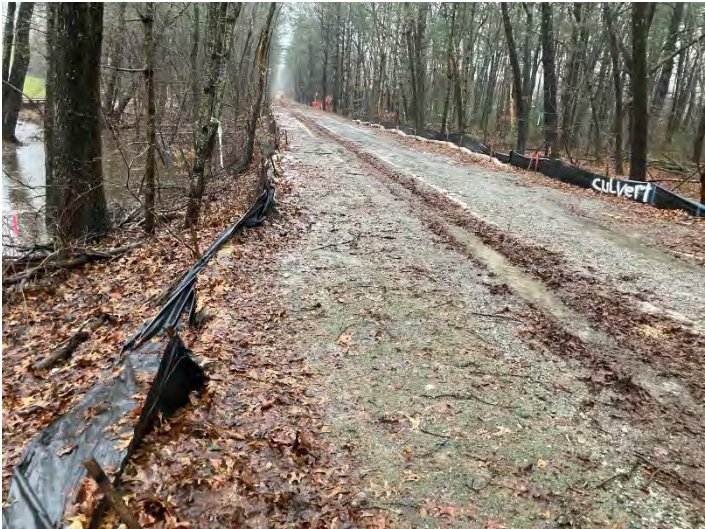
Description: View of approximately Sta. #206 in segment 4. E&S controls are in need of repair at this location. Facing west.

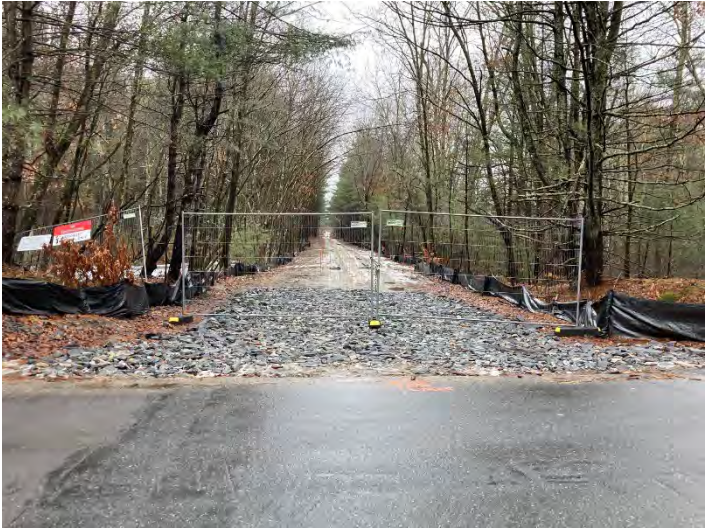
Description: View of construction entrance to segment 6 at White Pond Rd. Entrance pad is in good condition. Facing east.

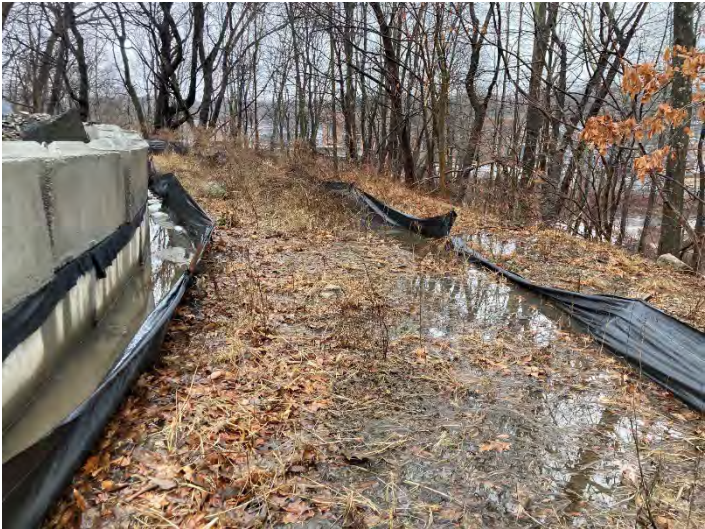
Description: View of damaged silt fence at Stowe Ct laydown yard. Facing north.

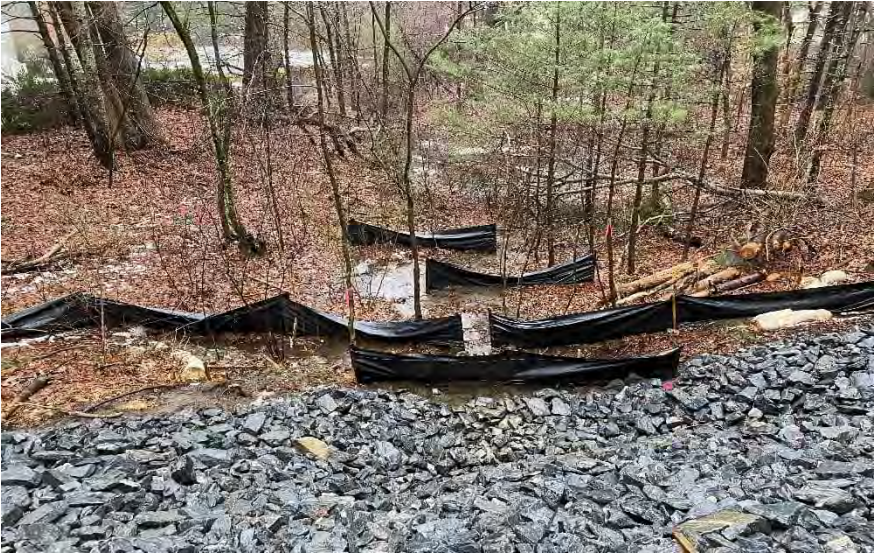
Description: Work area within segment 9, rehabilitated culvert area, free flow of rainfall runoff through culvert into adjacent wetland area, existing erosion control, looking southward.

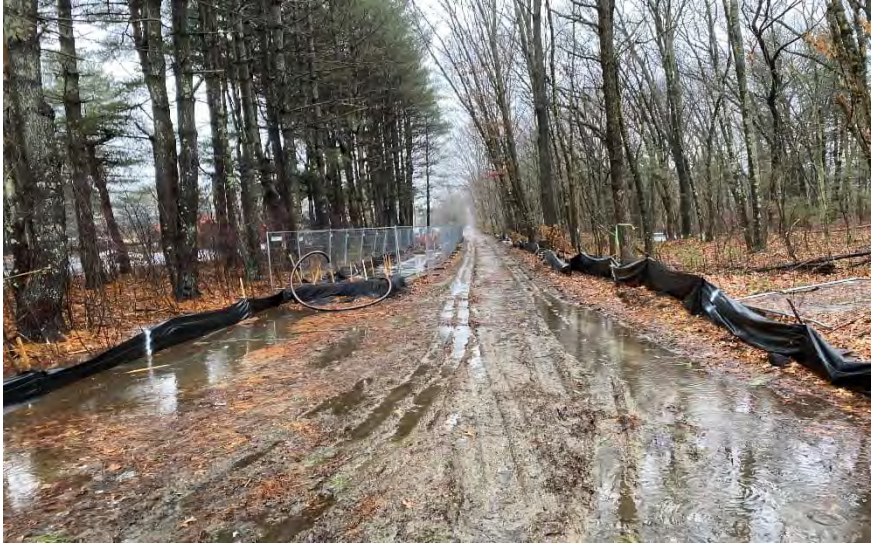
Description: Work area within segment 11, area flooded, existing erosion control, looking westward.

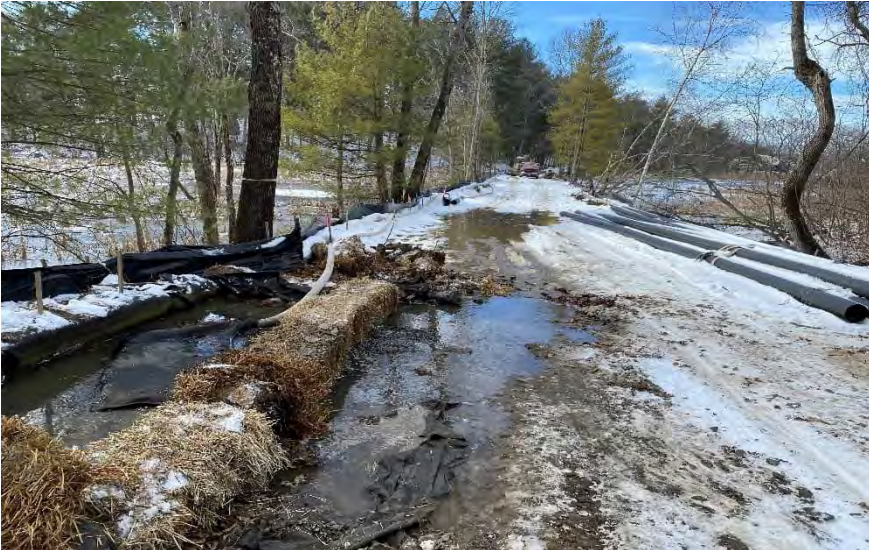
Description: Segment 14. View of discharge to corral/bag, looking westward. Water discharged to the work area & appeared slightly turbid, looking westward.

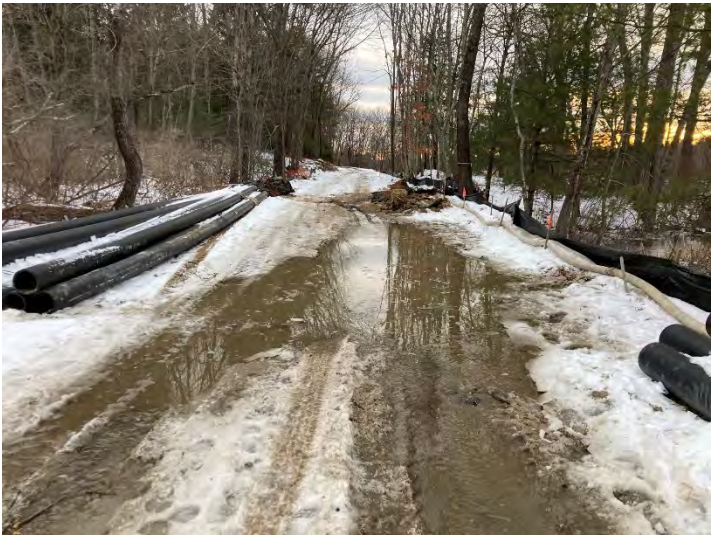
Description: View of discharge from controls. Discharge appeared turbid. Turbidity reading was higher than 50 NTUs. Facing east.

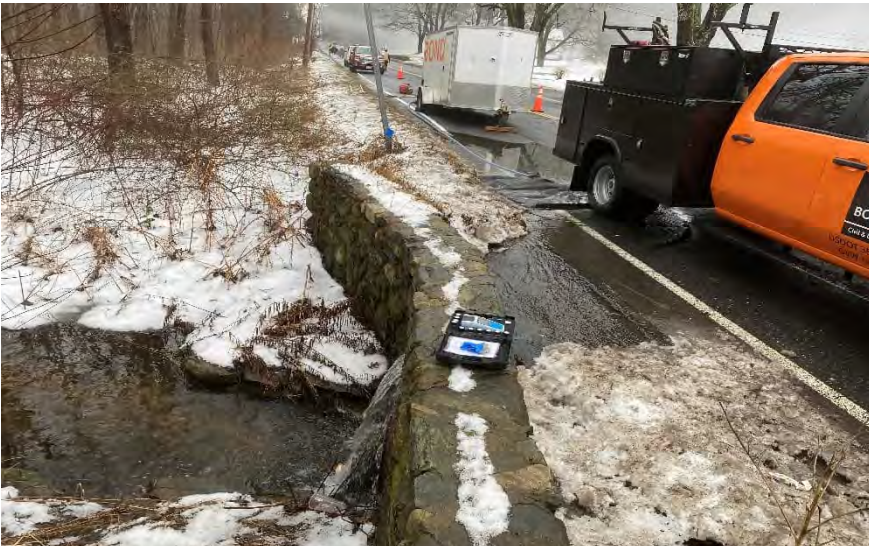
Description: Manhole #4. View of discharge to bag, looking southward. Water discharged to the roadway & adjacent stream, water appeared clear, looking southward.

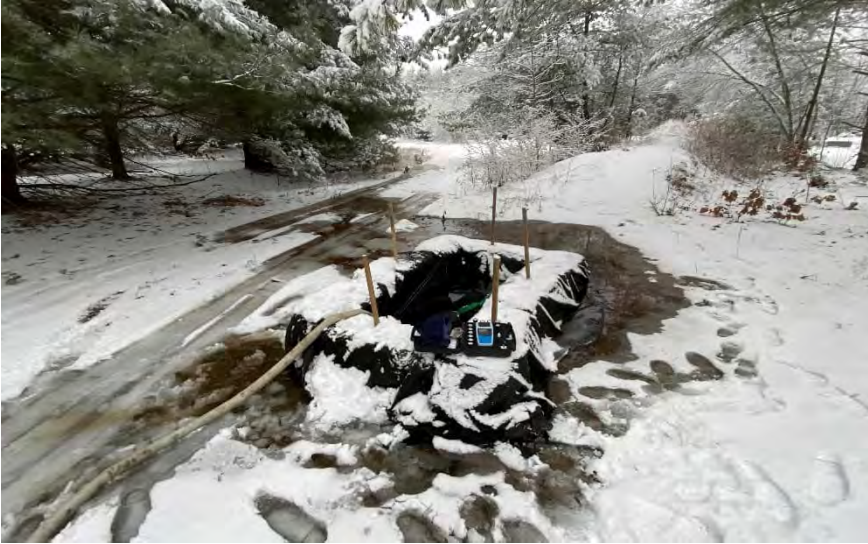
Description: Manhole #7. View of discharge bag, looking eastward. Water from bag/corral discharged to adjacent work area, water appeared clear, looking eastward.

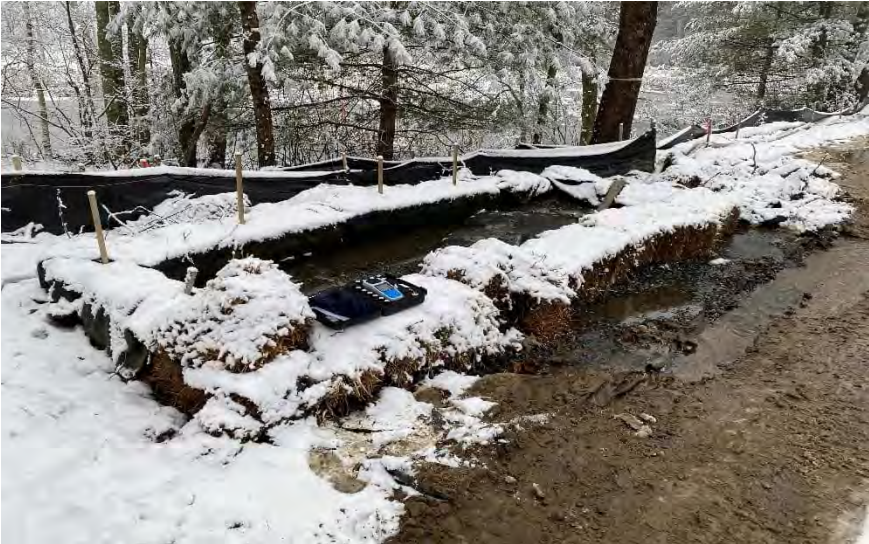
Description: Segment 14. View of discharge to corral/bag, looking westward. Water discharged to the work area & appeared clear, looking westward.

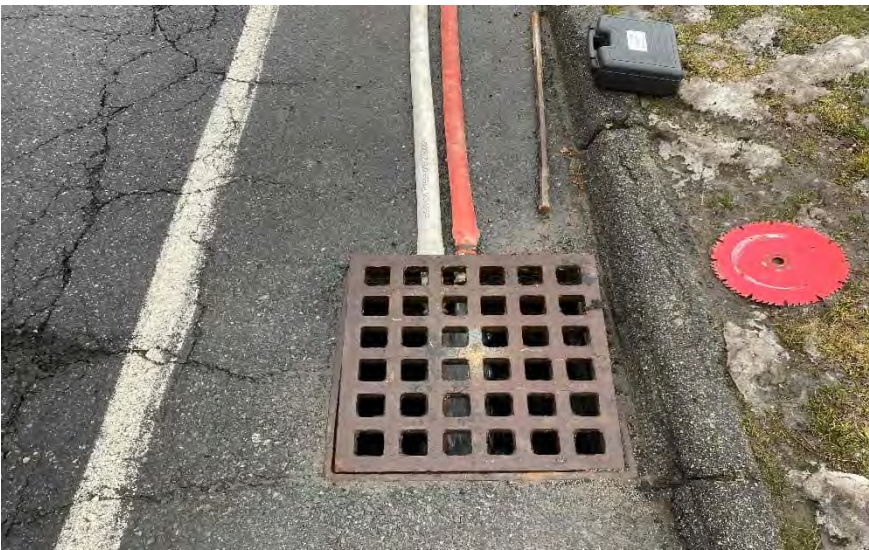
Description: Manhole #3. View of discharge to catch basin within Forest Avenue. Water discharged to catch basin, water appeared clear, looking southward.

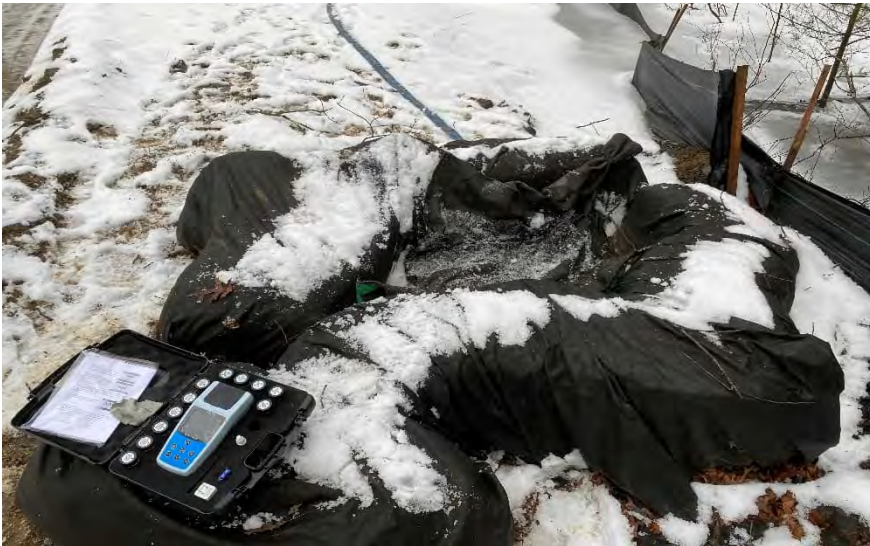
Description: Manhole #14. View of discharge to corral/bag, looking westward. Water discharged to the work area & appeared slightly turbid, looking westward.

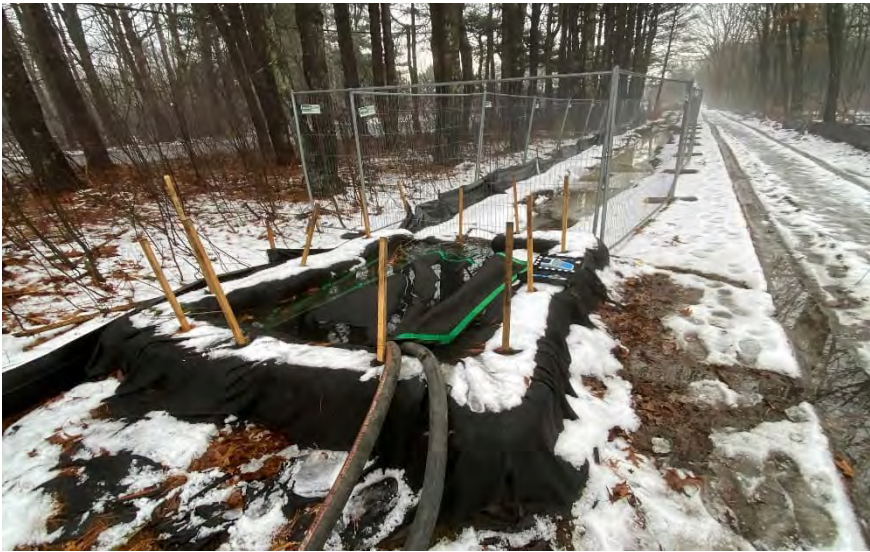
Description: Manhole #24. View of discharge corral/bag, looking westward. Water from bag discharged to adjacent work area to the west. Water appeared clear, looking westward.
