Weekly Environmental Compliance Summary

Sudbury to Hudson Transmission Reliability Project (USEPA Tracking # MAR1003UW)

Sudbury, Hudson, and Stow, MA

Week of: January 29, 2024 to February 2, 2024

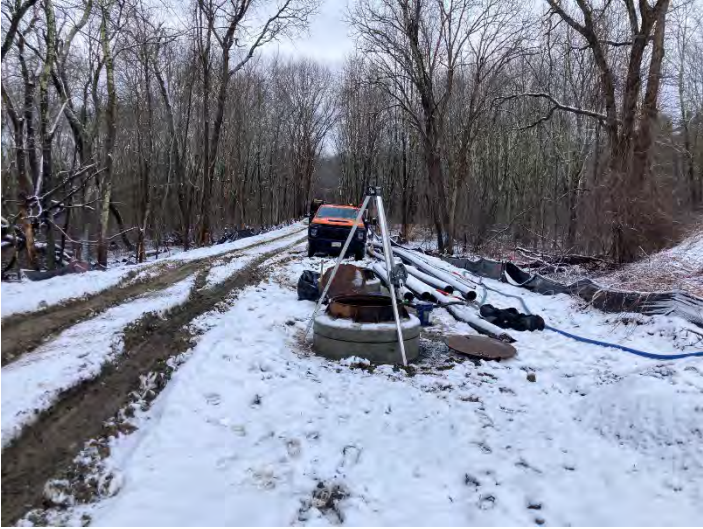
<p>Description: View of Bond working at MH #27 in segment 14. See additional dewatering inspection report. Facing west.</p>

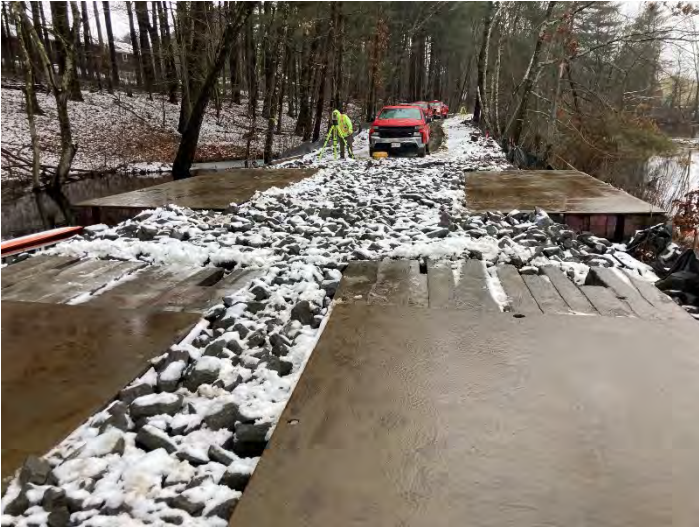
<p>Description: View of crane mats at Bridge 127 in segment 13. Facing west.</p>

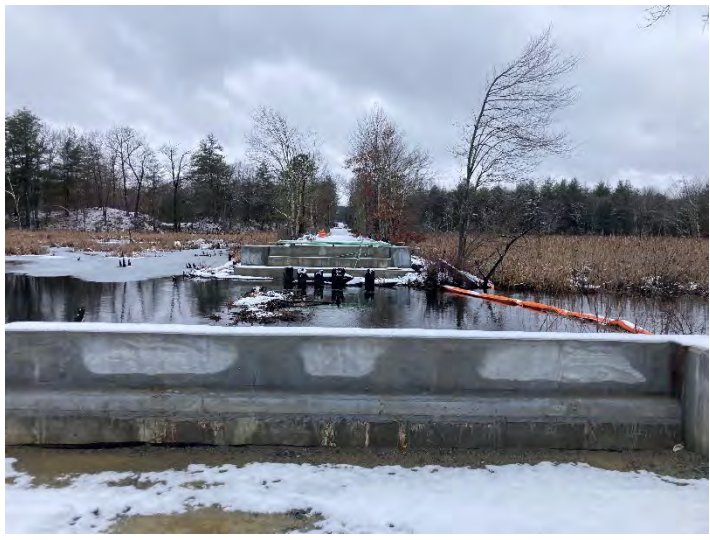
<p>Description: View of bridge 130 from segment 3. Facing west.</p>

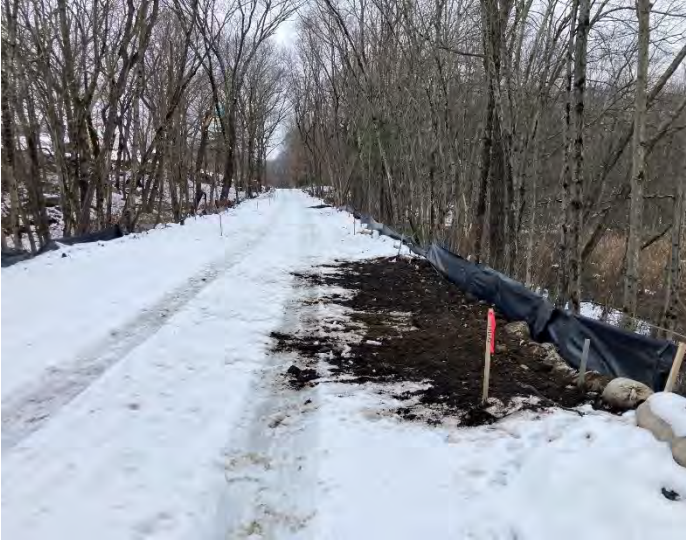
recommended that loam is stabilized and that E&S controls are repaired as needed. -E&S controls have been repaired at Sta. #130-131 in segment 1 and approximately Sta. #206 in segment 4.

Description: View of Sta. #130 in segment 1. E&S controls at this location have been repaired. Facing west.

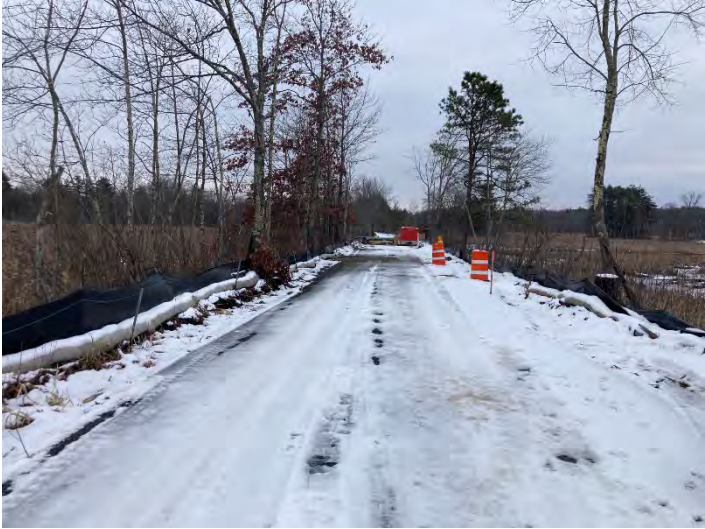
Description: View of E&S controls in segment 2. Facing east.

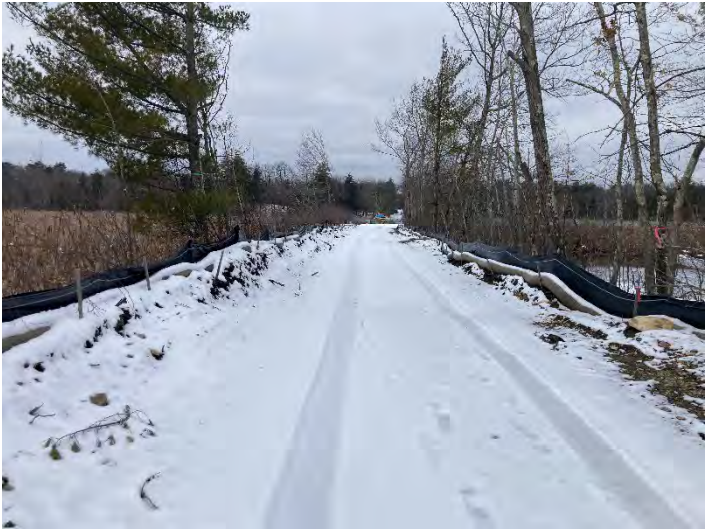
Description: View of E&S controls at west end of segment 3. Facing west.

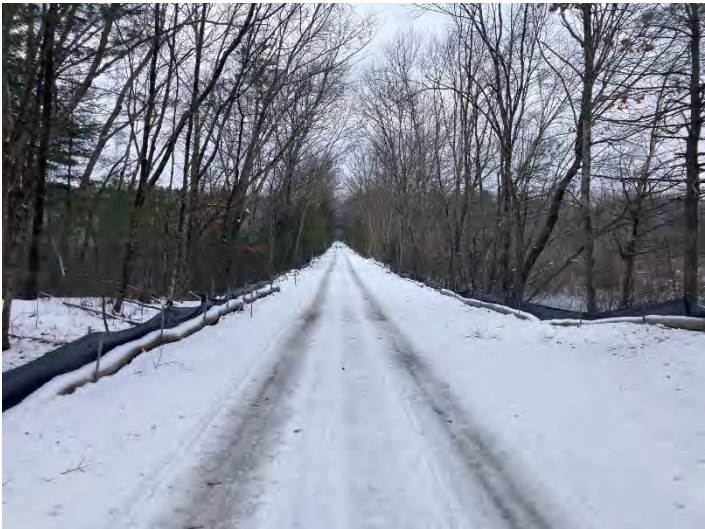
Description: View of E&S controls in segment 5. Facing west.

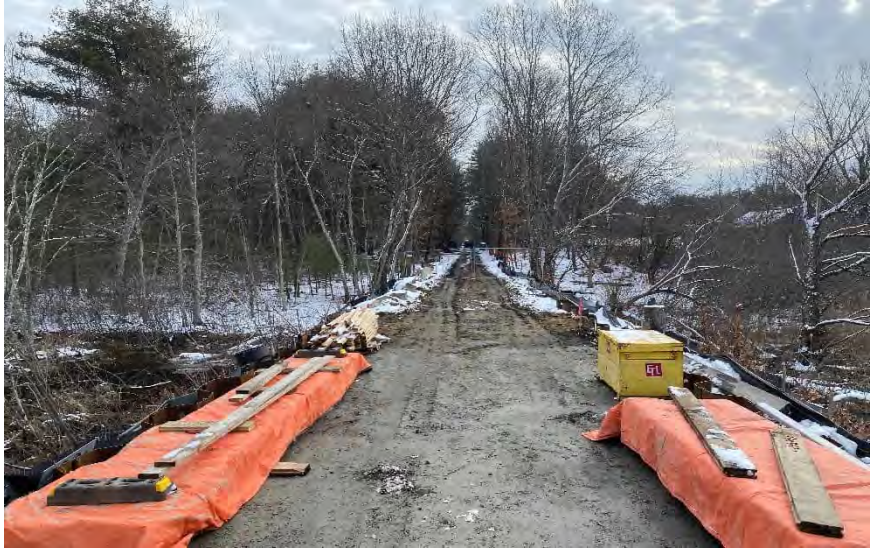
Description: Work area within segment 8, Bridge 128 work, existing erosion control, looking eastward.

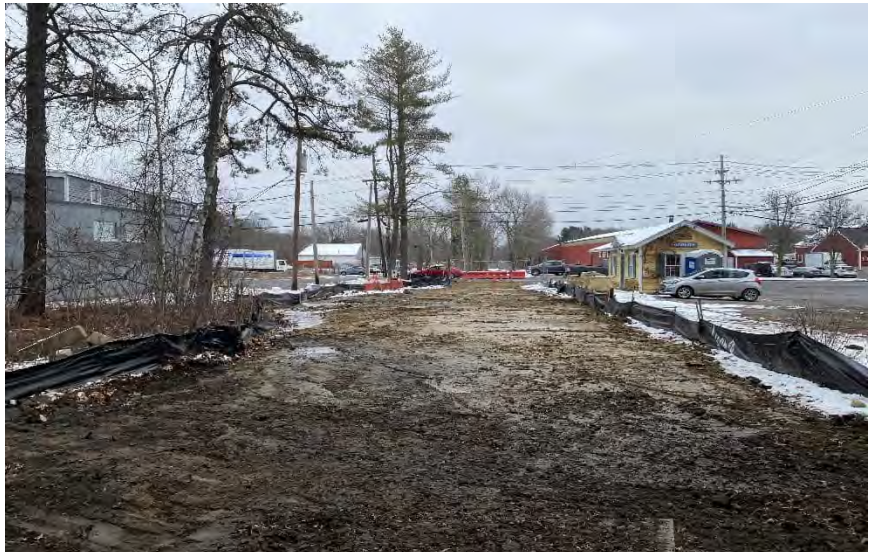
Description: Work area within segment 11, existing erosion control, looking eastward.

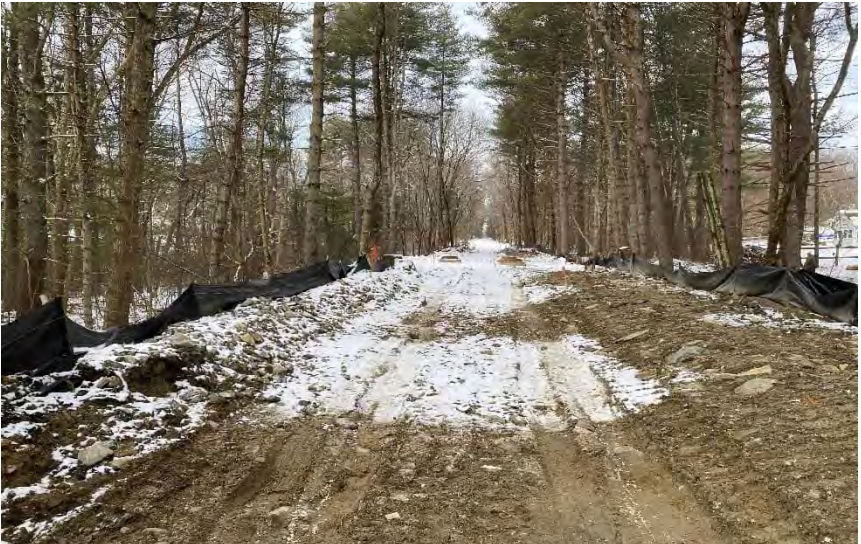
Description: Work area within segment 9, existing erosion control, looking westward.

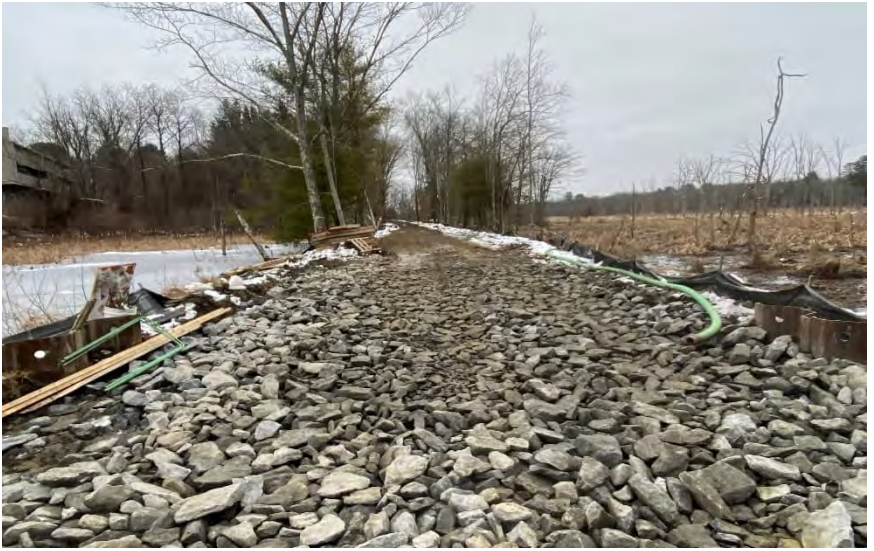
Description: Work area within segment 14, existing erosion control, looking eastward.

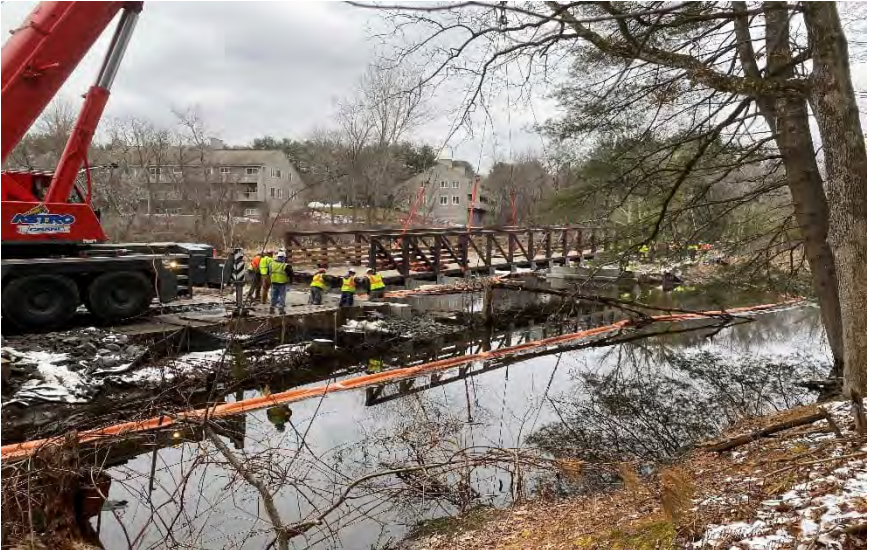
Description: Work area within segment 13 looking across Hop brook to segment 14, setting of Bridge 127, existing erosion control (floating silt curtain), looking eastward.

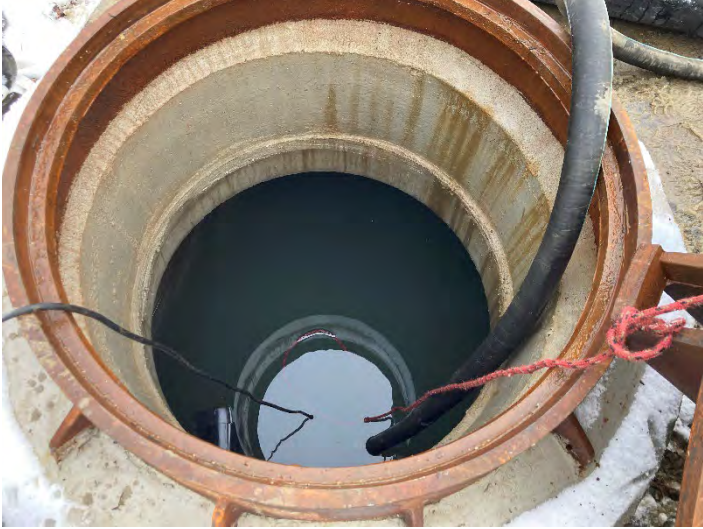
Description: View of pump in manhole. Water appeared mostly clear prior to treatment.

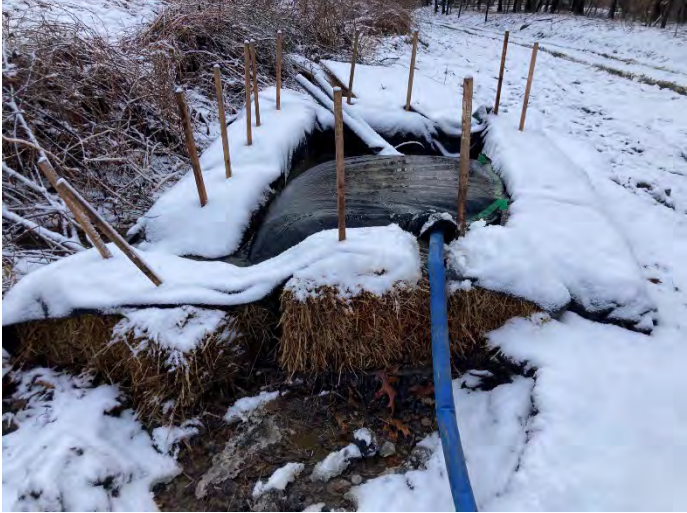
Description: View of dewatering controls (straw bale corral with filter fabric and silt bag). Facing east.

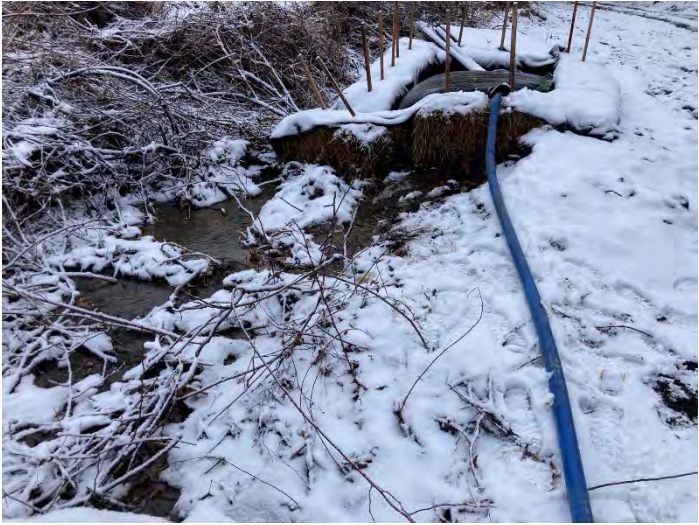
Description: Additional view of dewatering controls (straw bale corral with filter fabric and silt bag) and discharge from corral. Discharge appeared clear. Turbidity reading was below 50 NTUs. Facing east.

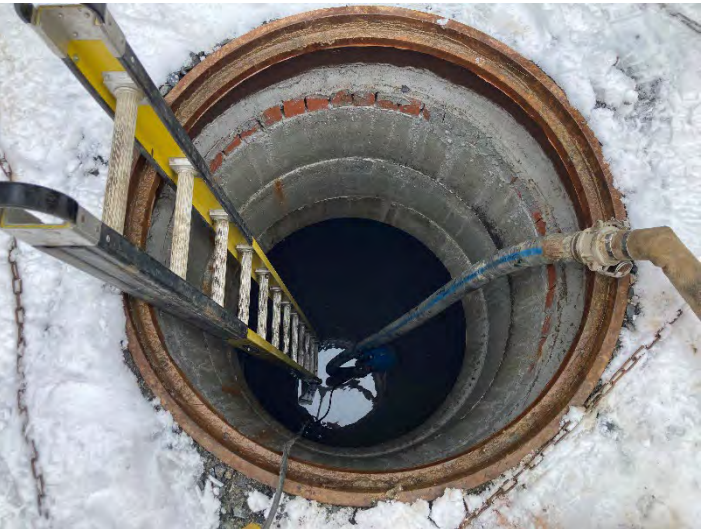
Description: View of pump in MH #16. Water appeared mostly clear prior to treatment.

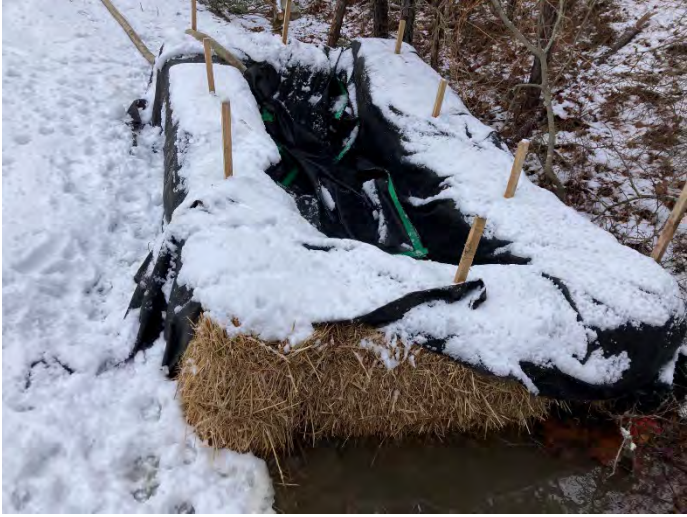
Description: View of dewatering controls (straw bale corral with filter fabric and silt bag). Facing west.

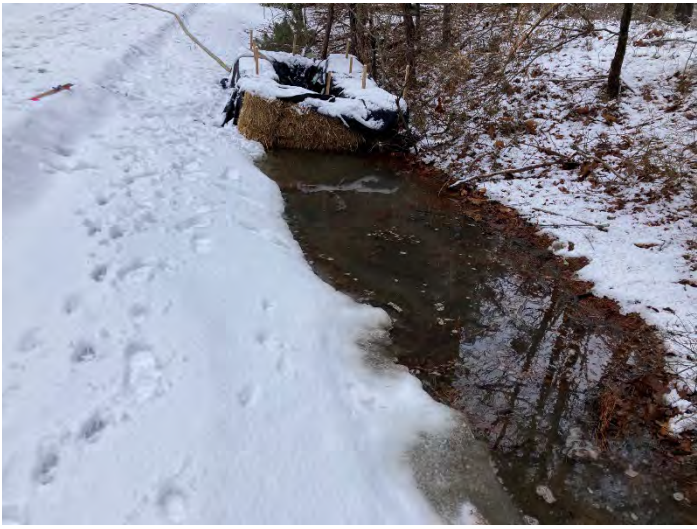
Description: View of dewatering controls (straw bale corral with filter fabric and silt bag) and discharge from corral. Discharge remained inside project work area. Discharge appeared mostly clear and turbidity reading was below 50 NTUs. Facing west.

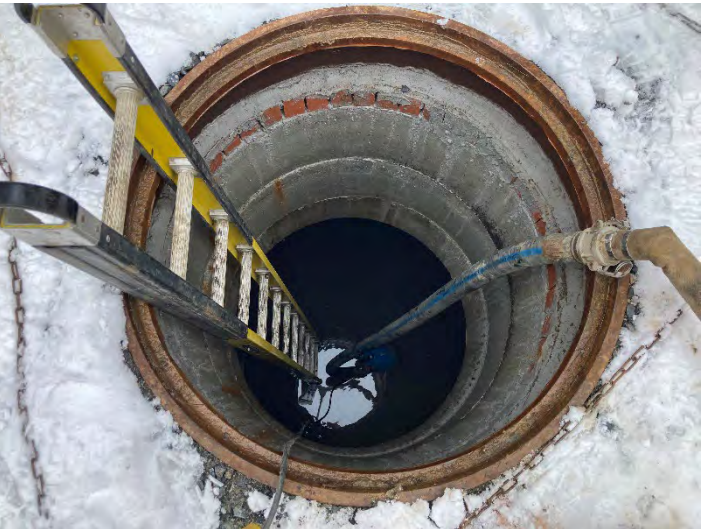
Description: View of pump in manhole. Water appeared mostly clear prior to treatment.

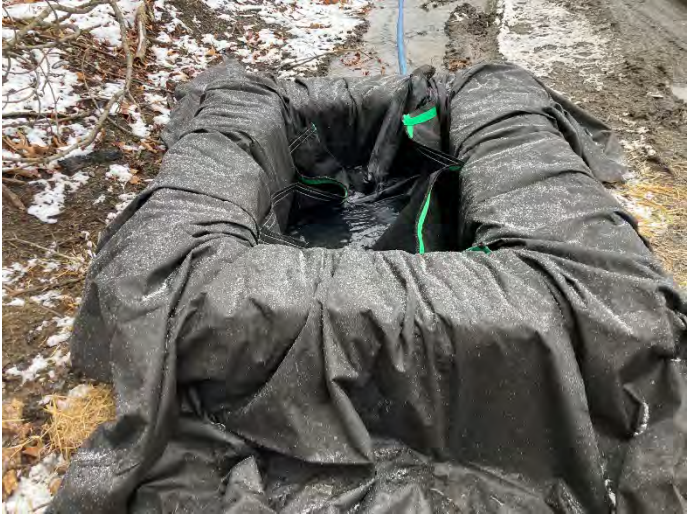
Description: View of dewatering controls (straw bale corral with filter fabric and silt bag). Facing east.

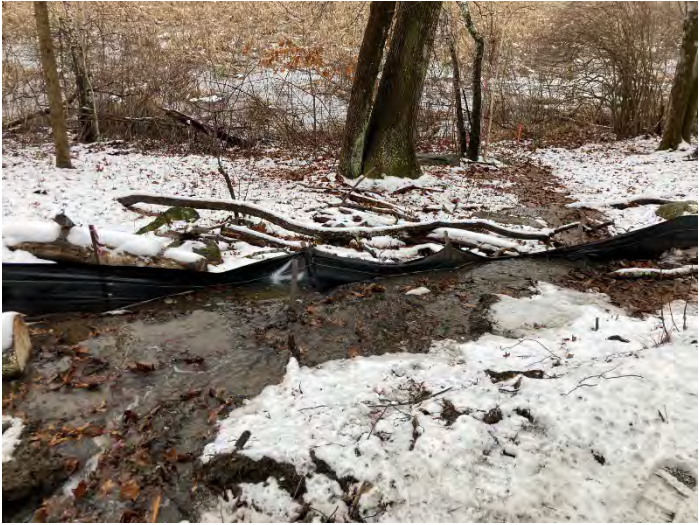
Description: View of discharge from project. Water traveled across project ROW and discharged through silt fence and into wetland adjacent to project. Discharge appeared clear and turbidity reading was below 50 NTUs. Silt fence was repaired/reset once dewatering was completed for the day. Facing south.

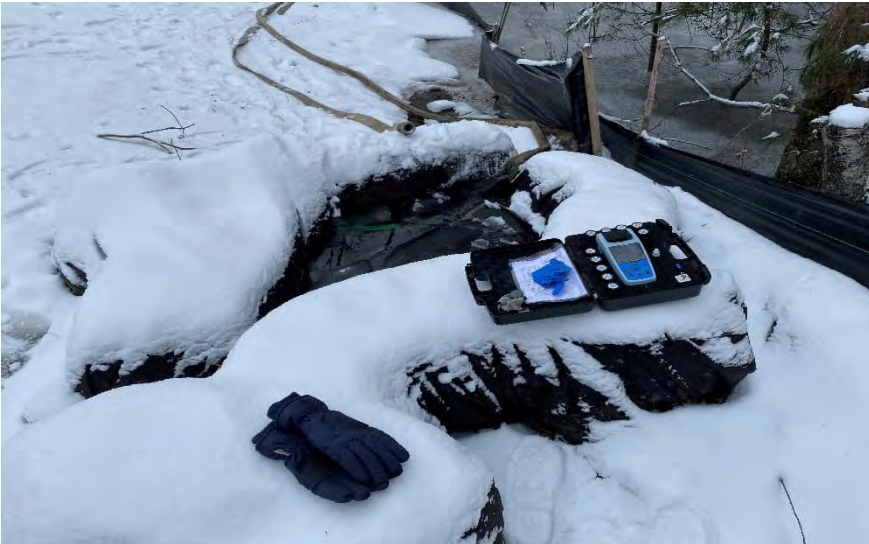
Description: Manhole #14. View of discharge to corral/bag, looking westward. Water discharged to the work area & appeared clear, looking westward.

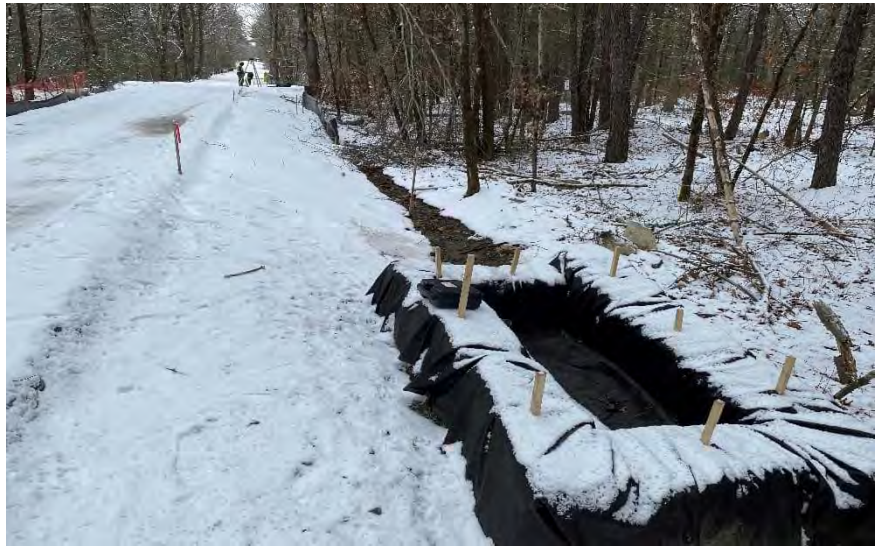
Manhole #15. View of dewatering bag/corral, water discharged to work area, looking westward.

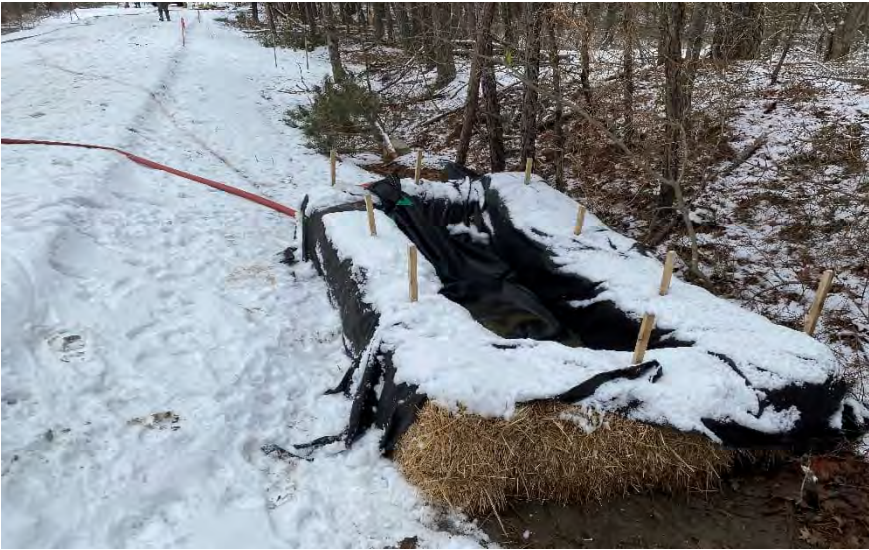
Description: Manhole #16. View of discharge corral/bag, looking westward. Water from bag discharged to adjacent work area to the west. Water appeared slightly turbid, looking westward.

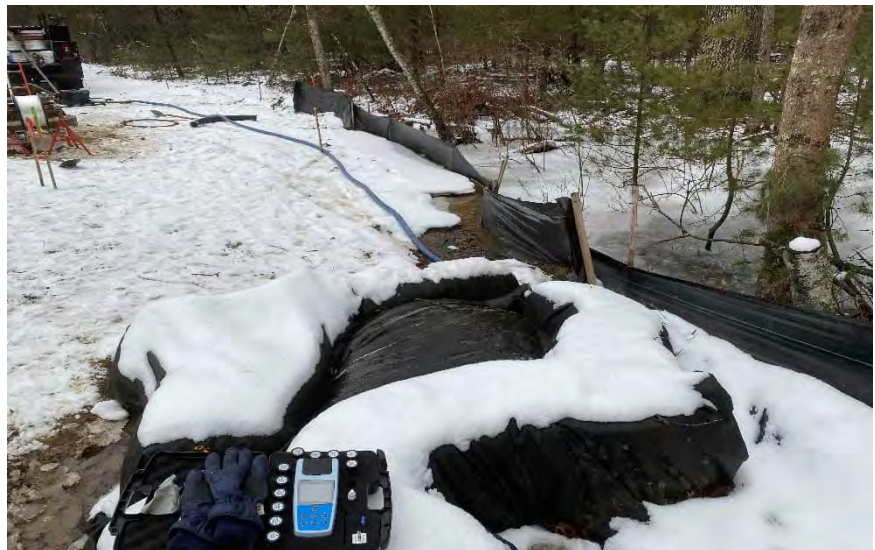
Description: Manhole #14. View of discharge to corral/bag, looking westward. Water discharged to the work area & appeared clear, looking westward.
