Weekly Environmental Compliance Summary

Sudbury to Hudson Transmission Reliability Project (USEPA Tracking # MAR1003UW)

Sudbury, Hudson, and Stow, MA

Week of: February 5, 2024 to February 9, 2024

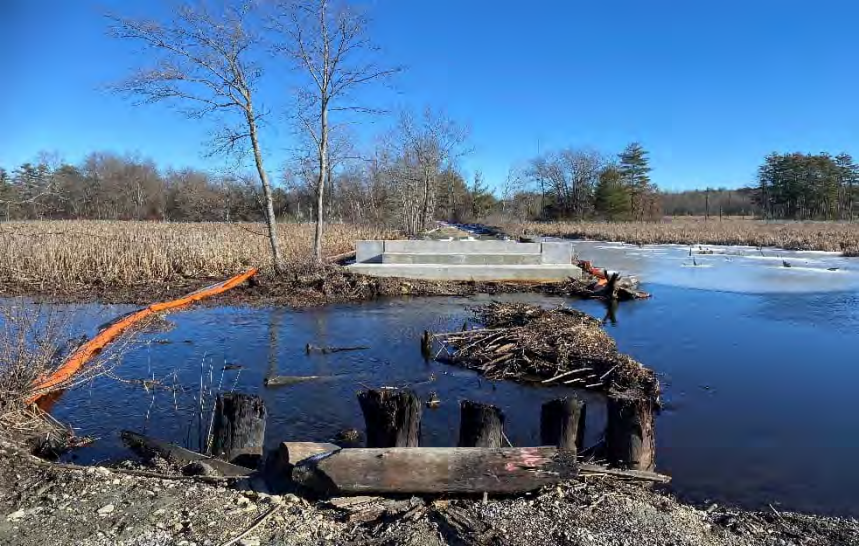
<p>PHOTOGRAPHIC LOG</p>	
<p>Client Name: Eversource</p>		<p>Site Location: Sudbury to Hudson Transmission Reliability Project</p>	<p>Town: Hudson</p>
<p>Photo No.: 2</p>	<p>Date: 2-5-24</p>

<p>Description:</p> <p>Work area at Bridge 130 from segment 2 toward segment 3 across Fort Meadow Brook, existing erosion control (floating silt curtain), looking eastward.</p>

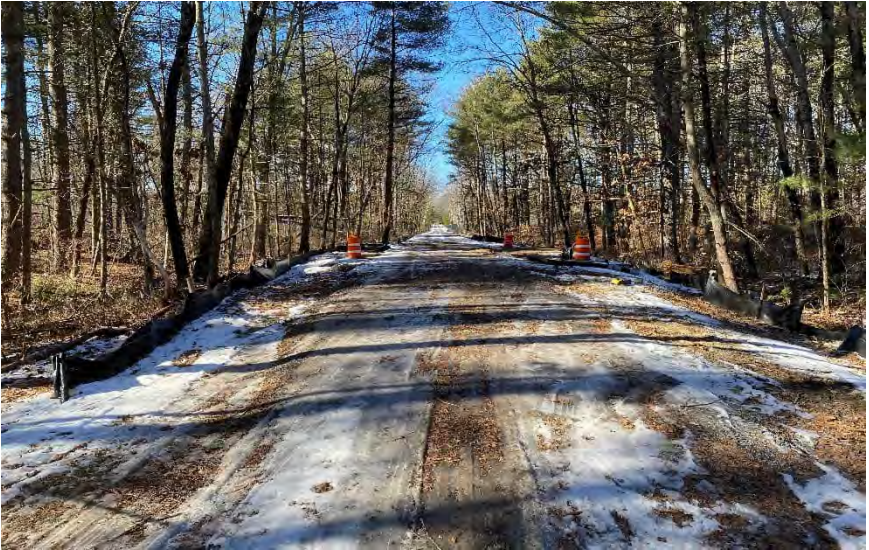
<p>PHOTOGRAPHIC LOG</p>	
<p>Client Name: Eversource</p>		<p>Site Location: Sudbury to Hudson Transmission Reliability Project</p>	<p>Town: Hudson</p>
<p>Photo No.: 3</p>	<p>Date: 2-5-24</p>

<p>Description:</p> <p>Work area within segment 5, manhole #13 area, existing erosion control, looking westward.</p>

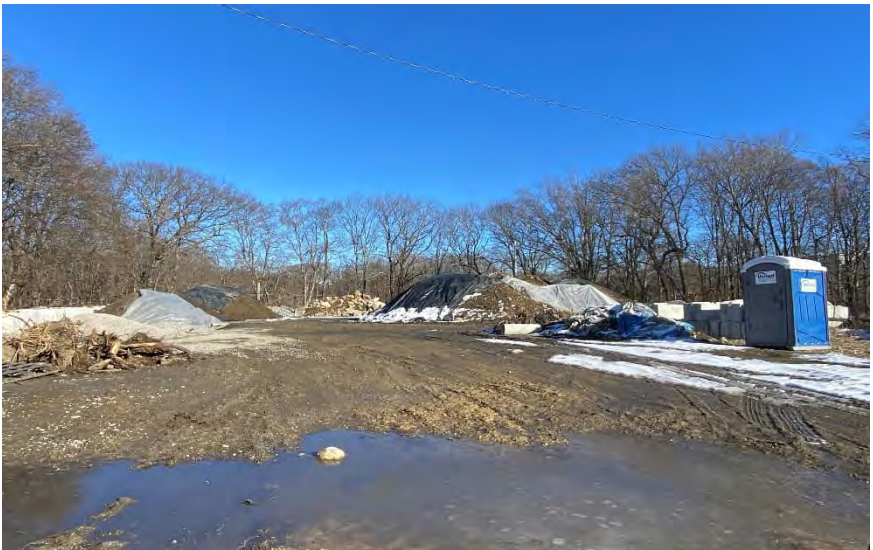
<p>PHOTOGRAPHIC LOG</p>	
<p>Client Name: Eversource</p>		<p>Site Location: Sudbury to Hudson Transmission Reliability Project</p>	<p>Town: Hudson</p>
<p>Photo No.: 4</p>	<p>Date: 2-5-24</p>

<p>Description:</p> <p>Laydown yard at Stowe Court, existing spoil piles covered with plastic tarps, looking southward.</p>

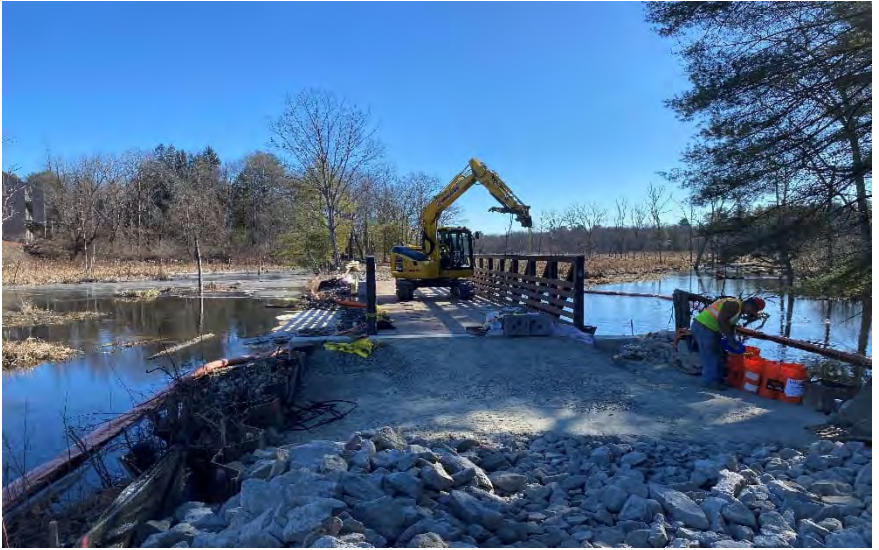
<p>PHOTOGRAPHIC LOG</p>	
<p>Client Name: Eversource</p>		<p>Site Location: Sudbury to Hudson Transmission Reliability Project</p>	<p>Town: Sudbury</p>
<p>Photo No.: 7</p>	<p>Date: 2-5-24</p>

<p>Description:</p> <p>Work area within segment 13 looking across Hop Brook from segment 13 toward segment 14, bridge 127 area, existing erosion control, looking eastward.</p>

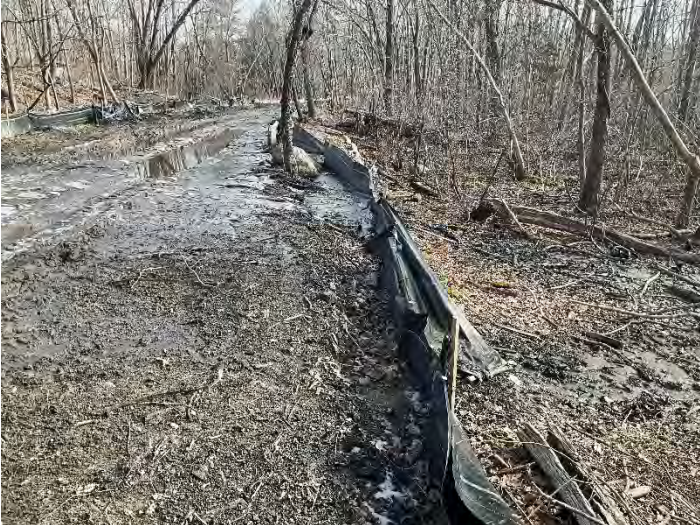
-Stormwater discharge was occurring at Sta. #741+50 in segment 14 at time of inspection. Skim layer of sediment appears to have deposited beyond silt fence but has not reached wetlands. Silt fence is in need of repair at this location (routine maintenance).

4. Silt Fencing on ROW in Sudbury	<input checked="" type="checkbox"/> Yes <input type="checkbox"/> No	1	<input type="checkbox"/> Yes <input checked="" type="checkbox"/> No	2/08/2024	-Silt fence is installed in segments 7-14. -Silt fence is in need of repair at Sta. 741+50 in segment 14 (routine maintenance).

Description: View of stormwater discharge occurring at Sta. #741+50 in segment 14. Skim layer of sediment appears to have deposited beyond silt fence but has not reached wetlands. Silt fence is in need of repair at this location. Facing east.

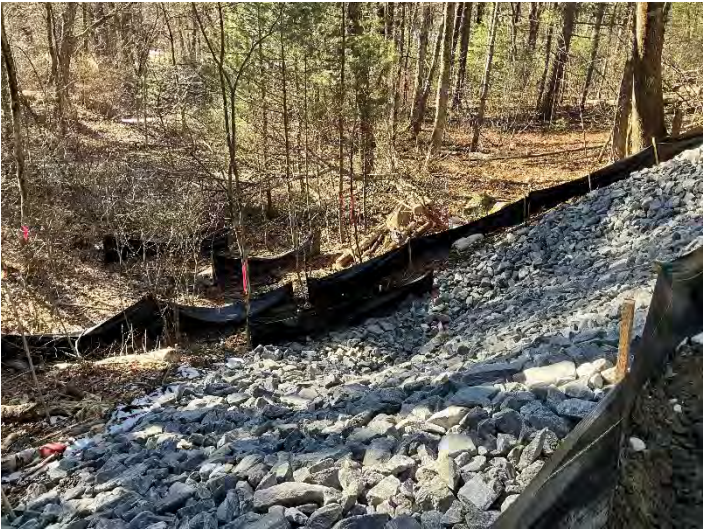
Description: View of south side/downstream side of repaired culvert in segment 9. Facing southwest.

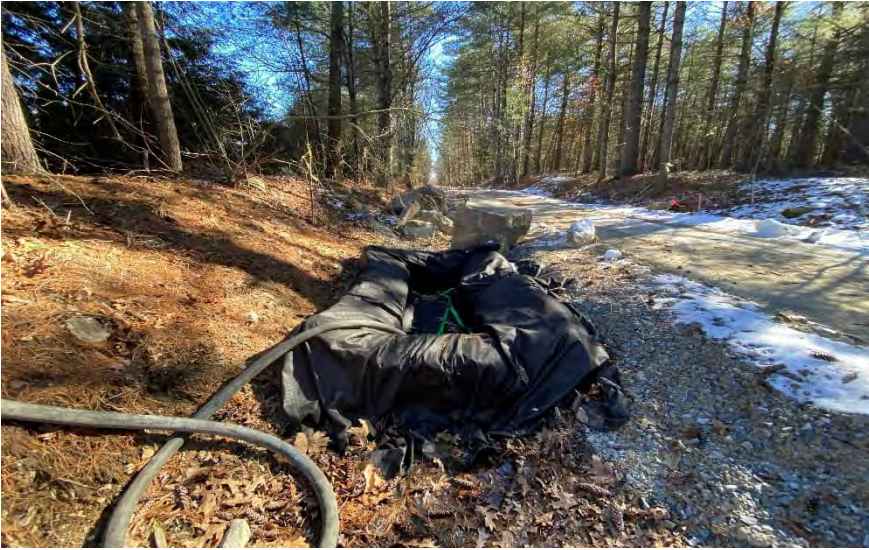
Description: Manhole #18. View of discharge to corral/bag, looking eastward. Water discharged to the work area & appeared clear, looking eastward.

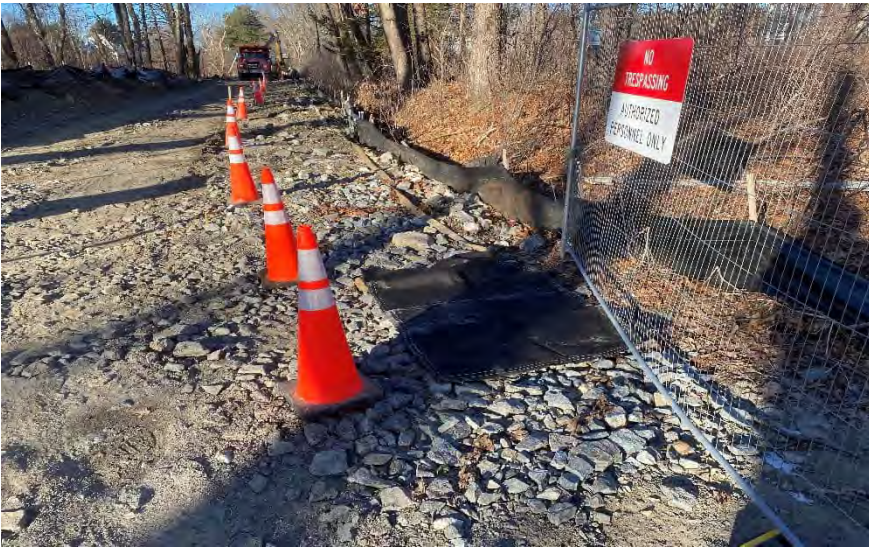
Description: Segment 14. View of discharge to bag, looking westward. Water discharged to the conduit trench portion of the work area & appeared turbid, looking westward.

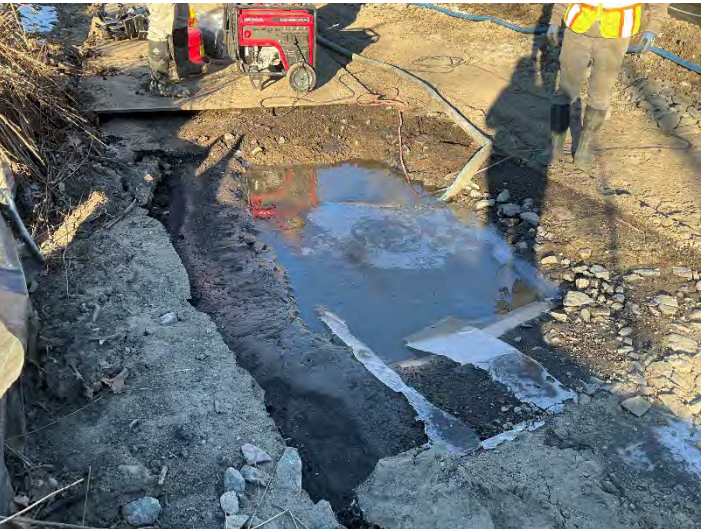
Description: View of pump in trench. Water appeared turbid prior to treatment. Facing west.

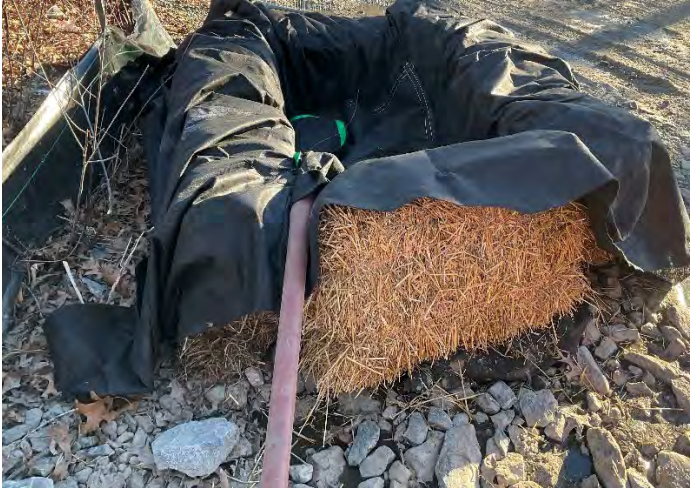
Description: View of dewatering controls (straw bale corral with filter fabric and silt bag). Facing east.

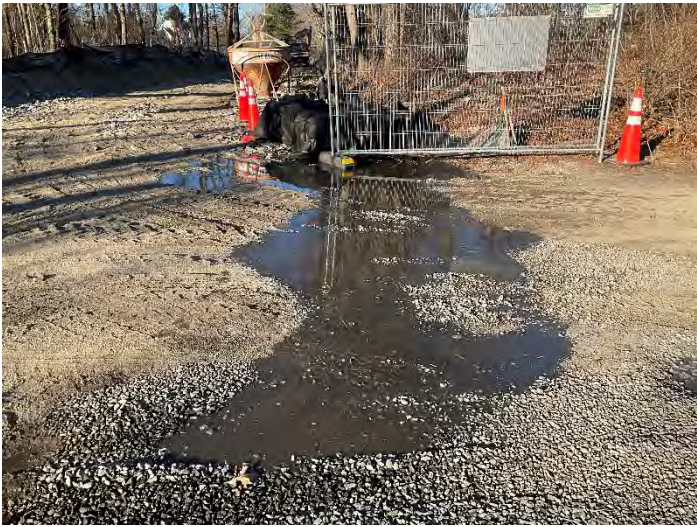
Description: View of discharge from corral. Discharge appeared turbid. Turbidity reading was higher than 50 NTUs. Facing west.

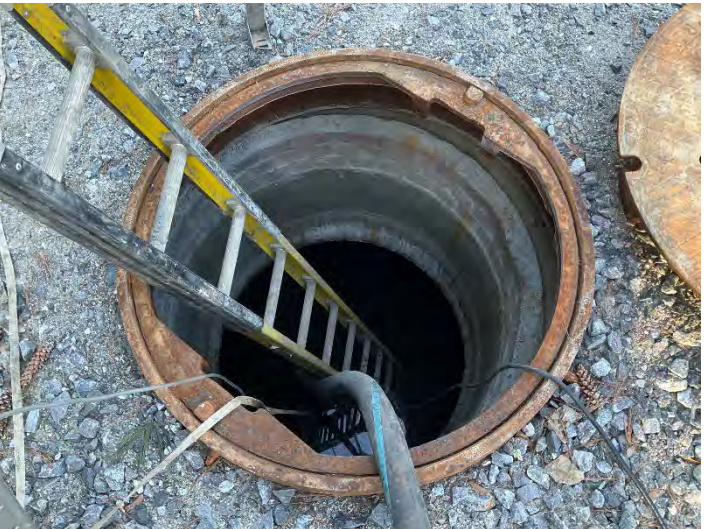
Description: View of pump in MH #21. Water appeared mostly clear prior to treatment.

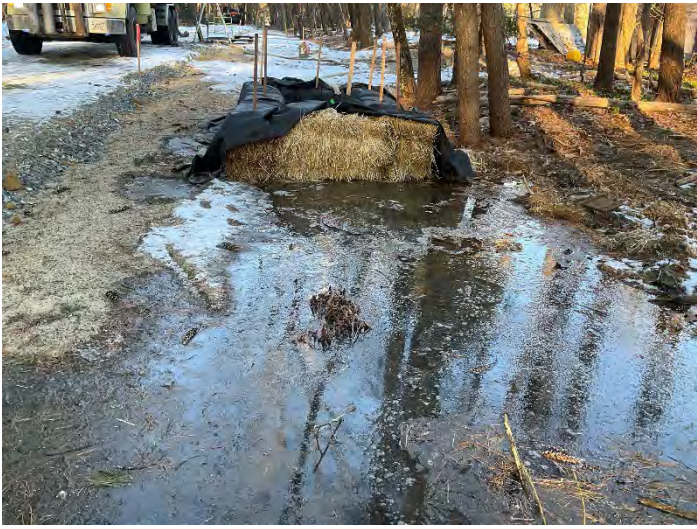
Description: View of dewatering controls (straw bale corral with filter fabric and silt bag) and discharge from corral. Discharge remained inside project work area. Discharge appeared mostly clear and turbidity reading was below 50 NTUs. Facing west.

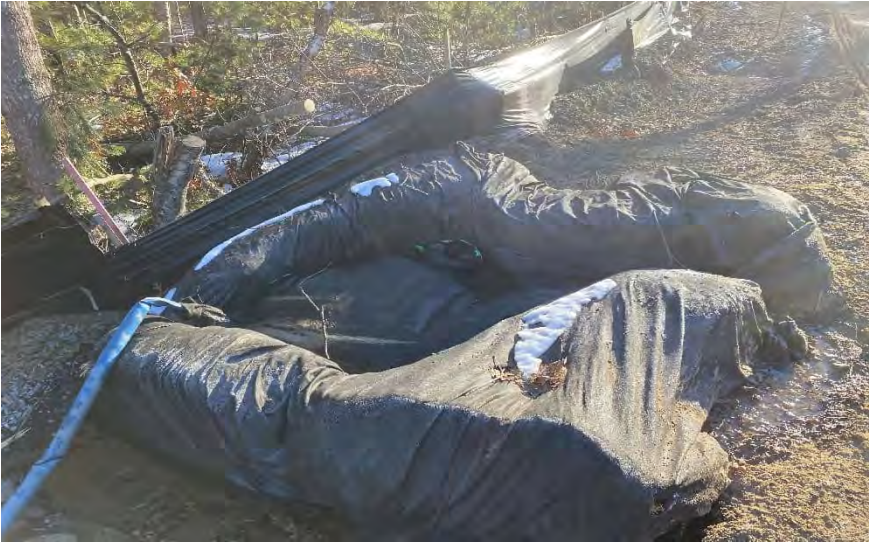
Description: Manhole #14. View of discharge to corral/bag, looking eastward. Water discharged to the work area & appeared clear, looking eastward.

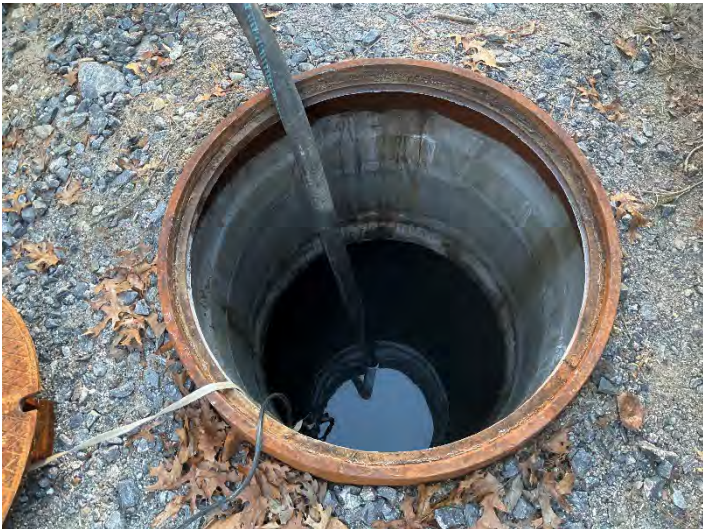
Description: View of pump in MH #22. Water appeared mostly clear prior to treatment.

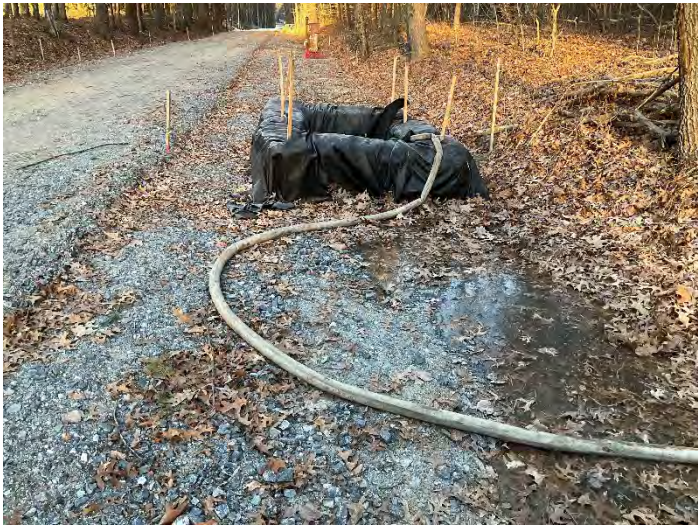
Description: View of dewatering controls (straw bale corral with filter fabric and silt bag) and discharge from corral. Discharge remained inside project work area. Discharge appeared mostly clear and turbidity reading was below 50 NTUs. Facing west.

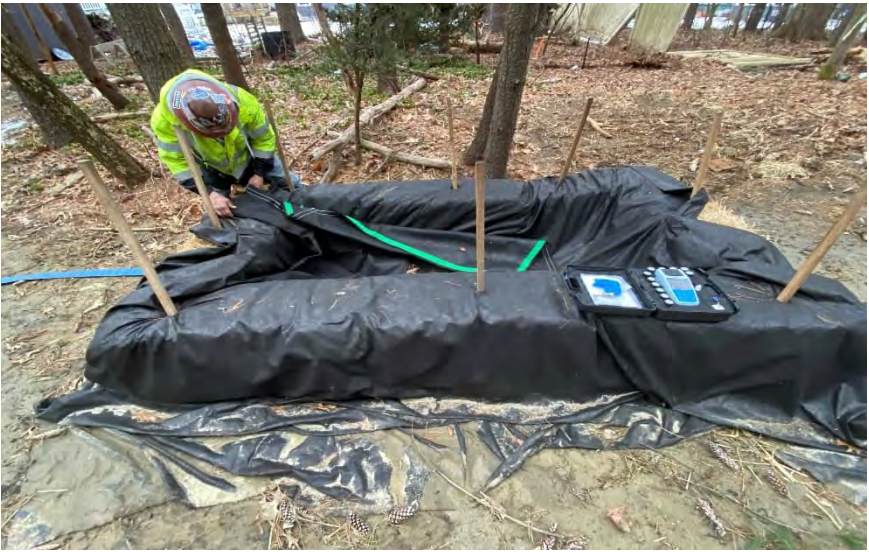
Description: Manhole #21. View of discharge to corral/bag, looking eastward. Water discharged to the work area & appeared clear, looking eastward.

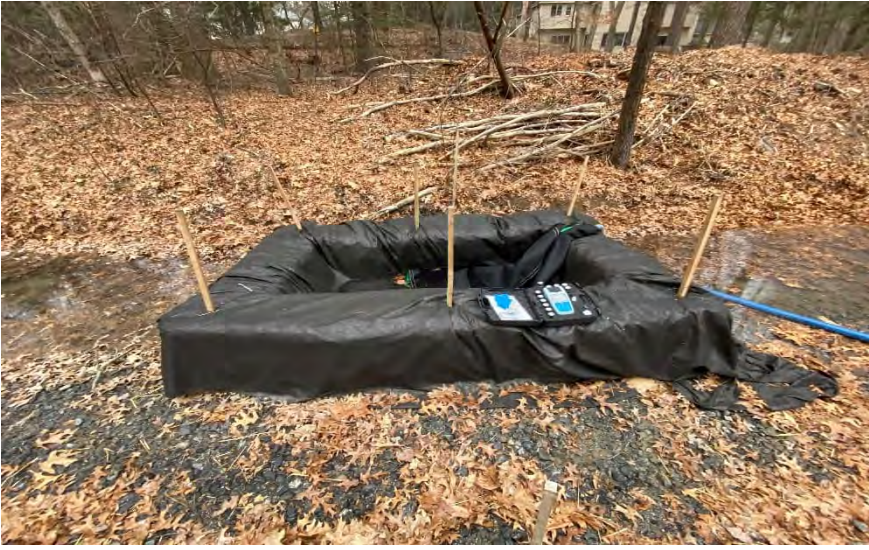
Description: Manhole #22. View of discharge to corral/bag, looking eastward. Water discharged to the work area & appeared clear, looking eastward.
