Weekly Environmental Compliance Summary

Sudbury to Hudson Transmission Reliability Project (USEPA Tracking # MAR1003UW)

Week of: February 12, 2024 to February 16, 2024

CONSTRUCTION MONITORING REPORT

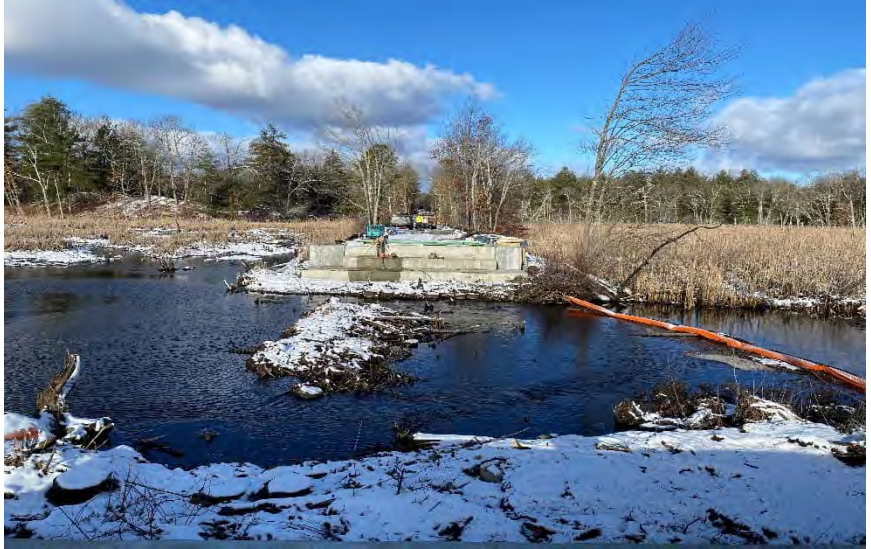
<p>Description:</p> <p>Work area at Bridge 130 from segment 3 toward segment 2 across Fort Meadow Brook, existing erosion control (floating silt curtain), looking westward.</p>

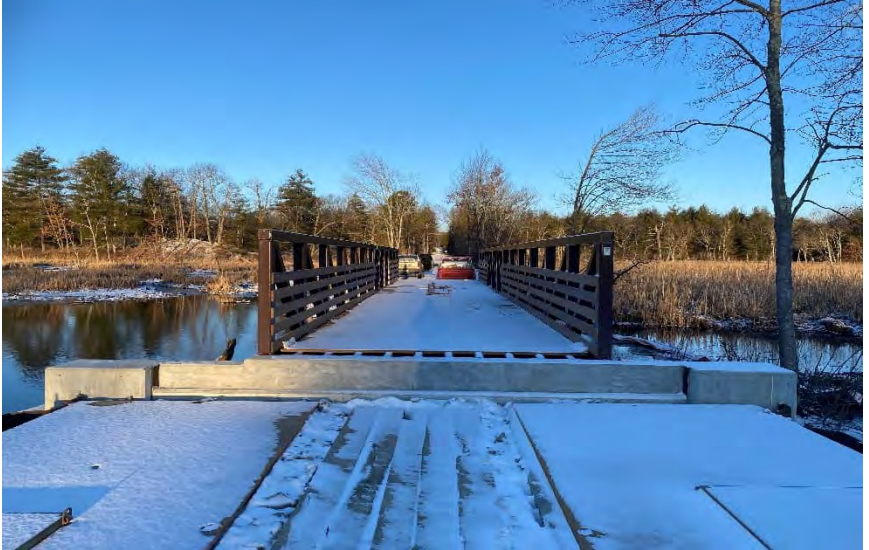
<p>Description:</p> <p>Work area at Bridge 130 looking from segment 3 toward segment 2 across Fort Meadow Brook, existing erosion control (floating silt curtain), looking westward.</p>

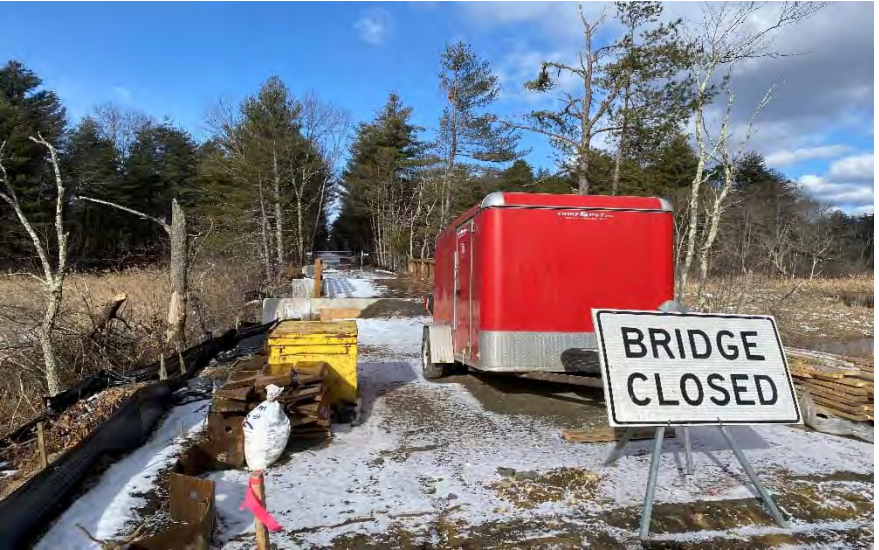
<p>Description:</p> <p>Work area at Bridge 128 looking from segment 8 toward segment 7 across Hop Brook, existing erosion control, looking westward.</p>

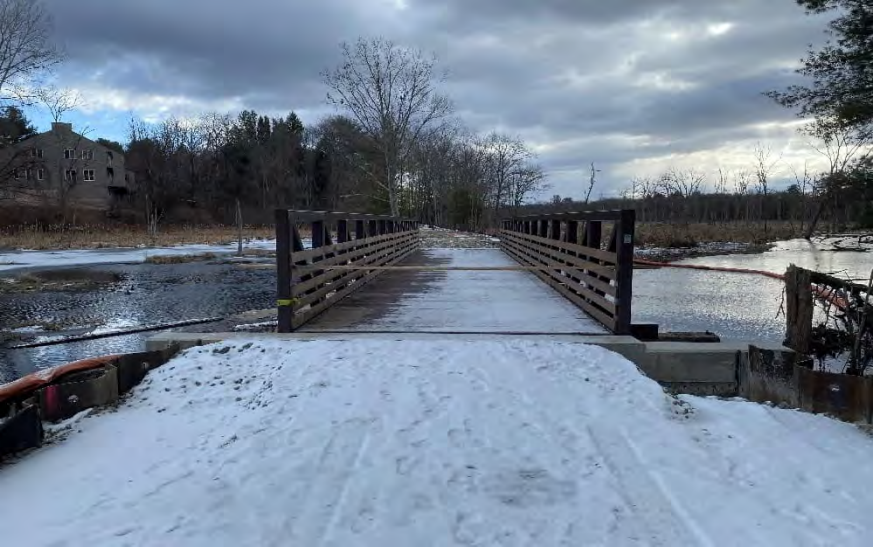
<p>Description:</p> <p>Work area at Bridge 127 looking from segment 13 toward segment 14 over Hop Brook, existing erosion control, looking eastward.</p>

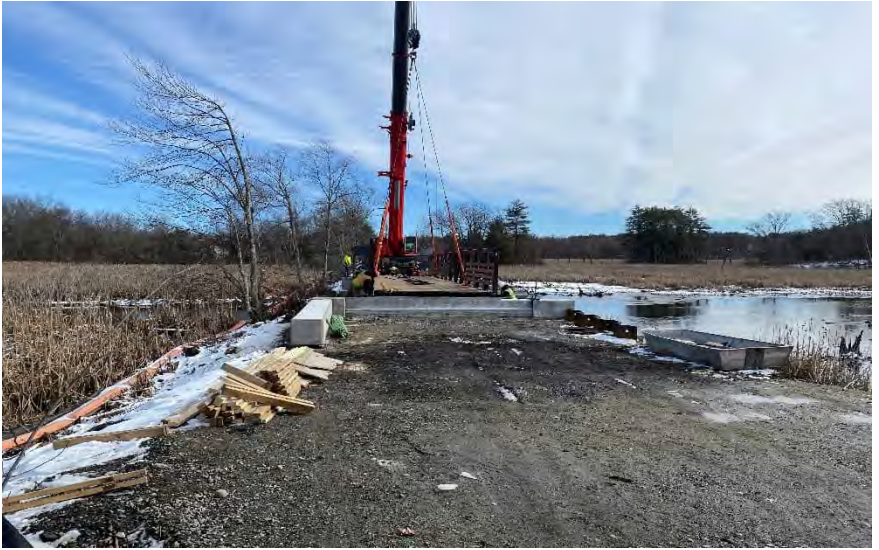
Description: Work area looking from segment 2 across Fort Meadow Brook toward segment 3 (Bridge 130 area), Bridge 130 placement across Fort Meadow Brook, looking eastward.

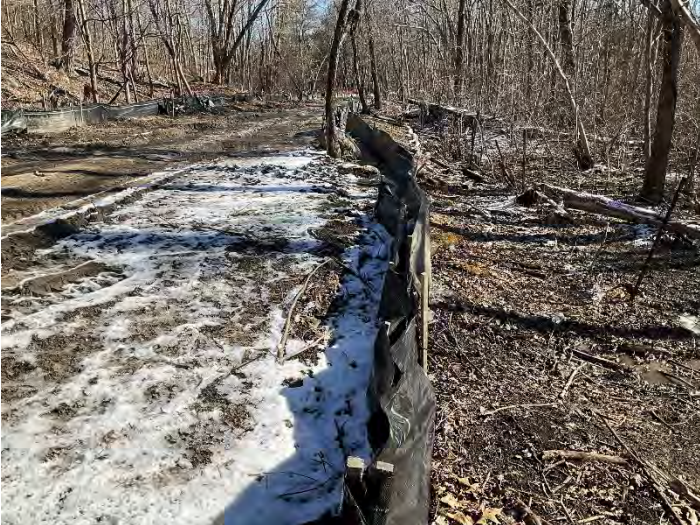
Description: View of stormwater discharge occurring at Sta. #741+50 in segment 14. Skim layer of sediment noted on previous SWPPP report has been removed and silt fence has been repaired. Facing east.

4. Silt Fencing on ROW in Sudbury	<input type="checkbox"/> Yes <input checked="" type="checkbox"/> No	N/A	<input type="checkbox"/> Yes <input checked="" type="checkbox"/> No	N/A	-Silt fence is installed in segments 7-14. -Silt fence at Sta. 741+50 has been repaired (previous routine maintenance item has been addressed).

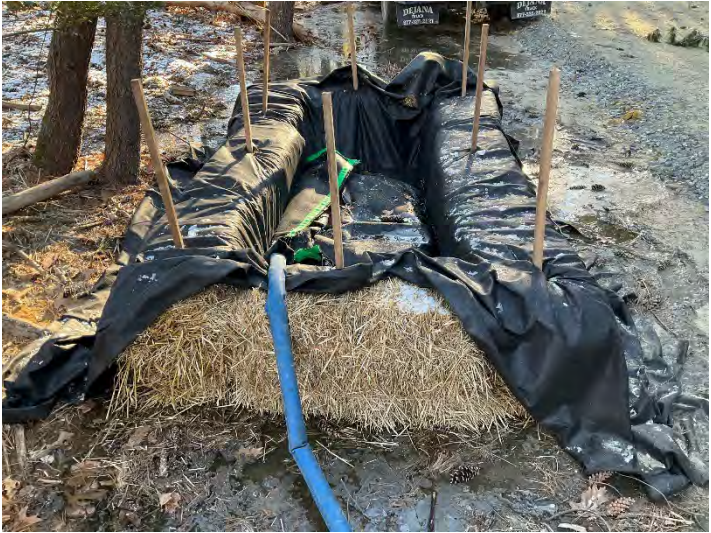
Description: View of dewatering controls in segment 10. See additional dewatering inspection report. Facing east.

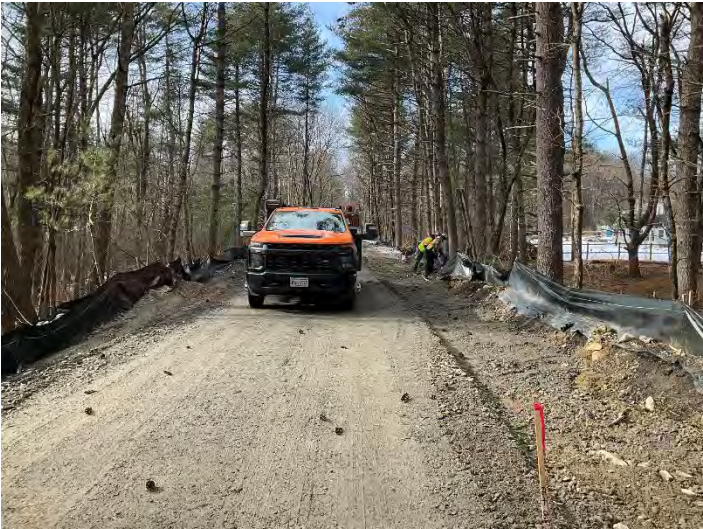
Description: View of Bond repairing E&S controls in segment 9. Facing west.

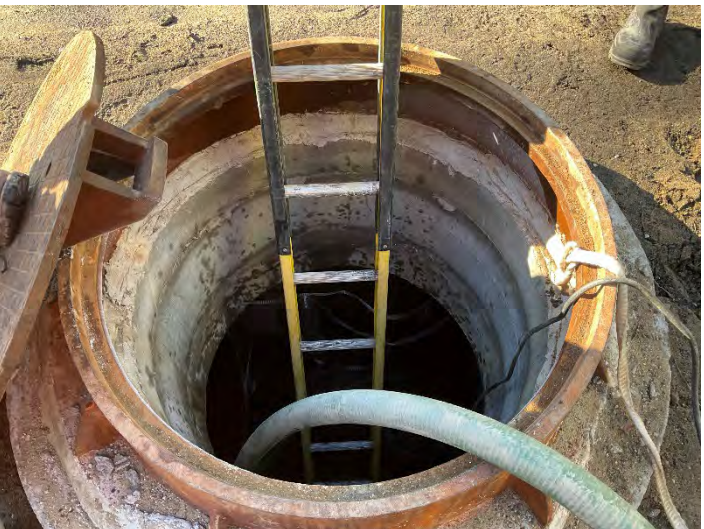
Description: View of pump in MH #14. Water appeared mostly clear prior to treatment.

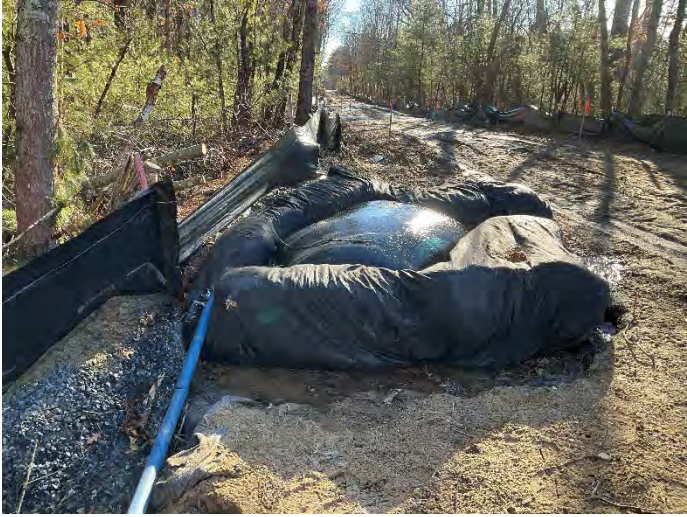
Description: View of dewatering controls (straw bale corral with filter fabric and silt bag). Facing east.

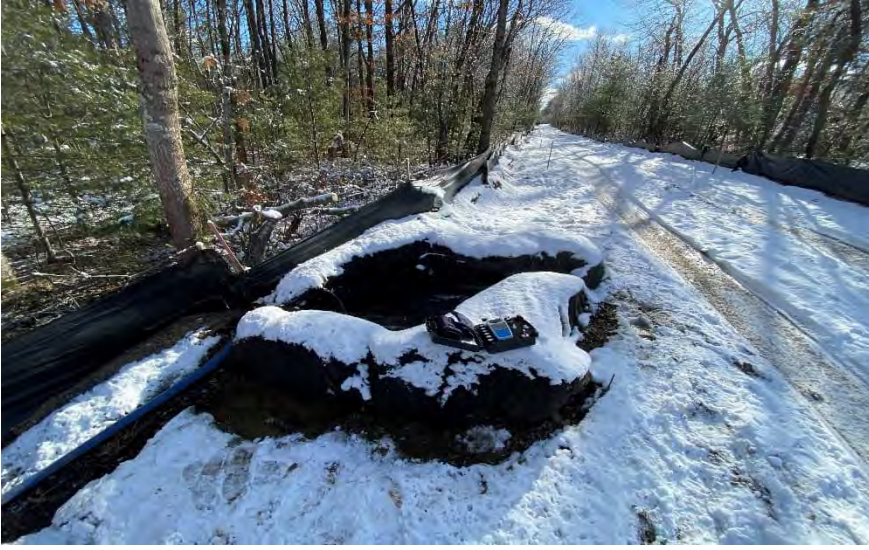
Description: Manhole #14. View of discharge to corral/bag, looking eastward. Water discharged to the work area & appeared clear, looking eastward.

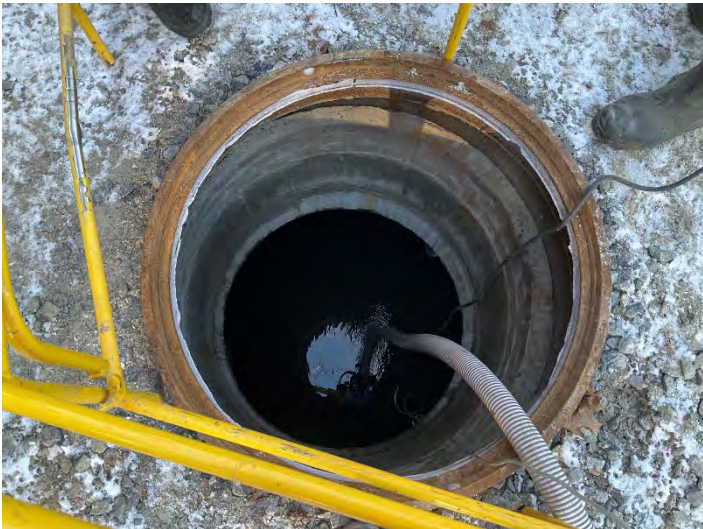
Description: View of pump in MH #21. Water appeared mostly clear prior to treatment.

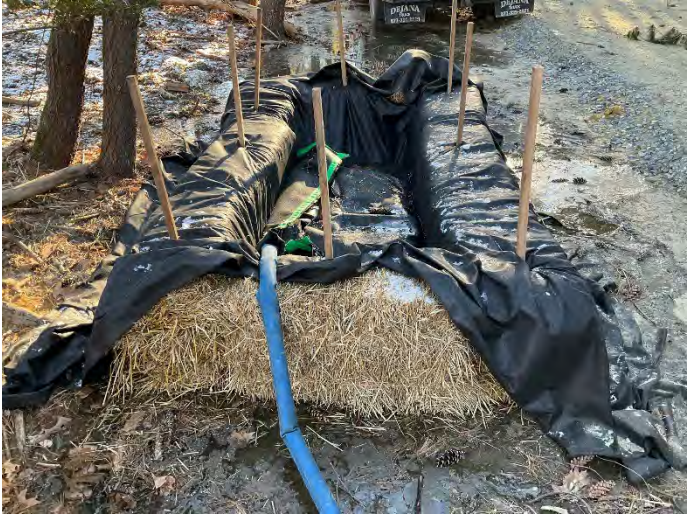
Description: View of dewatering controls (straw bale corral with filter fabric and silt bag). Facing east.

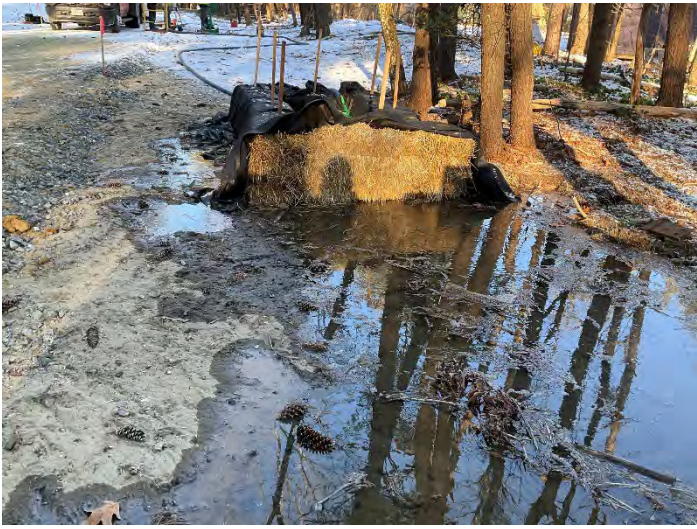
Description: View of dewatering controls (straw bale corral with filter fabric and silt bag) and discharge from corral. Discharge remained inside project work area. Discharge appeared mostly clear and turbidity reading was below 50 NTUs. Facing west.
