**Weekly Environmental Compliance Summary**

**Sudbury to Hudson Transmission Reliability Project (USEPA Tracking # MAR1003UW)**

Sudbury, Hudson, and Stow, MA

Week of: February 19, 2024 to February 23, 2024

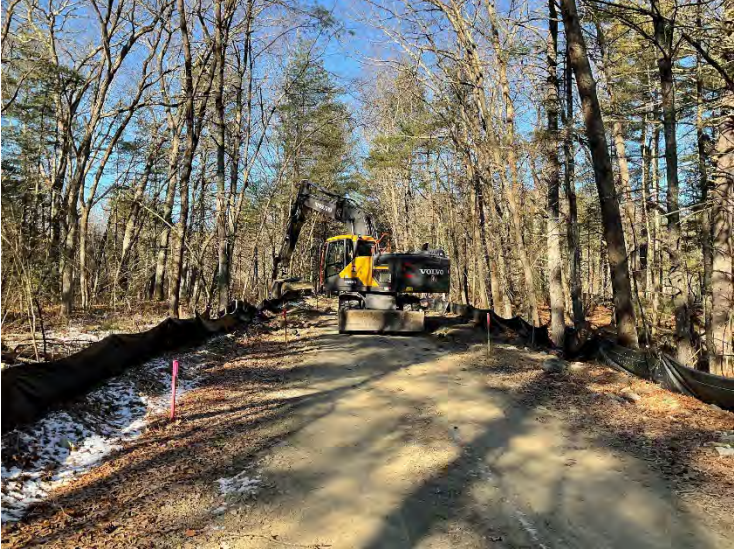
<b>PHOTOGRAPHIC LOG</b>	
Client Name: Eversource		Site Location: Sudbury to Hudson Transmission Reliability Project	Town: Sudbury
Photo No.: 3	Date: 2/20/2024

Description: View of ET&L working in segment 8. Silt fence is being repaired as needed. Facing east.

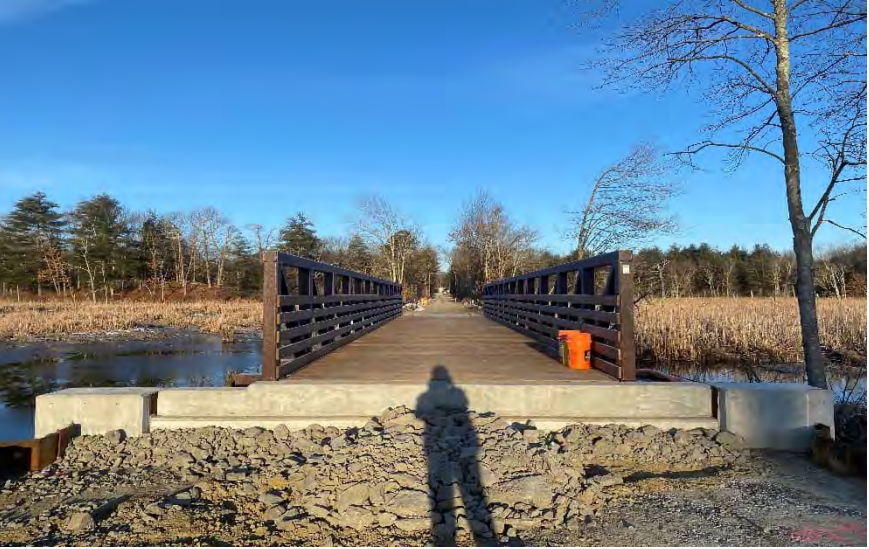
PHOTOGRAPHIC LOG	
Client Name: Eversource		Site Location: Sudbury to Hudson Transmission Reliability Project	Town: Hudson
Photo No.: 4	Date: 2-21-24

Description:  Work area within Segment 3 looking across newly placed bridge 130 (Fort Meadow Brook) toward segment 2, existing erosion control, looking westward.

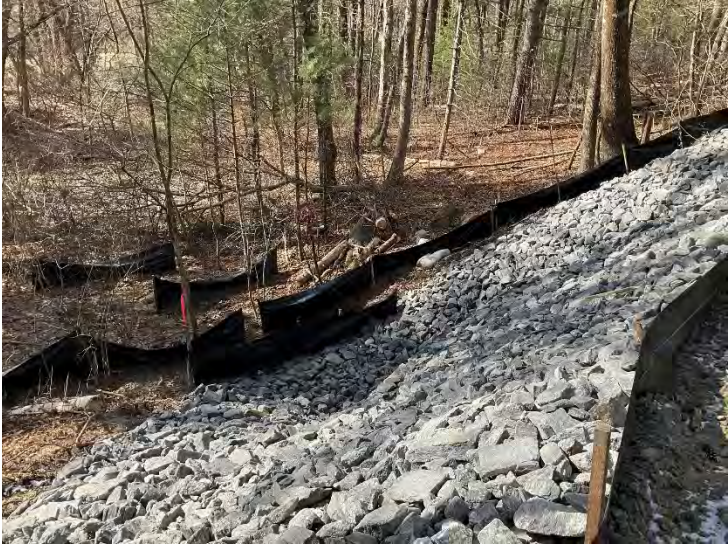
<p><b>PHOTOGRAPHIC LOG</b></p>	
<p>Client Name: Eversource</p>		<p>Site Location: Sudbury to Hudson Transmission Reliability Project</p>	<p>Town: Sudbury</p>
<p>Photo No.: 6</p>	<p>Date: 2/21/2024</p>

<p>Description: View of downstream side/south side of repaired culvert in segment 9. Facing southwest.</p>

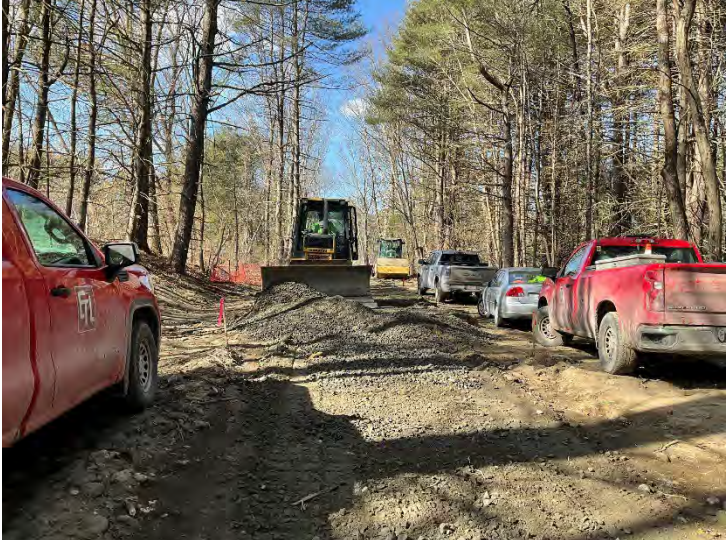
<p><b>PHOTOGRAPHIC LOG</b></p>	
<p>Client Name: Eversource</p>		<p>Site Location: Sudbury to Hudson Transmission Reliability Project</p>	<p>Town: Sudbury</p>
<p>Photo No.: 7</p>	<p>Date: 2/21/2024</p>

<p>Description: View of ET&amp;L working in segment 8. Silt fence is being repaired as needed. Facing west.</p>

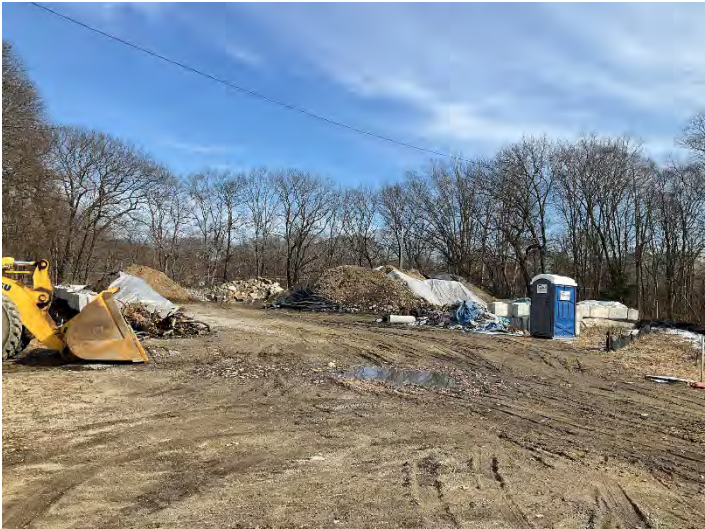
Description: View of Stowe Ct laydown yard. Stockpiles are scheduled to be re-covered tomorrow (2/23/2024). Facing northeast.

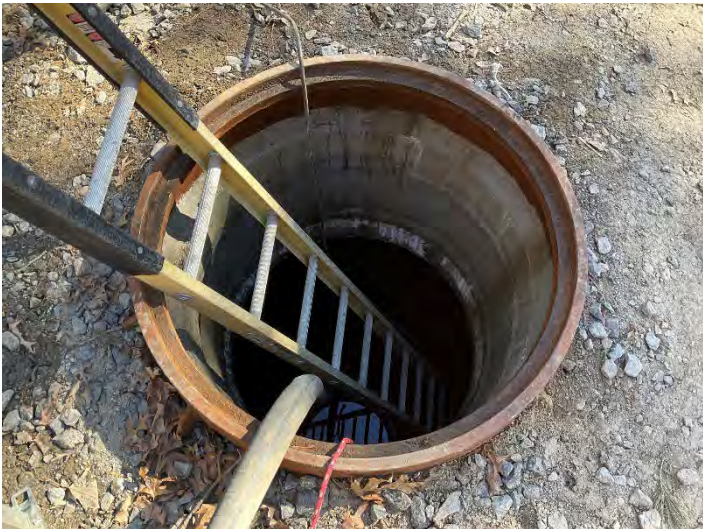
Description: View of pump in MH #22. Water appeared mostly clear prior to treatment.

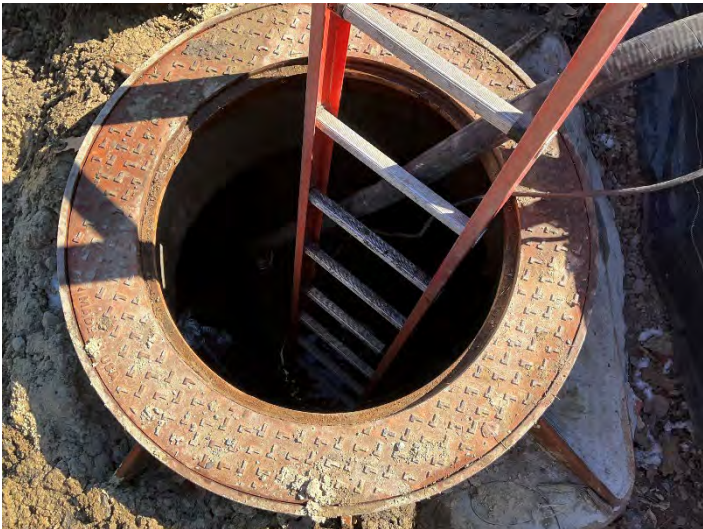
<b>Description:</b> View of pump in MH #24. Water appeared slightly turbid prior to treatment.

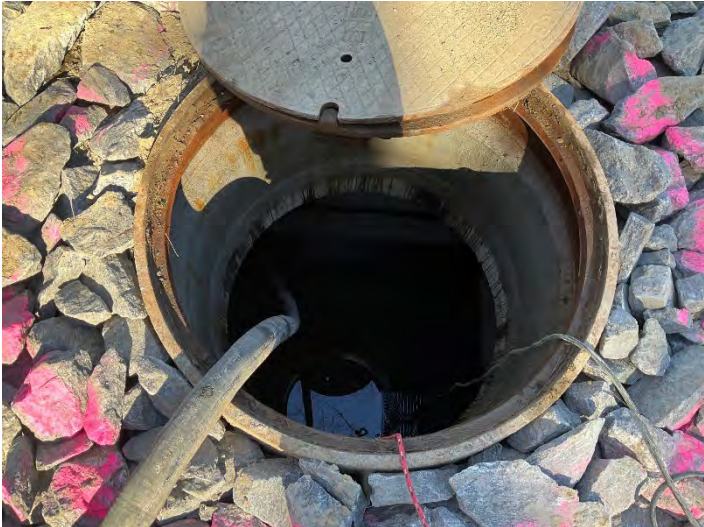
Description: View of pump in MH #25. Water appeared slightly turbid prior to treatment.

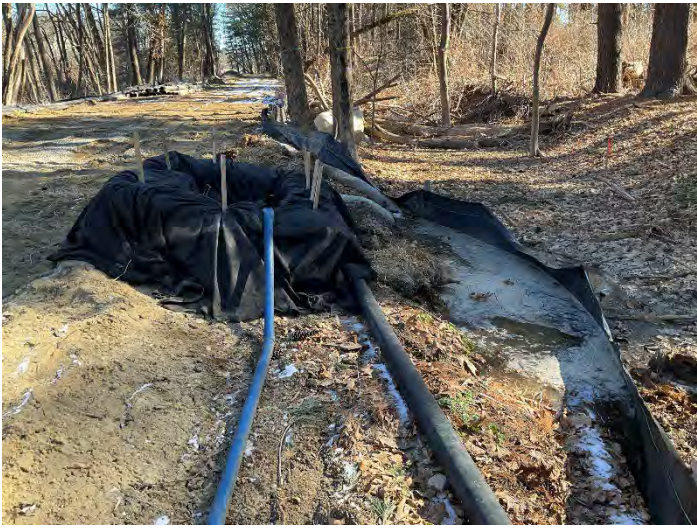
<b>Description:</b> View of dewatering controls (straw bale corral with filter fabric and silt bag) and discharge from corral. Discharge appeared slightly turbid, but turbidity reading was below 50 NTUs. Facing east.

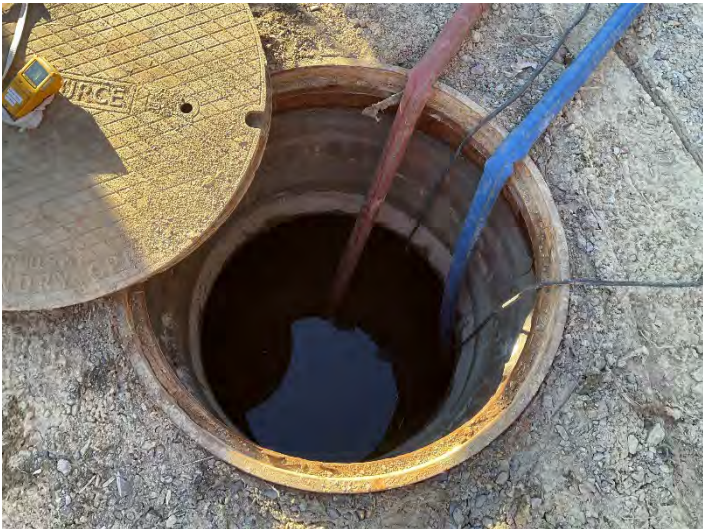
Description: View of pumps in MH #28. Water appeared turbid prior to treatment.

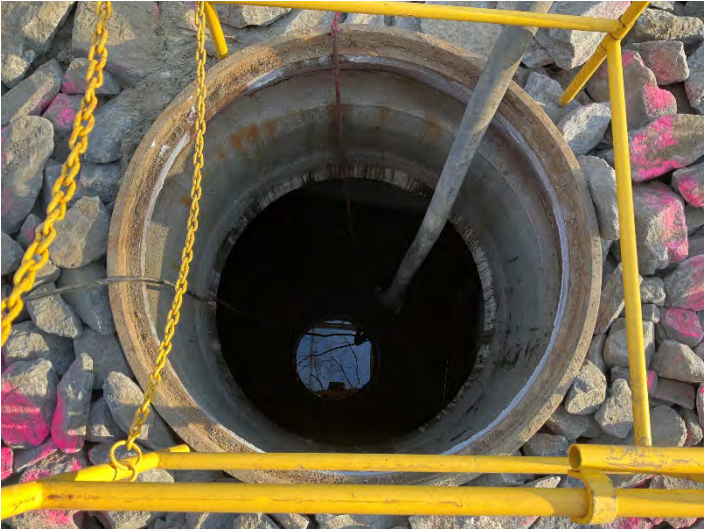
<b>Description:</b> View of pump in MH #25. Water appeared slightly turbid prior to treatment.

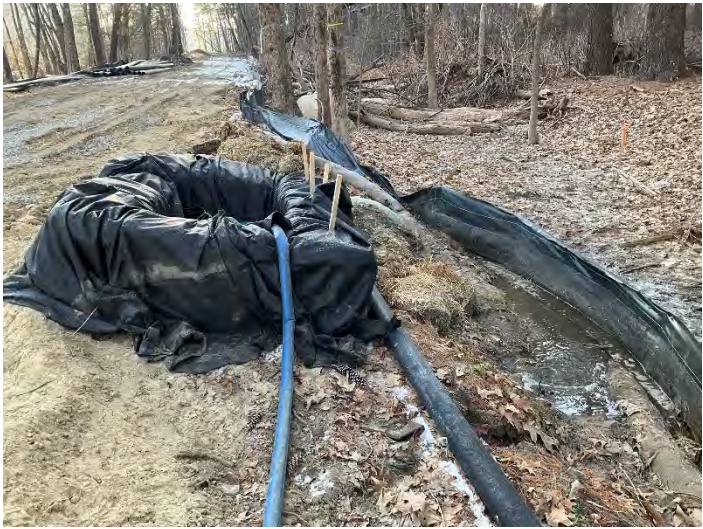
<b>Description:</b> View of dewatering controls (straw bale corral with filter fabric and silt bag) and discharge from corral. Discharge appeared turbid. Turbidity reading was higher 50 NTUs, but discharge did not reach any receiving waters. Facing east.

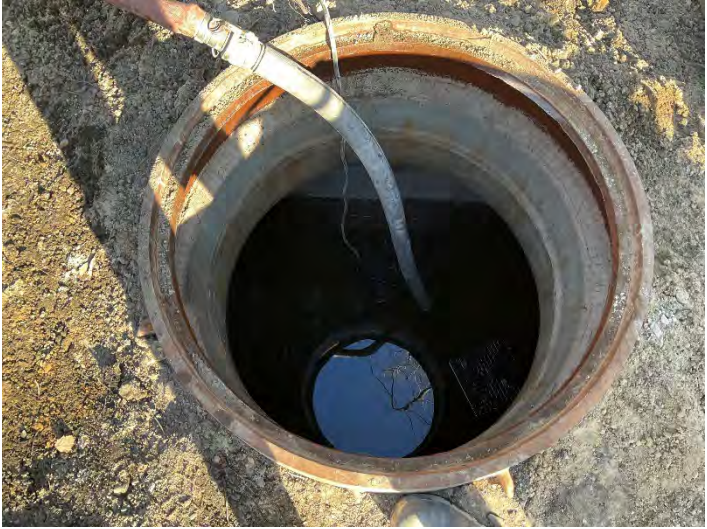
<b>Description:</b> View of pump in MH #26 in segment 14. Water appeared clear prior to treatment.

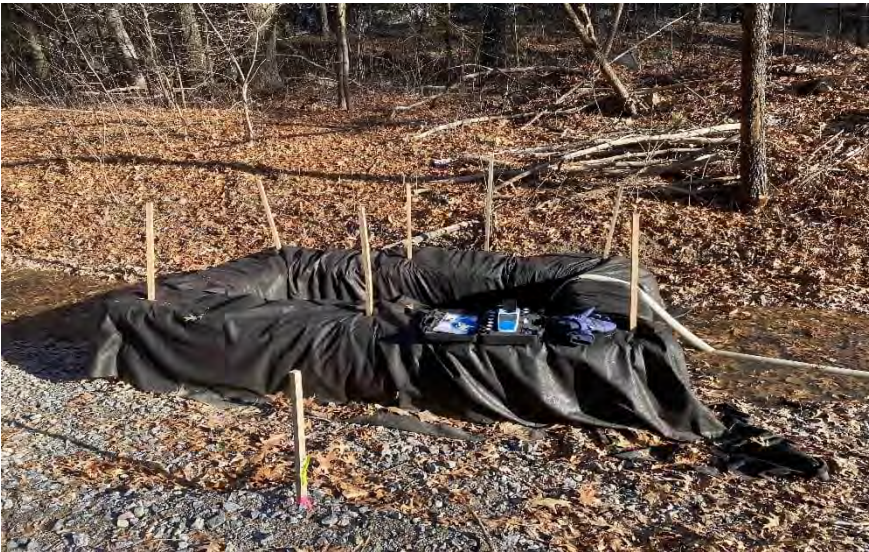
<b>Description:</b> Manhole #22. View of discharge to corral/bag, looking eastward. Water discharged to the work area & appeared clear, looking eastward.

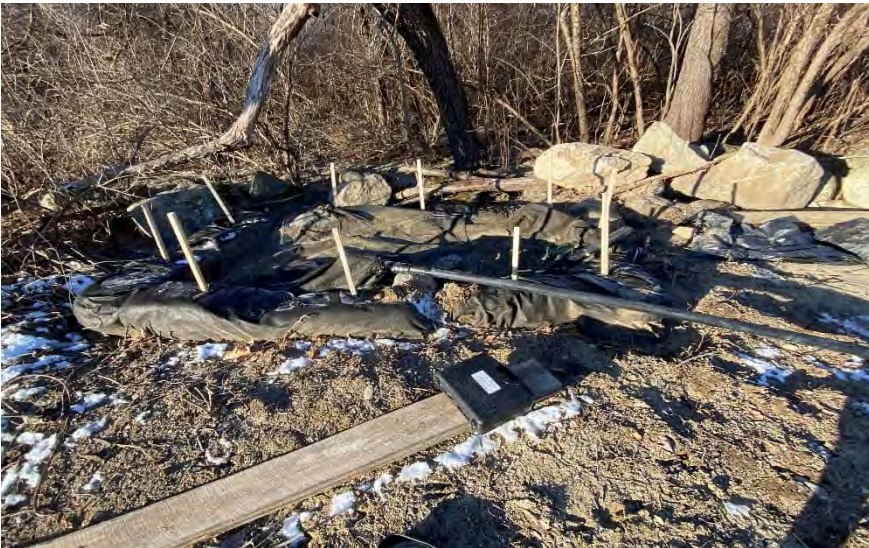
<b>Description:</b> Manhole #28. View of discharge to bag/corral, looking westward. Water discharged to the work area & appeared clear, looking westward.

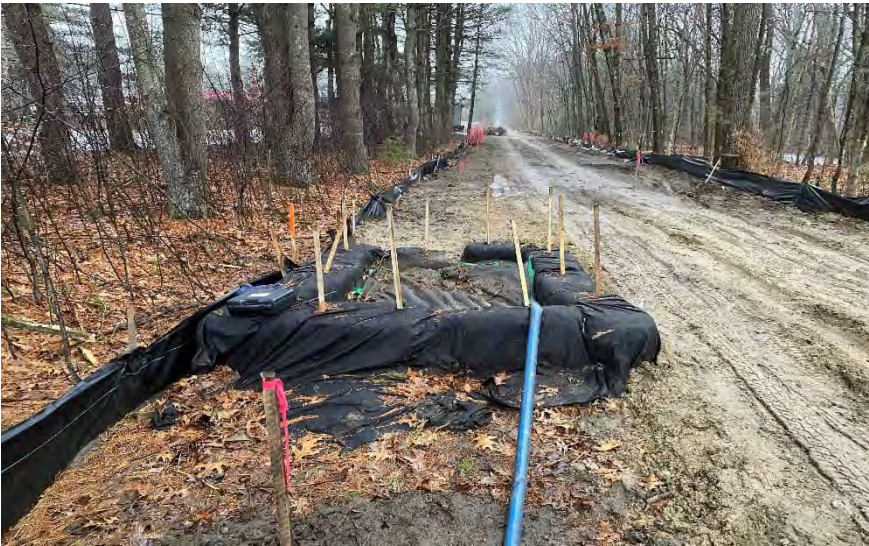
Description: Manhole #24. View of discharge to bag/corral, looking westward. Water discharged to the work area & appeared clear, looking westward.
