Weekly Environmental Compliance Summary

Sudbury to Hudson Transmission Reliability Project (USEPA Tracking # MAR1003UW)

Week of: February 26, 2024 to March 1, 2024

CONSTRUCTION MONITORING REPORT

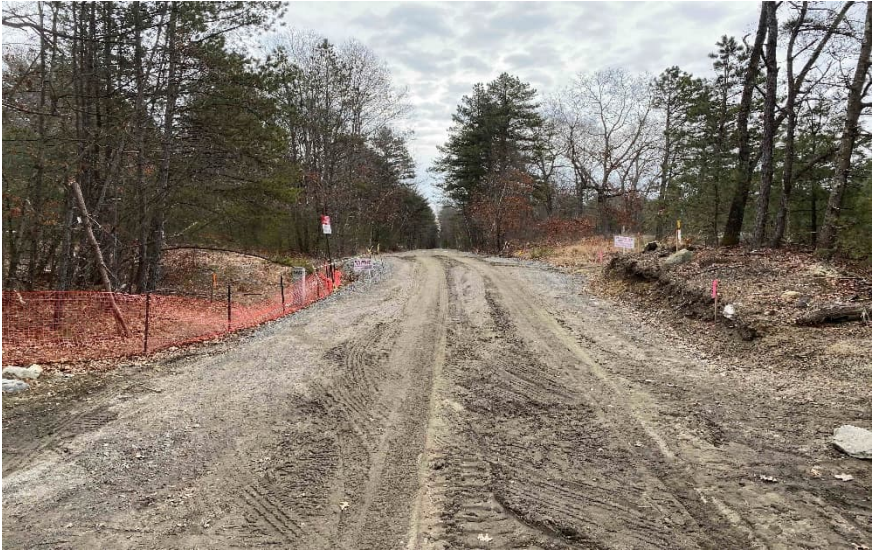
<p>PHOTOGRAPHIC LOG</p>	
<p>Client Name: Eversource</p>		<p>Site Location: Sudbury to Hudson Transmission Reliability Project</p>	<p>Town: Hudson</p>
<p>Photo No.: 1</p>	<p>Date: 2-26-24</p>

<p>Description:</p> <p>Work area within segment 6, town line area, looking eastward.</p>

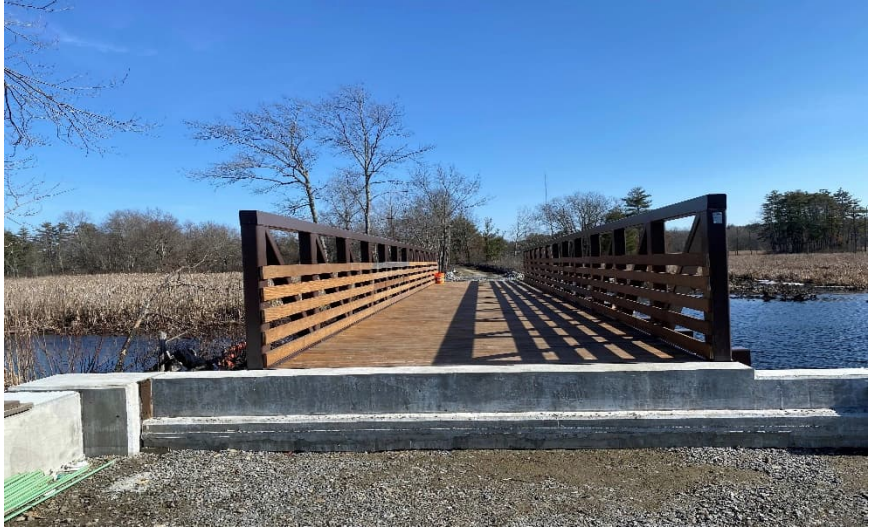
<p>PHOTOGRAPHIC LOG</p>	
<p>Client Name: Eversource</p>		<p>Site Location: Sudbury to Hudson Transmission Reliability Project</p>	<p>Town: Hudson</p>
<p>Photo No.: 2</p>	<p>Date: 2-26-24</p>

<p>Description:</p> <p>Work area at newly installed Bridge 130 looking from segment 2 toward segment 3 across Fort Meadow Brook, existing erosion control (floating silt curtain), looking eastward.</p>

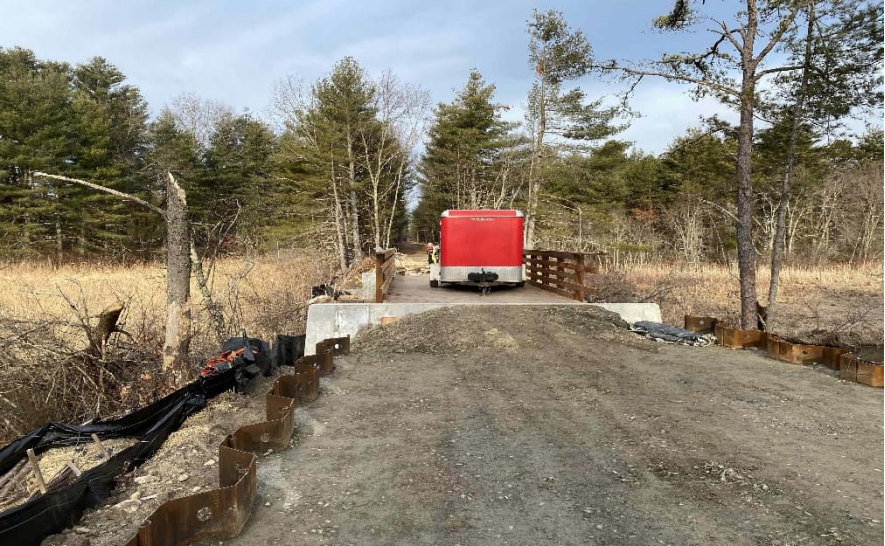
<p>PHOTOGRAPHIC LOG</p>	
<p>Client Name: Eversource</p>		<p>Site Location: Sudbury to Hudson Transmission Reliability Project</p>	<p>Town: Sudbury</p>
<p>Photo No.: 6</p>	<p>Date: 2-26-24</p>

<p>Description:</p> <p>Work area at Bridge 128 looking from segment 8 toward segment 7 across Hop Brook, existing erosion control, looking westward.</p>

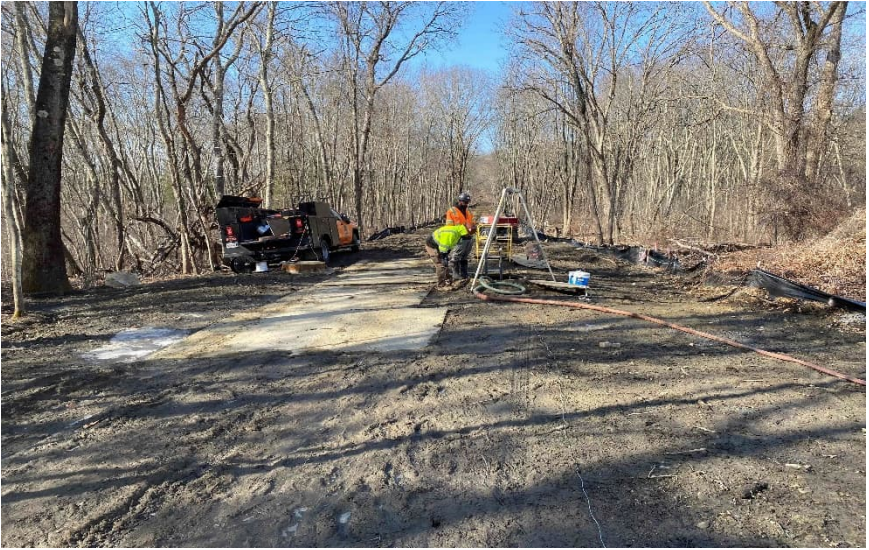
<p>PHOTOGRAPHIC LOG</p>	
<p>Client Name: Eversource</p>		<p>Site Location: Sudbury to Hudson Transmission Reliability Project</p>	<p>Town: Sudbury</p>
<p>Photo No.: 7</p>	<p>Date: 2-26-24</p>

<p>Description:</p> <p>Bond conducting proofing work within segment 14 at manhole #27, looking westward</p>

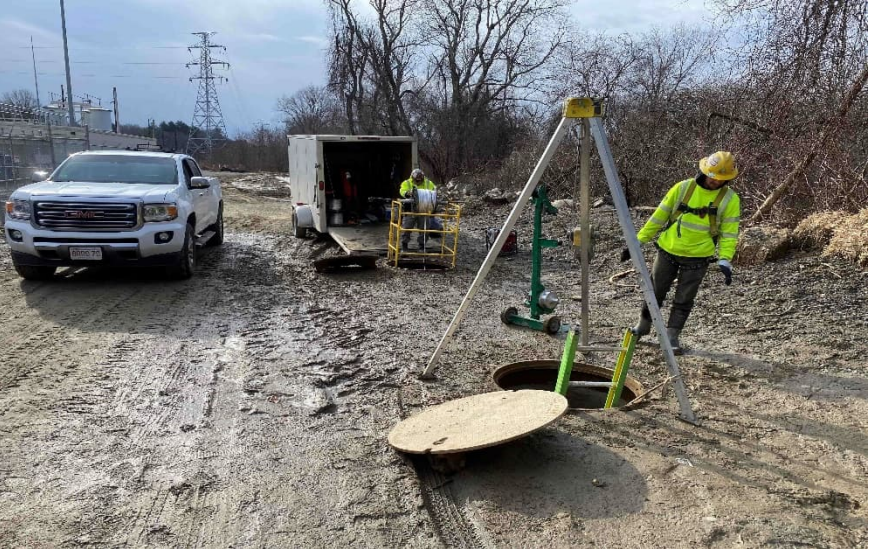
<p>PHOTOGRAPHIC LOG</p>	
<p>Client Name: Eversource</p>		<p>Site Location: Sudbury to Hudson Transmission Reliability Project</p>	<p>Town: Sudbury</p>
<p>Photo No.: 8</p>	<p>Date: 2-26-24</p>

<p>Description:</p> <p>Bond conducting proofing work outside substation at manhole #28, looking southward.</p>

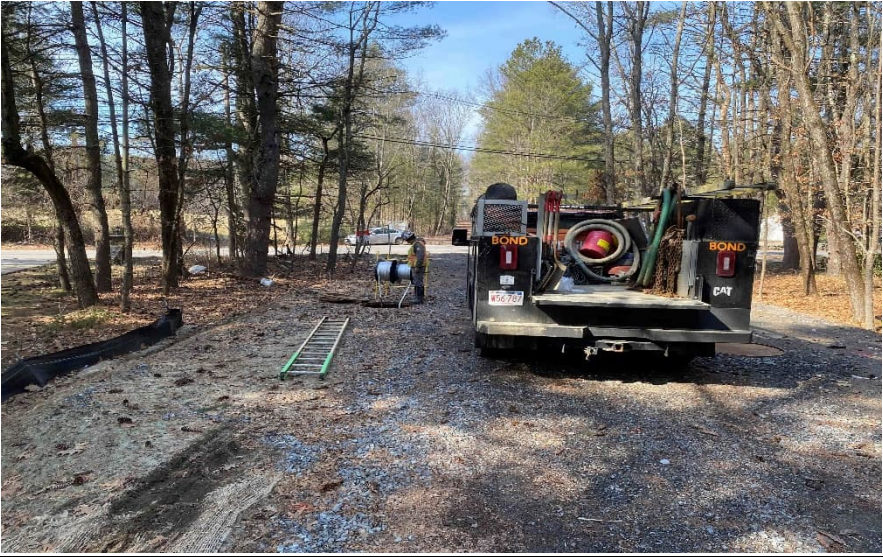
<p>PHOTOGRAPHIC LOG</p>	
<p>Client Name: Eversource</p>		<p>Site Location: Sudbury to Hudson Transmission Reliability Project</p>	<p>Town: Hudson</p>
<p>Photo No.: 1</p>	<p>Date: 2-27-24</p>

<p>Description:</p> <p>Bond conducting proofing work within segment 5 at manhole #11, looking westward.</p>

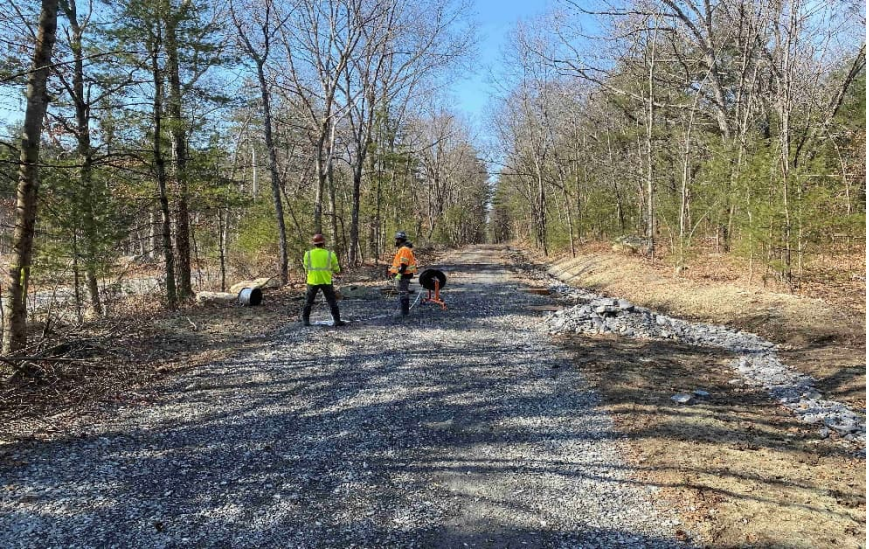
<p>PHOTOGRAPHIC LOG</p>	
<p>Client Name: Eversource</p>		<p>Site Location: Sudbury to Hudson Transmission Reliability Project</p>	<p>Town: Hudson</p>
<p>Photo No.: 2</p>	<p>Date: 2-27-24</p>

<p>Description:</p> <p>Bond conducting proofing work within segment 5 at manhole #12, looking westward.</p>

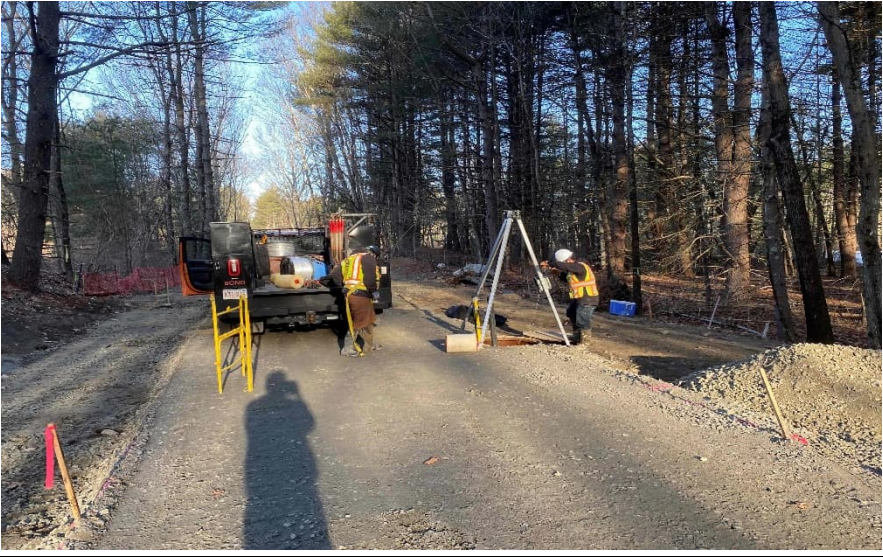
<p>PHOTOGRAPHIC LOG</p>	
<p>Client Name: Eversource</p>		<p>Site Location: Sudbury to Hudson Transmission Reliability Project</p>	<p>Town: Sudbury</p>
<p>Photo No.: 3</p>	<p>Date: 2-27-24</p>

<p>Description:</p> <p>Bond conducting proofing work within segment 8 at manhole #17, looking westward.</p>

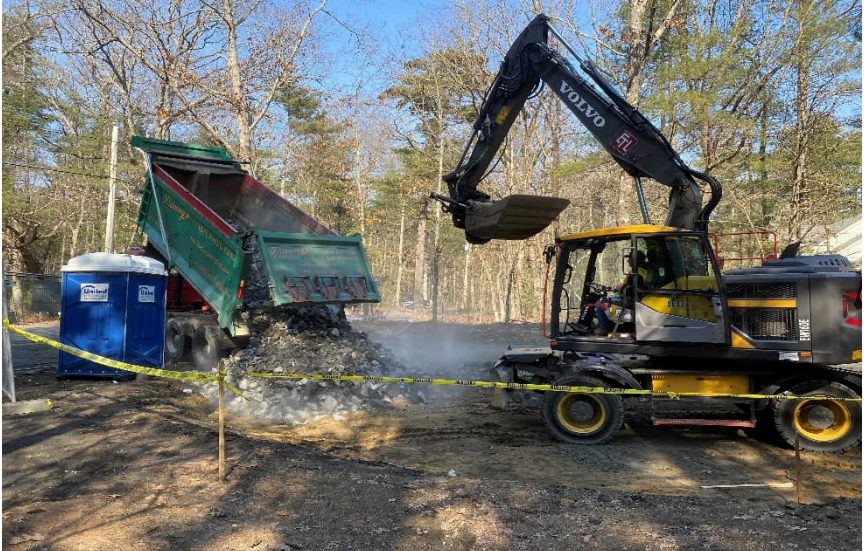
<p>PHOTOGRAPHIC LOG</p>	
<p>Client Name: Eversource</p>		<p>Site Location: Sudbury to Hudson Transmission Reliability Project</p>	<p>Town: Sudbury</p>
<p>Photo No.: 4</p>	<p>Date: 2-27-24</p>

<p>Description:</p> <p>ET&L conducting site work within segment 9, looking westward.</p>

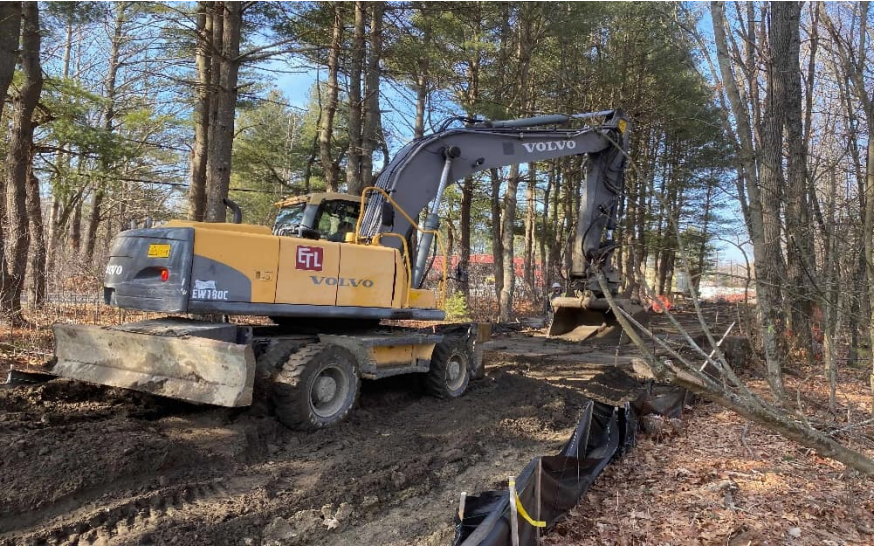
<p>PHOTOGRAPHIC LOG</p>	
<p>Client Name: Eversource</p>		<p>Site Location: Sudbury to Hudson Transmission Reliability Project</p>	<p>Town: Sudbury</p>
<p>Photo No.: 5</p>	<p>Date: 2-27-24</p>

<p>Description:</p> <p>ET&L conducting grading work within segment 11, looking westward.</p>

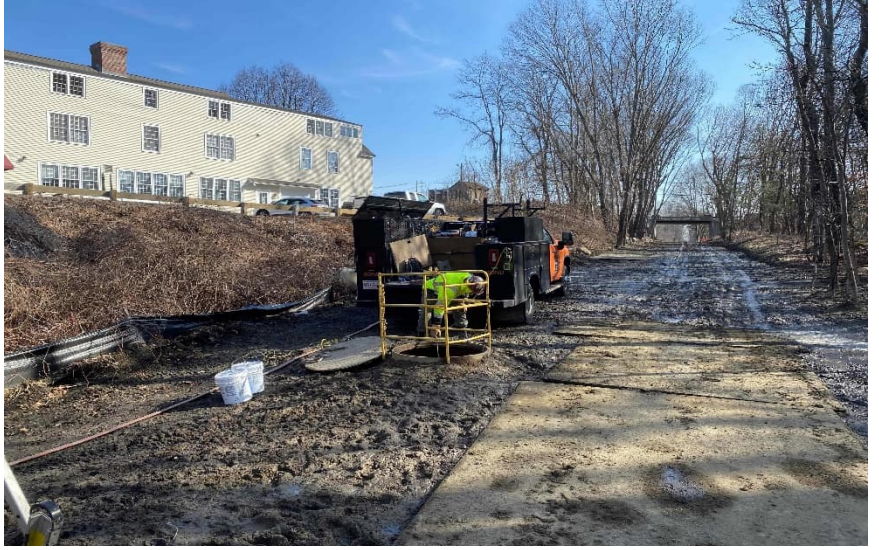
<p>PHOTOGRAPHIC LOG</p>	
<p>Client Name: Eversource</p>		<p>Site Location: Sudbury to Hudson Transmission Reliability Project</p>	<p>Town: Sudbury</p>
<p>Photo No.: 6</p>	<p>Date: 2-27-24</p>

<p>Description:</p> <p>Bond conducting proofing work within segment 14 at manhole #27, looking eastward</p>

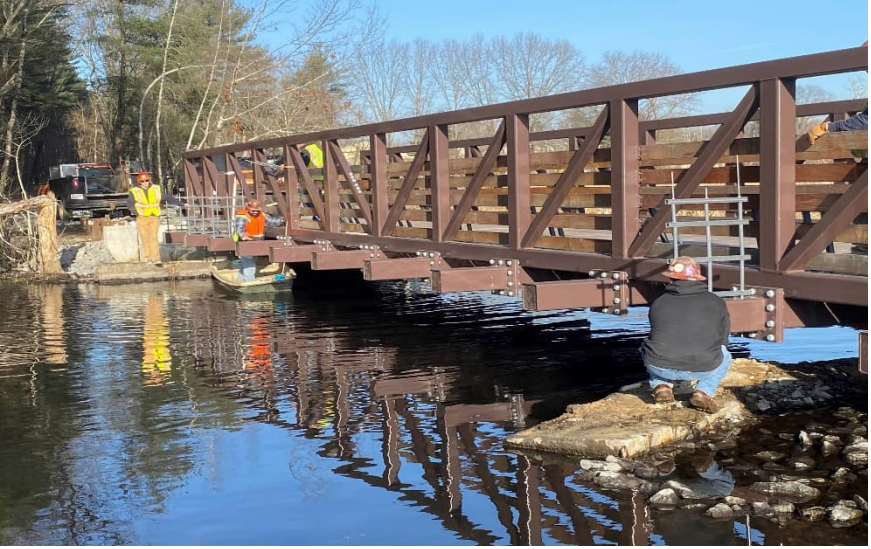
<p>PHOTOGRAPHIC LOG</p>	
<p>Client Name: Eversource</p>		<p>Site Location: Sudbury to Hudson Transmission Reliability Project</p>	<p>Town: Sudbury</p>
<p>Photo No.: 8</p>	<p>Date: 2-27-24</p>

<p>Description:</p> <p>Bond conducting conduit hanger work at bridge 127, over Hop Brook, looking westward.</p>

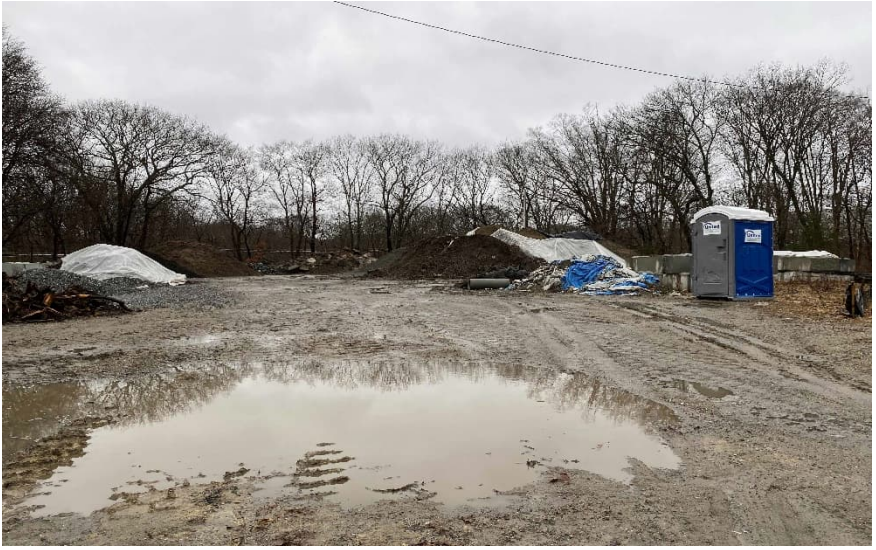
<p>PHOTOGRAPHIC LOG</p>	
<p>Client Name: Eversource</p>		<p>Site Location: Sudbury to Hudson Transmission Reliability Project</p>	<p>Town: Hudson</p>
<p>Photo No.: 3</p>	<p>Date: 2-28-24</p>

<p>Description:</p> <p>Laydown yard at Stowe Court, looking southward.</p>

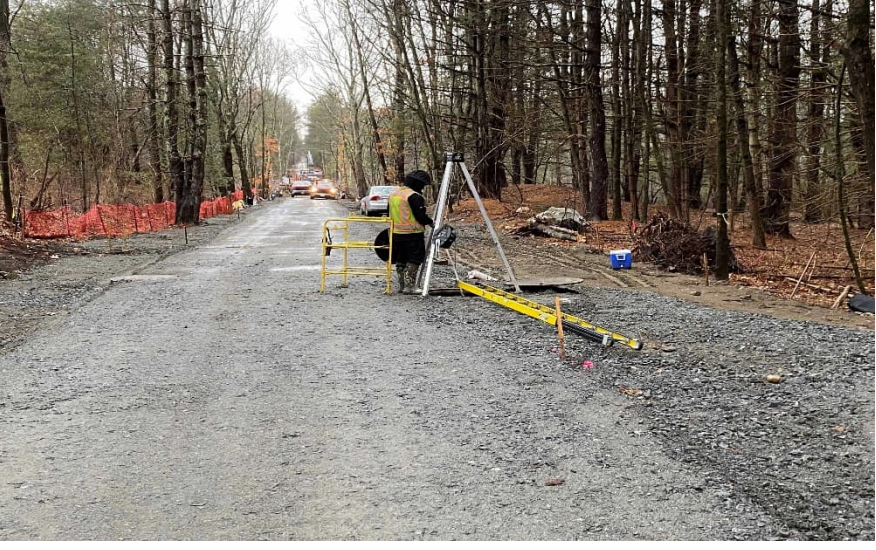
<p>PHOTOGRAPHIC LOG</p>	
<p>Client Name: Eversource</p>		<p>Site Location: Sudbury to Hudson Transmission Reliability Project</p>	<p>Town: Sudbury</p>
<p>Photo No.: 4</p>	<p>Date: 2-28-24</p>

<p>Description:</p> <p>Bond conducting proofing work within segment 8 at manhole #17, looking westward.</p>

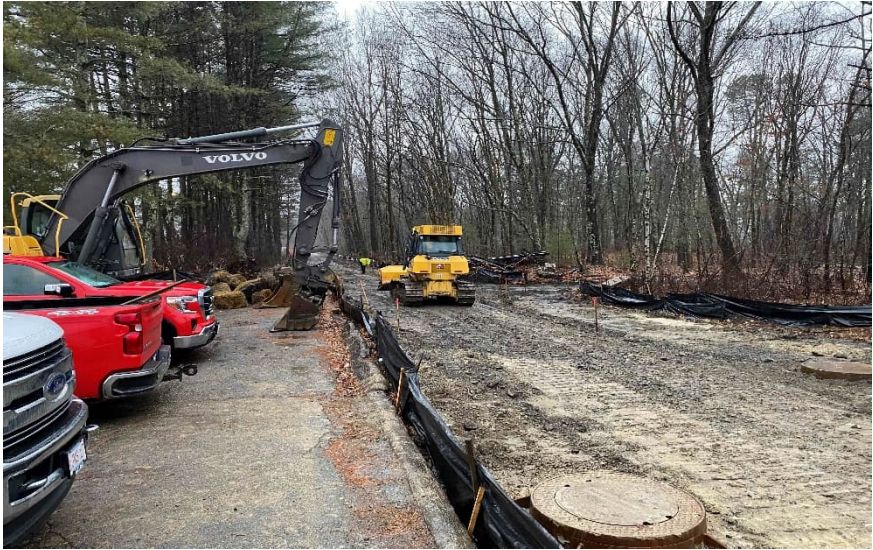
<p>PHOTOGRAPHIC LOG</p>	
<p>Client Name: Eversource</p>		<p>Site Location: Sudbury to Hudson Transmission Reliability Project</p>	<p>Town: Sudbury</p>
<p>Photo No.: 5</p>	<p>Date: 2-28-24</p>

<p>Description:</p> <p>ET&L conducting grading work within segment 11, looking westward.</p>

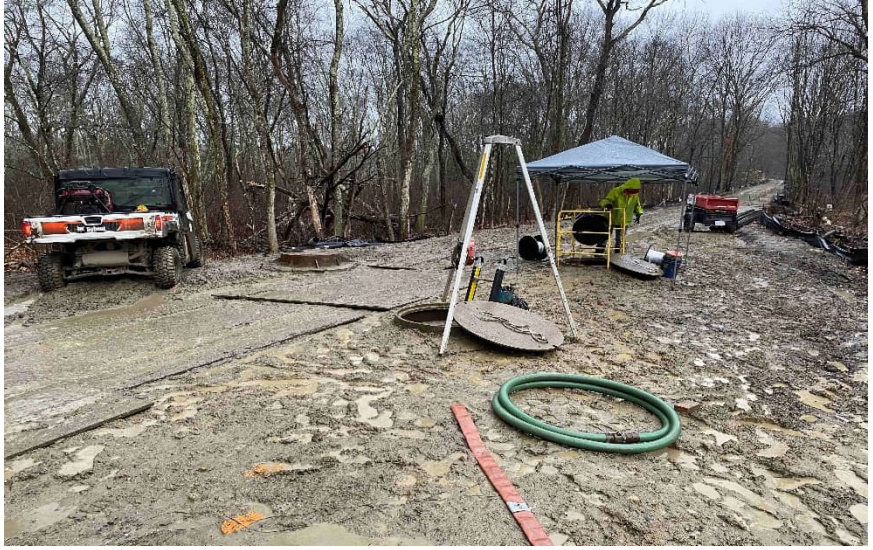
<p>PHOTOGRAPHIC LOG</p>	
<p>Client Name: Eversource</p>		<p>Site Location: Sudbury to Hudson Transmission Reliability Project</p>	<p>Town: Sudbury</p>
<p>Photo No.: 6</p>	<p>Date: 2-28-24</p>

<p>Description:</p> <p>Bond conducting proofing work within segment 14 at manhole #27, looking westward.</p>

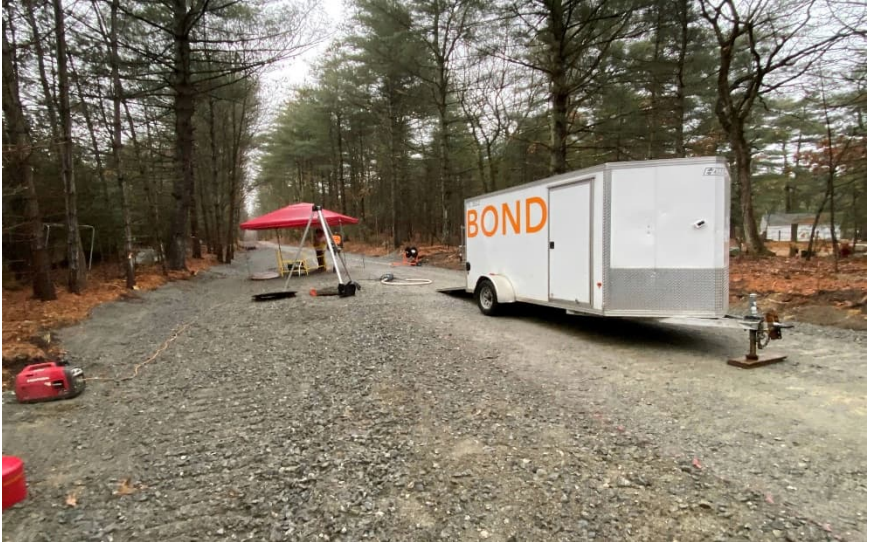
<p>PHOTOGRAPHIC LOG</p>	
<p>Client Name: Eversource</p>		<p>Site Location: Sudbury to Hudson Transmission Reliability Project</p>	<p>Town: Sudbury</p>
<p>Photo No.: 8</p>	<p>Date: 2-28-24</p>

<p>Description:</p> <p>Bond conducting proofing work within segment 9 at manhole #18, looking eastward.</p>

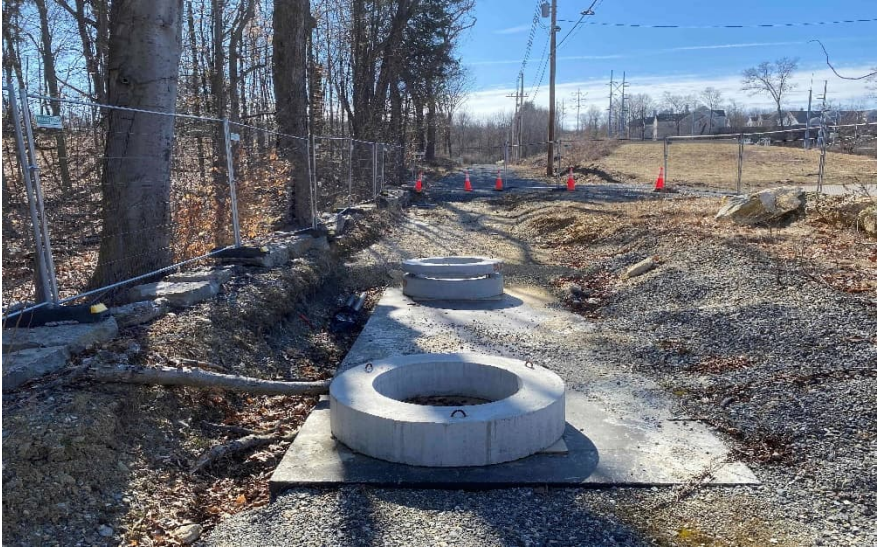
<p>PHOTOGRAPHIC LOG</p>	
<p>Client Name: Eversource</p>		<p>Site Location: Sudbury to Hudson Transmission Reliability Project</p>	<p>Town: Hudson</p>
<p>Photo No.: 2</p>	<p>Date: 3-1-24</p>

<p>Description:</p> <p>Manhole #1 adjacent to the Hudson Power & Light facility off Forest Avenue, looking eastward.</p>

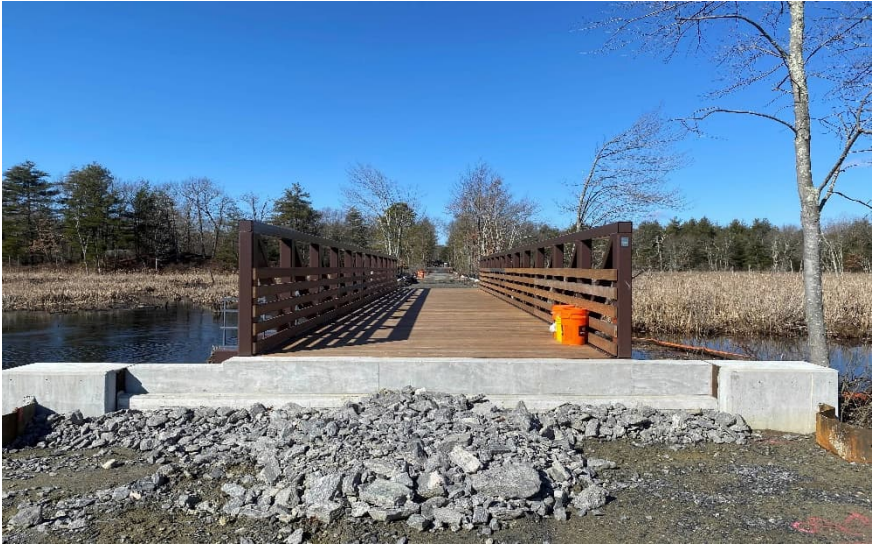
<p>PHOTOGRAPHIC LOG</p>	
<p>Client Name: Eversource</p>		<p>Site Location: Sudbury to Hudson Transmission Reliability Project</p>	<p>Town: Hudson</p>
<p>Photo No.: 3</p>	<p>Date: 3-1-24</p>

<p>Description:</p> <p>Work area within segment 3 looking toward segment 2 over Fort Meadow Brook at Bridge 130, looking westward.</p>

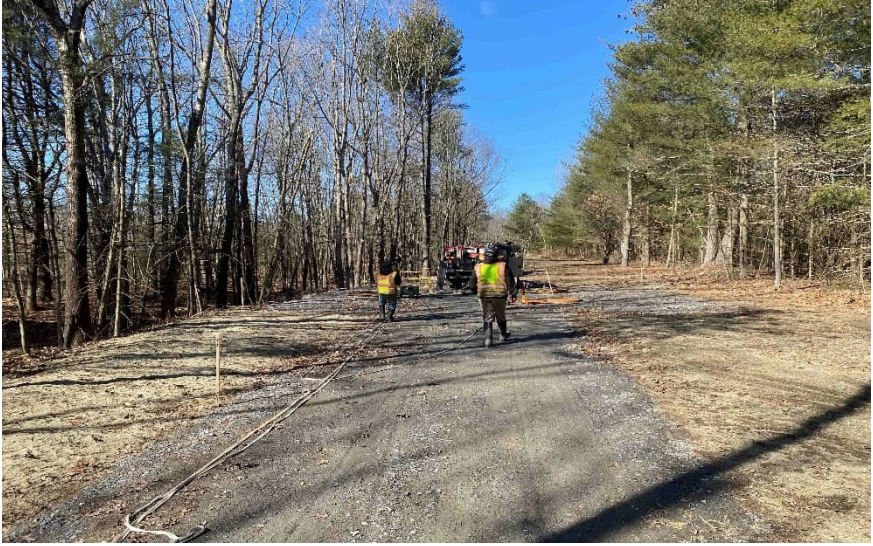
<p>PHOTOGRAPHIC LOG</p>	
<p>Client Name: Eversource</p>		<p>Site Location: Sudbury to Hudson Transmission Reliability Project</p>	<p>Town: Hudson</p>
<p>Photo No.: 4</p>	<p>Date: 3-1-24</p>

<p>Description:</p> <p>Bond conducting proofing work within segment 2 at manhole #7, looking westward.</p>

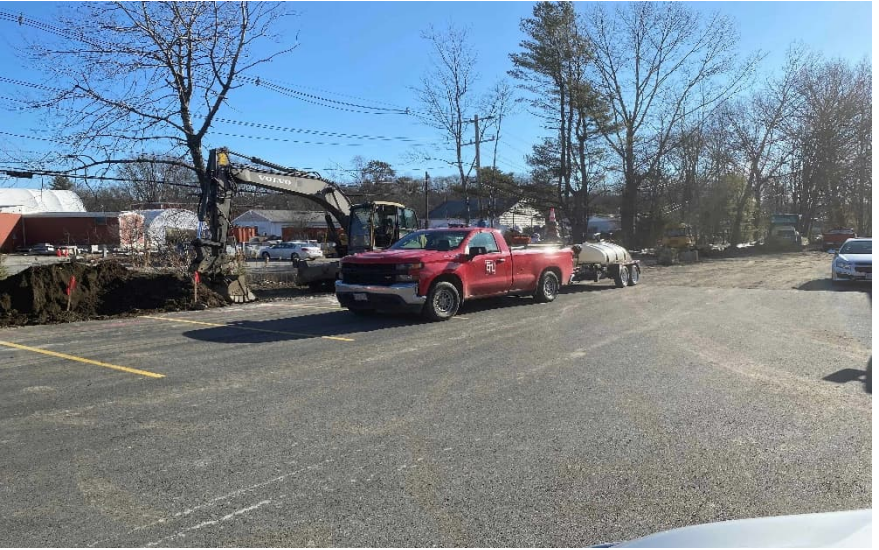
<p>PHOTOGRAPHIC LOG</p>	
<p>Client Name: Eversource</p>		<p>Site Location: Sudbury to Hudson Transmission Reliability Project</p>	<p>Town: Sudbury</p>
<p>Photo No.: 5</p>	<p>Date: 3-1-24</p>

<p>Description:</p> <p>ET&L conducting grading work within segment 12, looking eastward.</p>

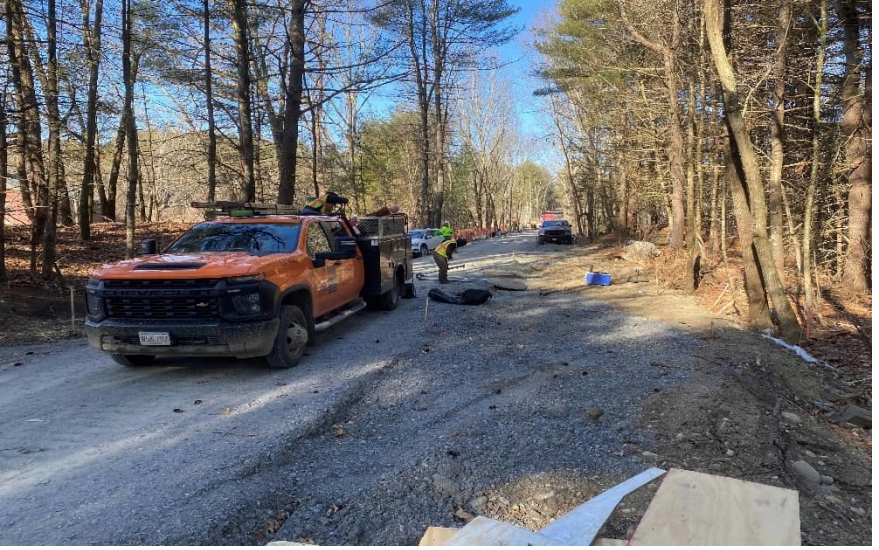
<p>PHOTOGRAPHIC LOG</p>	
<p>Client Name: Eversource</p>		<p>Site Location: Sudbury to Hudson Transmission Reliability Project</p>	<p>Town: Sudbury</p>
<p>Photo No.: 6</p>	<p>Date: 3-1-24</p>

<p>Description:</p> <p>Bond conducting proofing work within segment 8 at manhole #17, looking westward.</p>

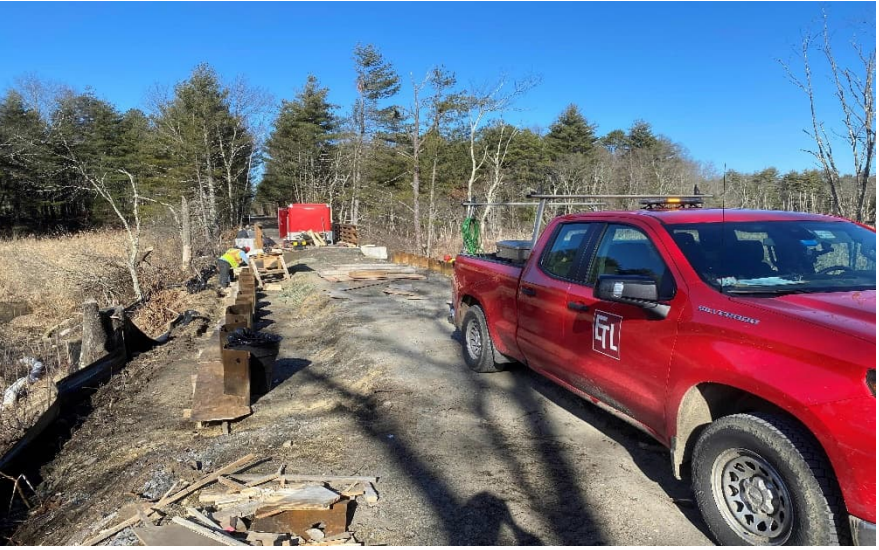
<p>PHOTOGRAPHIC LOG</p>	
<p>Client Name: Eversource</p>		<p>Site Location: Sudbury to Hudson Transmission Reliability Project</p>	<p>Town: Sudbury</p>
<p>Photo No.: 7</p>	<p>Date: 3-1-24</p>

<p>Description:</p> <p>Work area within segment 8 looking toward segment 7 over Hop Brook, Bridge 128, looking westward</p>

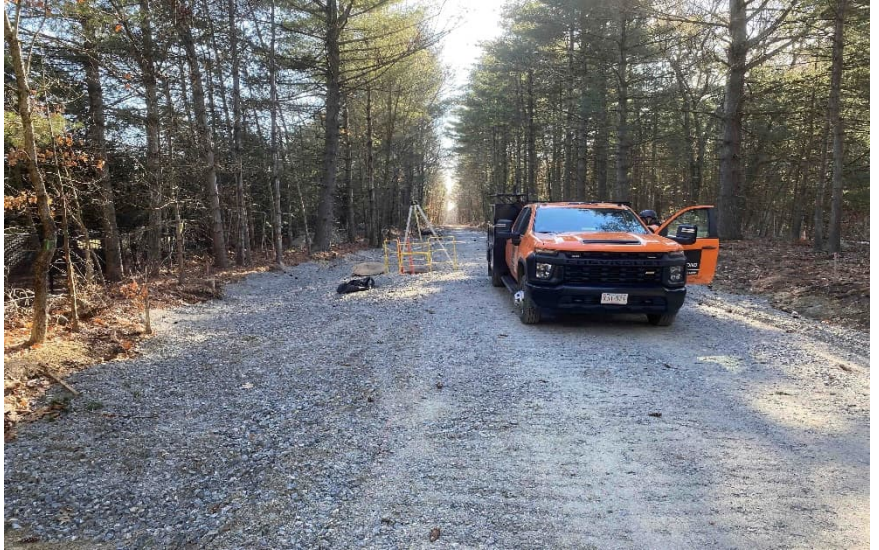
<p>PHOTOGRAPHIC LOG</p>	
<p>Client Name: Eversource</p>		<p>Site Location: Sudbury to Hudson Transmission Reliability Project</p>	<p>Town: Sudbury</p>
<p>Photo No.: 8</p>	<p>Date: 3-1-24</p>

<p>Description:</p> <p>Bond conducting proofing work within segment 9 at manhole #18, looking eastward.</p>

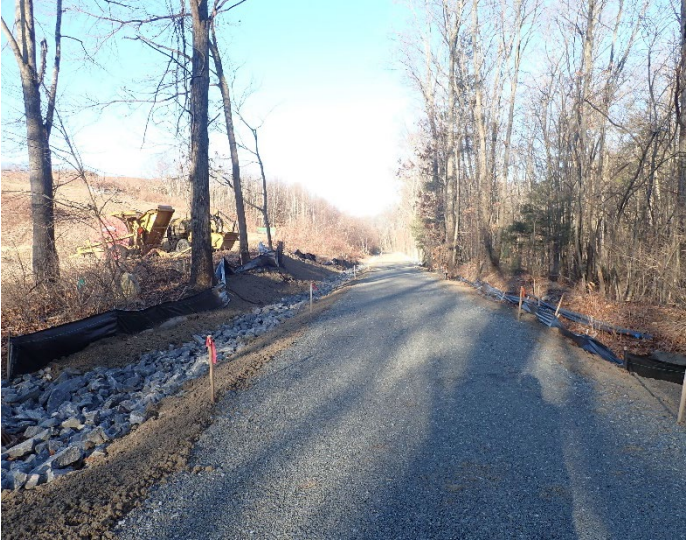
PHOTOGRAPHIC LOG	
Client Name: Eversource		Site Location: Sudbury to Hudson Transmission Reliability Project	Town: Stow
Photo No.: 1	Date: 2-29-2024

Description: View of Drainage Structures and E&S controls in segment 1. Facing west.

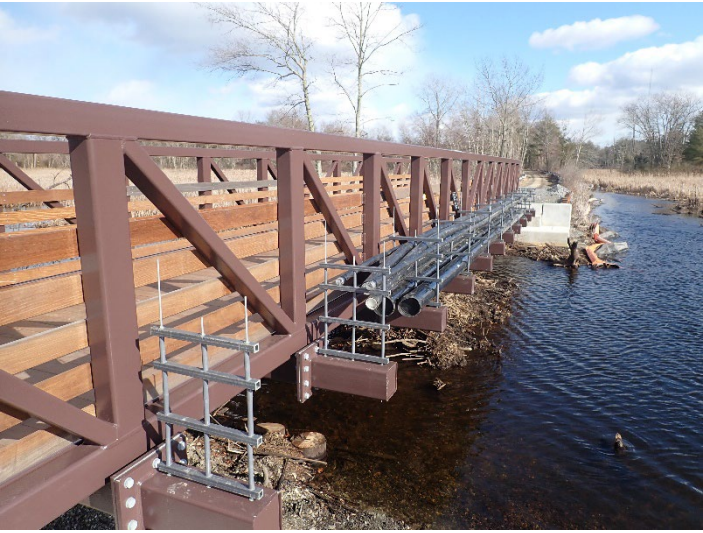
PHOTOGRAPHIC LOG	
Client Name: Eversource		Site Location: Sudbury to Hudson Transmission Reliability Project	Town: Hudson
Photo No.: 2	Date: 2-29-2024

Description: View of Bridge 130. Turbidity curtains are in place. Facing east.

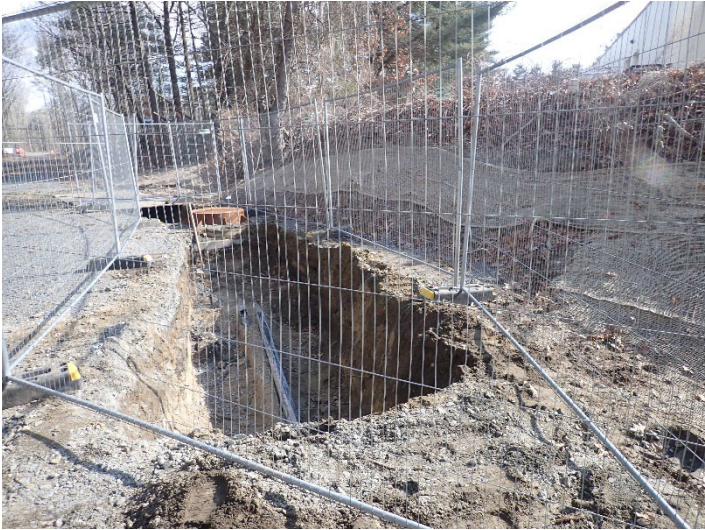
PHOTOGRAPHIC LOG	
Client Name: Eversource		Site Location: Sudbury to Hudson Transmission Reliability Project	Town: Hudson
Photo No.: 3	Date: 2-29-2024

Description: View of Bond excavating in segment 3 near MH#9. Facing east.

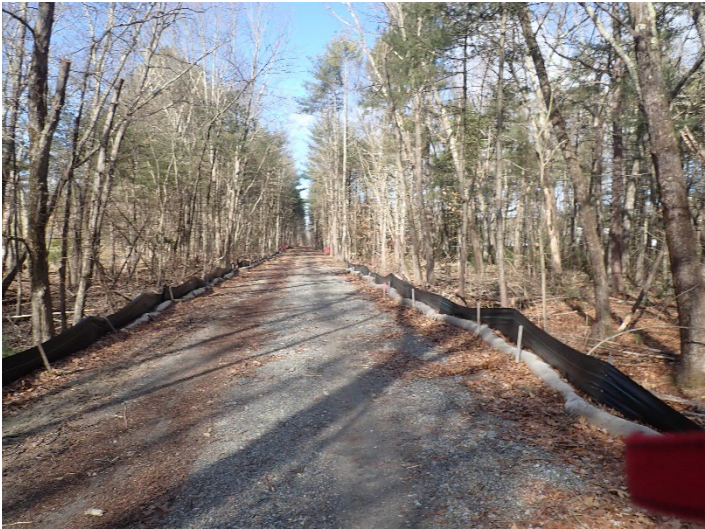
PHOTOGRAPHIC LOG	
Client Name: Eversource		Site Location: Sudbury to Hudson Transmission Reliability Project	Town: Hudson
Photo No.: 4	Date: 2-29-2024

Description: View of E&S controls in segment 4. Facing west.

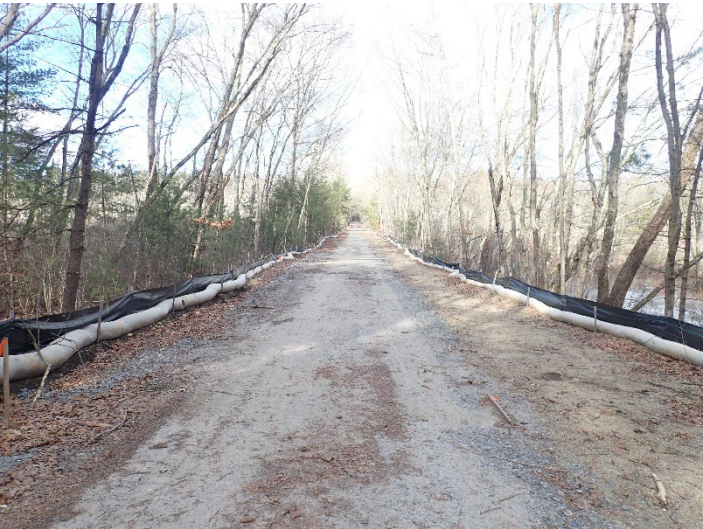
Epsilon ASSOCIATES INC.		PHOTOGRAPHIC LOG	
Client Name: Eversource		Site Location: Sudbury to Hudson Transmission Reliability Project	Town: Hudson
Photo No.: 5	Date: 2-29-2024

Description: View of E&S controls in segment 5. Facing west.

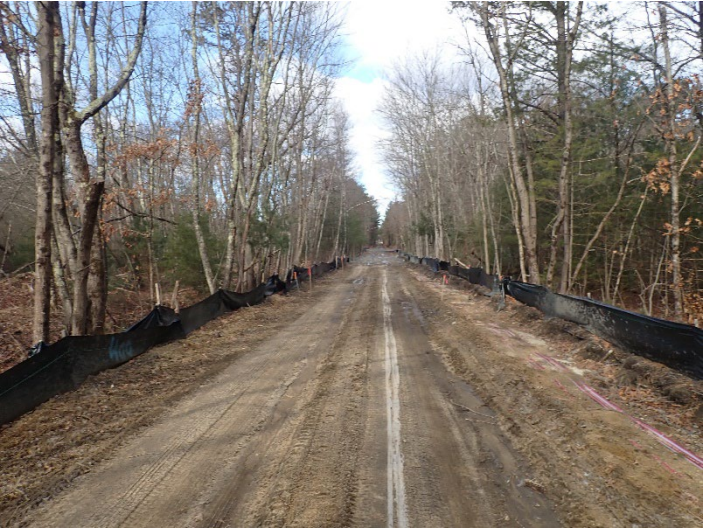
Epsilon ASSOCIATES INC.		PHOTOGRAPHIC LOG	
Client Name: Eversource		Site Location: Sudbury to Hudson Transmission Reliability Project	Town: Hudson
Photo No.: 6	Date: 2-29-2024

Description: View of E&S controls in segment 6. Facing west.

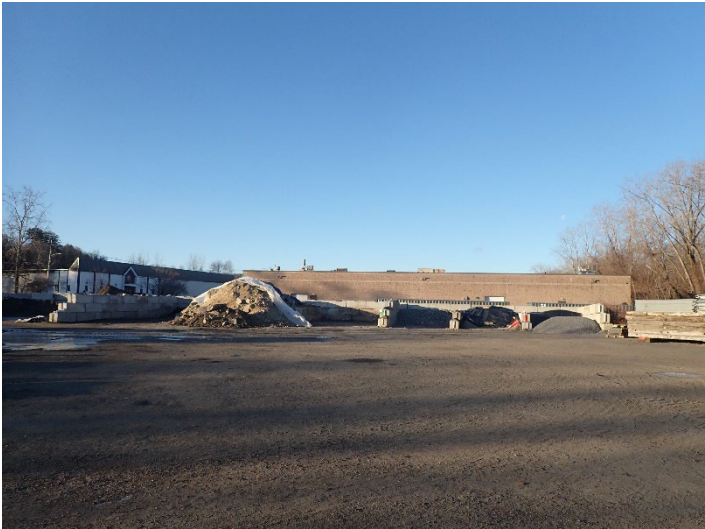
Epsilon ASSOCIATES INC.		PHOTOGRAPHIC LOG	
Client Name: Eversource		Site Location: Sudbury to Hudson Transmission Reliability Project	Town: Hudson
Photo No.: 8	Date: 2-29-2024

4. Silt Fencing at laydown yards (25 Stowe Ct and 17 Bonazzoli Avenue)	<input type="checkbox"/> Yes <input checked="" type="checkbox"/> No	N/A	<input type="checkbox"/> Yes <input checked="" type="checkbox"/> No	N/A	Silt fence at Bonazzoli laydown yard is in good condition.

Description: View of Bonazzoli laydown yard. Facing south.

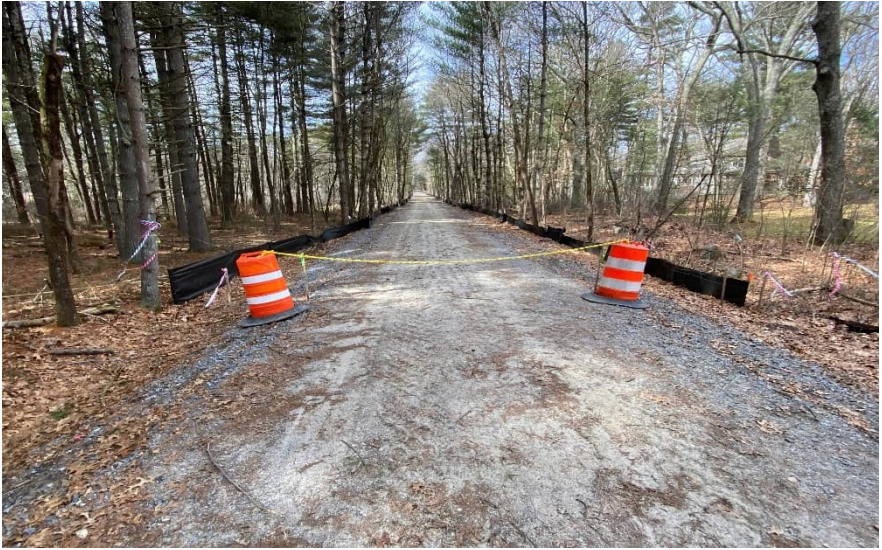
PHOTOGRAPHIC LOG	
Client Name: Eversource		Site Location: Sudbury to Hudson Transmission Reliability Project	Town: Sudbury
Photo No.: 1	Date: 2-29-24

Description: Work area within segment 11 showing new identification of vernal pool exclusion zones (flagging/orange barrels), looking eastward.

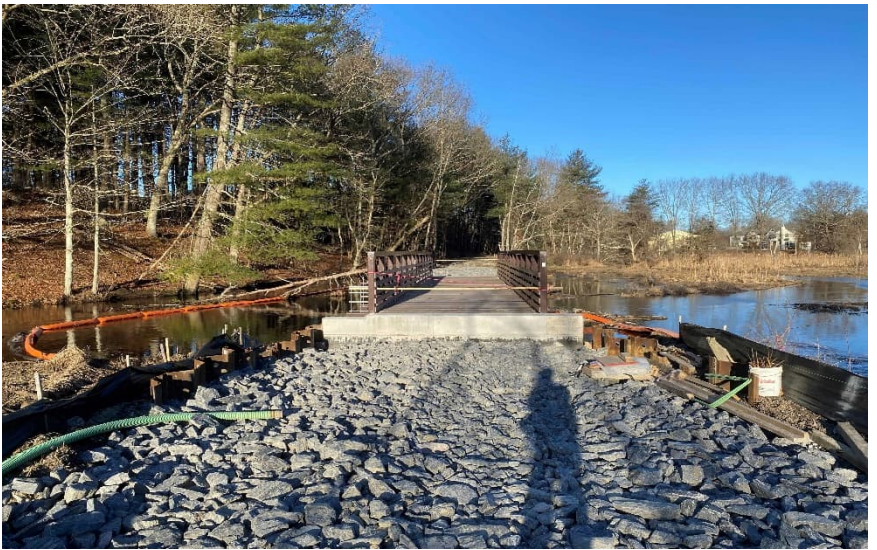
PHOTOGRAPHIC LOG	
Client Name: Eversource		Site Location: Sudbury to Hudson Transmission Reliability Project	Town: Sudbury
Photo No.: 2	Date: 2-29-24

7. Floating silt fencing located at segment 13/14 boundary at Bridge 127 in Sudbury	<input type="checkbox"/> Yes <input checked="" type="checkbox"/> No	N/A	<input type="checkbox"/> Yes <input checked="" type="checkbox"/> No	N/A	Floating silt fencing installed & operating properly within segments 13/14 at Bridge 127. Supplemental silt fence has been installed at top of bank per request of Sudbury CC agent.
If the same routine maintenance was found to be necessary three or more times for the same control at the same location (including this occurrence), follow the corrective action requirements and record the required information in your corrective action log, or describe here why you believe the specific condition should still be addressed as routine maintenance:

Description: Work area within segment 14 looking across Hop Brook into segment 13, Bridge 127, existing erosion control, looking westward.

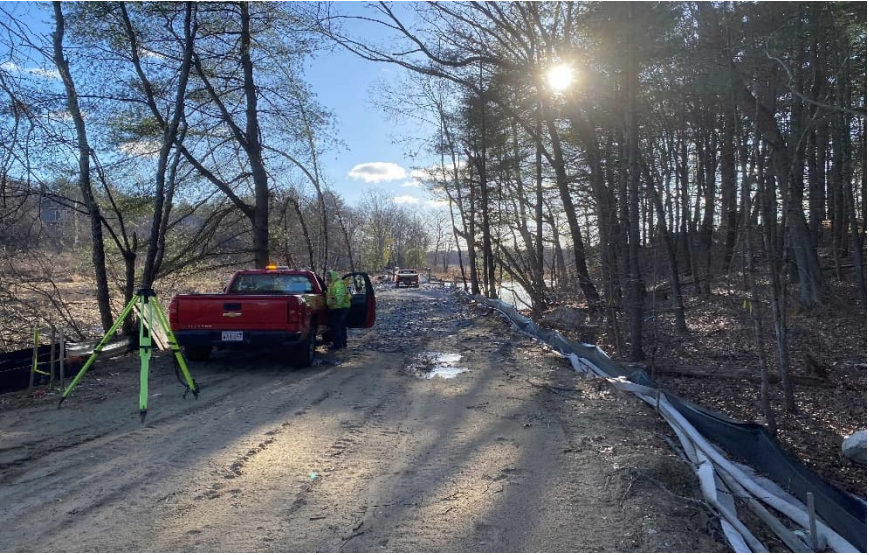
PHOTOGRAPHIC LOG	
Client Name: Eversource		Site Location: Sudbury to Hudson Transmission Reliability Project	Town: Sudbury
Photo No.: 3	Date: 2-29-24

Description: Work area within segment 13, ET&L conducting survey work, existing erosion control, looking eastward.

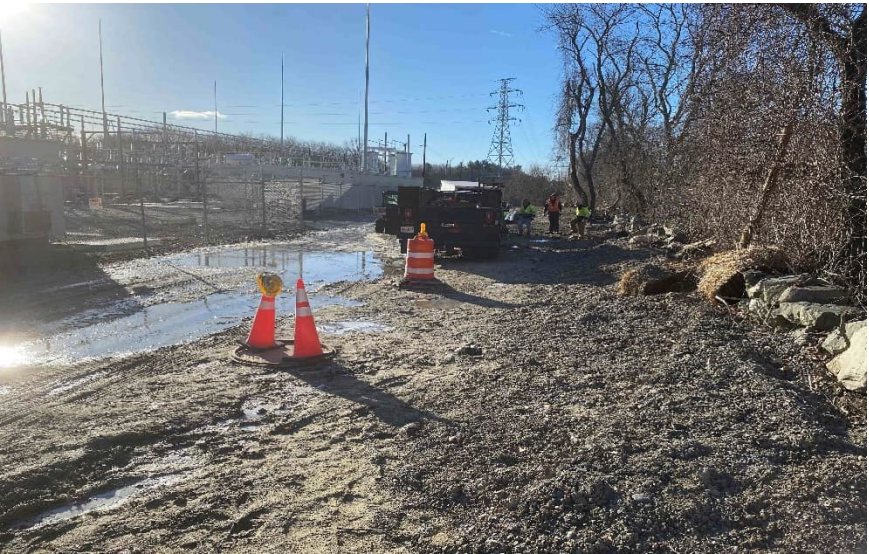
PHOTOGRAPHIC LOG	
Client Name: Eversource		Site Location: Sudbury to Hudson Transmission Reliability Project	Town: Sudbury
Photo No.: 4	Date: 2-29-24

Description: Proofing work at manhole #28, outside substation, looking southward.

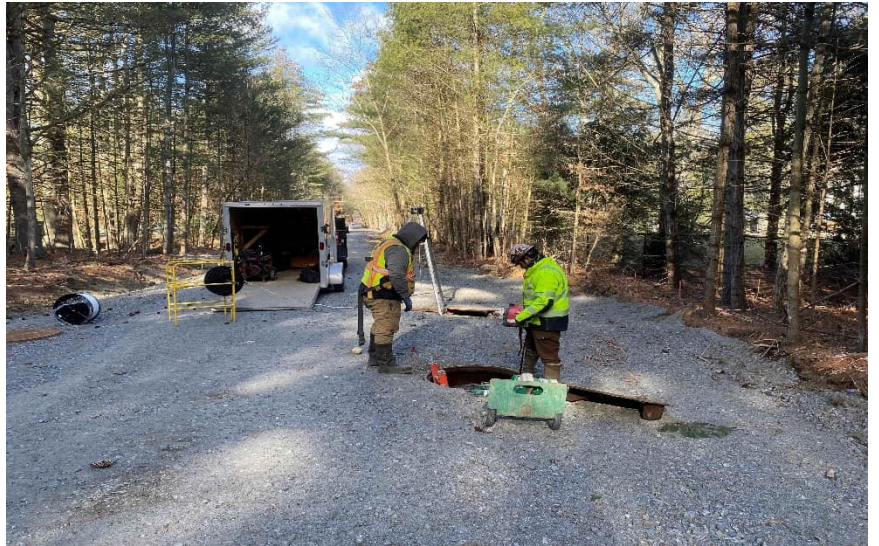
PHOTOGRAPHIC LOG	
Client Name: Eversource		Site Location: Sudbury to Hudson Transmission Reliability Project	Town: Sudbury
Photo No.: 6	Date: 2-29-24

Description: Proofing work at manhole #18 within segment 9, looking westward.

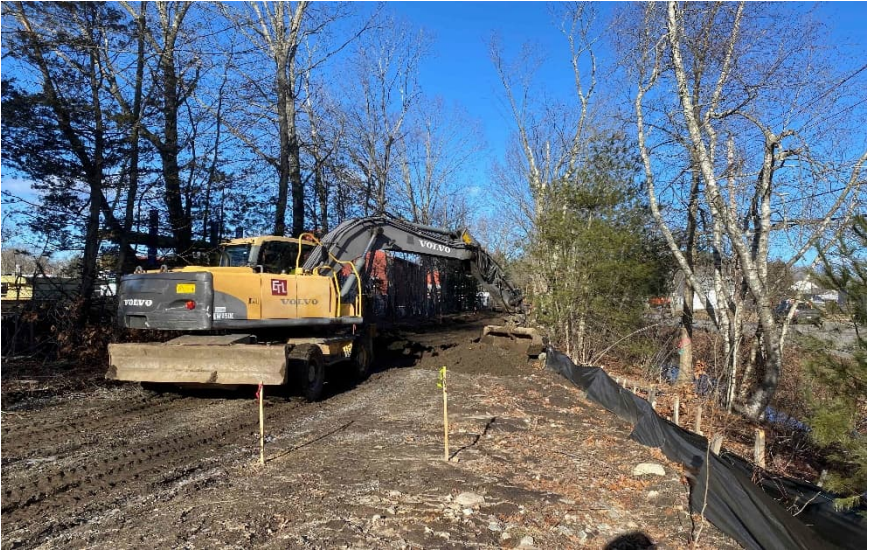
PHOTOGRAPHIC LOG	
Client Name: Eversource		Site Location: Sudbury to Hudson Transmission Reliability Project	Town: Sudbury
Photo No.: 7	Date: 2-29-24

Description: Work area within segment 12, ET&L conducting grading work, existing erosion control, looking westward.

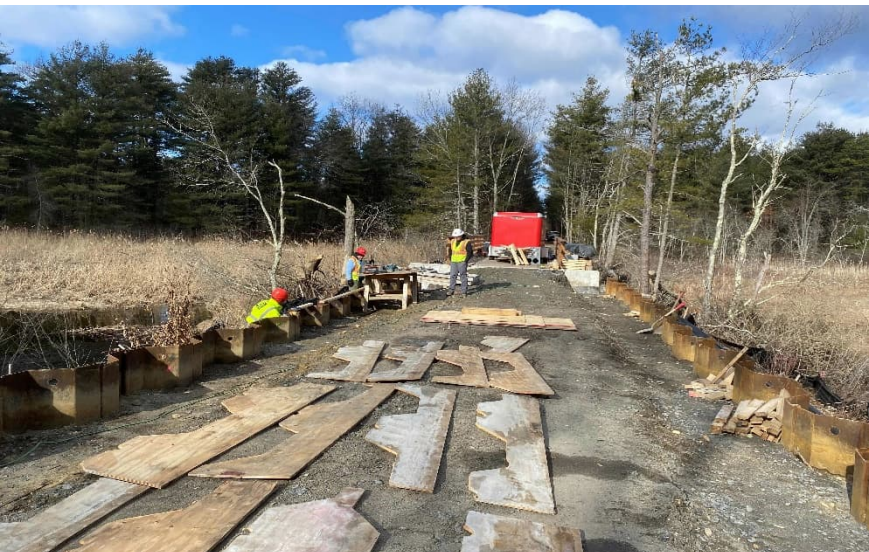
PHOTOGRAPHIC LOG	
Client Name: Eversource		Site Location: Sudbury to Hudson Transmission Reliability Project	Town: Sudbury
Photo No.: 8	Date: 2-29-24

Description: ET&L conducting concrete cap work within segment 8 looking across Hop brook toward segment 7, Bridge 128, existing erosion control, looking westward.
