Weekly Environmental Compliance Summary

Sudbury to Hudson Transmission Reliability Project (USEPA Tracking # MAR1003UW)

Sudbury, Hudson, and Stow, MA

Week of: March 4, 2024 to March 8, 2024

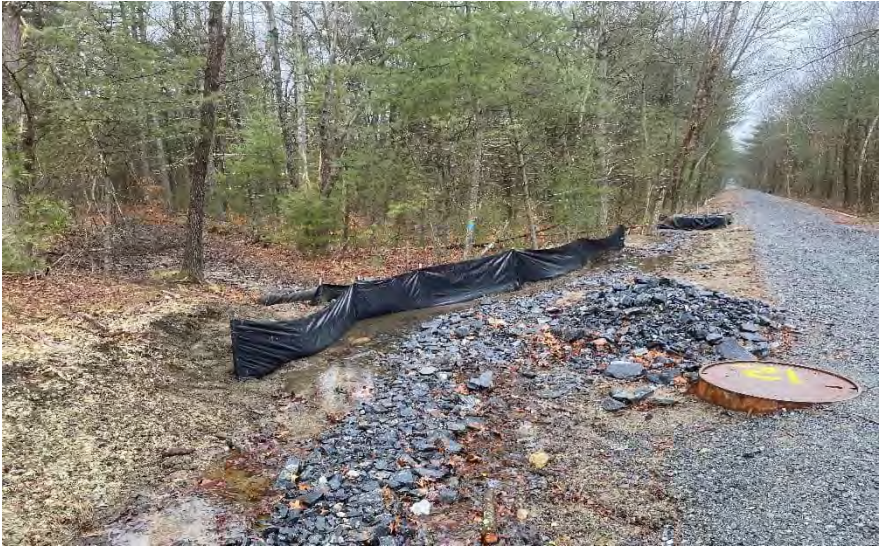
<p>PHOTOGRAPHIC LOG</p>	
<p>Client Name: Eversource</p>		<p>Site Location: Sudbury to Hudson Transmission Reliability Project</p>	<p>Town: Hudson</p>
<p>Photo No.: 5</p>	<p>Date: 3-5-24</p>

<p>Description:</p> <p>Work area within Segment 5, manhole #12 area, newly placed erosion control, looking eastward.</p>

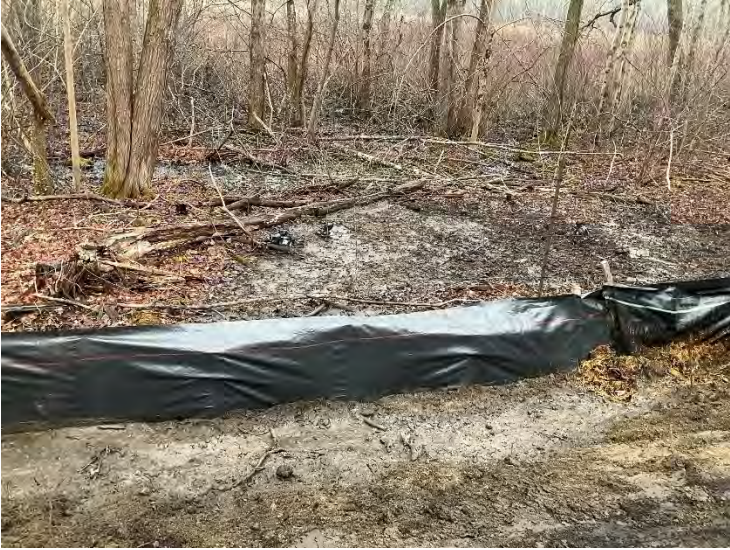
<p>PHOTOGRAPHIC LOG</p>	
<p>Client Name: Eversource</p>		<p>Site Location: Sudbury to Hudson Transmission Reliability Project</p>	<p>Town: Sudbury</p>
<p>Photo No.: 1</p>	<p>Date: 3/05/2024</p>

<p>Description: View of Sta. #741+25 in segment 14. Silt fence has been repaired and deposited sediment has been removed. Facing south.</p>

-E&S repairs have been completed at Sta. #741+25 in segment 14.

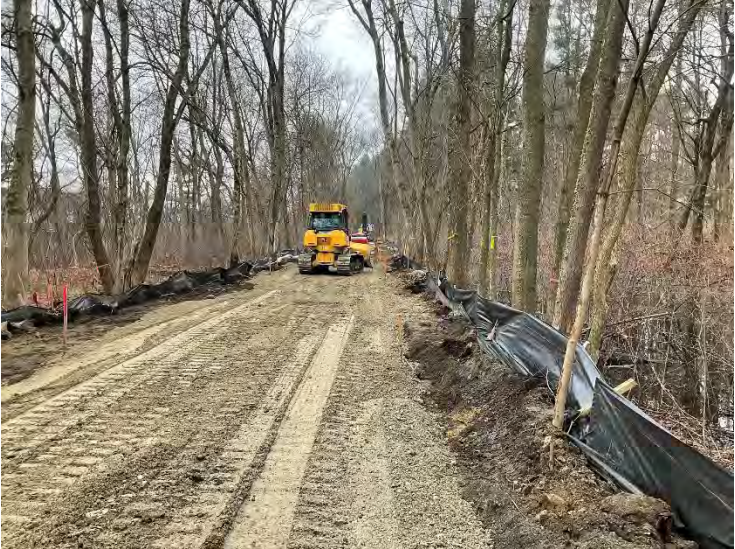
<p>PHOTOGRAPHIC LOG</p>	
<p>Client Name: Eversource</p>		<p>Site Location: Sudbury to Hudson Transmission Reliability Project</p>	<p>Town: Sudbury</p>
<p>Photo No.: 3</p>	<p>Date: 3/05/2024</p>

<p>Description: View of ET&L performing grading activities in segment 13. E&S controls are being repaired as needed. Facing east.</p>

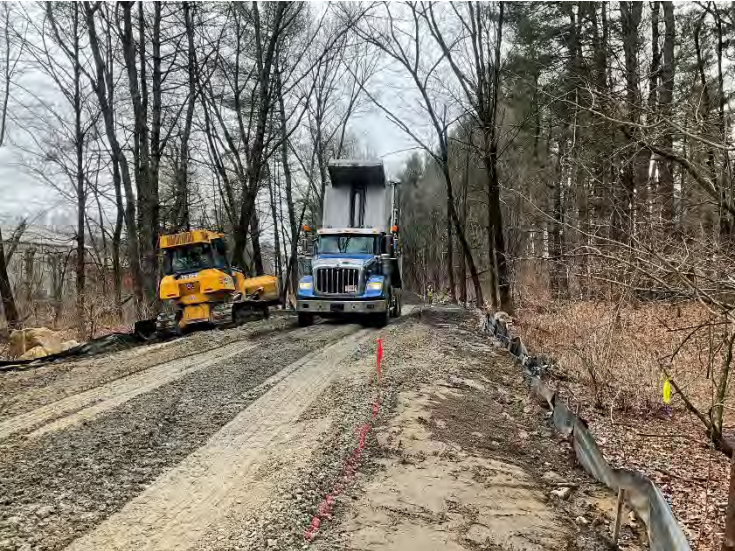
<p align="right">PHOTOGRAPHIC LOG</p>	
<p>Client Name: Eversource</p>		<p>Site Location: Sudbury to Hudson Transmission Reliability Project</p>	<p>Town: Sudbury</p>
<p>Photo No.: 2</p>	<p>Date: 3/06/2024</p>

<p>Description: View of ET&L performing grading activities in segment 13. E&S controls are being repaired as needed. Facing east.</p>

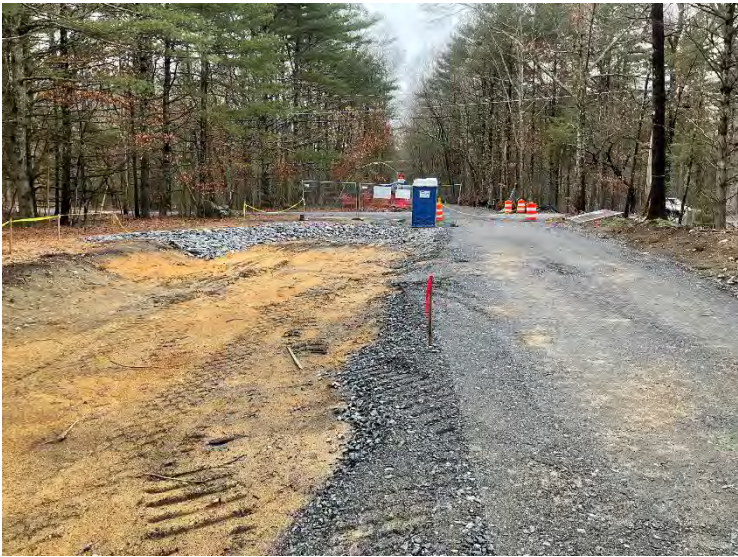
<p>PHOTOGRAPHIC LOG</p>	
<p>Client Name: Eversource</p>		<p>Site Location: Sudbury to Hudson Transmission Reliability Project</p>	<p>Town: Sudbury</p>
<p>Photo No.: 4</p>	<p>Date: 3/06/2024</p>

<p>Description: View of newly installed stormwater drainage feature "wide swale" at west end of segment 9. Facing east.</p>

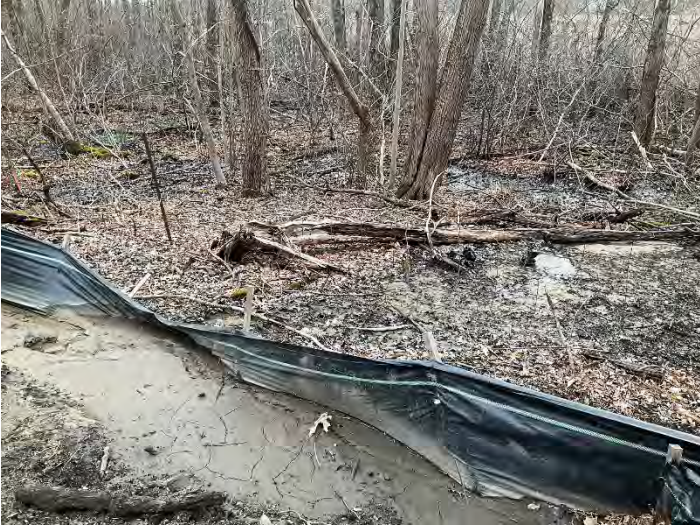
-Stormwater discharge was occurring at approximately Sta. #741+25 in segment 14 at time of inspection. Discharge appeared mostly clear, but a skim layer of sediment has deposited beyond the silt fence. Sediment had not reached the wetland at time of inspection. Silt fence repairs and sediment removal needed at this location.

Description: View of stormwater discharge occurring at Sta. #741+50 in segment 14. A skim layer of sediment has deposited beyond the silt fence. Sediment had not reached the wetland at time of inspection. Silt fence repairs and sediment removal needed at this location. Facing southeast.

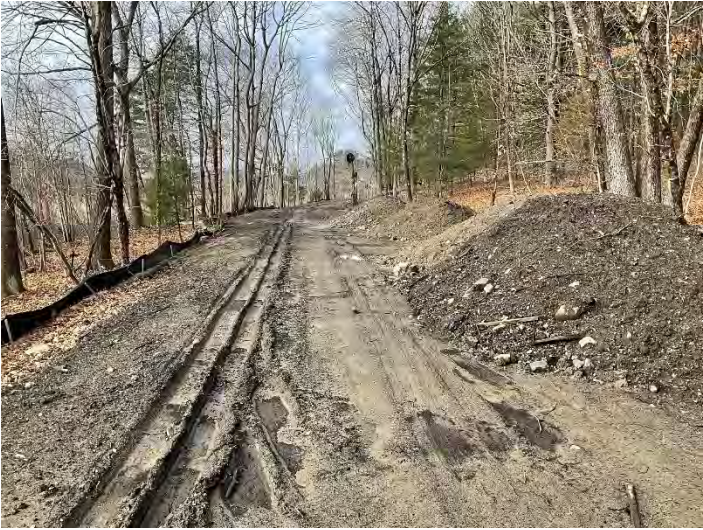
Description: View of stockpiles noted at approximately Sta. #738 in segment 14. Facing west.

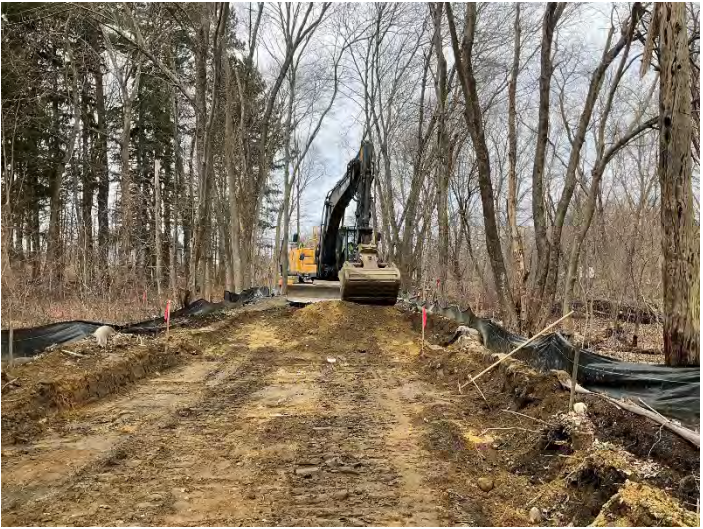
Description: View of ET&L performing grading activities in segment 13. E&S controls are being repaired as needed. Facing west.

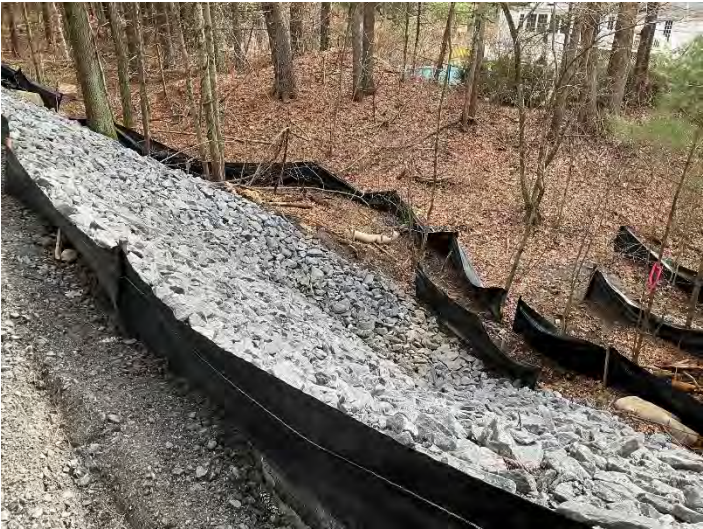
Description: View of south side/downstream side of repaired culvert in segment 9. Facing southeast.

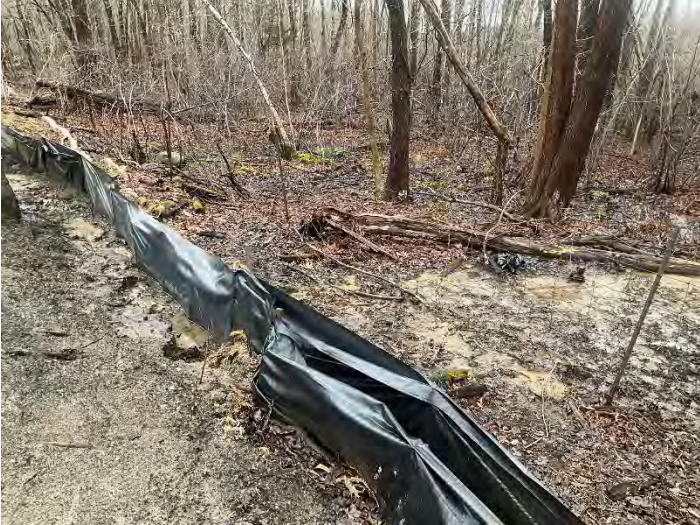
Description: View of stormwater discharge occurring at Sta. #741+50 in segment 14. A skim layer of sediment has deposited beyond the silt fence. Sediment had not reached the wetland at time of inspection. Repairs were made in this location earlier in the week, but are needed again following additional rain. Facing southeast.

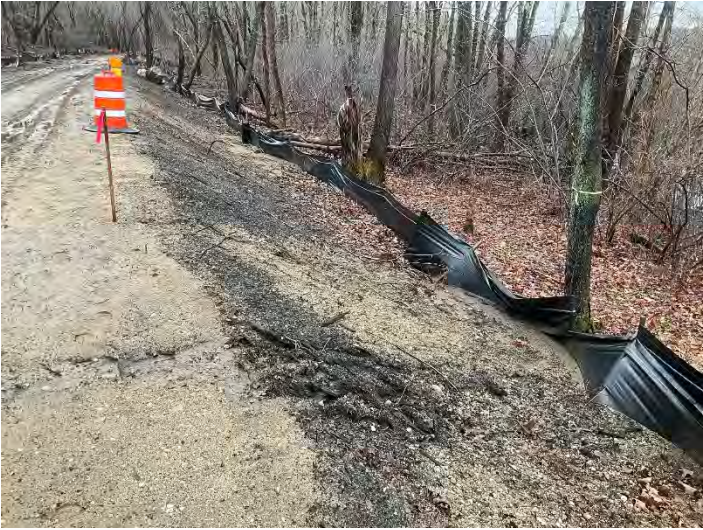
Description: View of silt fence in need of repair at approximately Sta. 739+50 in segment 14. Facing east.

Accompanied Bond crew into segments 10 (near manhole #20) & 14 (near manhole #27), 739+50 & 741+25, while they conducted erosion control repairs. Repairs at 741+25 also included removal of a skim layer of sediment beyond the silt fencing. The Bond crew hand shoveled material from beyond the silt fencing, but planned to return 3-11-24 with an excavator to remove any further material from the area.

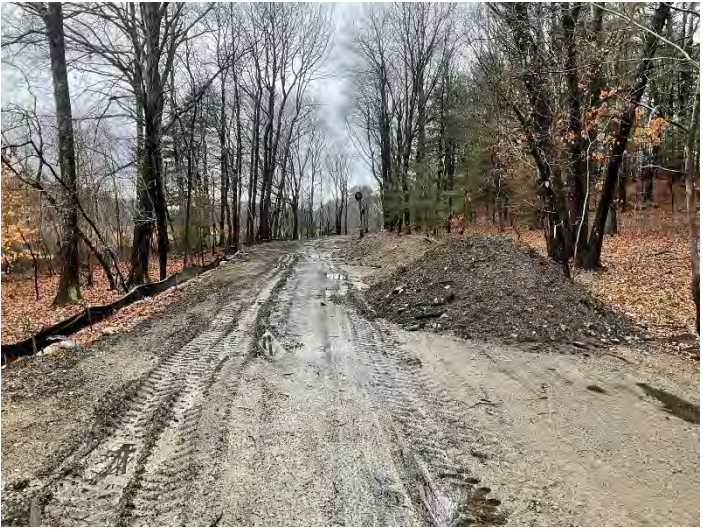
Description: View of stockpiles noted at approximately Sta. #738 in segment 14. Stockpiles have now been present for over a week and need to be removed or spread. Facing west.

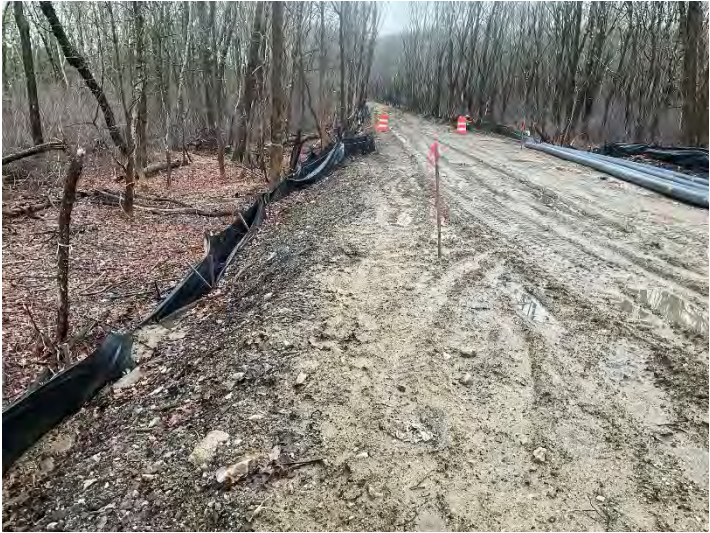
Description: View of silt fence in need of repair near MH #20 in segment 10. Facing east.

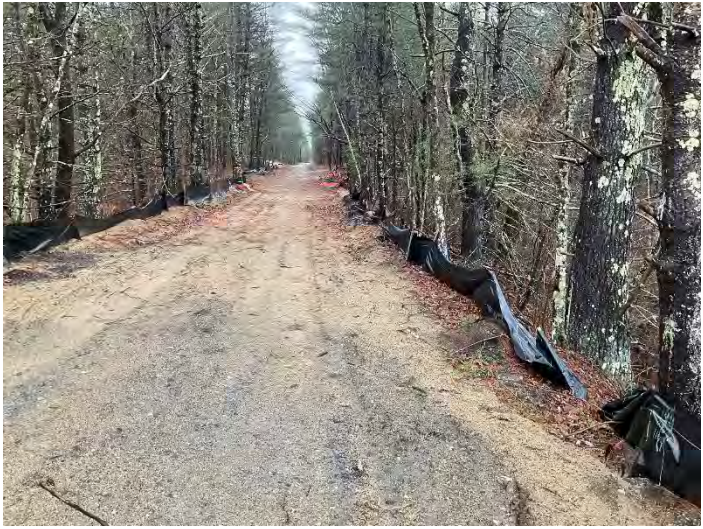
Description: View of silt fence at east end of segment 7, near bridge 128. Silt fence repairs are needed in this area. Facing west.
