Weekly Environmental Compliance Summary

Sudbury to Hudson Transmission Reliability Project (USEPA Tracking # MAR1003UW)

Sudbury, Hudson, and Stow, MA

Week of: March 25, 2024 to March 30, 2024

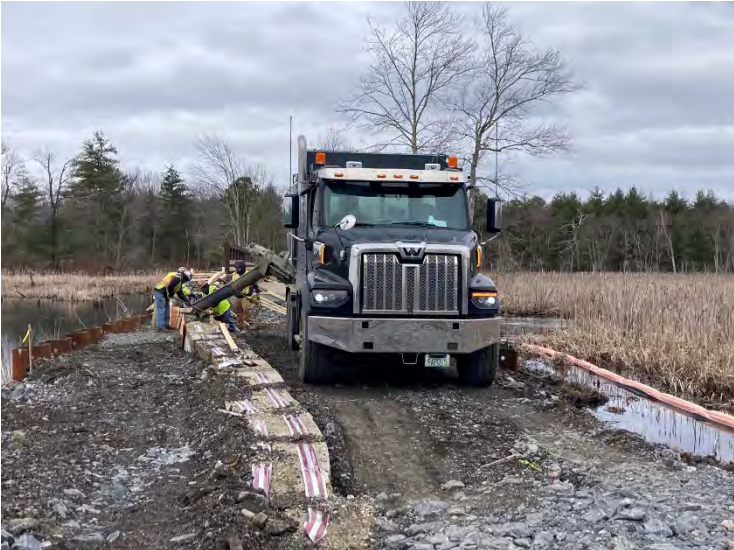
<p align="right">PHOTOGRAPHIC LOG</p>	
<p>Client Name: Eversource</p>		<p>Site Location: Sudbury to Hudson Transmission Reliability Project</p>	<p>Town: Hudson</p>
<p>Photo No.: 2</p>	<p>Date: 3/26/2024</p>

<p>Description: View of Bond working at Bridge 130. Facing west.</p>

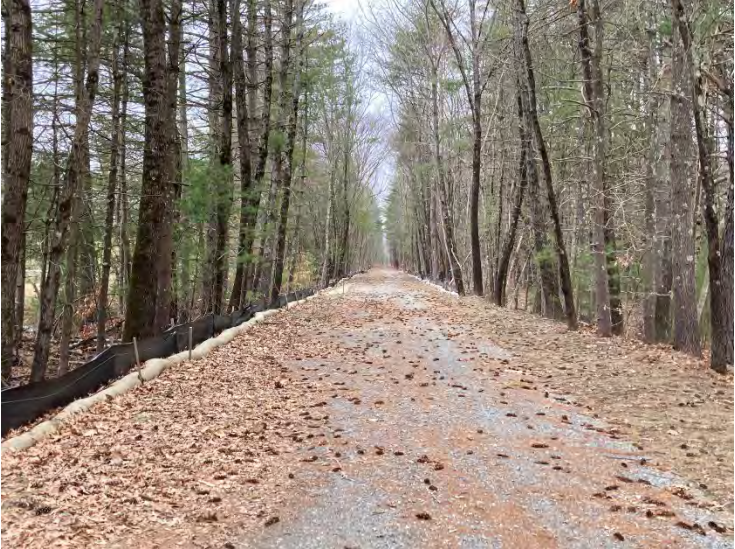
PHOTOGRAPHIC LOG	
Client Name: Eversource		Site Location: Sudbury to Hudson Transmission Reliability Project	Town: Hudson
Photo No.: 3	Date: 3/26/2024

Description: View of E&S controls in segment 4. Facing west.

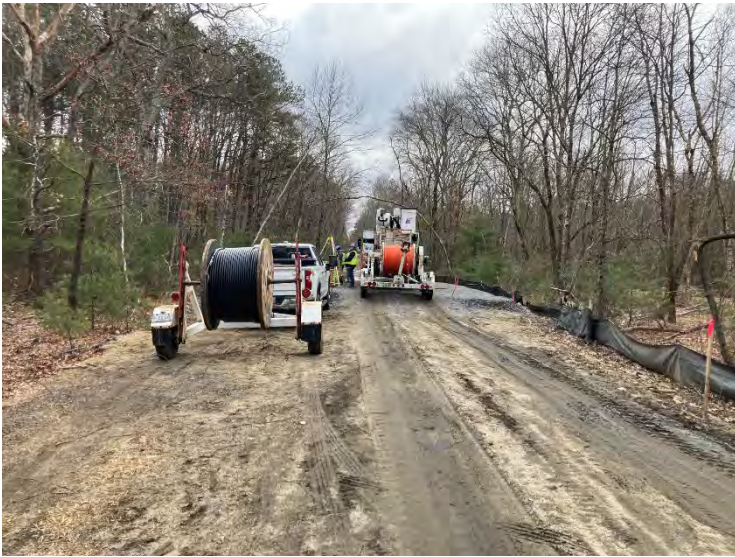
PHOTOGRAPHIC LOG	
Client Name: Eversource		Site Location: Sudbury to Hudson Transmission Reliability Project	Town: Hudson
Photo No.: 4	Date: 3/26/2024

Description: View of Haugland working at MH #14 in segment 6. See additional dewatering inspection report. Facing east.

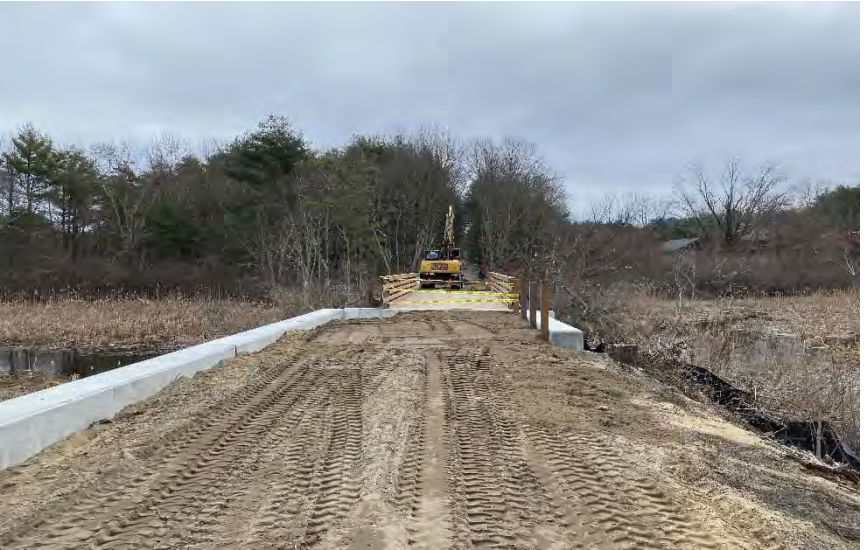
<p>PHOTOGRAPHIC LOG</p>	
<p>Client Name: Eversource</p>		<p>Site Location: Sudbury to Hudson Transmission Reliability Project</p>	<p>Town: Sudbury</p>
<p>Photo No.: 1</p>	<p>Date: 3-26-24</p>

<p>Description:</p> <p>Work area within segment 7, backfilling following conduit work, existing erosion control, looking eastward.</p>

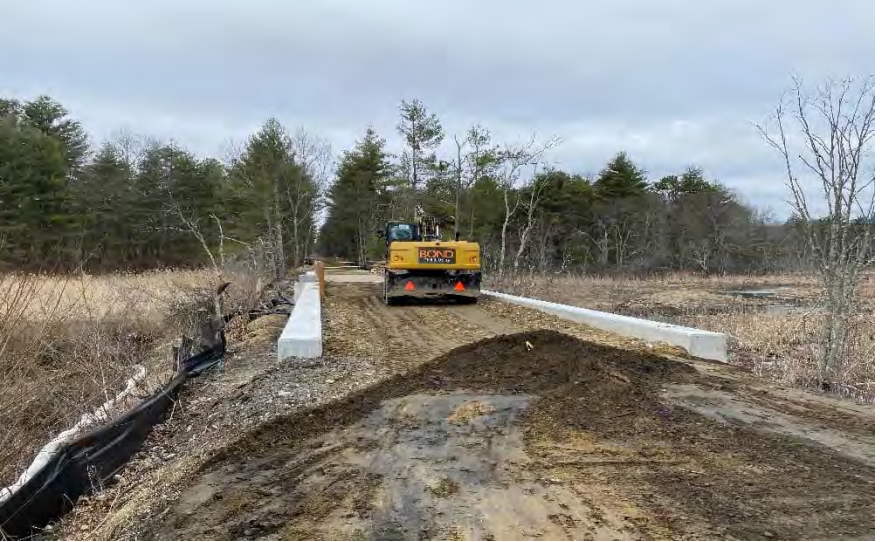
<p>PHOTOGRAPHIC LOG</p>	
<p>Client Name: Eversource</p>		<p>Site Location: Sudbury to Hudson Transmission Reliability Project</p>	<p>Town: Sudbury</p>
<p>Photo No.: 2</p>	<p>Date: 3-26-24</p>

<p>Description:</p> <p>Work area within segment 8, backfilling following conduit work, existing erosion control, looking westward.</p>

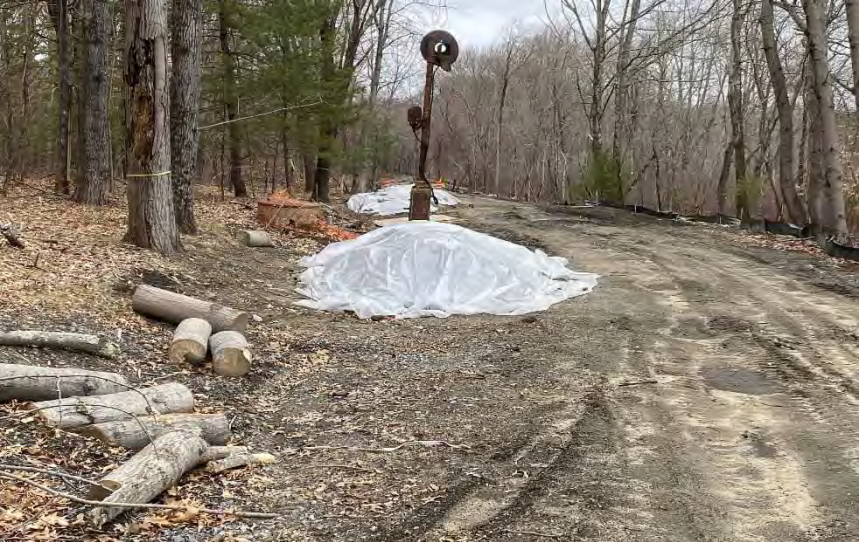
<p>PHOTOGRAPHIC LOG</p>	
<p>Client Name: Eversource</p>		<p>Site Location: Sudbury to Hudson Transmission Reliability Project</p>	<p>Town: Sudbury</p>
<p>Photo No.: 4</p>	<p>Date: 3-26-24</p>

Spoil Berm noted within segment 14, berm created 3-8-24, see photo 4.

<p>Description:</p> <p>Work area within Segment 14, covered spoil berm, looking eastward.</p>

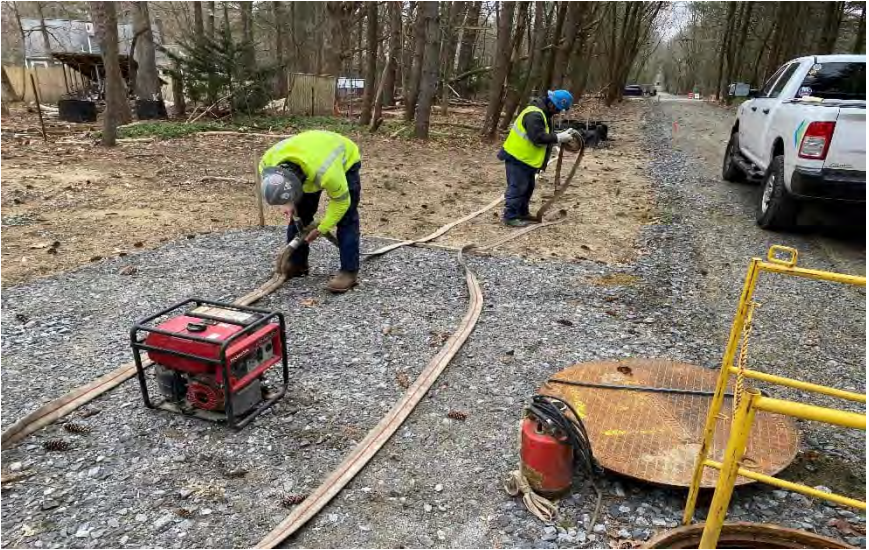
<p>PHOTOGRAPHIC LOG</p>	
<p>Client Name: Eversource</p>		<p>Site Location: Sudbury to Hudson Transmission Reliability Project</p>	<p>Town: Sudbury</p>
<p>Photo No.: 5</p>	<p>Date: 3-26-24</p>

<p>Description:</p> <p>Work area within Segment 10, wire pulling work (racking) at manhole #21, looking eastward.</p>

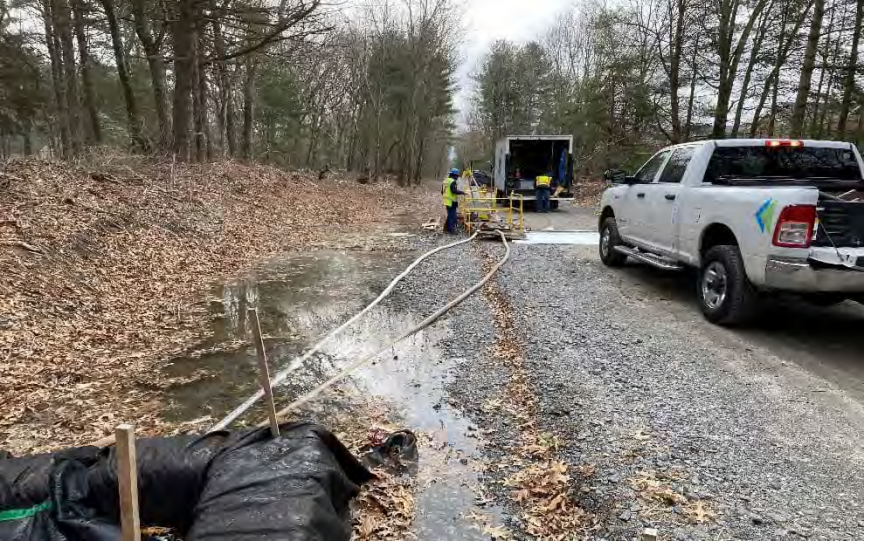
<p>PHOTOGRAPHIC LOG</p>	
<p>Client Name: Eversource</p>		<p>Site Location: Sudbury to Hudson Transmission Reliability Project</p>	<p>Town: Sudbury</p>
<p>Photo No.: 6</p>	<p>Date: 3-26-24</p>

<p>Description:</p> <p>Work area within Segment 11, wire pulling work (racking) at manhole #22, looking eastward.</p>

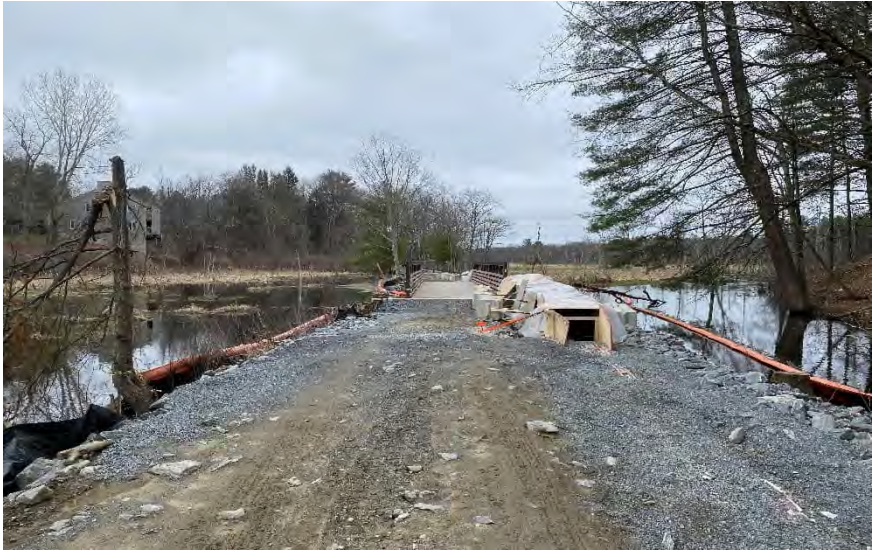
<p>PHOTOGRAPHIC LOG</p>	
<p>Client Name: Eversource</p>		<p>Site Location: Sudbury to Hudson Transmission Reliability Project</p>	<p>Town: Sudbury</p>
<p>Photo No.: 7</p>	<p>Date: 3-26-24</p>

<p>Description:</p> <p>Work area within Segment 13, post-conduit work at bridge 127, existing erosion control, looking eastward.</p>

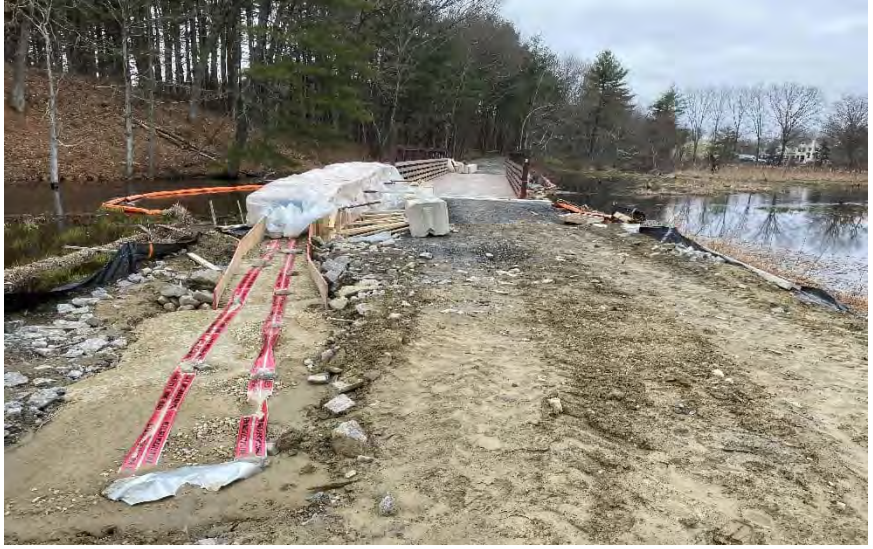
<p>PHOTOGRAPHIC LOG</p>	
<p>Client Name: Eversource</p>		<p>Site Location: Sudbury to Hudson Transmission Reliability Project</p>	<p>Town: Sudbury</p>
<p>Photo No.: 8</p>	<p>Date: 3-26-24</p>

<p>Description:</p> <p>Work area within Segment 14, post-conduit work at bridge 127, existing erosion control, looking westward.</p>

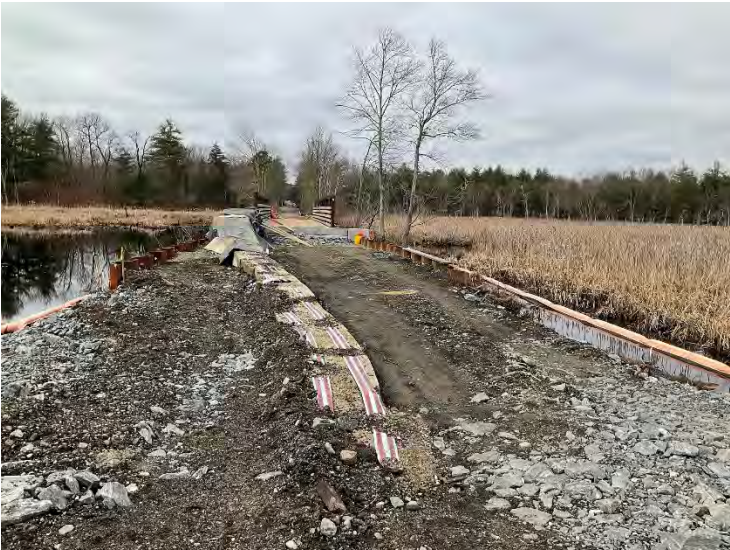
<p align="right">PHOTOGRAPHIC LOG</p>	
<p>Client Name: Eversource</p>		<p>Site Location: Sudbury to Hudson Transmission Reliability Project</p>	<p>Town: Hudson</p>
<p>Photo No.: 1</p>	<p>Date: 3/27/2024</p>

<p>Description: View of Bond's work area at Bridge 130. Facing west.</p>

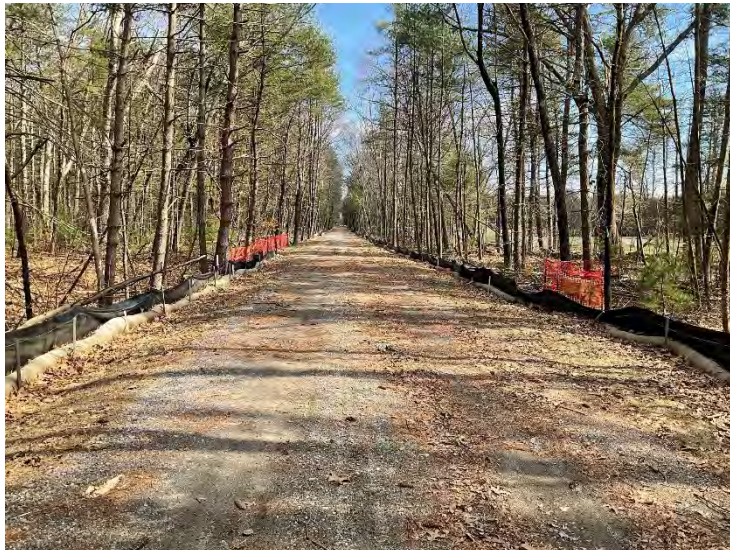
<p align="right">PHOTOGRAPHIC LOG</p>	
<p>Client Name: Eversource</p>		<p>Site Location: Sudbury to Hudson Transmission Reliability Project</p>	<p>Town: Hudson</p>
<p>Photo No.: 2</p>	<p>Date: 3/27/2024</p>

<p>Description: View of E&S controls in segment 4. Facing east.</p>

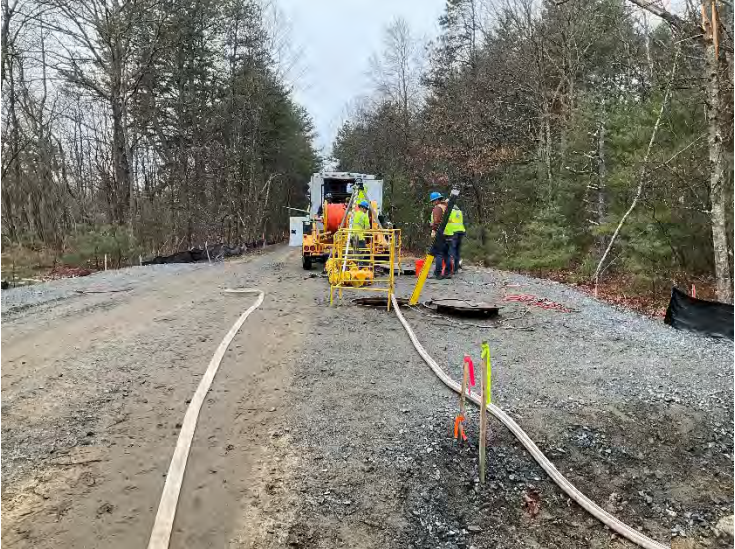
PHOTOGRAPHIC LOG	
Client Name: Eversource		Site Location: Sudbury to Hudson Transmission Reliability Project	Town: Hudson
Photo No.: 3	Date: 3/27/2024

Description: View of Haugland working at MH #14 in segment 6. Facing west.

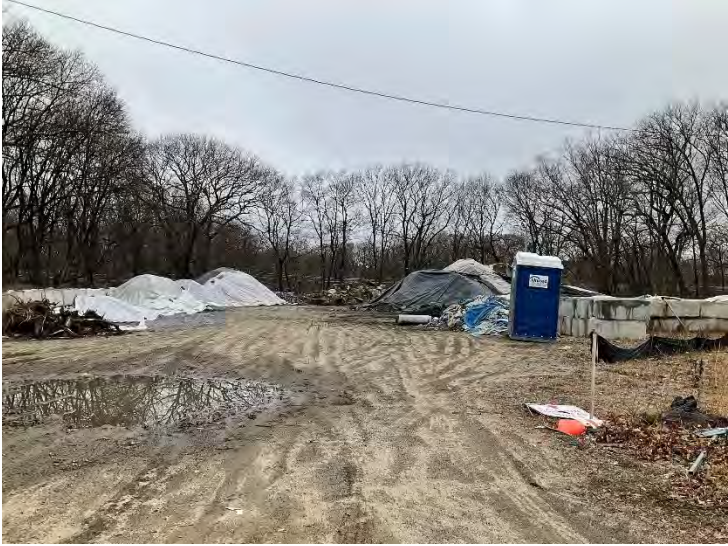
PHOTOGRAPHIC LOG	
Client Name: Eversource		Site Location: Sudbury to Hudson Transmission Reliability Project	Town: Hudson
Photo No.: 6	Date: 3/27/2024

Description: View of Stowe Ct laydown yard. Facing northeast.

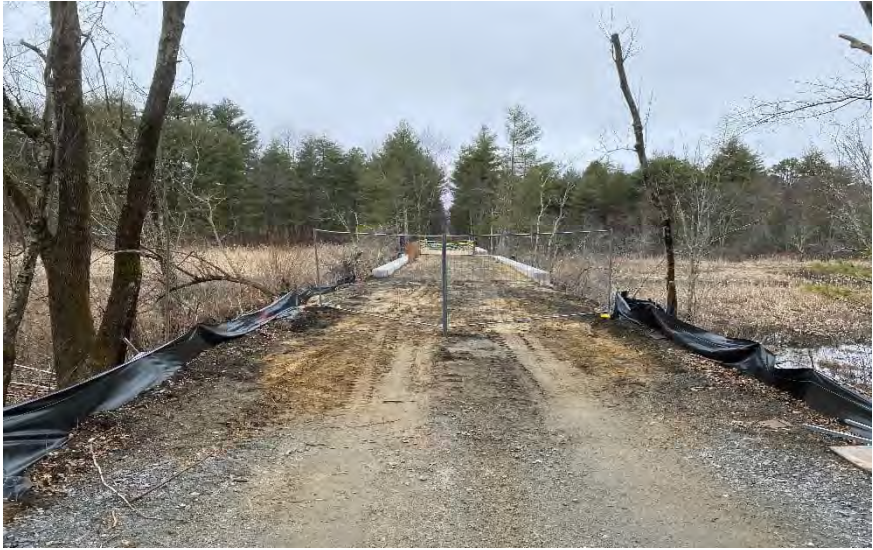
<p>PHOTOGRAPHIC LOG</p>	
<p>Client Name: Eversource</p>		<p>Site Location: Sudbury to Hudson Transmission Reliability Project</p>	<p>Town: Sudbury</p>
<p>Photo No.: 1</p>	<p>Date: 3-27-24</p>

<p>Description:</p> <p>Work area within segment 8, existing erosion control, looking westward.</p>

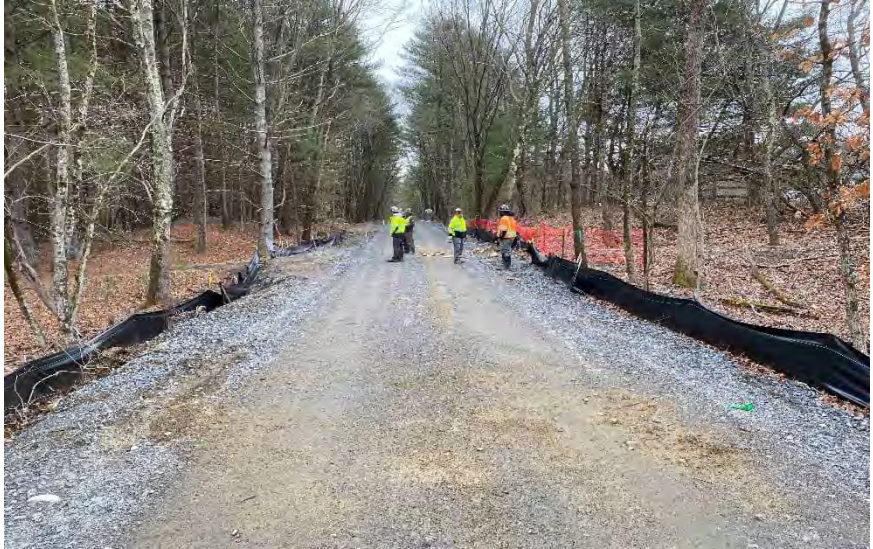
<p>PHOTOGRAPHIC LOG</p>	
<p>Client Name: Eversource</p>		<p>Site Location: Sudbury to Hudson Transmission Reliability Project</p>	<p>Town: Sudbury</p>
<p>Photo No.: 2</p>	<p>Date: 3-27-24</p>

<p>Description:</p> <p>Work area within segment 8, erosion control repairs, existing erosion control, looking eastward.</p>

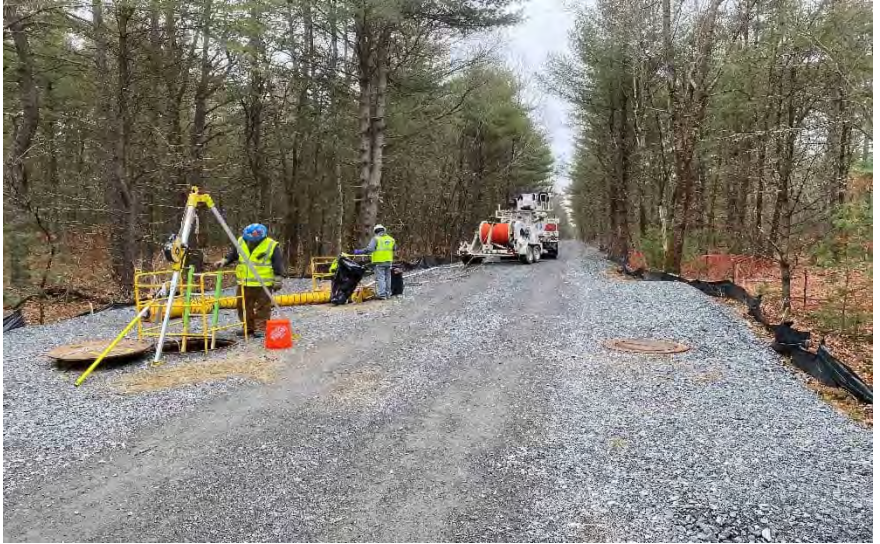
<p>PHOTOGRAPHIC LOG</p>	
<p>Client Name: Eversource</p>		<p>Site Location: Sudbury to Hudson Transmission Reliability Project</p>	<p>Town: Sudbury</p>
<p>Photo No.: 4</p>	<p>Date: 3-27-24</p>

<p>Description:</p> <p>Work area within Segment 7, wire pulling work at manhole #15, looking westward.</p>

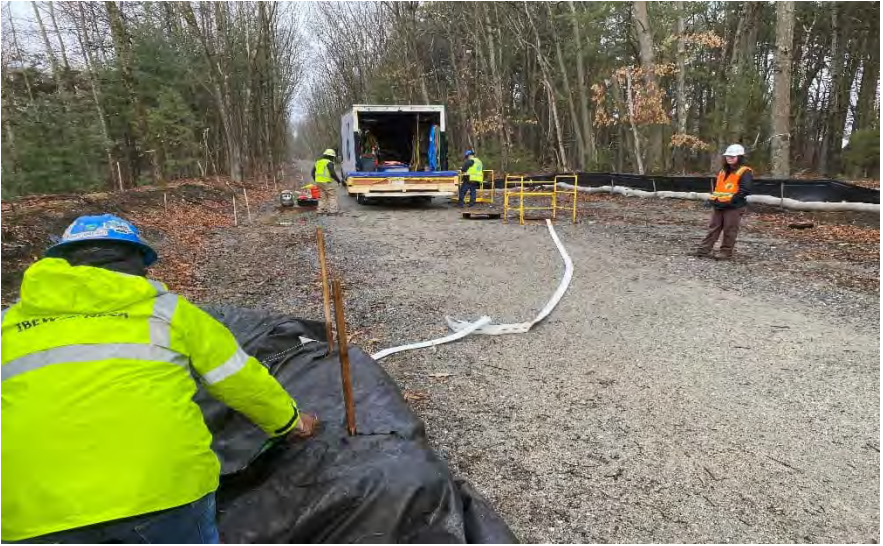
<p>PHOTOGRAPHIC LOG</p>	
<p>Client Name: Eversource</p>		<p>Site Location: Sudbury to Hudson Transmission Reliability Project</p>	<p>Town: Sudbury</p>
<p>Photo No.: 5</p>	<p>Date: 3-27-24</p>

<p>Description:</p> <p>Work area within Segment 11, wire pulling work (racking) at manhole #23, looking westward.</p>

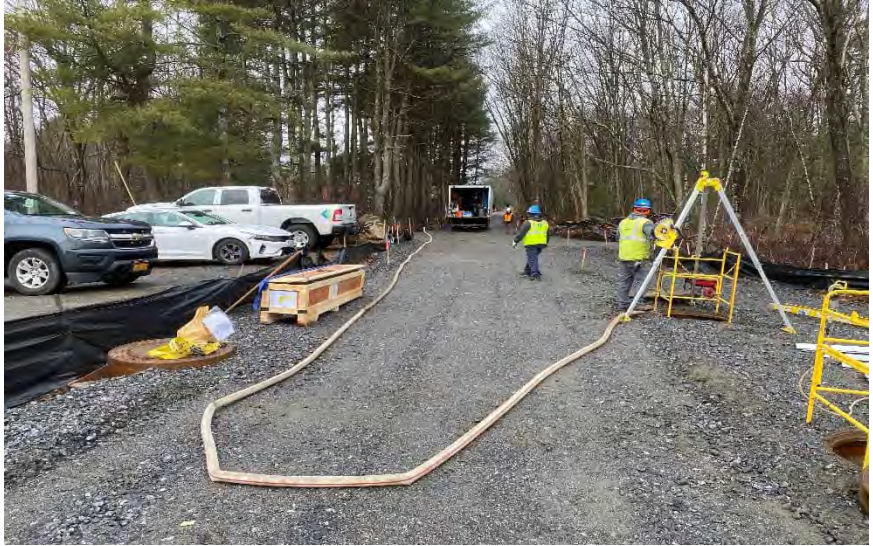
<p>PHOTOGRAPHIC LOG</p>	
<p>Client Name: Eversource</p>		<p>Site Location: Sudbury to Hudson Transmission Reliability Project</p>	<p>Town: Sudbury</p>
<p>Photo No.: 6</p>	<p>Date: 3-27-24</p>

<p>Description:</p> <p>Work area within Segment 11, wire pulling work (racking) at manhole #24, looking westward.</p>

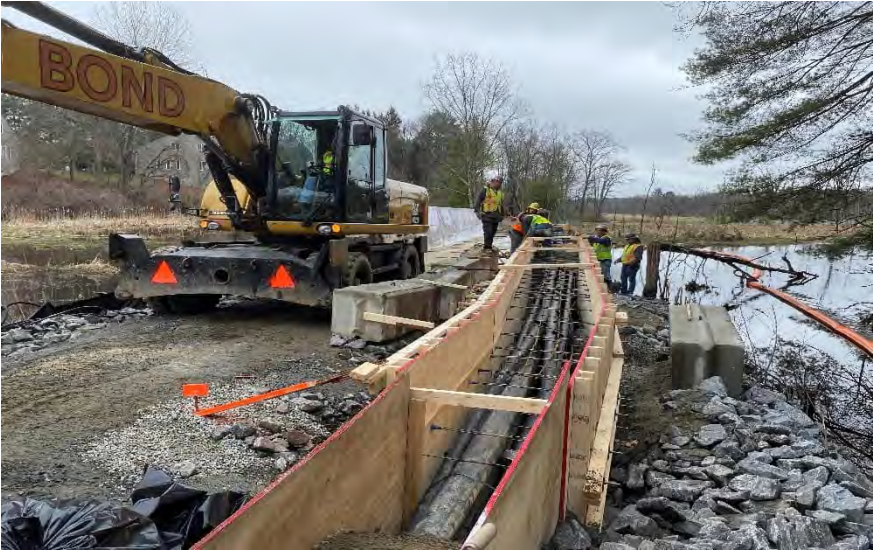
<p>Description:</p> <p>Work area within Segment 13, conduit work at bridge 127, existing erosion control, looking eastward.</p>

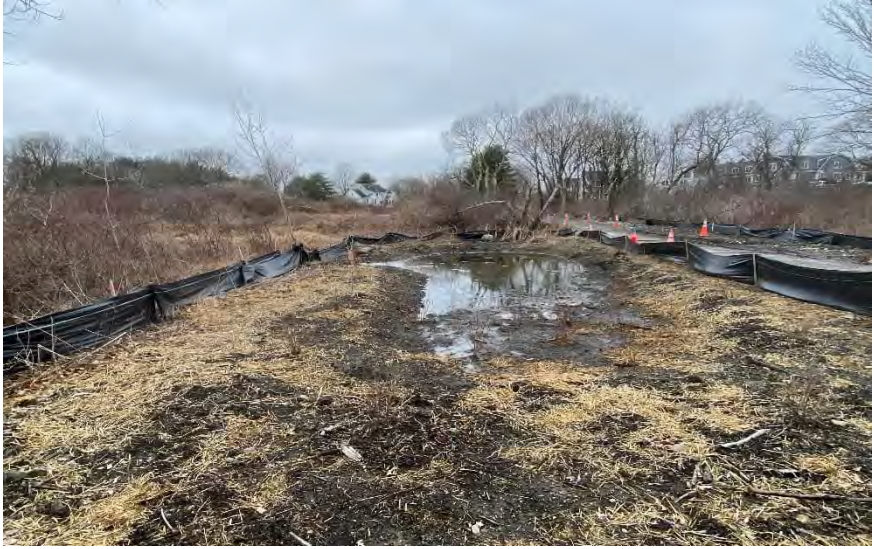
<p>Description:</p> <p>Wetland replication area within Segment 14, existing erosion control, looking westward.</p>

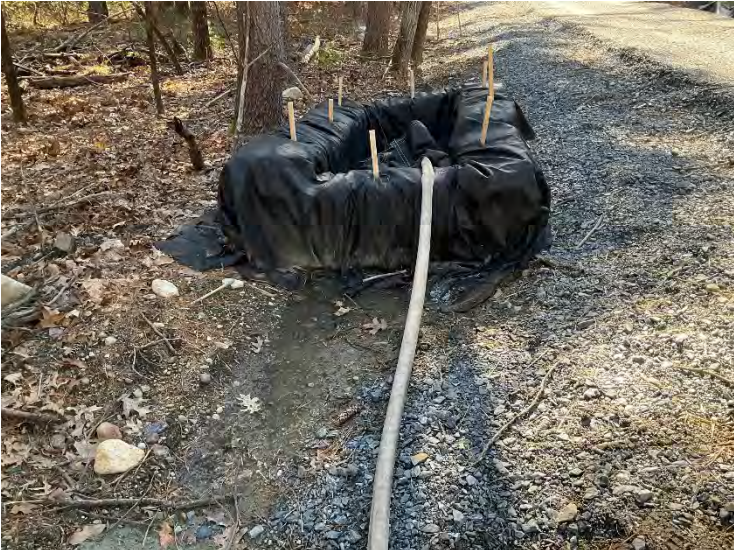
<p>Description: View of dewatering controls at MH #15 in segment 7. See additional dewatering report. Facing east.</p>

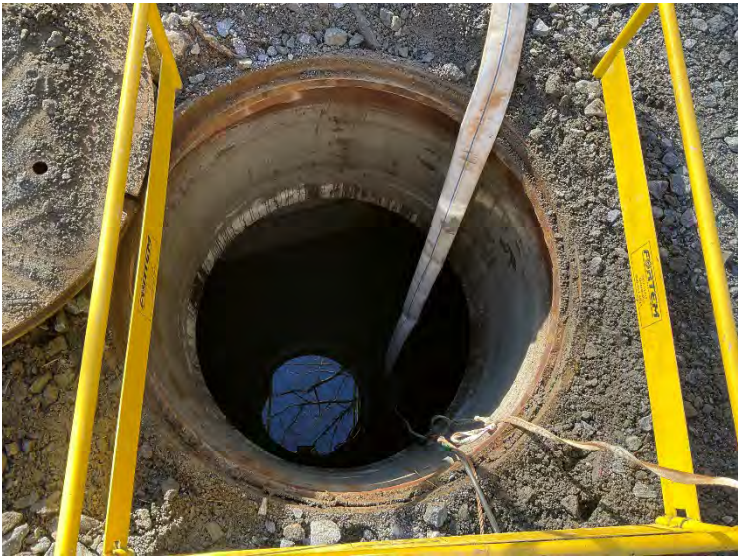
Description: View of pump in MH #25 in segment 13. See additional dewatering report.

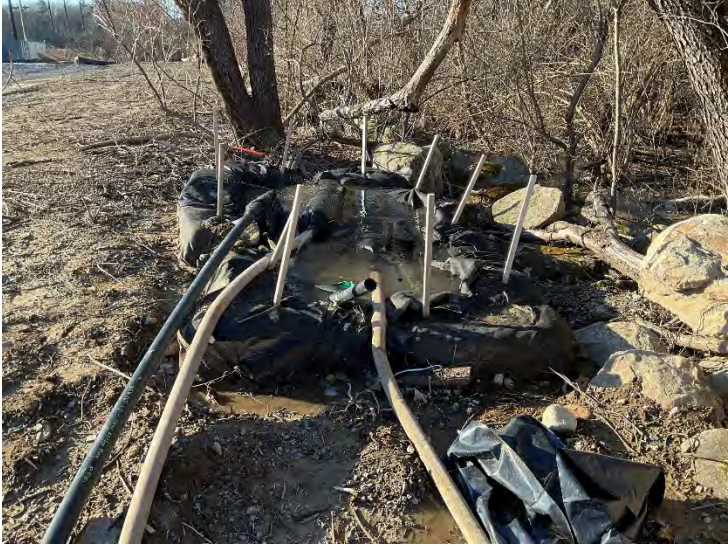
Description: View of dewatering controls at MH #28 at Sudbury Substation. See additional dewatering inspection report. Facing south.

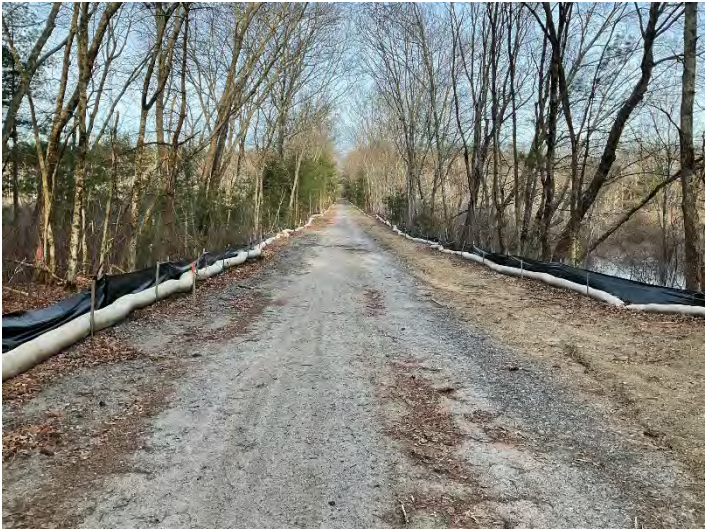
Description: View of E&S controls in segment 5. Facing west.

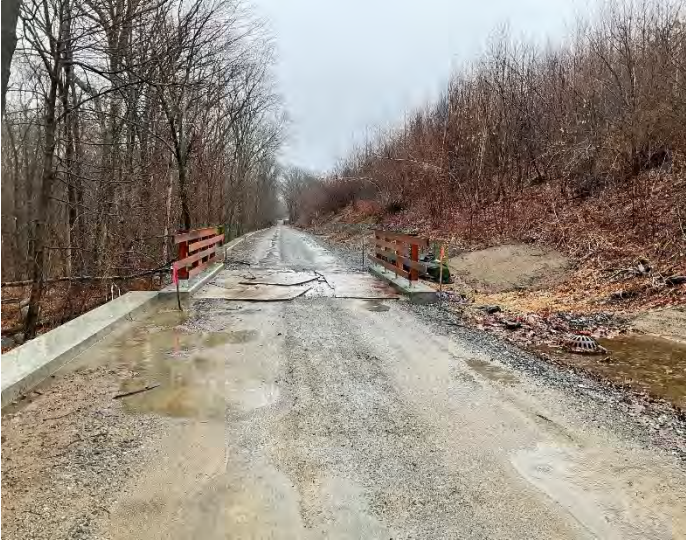
Description: View of drainage structures 3 and 4 and cattle crossing in segment 1. Discharge of stormwater and groundwater seep occurring at time of inspection, but no issues noted. Facing east.

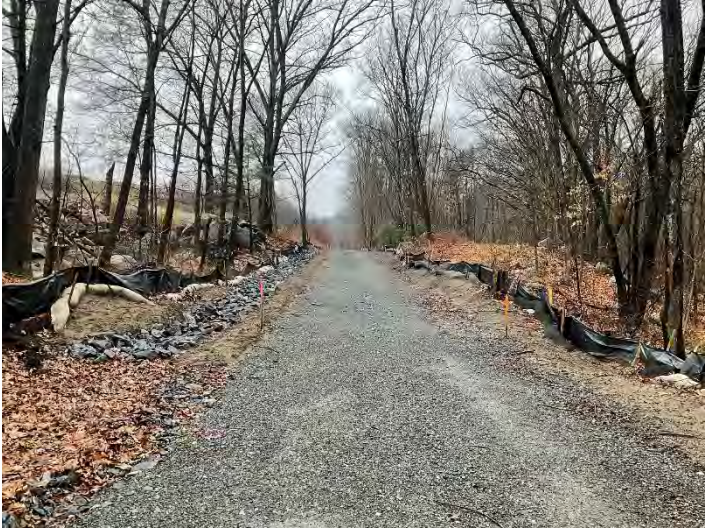
Description: View of E&S controls at the Stow/Hudson town line. Controls are operating properly. Facing west.

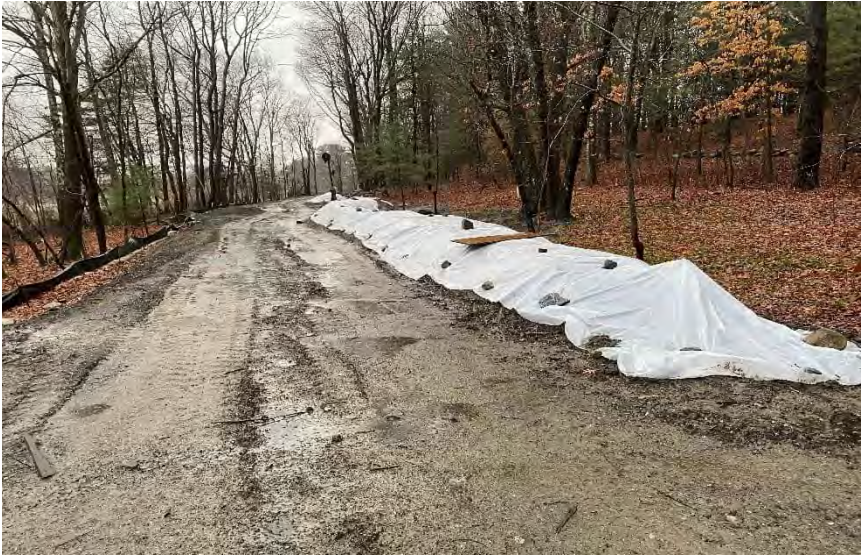
Description: Work area within segment 14, covered spoil pile, existing erosion control, looking westward.

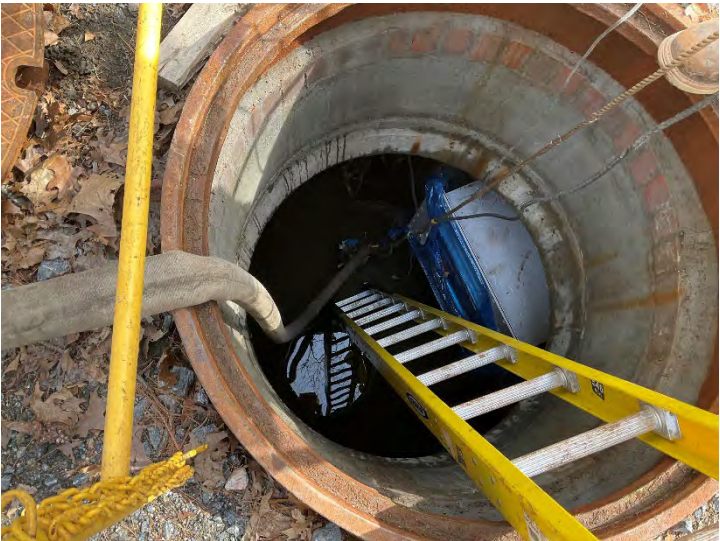
Description: View of pump in MH #13. Water appeared mostly clear prior to treatment.

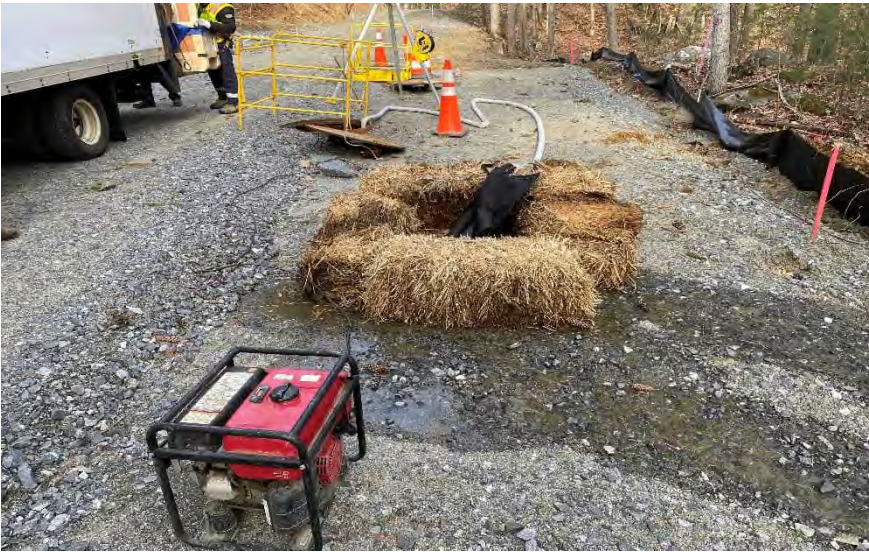
Description: Manhole #20. View of discharge bag/corral, looking westward. Water from bag/corral discharged to adjacent area.

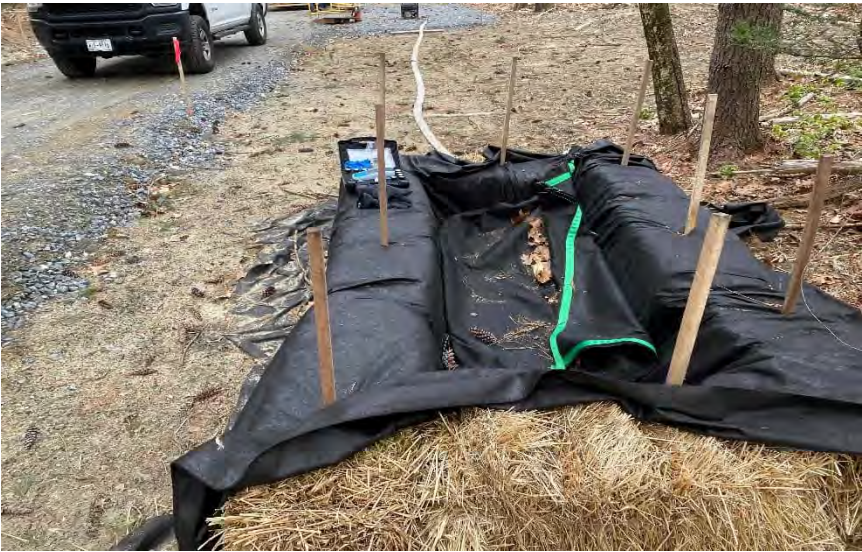
Description: Manhole #21. View of discharge bag/corral, looking westward. Water from bag/corral discharged to adjacent area.

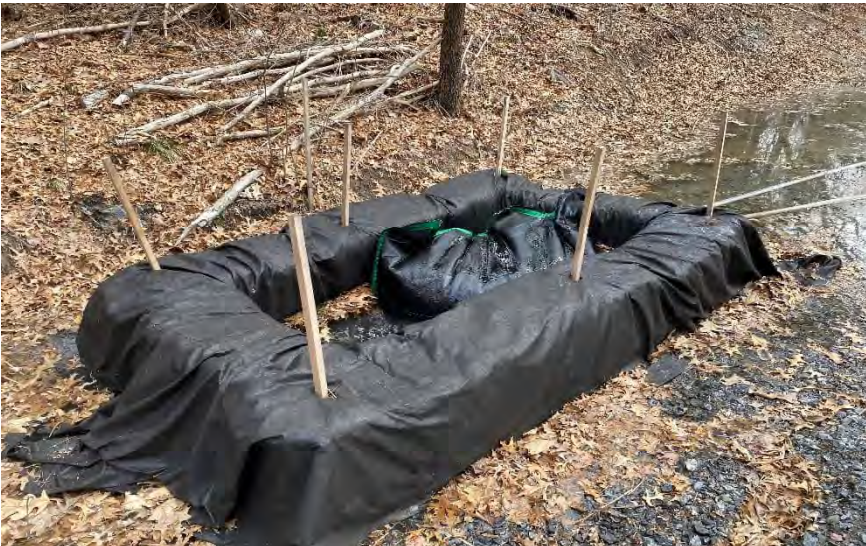
Description: Manhole #22. View of discharge bag/corral, looking eastward. Water from bag/corral discharged to adjacent area.
