Weekly Environmental Compliance Summary

Sudbury to Hudson Transmission Reliability Project (USEPA Tracking # MAR1003UW)

Sudbury, Hudson, and Stow, MA

Week of: April 1, 2024 to April 6, 2024

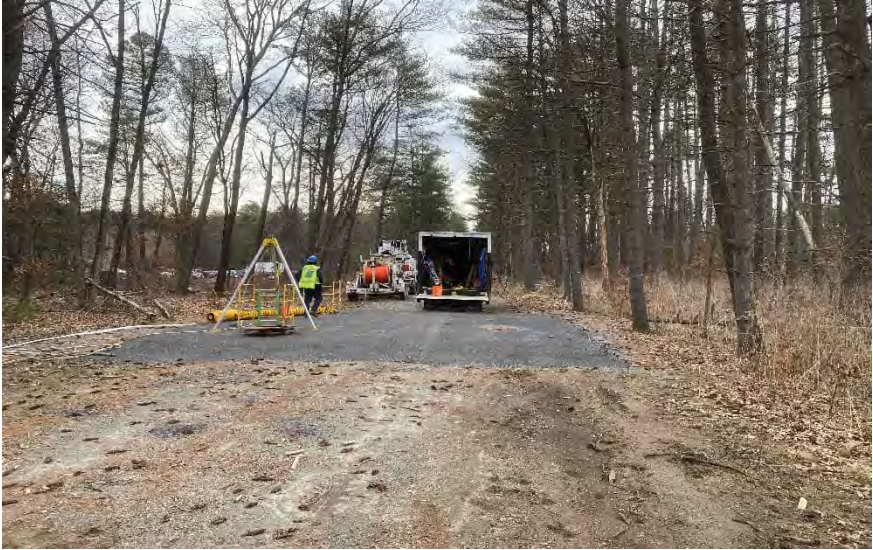
<p>PHOTOGRAPHIC LOG</p>	
<p>Client Name: Eversource</p>		<p>Site Location: Sudbury to Hudson Transmission Reliability Project</p>	<p>Town: Hudson</p>
<p>Photo No.: 2</p>	<p>Date: 4-1-24</p>

<p>Description:</p> <p>Work area within Segment 4, manhole #10, cable pulling work, looking eastward.</p>

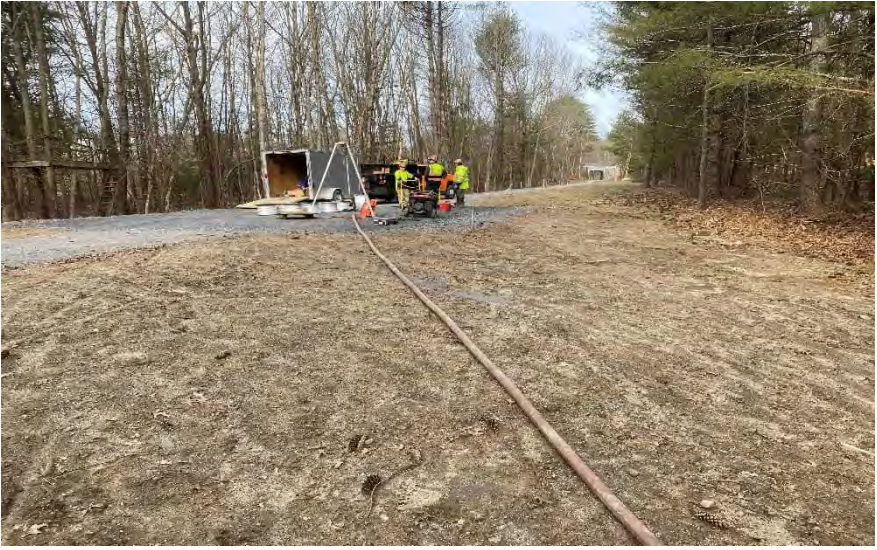
PHOTOGRAPHIC LOG	
Client Name: Eversource		Site Location: Sudbury to Hudson Transmission Reliability Project	Town: Hudson
Photo No.: 3	Date: 4-1-24

Description: Work area within Segment 2, manhole #7, proofing work, looking westward.

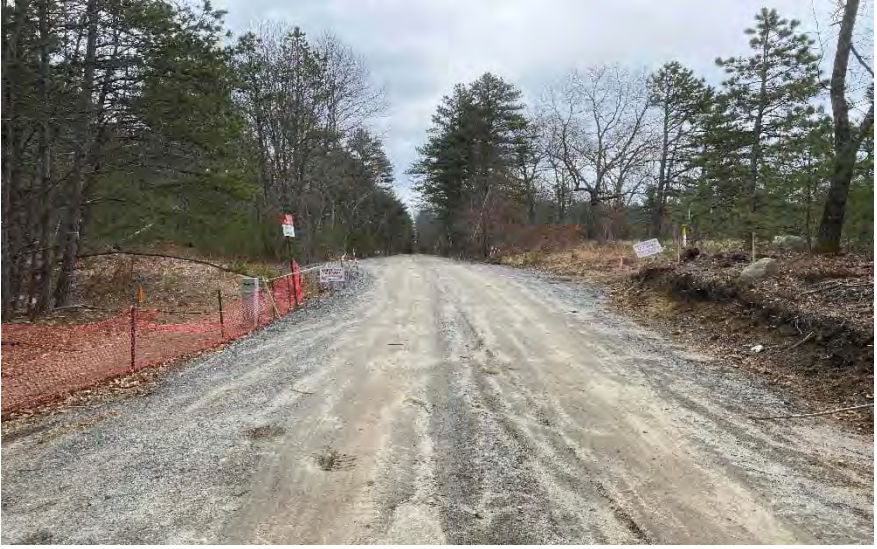
PHOTOGRAPHIC LOG	
Client Name: Eversource		Site Location: Sudbury to Hudson Transmission Reliability Project	Town: Hudson
Photo No.: 4	Date: 4-1-24

Description: Work area within segment 6, town line area, looking eastward.

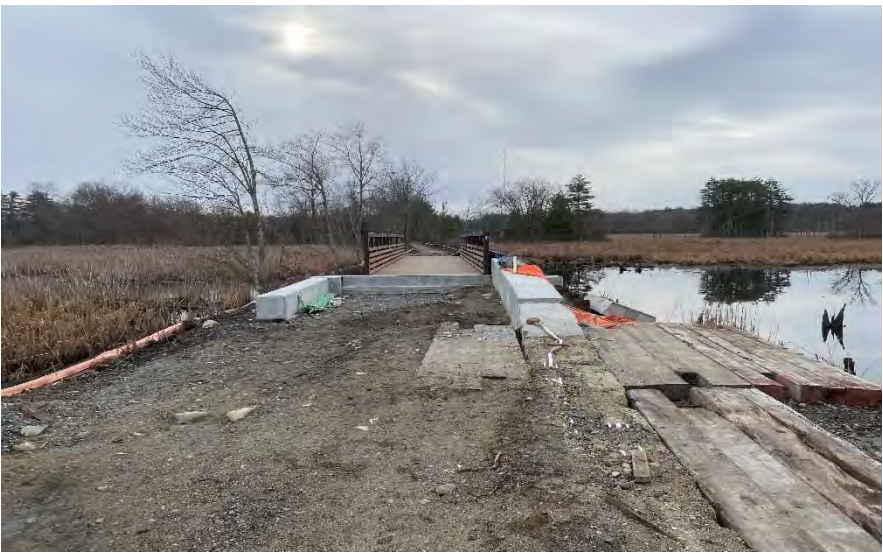
<p>PHOTOGRAPHIC LOG</p>	
<p>Client Name: Eversource</p>		<p>Site Location: Sudbury to Hudson Transmission Reliability Project</p>	<p>Town: Hudson</p>
<p>Photo No.: 5</p>	<p>Date: 4-1-24</p>

<p>Description:</p> <p>Work area within segment 2 looking across Fort Meadow Brook, existing erosion control, looking westward.</p>

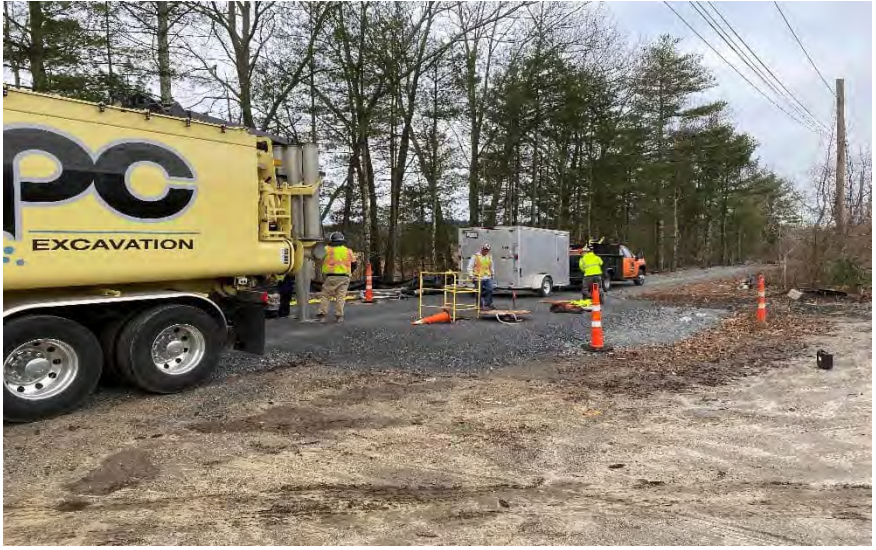
<p>PHOTOGRAPHIC LOG</p>	
<p>Client Name: Eversource</p>		<p>Site Location: Sudbury to Hudson Transmission Reliability Project</p>	<p>Town: Hudson</p>
<p>Photo No.: 7</p>	<p>Date: 4-1-24</p>

<p>Description:</p> <p>Work area within Segment 3, manhole #8, proofing work, existing erosion control, looking eastward.</p>

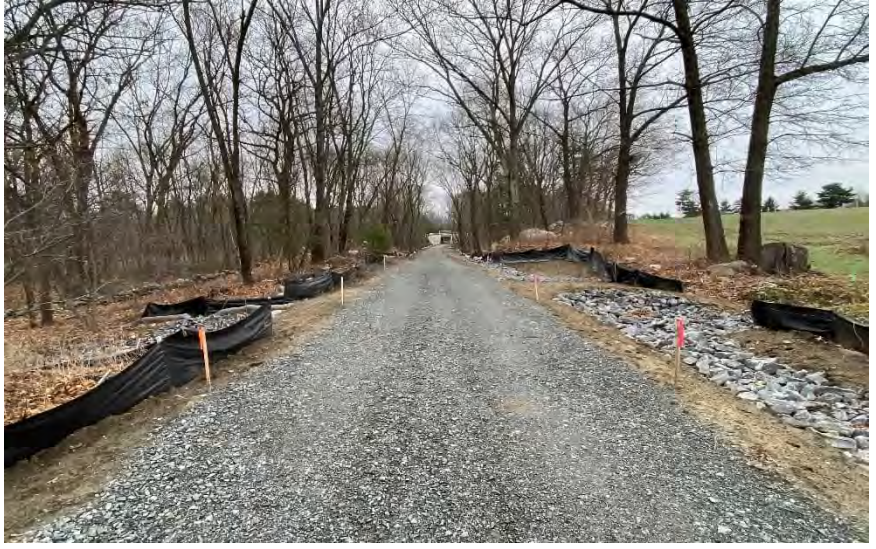
<p>PHOTOGRAPHIC LOG</p>	
<p>Client Name: Eversource</p>		<p>Site Location: Sudbury to Hudson Transmission Reliability Project</p>	<p>Town: Stow</p>
<p>Photo No.: 8</p>	<p>Date: 4-1-24</p>

<p>Description:</p> <p>Work area within segment 1, within Stow, existing erosion control, looking eastward.</p>

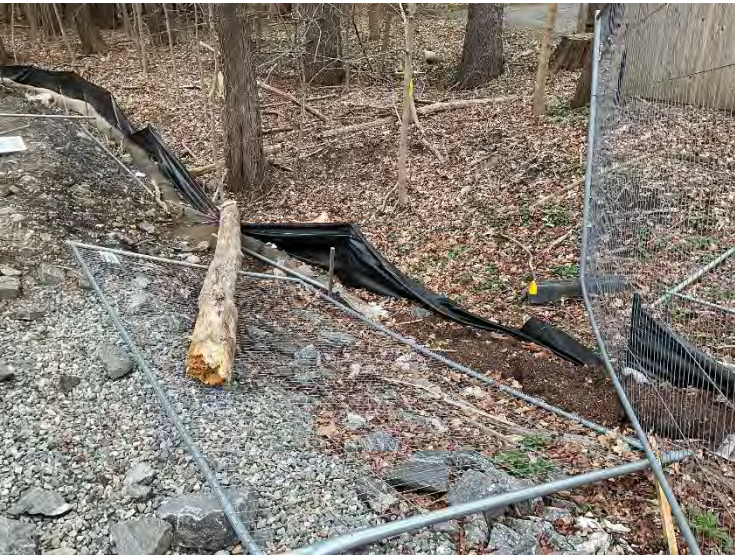
<p>PHOTOGRAPHIC LOG</p>	
<p>Client Name: Eversource</p>		<p>Site Location: Sudbury to Hudson Transmission Reliability Project</p>	<p>Town: Sudbury</p>
<p>Photo No.: 4</p>	<p>Date: 4/01/2024</p>

<p>Description: View of silt fence in need of repair at entrance to segment 13. Facing southeast.</p>

- Repair silt fence where needed in segments 13 and 14.**
-
-

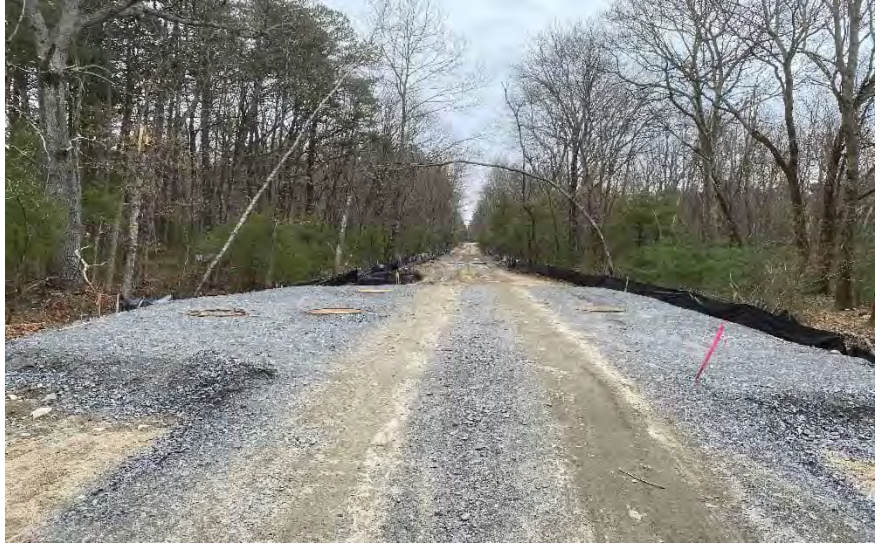
<p>PHOTOGRAPHIC LOG</p>	
<p>Client Name: Eversource</p>		<p>Site Location: Sudbury to Hudson Transmission Reliability Project</p>	<p>Town: Hudson</p>
<p>Photo No.: 8</p>	<p>Date: 4-2-24</p>

<p>Description:</p> <p>Work area within segment 6, manhole #14, existing erosion control, looking eastward.</p>

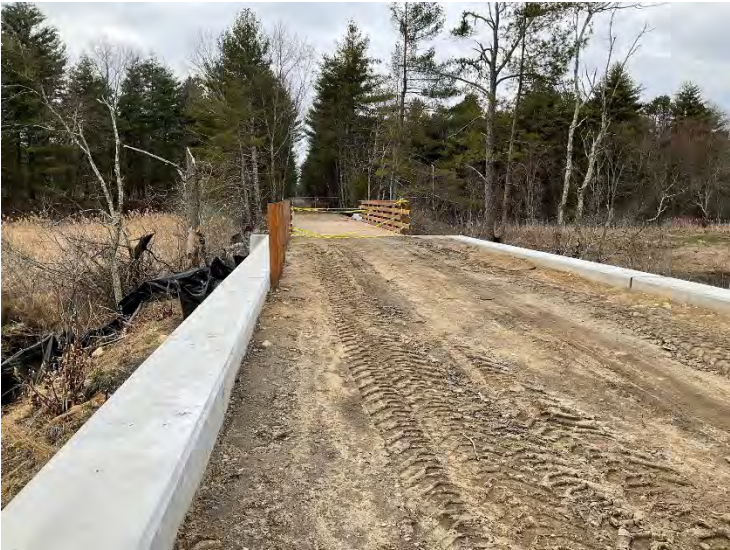
<p>PHOTOGRAPHIC LOG</p>	
<p>Client Name: Eversource</p>		<p>Site Location: Sudbury to Hudson Transmission Reliability Project</p>	<p>Town: Sudbury</p>
<p>Photo No.: 1</p>	<p>Date: 4/02/2024</p>

<p>Description: View of bridge 128. Facing west.</p>

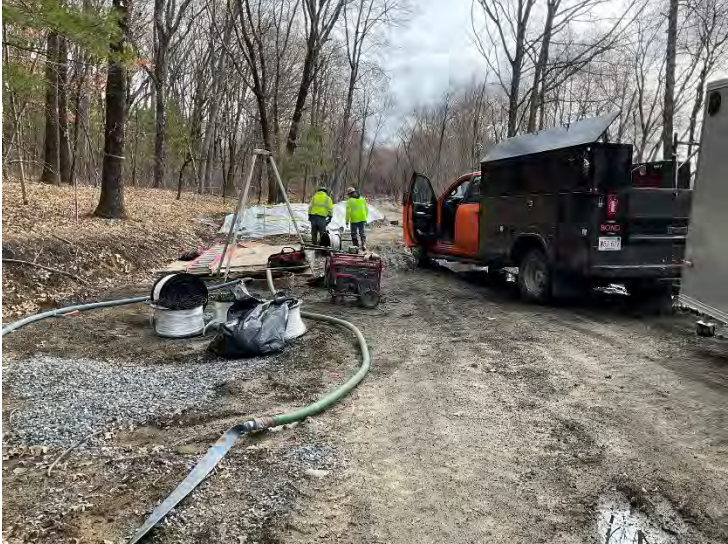
<p>PHOTOGRAPHIC LOG</p>	
<p>Client Name: Eversource</p>		<p>Site Location: Sudbury to Hudson Transmission Reliability Project</p>	<p>Town: Sudbury</p>
<p>Photo No.: 6</p>	<p>Date: 4/02/2024</p>

<p>Description: View of Bond working at MH #26 in segment 14. See additional dewatering inspection report. Facing east.</p>

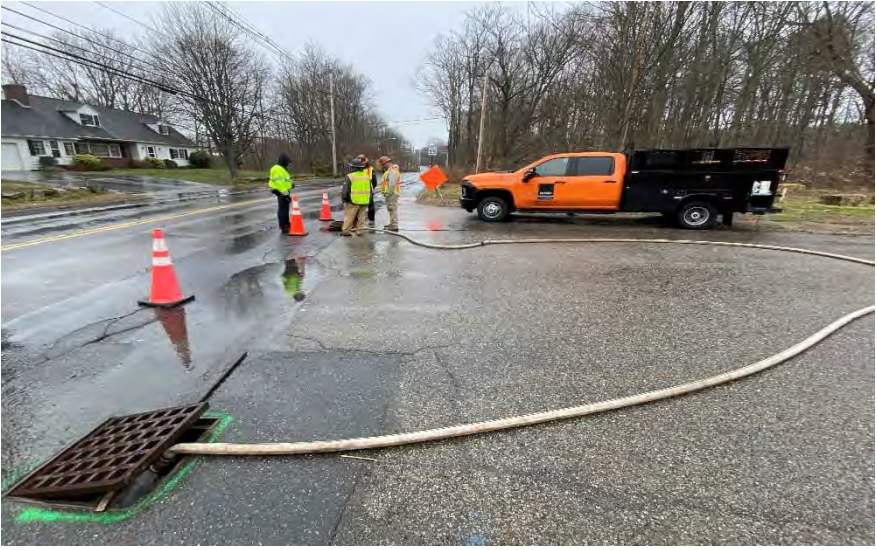
<p align="center">PHOTOGRAPHIC LOG</p>	
<p>Client Name: Eversource</p>		<p>Site Location: Sudbury to Hudson Transmission Reliability Project</p>	<p>Town: Hudson</p>
<p>Photo No.: 7</p>	<p>Date: 4-3-24</p>

<p>Description:</p> <p>Dewatering of decommissioned conduit within Forest Avenue near Hudson Power & Light facility, looking westward.</p>

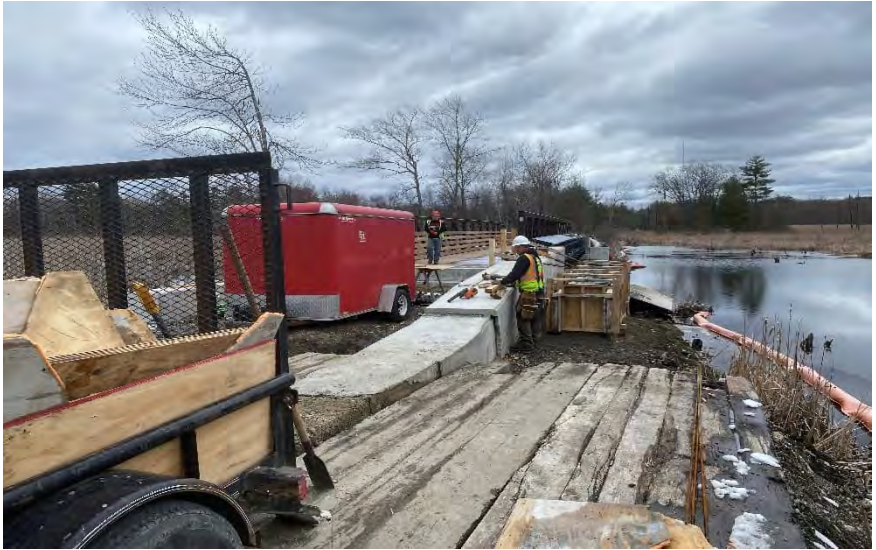
<p>PHOTOGRAPHIC LOG</p>	
<p>Client Name: Eversource</p>		<p>Site Location: Sudbury to Hudson Transmission Reliability Project</p>	<p>Town: Hudson</p>
<p>Photo No.: 5</p>	<p>Date: 4-5-24</p>

<p>Description: Work area within segment 2 looking across Fort Meadow Brook, Bridge 130, existing erosion control, looking eastward.</p>

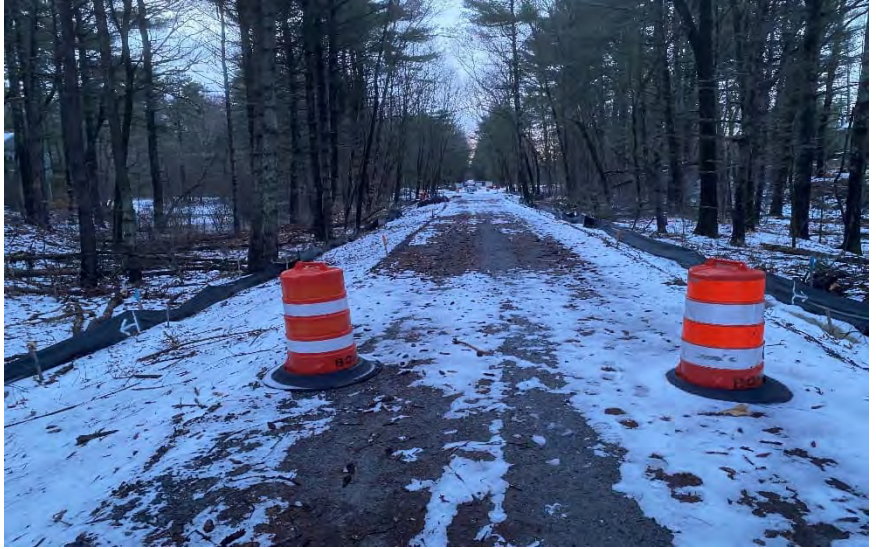
<p>PHOTOGRAPHIC LOG</p>	
<p>Client Name: Eversource</p>		<p>Site Location: Sudbury to Hudson Transmission Reliability Project</p>	<p>Town: Hudson</p>
<p>Photo No.: 6</p>	<p>Date: 4-5-24</p>

<p>Description: Work area within segment 5, existing erosion control, looking eastward.</p>

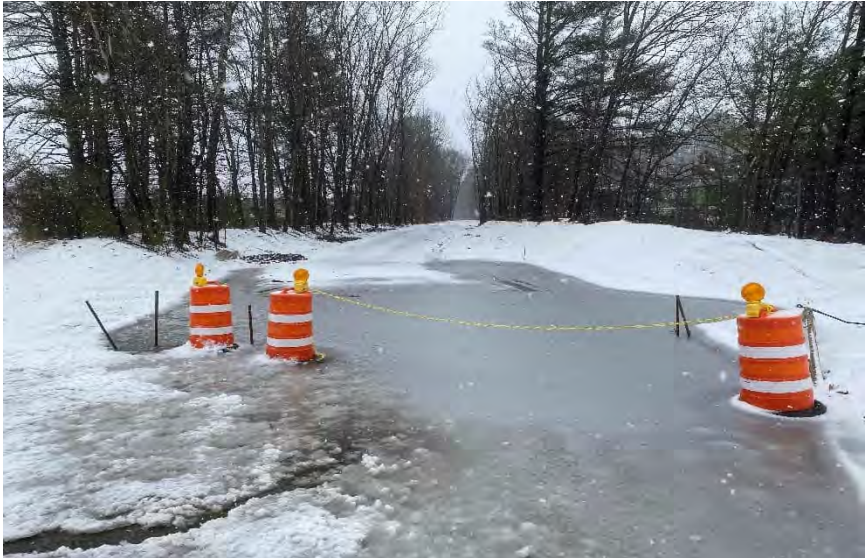
PHOTOGRAPHIC LOG	
Client Name: Eversource		Site Location: Sudbury to Hudson Transmission Reliability Project	Town: Hudson
Photo No.: 3	Date: 4-4-24

Description: Work area within segment 4, existing erosion control, looking eastward.

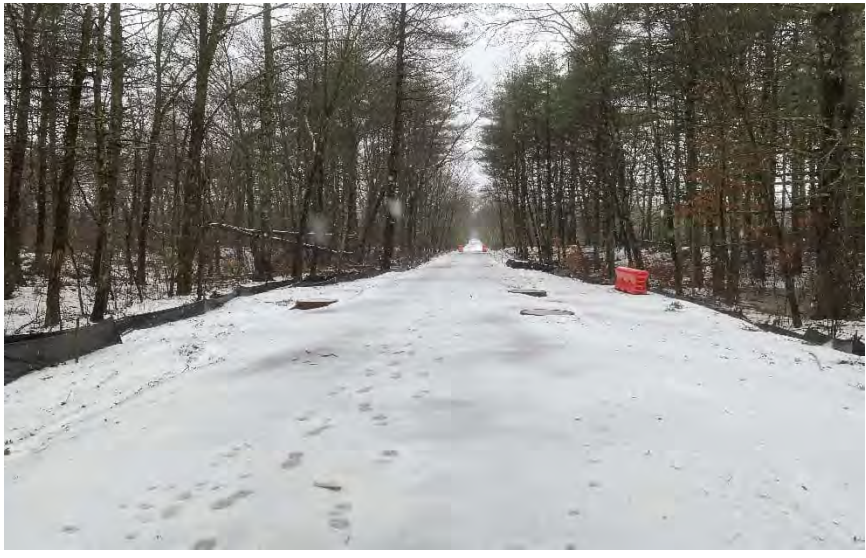
PHOTOGRAPHIC LOG	
Client Name: Eversource		Site Location: Sudbury to Hudson Transmission Reliability Project	Town: Hudson
Photo No.: 4	Date: 4-4-24

Description: Work area within segment 5 at manhole #13, existing erosion control, looking westward.

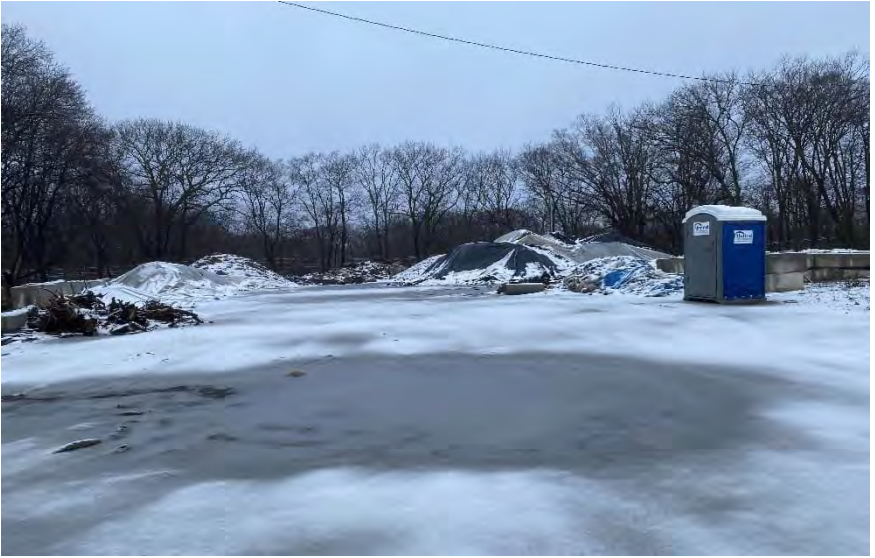
Description: Laydown yard off Stowe Court, covered spoil piles, looking southward.

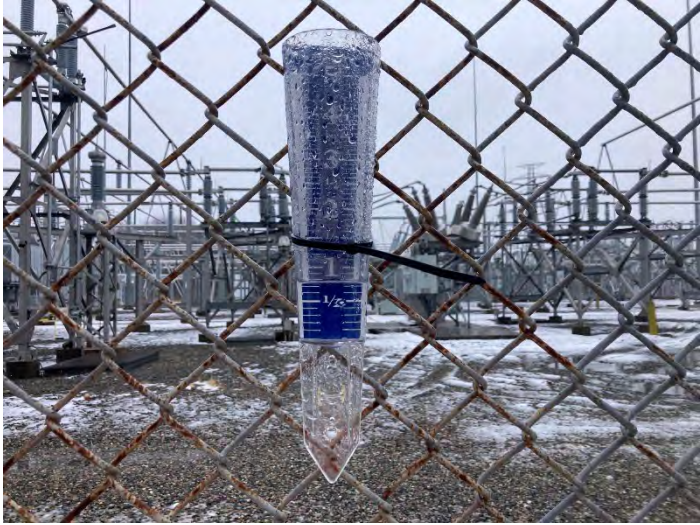
Description: View of rain gauge at Sudbury Substation. 0.80" observed in gauge. Facing south.

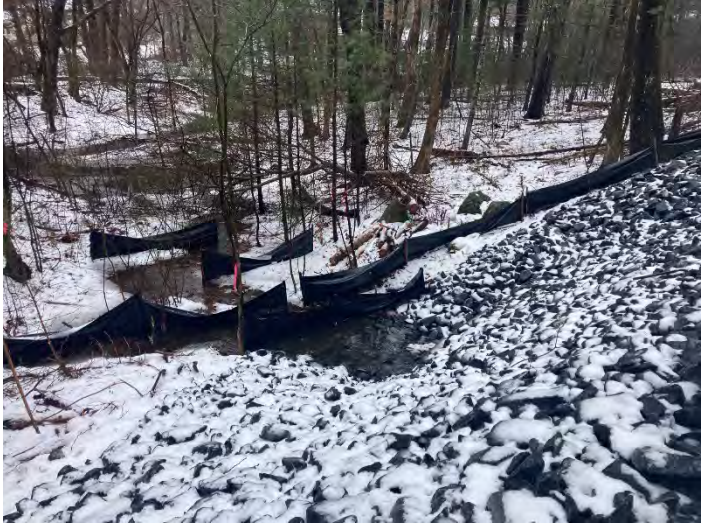
Description: View of south side/downstream side of repaired culvert in segment 9. Water was flowing through culvert at time of inspection. No issues observed. Facing southwest.

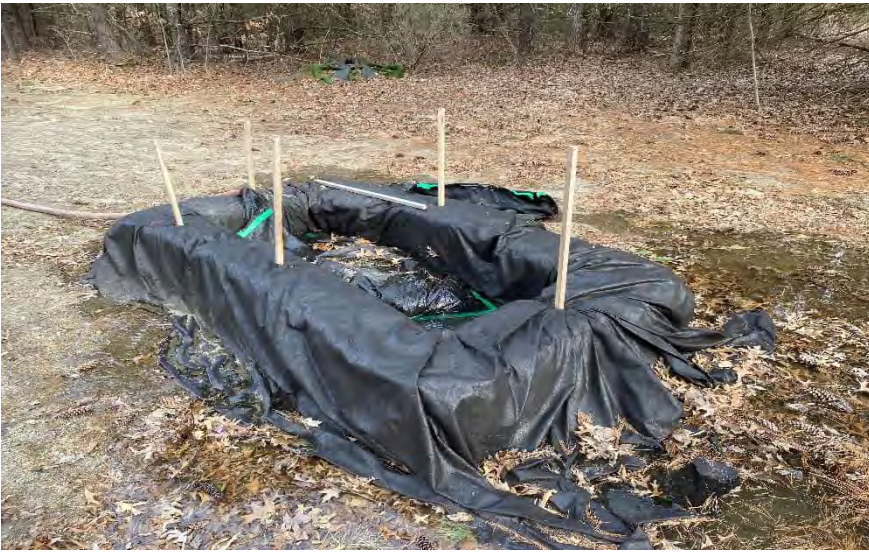
Description: Manhole #7. View of discharge bag/corral, looking westward. Water from bag/corral discharged to adjacent area.

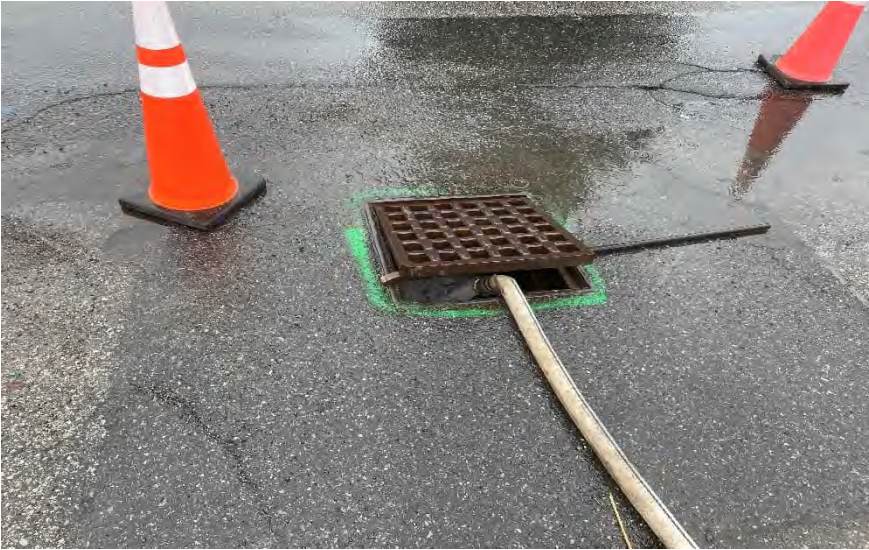
Description: Manhole @ Hudson PLF (1). Discharge of dewatering waters to catch basin within Forest Avenue.

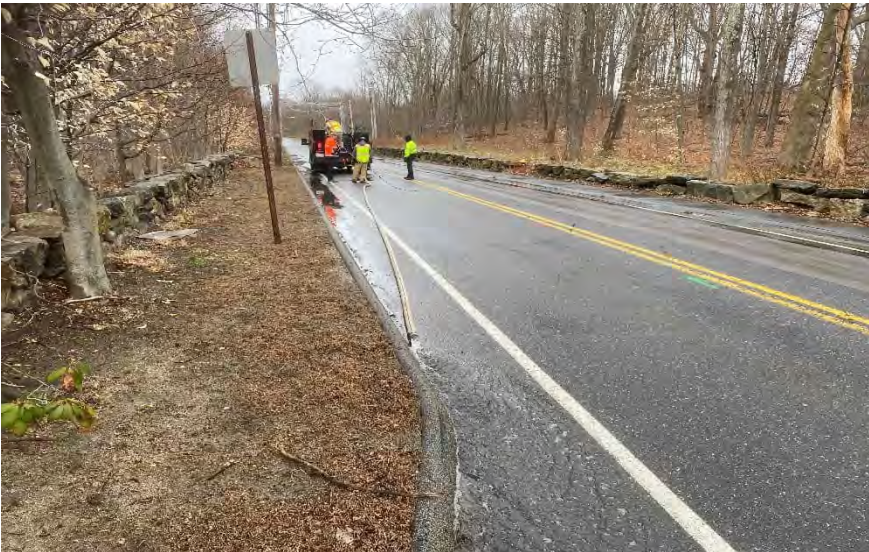
Description: Manhole @ Hudson PLF (2). Discharge of dewatering waters to catch basin within Forest Avenue.
