Horsley Witten Group, Inc.

Client: Town of Sudbury
 Project Name: Sudbury-Hudson Transmission Reliability
 Inspector: Jeffrey Polidor
 Project No: 22012F
 Inspection Date: 3/27/24 Arrival Time: 2:00 PM
 Weather: Clear, 50°F Departure Time: 5:00 PM

Sudbury to Hudson
 115kV Underground Transmission Line
 Sudbury - Hudson, MA
 Date: November 16, 2018

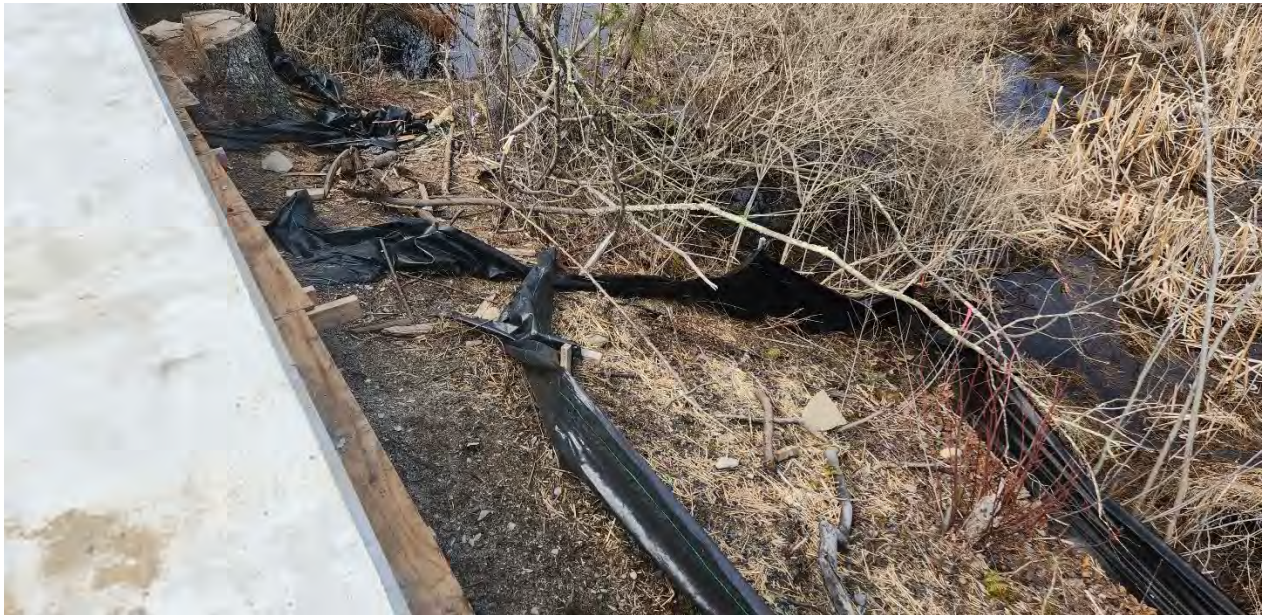
- Silt fence and filter tube are functioning properly along segments 7, 10, 11, and 14.
- Broken stake in silt fence at Bridge 128 along segment 8 (Photo 1).
- Conduit crossing installed underneath Bridge 128 (Photo 2).
- Broken stake and sagging in silt fence along segment 9 (Photo 3).
- Ripping in the silt fence along segment 12 (Photo 4).
- Wall cap installation under progress at Bridge 127 along segment 13 (Photo 5).
- Broken stake in silt fence along segment 13 (Photo 6).

Photo 1: Broken stake in silt fence at Bridge 128 along segment 8.
Photo taken on 3/27/24

1. Repair silt fence as noted above.

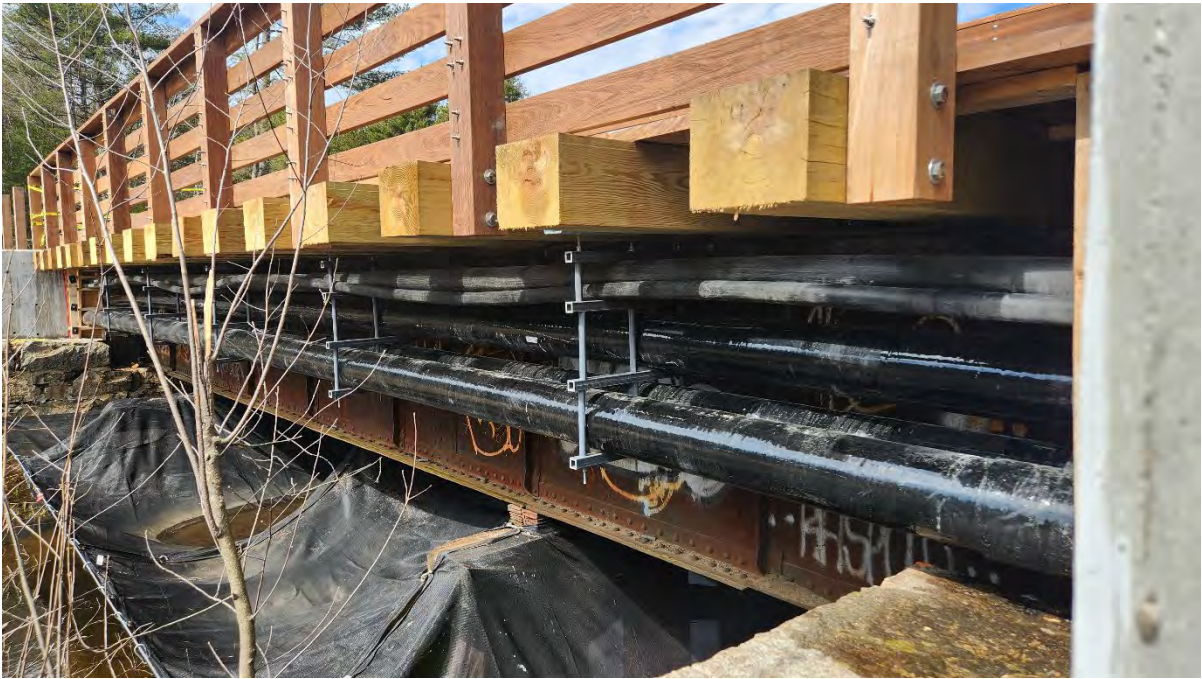
Photo 2: Conduit crossing installed underneath Bridge 128.
Photo taken on 3/27/24

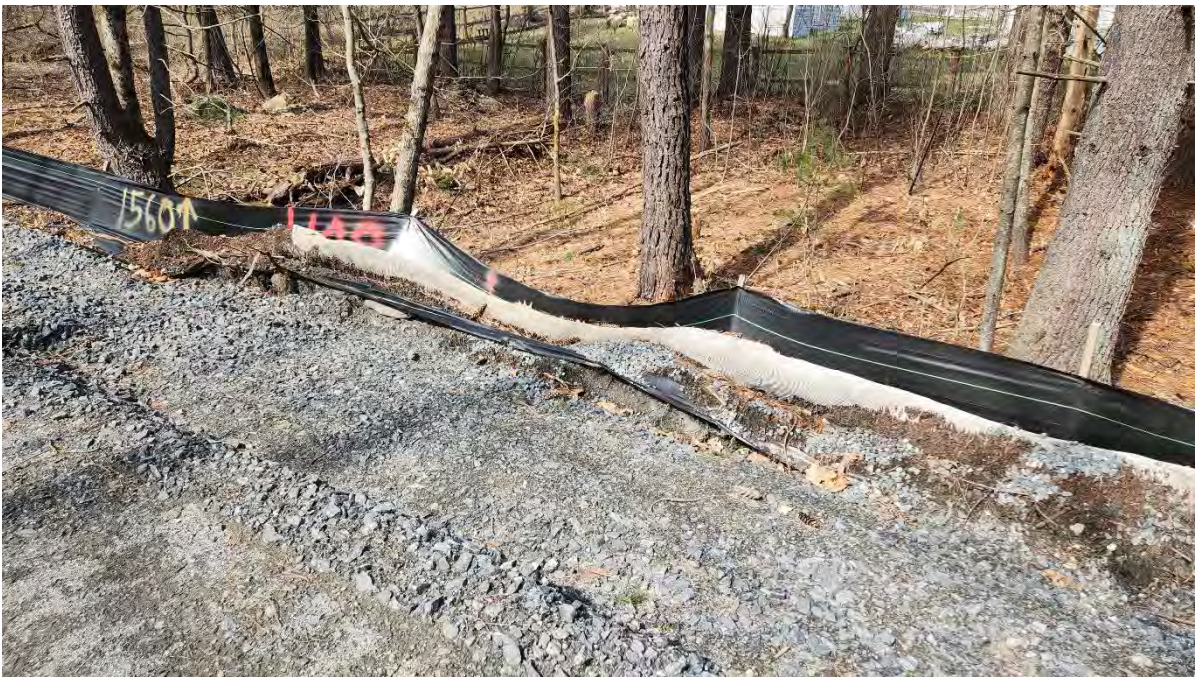
Photo 3: Broken stake and sagging in silt fence along segment 9.
Photo taken on 3/27/24

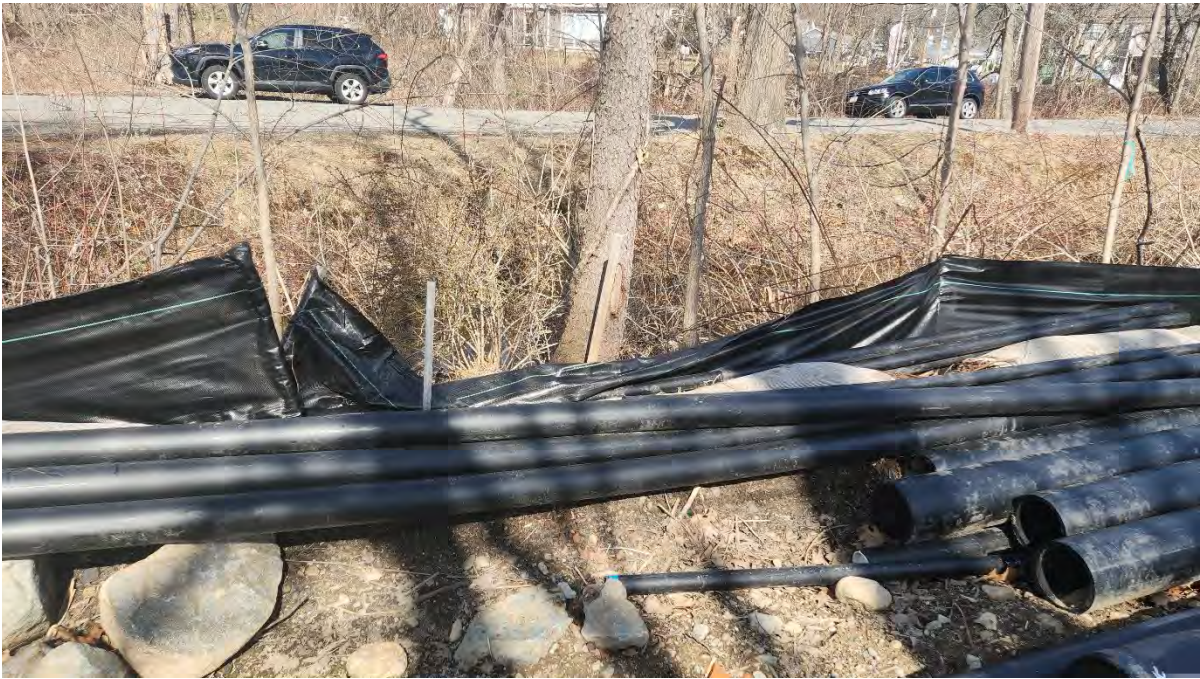
Photo 4: Ripping in the silt fence along segment 12.
Photo taken on 3/27/24

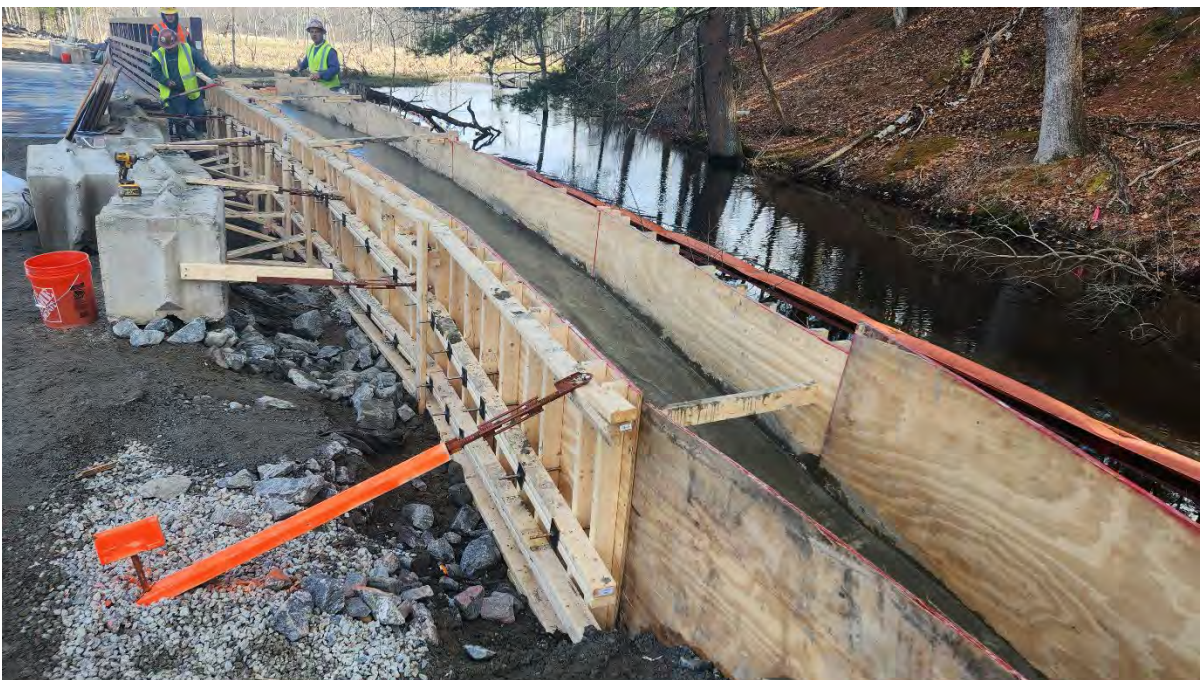
Photo 5: Wall cap installation under progress at Bridge 127 along segment 13
Photo taken on 3/27/24.

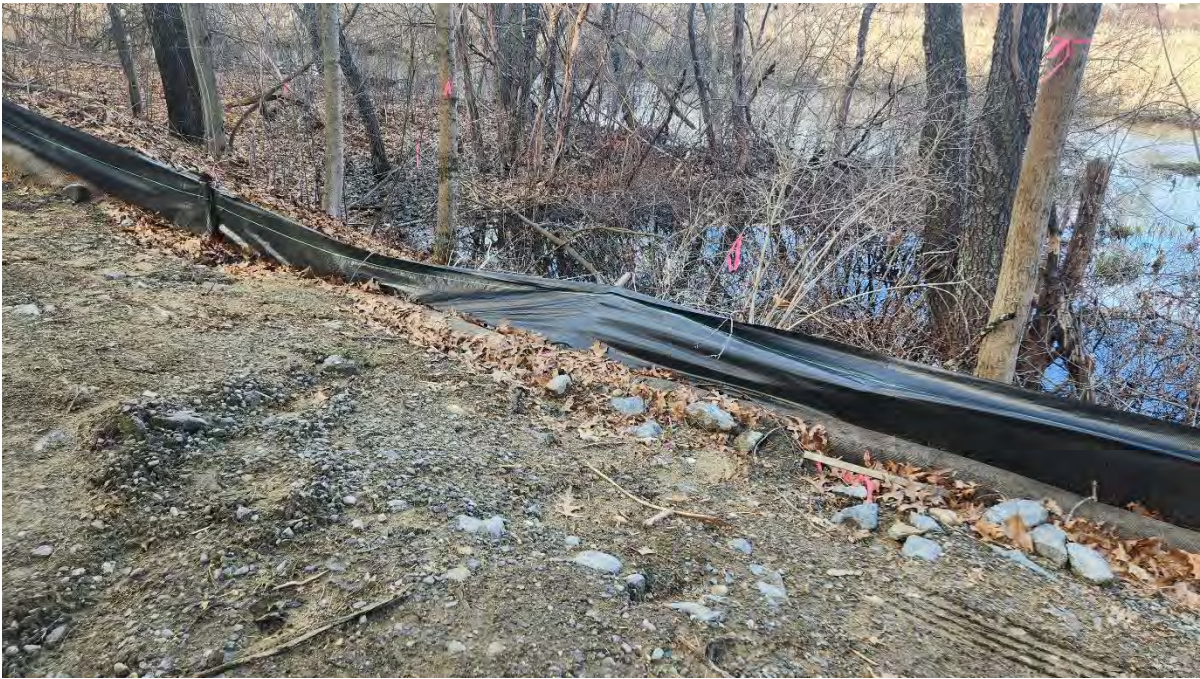
Photo 6: Broken stake in silt fence along segment 13.
Photo taken on 3/27/24.
