Weekly Environmental Compliance Summary

Sudbury to Hudson Transmission Reliability Project (USEPA Tracking # MAR1003UW)

Sudbury, Hudson, and Stow, MA

Week of: April 15, 2024 to April 20, 2024

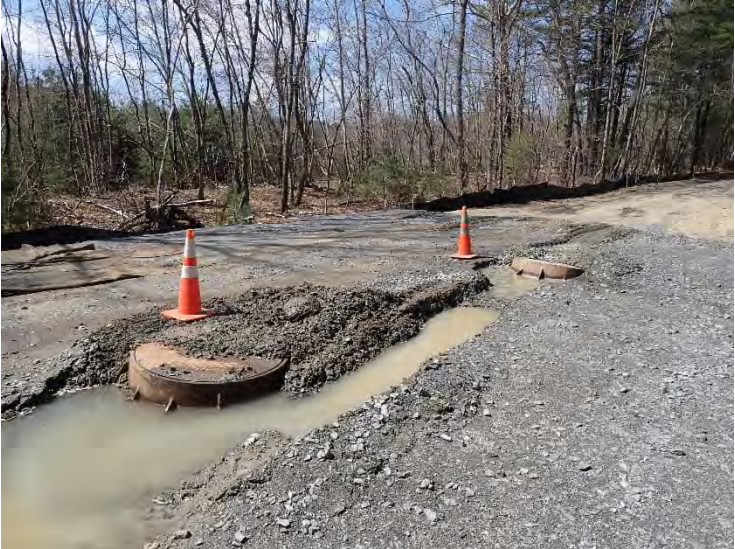
<p>PHOTOGRAPHIC LOG</p>	
<p>Client Name: Eversource</p>		<p>Site Location: Sudbury to Hudson Transmission Reliability Project</p>	<p>Town: Hudson</p>
<p>Photo No.: 2</p>	<p>Date: 4-15-24</p>

Haugland cable vehicle damaged two manhole pipes at Manhole #14.
Eversource was notified. Terry Ramborger (AECOM) will be contacting the Hudson Agent on Tuesday (4/16) for permission to repair the manhole.

<p>Description:</p> <p>View of damaged manhole pipes at Manhole #14 within segment 6. Facing southwest.</p>

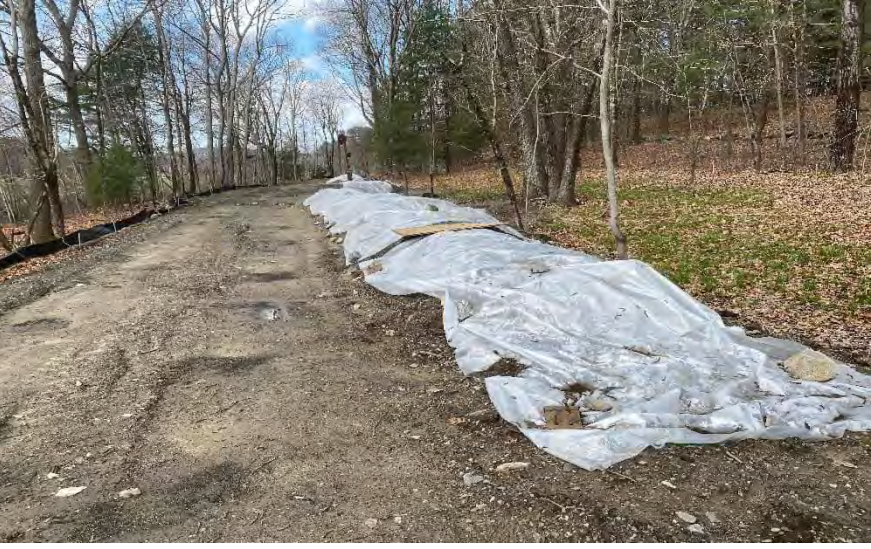
<p>PHOTOGRAPHIC LOG</p>	
<p>Client Name: Eversource</p>		<p>Site Location: Sudbury to Hudson Transmission Reliability Project</p>	<p>Town: Sudbury</p>
<p>Photo No.: 2</p>	<p>Date: 4-15-24</p>

Identify presence of stockpiles and document when placed and when removed (week maximum for stockpiles) Yes No
Spoil Berm noted within segment 14, berm created 3-8-24. See photo #2.

<p>Description:</p> <p>Work area within segment 14, covered spoil berm, existing erosion control, looking westward.</p>

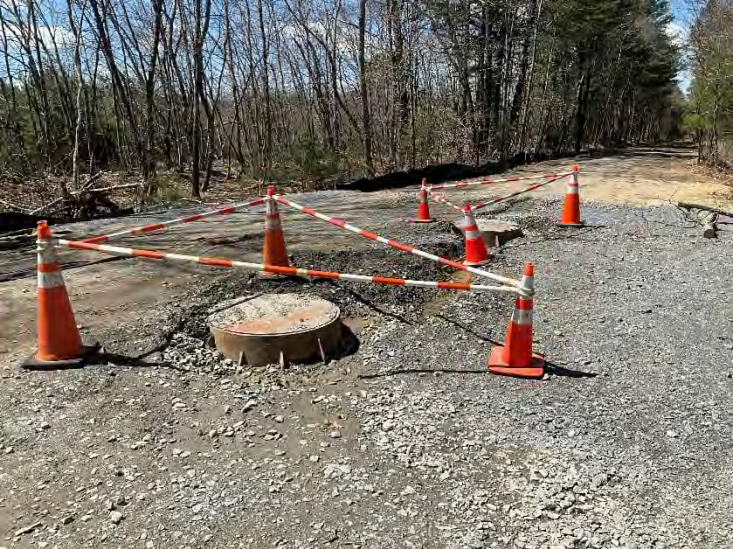
<p>PHOTOGRAPHIC LOG</p>	
<p>Client Name: Eversource</p>		<p>Site Location: Sudbury to Hudson Transmission Reliability Project</p>	<p>Town: Hudson</p>
<p>Photo No.: 4</p>	<p>Date: 4-16-24</p>

Haugland cable vehicle damaged manhole pipes at manhole #14. Eversource was notified. Terry Ramborger (AECOM) contacted the Hudson Conservation Commission Agent 4/16 for permission to repair the manhole. Permission granted with special conditions were given in order for repairs to be completed.

<p>Description:</p> <p>View of damaged manhole #14 in segment 6. Facing southwest.</p>

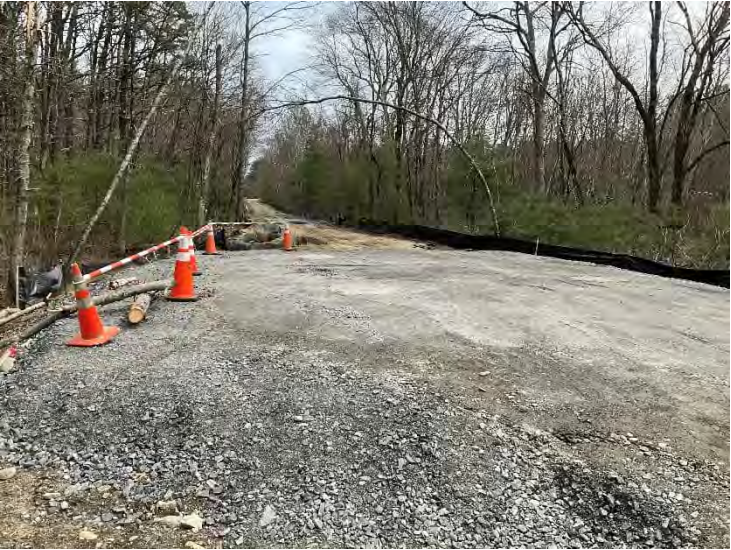
Manhole #14 was repaired following special conditions given by the Hudson Conservation Commission Agent.

<p>Description:</p> <p>Completed repairs on MH#14 in segment 6. Special conditions given by Hudson Conservation Commission Agent were followed while completing repairs. Facing east.</p>

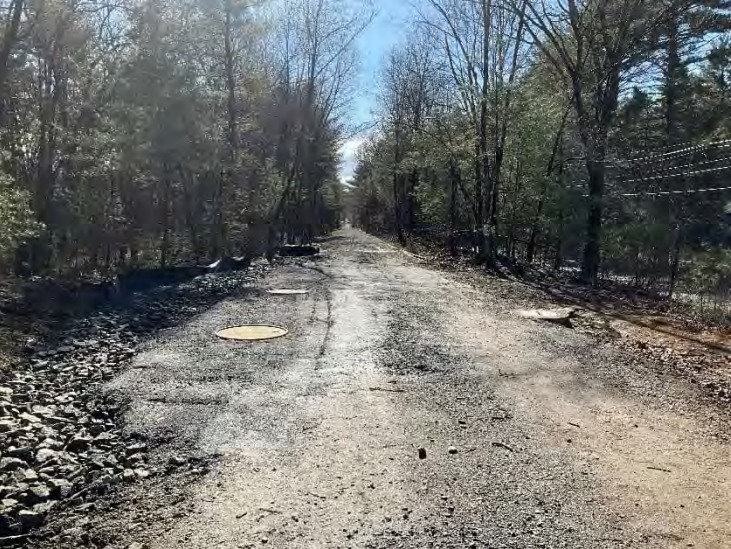
<p>Description:</p> <p>View of segment 5 MH#12. Conduit repairs have been completed and area regraded. Facing east.</p>

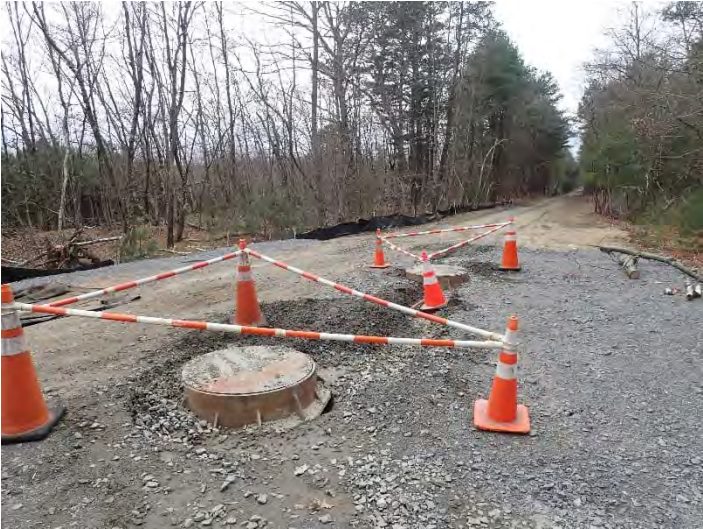
Description: View of manhole #14 chimneys that were damaged in Segment 6. Facing west.

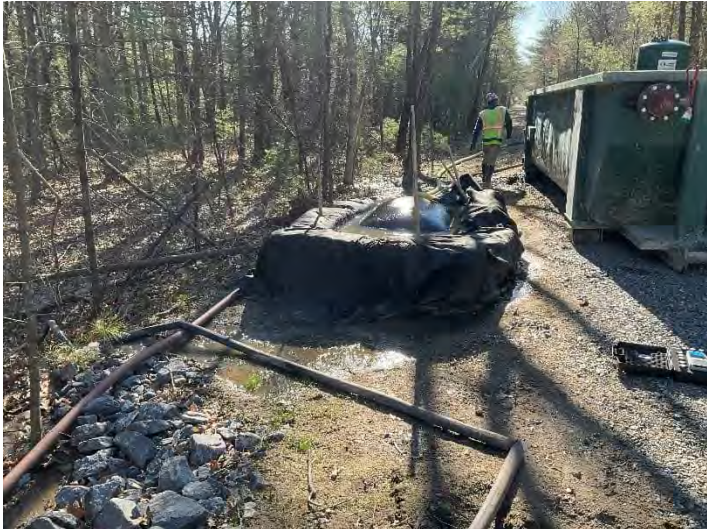
Description: View of dewatering controls (filtration tank, straw bale corral with filter fabric and silt bag) and discharge from corral. Discharge appeared slightly cloudy and turbidity reading was above 50 NTUs. Discharge did not appear to reach any jurisdictional resource areas. Facing east.

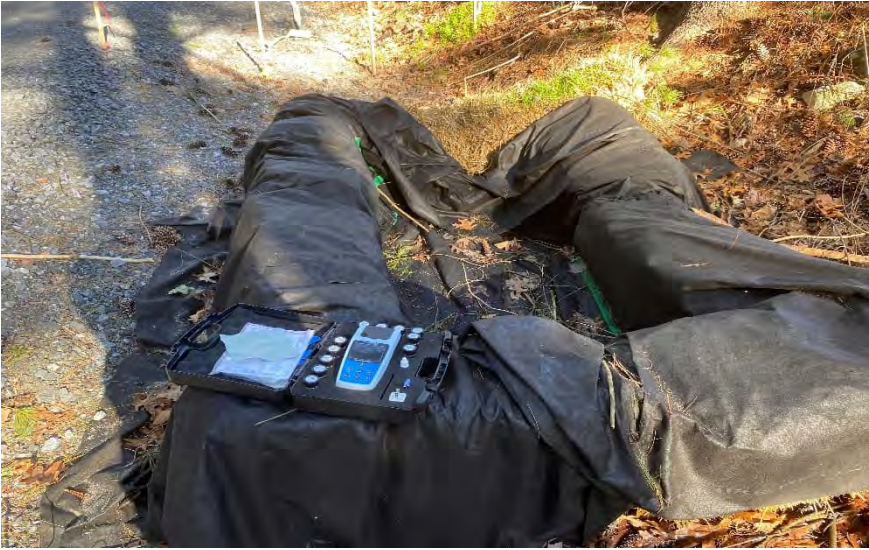
Description: Manhole #18, Segment 9. View of discharge corral/bag, looking westward. Water from corral/bag discharged to adjacent work area to the east. Water appeared slightly turbid.

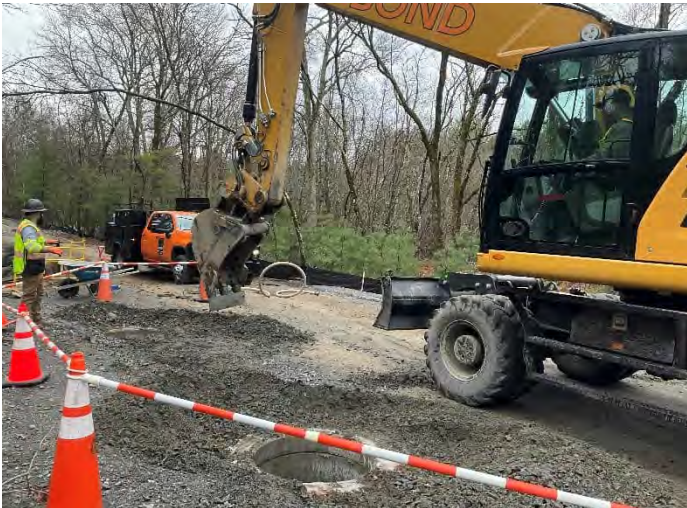
Description: View of MH #14 in segment 6. Manhole access was damaged earlier in the week and needed to be repaired. Facing southeast.

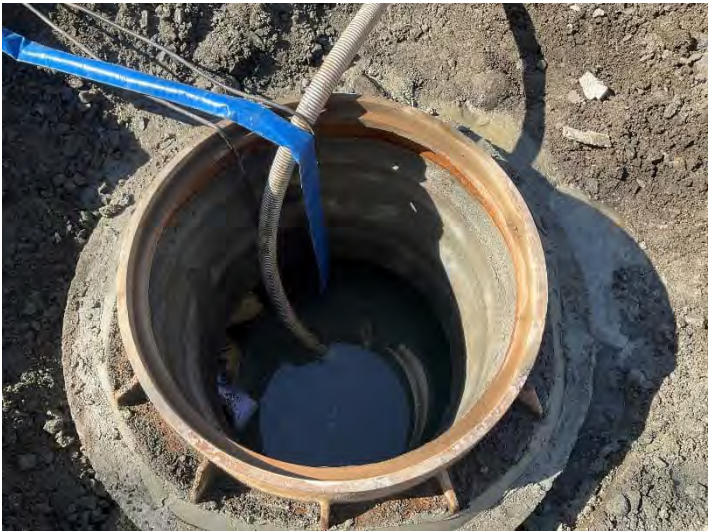
Description: View of pump in MH #14. Water appeared cloudy prior to treatment. Two pumps were used to dewater as manhole was full.

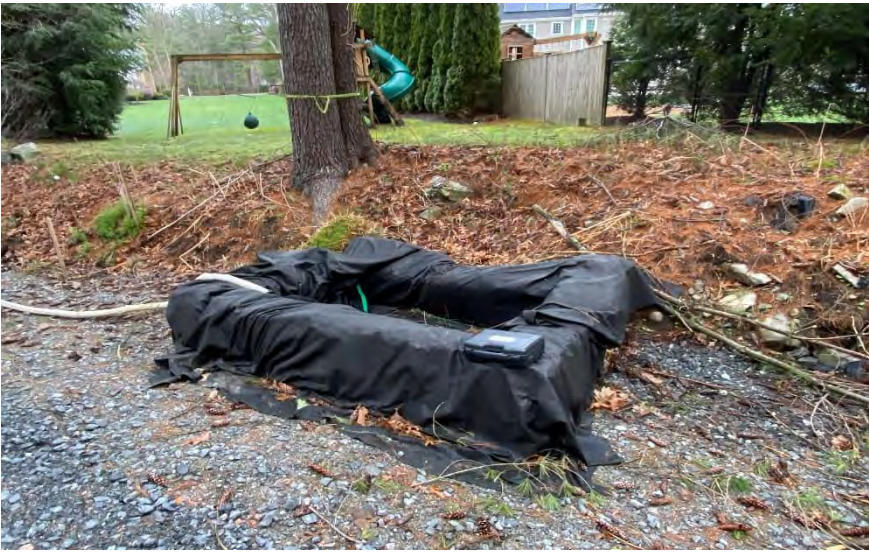
Description: Manhole #18, Segment 9. View of discharge corral/bag, looking westward. Water did not exit from corral/bag to adjacent work area. Water appeared turbid.
