Weekly Environmental Compliance Summary

Sudbury to Hudson Transmission Reliability Project (USEPA Tracking # MAR1003UW)

Week of: April 29, 2024 to May 4, 2024

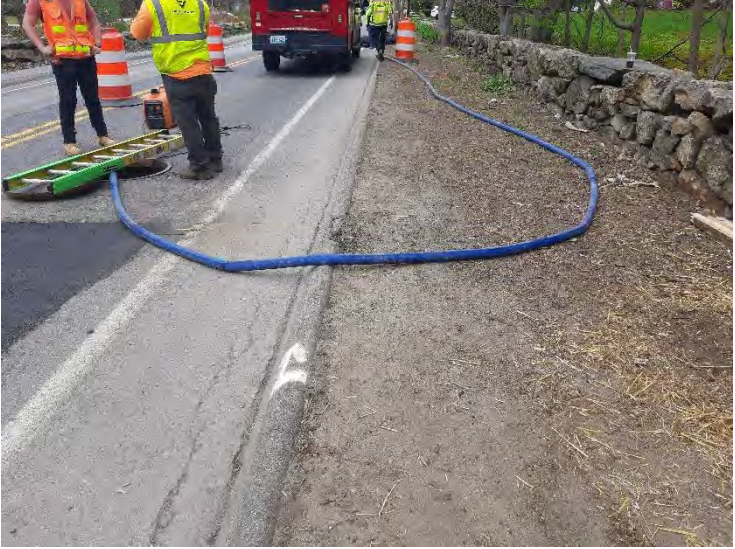
<p>PHOTOGRAPHIC LOG</p>	
<p>Client Name: Eversource</p>		<p>Site Location: Sudbury to Hudson Transmission Reliability Project</p>	<p>Town: Hudson</p>
<p>Photo No.: 1</p>	<p>Date: 4-29-24</p>

Sediment observed within Forest Ave roadway shoulder by Vinagro road work.

<p>Description:</p> <p>Vinagro pipe removal work zone along Forest Ave, at manhole between project manholes MH #1 and MH #2, near Hudson Light and Power. Dewatering conducted from manhole. Facing eastward. Traffic detail present but not visible in photo.</p>

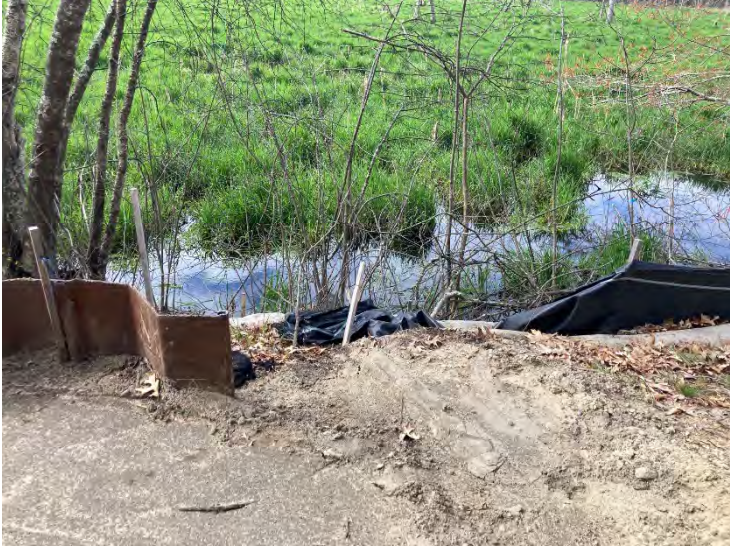
<p>PHOTOGRAPHIC LOG</p>	
<p>Client Name: Eversource</p>		<p>Site Location: Sudbury to Hudson Transmission Reliability Project</p>	<p>Town: Sudbury</p>
<p>Photo No.: 5</p>	<p>Date: 4/29/2024</p>

- Silt fence is in need of repair at west end of sheetwall in segment 14.**
-
-

<p>Description: View of damaged silt fence at west end of sheetwall in segment 14. Facing south.</p>

-Silt fence is in need of repair at west end of sheetwall in segment 14. Additional repairs to occur per full punchlist that was submitted to project contractors 4-17-2024. Implementation began 4-18-2024. Approval was sought from and granted by both Hudson and Sudbury Conservation Commission Agents for repairs of controls, particularly within vernal pool exculsion areas. MON will be onsite next week to help facilitate completion of items on the list.

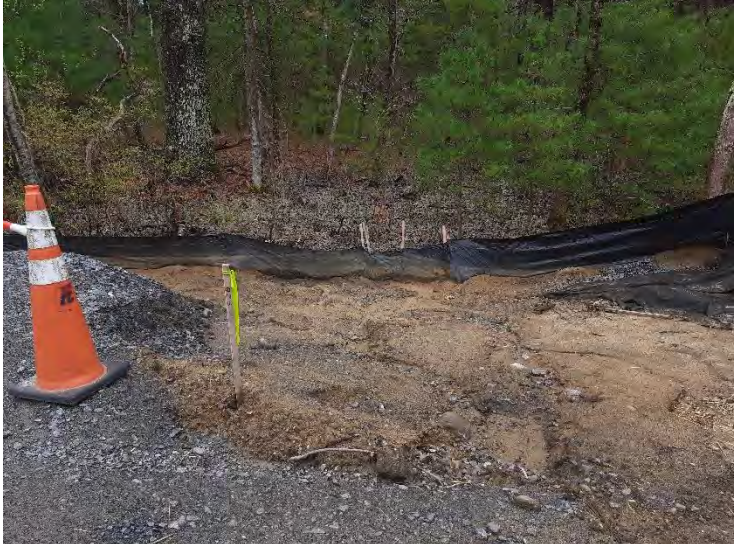
Accumulated sediment on silt fence at Manhole #14 in Segment 6 has been removed. Additional routine maintenance items are needed onsite. Full list of needed repairs has been submitted to project contractors. Approval has been given by both Hudson and Sudbury Conservation Commission Agents for repairs of controls.

Description: View of silt fence where accumulated sediment has been removed within segment 6, by MH#14. Repair appears effective. Facing northward.

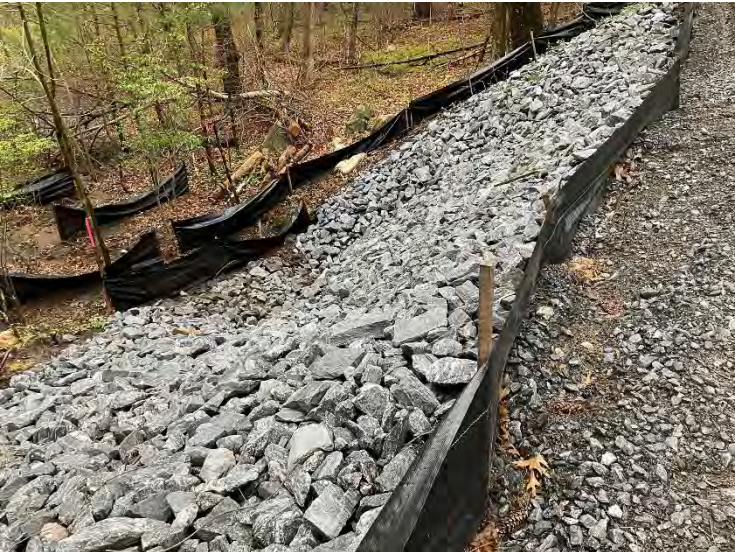
<p>Description: View of south side/downstream side of repaired culvert in segment 9. Facing southwest.</p>

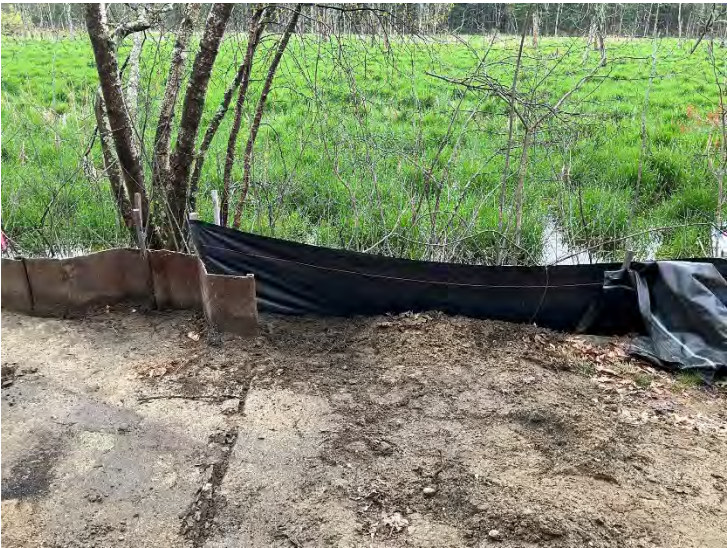
-Silt fence at west end of sheetwall in segment 14 has been repaired. Additional repairs to occur per full punchlist that was submitted to project contractors 4-17-2024. Implementation began 4-18-2024. Approval was sought from and granted by both Hudson and Sudbury Conservation Commission Agents for repairs of controls, particularly within vernal pool exculsion areas. MON will be onsite next week to help facilitate completion of items on the list.

Description: View of repaired silt fence at west end of sheetwall in segment 14. Facing south.

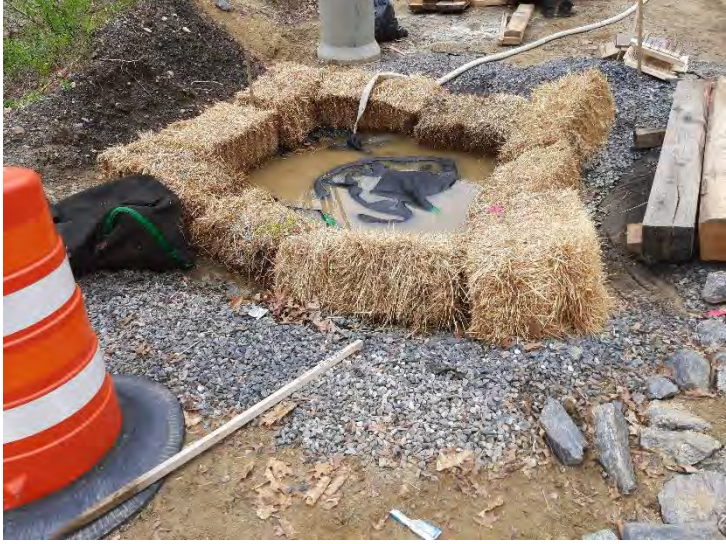
<p>Description:</p> <p>Dewatering corral for Wilkins Street roadwork near Segment 1. Damaged/inefficient filter bag (left) replaced with new bag (in corral) before pumping. Facing eastward.</p>

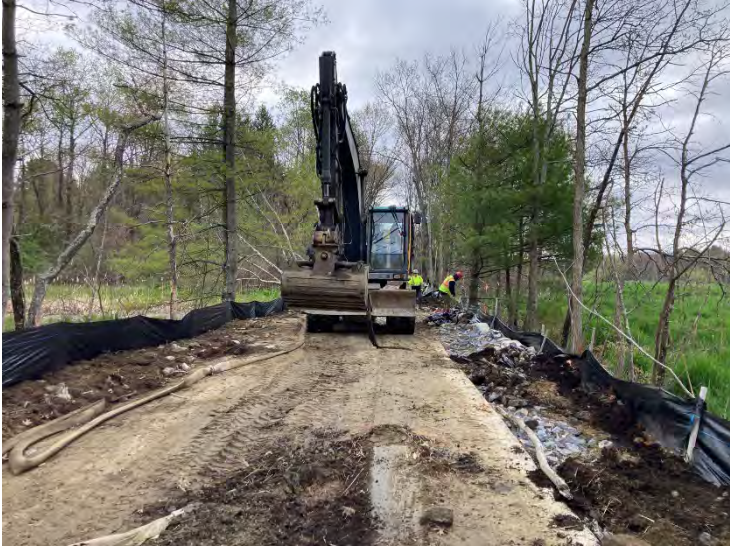
Description: View of ET&L and MON repairing E&S controls in segment 14. Facing east.

-MON onsite to assist ET&L with E&S repairs. I met with ET&L to guide needed E&S repairs in segments 12, 13, and 14 using list previously submitted to project contractors.

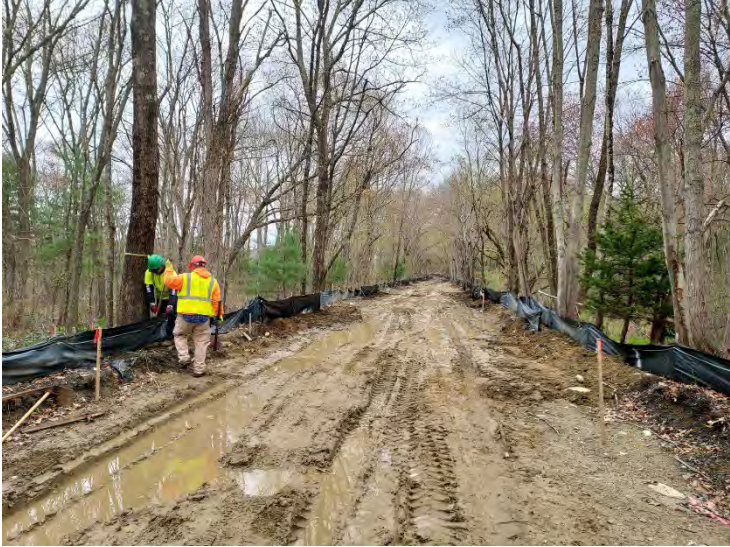
<p>Description: View of MON repairing E&S controls in segment 14. Facing east.</p>

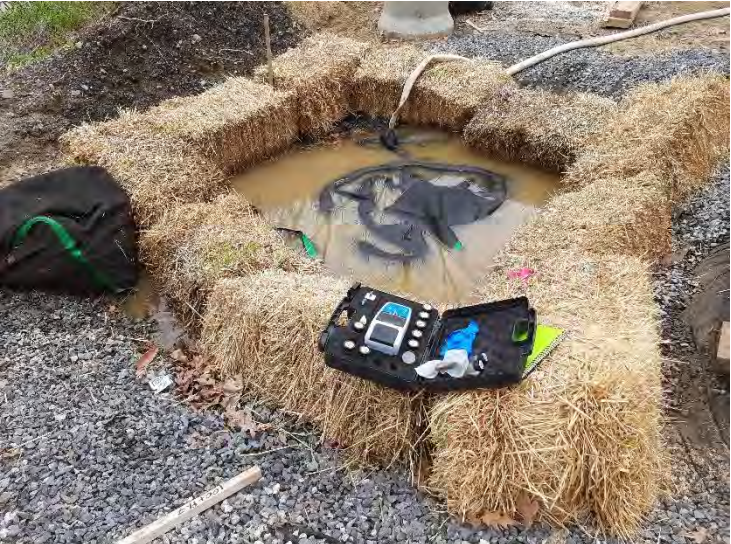
Description: Wilkins Street trench work near segment 1. View of discharge bag/corral, looking westward. Water discharged to drain below gravel and geotextile layers. Filter bag in corral is replacement for old bag on left of image.
