Weekly Environmental Compliance Summary

Sudbury to Hudson Transmission Reliability Project (USEPA Tracking # MAR1003UW)

Sudbury, Hudson, and Stow, MA

Week of: May 13, 2024 to May 18, 2024

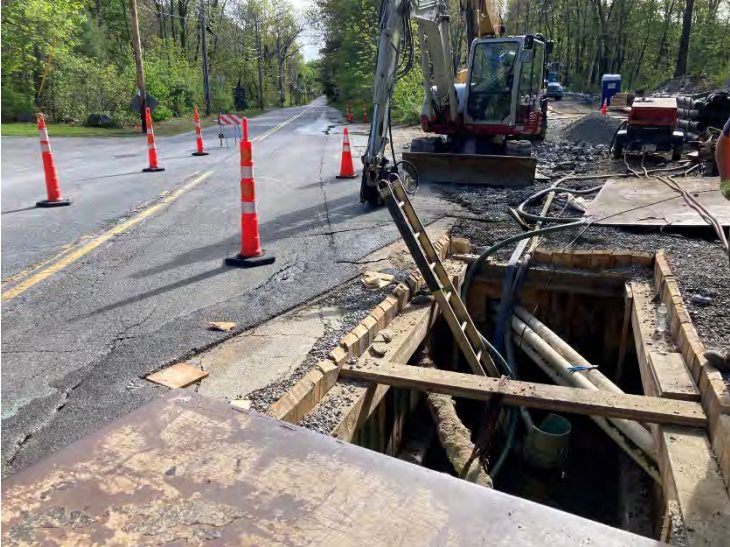
Description: View of Bond working in Wilkins St at entrance to segment 1. See additional dewatering inspection report. Facing northeast.

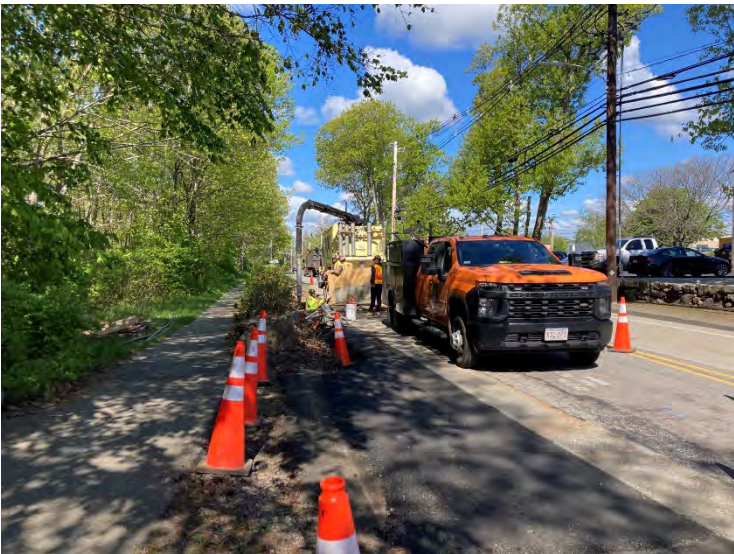
Description: View of Bond working in Forest Ave near MH #2. Small hydraulic fluid spill occurred at this location today. Facing south.

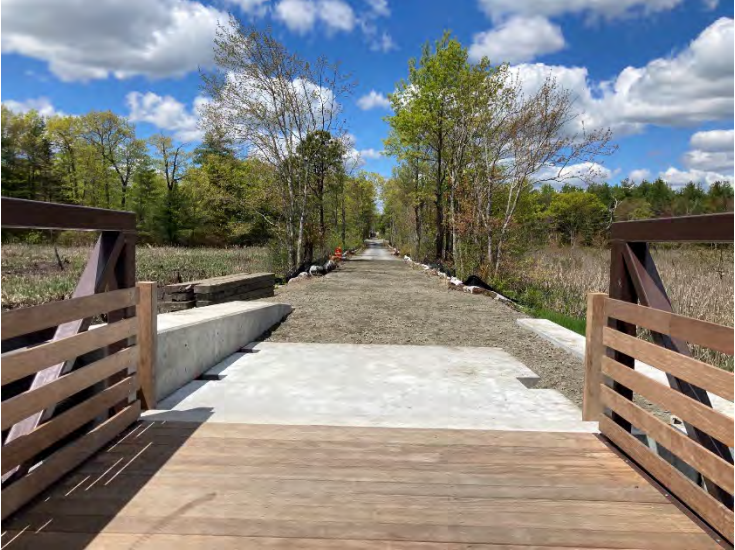
Description: View of newly spread gravel in segment 2 near bridge 130. Facing west.

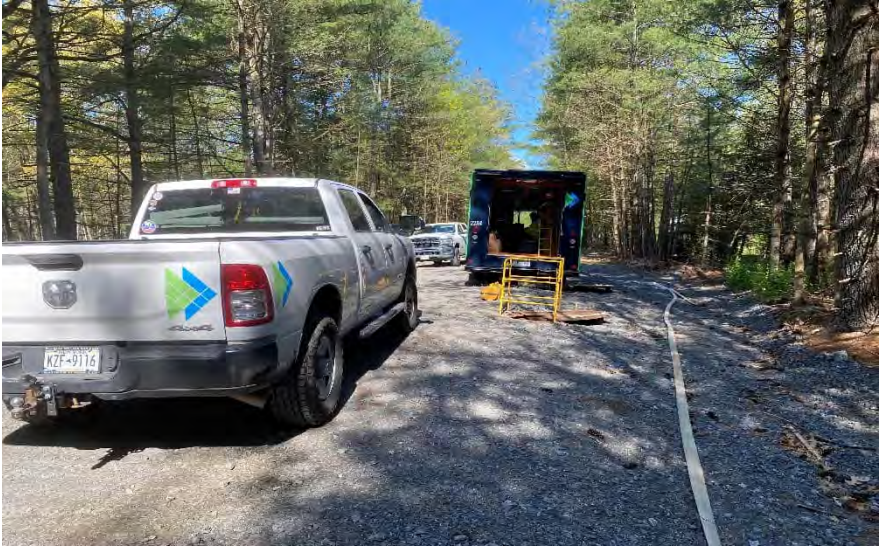
<p>Description:</p> <p>Work area within Segment 9, Haugland conducting splicing within handhole #18, existing erosion control, looking westward.</p>

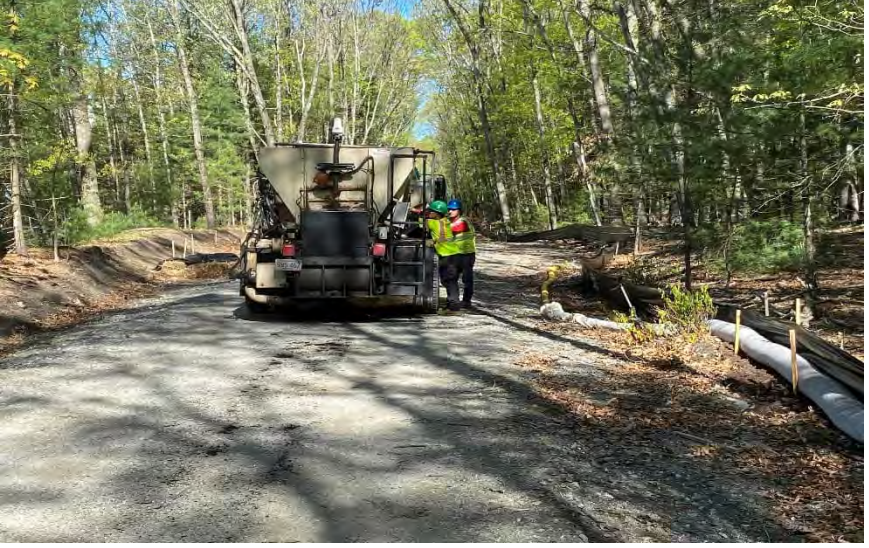
<p>Description:</p> <p>Work area within segment 11, MON improving erosion controls, existing erosion control, looking westward.</p>

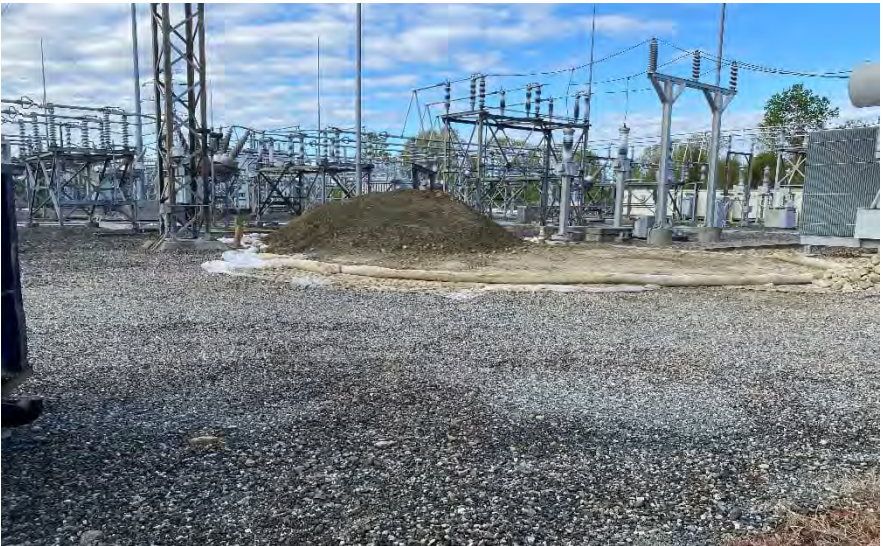
<p>Description:</p> <p>Work area within substation, newly placed spoil pile surrounded by compost tubing, existing erosion control, looking southward.</p>

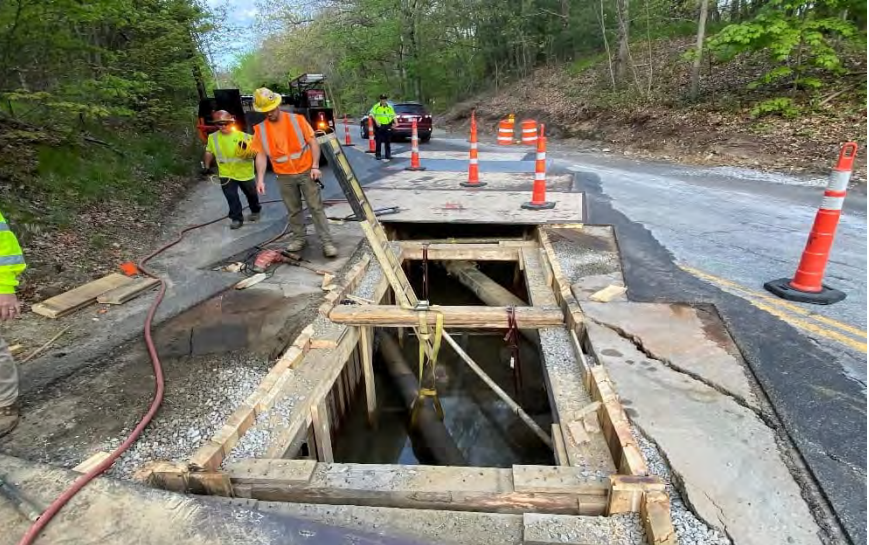
<p>Description:</p> <p>Work area within Wilkins Street, ledge removal for conduit work, looking westward.</p>

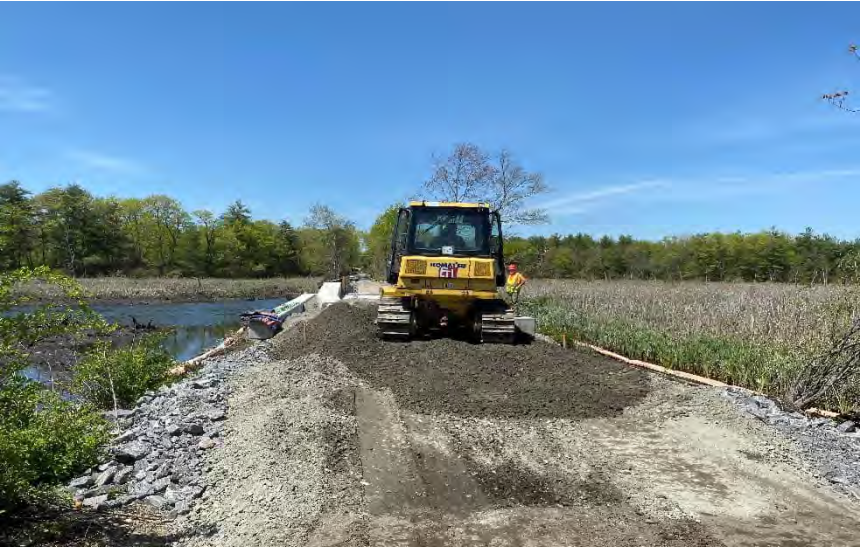
<p>Description:</p> <p>Work area within segment 3 across Fort Meadow Brook along bridge 130, grading, existing erosion control, looking westward.</p>

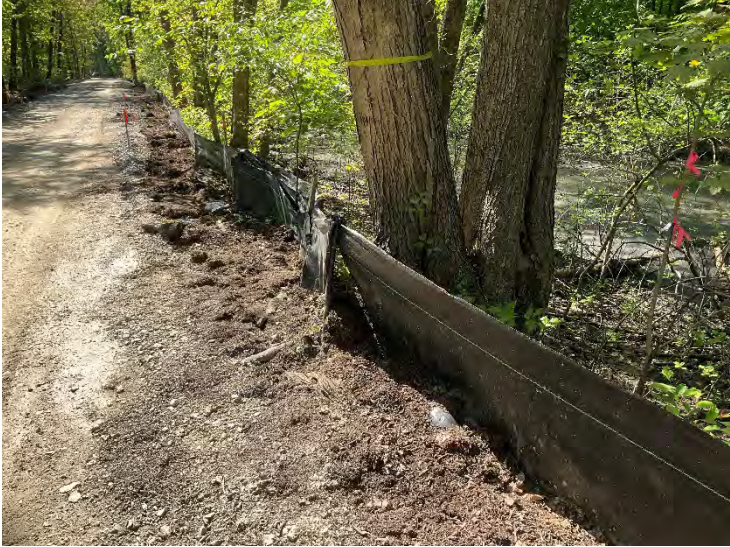
Description: View of gap between silt fencing at approximately station #714+50 in segment 13. Facing east.

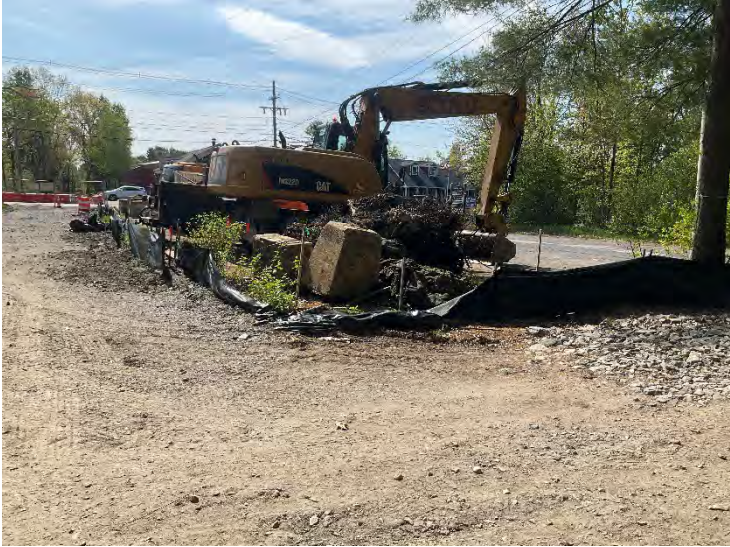
-Repairs needed to silt fence within Segment 11 off of Union Ave by entrance to Bruce Freeman Trail.

Description: View of E&S controls in need of repairing within segment 11 off of Union Ave. Facing south.

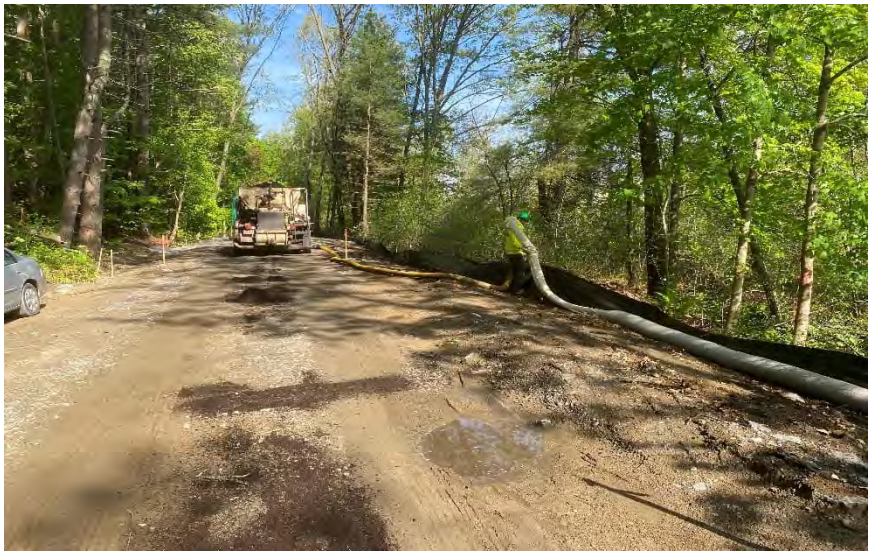
<p>Description:</p> <p>Work area within segment 13, MON adding new compost filter tubes, existing erosion control, looking westward.</p>

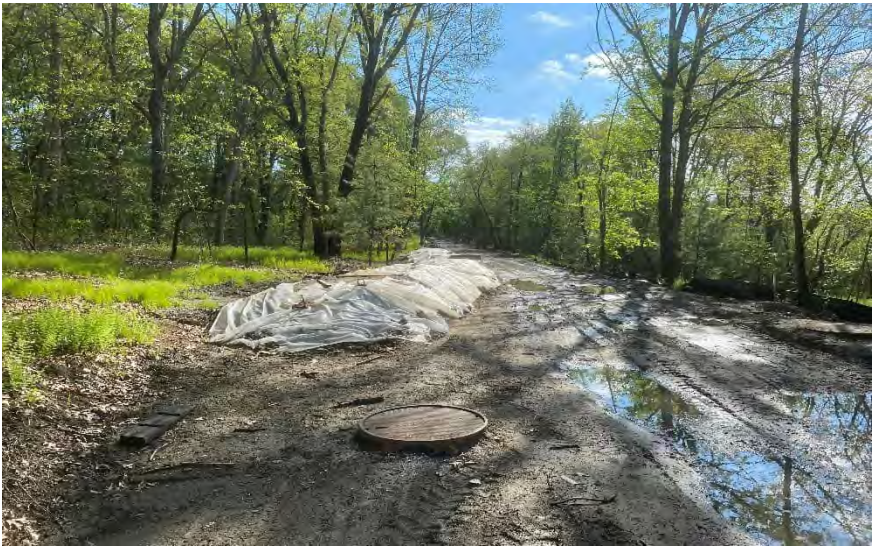
<p>Description:</p> <p>Work area within Segment 14, covered spoil berm, existing erosion control, looking eastward.</p>

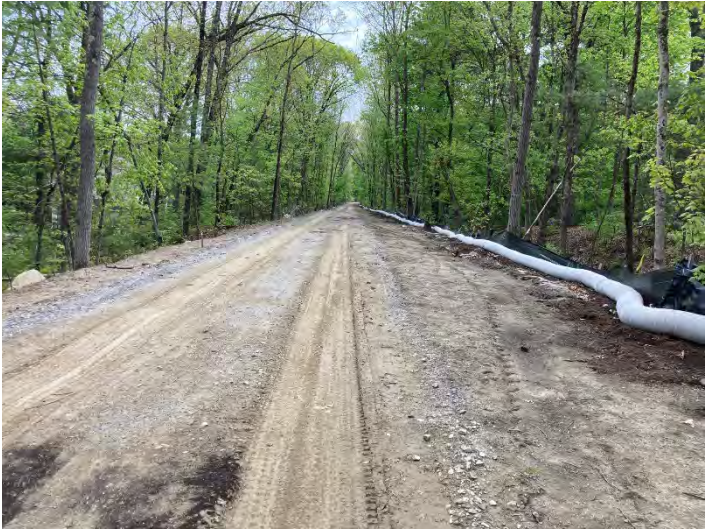
Description: View of E&S controls at west end of segment 1. Wattles have been replaced in some areas of this segment. Facing east.

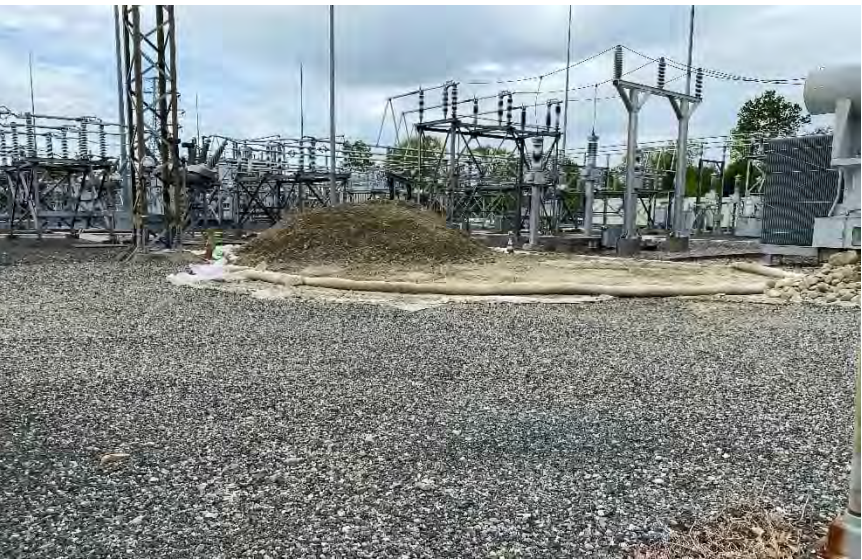
Description: Spoils generated within substation stockpiled with erosion control (compost tubing) surrounding the piles, looking southward.

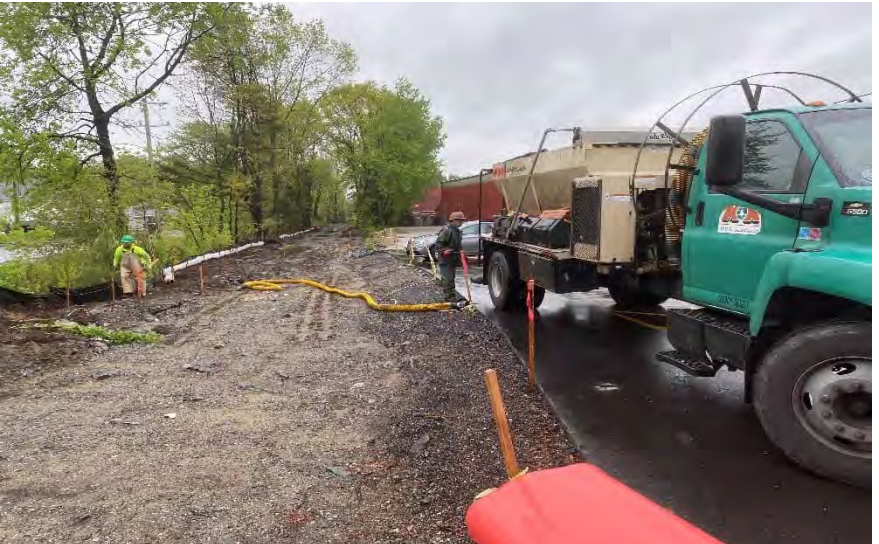
Description: Work area within segment 12, adding new compost filter tubes, existing erosion control, looking eastward.

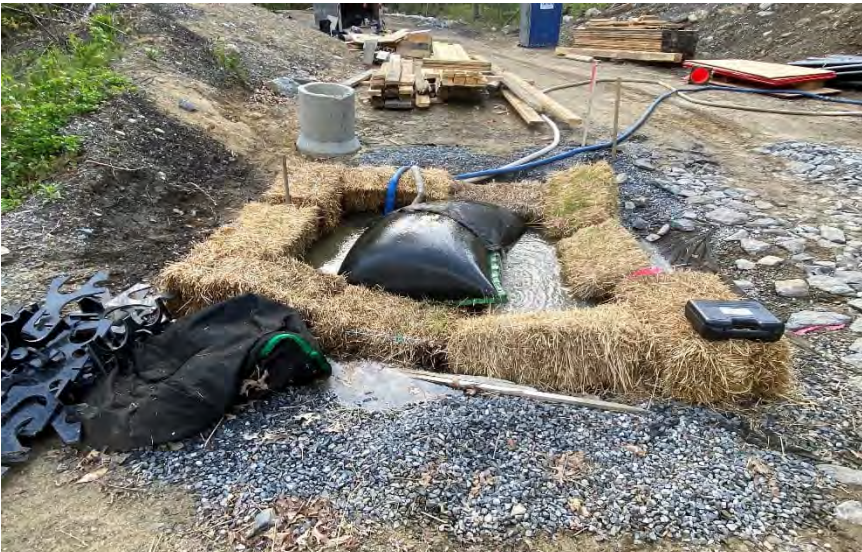
Description: Wilkins Street trench. View of discharge bag/corral, looking eastward. Water from bag/corral discharged to underlying catch basin.

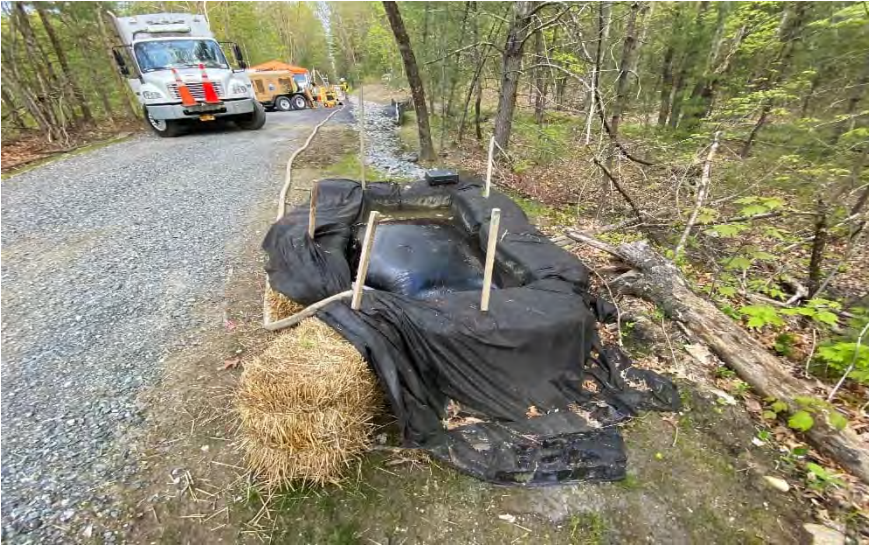
Description: Manhole #12. View of discharge bag/corral, looking westward. Water from bag/corral discharged to adjacent area.

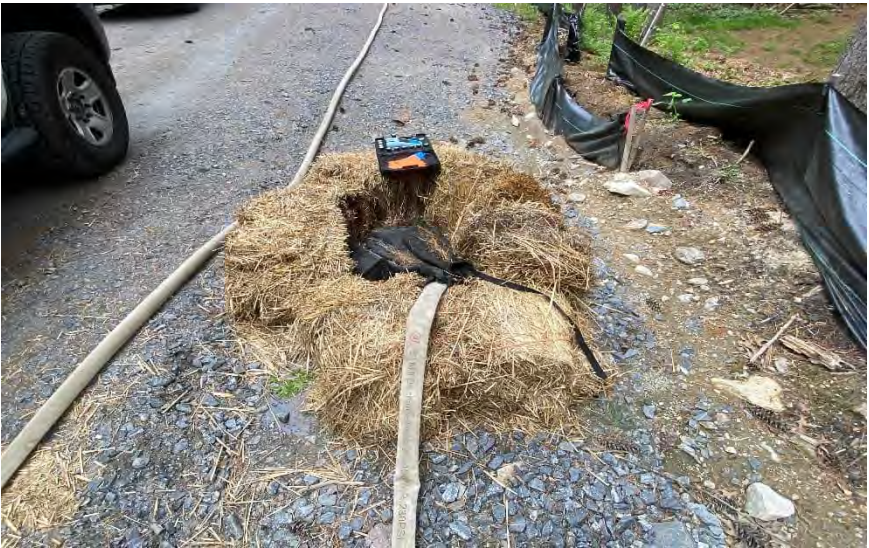
Description: Manhole #19. View of discharge bag/corral, looking westward. Water from bag/corral discharged to adjacent area.

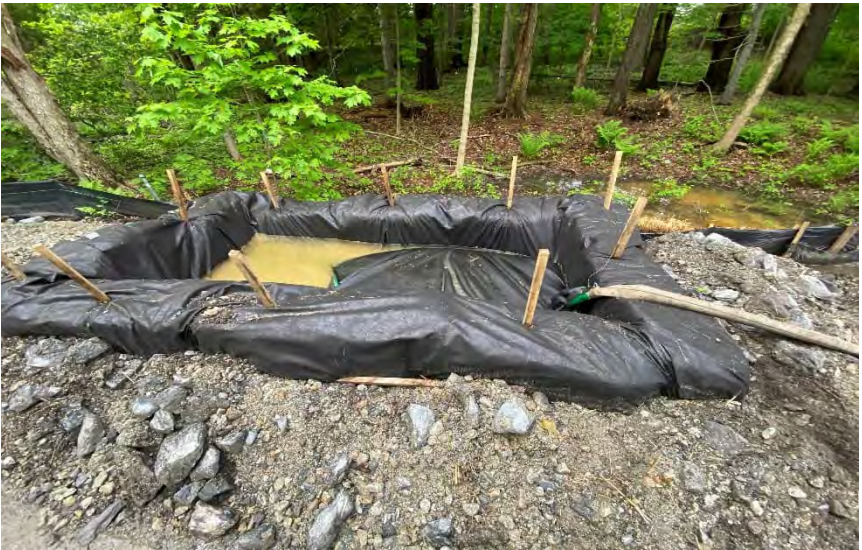
Description: Boston Post Road trench. View of discharge bag/corral, looking westward. Water from bag/corral discharged to adjacent area down slope.
