Weekly Environmental Compliance Summary

Sudbury to Hudson Transmission Reliability Project (USEPA Tracking # MAR1003UW)

Week of: May 28, 2024 to June 1, 2024

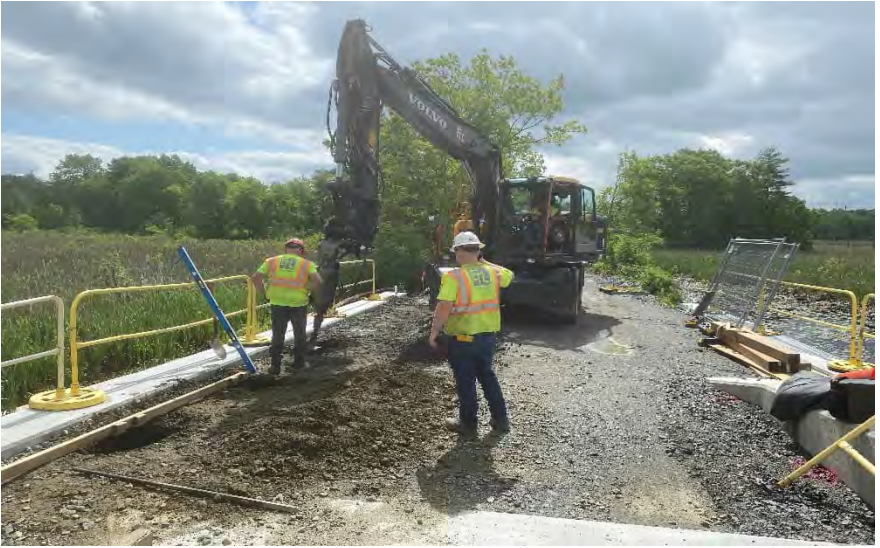
<p align="center">PHOTOGRAPHIC LOG</p>	
<p>Client Name: Eversource</p>		<p>Site Location: Sudbury to Hudson Transmission Reliability Project</p>	<p>Town: Hudson</p>
<p>Photo No.: 3</p>	<p>Date: 5-28-24</p>

<p>Description:</p> <p>Work area within segment 2 along Fort Meadow Brook at bridge 130, existing erosion control, looking westward.</p>

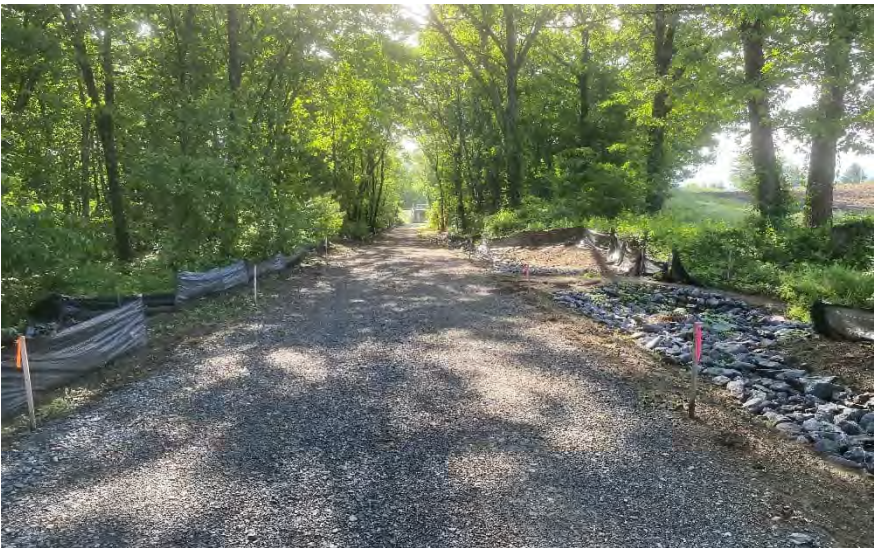
<p align="center">PHOTOGRAPHIC LOG</p>	
<p>Client Name: Eversource</p>		<p>Site Location: Sudbury to Hudson Transmission Reliability Project</p>	<p>Town: Stow</p>
<p>Photo No.: 4</p>	<p>Date: 5-28-24</p>

<p>Description:</p> <p>Work area within segment 1, existing erosion control, looking eastward.</p>

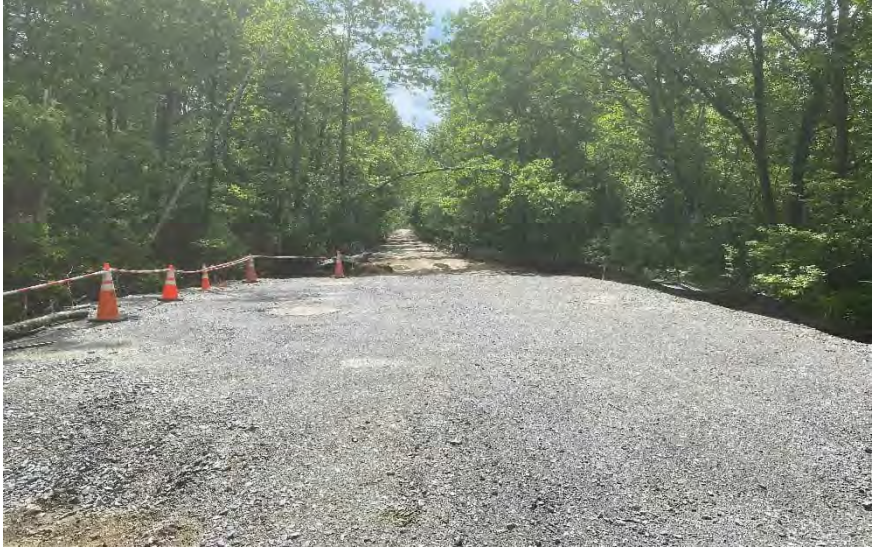
<p>PHOTOGRAPHIC LOG</p>	
<p>Client Name: Eversource</p>		<p>Site Location: Sudbury to Hudson Transmission Reliability Project</p>	<p>Town: Hudson</p>
<p>Photo No.: 5</p>	<p>Date: 5-28-24</p>

<p>Description:</p> <p>Work area within segment 6, manhole 14, existing erosion control, looking eastward.</p>

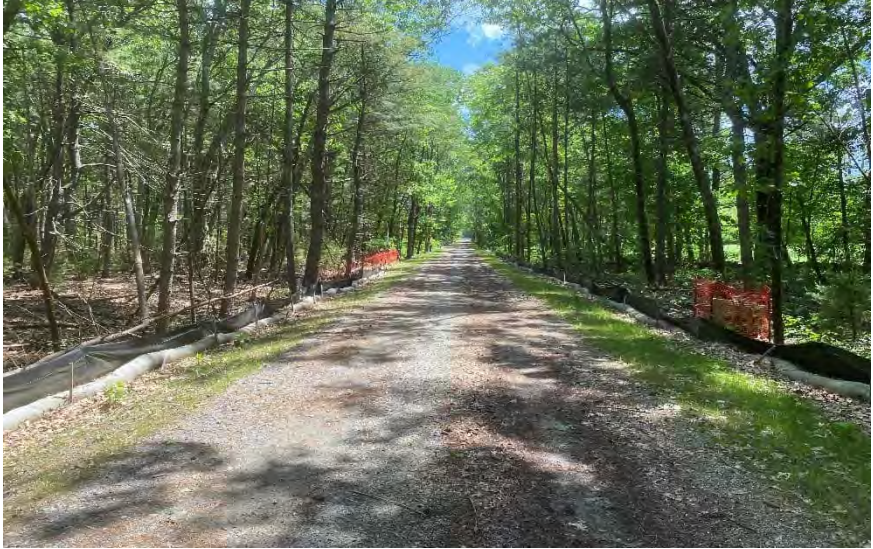
PHOTOGRAPHIC LOG	
Client Name: Eversource		Site Location: Sudbury to Hudson Transmission Reliability Project	Town: Hudson
Photo No.: 7	Date: 5-28-24

Description: Work area within segment 4, existing erosion control, looking eastward.

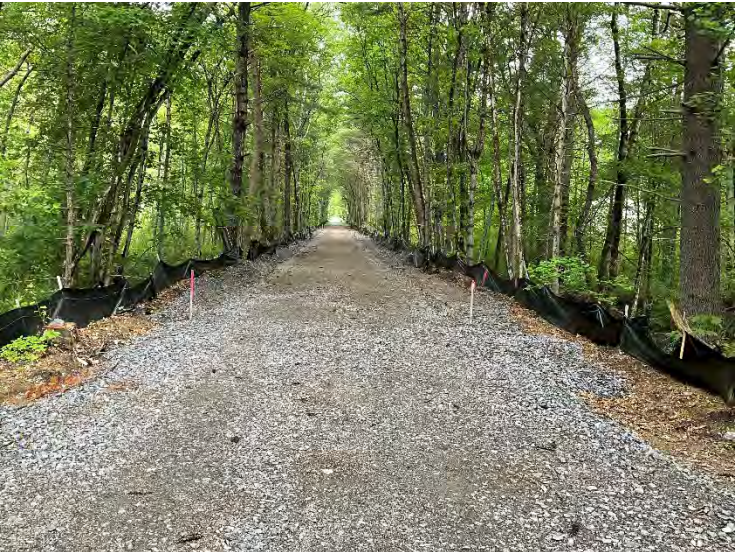
PHOTOGRAPHIC LOG	
Client Name: Eversource		Site Location: Sudbury to Hudson Transmission Reliability Project	Town: Sudbury
Photo No.: 2	Date: 5/28/2024

Description: View of E&S controls in segment 9. Facing west.

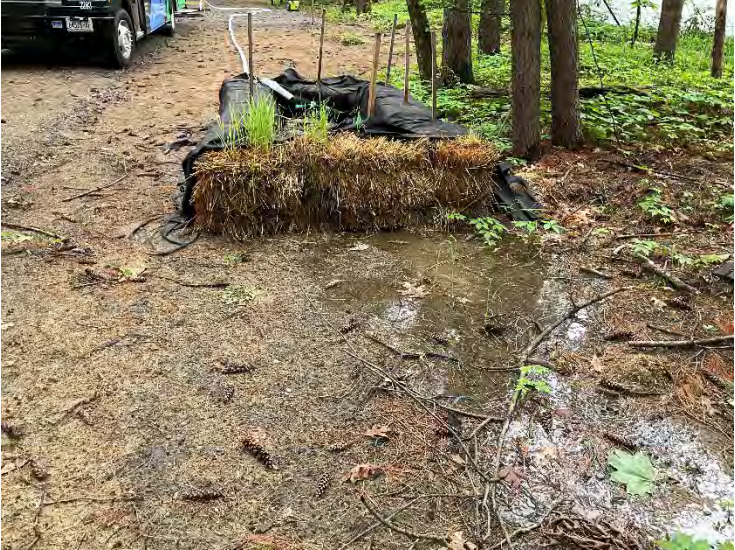
<p>PHOTOGRAPHIC LOG</p>	
<p>Client Name: Eversource</p>		<p>Site Location: Sudbury to Hudson Transmission Reliability Project</p>	<p>Town: Sudbury</p>
<p>Photo No.: 3</p>	<p>Date: 5/28/2024</p>

<p>Description: View of dewatering controls at MH #21 in segment 10. See additional dewatering inspection report. Facing west.</p>

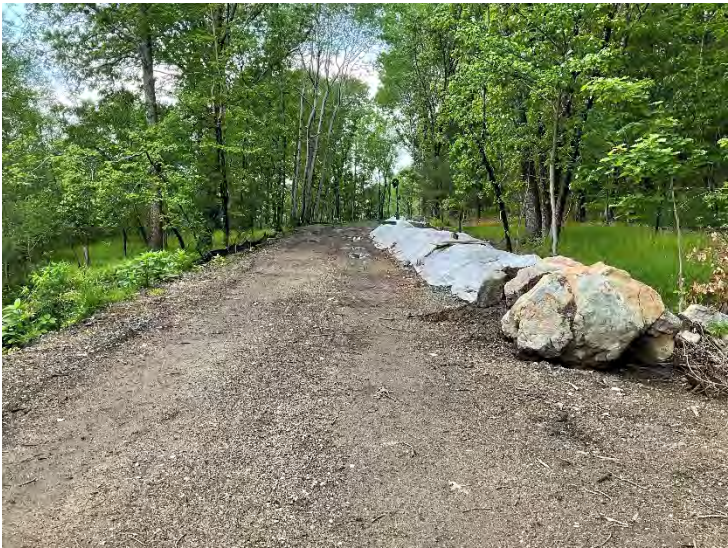
PHOTOGRAPHIC LOG	
Client Name: Eversource		Site Location: Sudbury to Hudson Transmission Reliability Project	Town: Sudbury
Photo No.: 6	Date: 5/28/2024

Description: View of stockpiles/spoil berm in segment 14. Facing west.

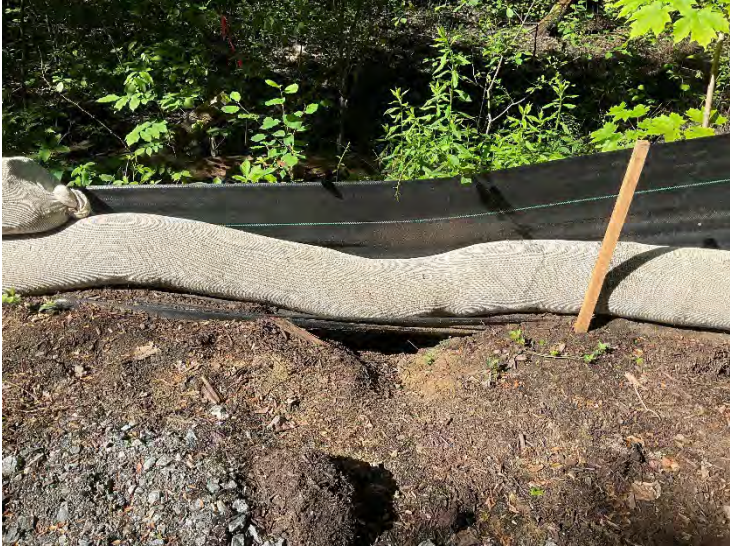
PHOTOGRAPHIC LOG	
Client Name: Eversource		Site Location: Sudbury to Hudson Transmission Reliability Project	Town: Sudbury
Photo No.: 5	Date: 5/29/2024

Description: View of undermined silt fence at Sta. #713+25 in segment 13. Facing south.

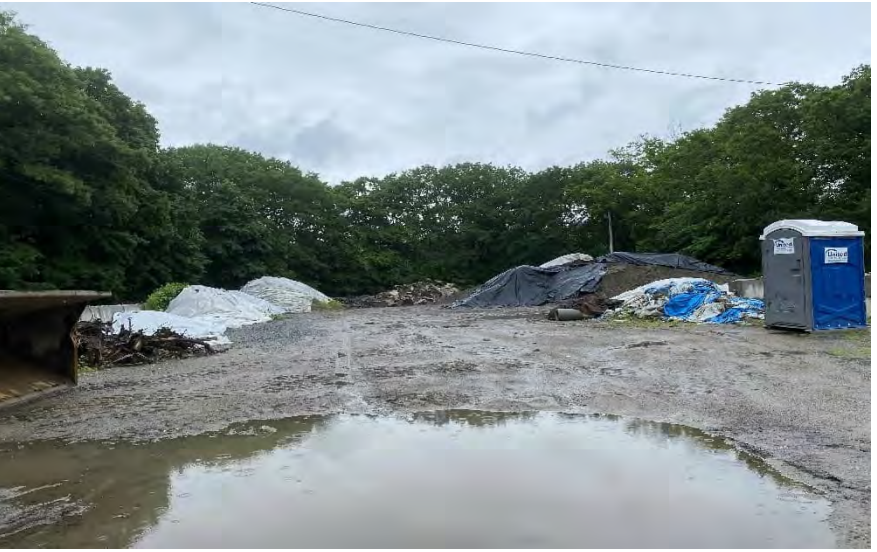
Description: Laydown yard off Stowe Court, spoil piles covered, looking westward.

Spoil stockpiles within Stowe Court laydown yard need re-covering with plastic. Contractor contacted to perform the re-covering (first noted on 5/28/24).

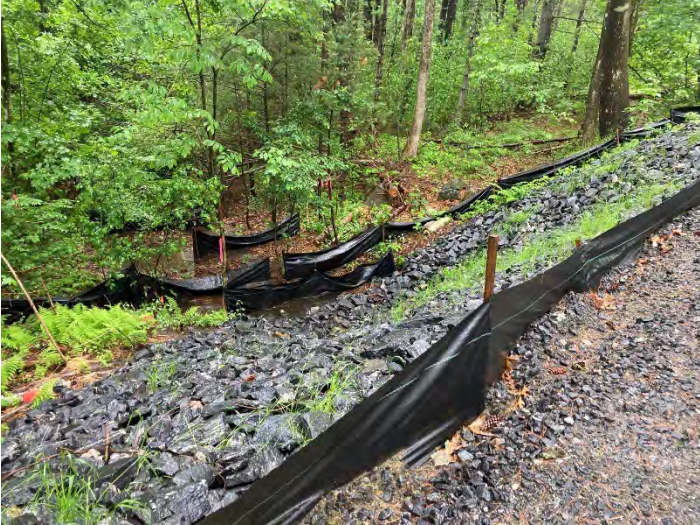
Description: View of downstream side/south side of repaired culvert in segment 9. Facing southwest.

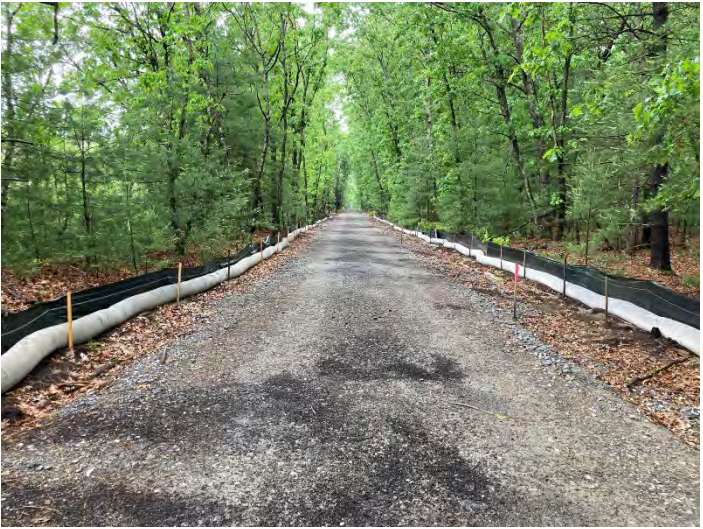
Description: View of E&S controls in segment 11. Compost filter tubes have been replaced in this area. Facing west.

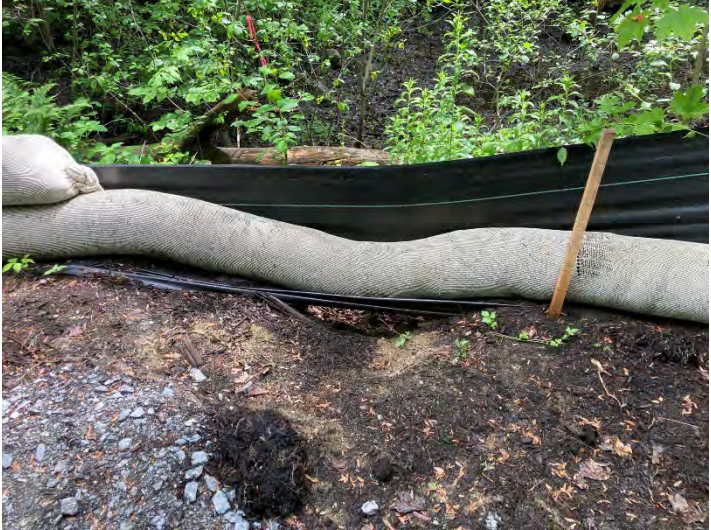
Description: View of undermined silt fence at Sta. #713+25 in segment 13. Facing south.

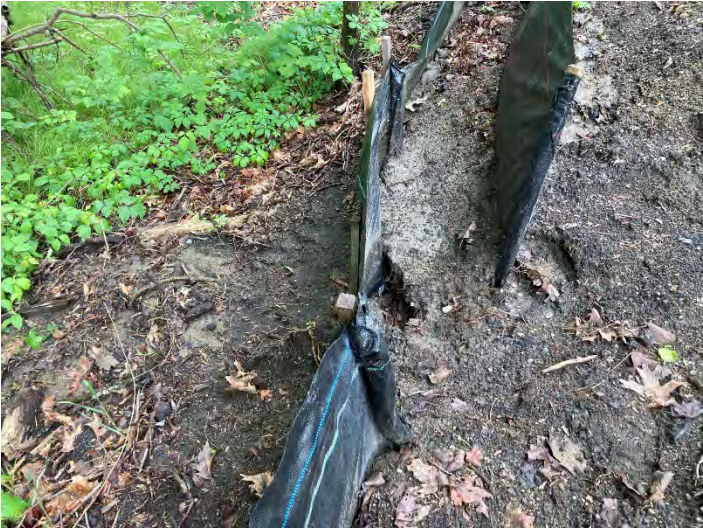
Description: View of undermined silt fence at Sta. #752 in segment 14. Facing west.

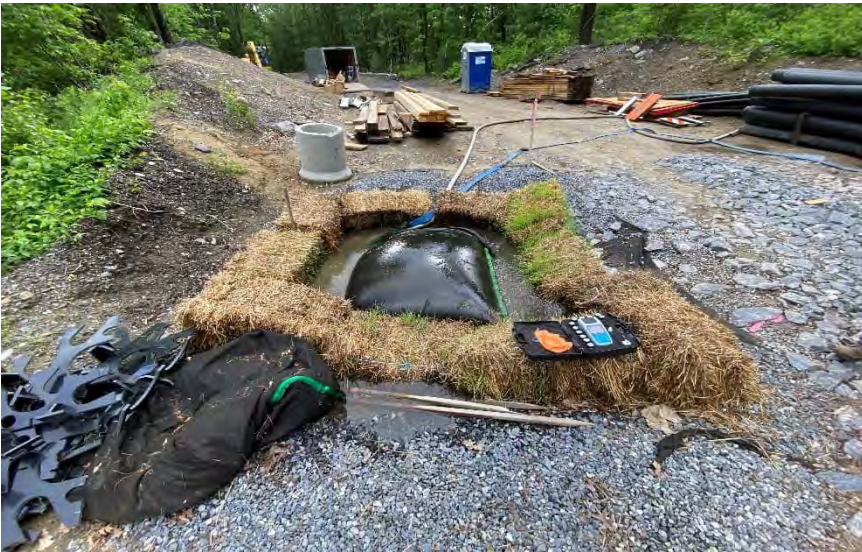
Description: Wilkins Street trench. View of discharge bag/corral, looking eastward. Water from bag/corral discharged to underlying catch basin.

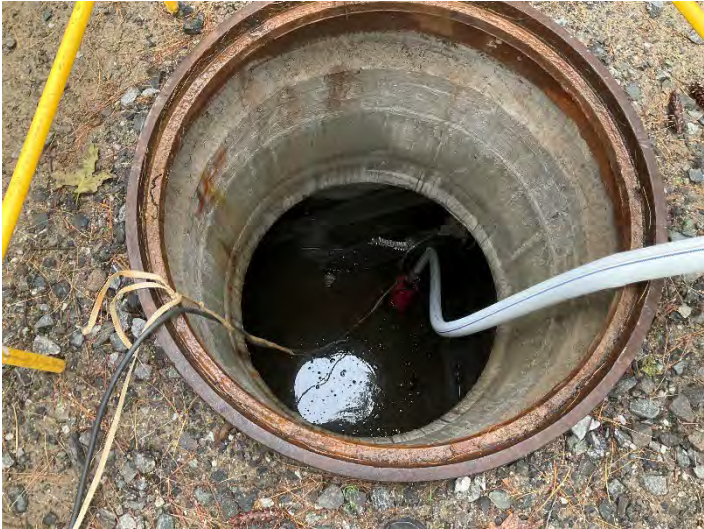
Description: View of pump in MH #21. Water appeared mostly clear prior to treatment.

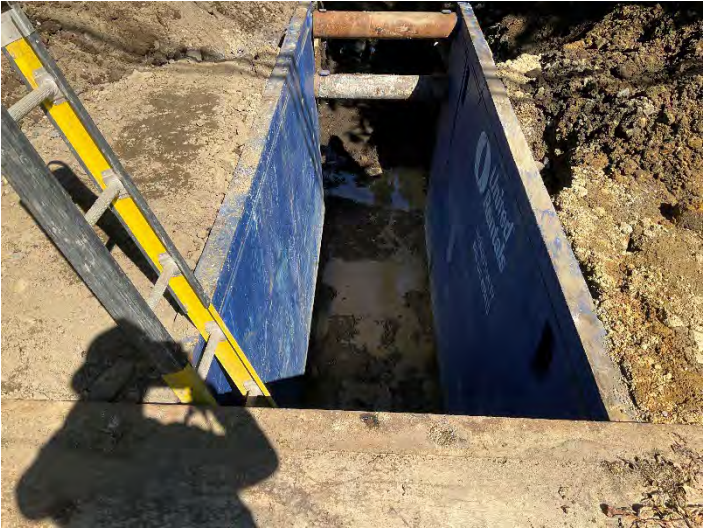
Description: View of water in trench. Water appeared turbid prior to treatment. Facing west.

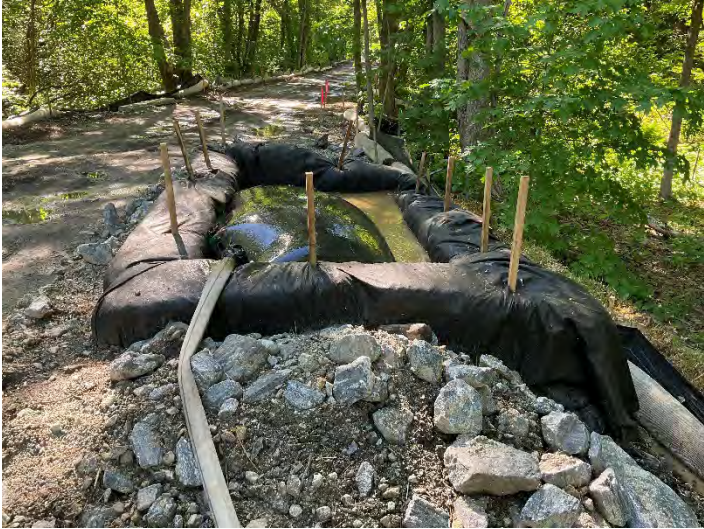
Description: View of dewatering controls (straw bale corral with filter fabric and silt bag) in segment 13. Facing east.

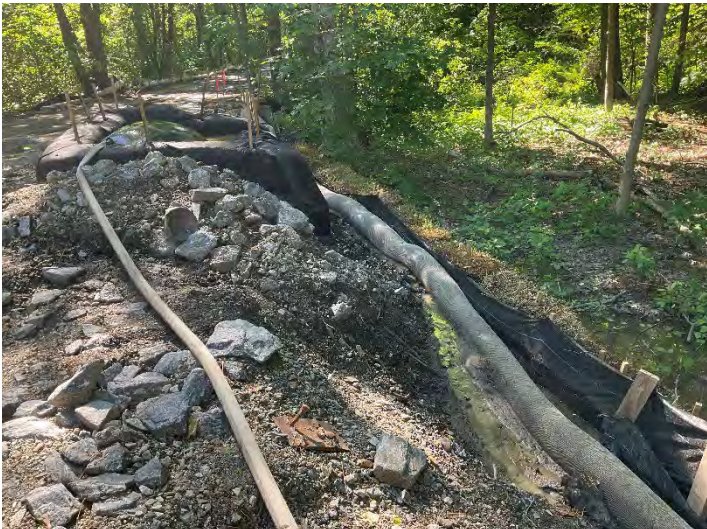
Description: View of water discharging from site. Discharge appeared turbid. Turbidity reading was higher than 50 NTUs, but discharge did not appear to reach any jurisdictional resource areas. Facing east.

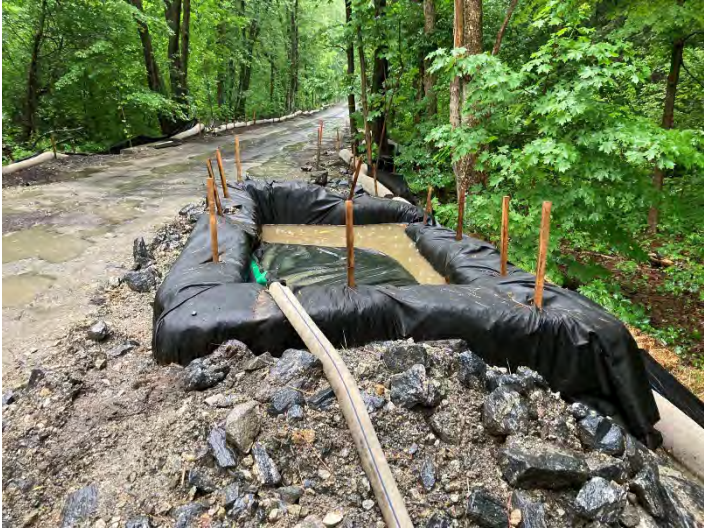
Description: View of dewatering controls (straw bale corral with filter fabric and silt bag) in segment 13. Facing east.

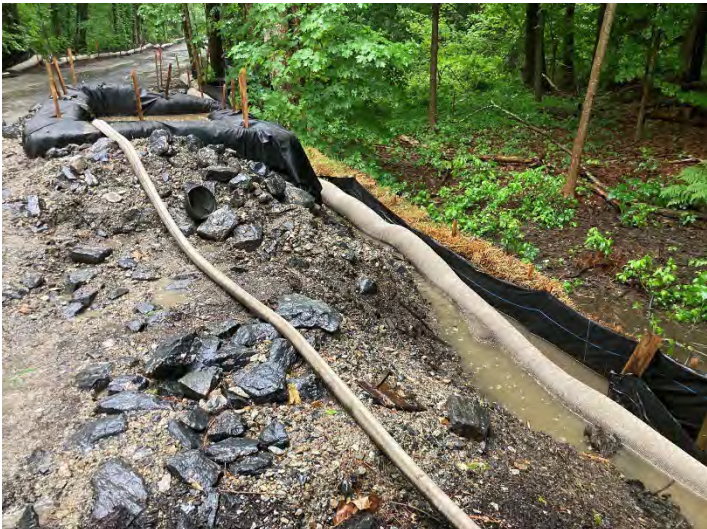
Description: View of water discharging from site. Discharge appeared turbid. Turbidity reading was higher than 50 NTUs, but discharge did not appear to reach any jurisdictional resource areas. Facing east.
