Weekly Environmental Compliance Summary

Sudbury to Hudson Transmission Reliability Project (USEPA Tracking # MAR1003UW)

Sudbury, Hudson, and Stow, MA

Week of: June 3, 2024 to June 8, 2024

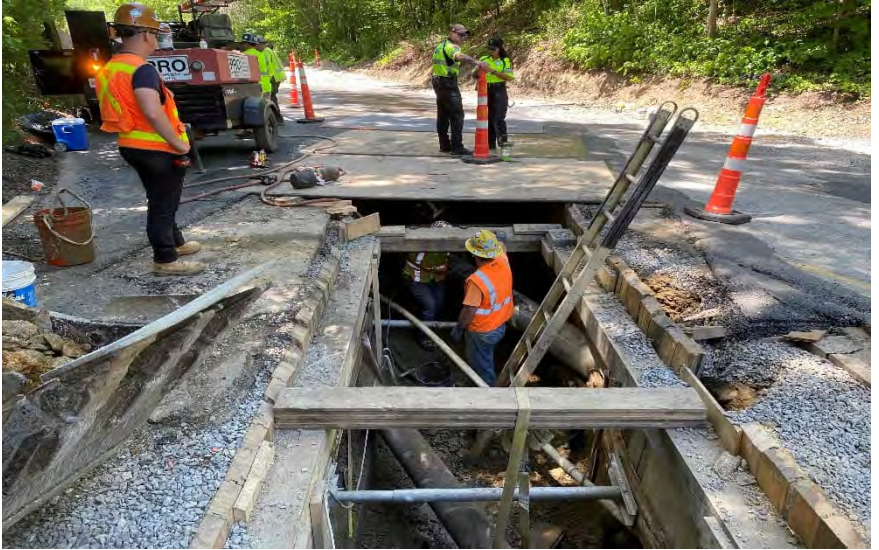
Description: Work area within Wilkins Street, ledge removal for conduit work, looking westward.

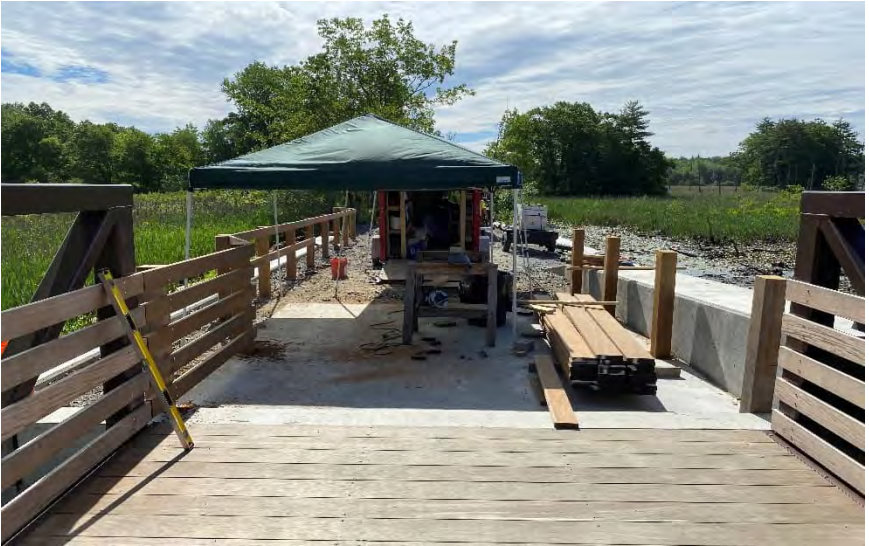
<p>Description: Work area within segment 3 along bridge 130, looking eastward.</p>

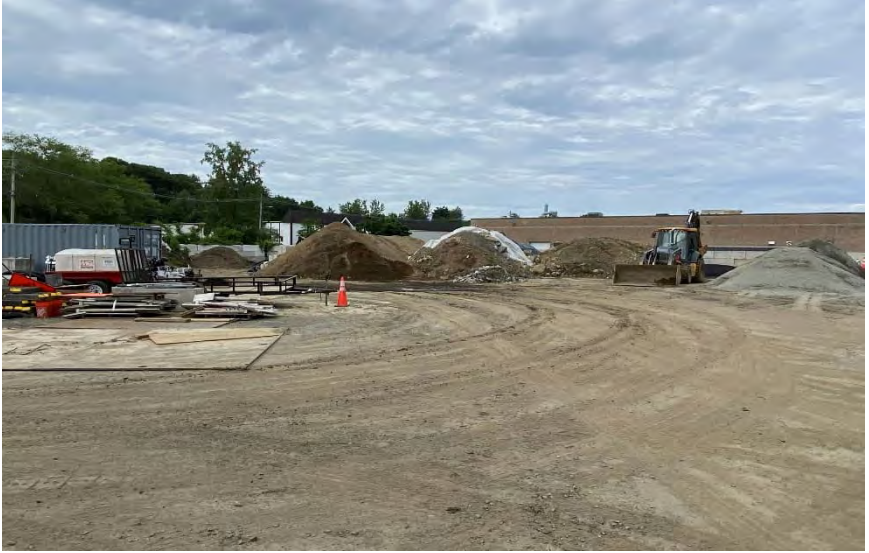
<p>Description:</p> <p>Bonazzoli laydown yard, active spoil piles, looking westward.</p>

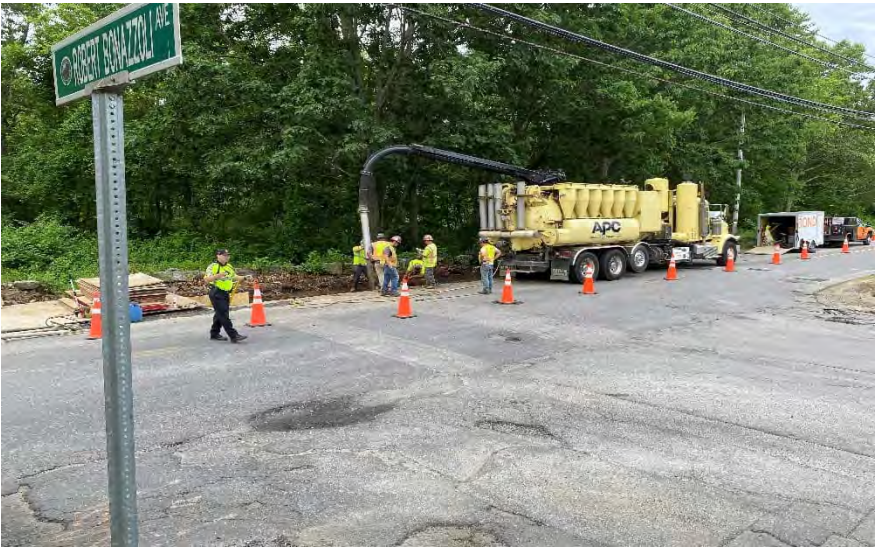
<p>Description:</p> <p>Work area within Forest Avenue, conduit work, looking westward.</p>

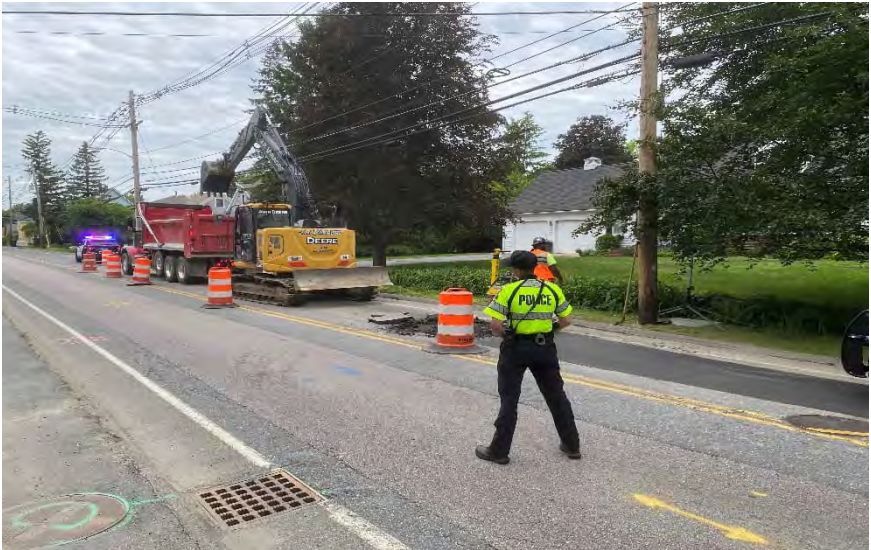
<p>Description: Work area within Forest Avenue, conduit removal work, looking southward.</p>

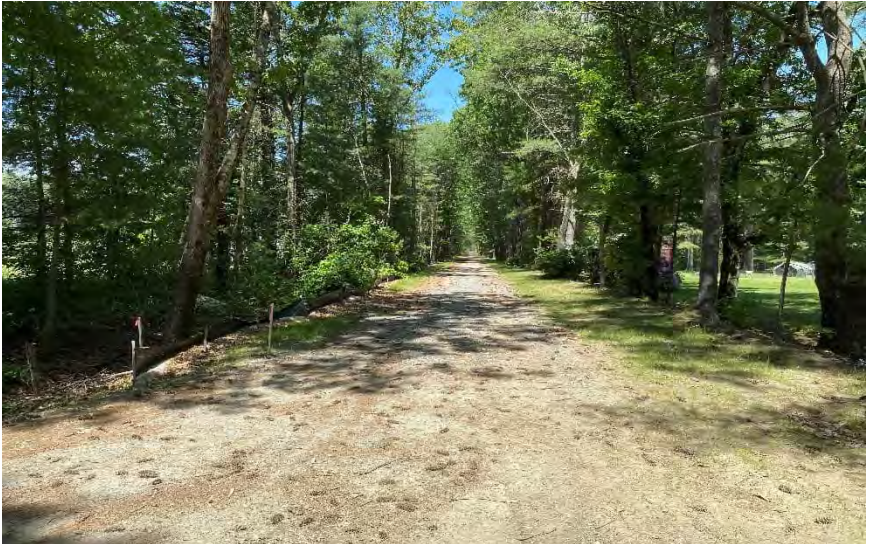
<p>Description: Work area within segment 4, existing erosion control, looking westward.</p>

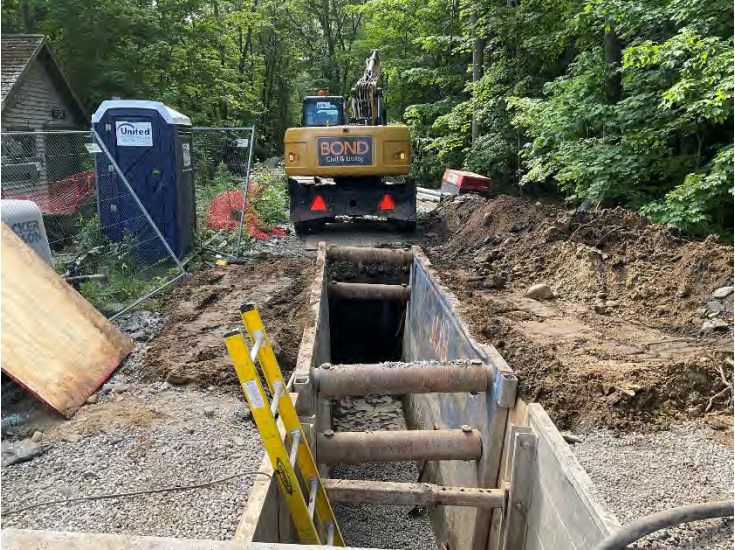
<p>Description: View of Bond working on Boston Post Rd conduit crossing. See additional dewatering inspection report. Facing east.</p>

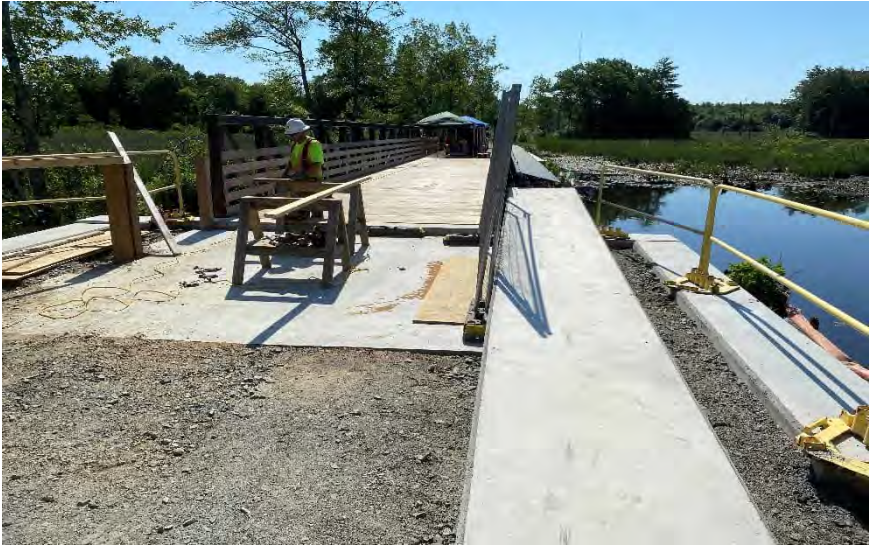
<p>Description:</p> <p>Work area within segment 2 along bridge 130, existing erosion control, looking eastward.</p>

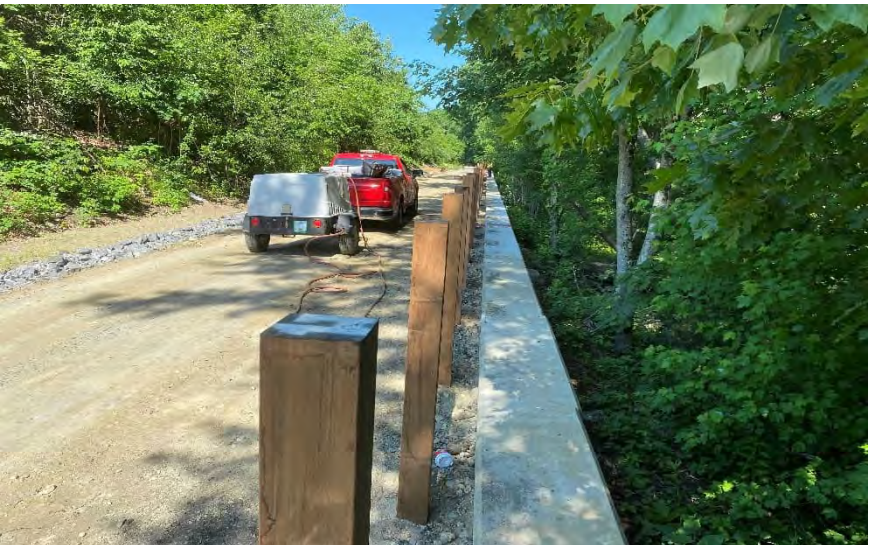
<p>Description:</p> <p>Work area within segment 1, wall work, looking westward.</p>

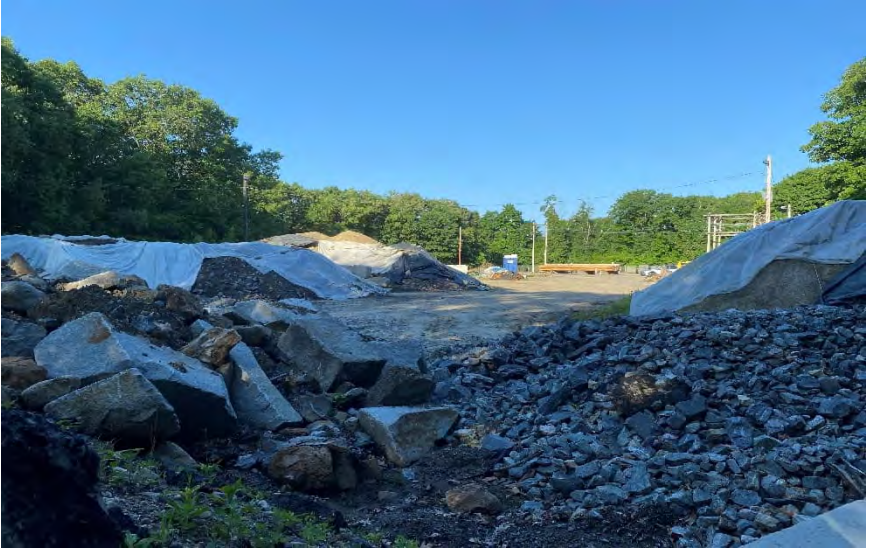
<p>Description:</p> <p>Stowe Court laydown yard, active spoil piles, looking northward.</p>

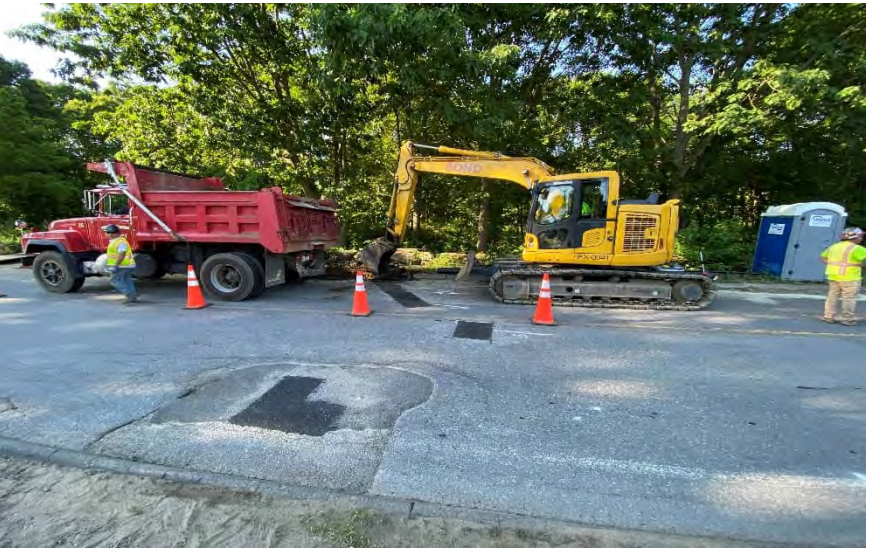
<p>Description:</p> <p>Work area within Forest Avenue, conduit work, looking westward.</p>

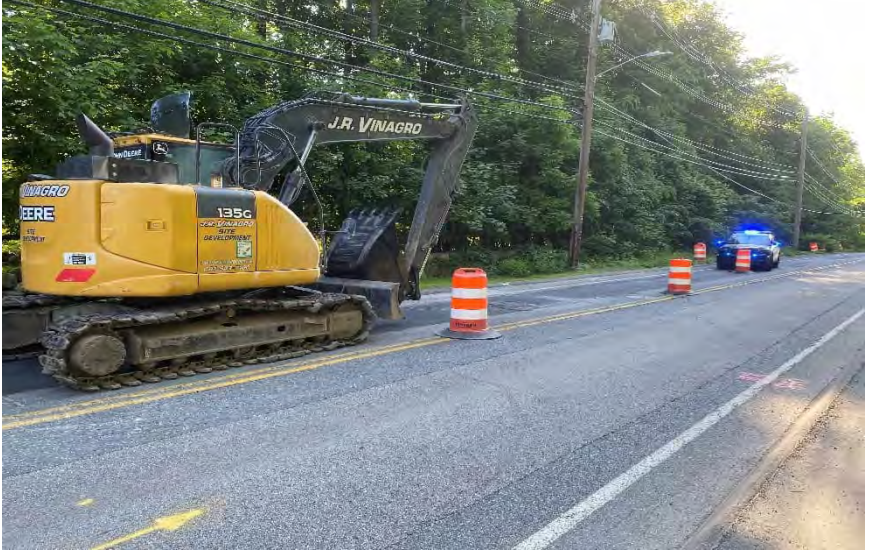
<p>Description:</p> <p>Work area within Forest Avenue, conduit removal work, looking southward.</p>

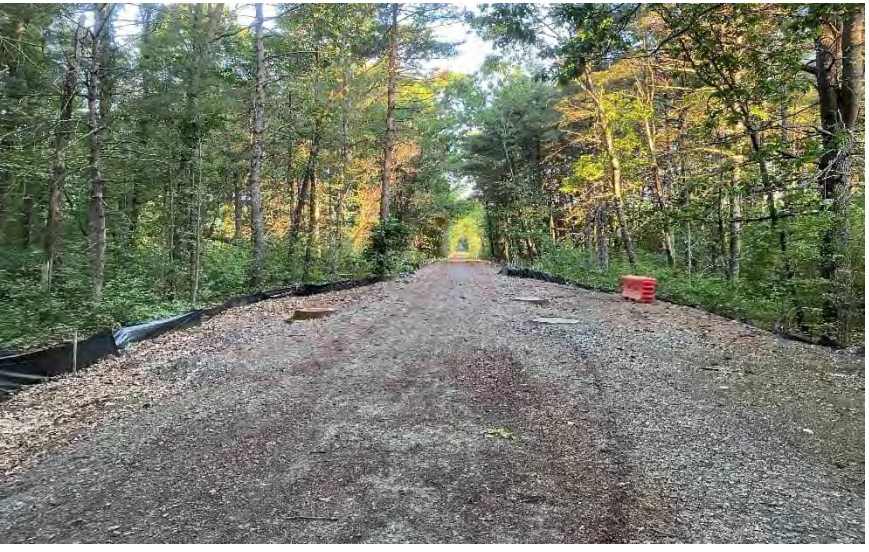
<p>Description:</p> <p>Work area within segment 5, manhole #13, existing erosion control, looking westward.</p>

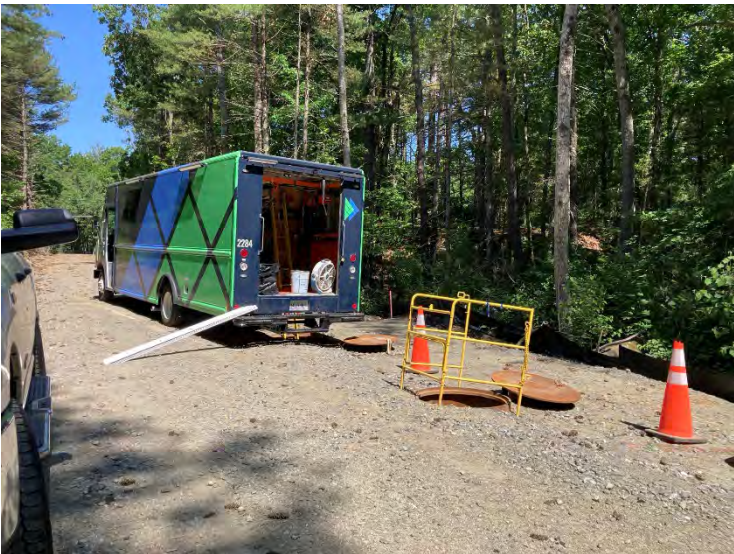
Description: View of Haugland splicing crew working at MH #20 in segment 10. Facing northwest.

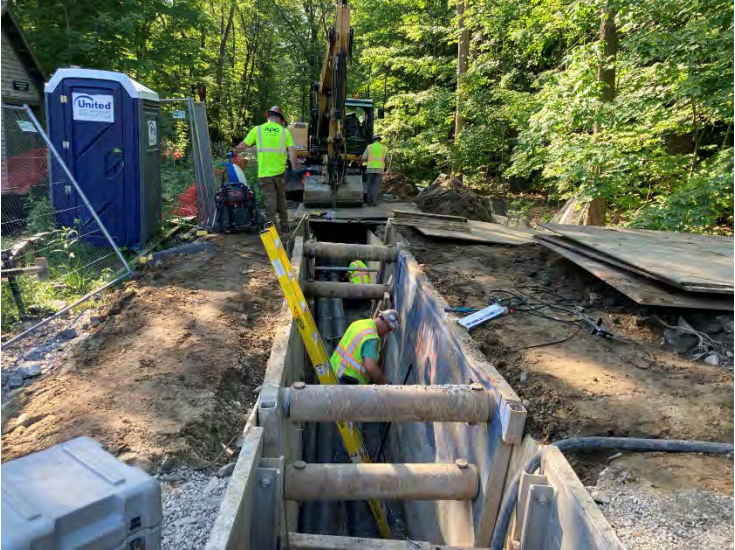
<p>Description: View of Bond working on Boston Post Rd conduit crossing. See additional dewatering inspection report. Facing east.</p>

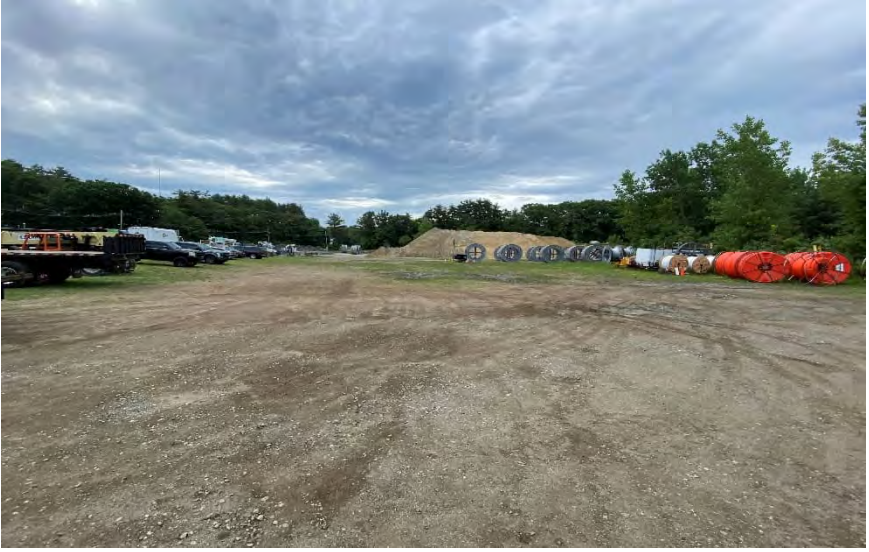
<p>Description:</p> <p>Work area within Haugland laydown yard, stored cable on reels, looking westward.</p>

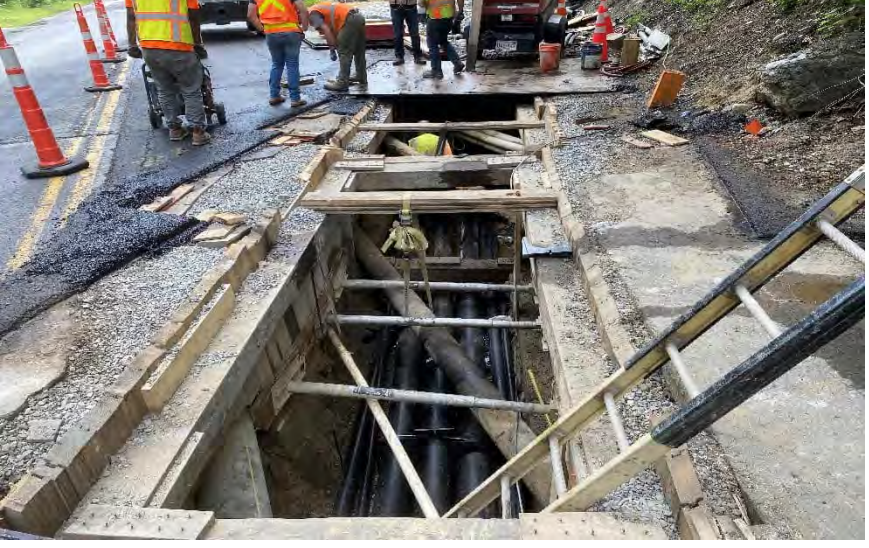
<p>Description:</p> <p>Work area within Wilkins Street, ledge removal for conduit work, looking westward.</p>

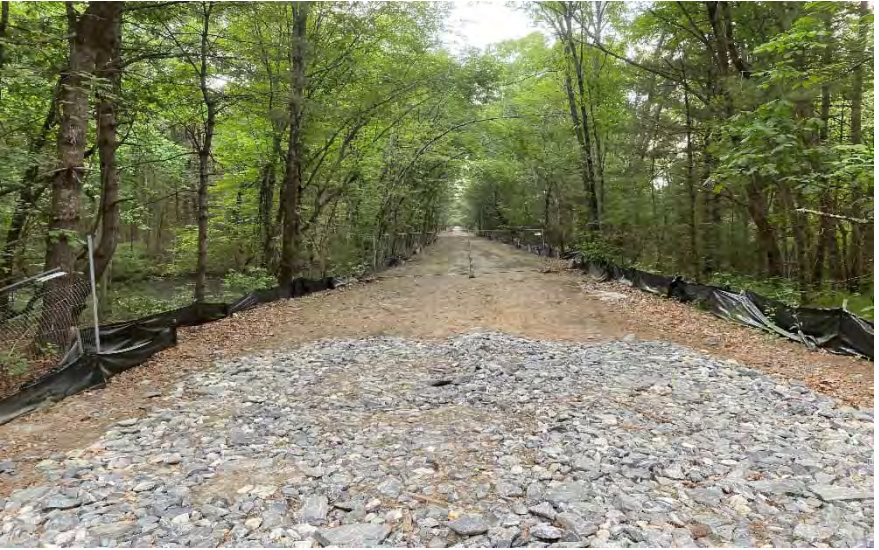
Description: Work area within segment 6, existing erosion control, looking eastward.

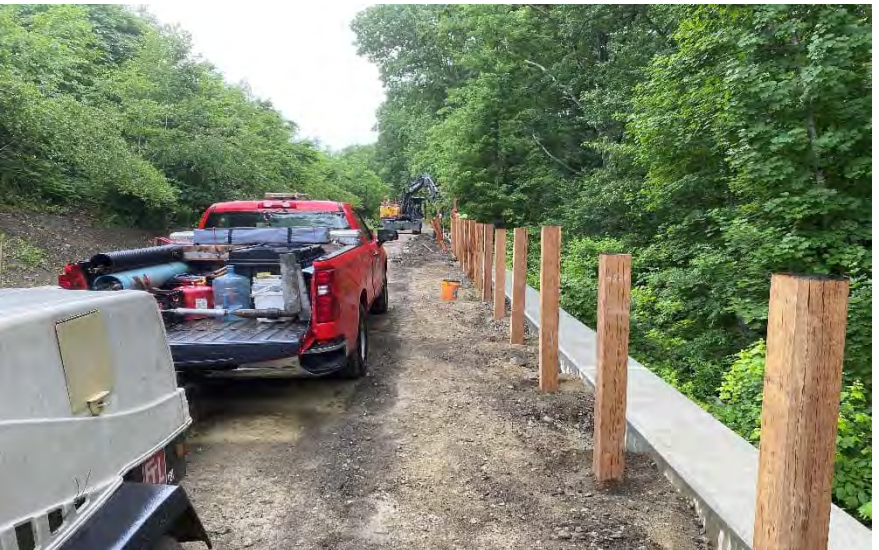
Description: Work area within segment 1, wall work, looking westward.

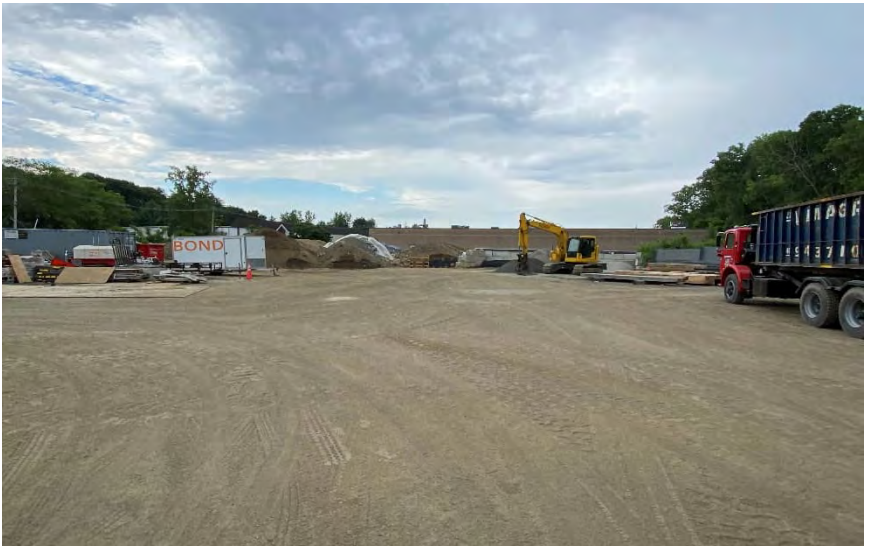
Description: Bonazzoli laydown yard, active spoil piles, looking westward.

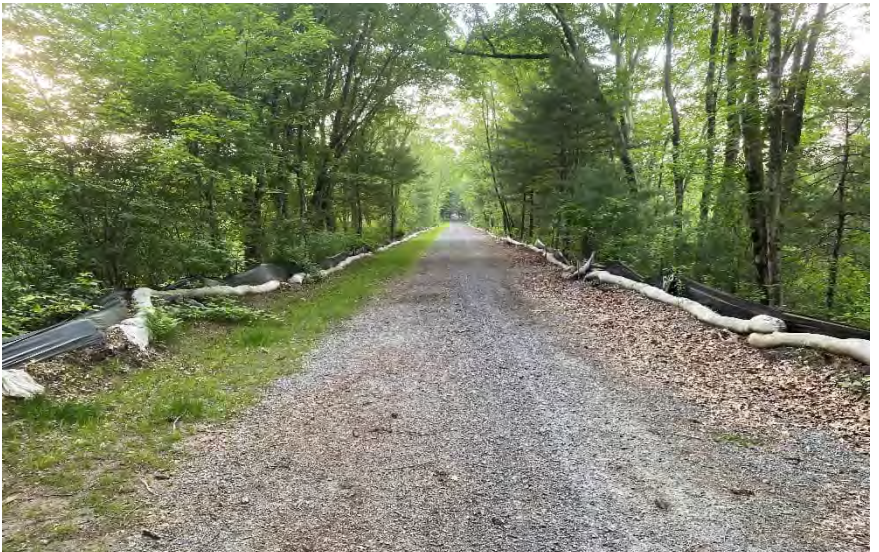
<p>Description:</p> <p>Work area within segment 5, existing erosion control, looking westward.</p>

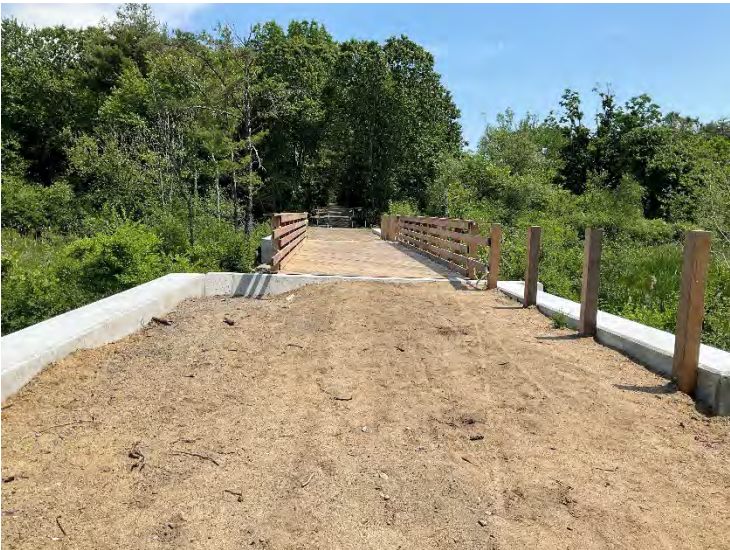
Description: View of bridge 128. Facing west.

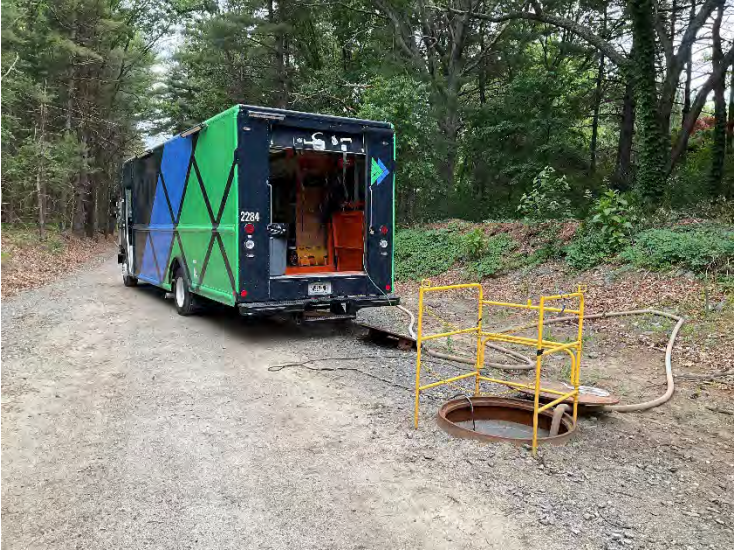
<p>Description: View of Haugland splicing crew working at MH #22 in segment 11. See additional dewatering inspection report. Facing west.</p>

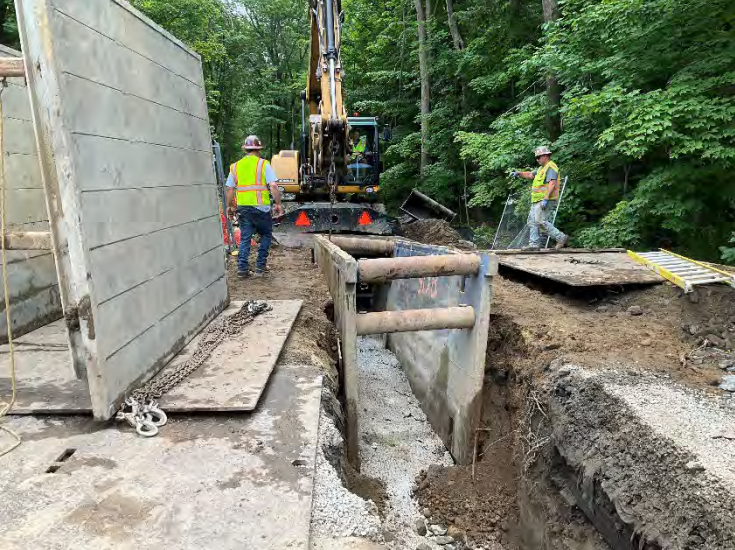
<p>Description: View of Bond working on Boston Post Rd conduit crossing. Facing east.</p>

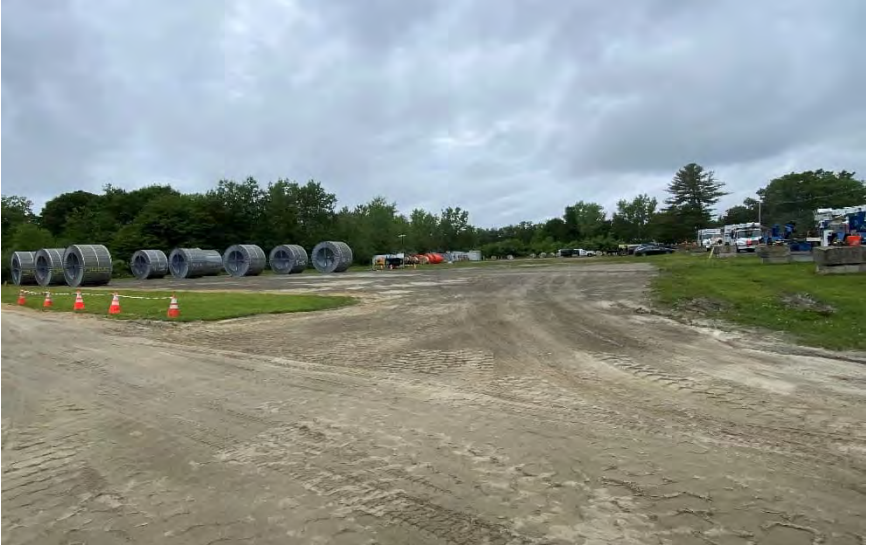
Description: Work area within Haugland laydown yard, stored cable on reels, looking westward.

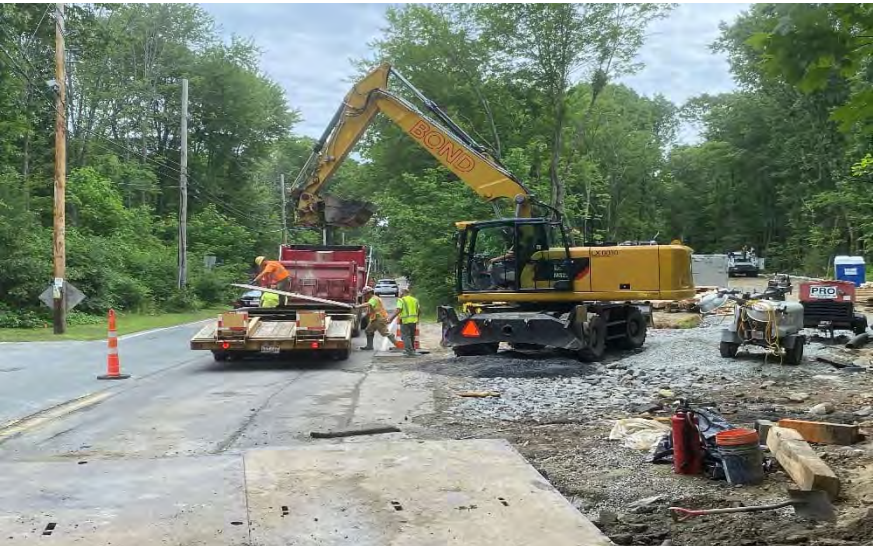
Description: Work area within Wilkins Street, ledge removal for conduit work, looking eastward.

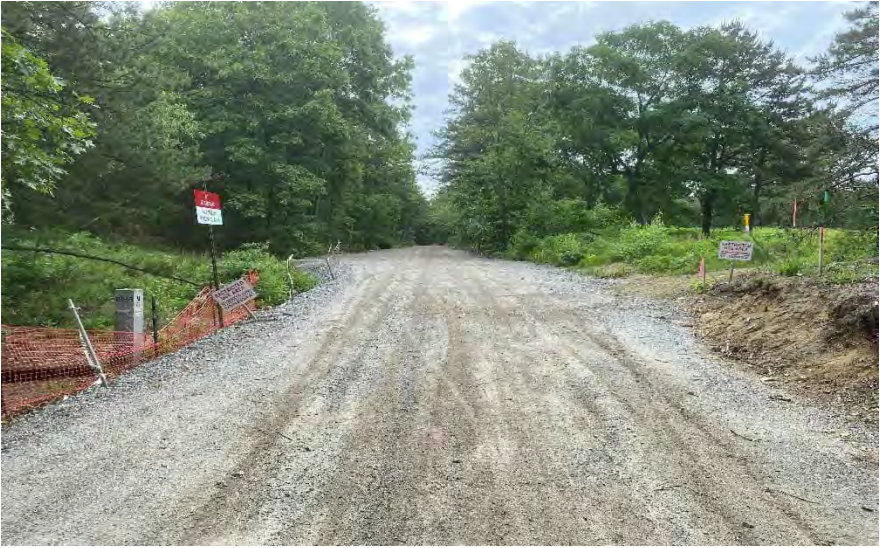
<p>Description:</p> <p>Work area within segment 6, town line area (Hudson-Sudbury), looking eastward.</p>

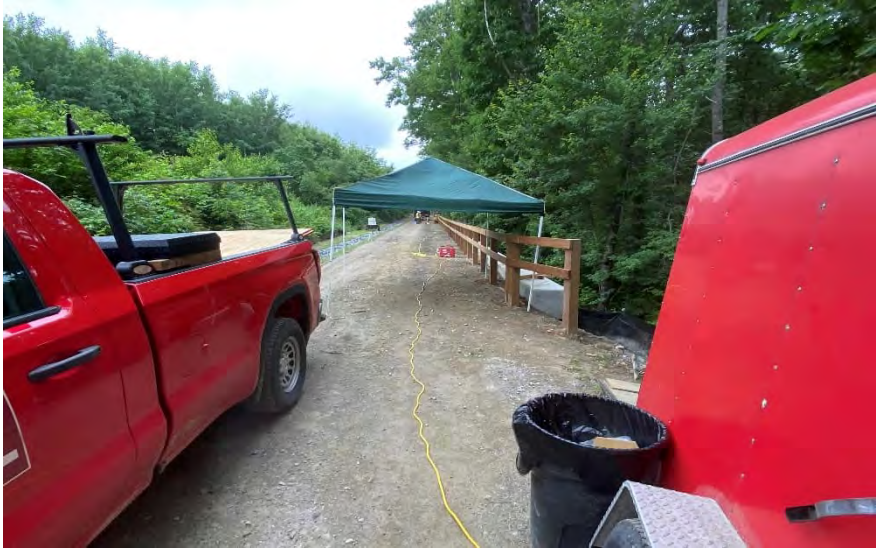
<p>Description:</p> <p>Work area within segment 1, wall work, looking westward.</p>

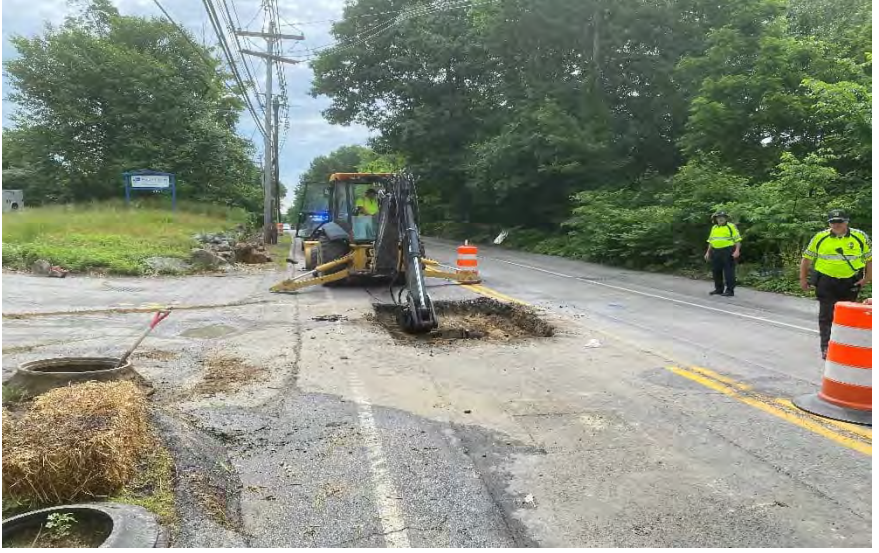
<p>Description:</p> <p>Conduit removal work within Forest Avenue (removal of old manhole @ Sta #13+00), looking northward.</p>

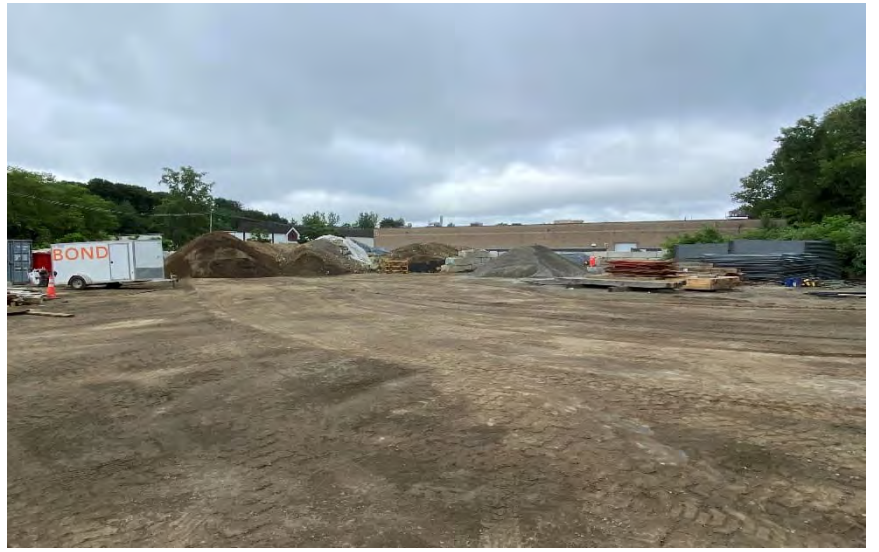
<p>Description:</p> <p>Bonazzoli laydown yard, active spoil piles, looking westward.</p>

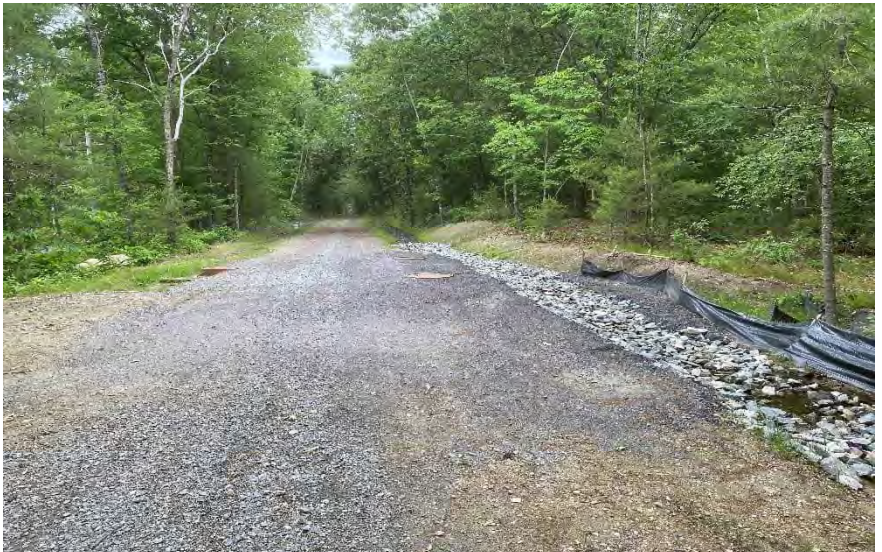
<p>Description:</p> <p>Work area within segment 5, manhole #12, existing erosion control, looking westward.</p>

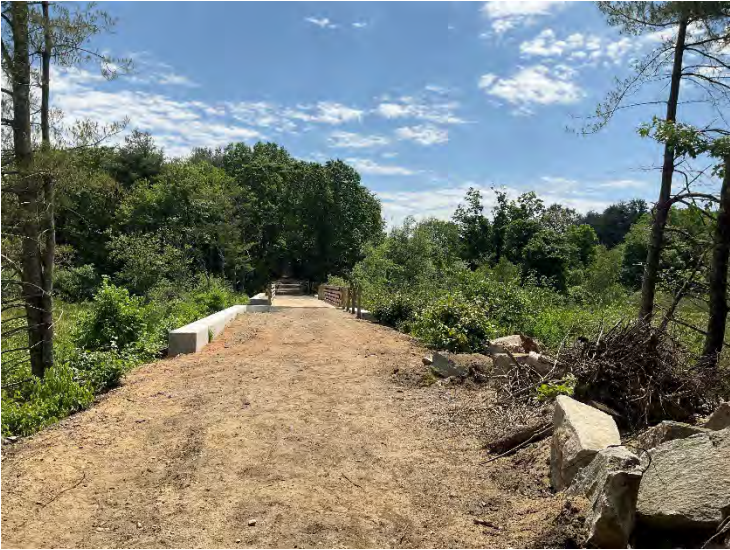
Description: View of bridge 128 from segment 7. Facing east.

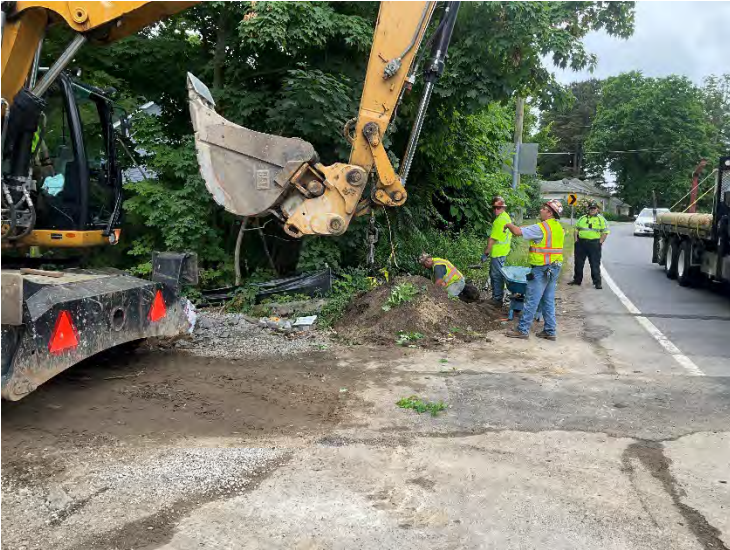
Description: View of Bond installing handhole at construction entrance to segment 13. Facing northeast.

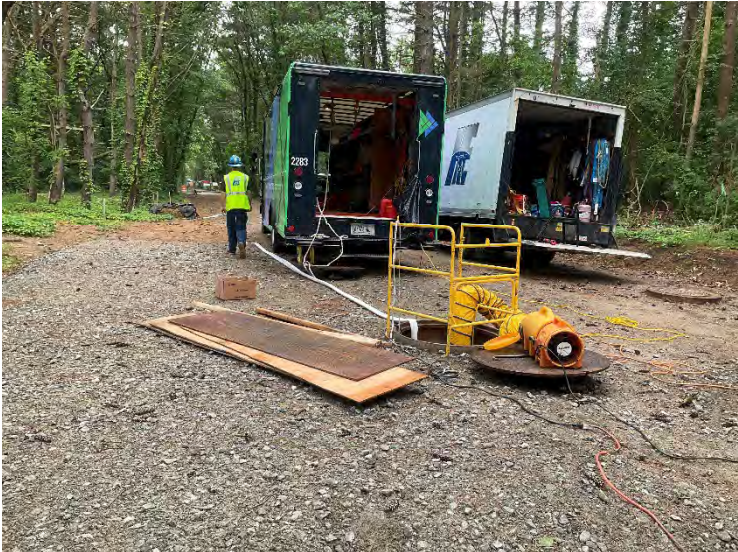
<p>Description: View of Haugland splicing crew working at MH #21 in segment 10. Facing east.</p>

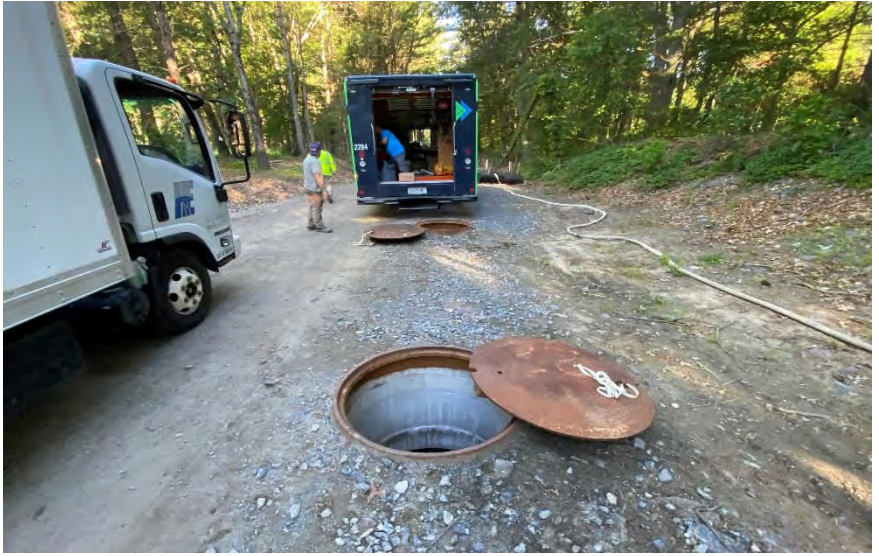
<p>Description:</p> <p>Work area within segment 11, manhole #22 splicing, looking westward.</p>

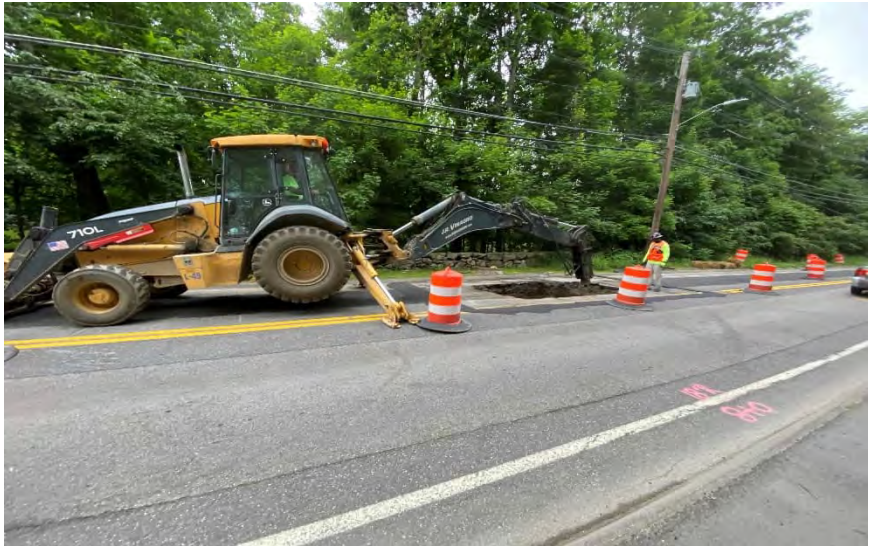
Description: Vinagro conducting conduit removal work within Forest Avenue, looking northward.

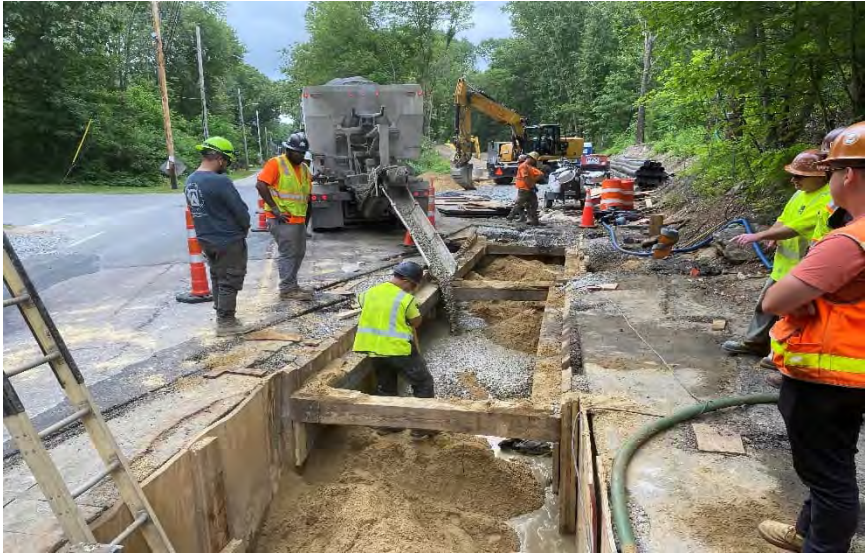
Description: Ledge removal work within Wilkins Street, looking eastward.

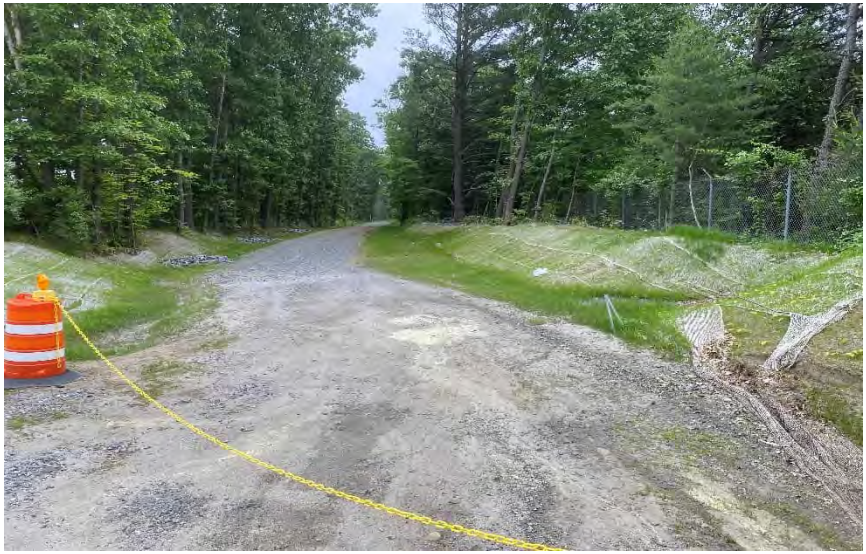
Description: Work area within segment 4 at Main Street, existing erosion control, looking eastward.

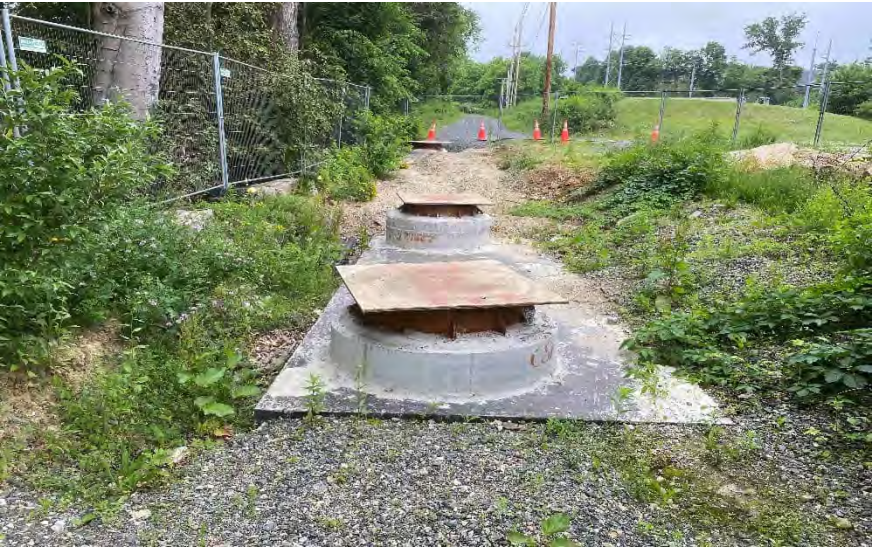
Description: Manhole #1 near Hudson Light & Power facility off Forest Avenue, looking eastward.

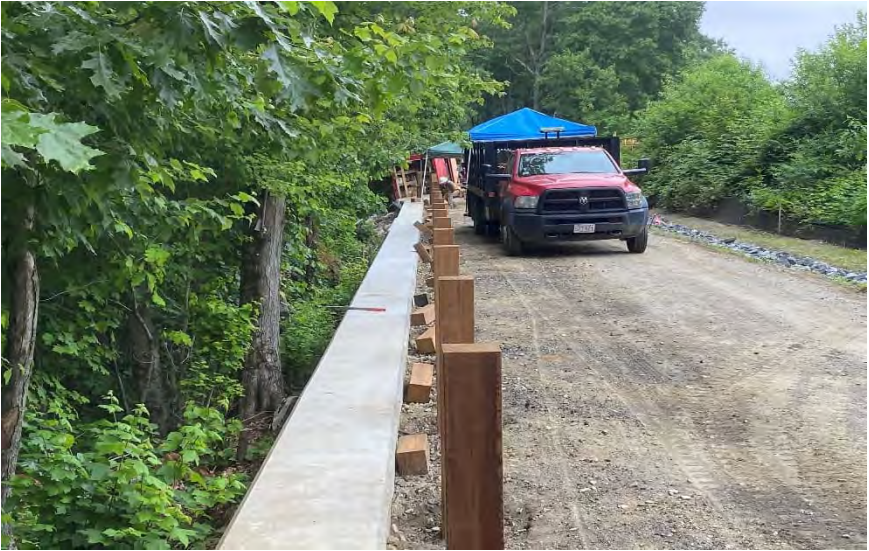
Description: Work area within segment 1, ET&L preparing for wall work, looking eastward.

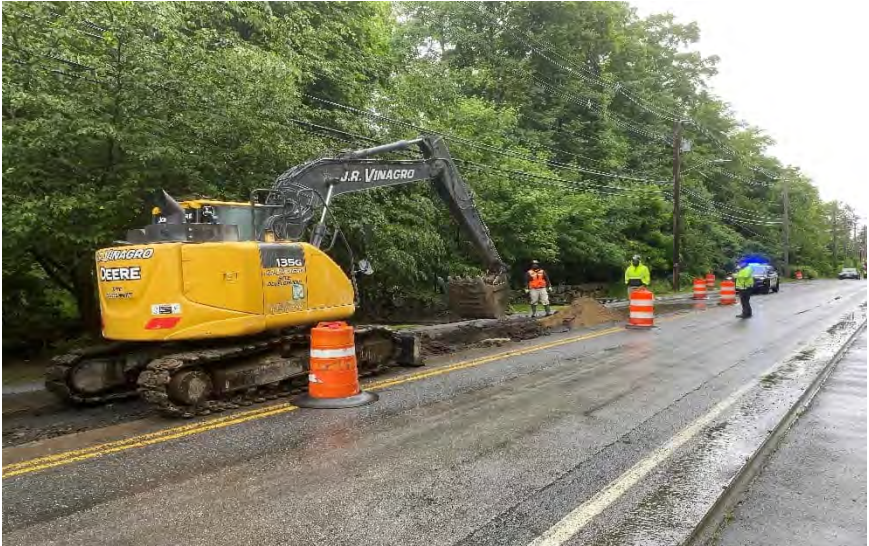
Description: Vinagro conducting conduit removal work within Forest Avenue, looking northward.

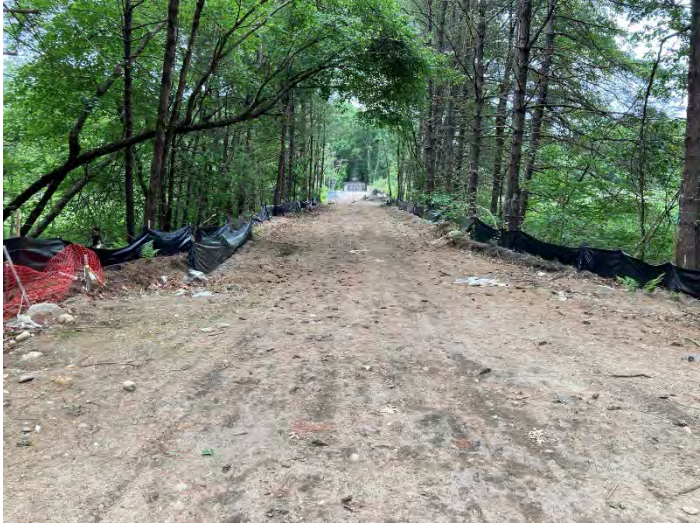
Description: View of east end of segment 7. E&S controls are in good condition. Seeded areas are beginning to vegetate. Facing east.

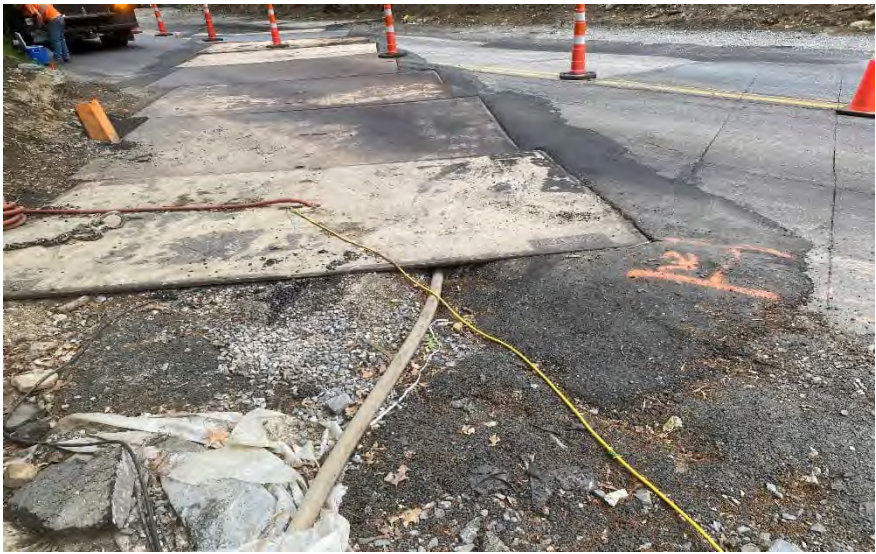
Description: View of area being pumped from trench across Wilkins Street.

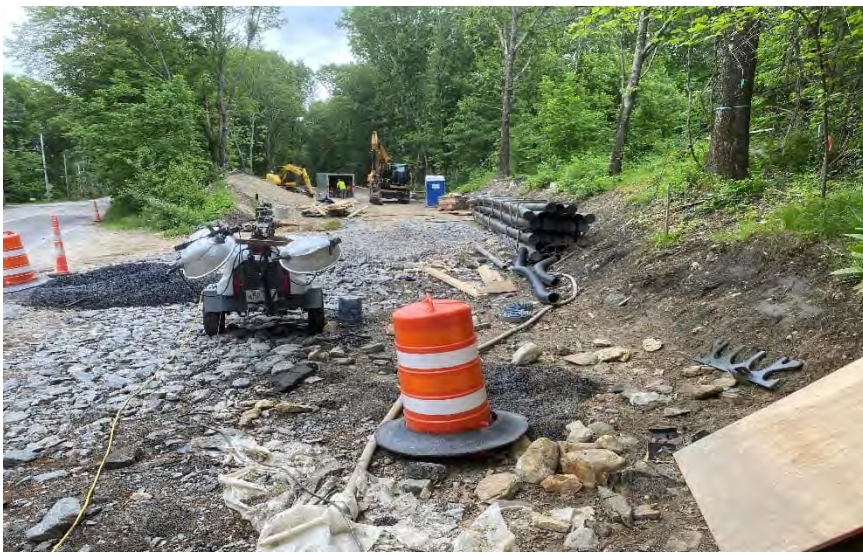
Description: Wilkins Street trench. View of dewatering operation. Looking eastward.

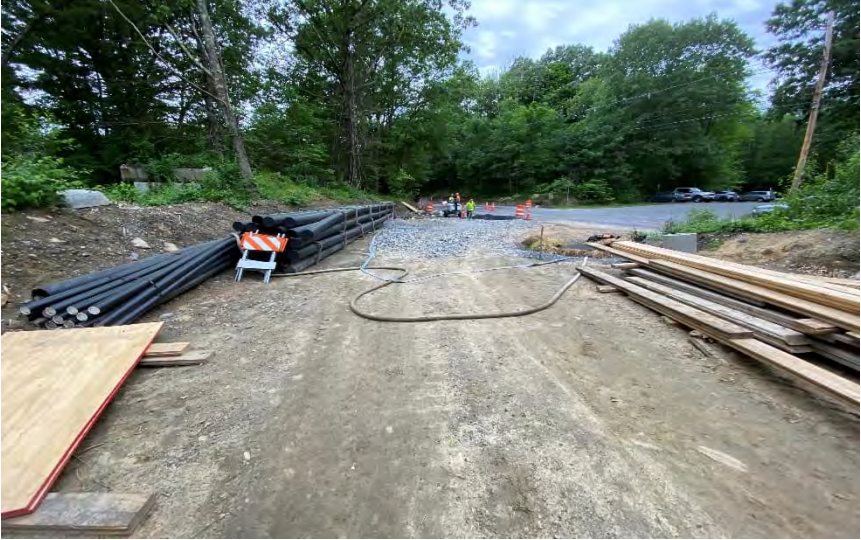
Description: Wilkins Street trench. View of dewatering operation, looking westward.

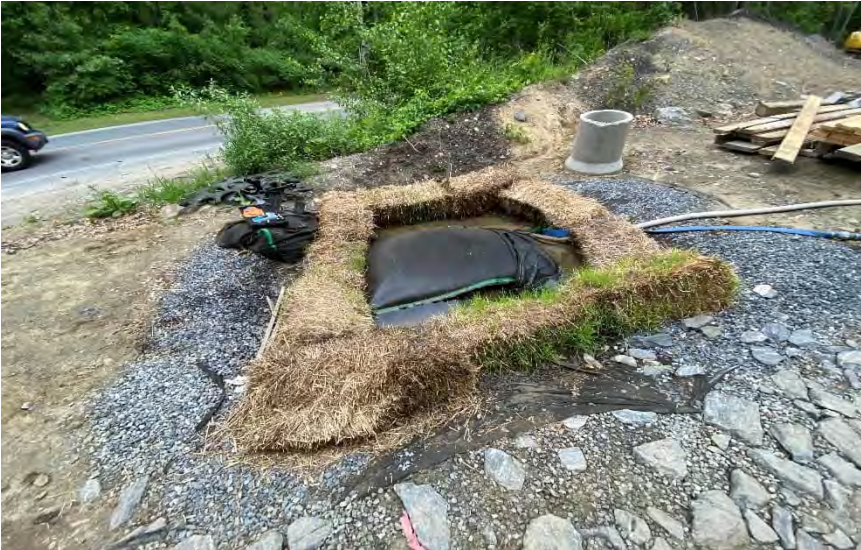
Description: Wilkins Street trench. View of discharge bag/corral, looking eastward. Water from bag/corral discharged to underlying catch basin.

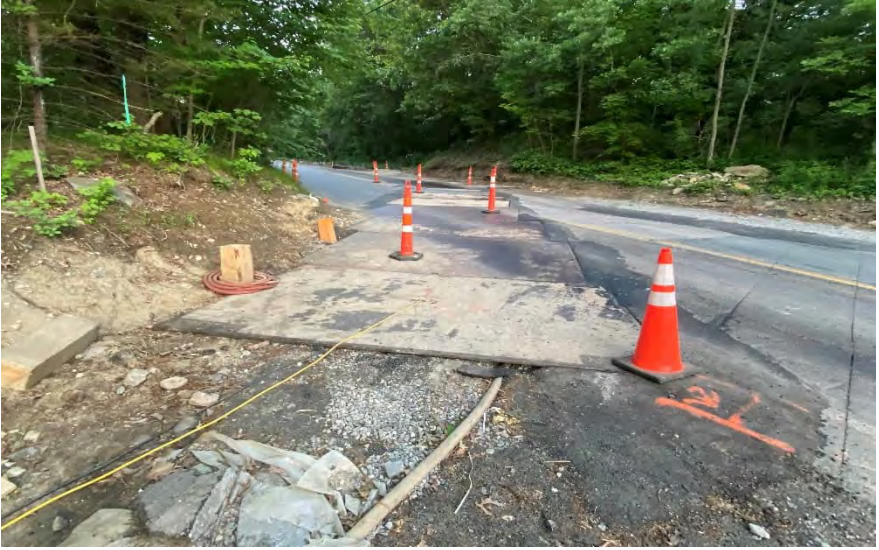
Description: View of area being pumped from trench across Wilkins Street.
