Weekly Environmental Compliance Summary

Sudbury to Hudson Transmission Reliability Project (USEPA Tracking # MAR1003UW)

Sudbury, Hudson, and Stow, MA

Week of: June 3, 2024 to June 8, 2024

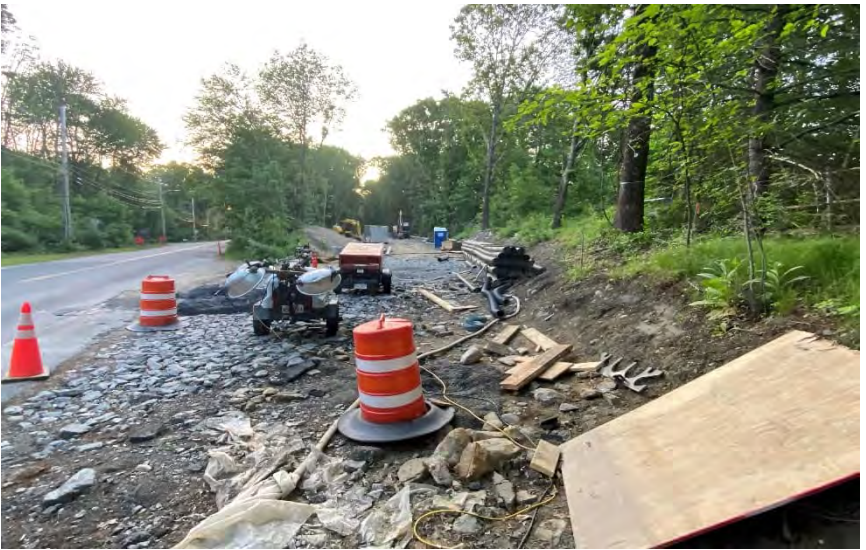
Description: Wilkins Street trench. View of dewatering operation. Looking eastward.

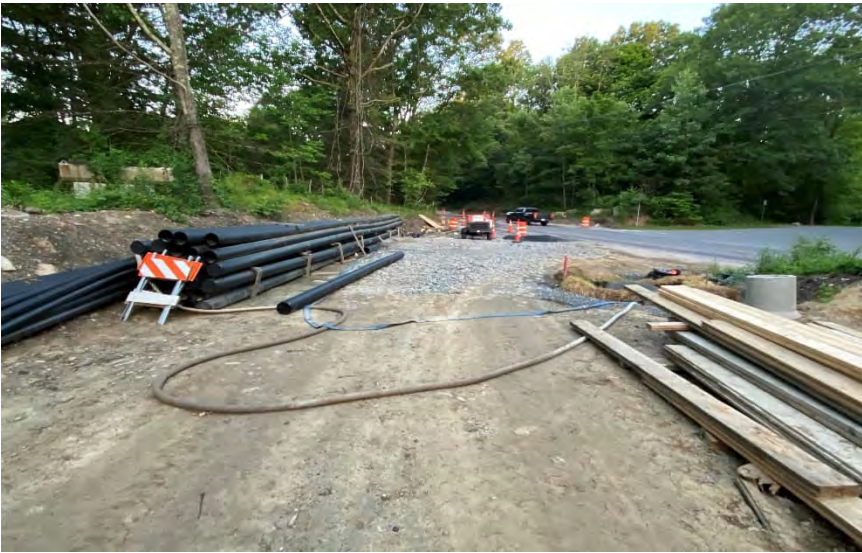
Description: Wilkins Street trench. View of dewatering operation, looking westward.

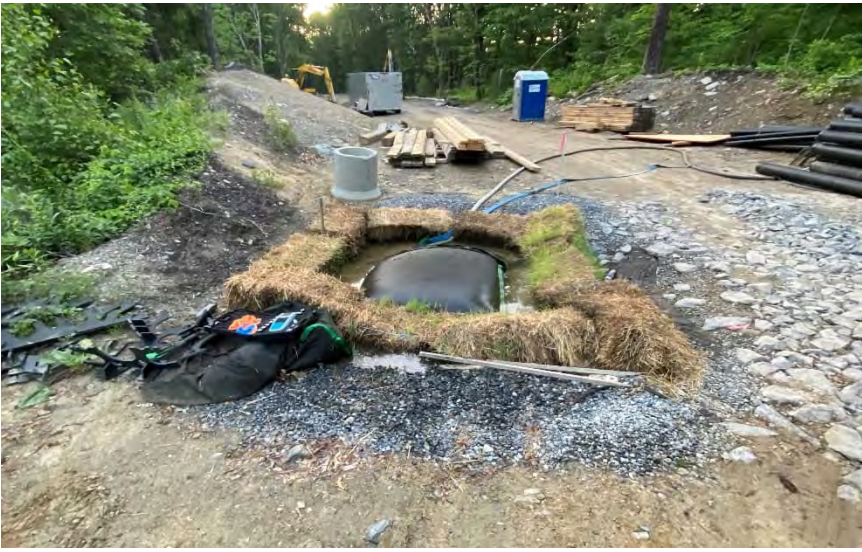
Description: Wilkins Street trench. View of discharge bag/corral, looking eastward. Water from bag/corral discharged to underlying catch basin.

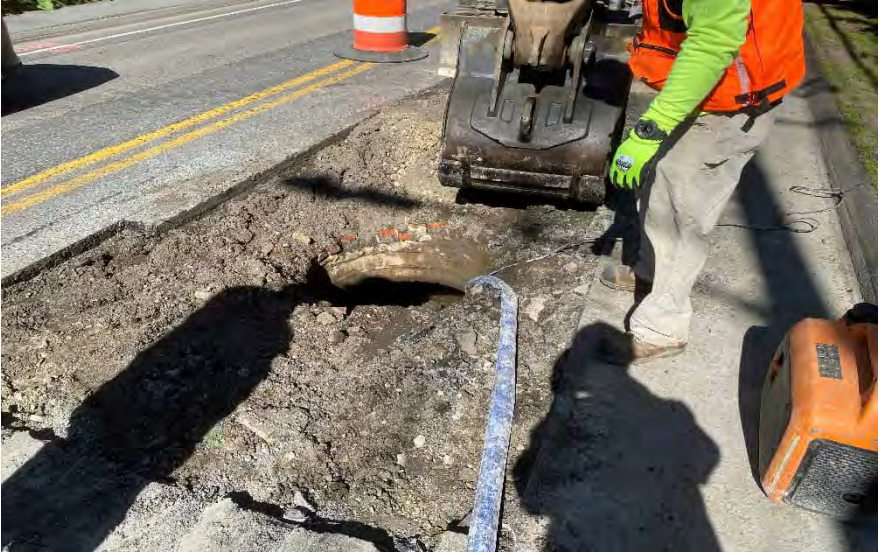
Description: View of manhole within Forest Avenue being pumped.

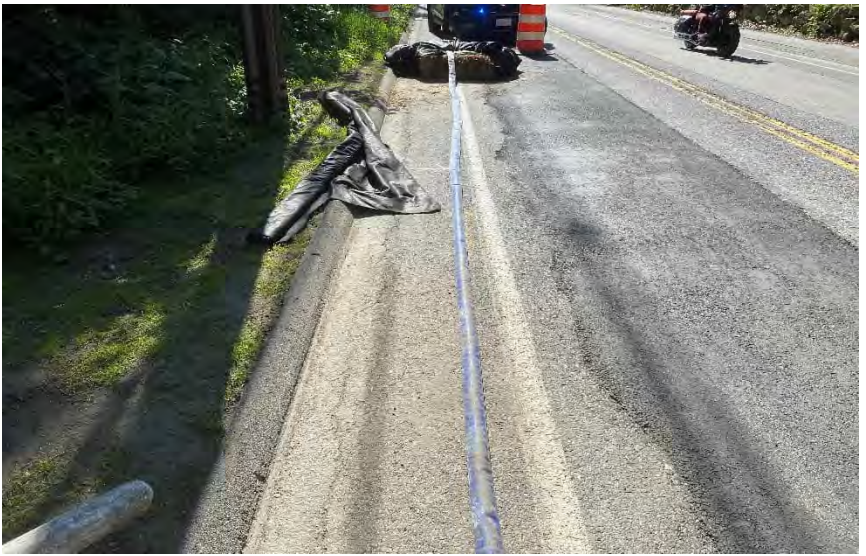
Description: Forest Avenue. View of dewatering operation, looking westward.

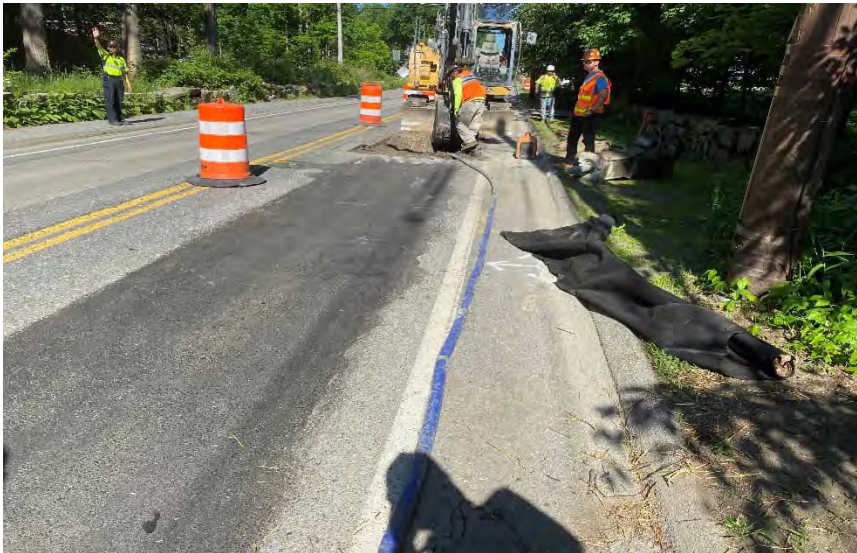
Description: Forest Avenue. View of dewatering operation, looking eastward.

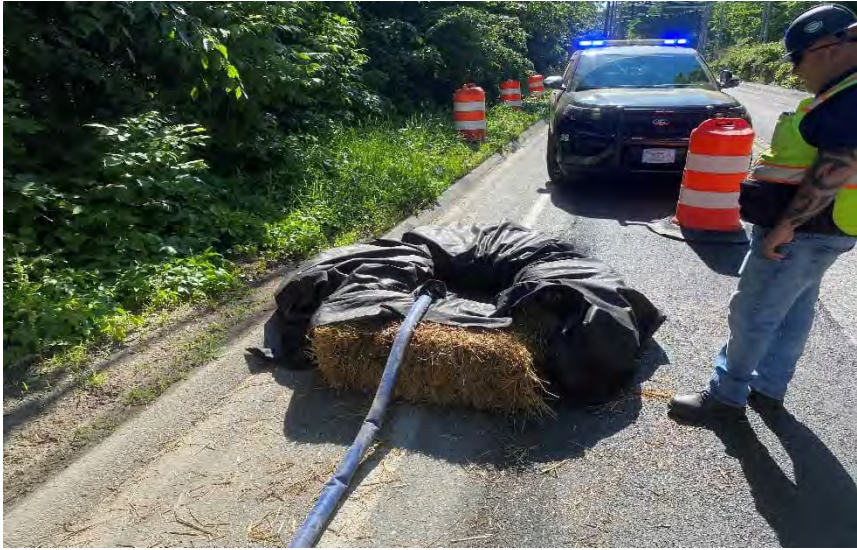
Description: Forest Avenue. View of discharge bag/corral, looking westward. Water from bag/corral discharged to roadway & exited roadway via two catch basins within the road.

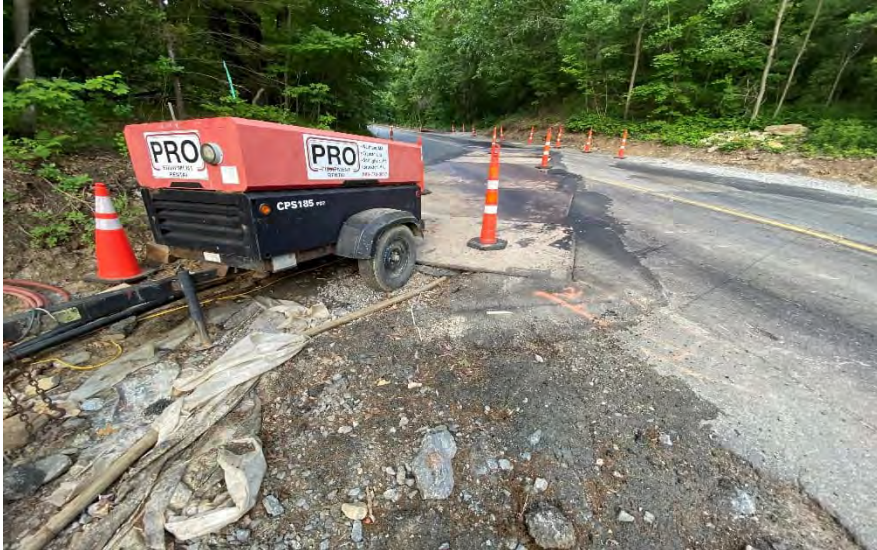
Description: View of area being pumped from trench across Wilkins Street.

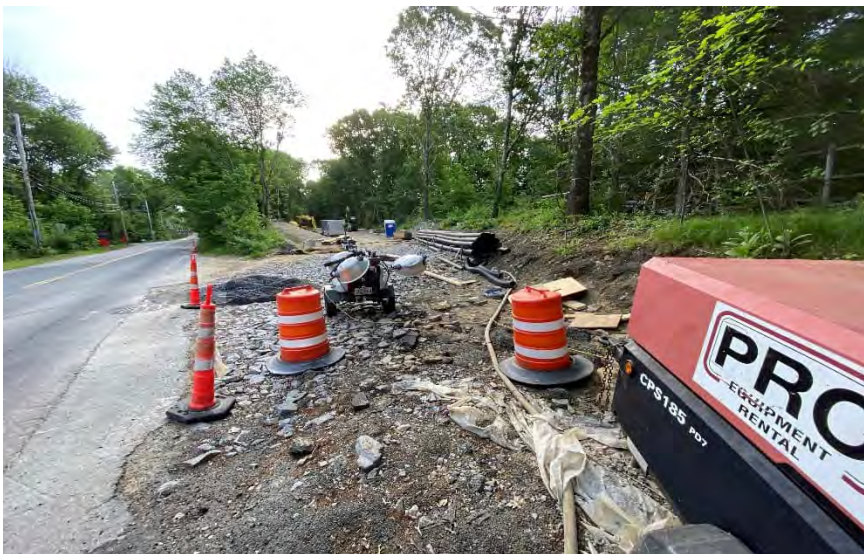
Description: Wilkins Street trench. View of dewatering operation. Looking eastward.

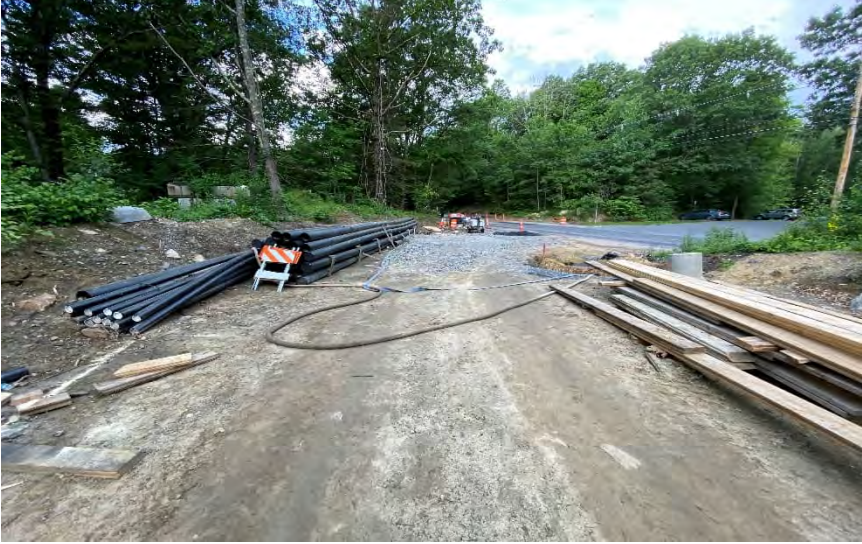
Description: Wilkins Street trench. View of dewatering operation, looking westward.

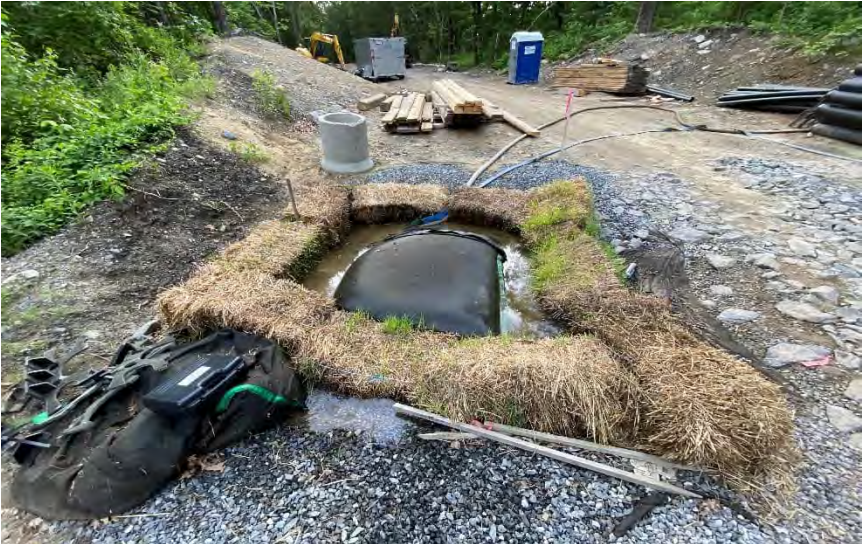
Description: Wilkins Street trench. View of discharge bag/corral, looking eastward. Water from bag/corral discharged to underlying catch basin.

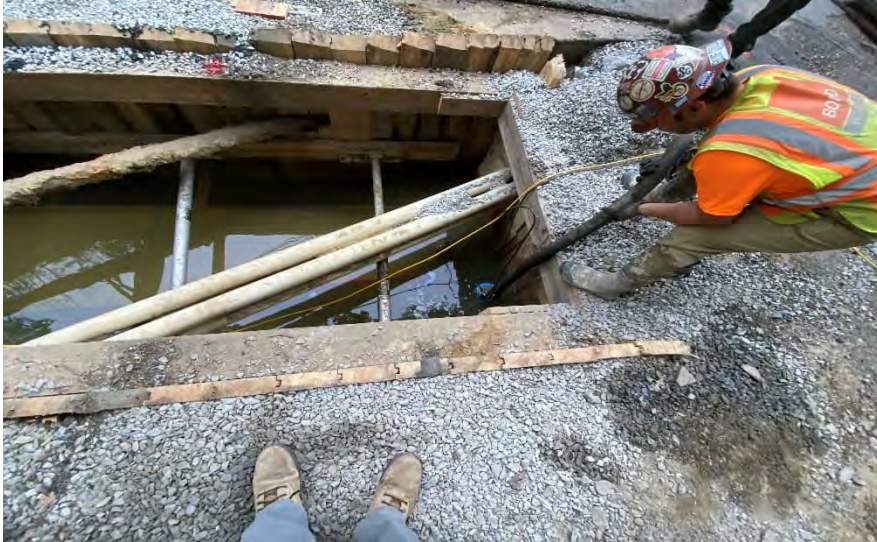
Description: View of area being pumped from trench across Wilkins Street.

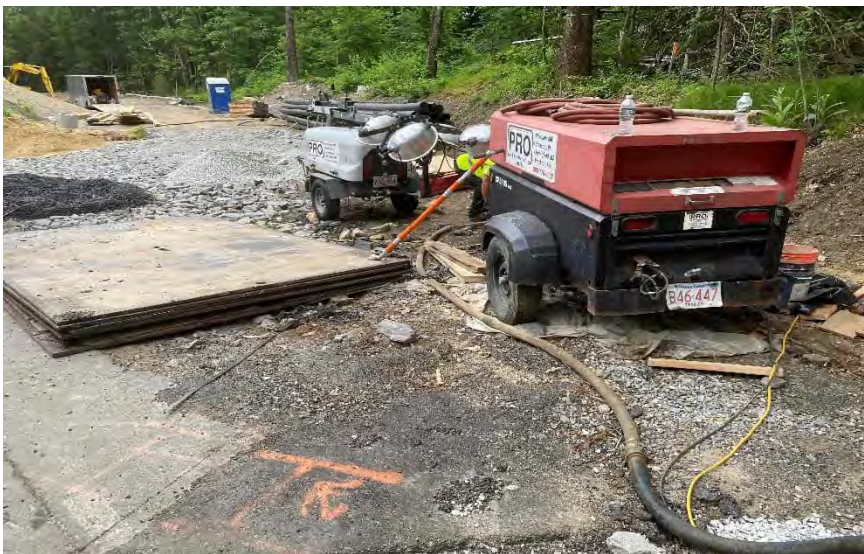
Description: Wilkins Street trench. View of dewatering operation. Looking eastward.

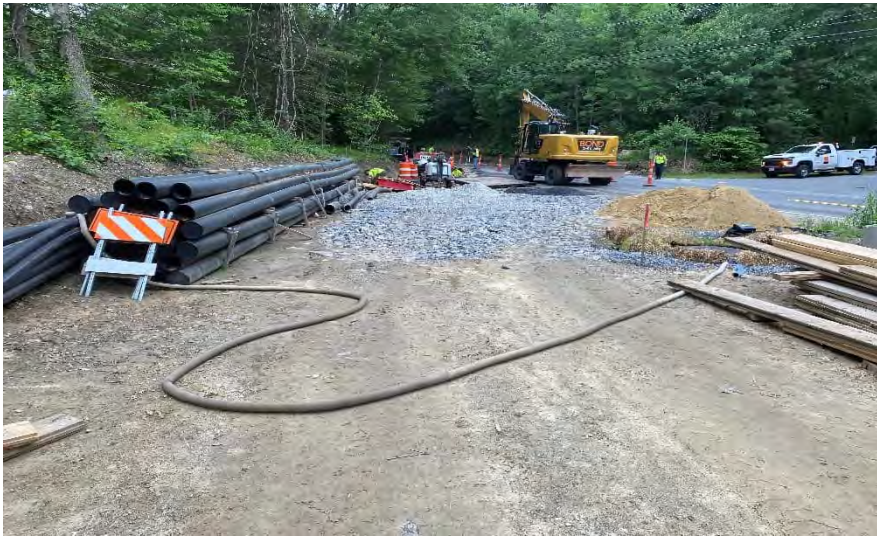
Description: Wilkins Street trench. View of dewatering operation, looking westward.

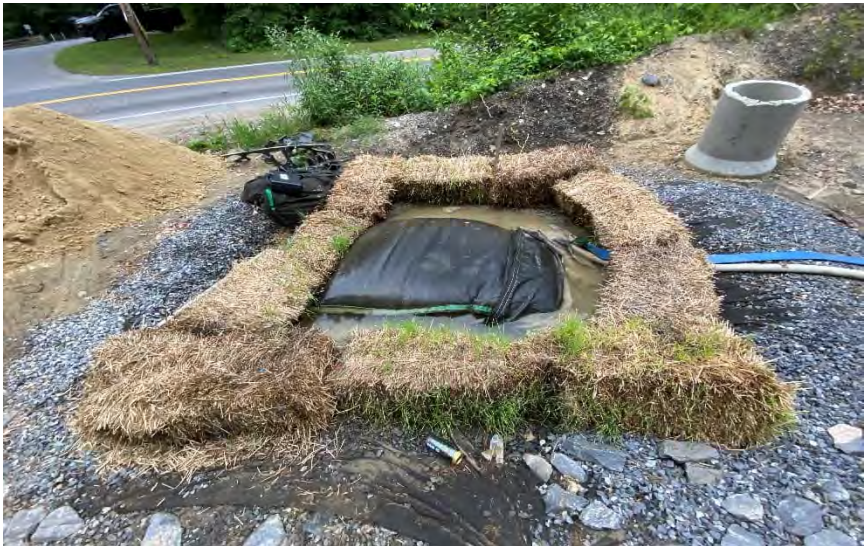
Description: Wilkins Street trench. View of discharge bag/corral, looking eastward. Water from bag/corral discharged to underlying catch basin.

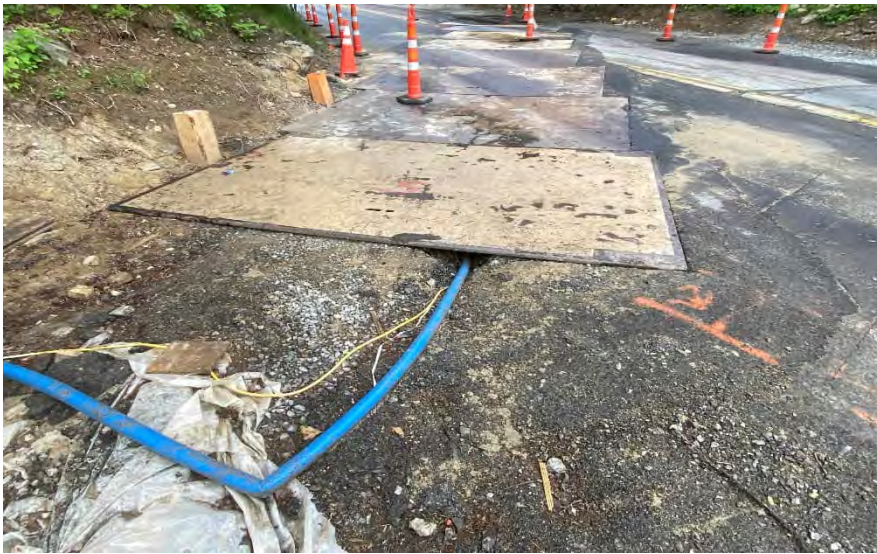
Description: View of area being pumped from trench across Wilkins Street.

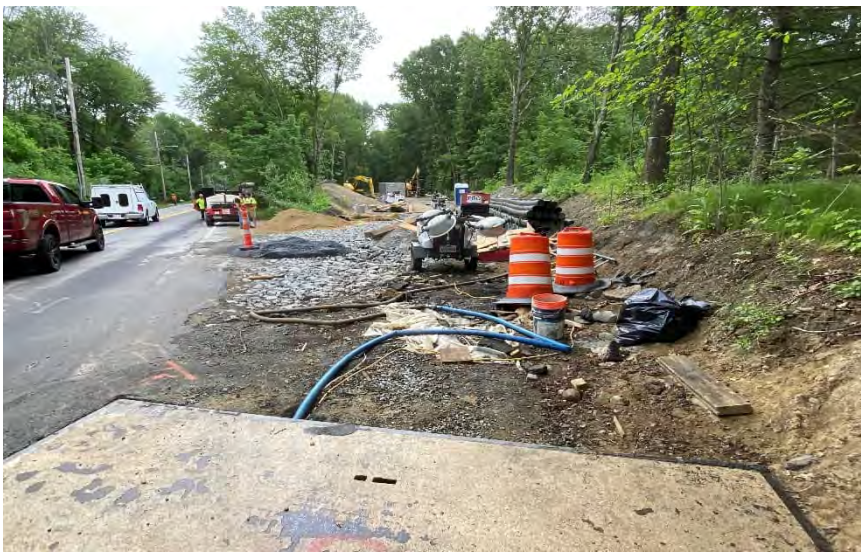
Description: Wilkins Street trench. View of dewatering operation. Looking eastward.

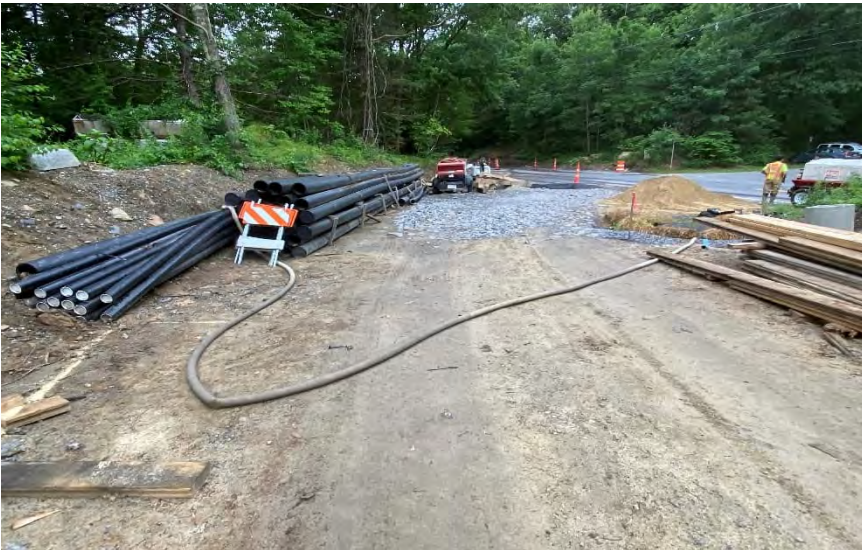
Description: Wilkins Street trench. View of dewatering operation, looking westward.

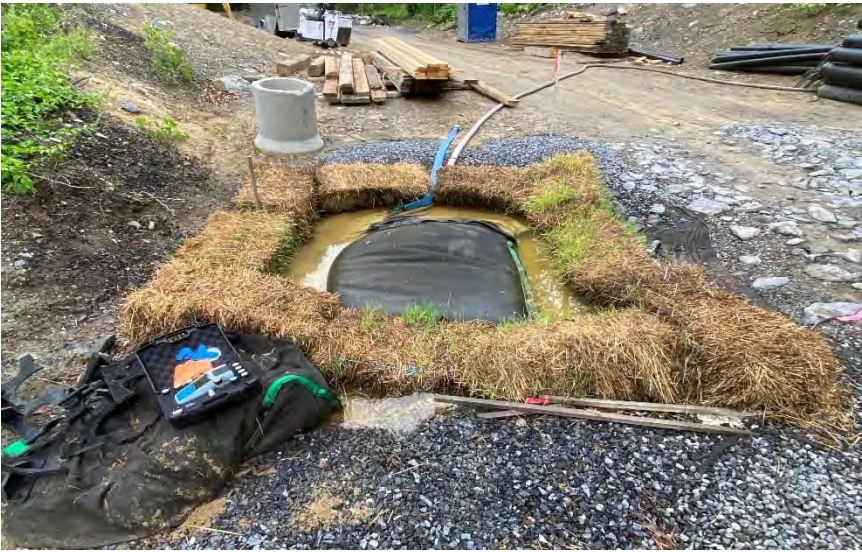
Description: Wilkins Street trench. View of discharge bag/corral, looking eastward. Water from bag/corral discharged to underlying catch basin.

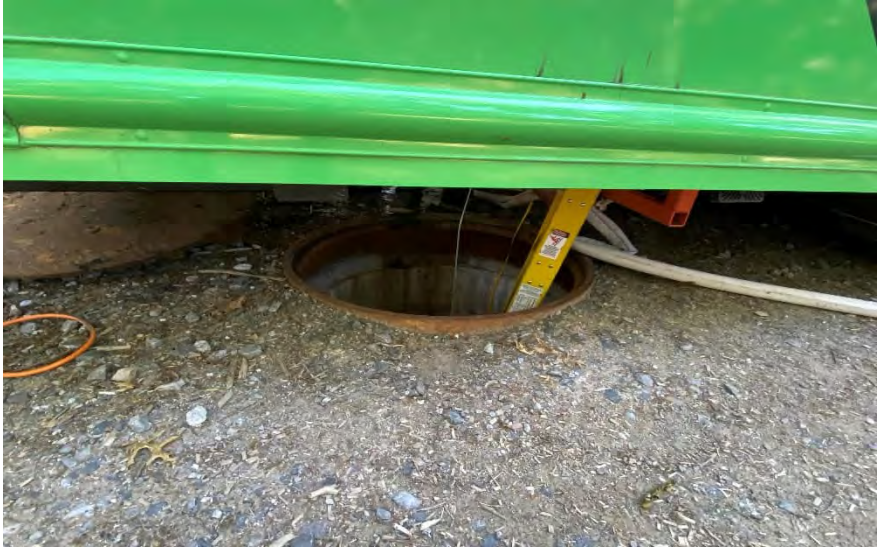
Description: View of manhole #23 within Segment 11 being pumped.

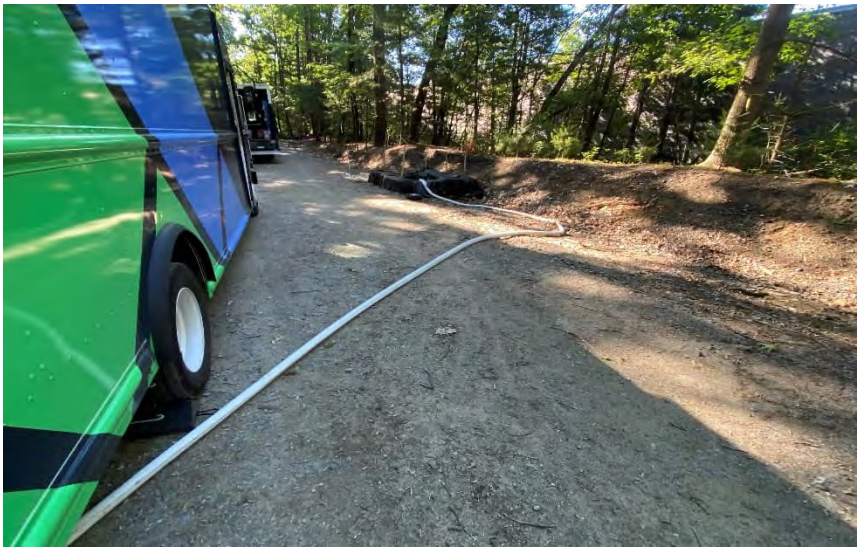
Description: Manhole #23. View of dewatering operation, looking westward.

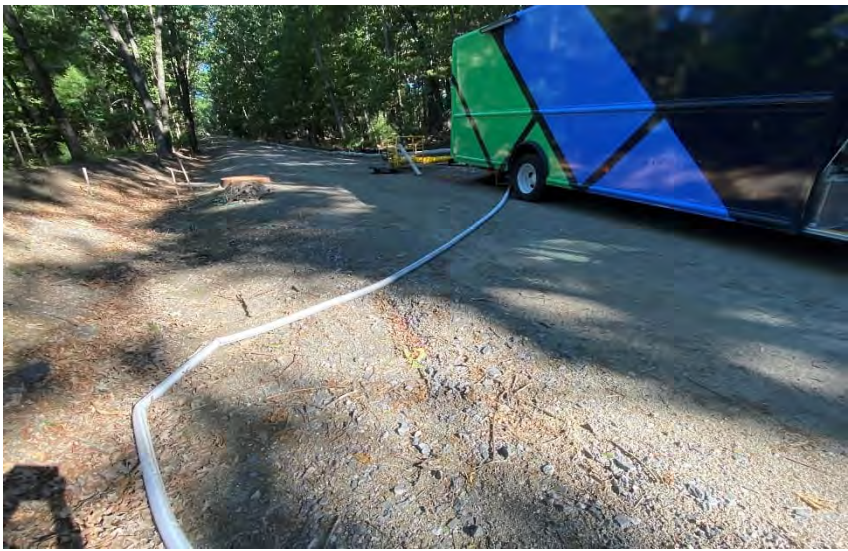
Description: Manhole #23. View of dewatering operation, looking westward.

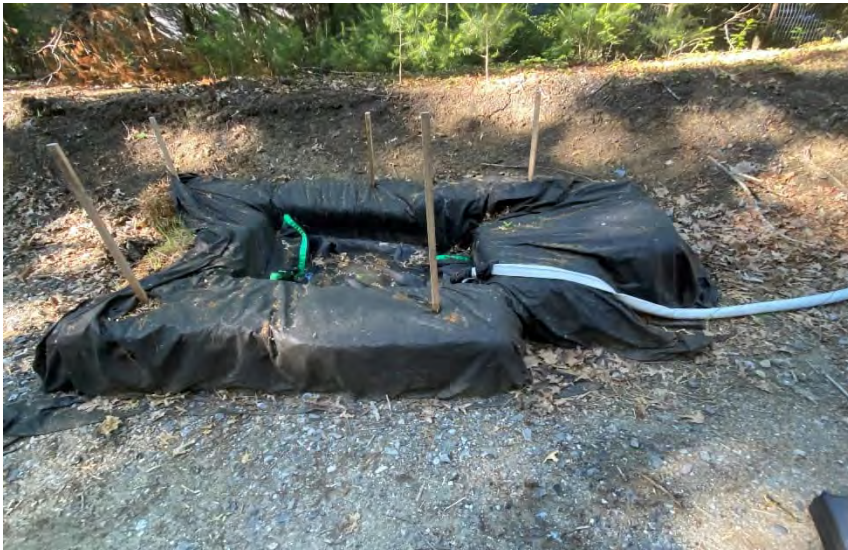
Description: Manhole #23. View of discharge bag/corral, looking westward. Water from bag/corral discharged to adjacent work area.
