Weekly Environmental Compliance Summary

Sudbury to Hudson Transmission Reliability Project (USEPA Tracking # MAR1003UW)

Week of: June 10, 2024 to June 15, 2024

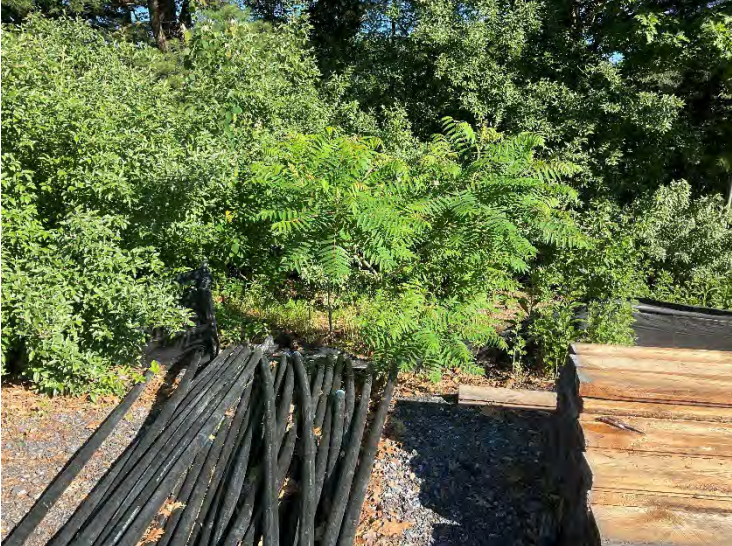
<p>PHOTOGRAPHIC LOG</p>	
<p>Client Name: Eversource</p>		<p>Site Location: Sudbury to Hudson Transmission Reliability Project</p>	<p>Town: Hudson</p>
<p>Photo No.: 6</p>	<p>Date: 6-10-24</p>

Silt fencing in need of repair behind Bonazzoli laydown yard.

<p>Description: View of damaged silt fencing behind Bonazzoli laydown yard. Facing west.</p>

-Silt fencing in need of repair behind Bonazzoli laydown yard.

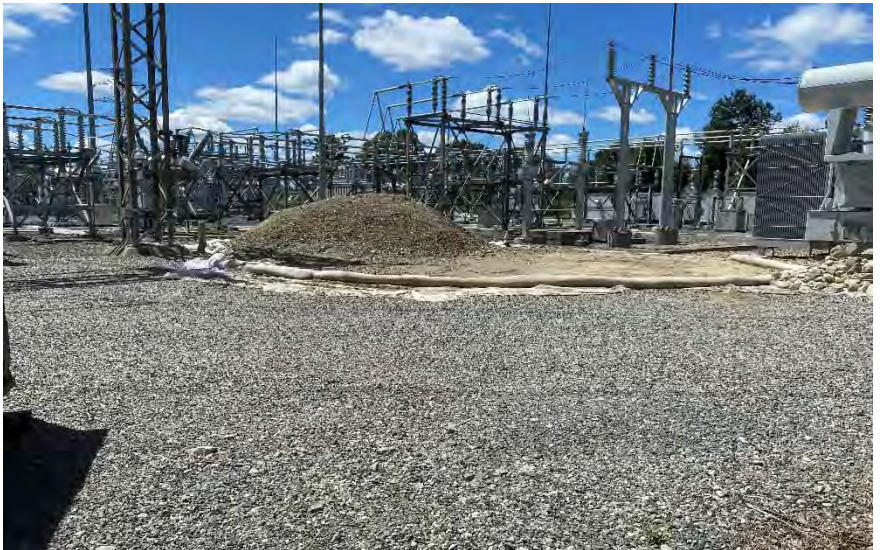
PHOTOGRAPHIC LOG	
Client Name: Eversource		Site Location: Sudbury to Hudson Transmission Reliability Project	Town: Sudbury
Photo No.: 6	Date: 6-10-24

Description: Work area within substation, newly placed spoil pile, existing erosion control (compost tubing), looking southward.

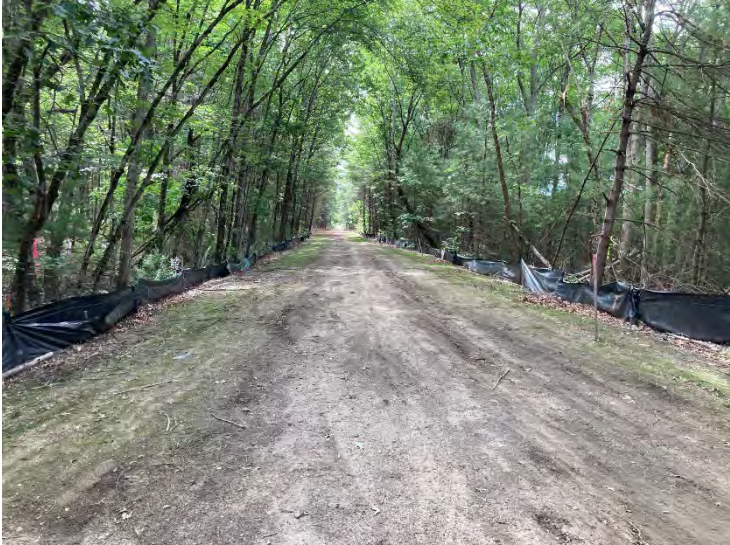
PHOTOGRAPHIC LOG	
Client Name: Eversource		Site Location: Sudbury to Hudson Transmission Reliability Project	Town: Hudson
Photo No.: 6	Date: 6/11/2024

Description: View of E&S controls in segment 6. Seeded areas are beginning to vegetate. Facing east.

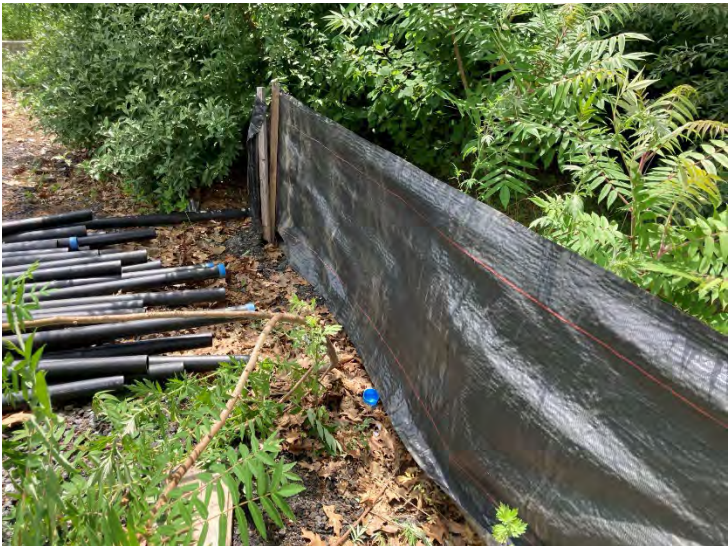
Description: New row of silt fence has been installed at Bonazzoli laydown yard. Crews will entrench the fence tomorrow, 6/13/2024. Facing southwest.

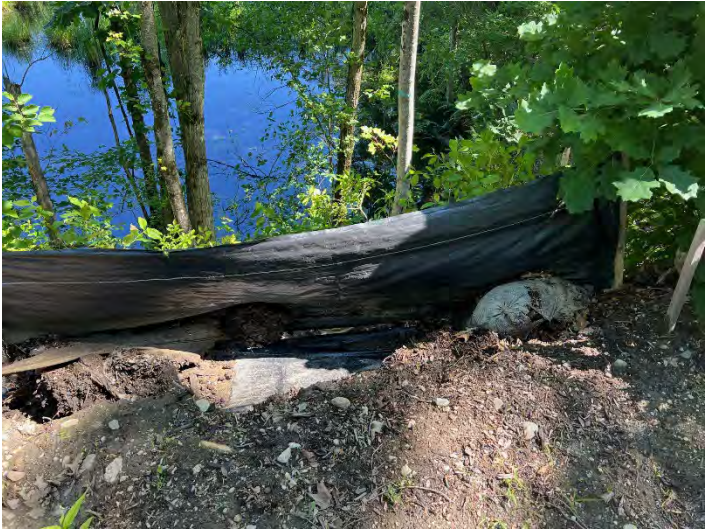
Description: View of damaged silt fencing in need of repair at station #131+50 in segment 1. Facing north.

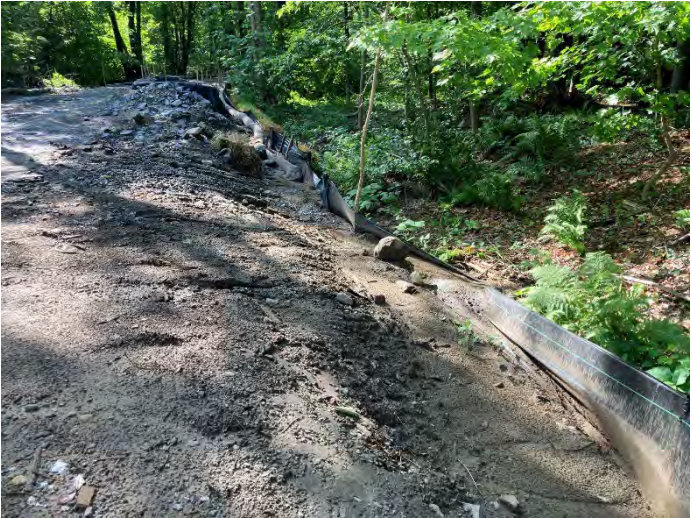
Description: View of silt fence in need of repair near entrance to segment 13 off Boston Post Rd. Facing east.

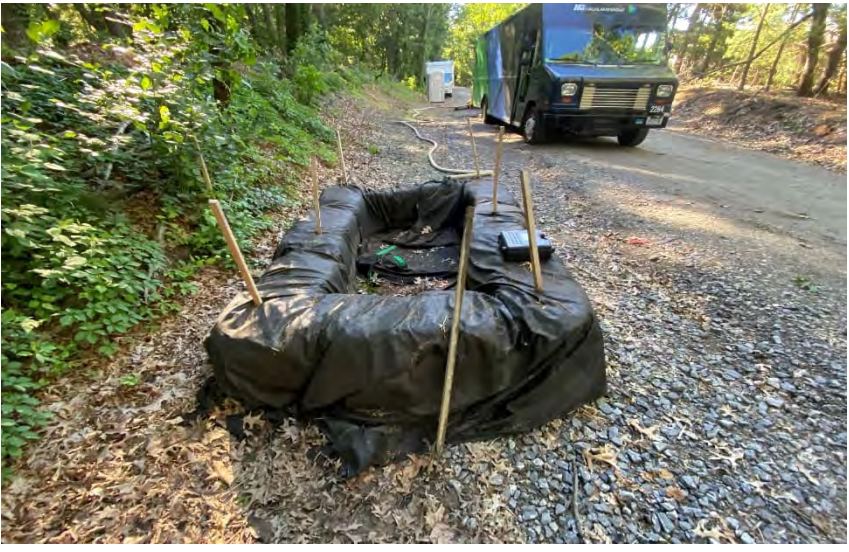
Description: Manhole #22. View of discharge bag/corral, looking eastward. Water from bag/corral did not leave corral and discharge to the adjacent work area.

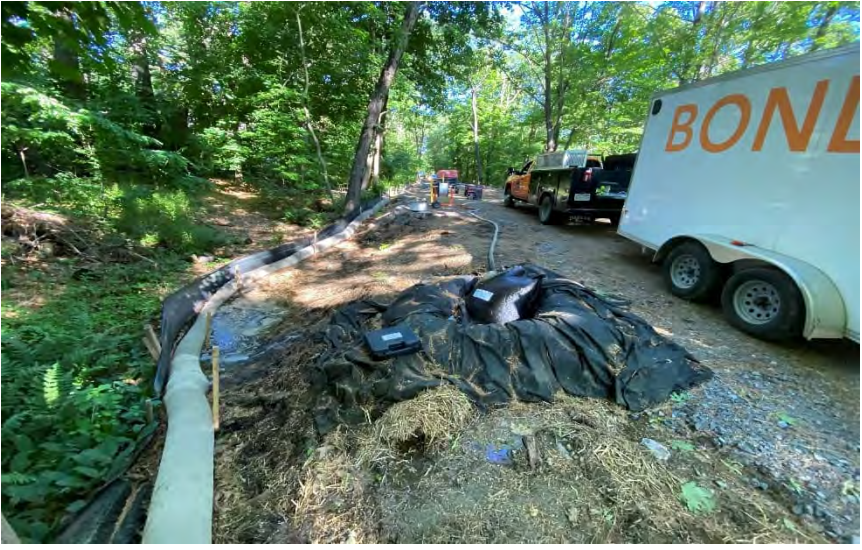
Description: Manhole #25. View of discharge bag/corral, looking eastward. Water from bag/corral discharged to adjacent area.
