Horsley Witten Group, Inc.

Client:		Town of Sudbury
Project Name:	Sudbury-Hudson T	ransmission Reliability
Inspector:	Jeffrey Polidor	
Project No:		<u>22012F</u>
Inspection Date:	5/31/24 Arrival Time:	9:00 AM
Weather:	<u>Clear, 70°</u> F <b>Departure Time:</b>	12:00 PM

**Contractor(s) equipment:** Cement Truck (1) Bucket Truck (1) Reference Plan: Sudbury to Hudson 115kV Underground Transmission Line Sudbury - Hudson, MA Date: November 16, 2018

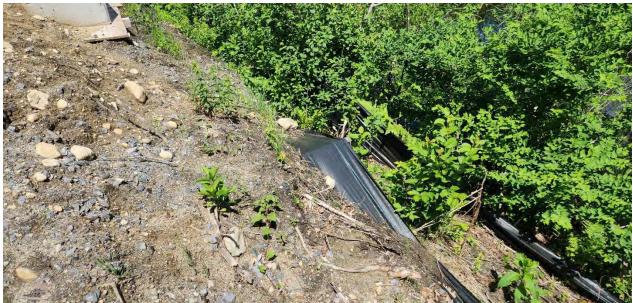
- Broken stake in the silt fence observed along segment 8 near bridge 128 (Photo 1).
- Silt fence has become untucked in various sections along the trail. In most cases these fences are above grade along cuts in the trail and are not of concern. The contractor is aware and will fix the fences as needed when grade is raised during construction (example along segment 9, photo 2).

**Photo 1:** Broken stake in the silt fence along segment 8 near bridge 128. Photo taken on 5/31/24

1. Repair silt fence and filter tube as noted above.

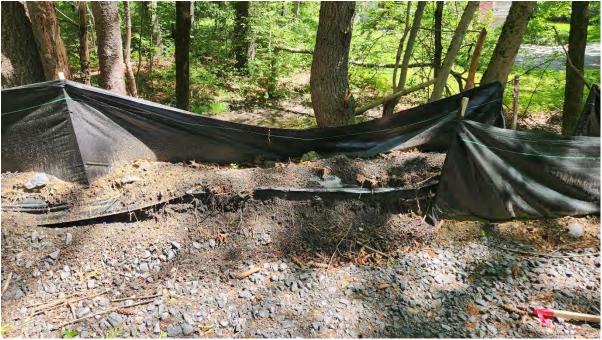
**Photo 2:** Silt fence untucked but above grade along segment 9. Photo taken on 5/31/24

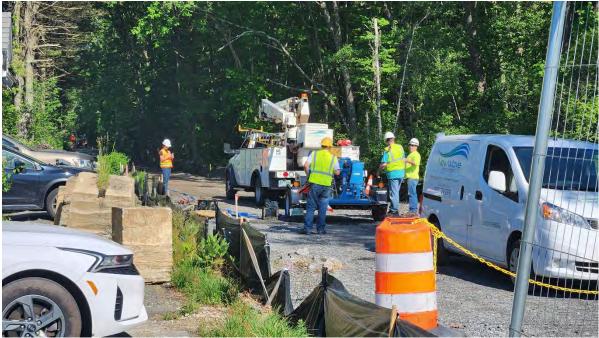
- Cable splicing work taking place during site visit along segment 10 and 11 (Photo 3).
- Concrete being poured over installed duct banks at Boston Post Road along segment 12 (Photo 4).

**Photo 3:** Cable splicing work along segment 11. Photo taken on 5/31/24

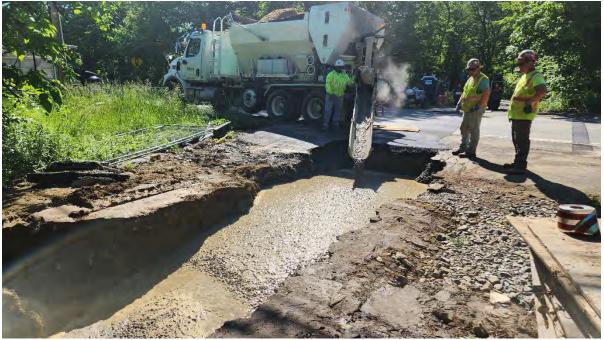
**Photo 4:** Concrete being poured over installed duct banks at Boston Post Road along segment 12. Photo taken on 5/31/24

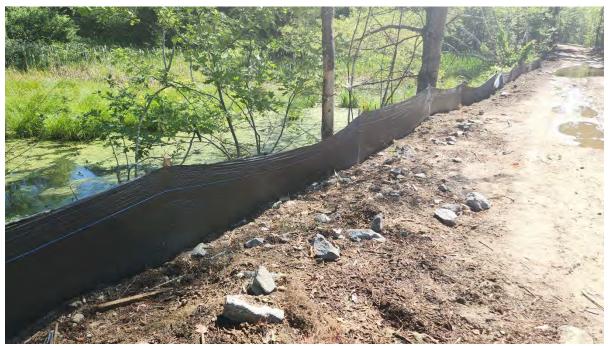
- Newly installed silt fence along segment 14. Still awaiting new filter tube (Photo 5).
- Concrete cap installed over sheeting wall along segment 14 (Photo 6).

**Photo 5:** Newly installed silt fence along segment 14. Still awaiting new filter tube. Photo taken on 5/31/24.

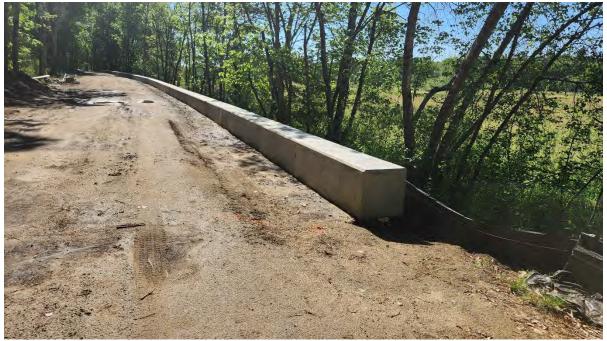
**Photo 6:** Concrete cap installed over sheeting wall along segment 14. Photo taken on 5/31/24.
