Weekly Environmental Compliance Summary

Sudbury to Hudson Transmission Reliability Project (USEPA Tracking # MAR1003UW)

Sudbury, Hudson, and Stow, MA

Week of: June 17, 2024 to June 22, 2024

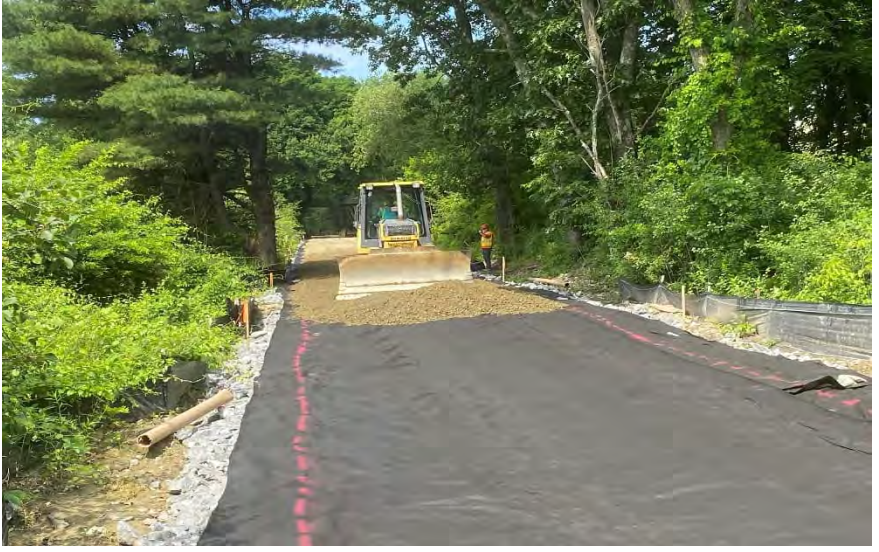
<p align="center">PHOTOGRAPHIC LOG</p>	
<p>Client Name: Eversource</p>		<p>Site Location: Sudbury to Hudson Transmission Reliability Project</p>	<p>Town: Sudbury</p>
<p>Photo No.: 1</p>	<p>Date: 6-17-24</p>

<p>Description:</p> <p>Work area within Segment 14, grading work, existing erosion control, looking westward.</p>

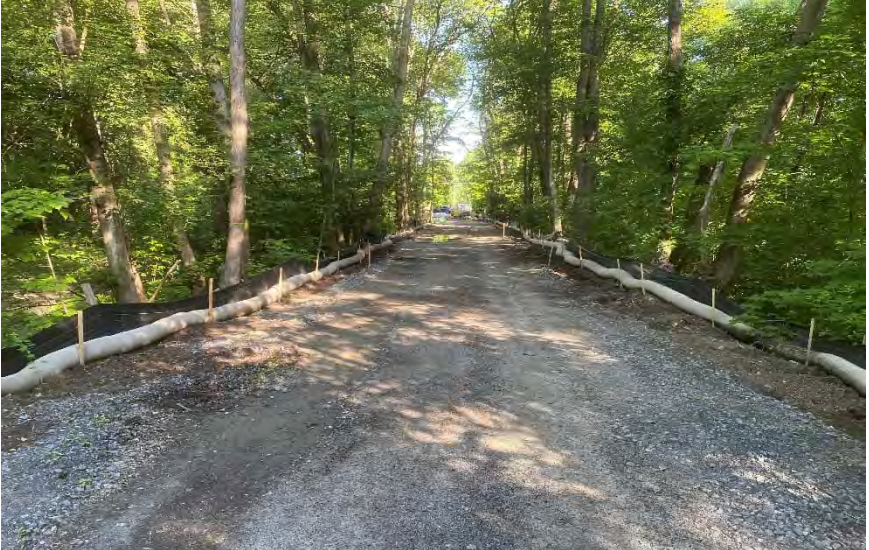
<p>PHOTOGRAPHIC LOG</p>	
<p>Client Name: Eversource</p>		<p>Site Location: Sudbury to Hudson Transmission Reliability Project</p>	<p>Town: Sudbury</p>
<p>Photo No.: 3</p>	<p>Date: 6-17-24</p>

<p>Description: Work area within segment 13, existing erosion control, looking westward.</p>

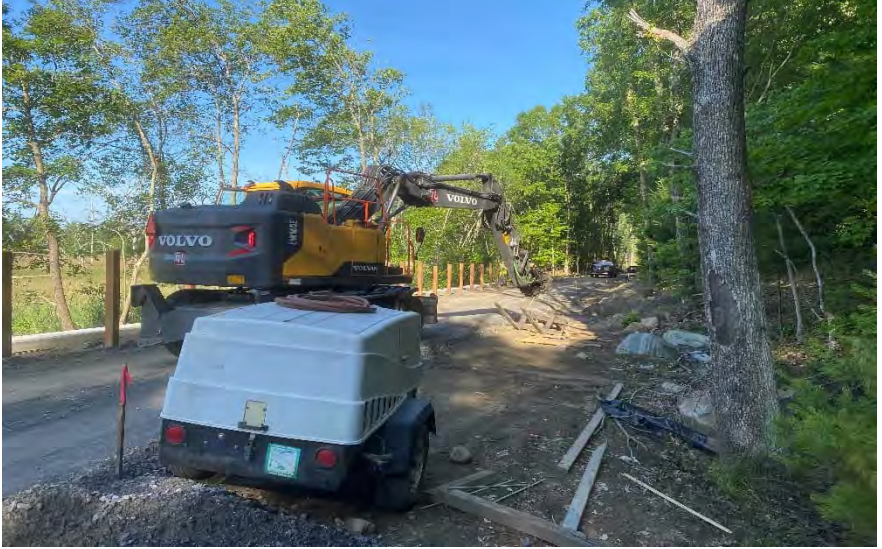
<p>PHOTOGRAPHIC LOG</p>	
<p>Client Name: Eversource</p>		<p>Site Location: Sudbury to Hudson Transmission Reliability Project</p>	<p>Town: Sudbury</p>
<p>Photo No.: 5</p>	<p>Date: 6-17-24</p>

<p>Description:</p> <p>Work area within segment 14, wall work, existing erosion control, looking westward.</p>

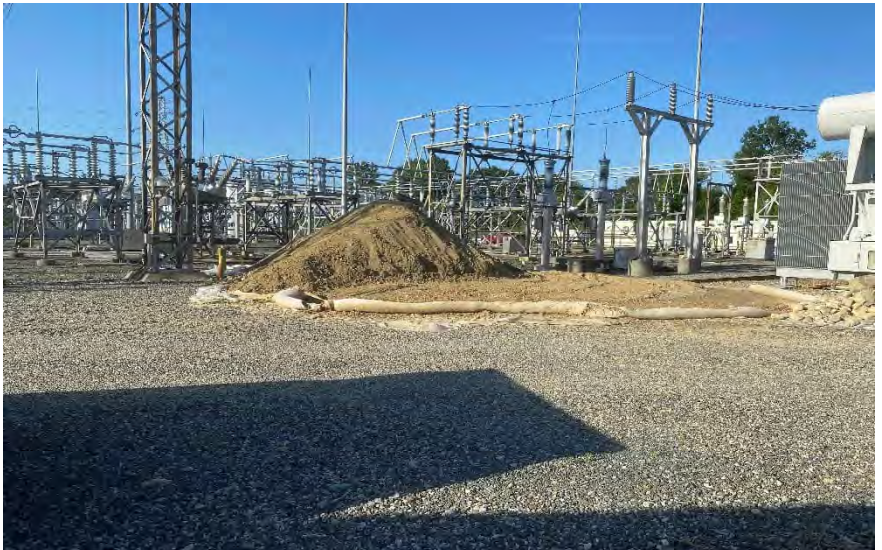
<p>PHOTOGRAPHIC LOG</p>	
<p>Client Name: Eversource</p>		<p>Site Location: Sudbury to Hudson Transmission Reliability Project</p>	<p>Town: Sudbury</p>
<p>Photo No.: 6</p>	<p>Date: 6-17-24</p>

<p>Description:</p> <p>Work area within substation, newly placed spoil pile, existing erosion control (compost tubing), looking southward.</p>

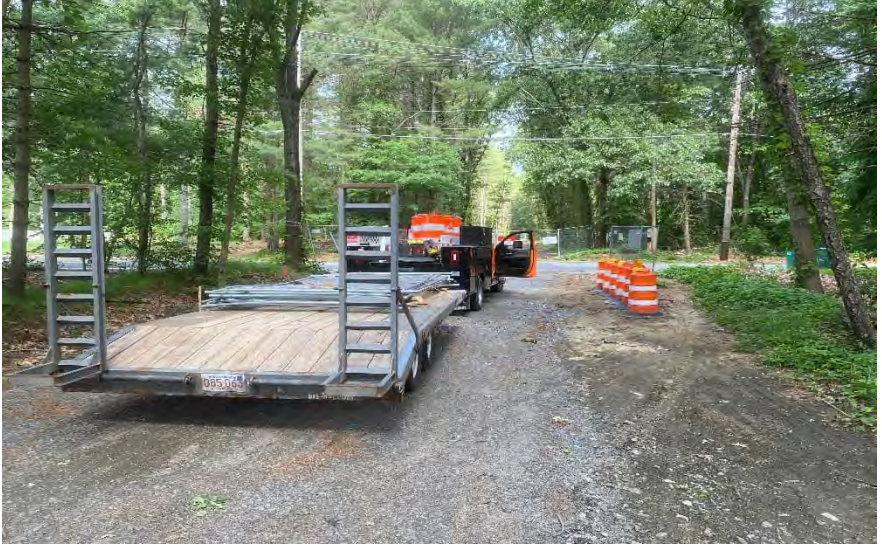
<p>PHOTOGRAPHIC LOG</p>	
<p>Client Name: Eversource</p>		<p>Site Location: Sudbury to Hudson Transmission Reliability Project</p>	<p>Town: Sudbury</p>
<p>Photo No.: 7</p>	<p>Date: 6-17-24</p>

<p>Description:</p> <p>Work area within segment 11, cleanup, existing erosion control, looking westward.</p>

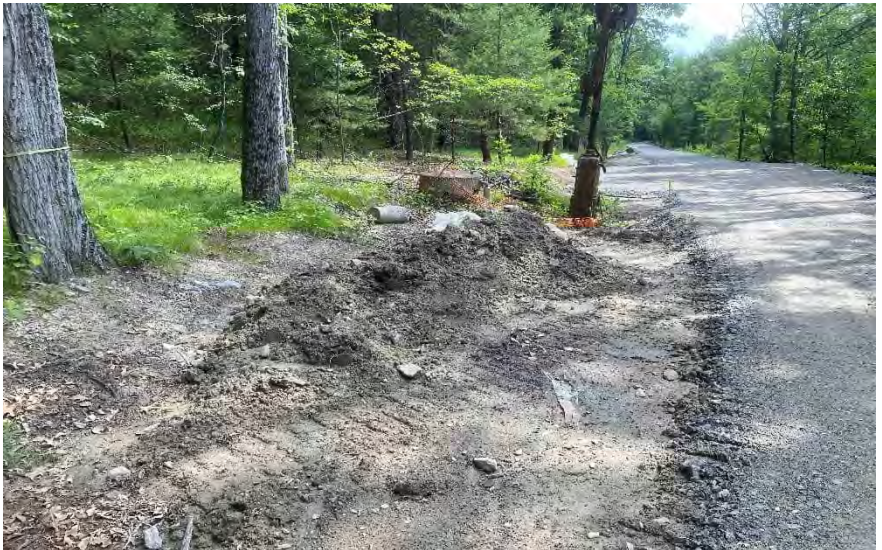
<p>PHOTOGRAPHIC LOG</p>	
<p>Client Name: Eversource</p>		<p>Site Location: Sudbury to Hudson Transmission Reliability Project</p>	<p>Town: Sudbury</p>
<p>Photo No.: 8</p>	<p>Date: 6-17-24</p>

Spoil pile noted at Sta# 336+00 within segment 14, contractor notified to remove. This spoil berm originally created 3-8-24. See Photo 8.

<p>Description:</p> <p>Work area within segment 14, spoil pile to be removed @ Sta# 336+00, existing erosion control, looking eastward.</p>

Identify presence of stockpiles and document when placed and when removed (week maximum for stockpiles) Yes No
Spoil pile previously noted at Sta# 336+00 within segment 14, removed.

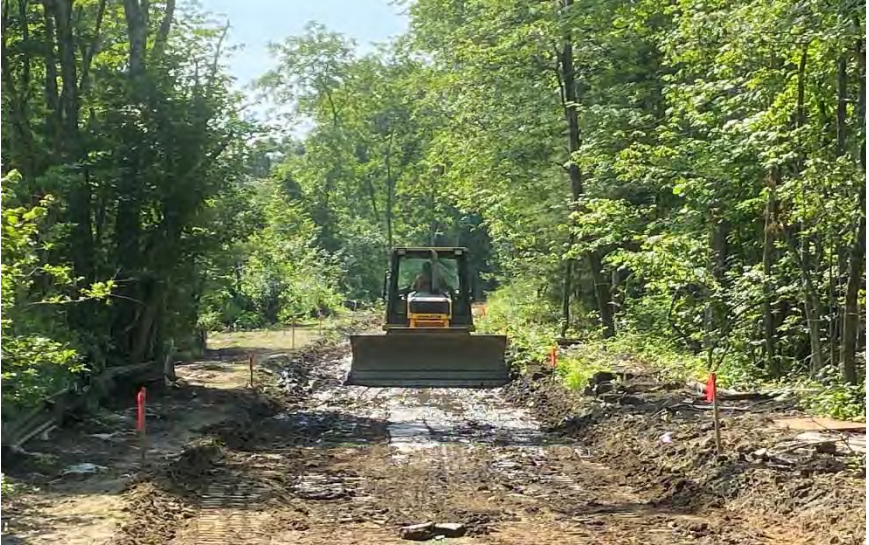
<p align="center">PHOTOGRAPHIC LOG</p>	
<p>Client Name: Eversource</p>		<p>Site Location: Sudbury to Hudson Transmission Reliability Project</p>	<p>Town: Sudbury</p>
<p>Photo No.: 1</p>	<p>Date: 6-18-24</p>

<p>Description:</p> <p>Work area within Segment 12, grading work, existing erosion control, looking eastward.</p>

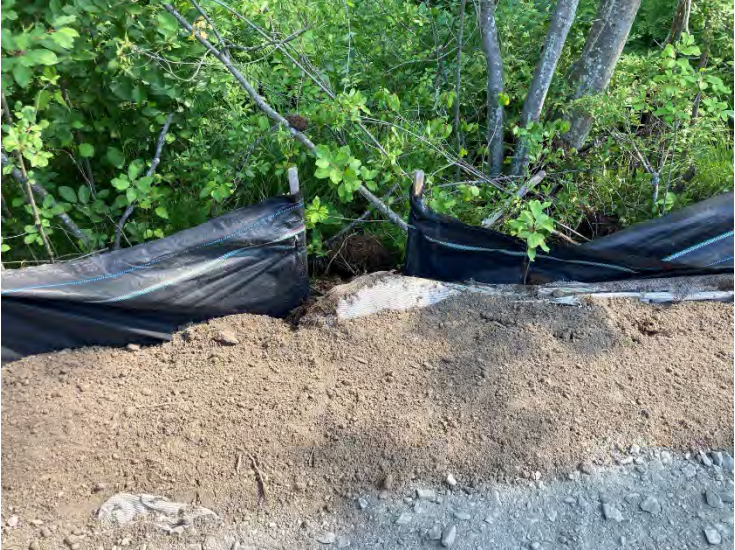
PHOTOGRAPHIC LOG	
Client Name: Eversource		Site Location: Sudbury to Hudson Transmission Reliability Project	Town: Hudson
Photo No.: 3	Date: 6/19/2024

-Silt fence is in need of repair in segment 3.

Description: View of silt fence in need of repair in segment 3. Facing north.

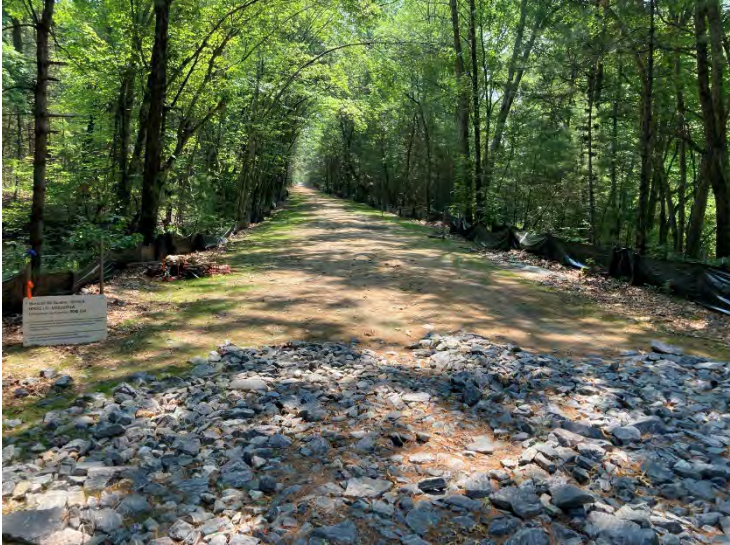
PHOTOGRAPHIC LOG	
Client Name: Eversource		Site Location: Sudbury to Hudson Transmission Reliability Project	Town: Hudson
Photo No.: 5	Date: 6/19/2024

Description: View of entrance to segment 6 at White Pond Rd. E&S controls are in good condition. Project fences have been removed in multiple locations. Facing east.

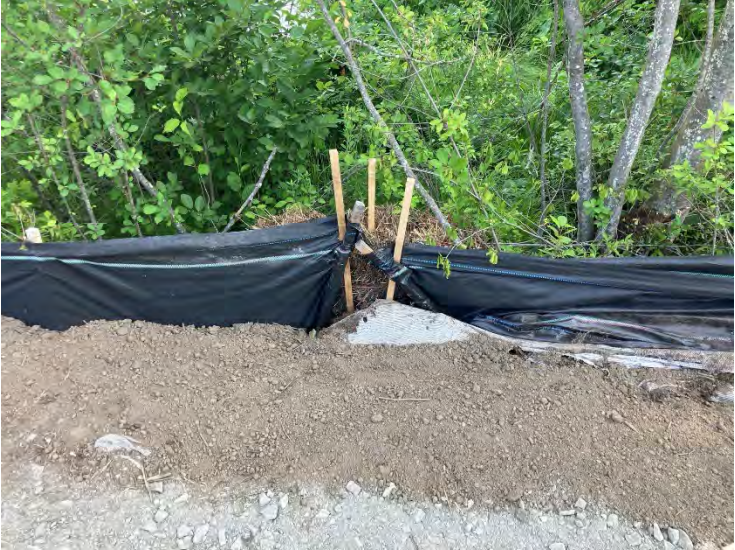
-Silt fence has been repaired in segment 3. A straw bale was used to close gap in fence.

Description: View of silt fence that has been repaired in segment 3. A straw bale was used to close gap in fence. Facing north.

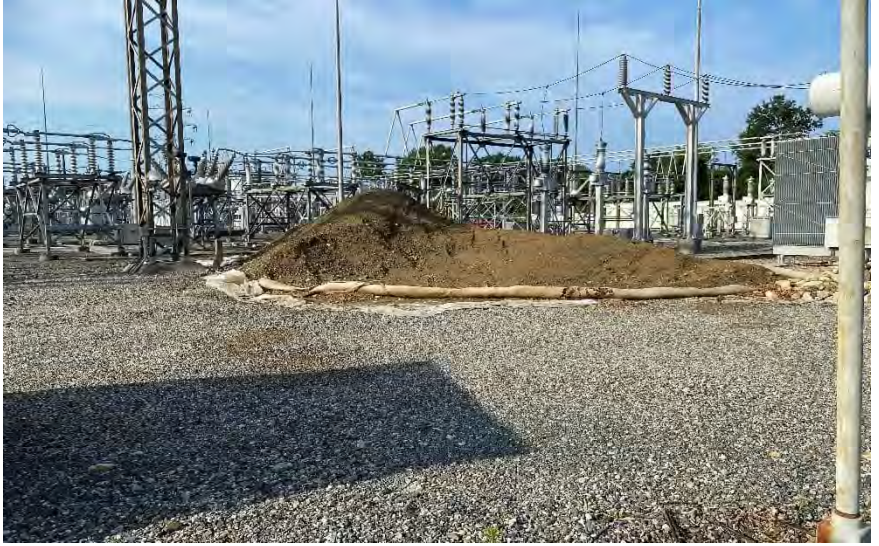
Description: Work area within substation, spoil pile with compost tubes surrounding pile, looking southward.

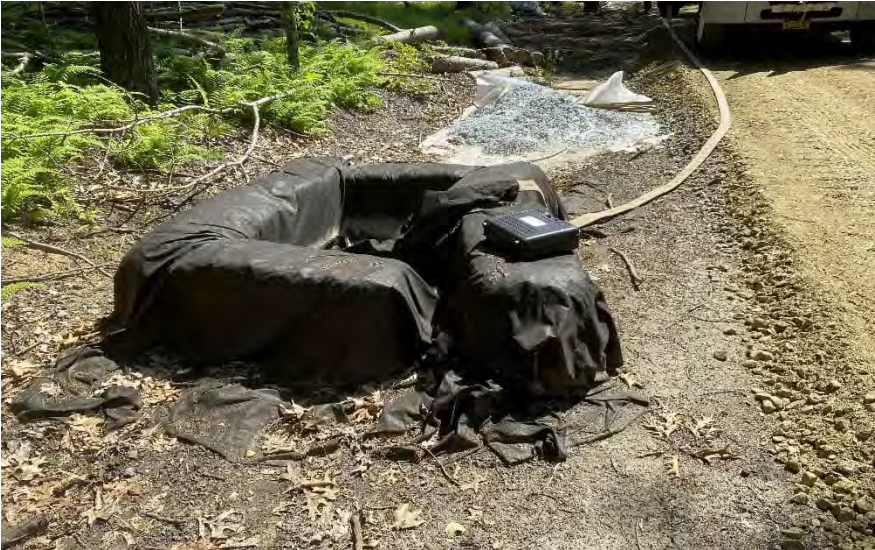
Description: Manhole #26. View of discharge bag/corral, looking eastward. Water from bag/corral discharged to adjacent area.

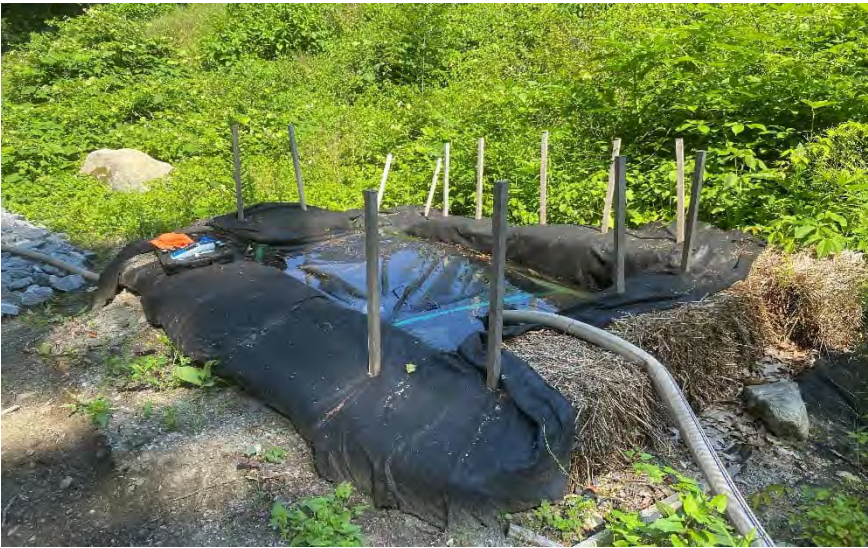
Description: Manhole #27. View of discharge bag/corral, looking westward. Water from bag/corral discharged to adjacent area.
