Weekly Environmental Compliance Summary

Sudbury to Hudson Transmission Reliability Project (USEPA Tracking # MAR1003UW)

Week of: June 24, 2024 to June 29, 2024

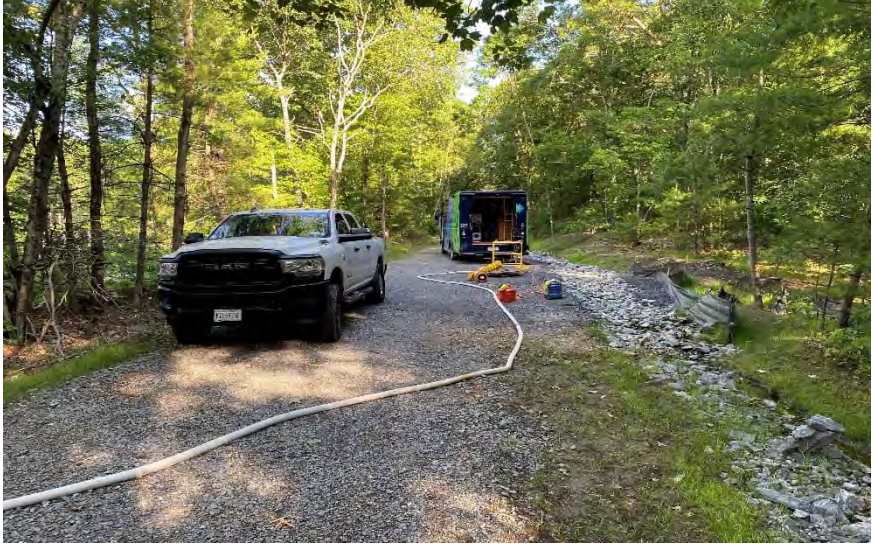
PHOTOGRAPHIC LOG	
Client Name: Eversource		Site Location: Sudbury to Hudson Transmission Reliability Project	Town: Hudson
Photo No.: 5	Date: 6-24-24

Description: Work area within segment 5 near manhole #12, existing erosion control, looking westward.

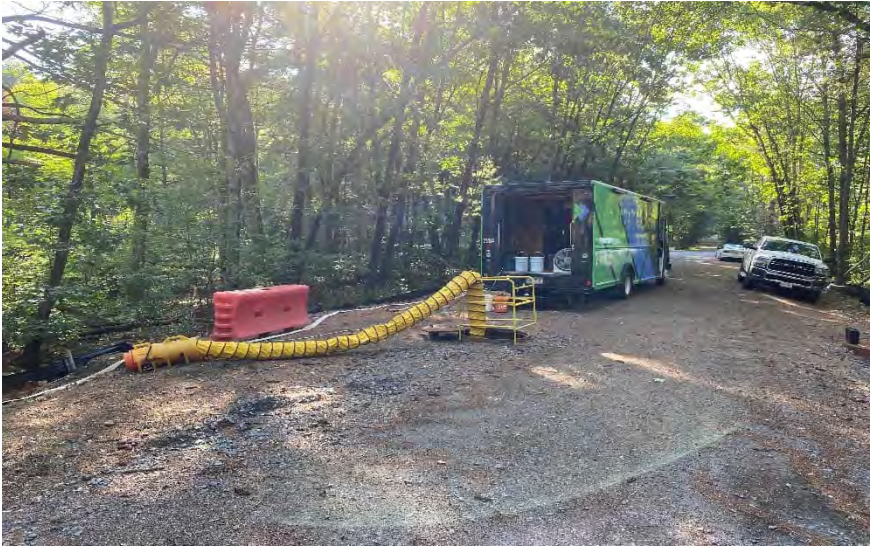
PHOTOGRAPHIC LOG	
Client Name: Eversource		Site Location: Sudbury to Hudson Transmission Reliability Project	Town: Hudson
Photo No.: 6	Date: 6-24-24

Description: Work area within segment 5 near manhole #13, existing erosion control, looking westward.

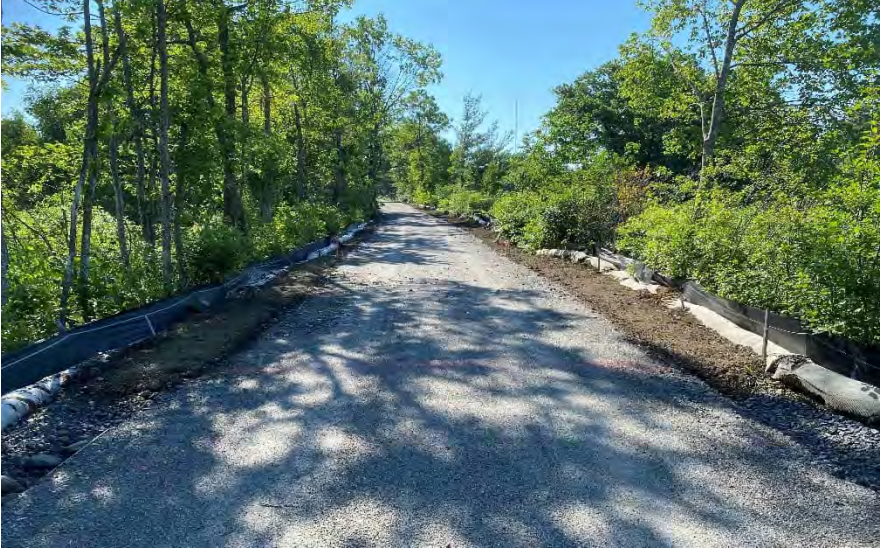
PHOTOGRAPHIC LOG	
Client Name: Eversource		Site Location: Sudbury to Hudson Transmission Reliability Project	Town: Hudson
Photo No.: 7	Date: 6-25-24

Description: Work area within Segment 3, recently placed loam on shoulders off work area, existing erosion control, looking eastward.

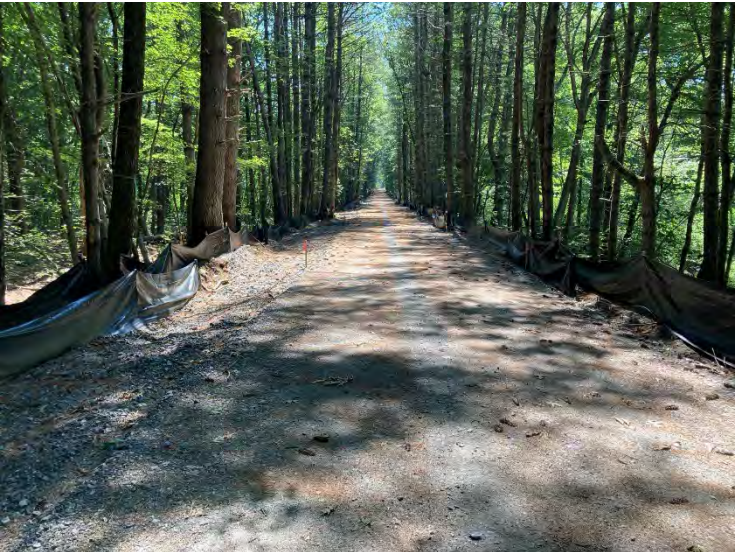
PHOTOGRAPHIC LOG	
Client Name: Eversource		Site Location: Sudbury to Hudson Transmission Reliability Project	Town: Sudbury
Photo No.: 2	Date: 6/25/2024

Description: View of E&S controls in segment 10. Facing east.

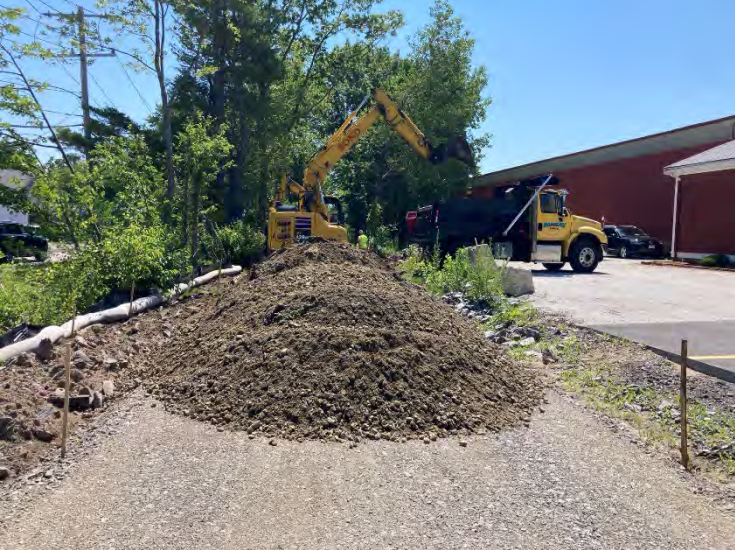
<p>PHOTOGRAPHIC LOG</p>	
<p>Client Name: Eversource</p>		<p>Site Location: Sudbury to Hudson Transmission Reliability Project</p>	<p>Town: Sudbury</p>
<p>Photo No.: 4</p>	<p>Date: 6/25/2024</p>

Identify presence of stockpiles and document when placed and when removed (week maximum for stockpiles)
Spoil stockpiles noted at west end of segment 12.

<p>Description: View of spoil stockpiles at Bond's work area in segment 12. Facing east.</p>

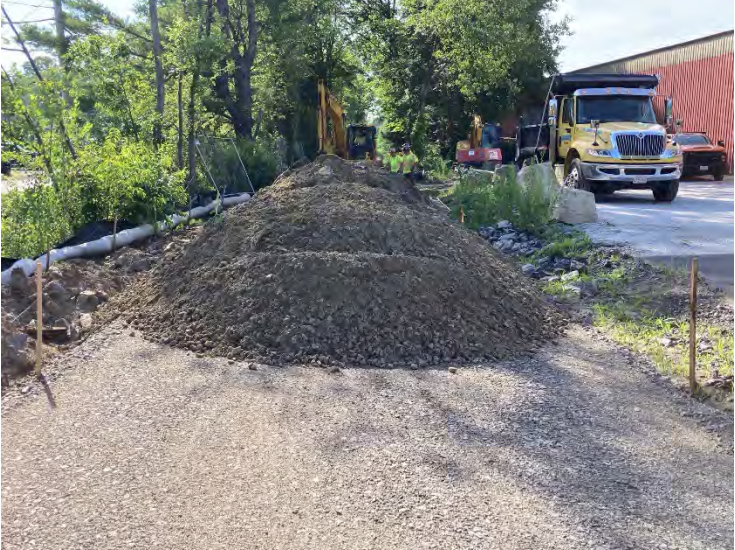
Description: View of Bond's work area and spoil stockpiles in segment 12. Facing east.

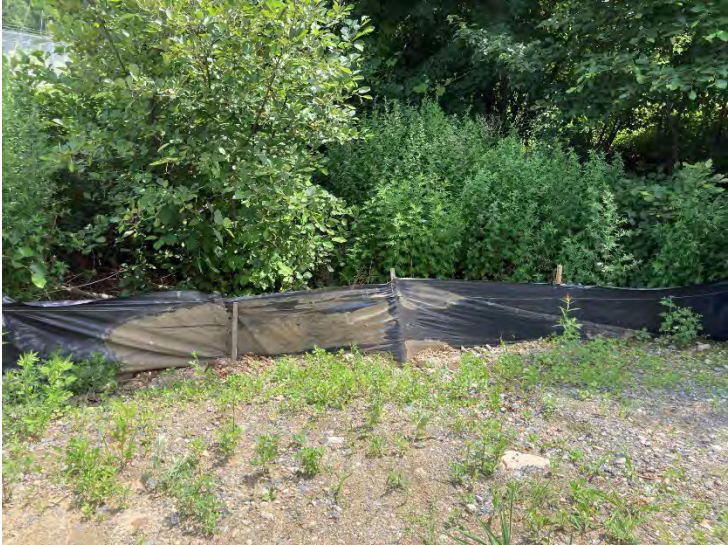
-Silt fence outside of Sudbury substation is in need of repair.

<p>Description: View of silt fence outside of Sudbury substation that has been repaired. Facing south.</p>

-Silt fence outside of Sudbury substation has been repaired.

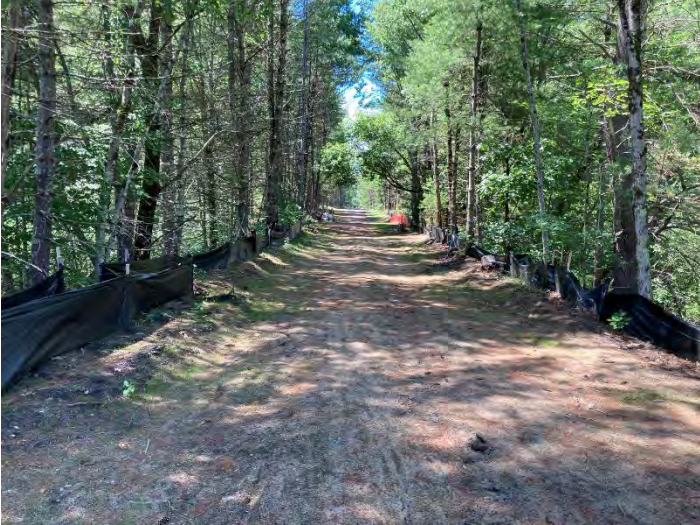
Description: View of east end of segment 7. E&S controls are in good condition. Seeded areas are vegetating. Facing west.

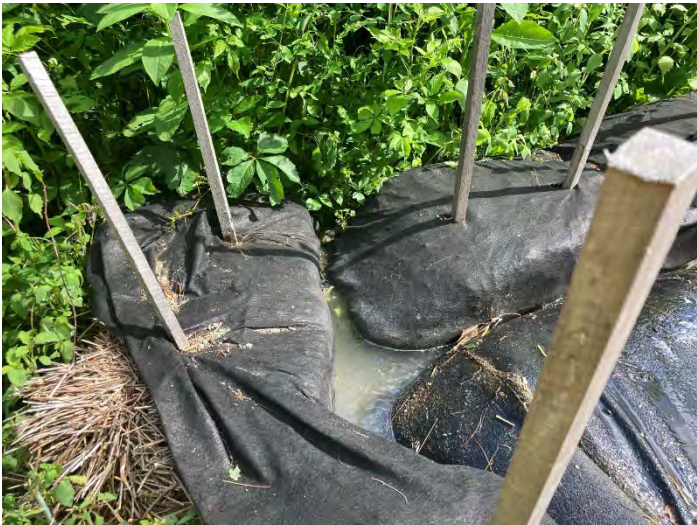
Description: View of discharge form corral. Discharge appeared mostly clear and turbidity reading was below 50 NTUs. Sediment staining observed in corral from previous dewatering operations. Discharge did not appear to reach any jurisdictional resource areas. Facing north.

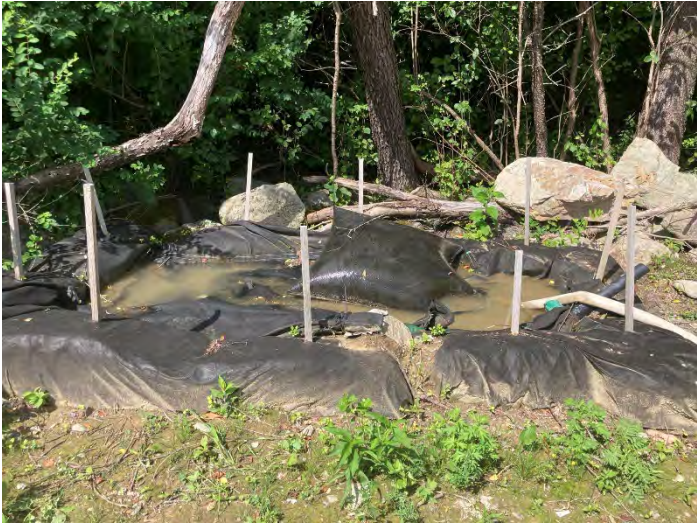
Description: Additional view of dewatering controls (straw bale corral with filter fabric and silt bag) and discharge form corral. Discharge appeared mostly clear and turbidity reading was below 50 NTUs. Sediment staining observed in corral from previous dewatering operations. Facing west.

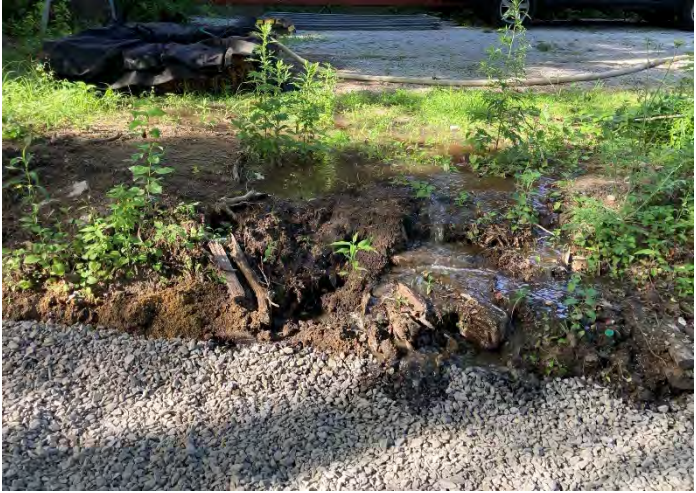
Description: View of discharge from corral. Discharge from corral appeared turbid. Turbidity reading was higher than 50 NTUs. Water from corral discharged into infiltration trench/French drain created by Bond and did not leave the site. Facing south.

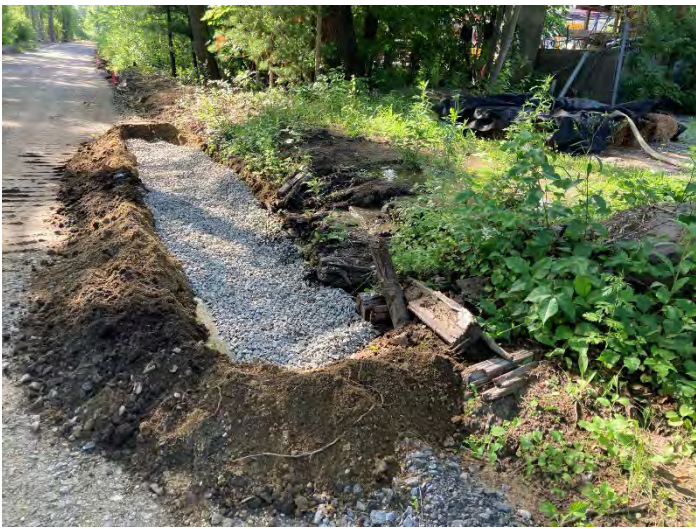
Description: Additional view of dewatering controls including infiltration trench/French drain created by Bond. Water from corral discharged into infiltration trench/French drain and did not leave the site. Facing east.

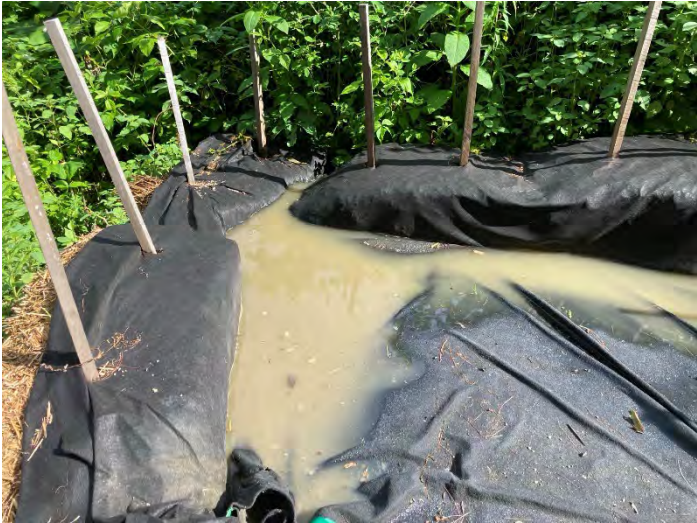
Description: View of discharge form corral. Discharge appeared turbid and turbidity reading was higher than 50 NTUs. Sediment staining observed in corral from previous dewatering operations. Discharge did not appear to reach any jurisdictional resource areas. Facing north.

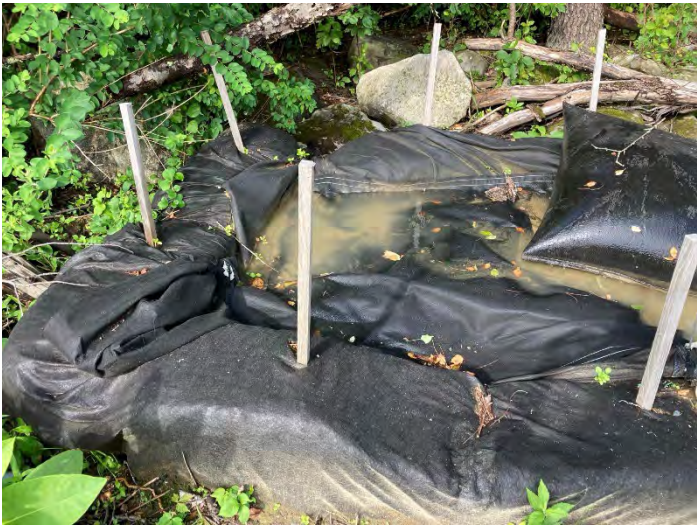
Description: Additional view of dewatering controls (straw bale corral with filter fabric and silt bag) and discharge from filter bag. Only a small amount of water was pumped. Water did not leave corral, but a sample was collected from within the corral. Turbidity reading was slightly higher than 50 NTUs. Sediment staining observed in corral from previous dewatering operations. Facing west.
