**Weekly Environmental Compliance Summary**

**Sudbury to Hudson Transmission Reliability Project (USEPA Tracking # MAR1003UW)**

Sudbury, Hudson, and Stow, MA

Week of: July 8, 2024 to July 13, 2024

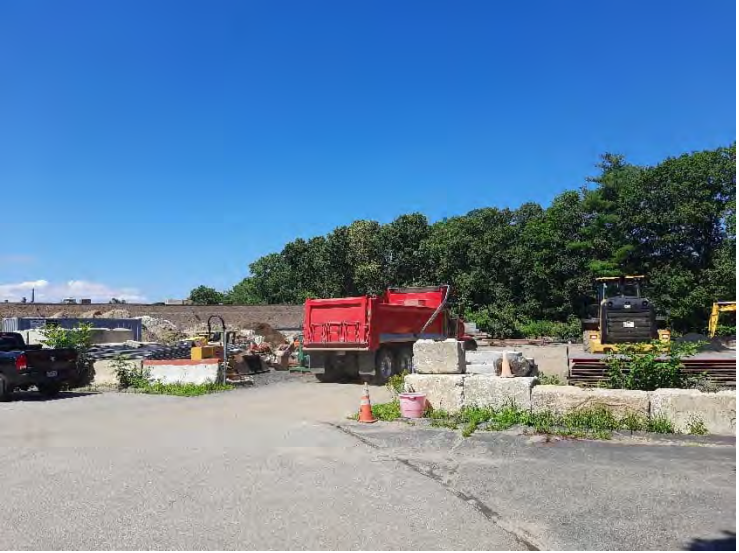
<b>PHOTOGRAPHIC LOG</b>	
Client Name: Eversource		Site Location: Sudbury to Hudson Transmission Reliability Project	Town: Hudson
Photo No.: 7	Date: 7-8-24

Description:  Bonazzoli laydown yard, unloading and storage of material excavated near manhole #1, looking westward.

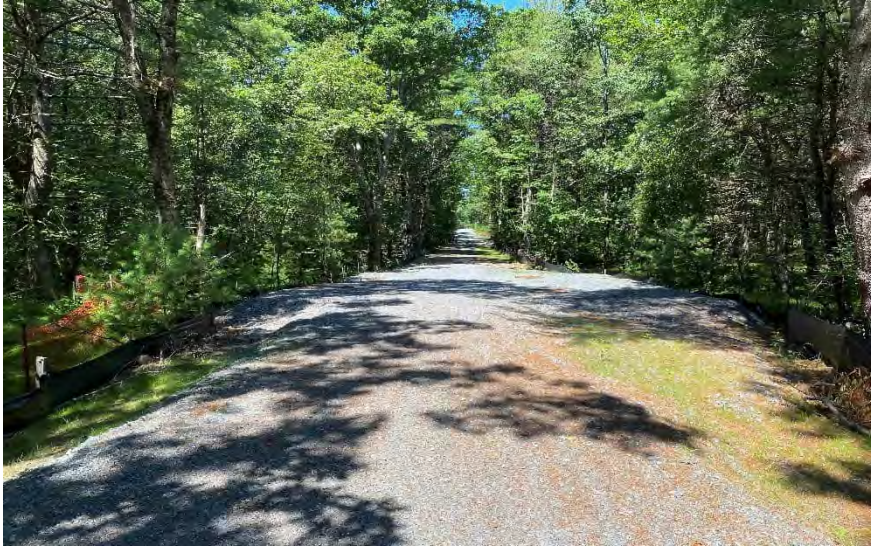
<p align="center">PHOTOGRAPHIC LOG</p>	
<p>Client Name: Eversource</p>		<p>Site Location: Sudbury to Hudson Transmission Reliability Project</p>	<p>Town: Sudbury</p>
<p>Photo No.: 1</p>	<p>Date: 7-8-24</p>

<p>Description:  Work area within Segment 7, manhole #15, existing erosion control, looking westward.</p>

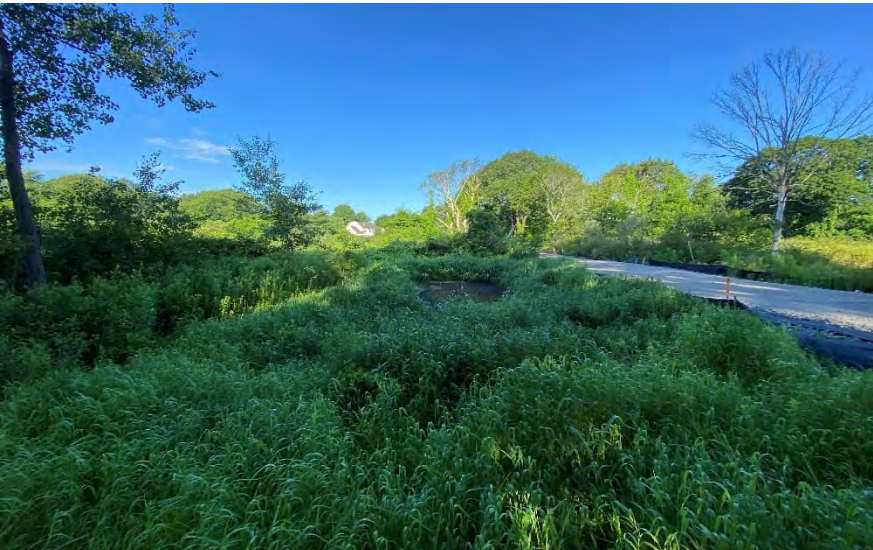
<p align="center">PHOTOGRAPHIC LOG</p>	
<p>Client Name: Eversource</p>		<p>Site Location: Sudbury to Hudson Transmission Reliability Project</p>	<p>Town: Sudbury</p>
<p>Photo No.: 2</p>	<p>Date: 7-8-24</p>

<p>Description:  Wetland replication area, segment 14, existing erosion control, looking westward.</p>

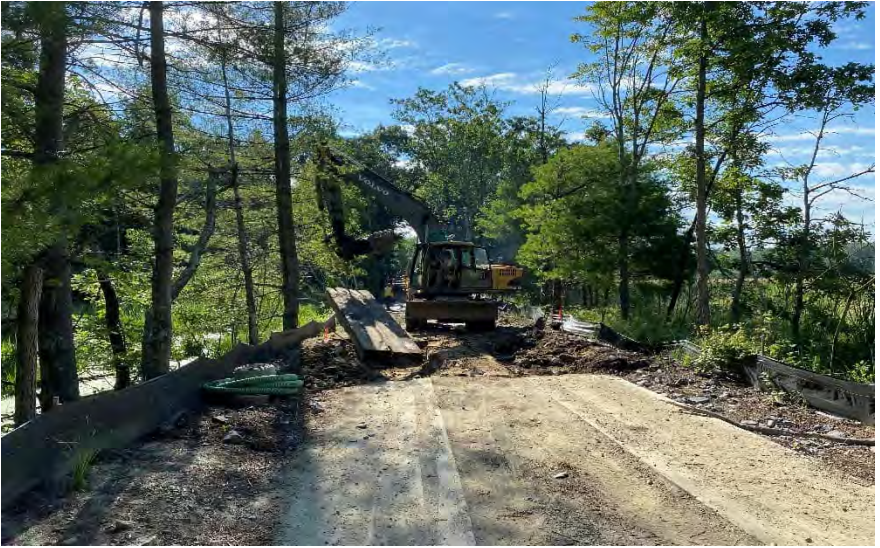
<p align="center"><b>PHOTOGRAPHIC LOG</b></p>	
<p>Client Name: Eversource</p>		<p>Site Location: Sudbury to Hudson Transmission Reliability Project</p>	<p>Town: Sudbury</p>
<p>Photo No.: 3</p>	<p>Date: 7-8-24</p>

<p>Description:</p> <p>Work area within segment 14, grading work, existing erosion control, looking eastward.</p>

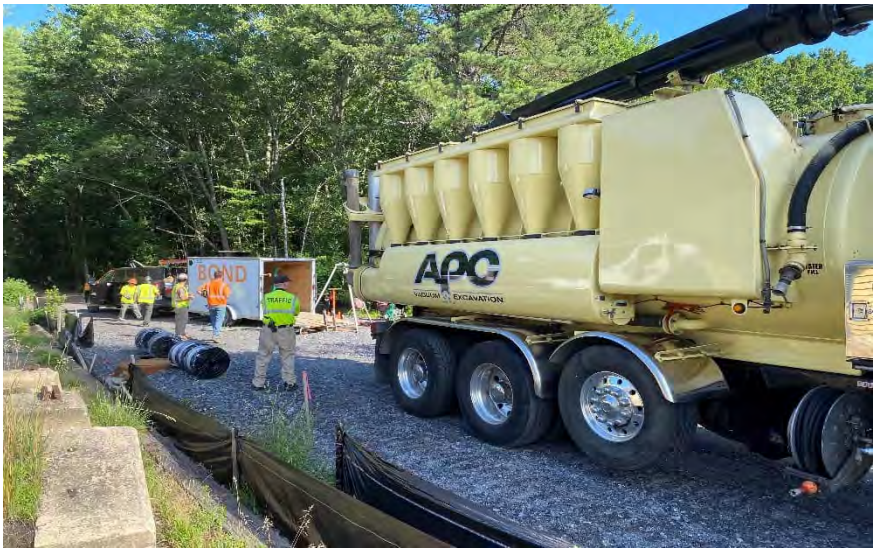
<p align="center"><b>PHOTOGRAPHIC LOG</b></p>	
<p>Client Name: Eversource</p>		<p>Site Location: Sudbury to Hudson Transmission Reliability Project</p>	<p>Town: Sudbury</p>
<p>Photo No.: 4</p>	<p>Date: 7-8-24</p>

<p>Description:</p> <p>Work area within segment 11, Bond proofing conduit at manhole #24, existing erosion control, looking westward.</p>

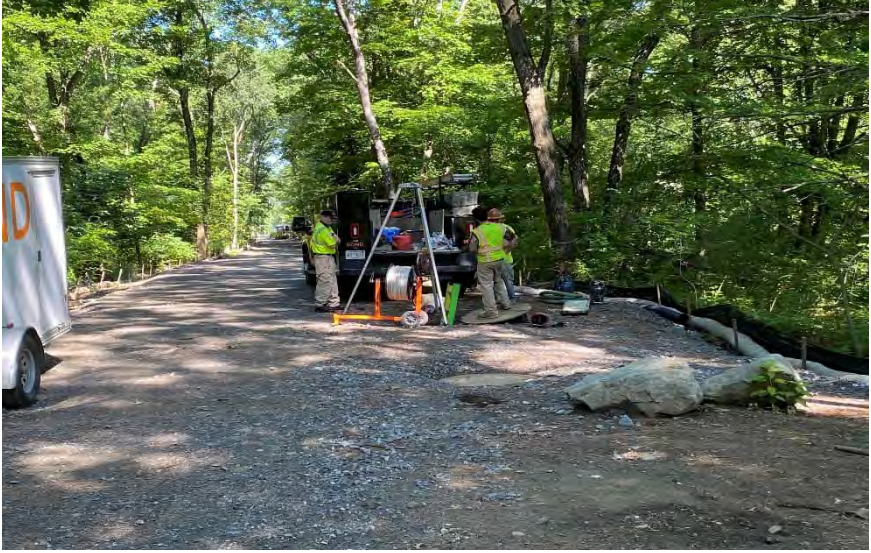
<p>PHOTOGRAPHIC LOG</p>	
<p>Client Name: Eversource</p>		<p>Site Location: Sudbury to Hudson Transmission Reliability Project</p>	<p>Town: Sudbury</p>
<p>Photo No.: 5</p>	<p>Date: 7-8-24</p>

<p>Description:</p> <p>Work area within segment 13, Bond proofing conduit at manhole #25, existing erosion control, looking westward.</p>

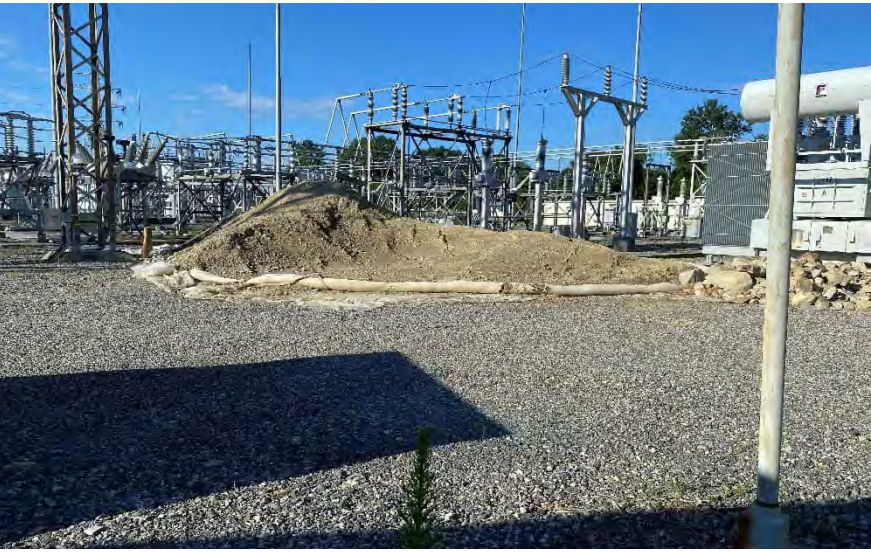
<p>PHOTOGRAPHIC LOG</p>	
<p>Client Name: Eversource</p>		<p>Site Location: Sudbury to Hudson Transmission Reliability Project</p>	<p>Town: Sudbury</p>
<p>Photo No.: 6</p>	<p>Date: 7-8-24</p>

<p>Description:</p> <p>Work area within substation, newly placed spoil pile, existing erosion control (compost tubing), looking southward.</p>

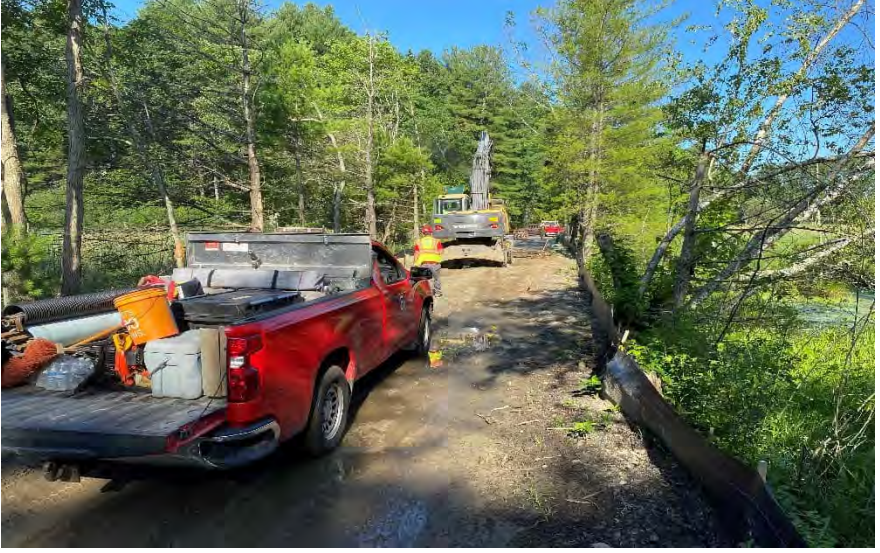
<p align="center">PHOTOGRAPHIC LOG</p>	
<p>Client Name: Eversource</p>		<p>Site Location: Sudbury to Hudson Transmission Reliability Project</p>	<p>Town: Sudbury</p>
<p>Photo No.: 7</p>	<p>Date: 7-8-24</p>

<p>Description:</p> <p>Work area within segment 14, bridge 127 work, existing erosion control, looking westward.</p>

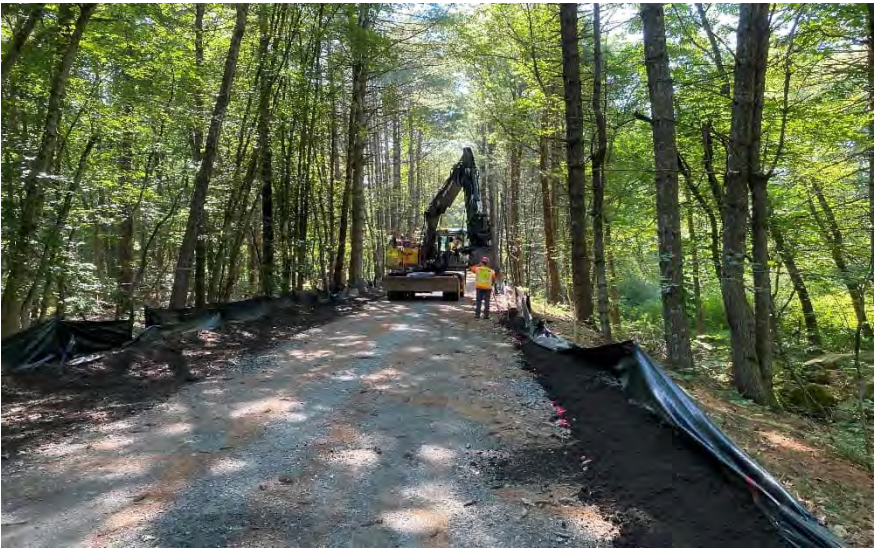
<p align="center">PHOTOGRAPHIC LOG</p>	
<p>Client Name: Eversource</p>		<p>Site Location: Sudbury to Hudson Transmission Reliability Project</p>	<p>Town: Sudbury</p>
<p>Photo No.: 8</p>	<p>Date: 7-8-24</p>

<p>Description:</p> <p>Work area within segment 10, loam being added to work area shoulders, existing erosion control, looking eastward.</p>

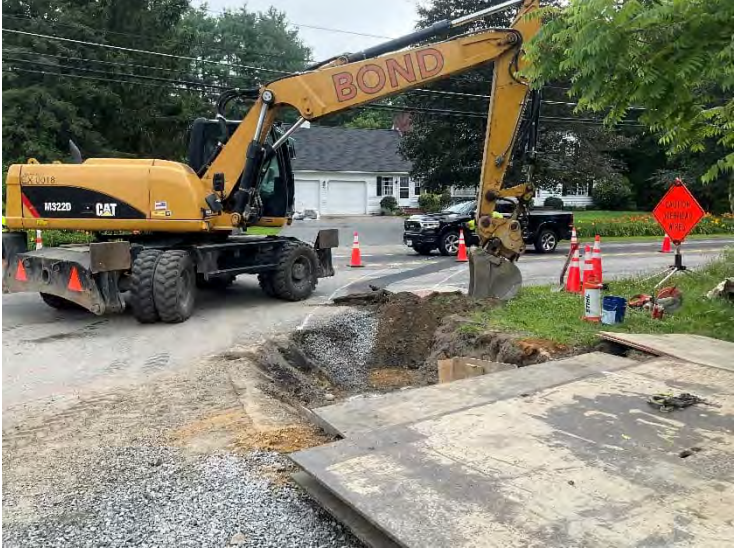
<p>PHOTOGRAPHIC LOG</p>	
<p>Client Name: Eversource</p>		<p>Site Location: Sudbury to Hudson Transmission Reliability Project</p>	<p>Town: Hudson</p>
<p>Photo No.: 1</p>	<p>Date: 7-10-24</p>

<p>Description:</p> <p>View of Bond trenching for conduit work by Hudson Light &amp; Power near MH #1. See additional dewatering report. Facing east.</p>

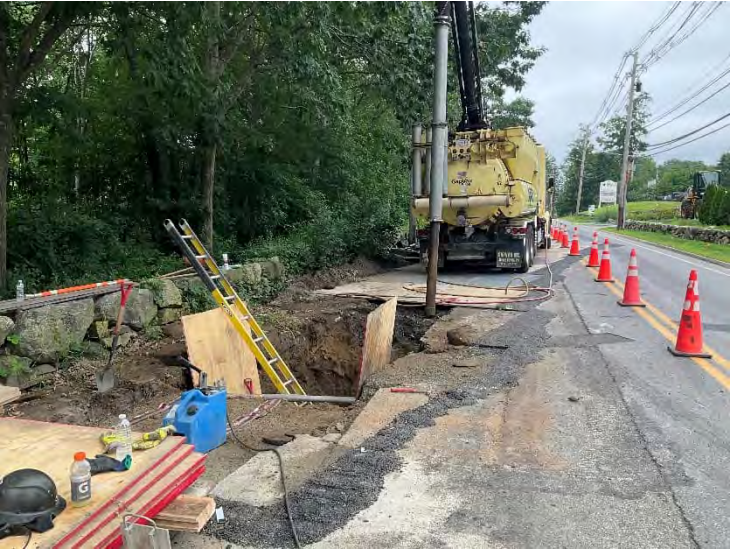
<p>PHOTOGRAPHIC LOG</p>	
<p>Client Name: Eversource</p>		<p>Site Location: Sudbury to Hudson Transmission Reliability Project</p>	<p>Town: Hudson</p>
<p>Photo No.: 3</p>	<p>Date: 7-10-24</p>

<p>Description:</p> <p>View of Bond work area on Forest Ave by MH #2 Facing west.</p>

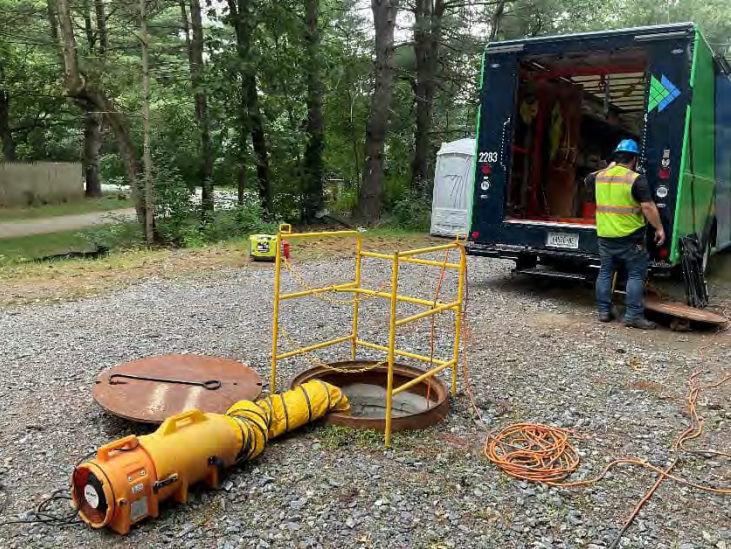
<p>PHOTOGRAPHIC LOG</p>	
<p>Client Name: Eversource</p>		<p>Site Location: Sudbury to Hudson Transmission Reliability Project</p>	<p>Town: Hudson</p>
<p>Photo No.: 4</p>	<p>Date: 7-10-24</p>

<p>Description:</p> <p>View of Haugland splicers at MH #11 in segment 5. Facing east.</p>

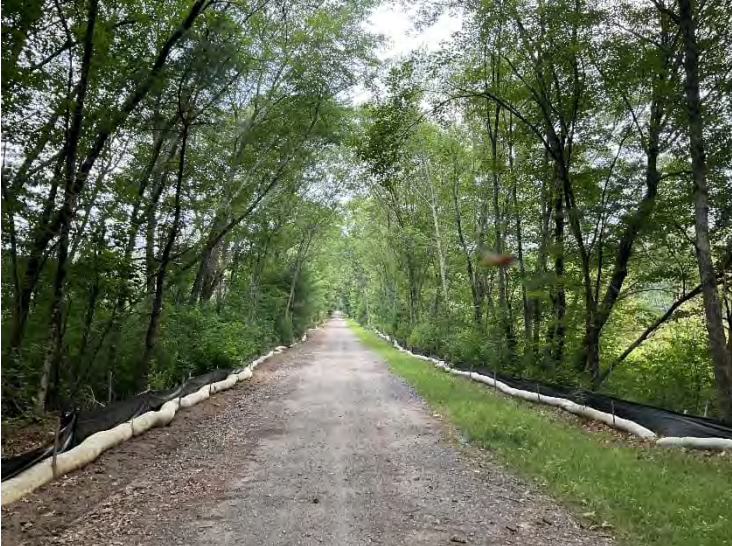
<p>PHOTOGRAPHIC LOG</p>	
<p>Client Name: Eversource</p>		<p>Site Location: Sudbury to Hudson Transmission Reliability Project</p>	<p>Town: Hudson</p>
<p>Photo No.: 6</p>	<p>Date: 7-10-24</p>

<p>Description: View of E&amp;S controls in segment 5. Facing west.</p>

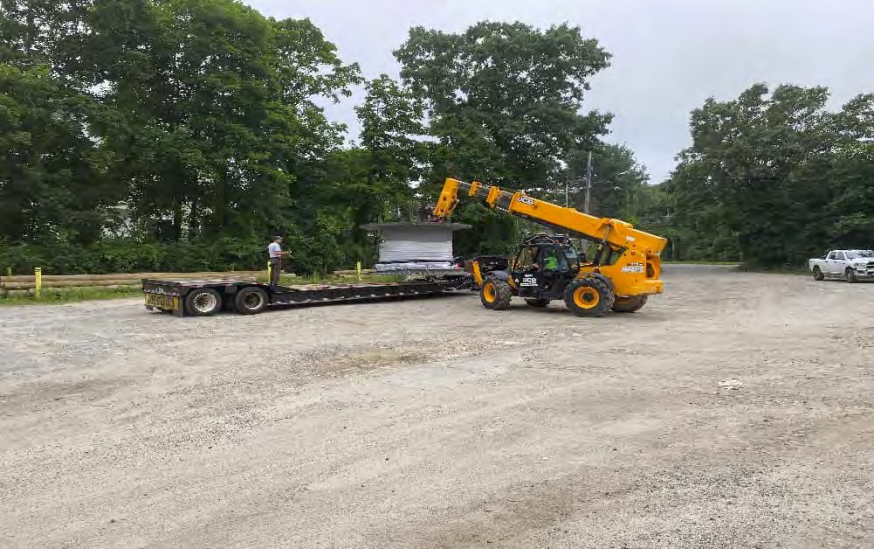
<p>PHOTOGRAPHIC LOG</p>	
<p>Client Name: Eversource</p>		<p>Site Location: Sudbury to Hudson Transmission Reliability Project</p>	<p>Town: Sudbury</p>
<p>Photo No.: 1</p>	<p>Date: 7-10-24</p>

<p>Description:</p> <p>Reel removal from substation area, looking westward.</p>

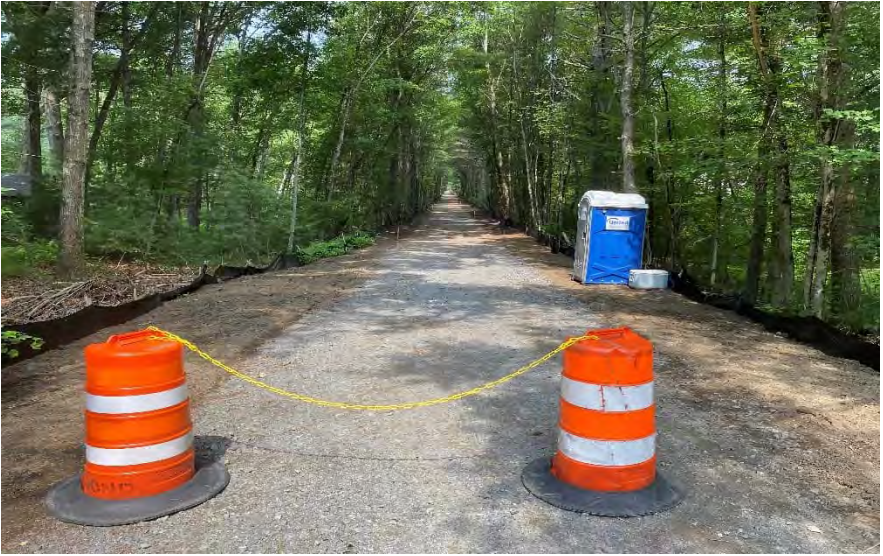
<p align="center"><b>PHOTOGRAPHIC LOG</b></p>	
<p>Client Name: Eversource</p>		<p>Site Location: Sudbury to Hudson Transmission Reliability Project</p>	<p>Town: Sudbury</p>
<p>Photo No.: 3</p>	<p>Date: 7-10-24</p>

<p>Description:</p> <p>Work area within segment 9, recently placed loam adjacent to the work area, existing erosion control, looking westward.</p>

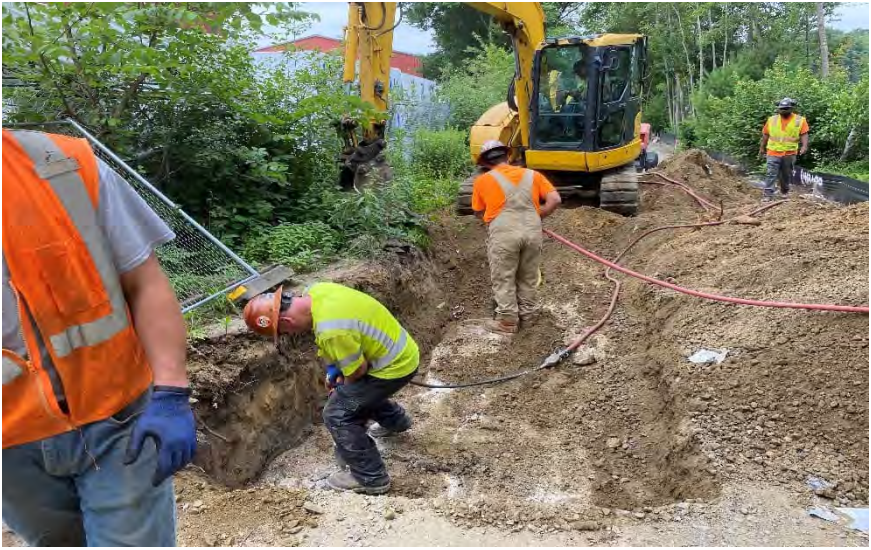
<p>Description:</p> <p>Work area within segment 12, Bond conducting conduit replacement work, existing erosion control, looking westward.</p>

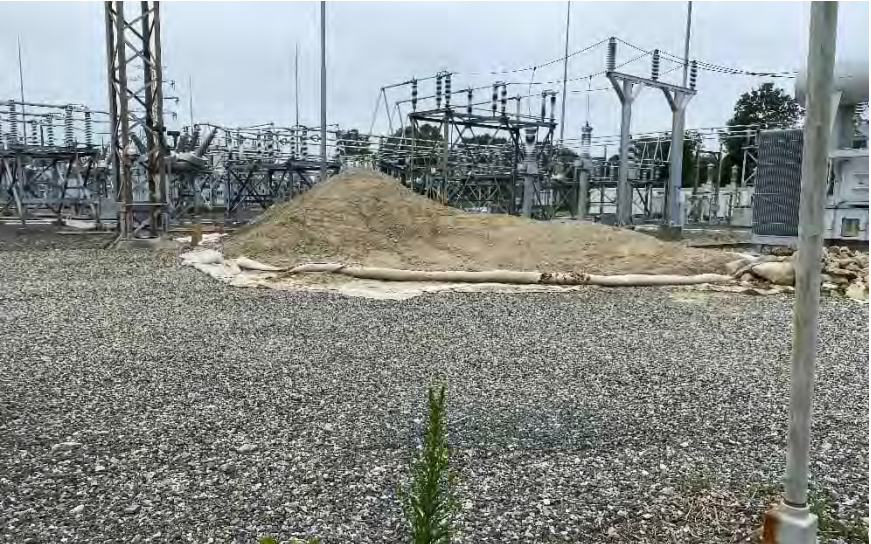
<p>Description:</p> <p>Work area within substation, newly placed spoil pile, existing erosion control (compost tubing), looking southward.</p>

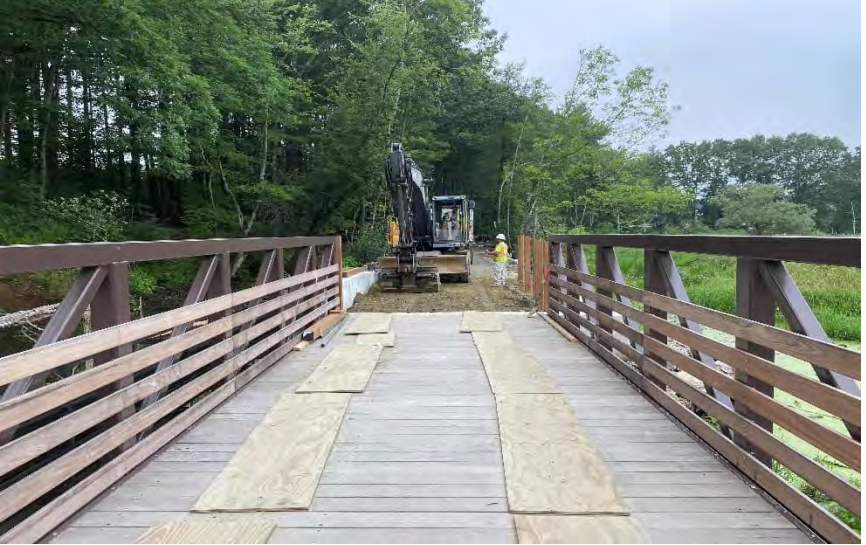
<p>Description:</p> <p>Work area within segment 13, bridge 127 work, existing erosion control, looking westward.</p>

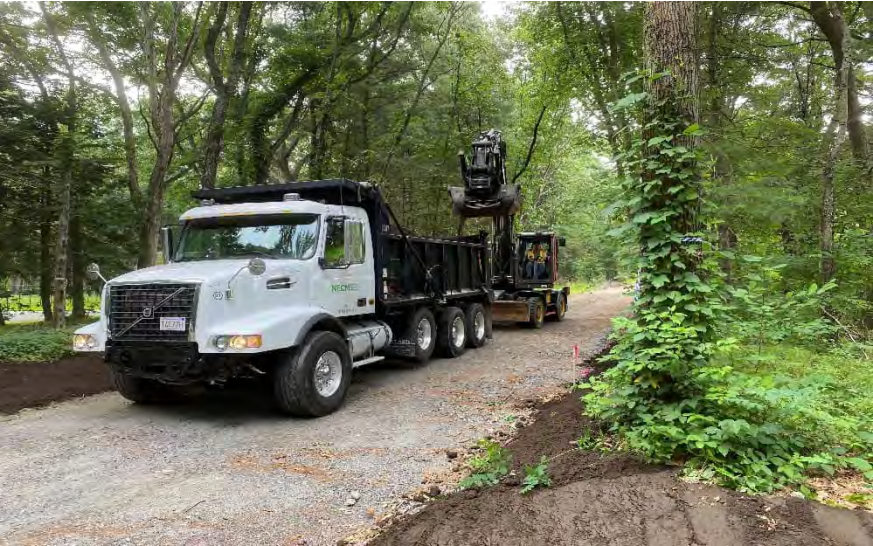
<p>Description:</p> <p>Work area within segment 11, loam being added to work area shoulders, existing erosion control, looking eastward.</p>

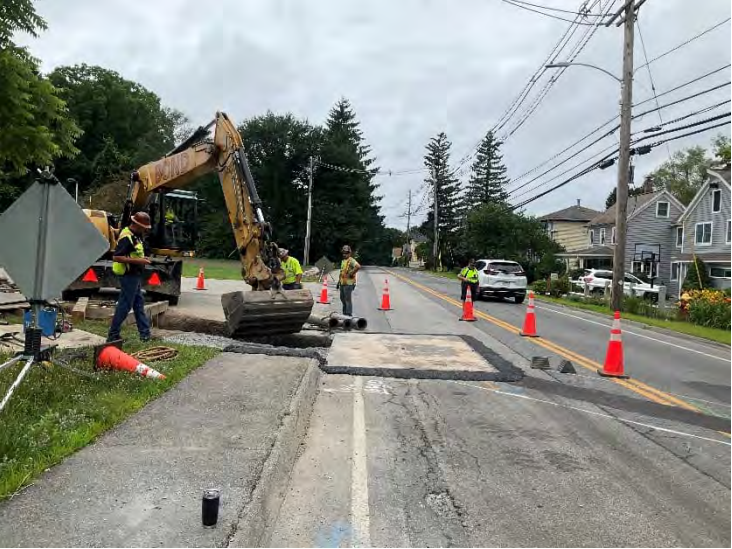
Description:  View of Bond trenching for conduit work by Hudson Light & Power near MH #1. See additional dewatering report. Facing west.

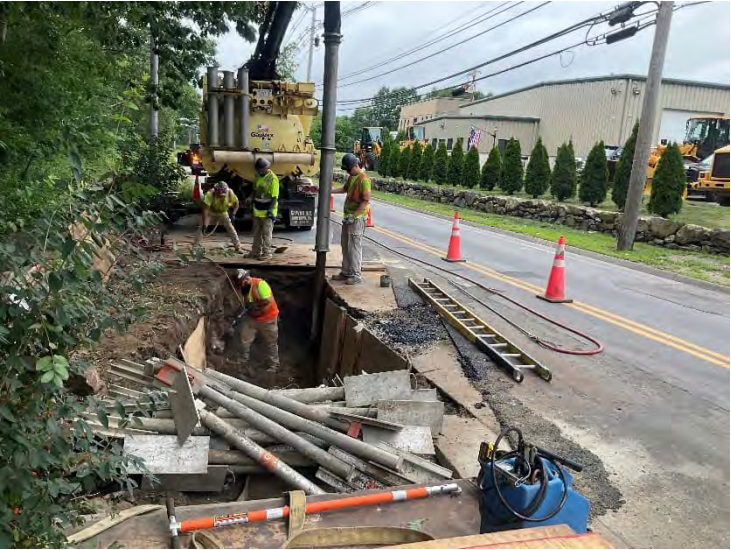
<p>Description:</p> <p>View of Bond excavating with vac truck at work area on Forest Ave by MH #2. Facing west.</p>

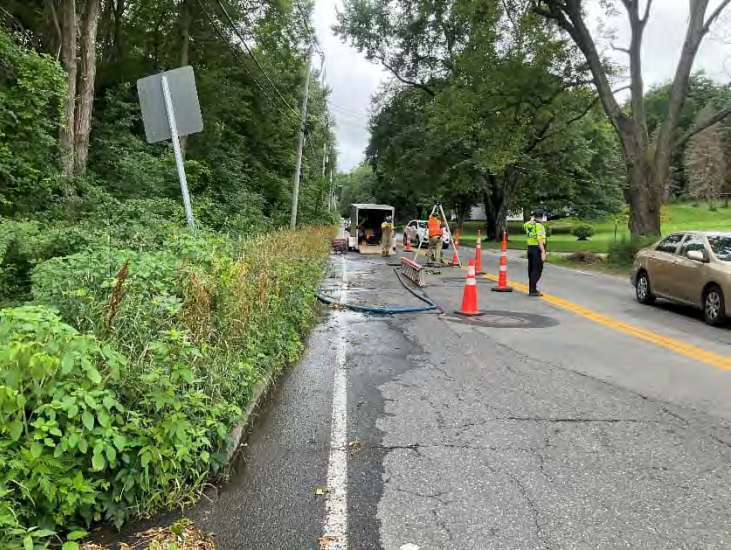
<p>Description:</p> <p>View of Bond work area at MH #4 on Forest Ave for proofing. See additional dewatering report. Facing southwest.</p>

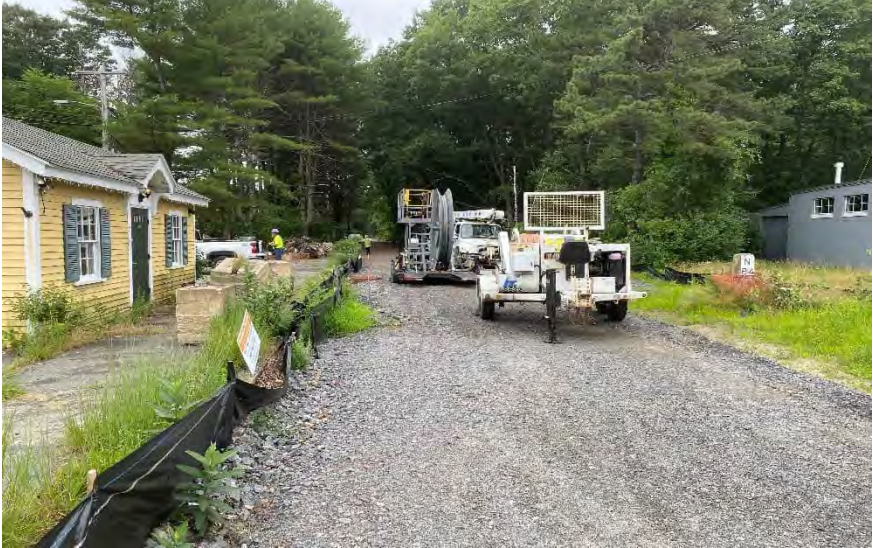
<p>Description:</p> <p>Work area within segment 11, manhole #24, wire pulling work, existing erosion control, looking westward.</p>

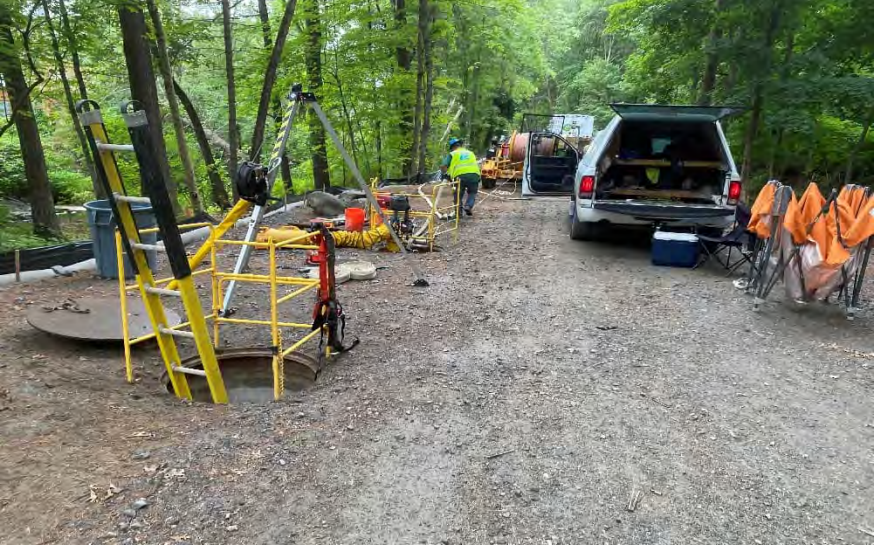
<p>Description:</p> <p>Work area within segment 13, manhole #25, wire pulling work, existing erosion control, looking westward.</p>

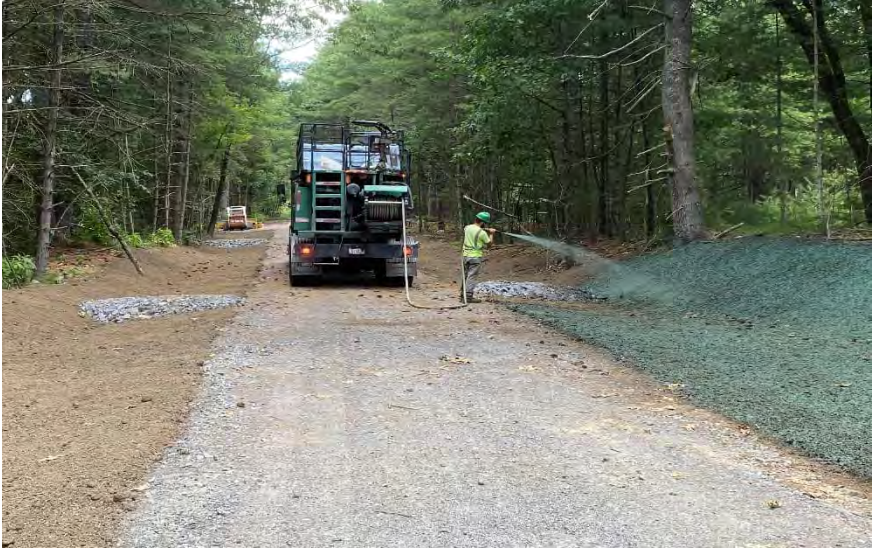
<p>Description:</p> <p>Work area within segment 9, hydroseeding, existing erosion control, looking eastward.</p>

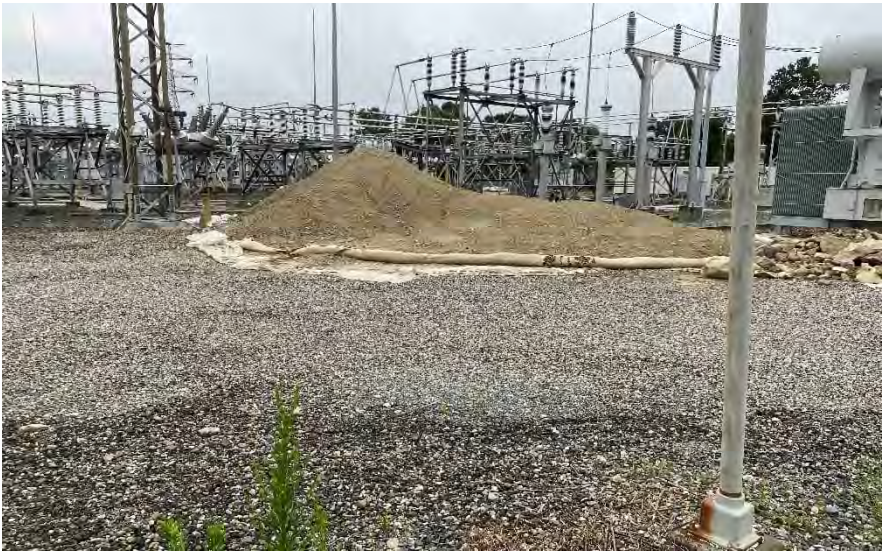
<p>Description:</p> <p>Work area within substation, newly placed spoil pile, existing erosion control (compost tubing), looking southward.</p>

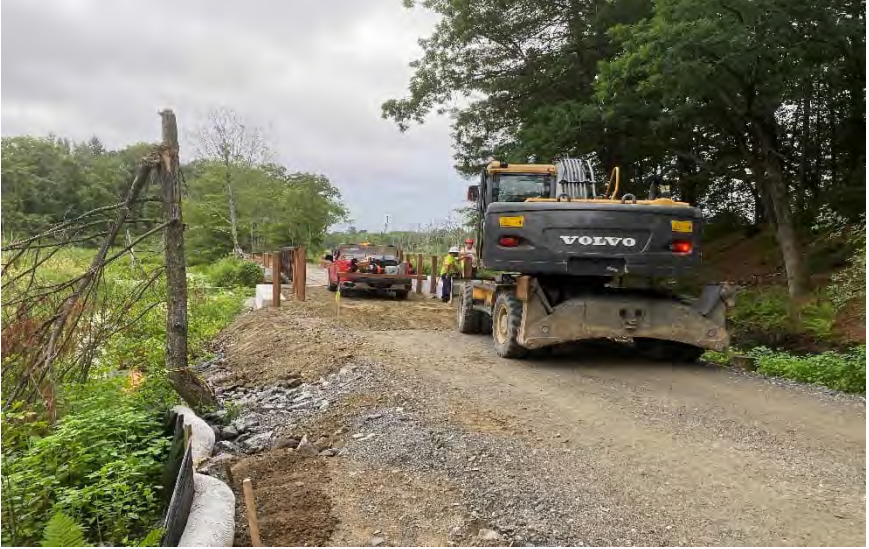
<p>Description:</p> <p>Work area within segment 13, bridge 127 work, existing erosion control, looking eastward.</p>

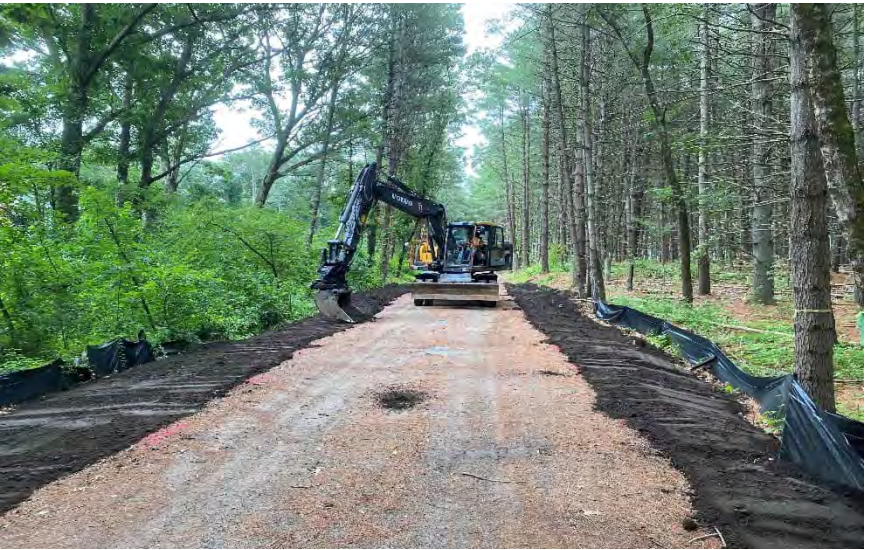
<p>Description:</p> <p>Work area within segment 11, loam being added to work area shoulders, existing erosion control, looking eastward.</p>

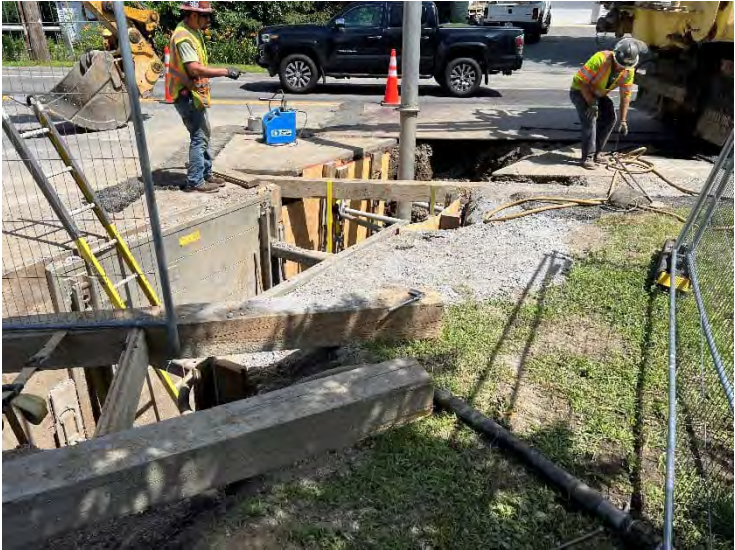
<p>Description:</p> <p>View of Bond trenching for conduit work by Hudson Light &amp; Power near MH #1. See additional dewatering report. Facing north.</p>

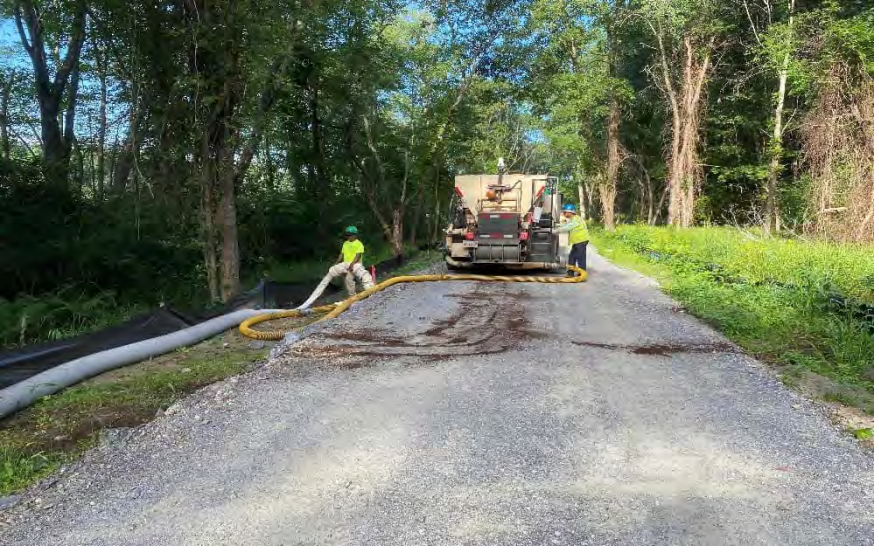
<p>Description:</p> <p>Work area within segment 14, new erosion control (compost filter tubes) being added, existing erosion control, looking westward.</p>

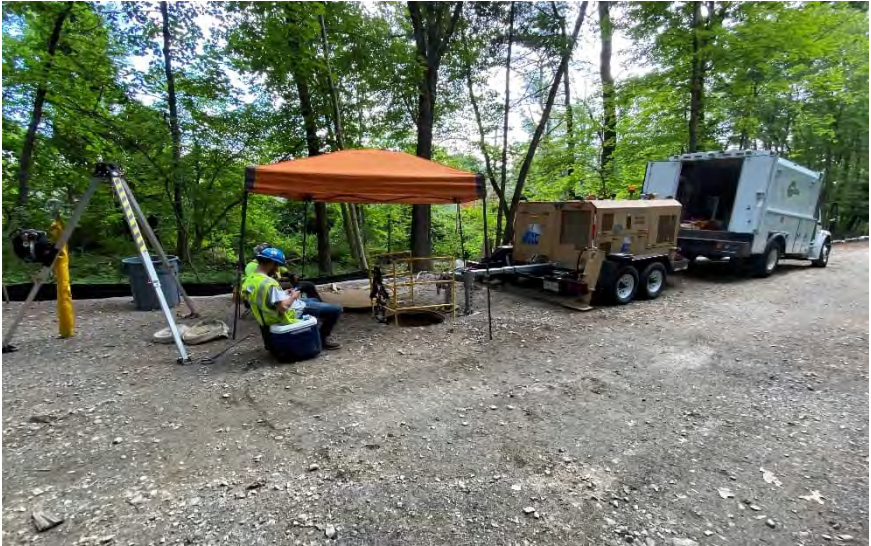
<p>Description:</p> <p>Work area within segment 13, manhole #25, wire pulling work, existing erosion control, looking eastward.</p>

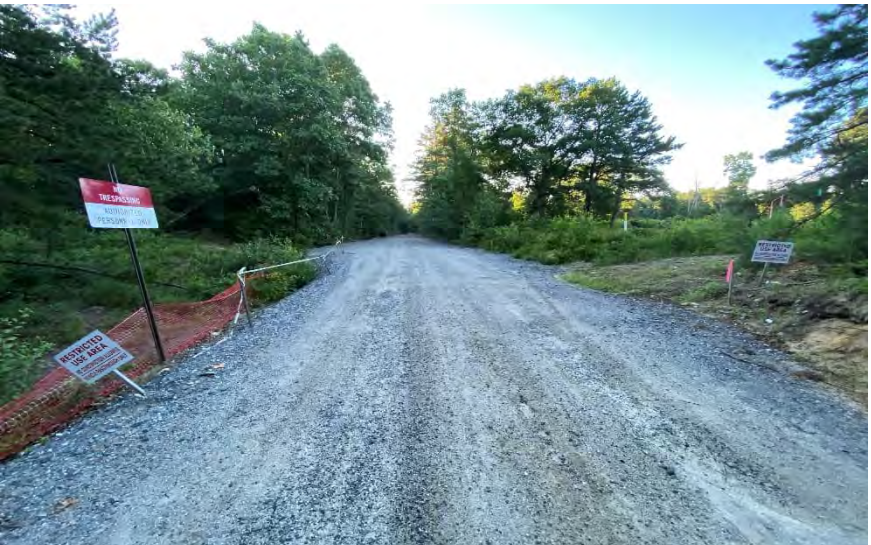
<p>Description:</p> <p>Work area within segment 7, town line area Hudson-Sudbury, looking eastward.</p>

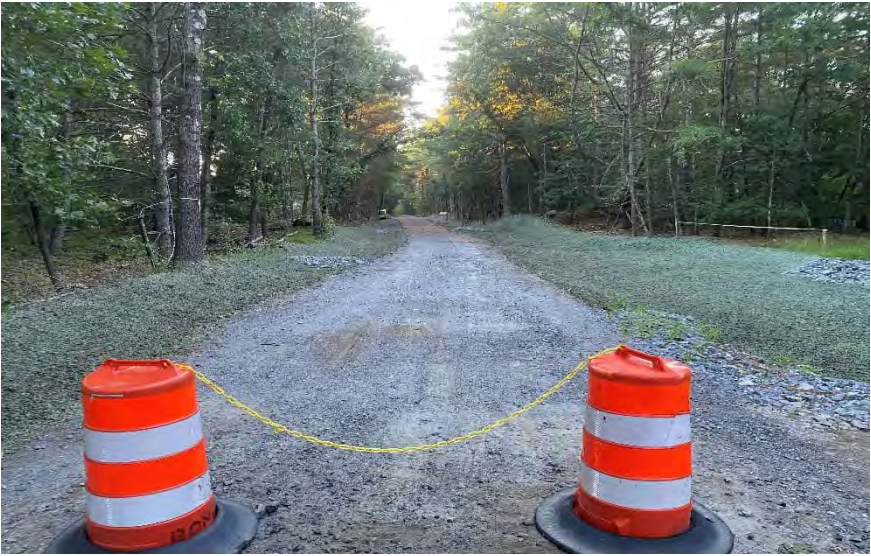
<p>Description:</p> <p>Work area within segment 9, recent hydroseeding, existing erosion control, looking eastward.</p>

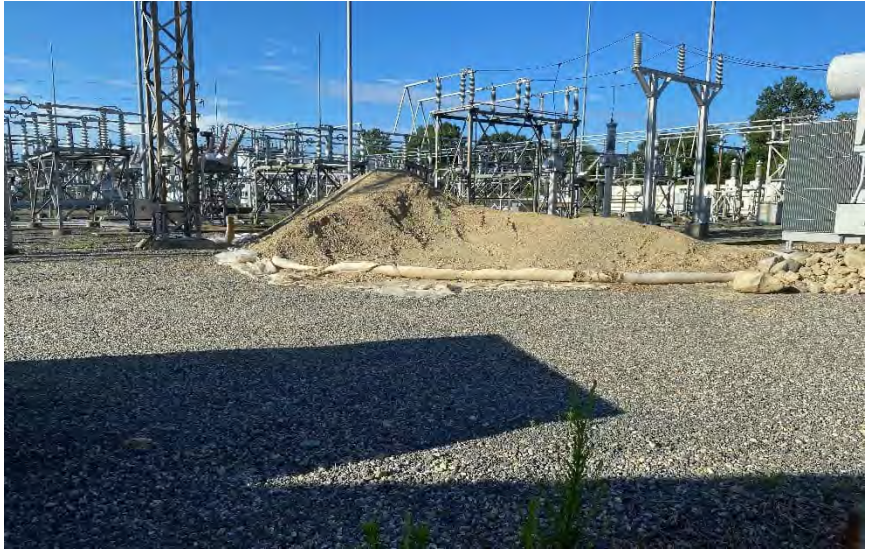
<p>Description:</p> <p>Work area within substation, newly placed spoil pile, existing erosion control (compost tubing), looking southward.</p>

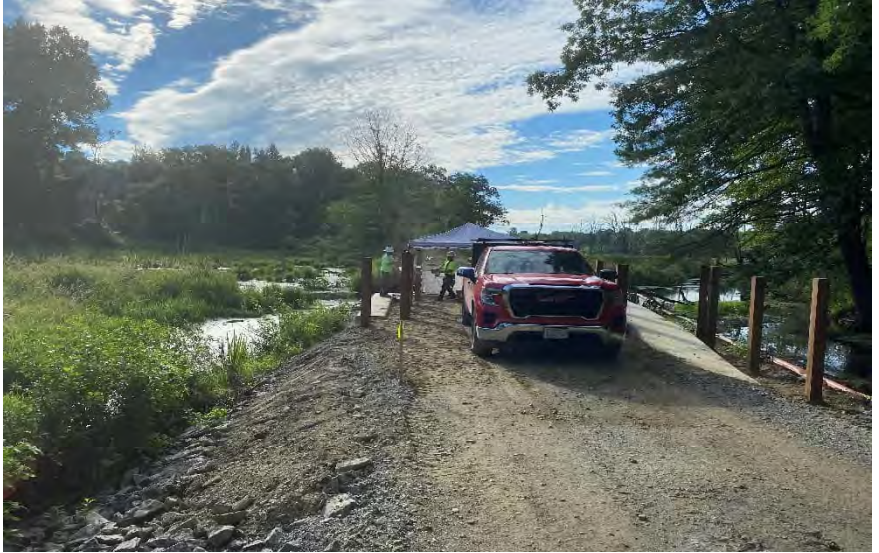
<p>Description:</p> <p>Work area within segment 13, bridge 127 work, existing erosion control, looking eastward.</p>

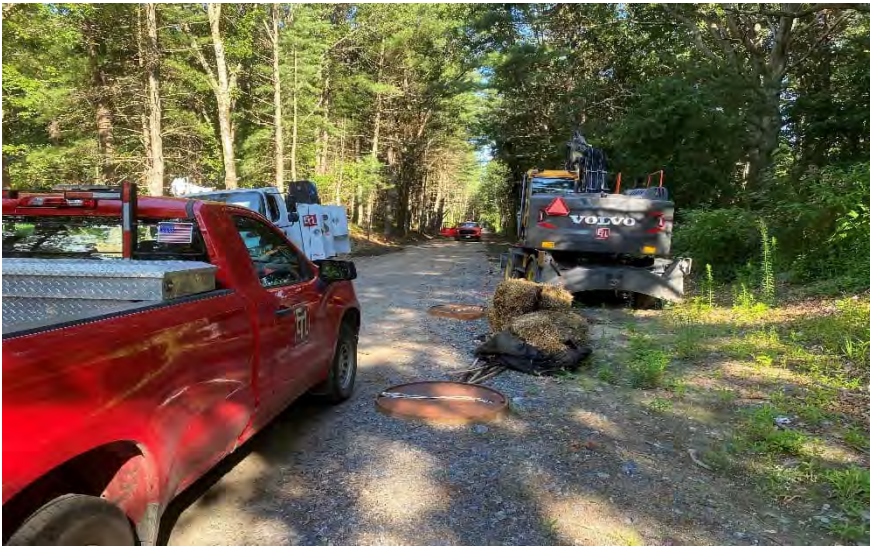
<p>Description:</p> <p>Work area within segment 11, loam being added to work area shoulders, existing erosion control, looking westward.</p>

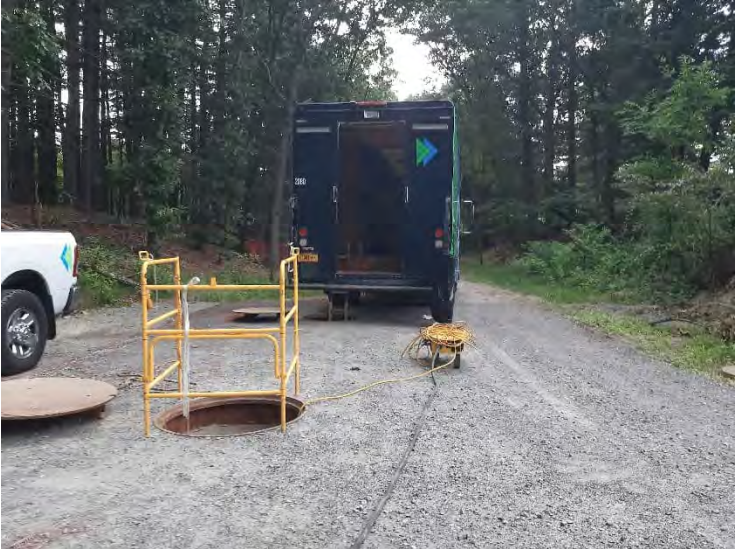
<p>Description:</p> <p>Haugland crimping and splicing at manhole #9, looking eastward.</p>

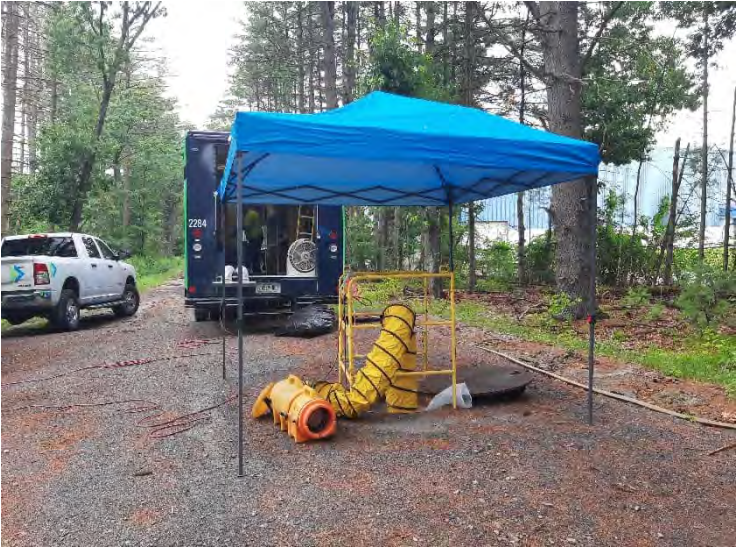
<p>Description:                  Haugland crimping and splicing at manhole #10, looking westward.</p>

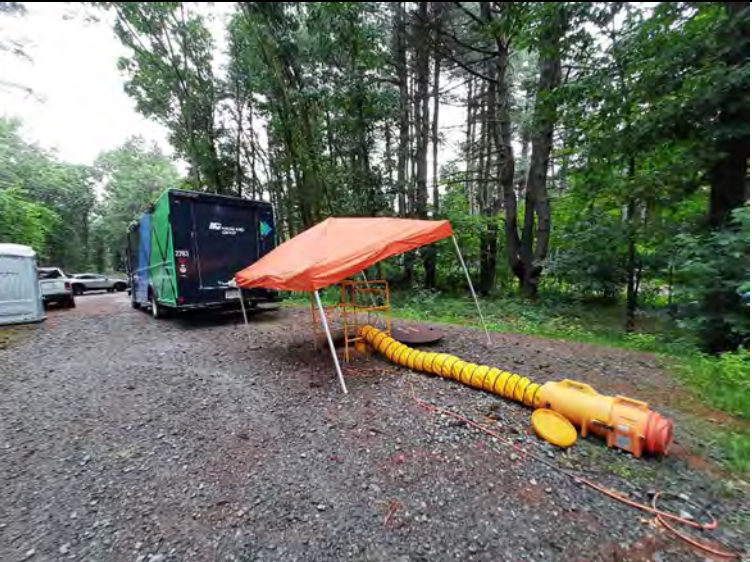
<p>Description:                  Haugland crimping and splicing at manhole #11. Looking westward.</p>

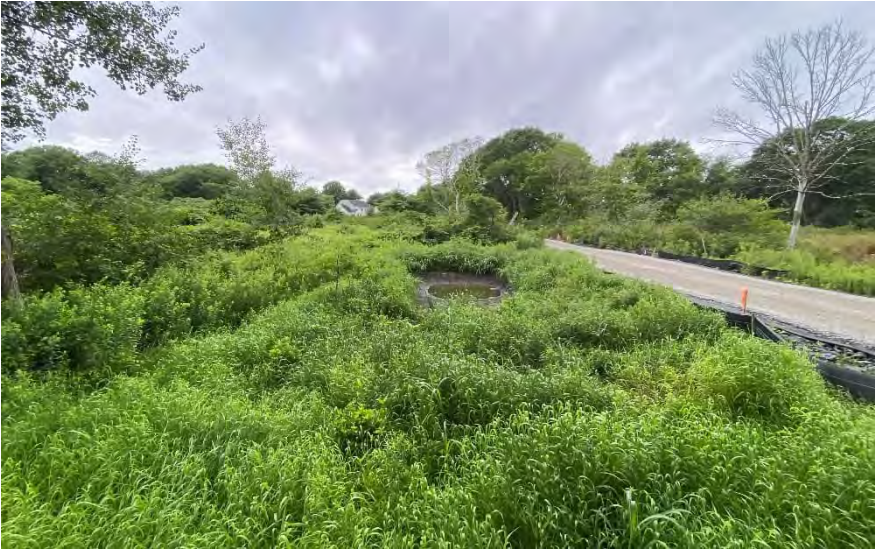
<p>Description:</p> <p>Wetland replication area within segment 14, existing erosion control, looking westward.</p>

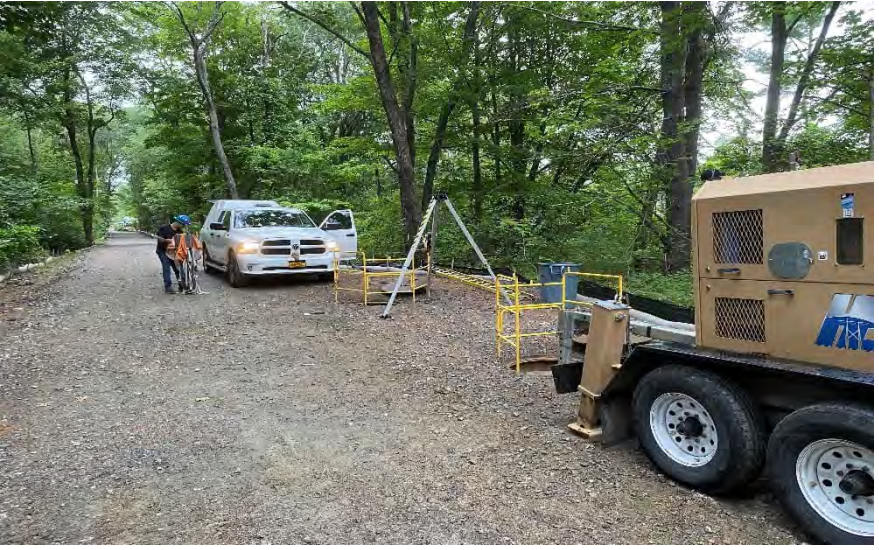
<p>Description:</p> <p>Haugland pulling wire at manhole #25 (Segment 13), existing erosion control, looking westward.</p>

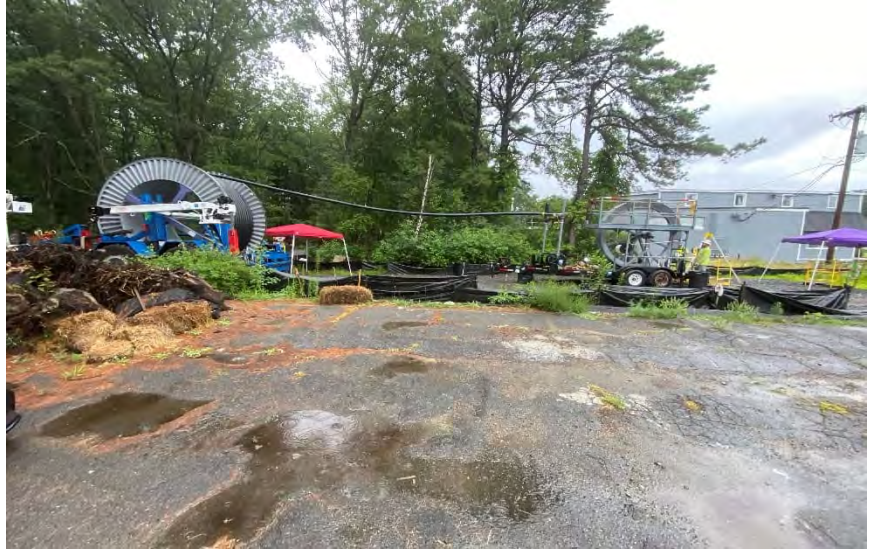
<p>Description:</p> <p>Haugland pulling wire at manhole #24 (Segment 11), existing erosion control, looking eastward.</p>

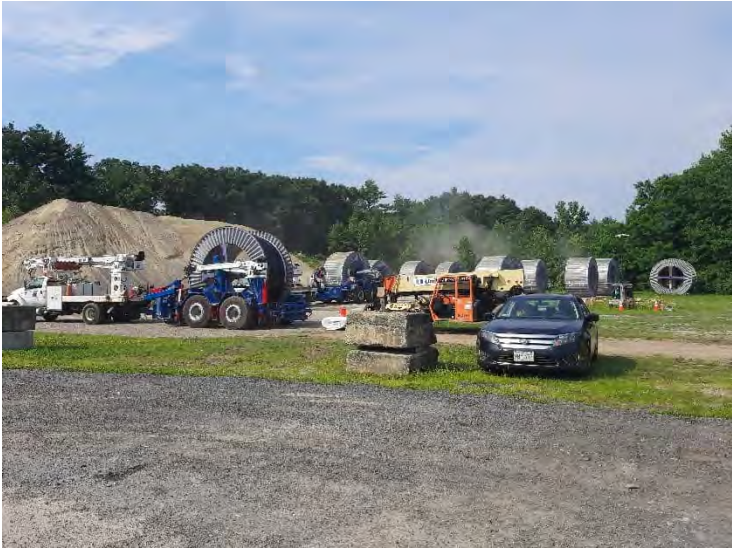
Description:  Haugland laydown yard, stored wire on reels, including two reels loaded onto Mirks. Looking westward. Dust plume in background unrelated to project and outside of site boundaries.

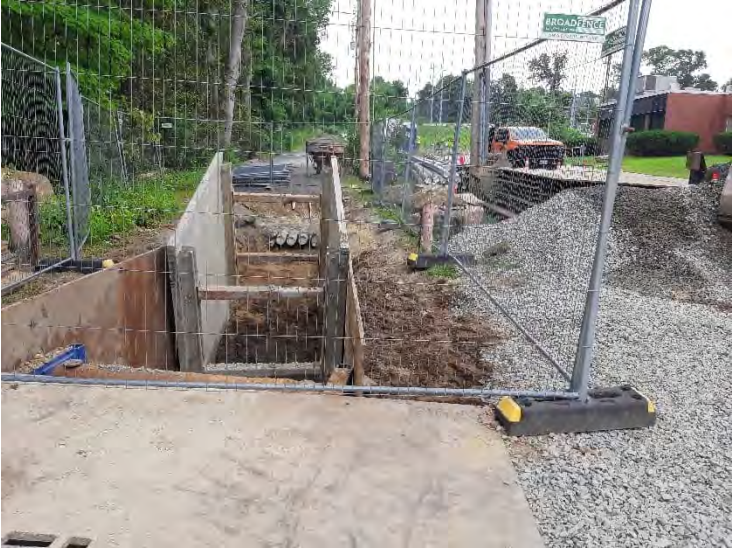
Description:  Work area at MH #1, beside Hudson Light and Power, installing conduit and establishing construction pad, looking eastward.

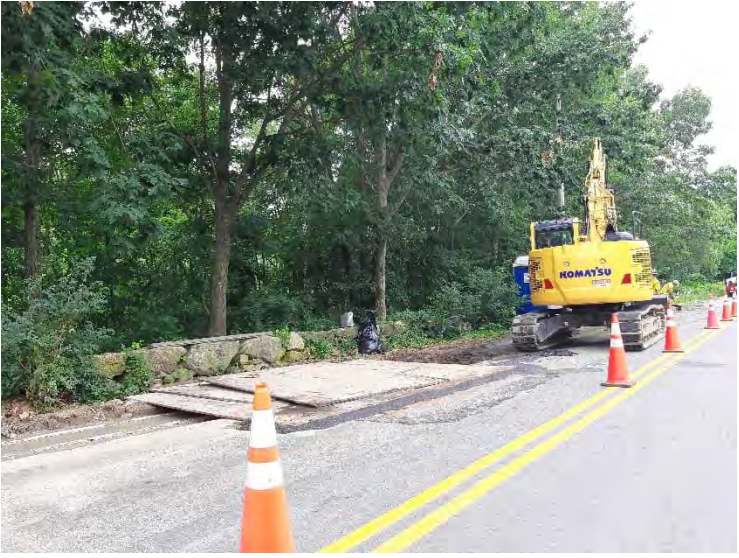
Description:  Work area in Forest Ave between MH #2 and MH #1, near Bonazzoli Ave, installing conduit. Looking westward.
