**Weekly Environmental Compliance Summary**

**Sudbury to Hudson Transmission Reliability Project (USEPA Tracking # MAR1003UW)**

Sudbury, Hudson, and Stow, MA

Week of: July 8, 2024 to July 13, 2024

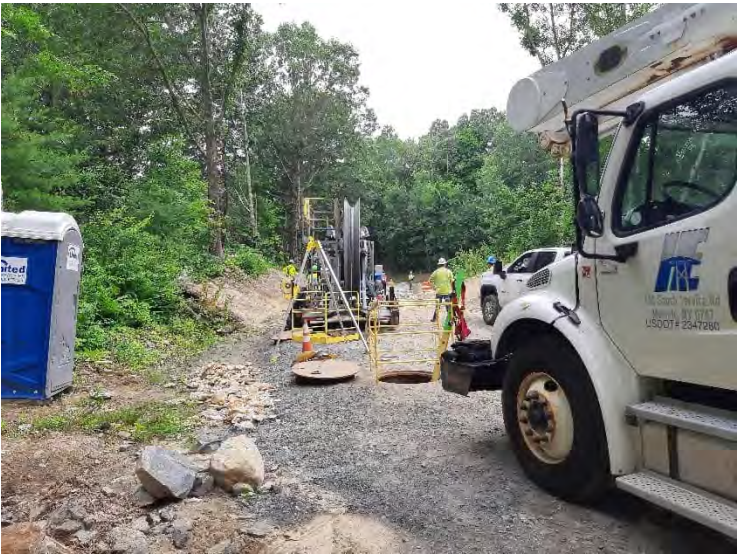
Description:  Work area at MH #5 (segment 1), cable pulling from MH #5 to MH #6 (segment 1), looking westward.

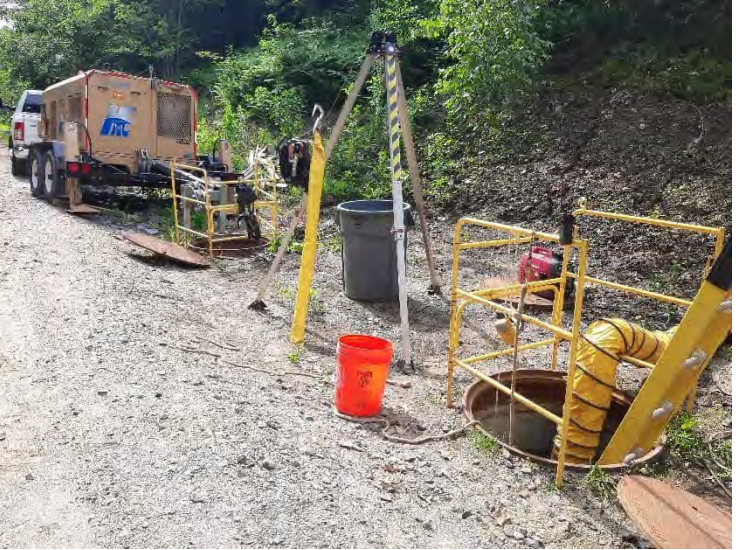
Description:  Work area at MH #6 (segment 1), cable pulling from MH #5 (segment 1) to MH #6, looking eastward.

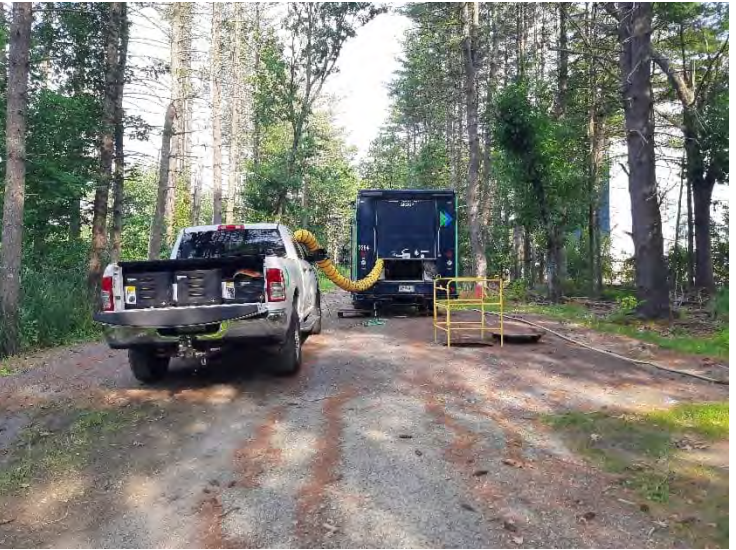
Description:  Work area at MH #10 (segment 4), cable crimping and splicing, looking westward. Dewatering and turbidity monitoring conducted here.

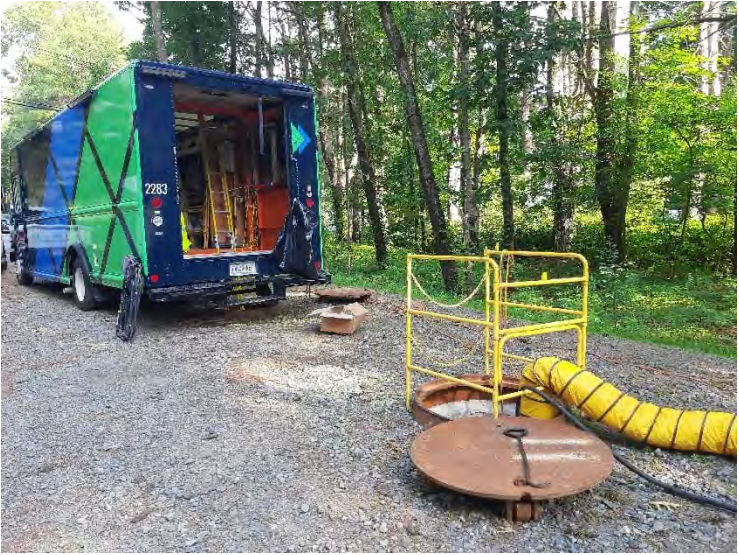
Description:  Work area at MH #11 (segment 5), cable crimping and splicing, looking westward.

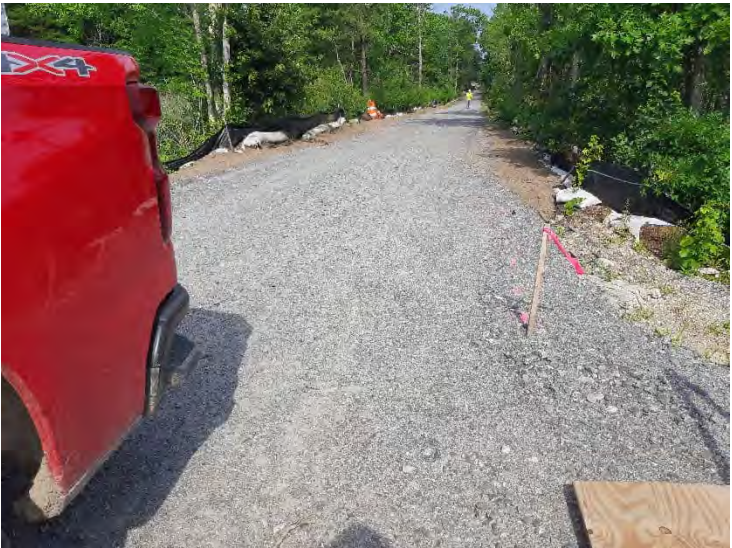
Description:  ET&L in segment 2 (right) and segment 3 (not shown), inspecting loam, seed, and coconut mats. Looking westward.

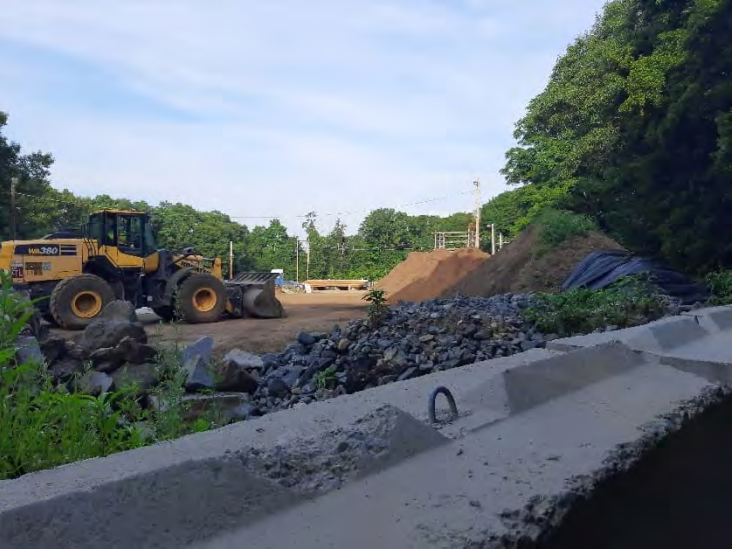
Description:  ET&L working in Stow Ct laydown yard, looking westward.

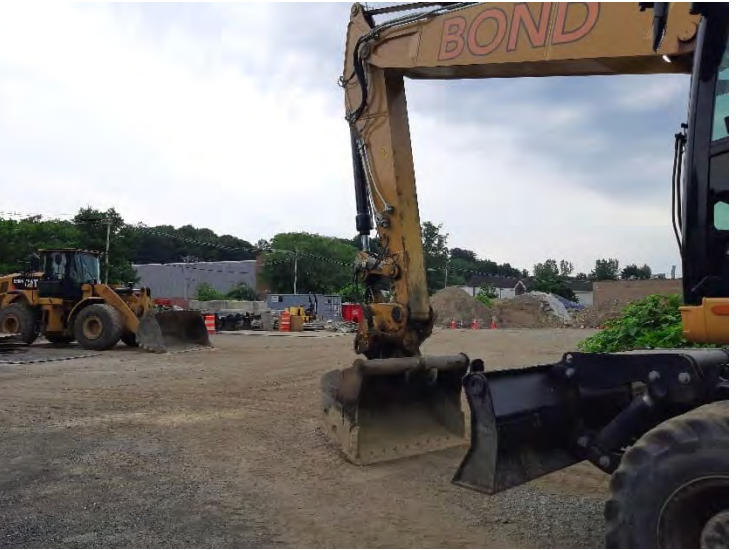
Description:  Bond working in Bonazzoli Ave laydown yard, looking westward.

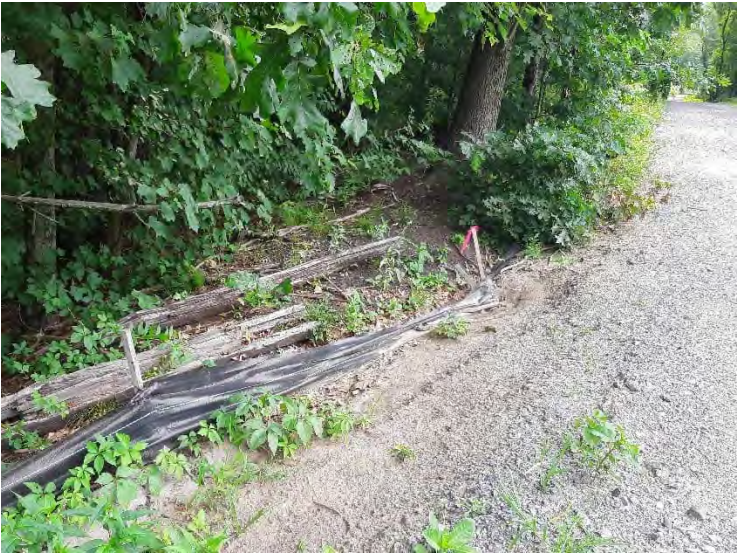
Description:  Silt fence near STA 99 in segment 1 on north side of ROW, sediment accumulation, routine maintenance. Contractor notified. Looking eastward.

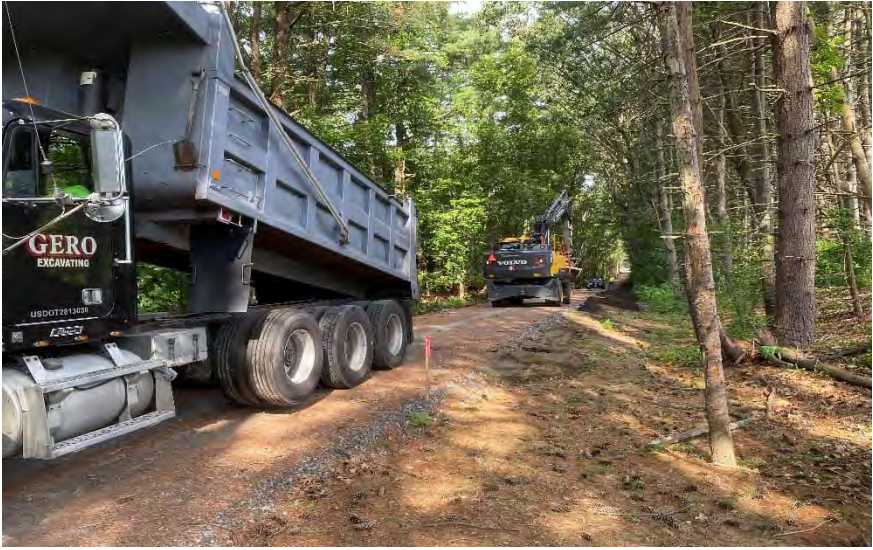
Description:  Work area within segment 10, adding loam to shoulders, looking eastward.

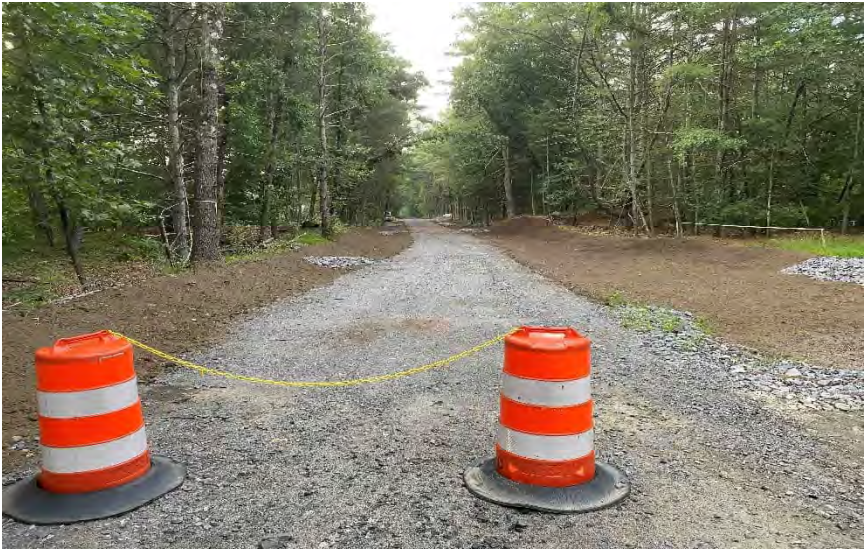
Description:  Work area within segment 9, recently placed loam, looking eastward.

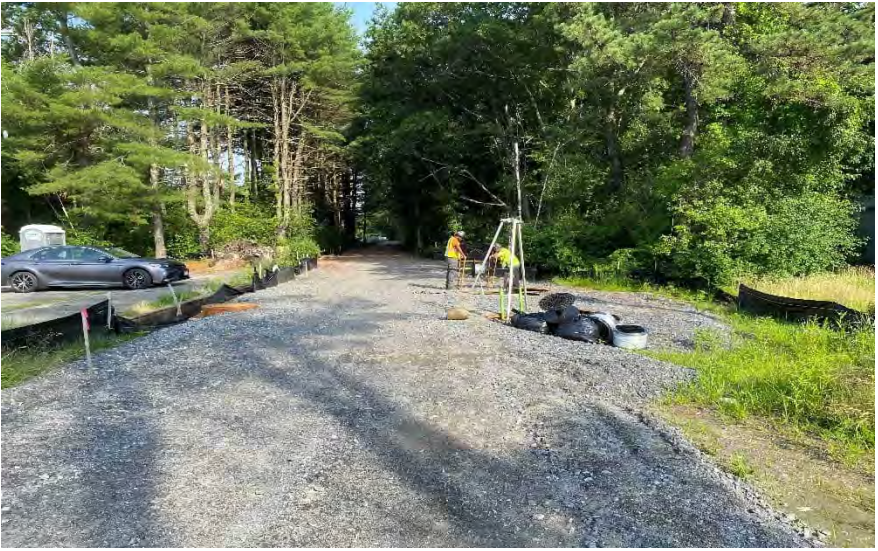
Description:  Work area within segment 11 (manhole #24), proofing, existing erosion control, looking westward.

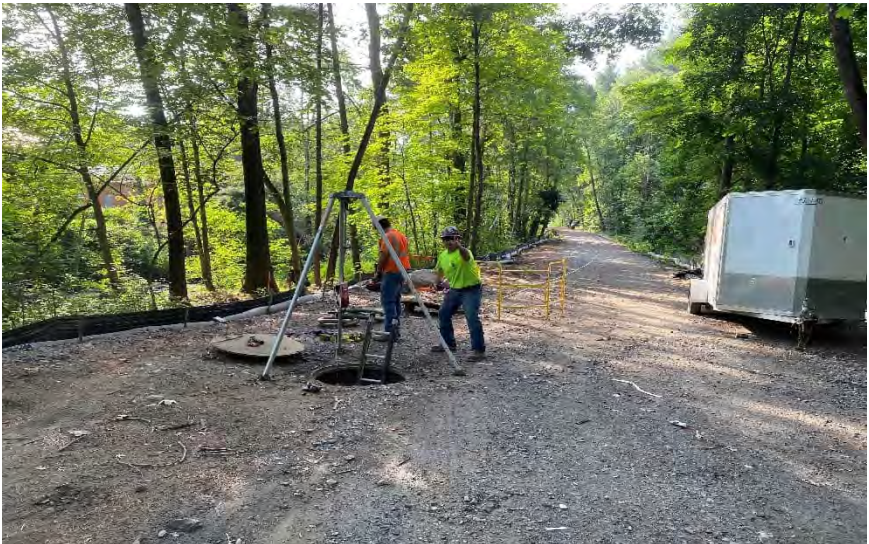
Description:  Work area within segment 13 (manhole #25), proofing, existing erosion control, looking eastward.

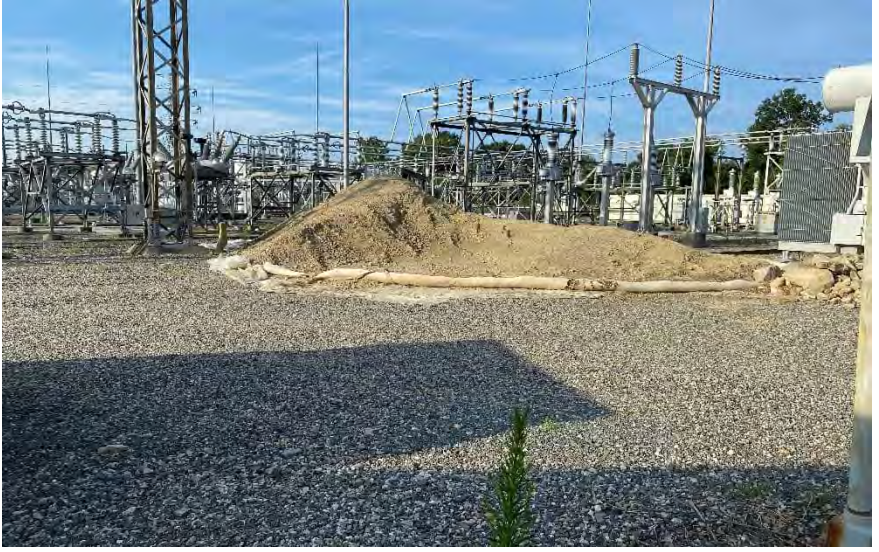
Description:  Work area within substation, spoil pile with compost tubes surrounding pile, looking southward.

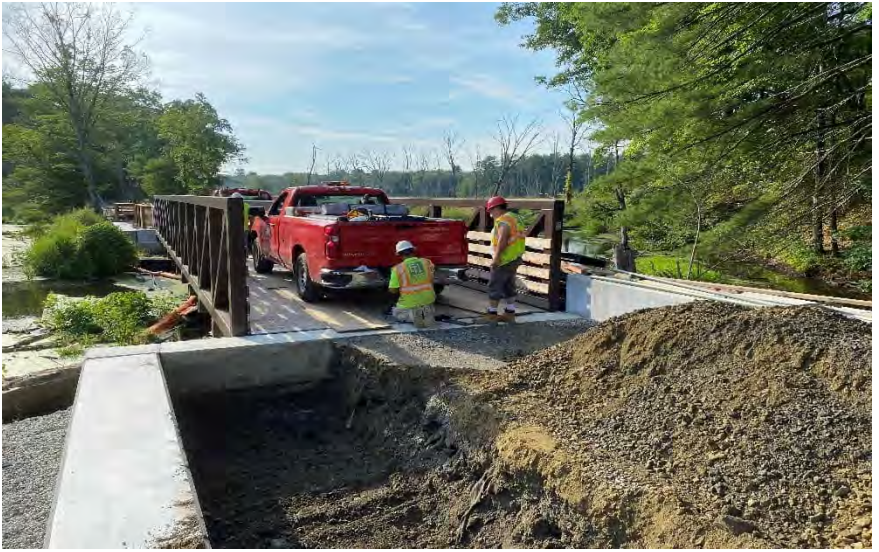
Description:  Work area within section 13 at bridge 127, grading work, looking eastward.

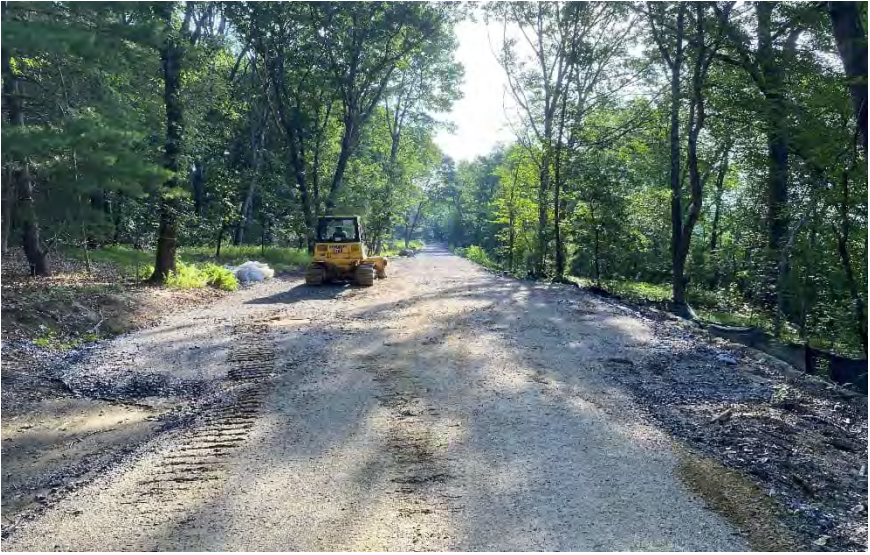
Description:  Work area within segment 14, manhole #26 area, existing erosion control, looking eastward.

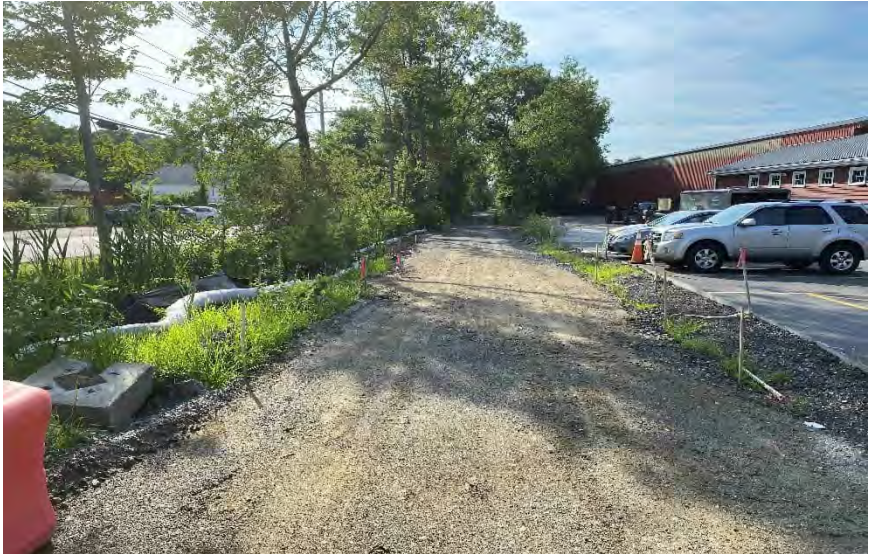
Description:  Work area within segment 12, existing erosion control, looking eastward.

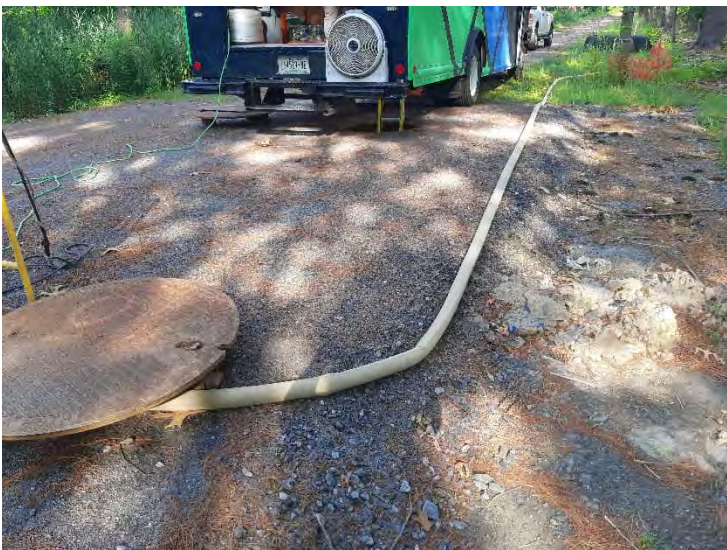
Description: Manhole #10. View of dewatering operation. Looking westward.

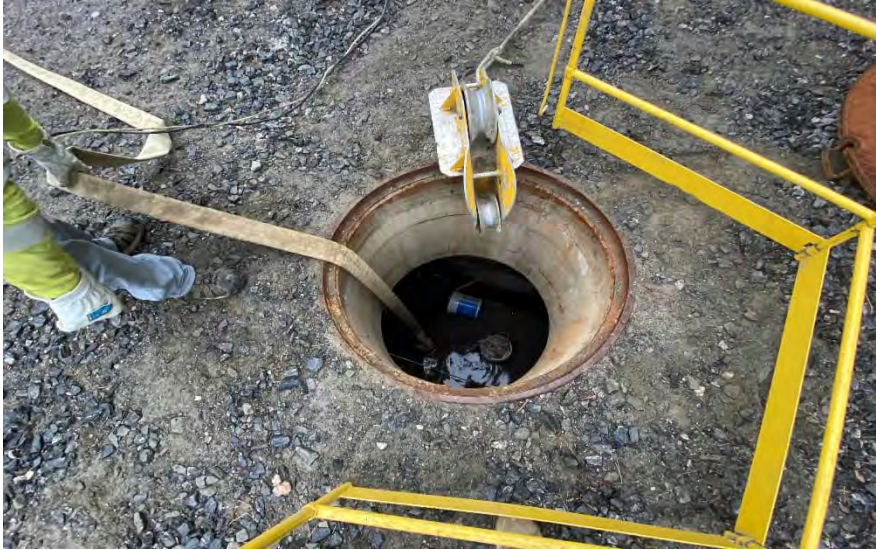
Description: View of area being pumped from manhole #24, Segment 11.

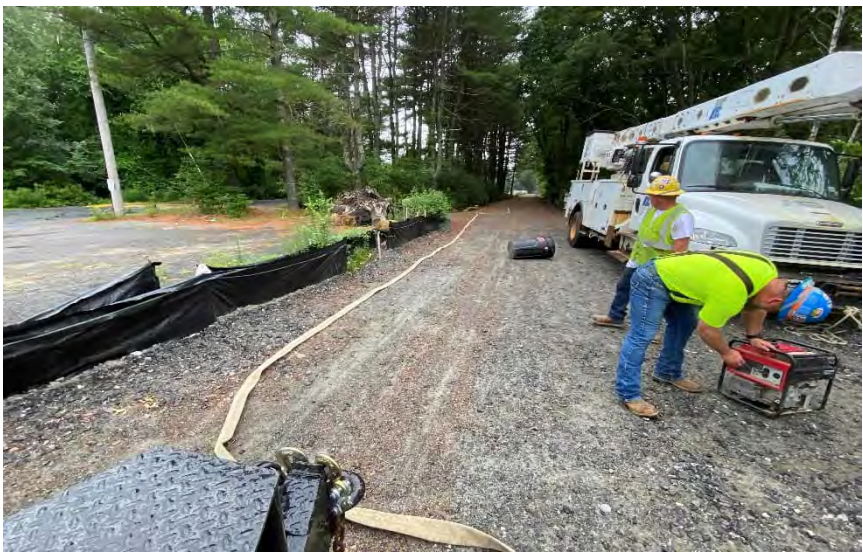
Description: Manhole #24. View of dewatering operation. Looking westward.

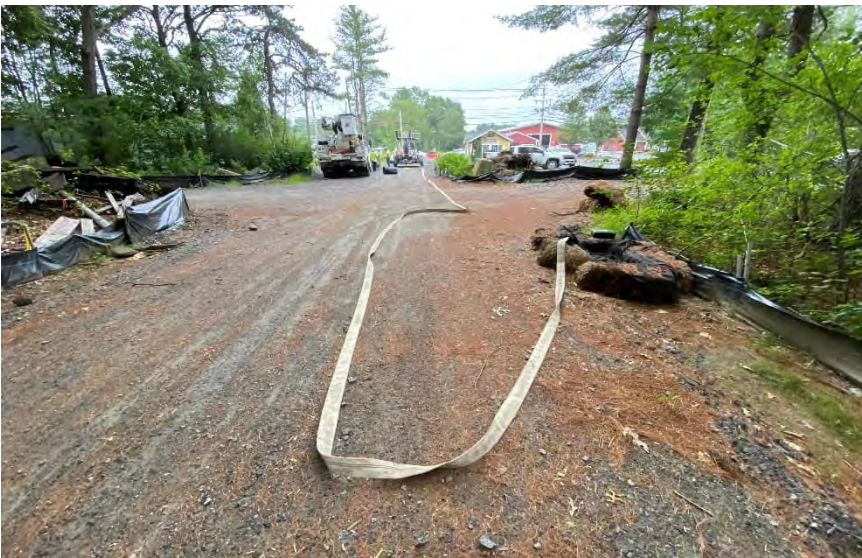
Description: Manhole #24. View of dewatering operation, looking eastward.

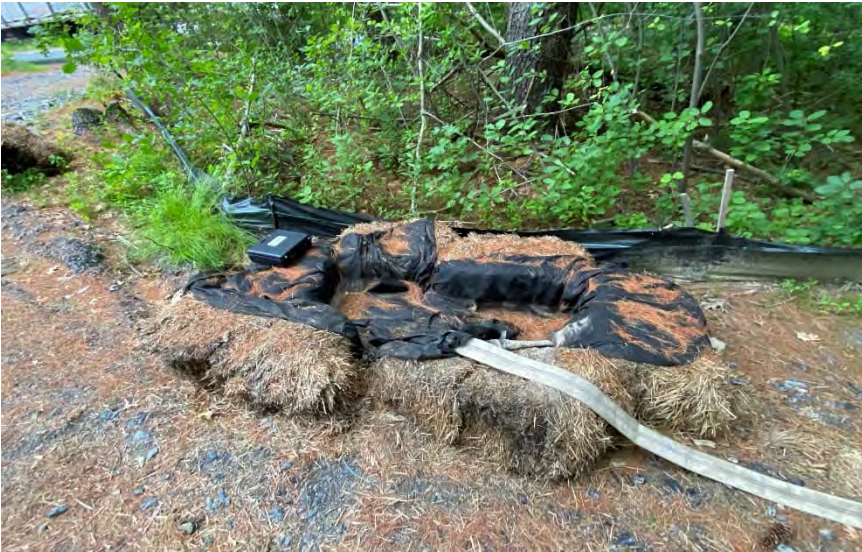
Description: Manhole #24. View of discharge bag/corral, looking westward. Water from bag/corral discharged to adjacent area.

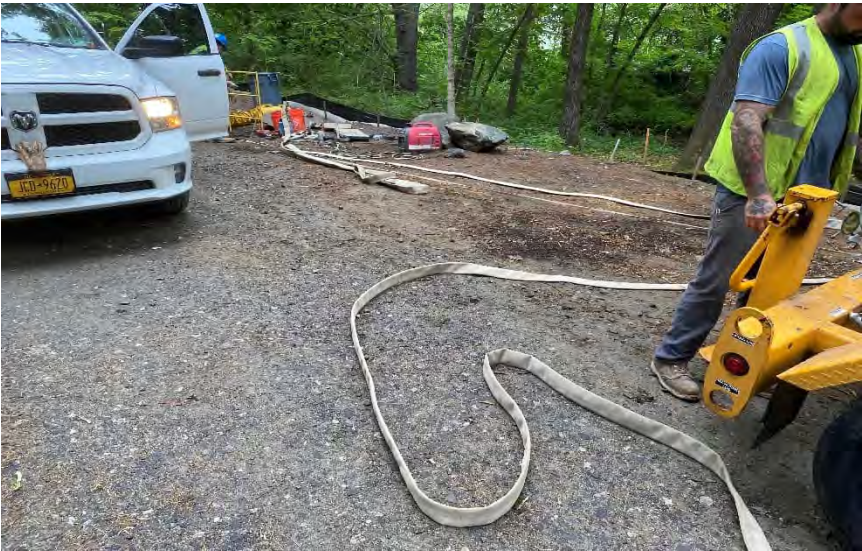
Description: Manhole #25. View of dewatering operation, looking westward.

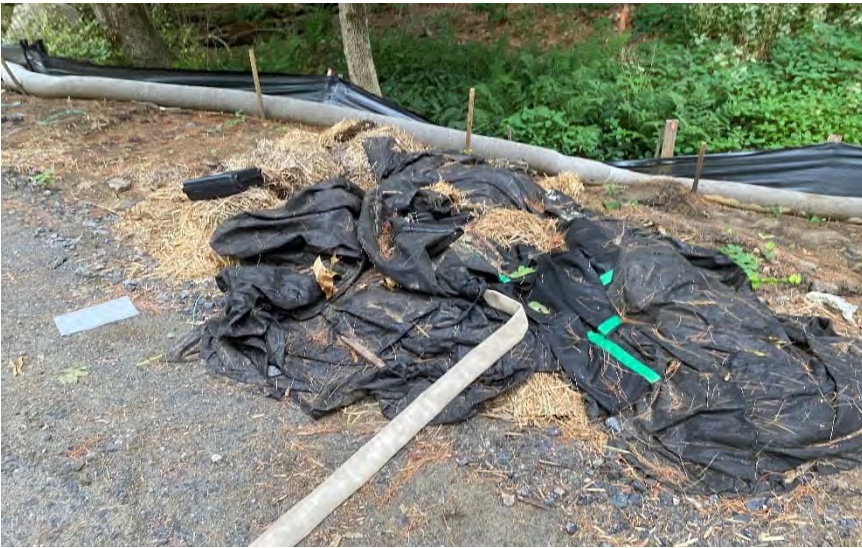
Description: Manhole #25. View of discharge bag/corral, looking eastward. Water from bag/corral discharged to adjacent area.
