Weekly Environmental Compliance Summary

Sudbury to Hudson Transmission Reliability Project (USEPA Tracking # MAR1003UW)

Week of: July 15, 2024 to July 20, 2024

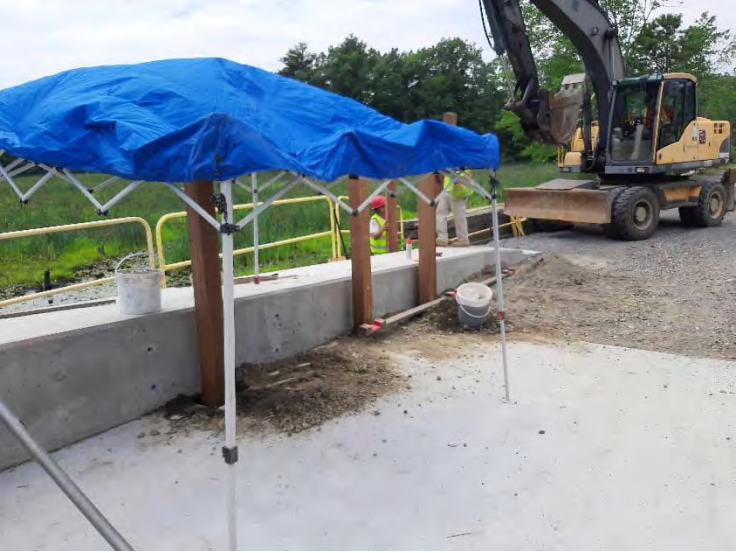
<p>PHOTOGRAPHIC LOG</p>	
<p>Client Name: Eversource</p>		<p>Site Location: Sudbury to Hudson Transmission Reliability Project</p>	<p>Town: Hudson</p>
<p>Photo No.: 7</p>	<p>Date: 7-15-24</p>

<p>Description:</p> <p>Work area at bridge 130, between segments #2 and #3, installing posts for bridge railings. Photograph on Segment #2 side, work conducted on both sides. Looking southward.</p>

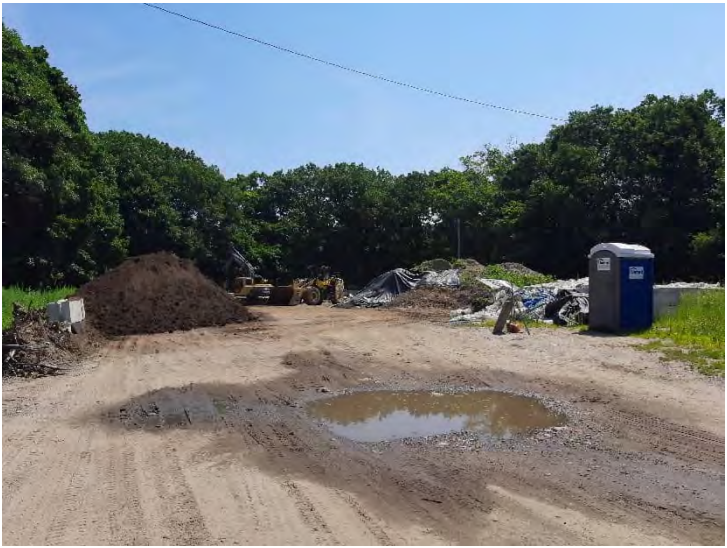
<p>PHOTOGRAPHIC LOG</p>	
<p>Client Name: Eversource</p>		<p>Site Location: Sudbury to Hudson Transmission Reliability Project</p>	<p>Town: Hudson</p>
<p>Photo No.: 8</p>	<p>Date: 7-15-24</p>

<p>Description:</p> <p>Stowe Court laydown yard, dust suppression and working around stockpiles, looking southward.</p>

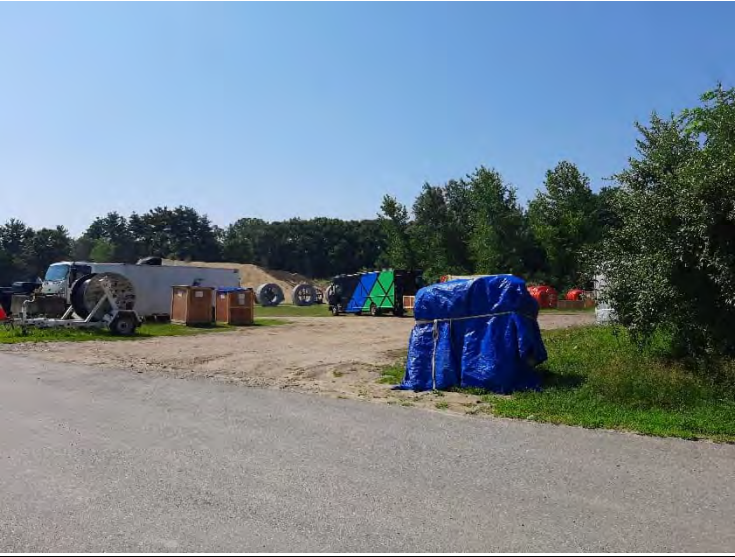
<p>PHOTOGRAPHIC LOG</p>	
<p>Client Name: Eversource</p>		<p>Site Location: Sudbury to Hudson Transmission Reliability Project</p>	<p>Town: Hudson</p>
<p>Photo No.: 7</p>	<p>Date: 7-15-24</p>

<p>Description:</p> <p>Activity and stored reels in Haugland laydown yard. Looking westward.</p>

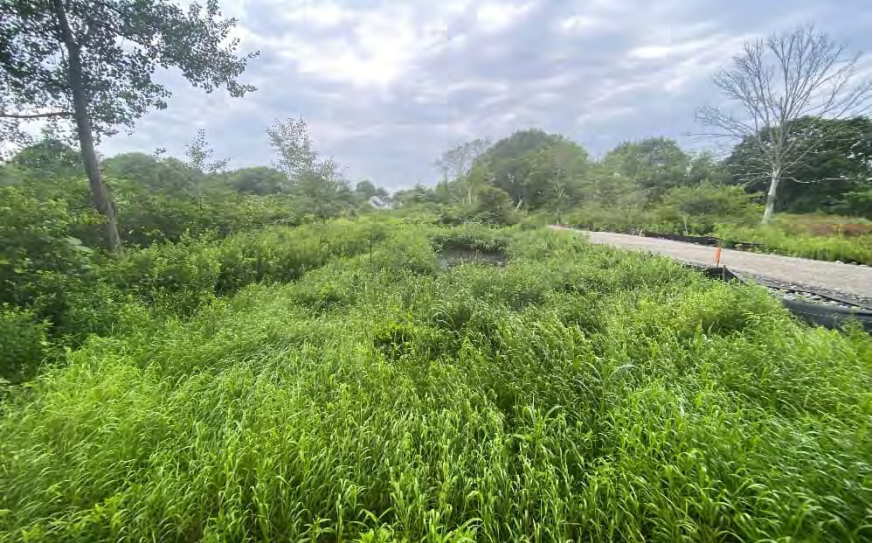
<p align="right">PHOTOGRAPHIC LOG</p>	
<p>Client Name: Eversource</p>		<p>Site Location: Sudbury to Hudson Transmission Reliability Project</p>	<p>Town: Sudbury</p>
<p>Photo No.: 1</p>	<p>Date: 7-15-24</p>

<p>Description:</p> <p>Wetland replication area within segment 14, existing erosion control, looking westward.</p>

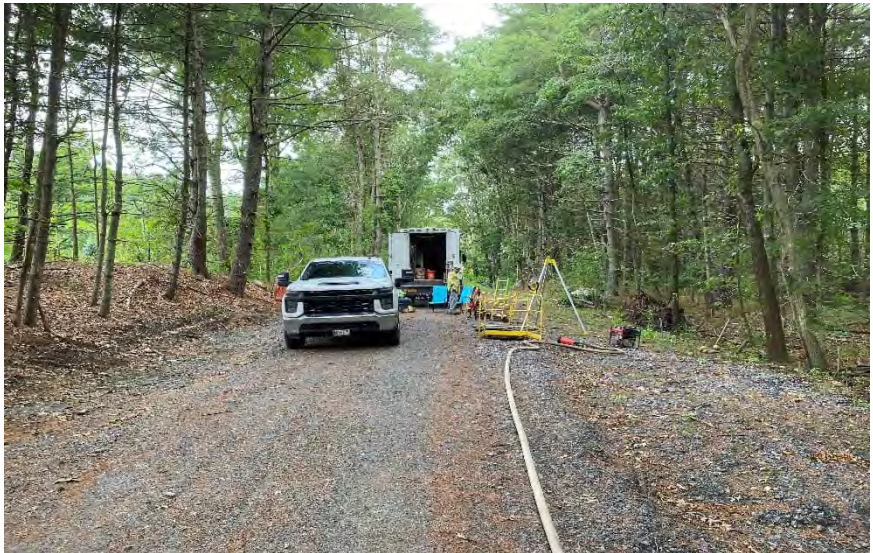
<p align="right">PHOTOGRAPHIC LOG</p>	
<p>Client Name: Eversource</p>		<p>Site Location: Sudbury to Hudson Transmission Reliability Project</p>	<p>Town: Sudbury</p>
<p>Photo No.: 2</p>	<p>Date: 7-15-24</p>

<p>Description:</p> <p>Work area within segment 8, manhole #17, splicing work, existing erosion control, looking westward.</p>

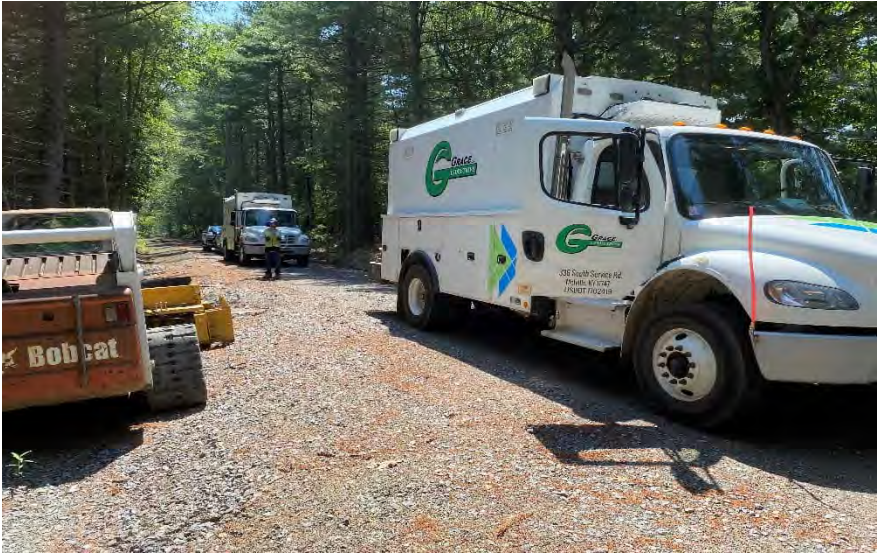
<p>PHOTOGRAPHIC LOG</p>	
Client Name: Eversource		Site Location: Sudbury to Hudson Transmission Reliability Project	Town: Sudbury
Photo No.: 3	Date: 7-15-24

<p>Description:</p> <p>Work area within segment 9, manhole #18, splicing work, existing erosion control, looking eastward.</p>

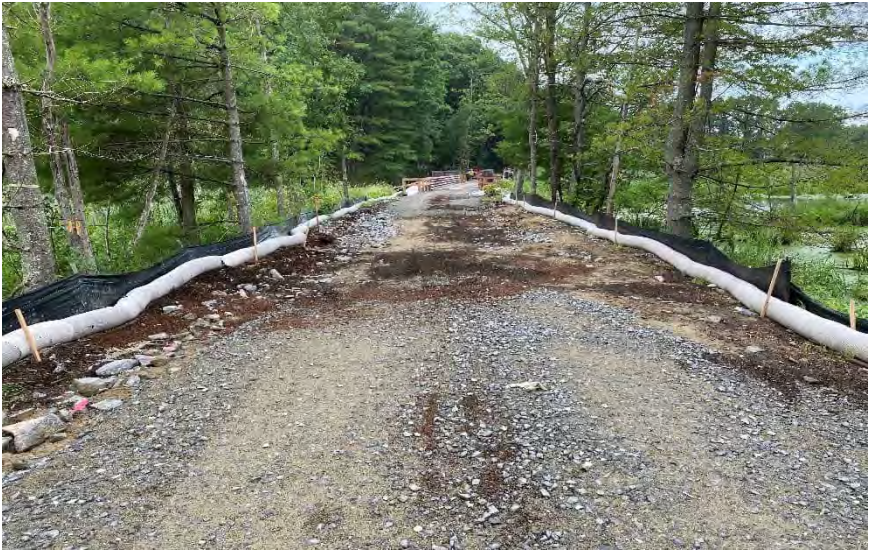
<p>PHOTOGRAPHIC LOG</p>	
Client Name: Eversource		Site Location: Sudbury to Hudson Transmission Reliability Project	Town: Sudbury
Photo No.: 4	Date: 7-15-24

<p>Description:</p> <p>Work area within segment 14, new compost filter tubes added, existing erosion control, looking eastward.</p>

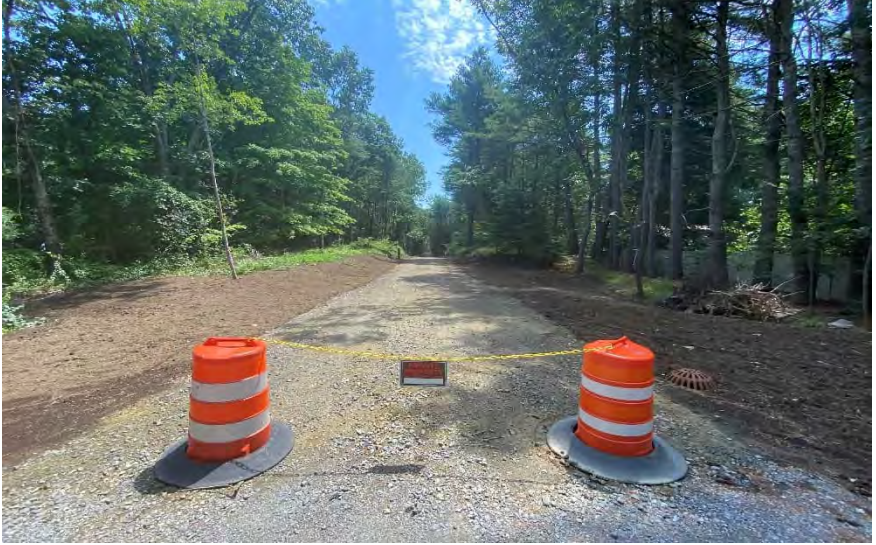
<p align="center">PHOTOGRAPHIC LOG</p>	
<p>Client Name: Eversource</p>		<p>Site Location: Sudbury to Hudson Transmission Reliability Project</p>	<p>Town: Sudbury</p>
<p>Photo No.: 5</p>	<p>Date: 7-15-24</p>

<p>Description:</p> <p>Work area within segment 10, recent loam added to shoulders, existing erosion control, looking eastward.</p>

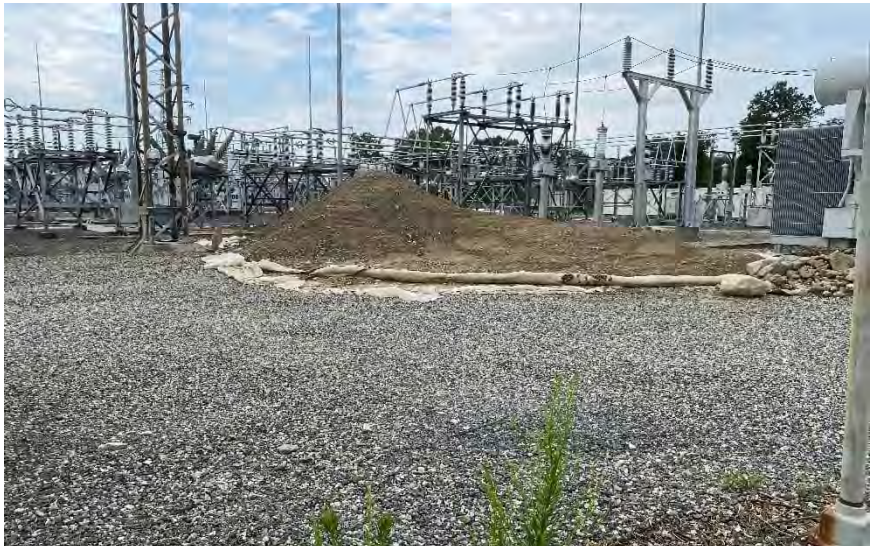
<p align="center">PHOTOGRAPHIC LOG</p>	
<p>Client Name: Eversource</p>		<p>Site Location: Sudbury to Hudson Transmission Reliability Project</p>	<p>Town: Sudbury</p>
<p>Photo No.: 6</p>	<p>Date: 7-15-24</p>

<p>Description:</p> <p>Work area within substation, newly placed spoil pile, existing erosion control (compost tubing), looking southward.</p>

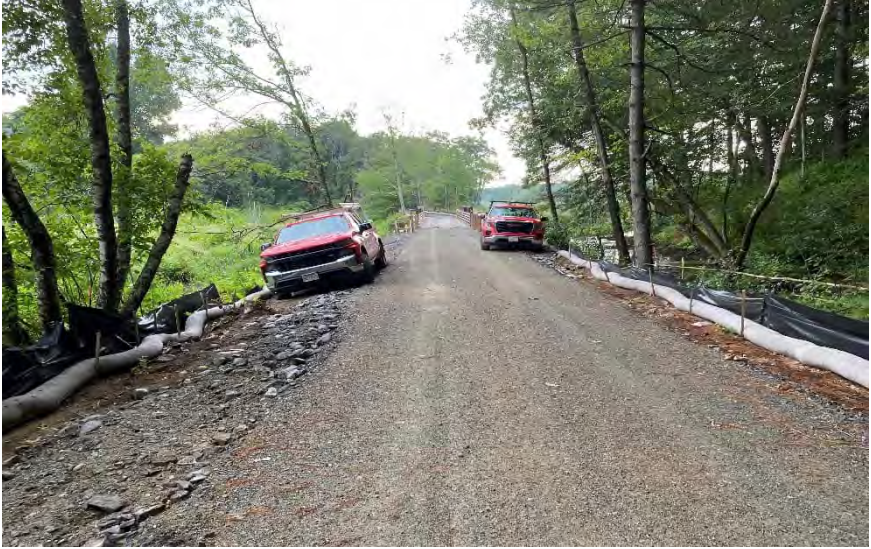
<p align="center">PHOTOGRAPHIC LOG</p>	
<p>Client Name: Eversource</p>		<p>Site Location: Sudbury to Hudson Transmission Reliability Project</p>	<p>Town: Sudbury</p>
<p>Photo No.: 7</p>	<p>Date: 7-15-24</p>

<p>Description:</p> <p>Work area within segment 13, bridge 127 work, existing erosion control, looking eastward.</p>

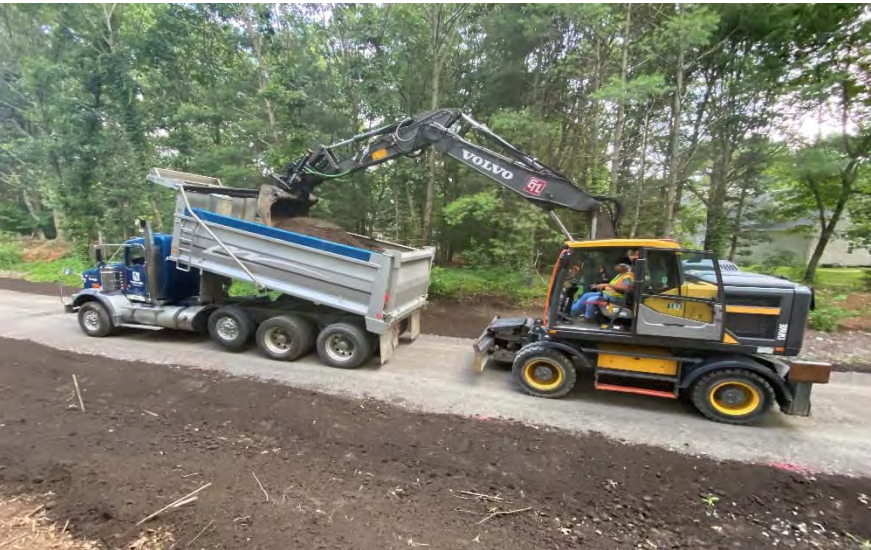
<p align="center">PHOTOGRAPHIC LOG</p>	
<p>Client Name: Eversource</p>		<p>Site Location: Sudbury to Hudson Transmission Reliability Project</p>	<p>Town: Sudbury</p>
<p>Photo No.: 8</p>	<p>Date: 7-15-24</p>

<p>Description:</p> <p>Work area within segment 11, loam being added to work area shoulders, existing erosion control, looking westward.</p>

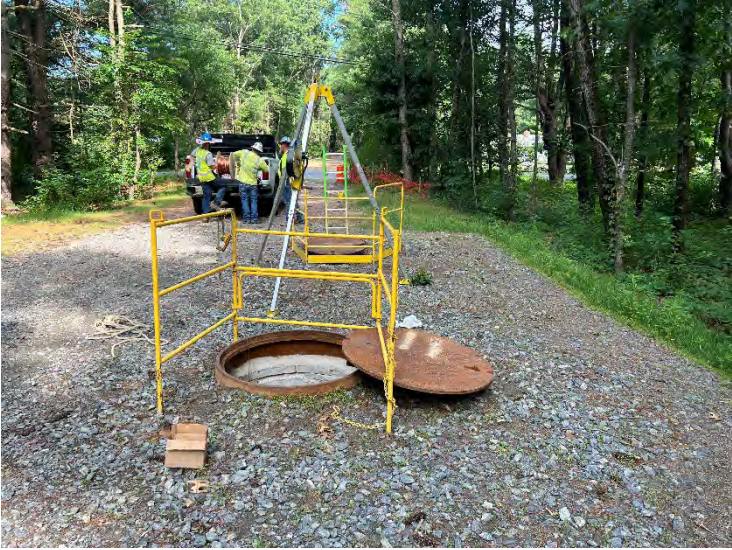
<p>PHOTOGRAPHIC LOG</p>	
<p>Client Name: Eversource</p>		<p>Site Location: Sudbury to Hudson Transmission Reliability Project</p>	<p>Town: Hudson</p>
<p>Photo No.: 1</p>	<p>Date: 7-17-24</p>

<p>Description:</p> <p>View of Haugland at MH #11 in segment 5 installing grounding. Facing west.</p>

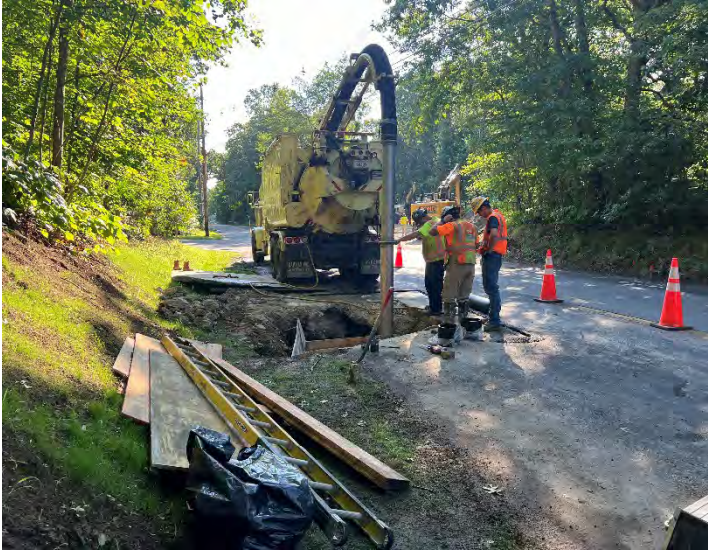
<p>PHOTOGRAPHIC LOG</p>	
<p>Client Name: Eversource</p>		<p>Site Location: Sudbury to Hudson Transmission Reliability Project</p>	<p>Town: Hudson</p>
<p>Photo No.: 2</p>	<p>Date: 7-17-24</p>

<p>Description:</p> <p>View of Bond trenching with vac truck on Wilkins Street by entrance to segment 1 for conduit repairs. Facing northeast.</p>

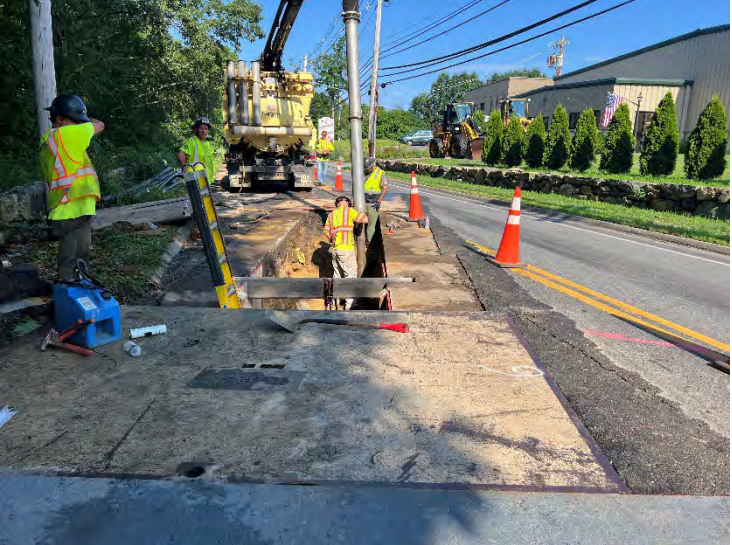
<p>Description: View of Bond work area on Forest Ave by MH #2. Facing west.</p>

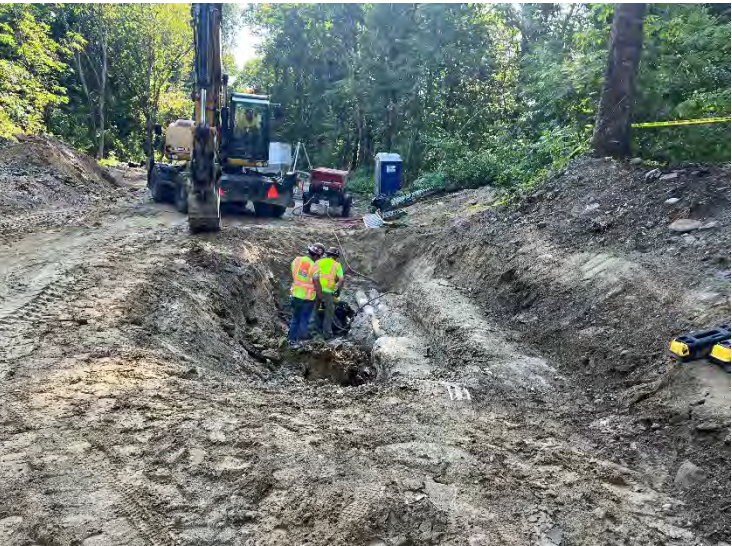
<p>Description: View of Bond work area in segment 1 by MH#5. Repairs to the conduit were made before proofing. Facing east.</p>

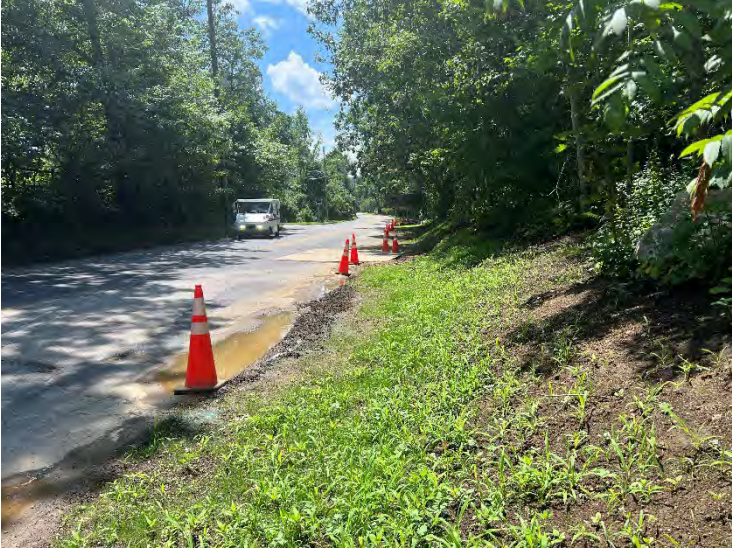
<p>Description:</p> <p>View of steel plates within Wilkins Street by entrance to segment 1. Roadway expected to be paved Friday 7/19/24. Facing southwest.</p>

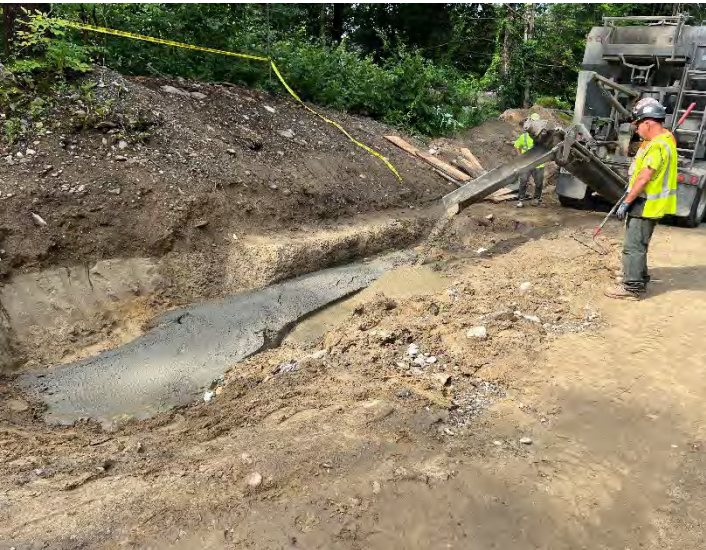
<p>Description:</p> <p>View of Bond backfilling trench in segment 1 by MH #5 with flowable fill. Conduit repairs have been completed. Facing southwest.</p>

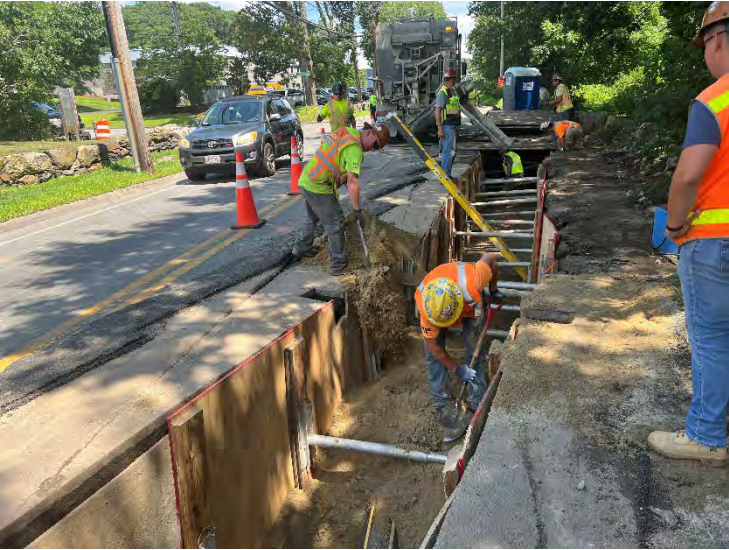
<p>Description:</p> <p>View of Bond work area on Forest Ave by MH #2. Pipe was installed and backfilled in a portion of the trench. Facing east.</p>

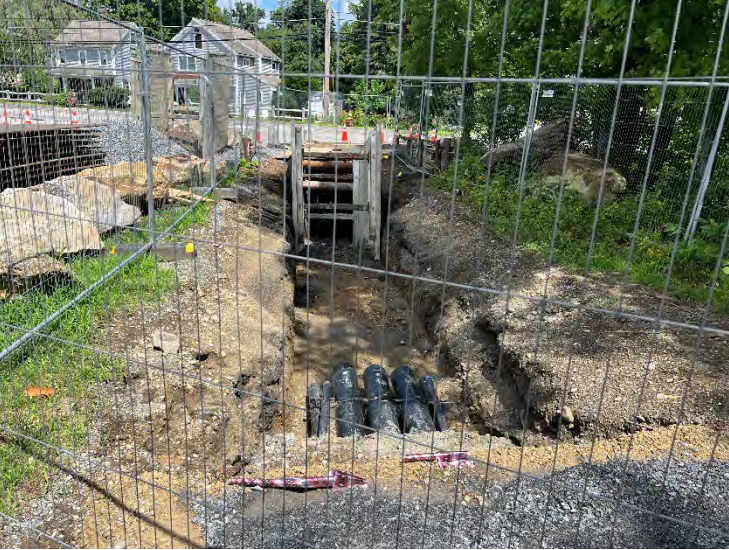
<p>Description:</p> <p>View of Bond work area by MH #1. No active construction in this area today. See additional dewatering report. Facing north.</p>

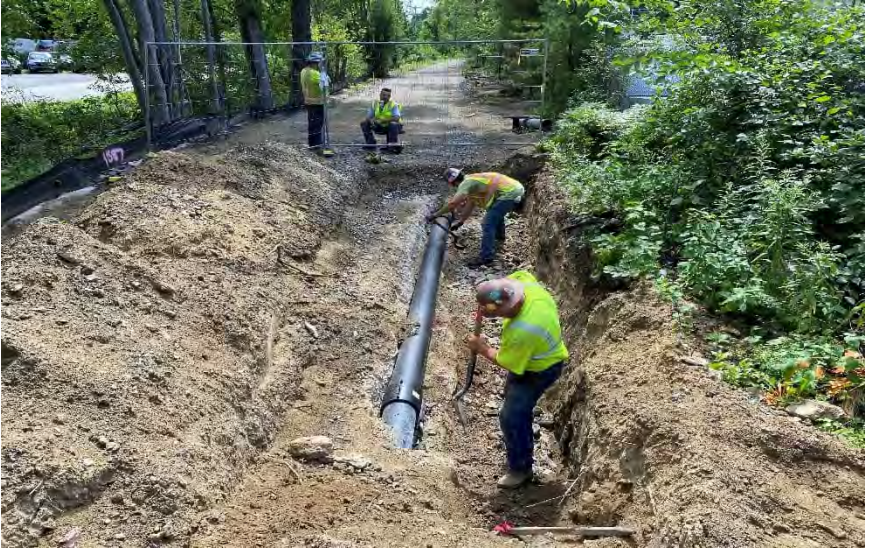
<p>Description:</p> <p>Work area within segment 12, preparation of trench for flow fill/concrete addition, existing erosion control, looking eastward.</p>

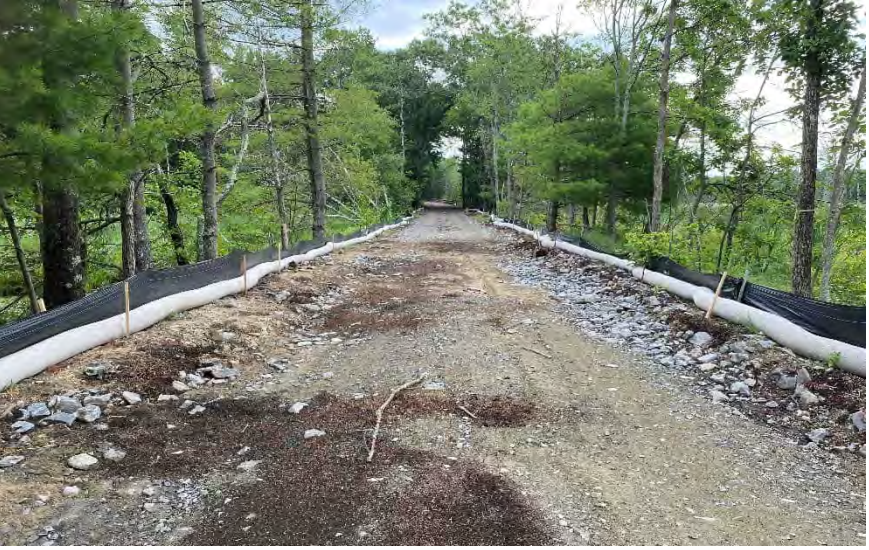
<p>Description:</p> <p>Work area within segment 14, new compost tubing added, existing erosion control, looking eastward.</p>

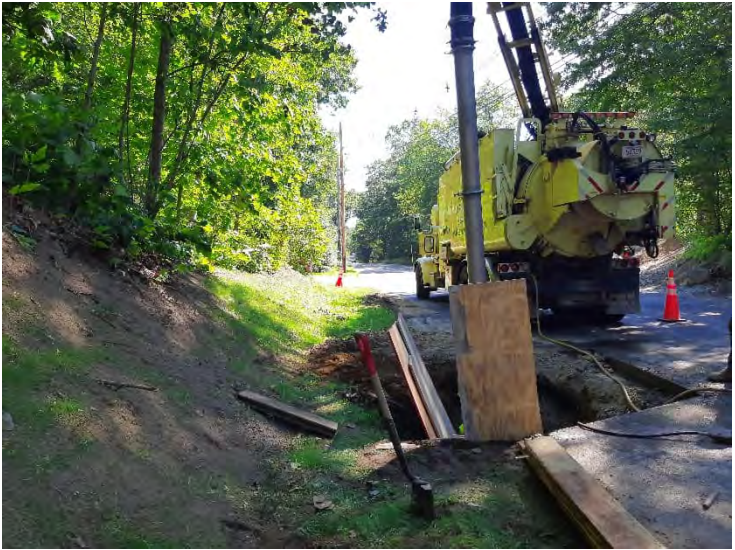
Description: Work area along west shoulder of Wilkins Street near MH #5, investigating conduit obstructions. Looking eastward.

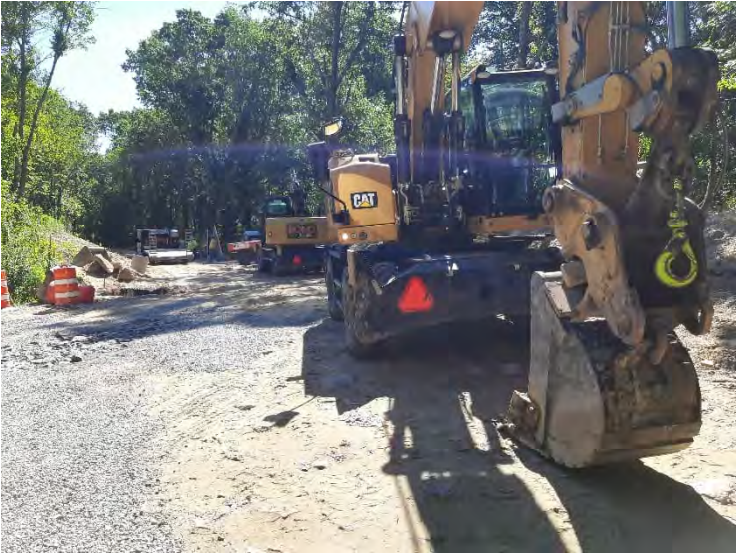
Description: Work area at MH #5 (segment 1), conduit clearing, looking eastward.

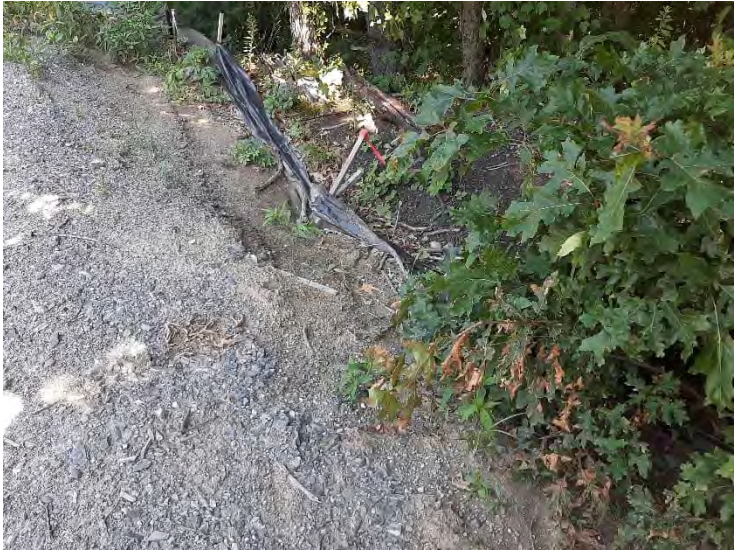
Description: Silt fence location in segment 1 requiring sediment clearing, near STA 125+50, north side of ROW. Previously misidentified as STA 99 due to grade stake labelling.

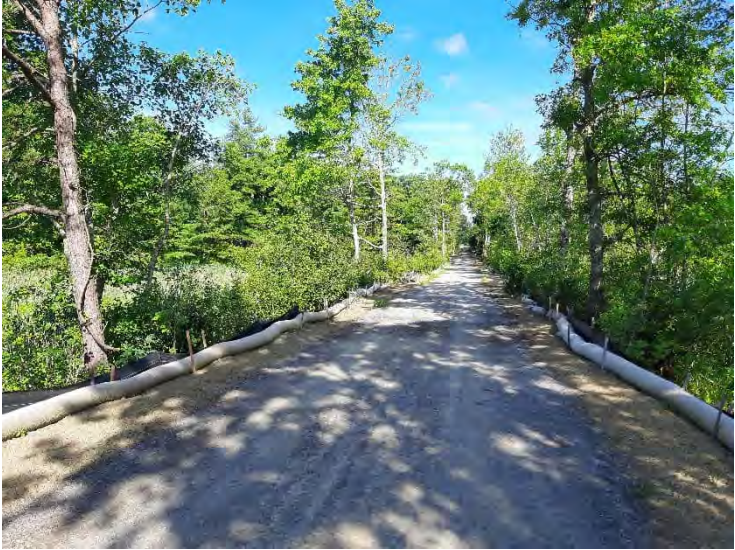
2. Silt Fencing on ROW within Hudson.	<input checked="" type="checkbox"/> Yes <input type="checkbox"/> No	N/A	<input type="checkbox"/> Yes <input checked="" type="checkbox"/> No	N/A	Silt fencing is installed within segments 1 - 6. E&S repairs in progress per full punch list that was submitted to project contractors. Silt fencing near STA 125 +50 in segment 1 partially toppled by sediment, excess sediment removal needed. This was previously misidentified as STA 99+00 due to grade stake labeling. Construction barrels atop silt fencing roughly near STA 122 in segment 2 have been removed.

Description: Segment 2 near Bridge 130, former location of routine maintenance with barrels atop silt fence on south (left) side. Confirmed barrels removed. Looking westward.

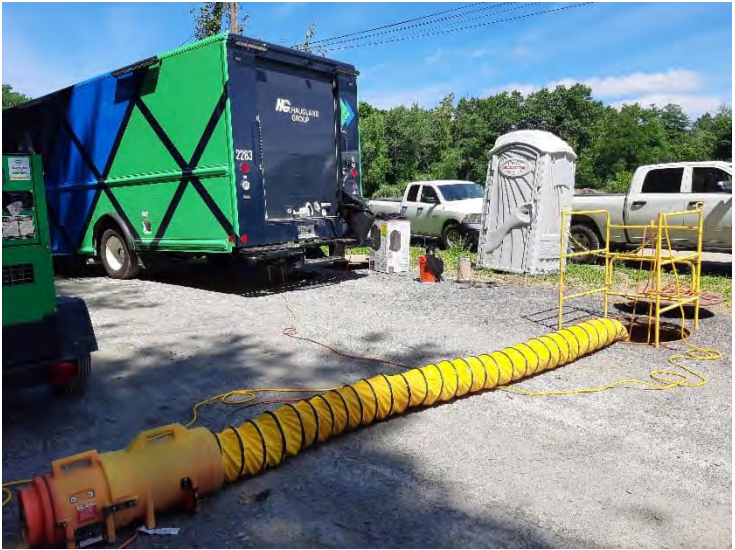
Description: Work area at MH #8 (segment 3), crimping and splicing, looking east. Dewatering required corral reassembly, turbidity monitoring conducted, turbidity < 50 NTUs.

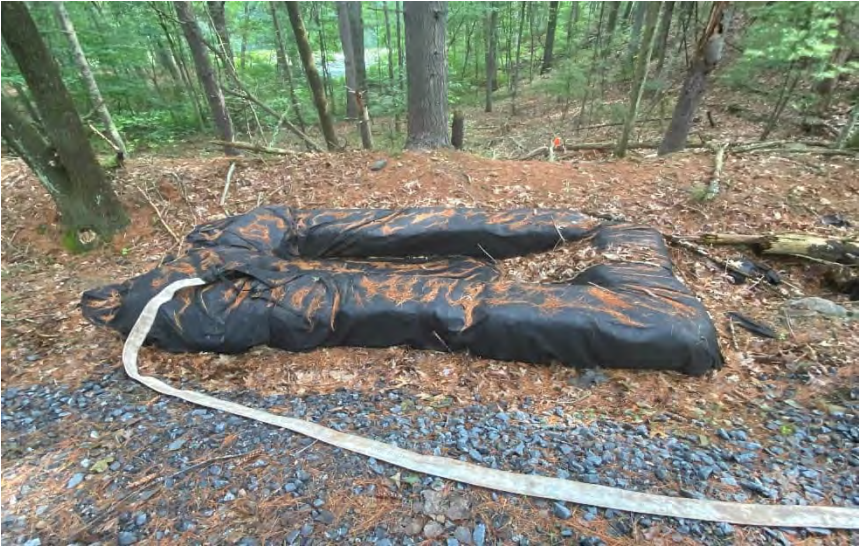
Description: Manhole #17. View of discharge bag/corral, looking westward. Water from bag/corral discharged to adjacent area.

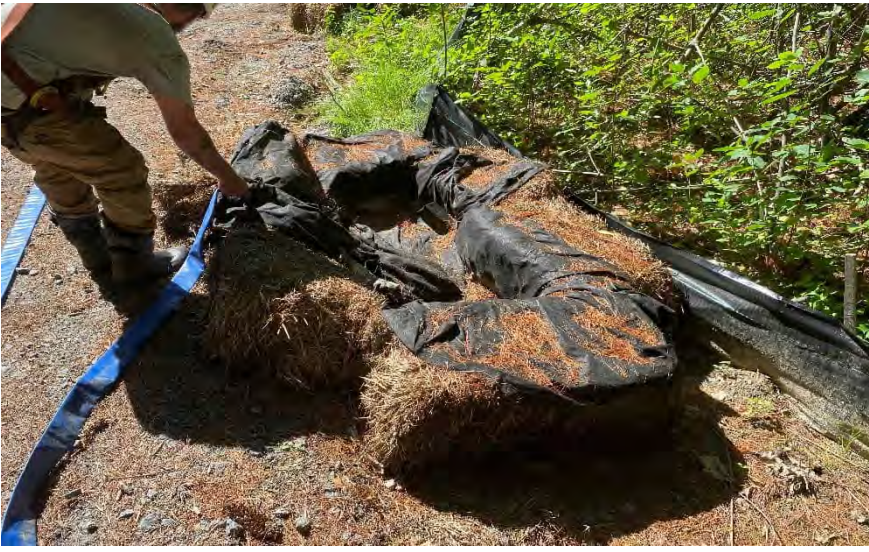
Description: Handhole #24. View of discharge bag/corral, looking eastward. Water from bag/corral discharged to adjacent area.

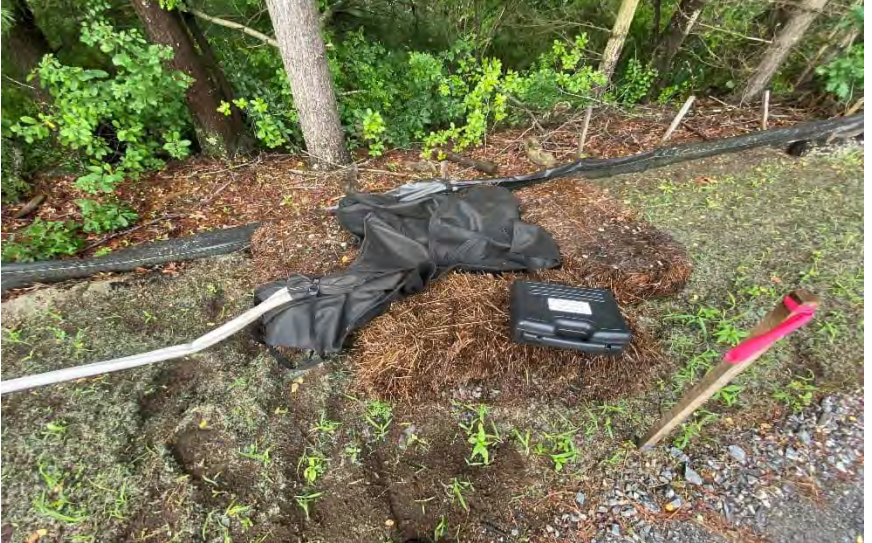
Description: Manhole #24. View of discharge bag/corral, looking westward. Water to bag/corral did not discharge to adjacent area.
