Weekly Environmental Compliance Summary

Sudbury to Hudson Transmission Reliability Project (USEPA Tracking # MAR1003UW)

Week of: July 22, 2024 to July 27, 2024

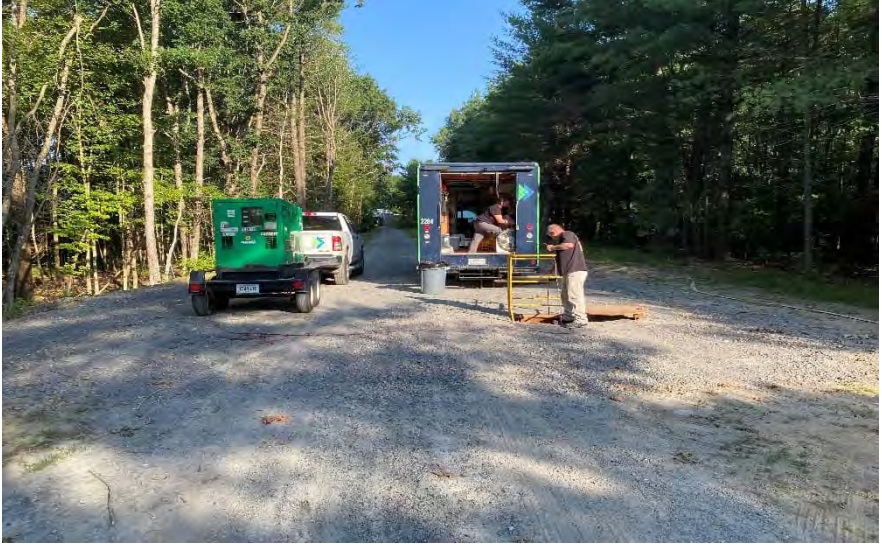
<p>PHOTOGRAPHIC LOG</p>	
<p>Client Name: Eversource</p>		<p>Site Location: Sudbury to Hudson Transmission Reliability Project</p>	<p>Town: Hudson</p>
<p>Photo No.: 7</p>	<p>Date: 7-22-24</p>

<p>Description:</p> <p>Work area within segment 2, manhole #7, clipping, existing erosion control, looking westward</p>

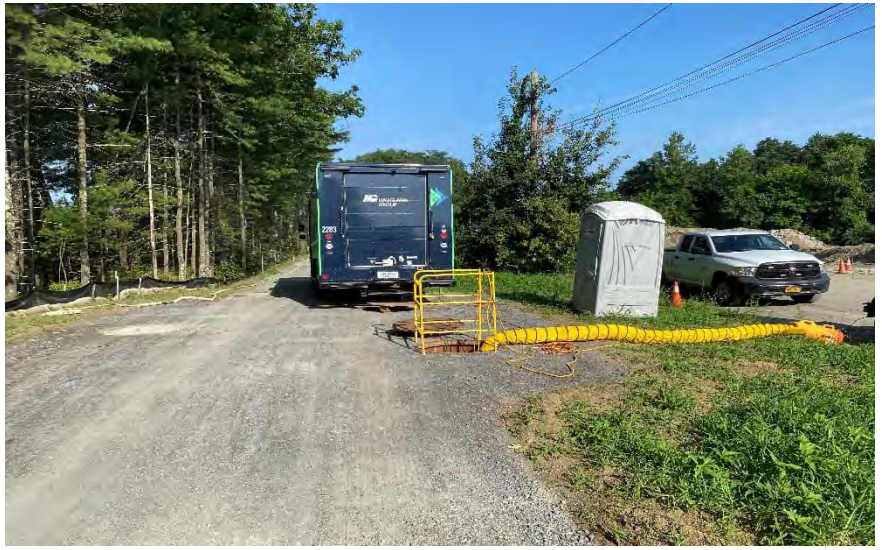
<p>PHOTOGRAPHIC LOG</p>	
<p>Client Name: Eversource</p>		<p>Site Location: Sudbury to Hudson Transmission Reliability Project</p>	<p>Town: Hudson</p>
<p>Photo No.: 8</p>	<p>Date: 7-22-24</p>

<p>Description:</p> <p>Work area within segment 3, manhole #8, clipping, existing erosion control, looking westward</p>

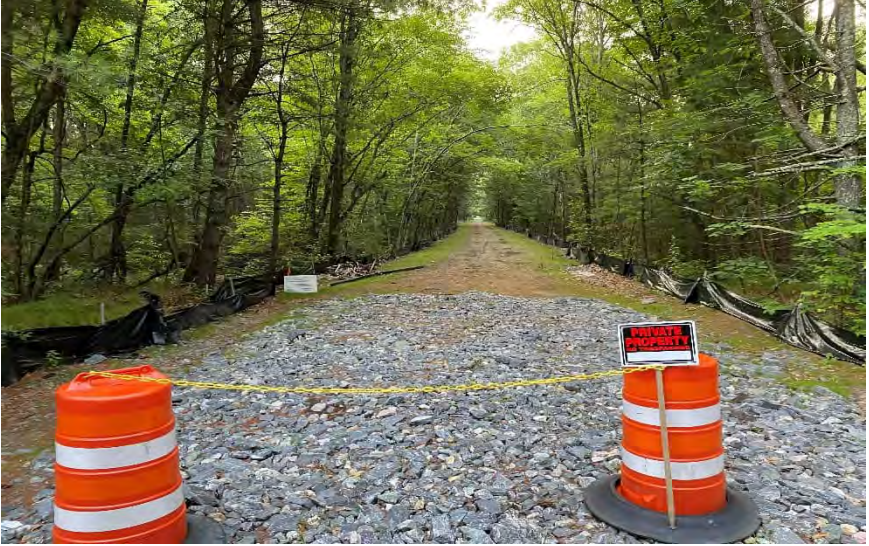
<p align="center">PHOTOGRAPHIC LOG</p>	
<p>Client Name: Eversource</p>		<p>Site Location: Sudbury to Hudson Transmission Reliability Project</p>	<p>Town: Hudson</p>
<p>Photo No.: 3</p>	<p>Date: 7-24-24</p>

<p>Description:</p> <p>Work area within segment 6, existing erosion control, looking eastward.</p>

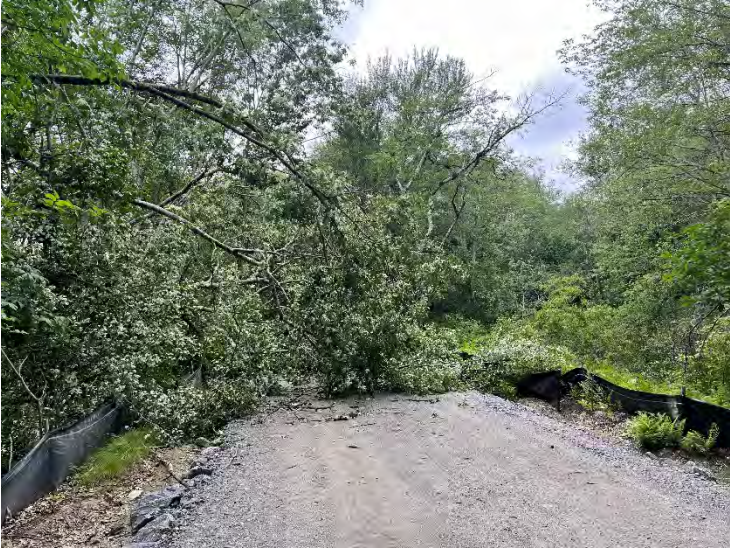
<p>PHOTOGRAPHIC LOG</p>	
<p>Client Name: Eversource</p>		<p>Site Location: Sudbury to Hudson Transmission Reliability Project</p>	<p>Town: Sudbury</p>
<p>Photo No.: 1</p>	<p>Date: 7/24/2024</p>

-Downed tree within segment 14 across ROW to be removed. Repairs to silt fencing will be needed. Sudbury Conservation Agent informed regarding tree removal. Meeting on site at downed tree tomorrow 7/25/24 at 10:00am with agent and crew members.

<p>Description: View of downed tree across ROW in segment 14. Silt fencing will be in need of repairs after tree removal. Facing west.</p>

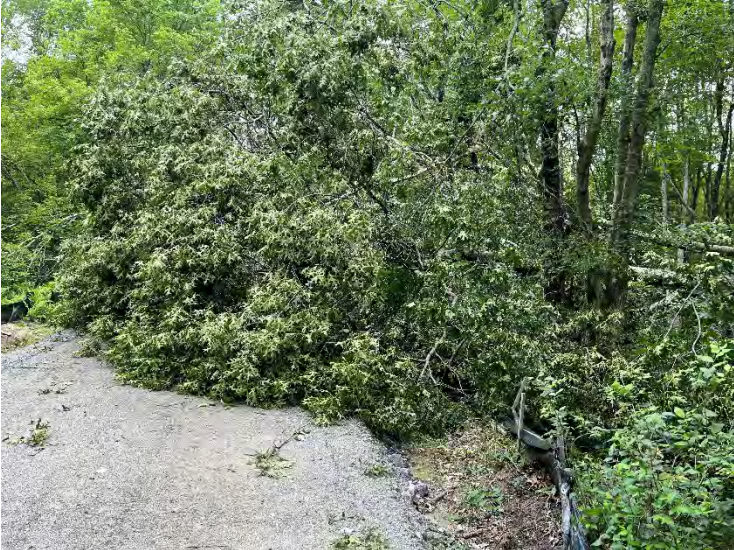
-Downed tree in segment 14 to be removed tomorrow, 7/27/24, by outsourced tree removal company. Repairs to silt fencing will be needed after tree is removed.

<p>Description: View of downed tree across ROW within segment 14. Tree to be removed 7/27/24. Repairs to silt fencing will be needed after tree removal. Facing east.</p>

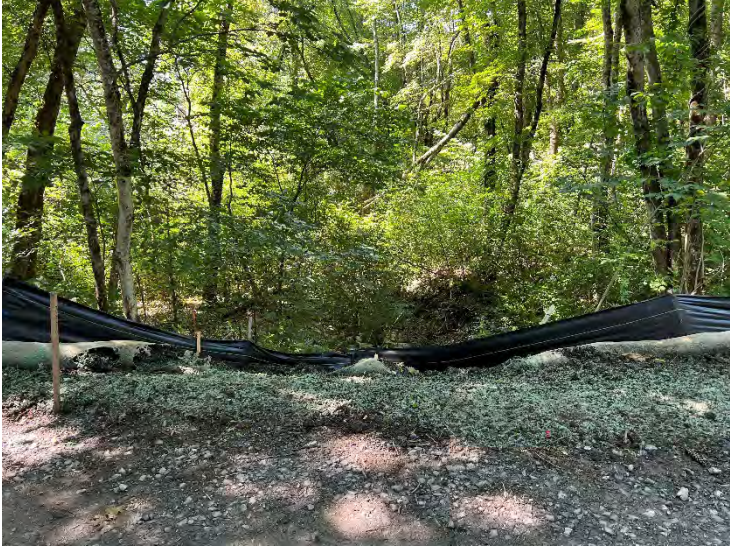
-Repairs need to silt fencing and tubing in segment 9 at Sta. # 518+00.

Description: View of repairs needed to erosion controls in segment 9 at Sta. # 518+00. Facing north.

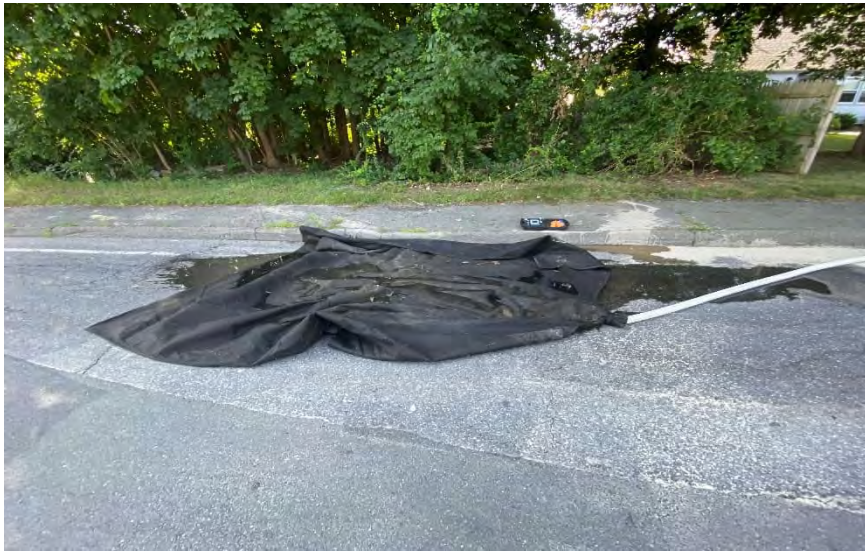
Description: Manhole #3. View of discharge bag/filter fabric barrier, looking eastward. Water from bag/filter fabric barrier discharged to underlying catch basin.

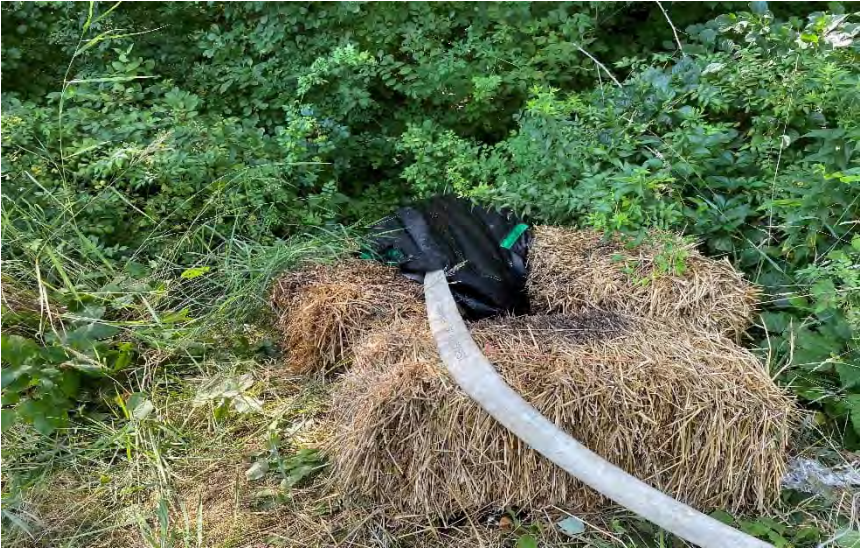
Description: Manhole #4. View of discharge bag/corral, looking westward. Water from bag/corral discharged to adjacent vegetated area.

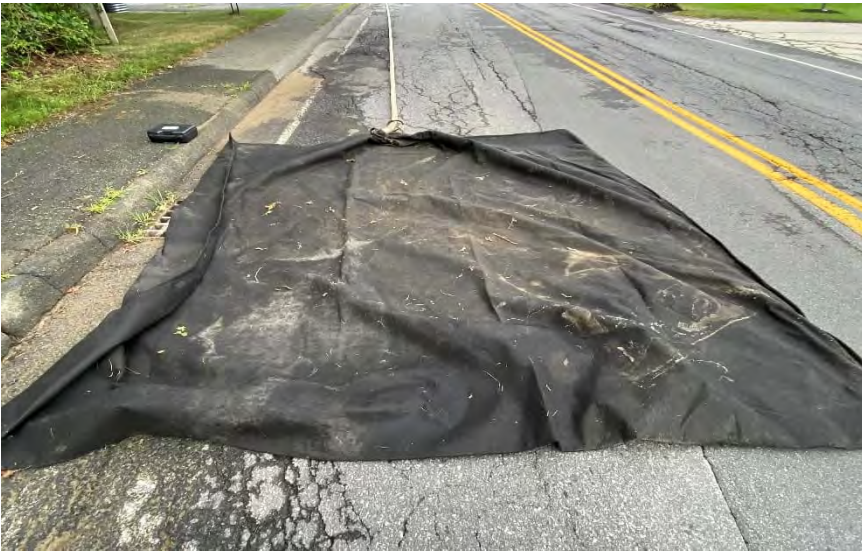
Description: Manhole #3. View of discharge bag/filter fabric barrier, looking northward. Water from bag/filter fabric barrier discharged to underlying catch basin.

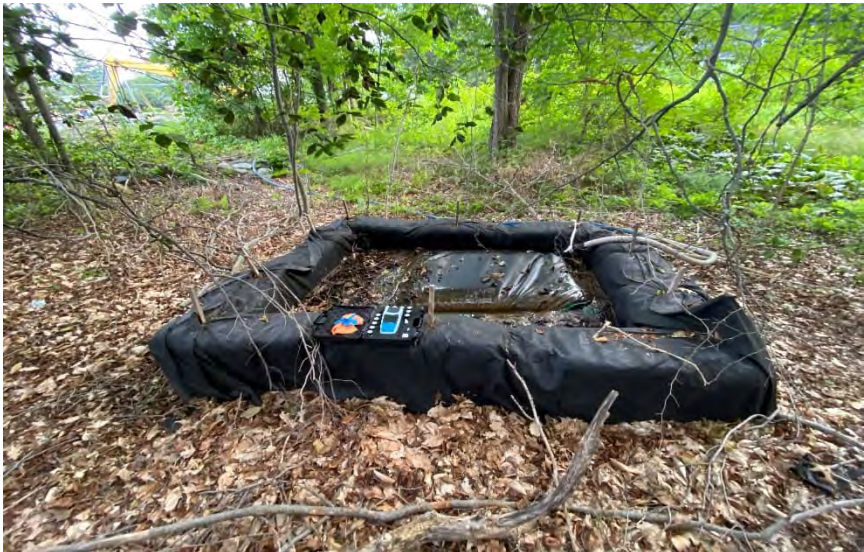
Description: Near manhole #1. View of discharge bag/corral, looking southward. Water from bag/corral did not discharge to adjacent area.

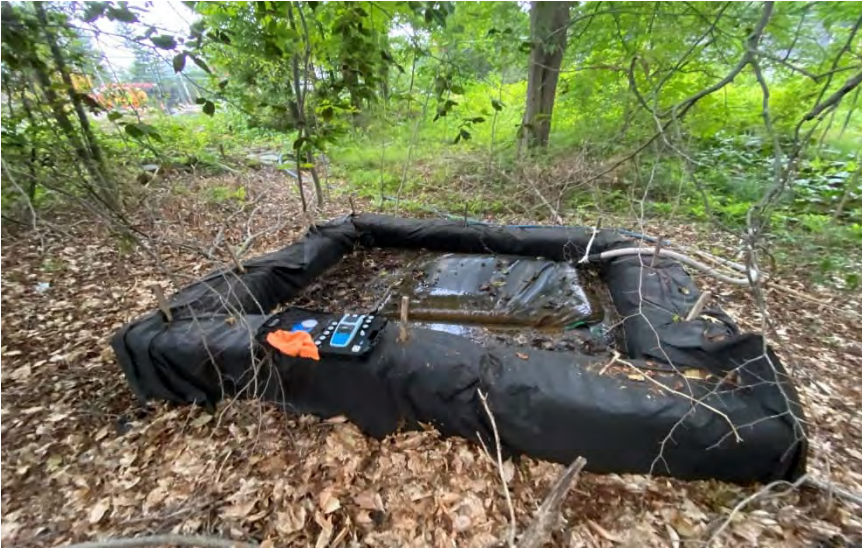
Description: Near manhole #1. View of discharge bag/corral, looking southward. Water from bag/corral did not discharge to adjacent area.

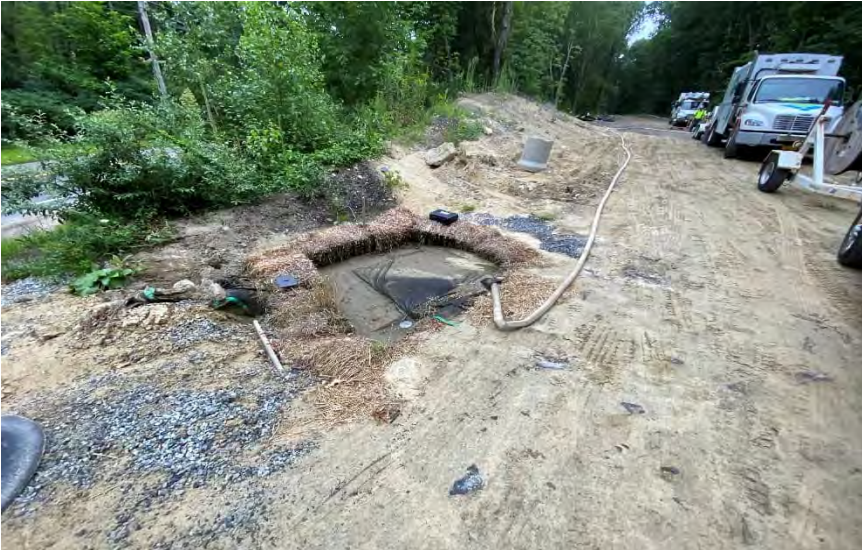
Description: Manhole #5. View of discharge bag/corral, looking eastward. Water to bag/corral did not discharge to adjacent area.
