Weekly Environmental Compliance Summary

Sudbury to Hudson Transmission Reliability Project (USEPA Tracking # MAR1003UW)

Sudbury, Hudson, and Stow, MA

Week of: August 19, 2024 to August 24, 2024

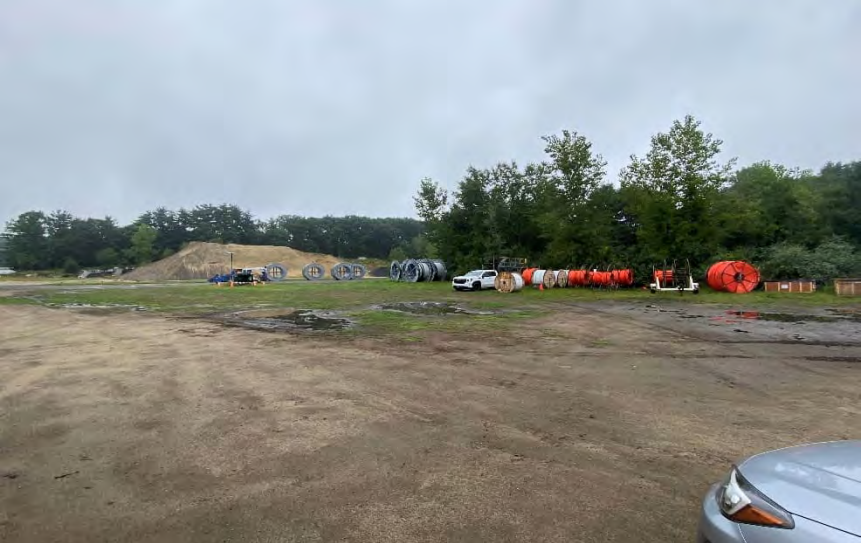
<p align="center">PHOTOGRAPHIC LOG</p>	
<p>Client Name: Eversource</p>		<p>Site Location: Sudbury to Hudson Transmission Reliability Project</p>	<p>Town: Hudson</p>
<p>Photo No.: 1</p>	<p>Date: 8-19-24</p>

<p>Description:</p> <p>Haugland laydown yard, stored wire on reels, looking westward.</p>

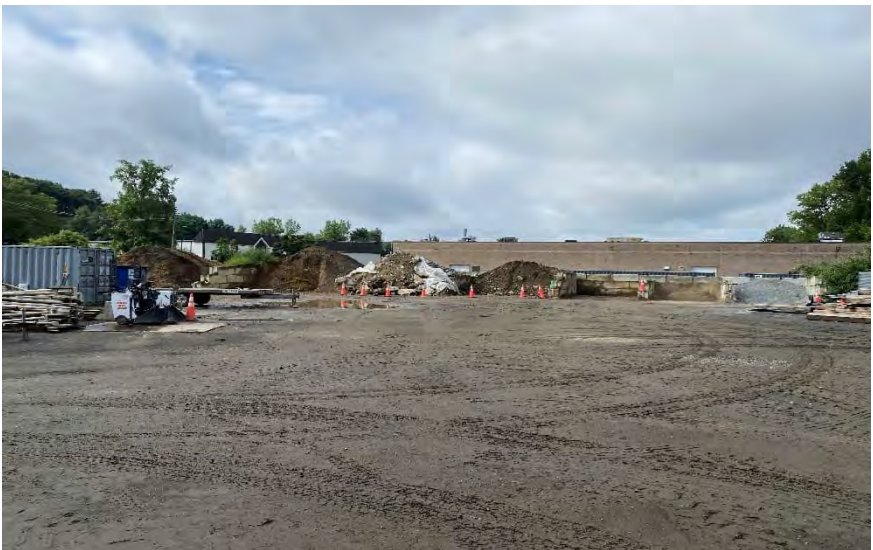
<p align="center">PHOTOGRAPHIC LOG</p>	
<p>Client Name: Eversource</p>		<p>Site Location: Sudbury to Hudson Transmission Reliability Project</p>	<p>Town: Hudson</p>
<p>Photo No.: 2</p>	<p>Date: 8-19-24</p>

<p>Description:</p> <p>Bonazzoli laydown yard, existing spoil piles, looking westward.</p>

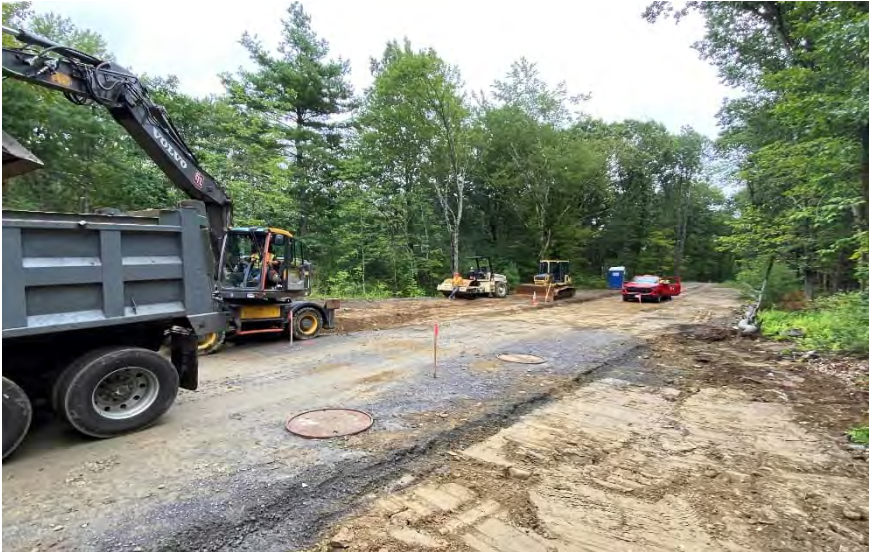
<p align="center">PHOTOGRAPHIC LOG</p>	
<p>Client Name: Eversource</p>		<p>Site Location: Sudbury to Hudson Transmission Reliability Project</p>	<p>Town: Hudson</p>
<p>Photo No.: 3</p>	<p>Date: 8-19-24</p>

<p>Description:</p> <p>Work area within Segment 1, site work, manhole #5, existing erosion control, looking eastward.</p>

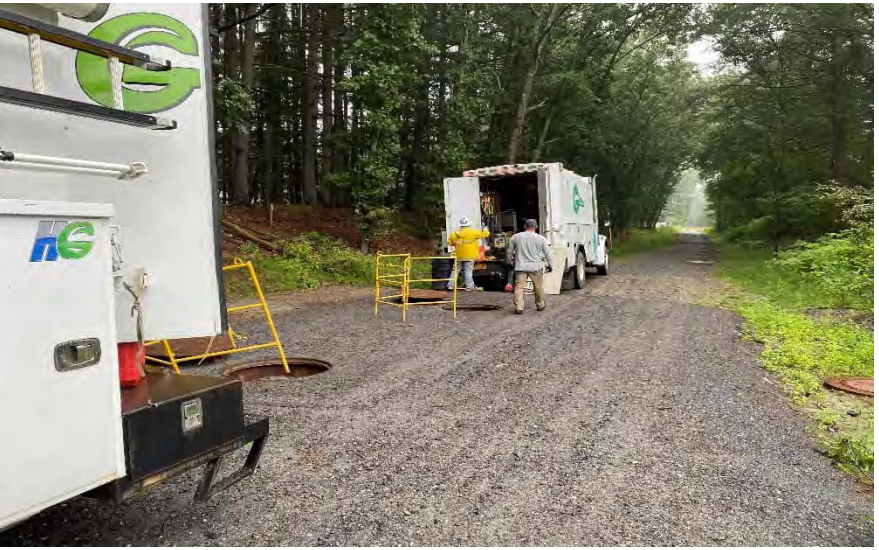
<p>PHOTOGRAPHIC LOG</p>	
<p>Client Name: Eversource</p>		<p>Site Location: Sudbury to Hudson Transmission Reliability Project</p>	<p>Town: Hudson</p>
<p>Photo No.: 6</p>	<p>Date: 8-19-24</p>

<p>Description:</p> <p>Work area within segment 3, manhole #9, splicing work, existing erosion control, looking westward.</p>

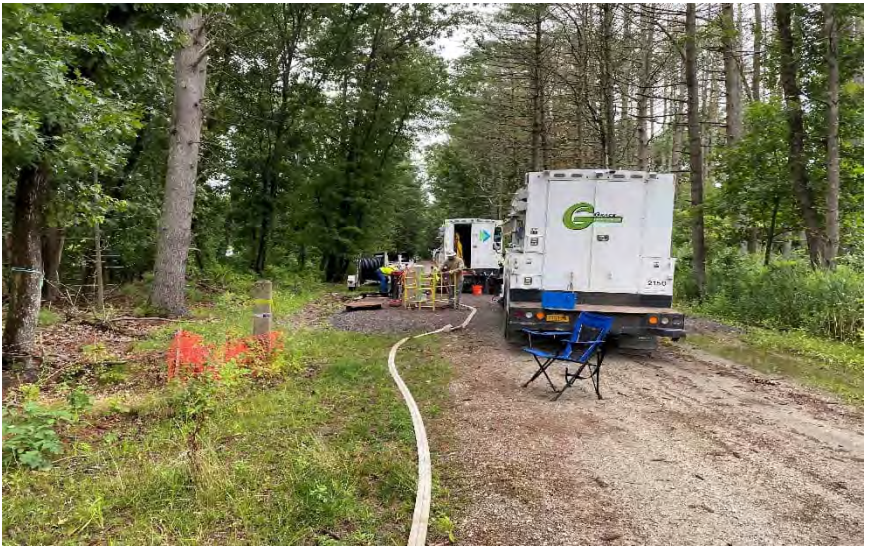
<p>PHOTOGRAPHIC LOG</p>	
<p>Client Name: Eversource</p>		<p>Site Location: Sudbury to Hudson Transmission Reliability Project</p>	<p>Town: Hudson</p>
<p>Photo No.: 6</p>	<p>Date: 8-20-24</p>

<p>Description:</p> <p>Work area within segment 4, manhole #10, splicing work, existing erosion control, looking westward.</p>

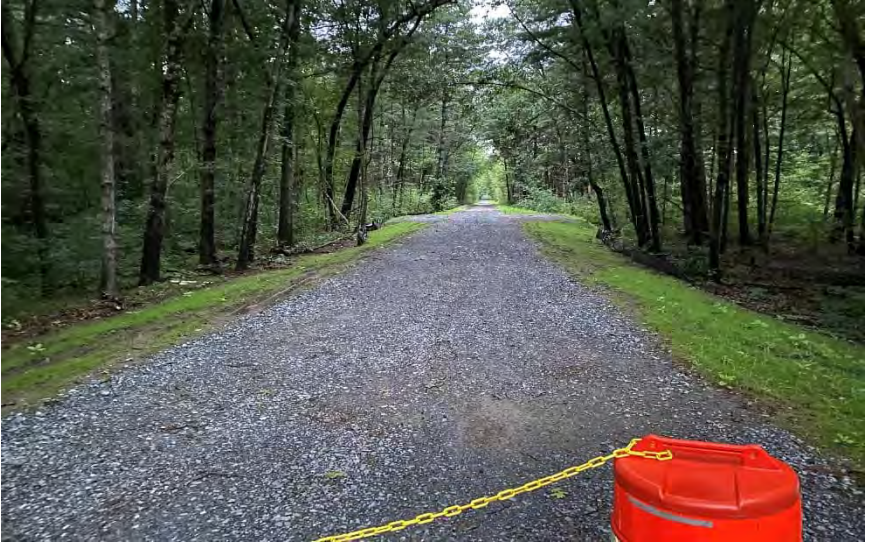
<p>PHOTOGRAPHIC LOG</p>	
<p>Client Name: Eversource</p>		<p>Site Location: Sudbury to Hudson Transmission Reliability Project</p>	<p>Town: Hudson</p>
<p>Photo No.: 7</p>	<p>Date: 8-20-24</p>

<p>Description:</p> <p>Work area within segment 5, existing erosion control, looking westward.</p>

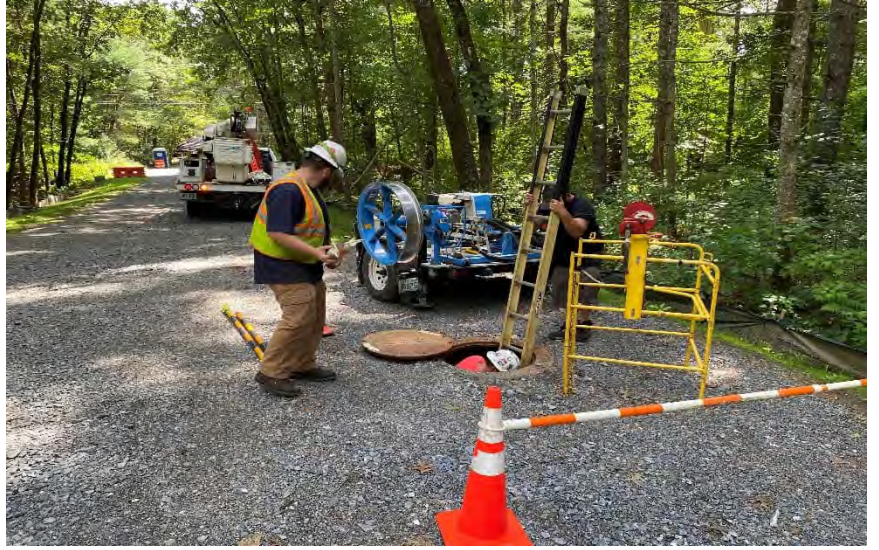
<p align="right">PHOTOGRAPHIC LOG</p>	
<p>Client Name: Eversource</p>		<p>Site Location: Sudbury to Hudson Transmission Reliability Project</p>	<p>Town: Hudson</p>
<p>Photo No.: 2</p>	<p>Date: 8-21-24</p>

<p>Description:</p> <p>New Wave working within segment 5, handhole #13, existing erosion control, looking eastward.</p>

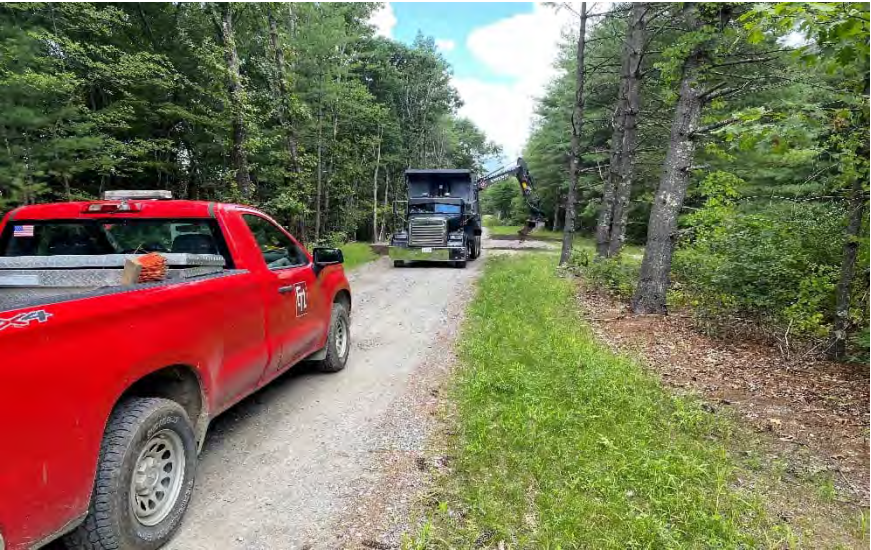
<p align="center">PHOTOGRAPHIC LOG</p>	
<p>Client Name: Eversource</p>		<p>Site Location: Sudbury to Hudson Transmission Reliability Project</p>	<p>Town: Hudson</p>
<p>Photo No.: 4</p>	<p>Date: 8-21-24</p>

<p>Description:</p> <p>Work area within segment 2, loam added to shoulders, looking westward.</p>

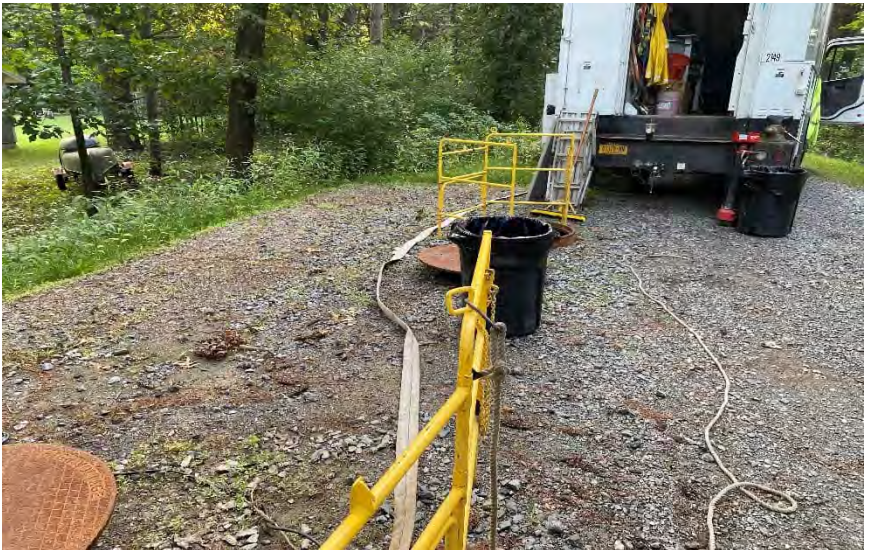
<p>PHOTOGRAPHIC LOG</p>	
<p>Client Name: Eversource</p>		<p>Site Location: Sudbury to Hudson Transmission Reliability Project</p>	<p>Town: Hudson</p>
<p>Photo No.: 6</p>	<p>Date: 8-21-24</p>

<p>Description:</p> <p>Work area within segment 5, manhole #11, splicing work, existing erosion control, looking eastward.</p>

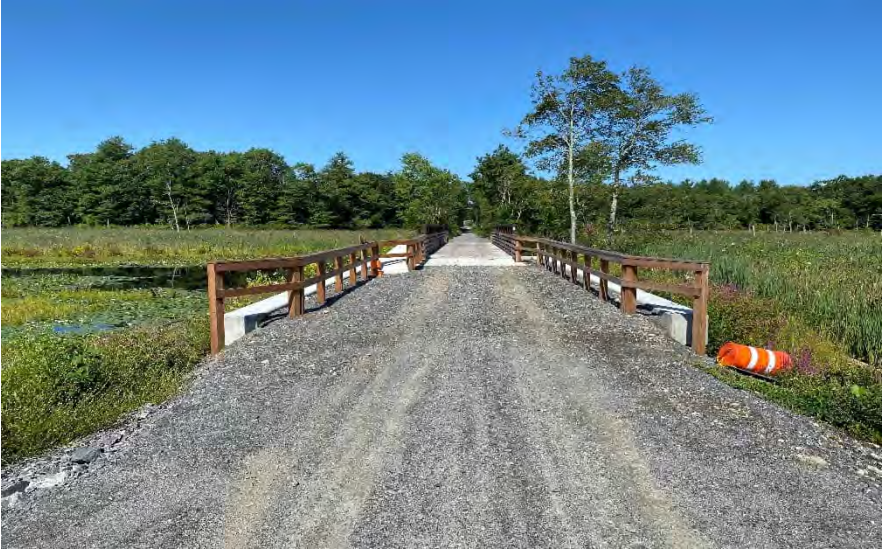
<p align="center">PHOTOGRAPHIC LOG</p>	
<p>Client Name: Eversource</p>		<p>Site Location: Sudbury to Hudson Transmission Reliability Project</p>	<p>Town: Hudson</p>
<p>Photo No.: 1</p>	<p>Date: 8-23-24</p>

<p>Description:</p> <p>Bridge 130, over Fort Meadow Brook, existing erosion control, looking westward.</p>

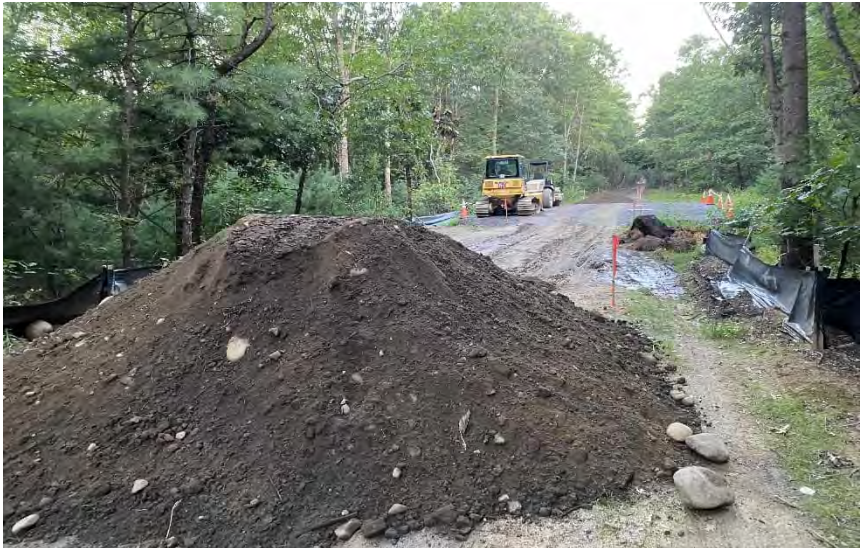
<p align="center">PHOTOGRAPHIC LOG</p>	
<p>Client Name: Eversource</p>		<p>Site Location: Sudbury to Hudson Transmission Reliability Project</p>	<p>Town: Hudson</p>
<p>Photo No.: 4</p>	<p>Date: 8-23-24</p>

<p>Description:</p> <p>Work area within segment 6, loam added to shoulders, looking westward.</p>

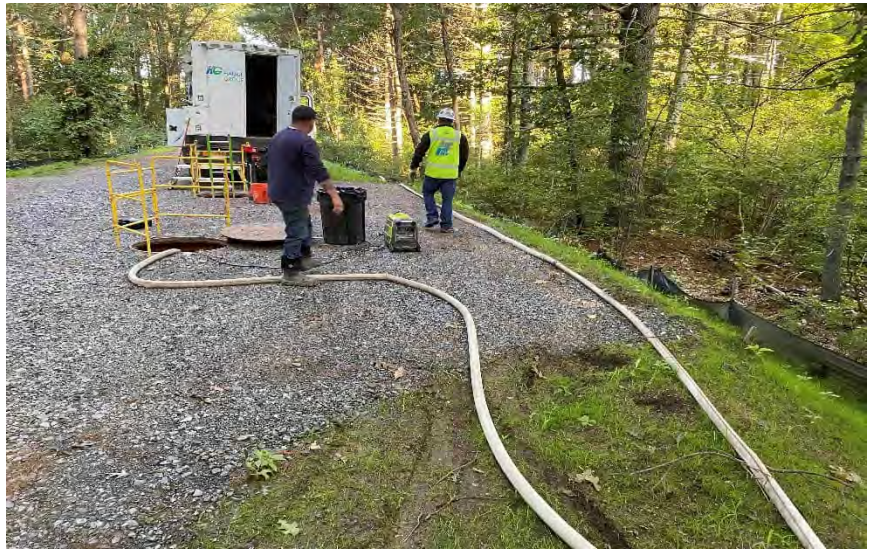
Description: Work area within segment 5, manhole #13, splicing work, existing erosion control, looking westward.

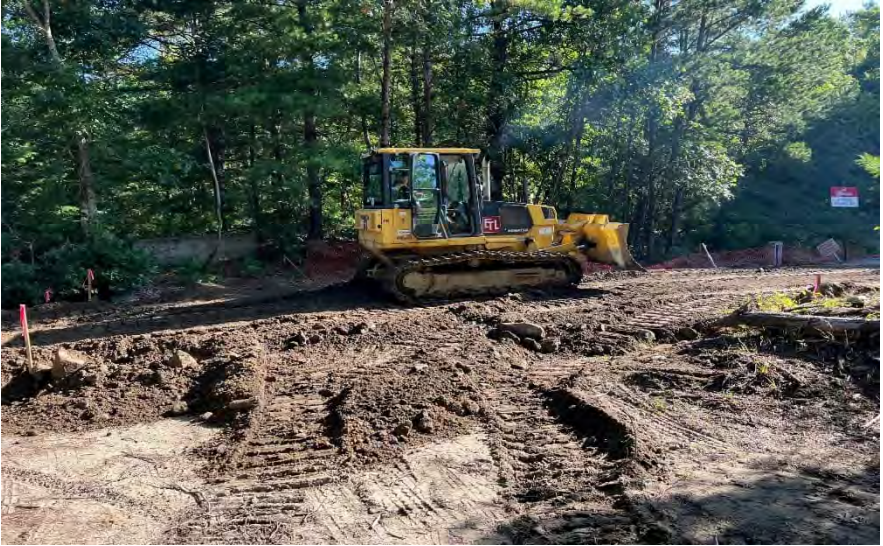
Description: Work area within segment 6, ET&L grading work, existing erosion control, looking southward.

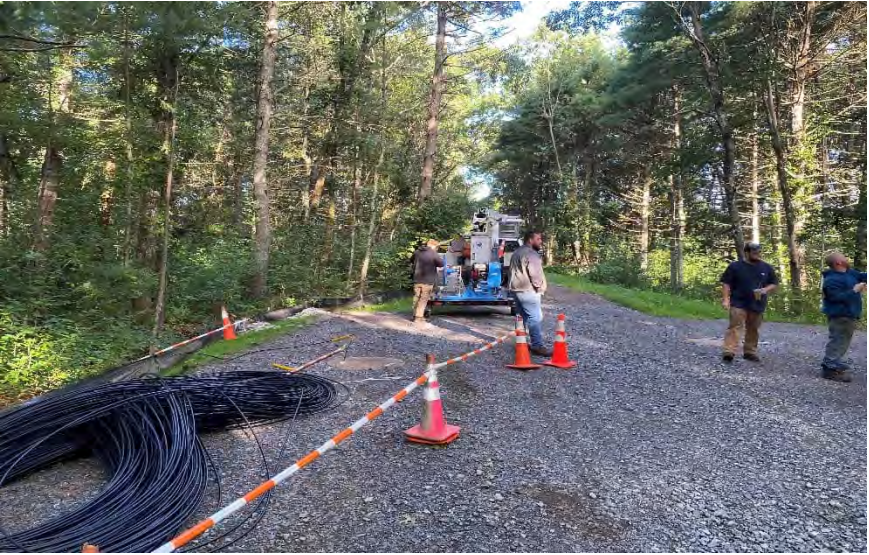
Description: Work area within segment 5, handhole #13, fiber optic work, existing erosion control, looking westward.

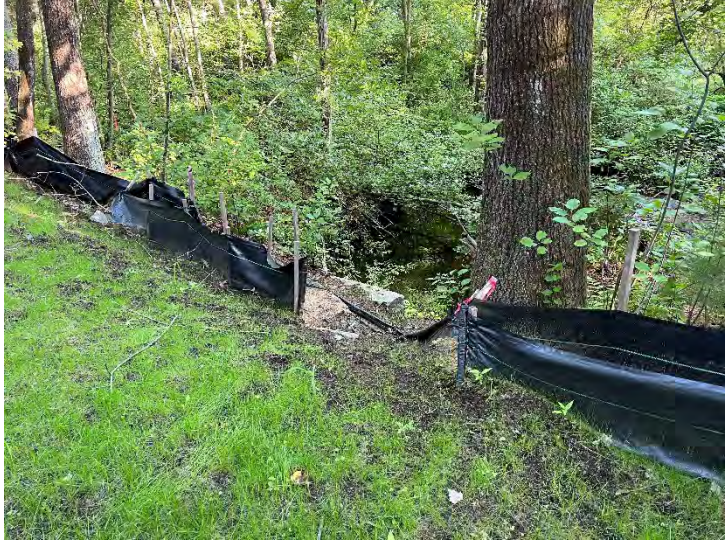
-Silt fencing in need of repairs in segment 10 at Sta. #540+00. Silt fencing has fallen down slope with sediment greater than half the height of the fencing.

Description: View of silt fencing in need of repairs in segment 10 at Sta. #540+00. Facing north.

- Silt fencing in need of repairs in segment 10 at Sta. #540+00. Silt fencing has fallen down slope with sediment greater than half the height of the fencing. Contractors are aware of the issue and will be addressing.

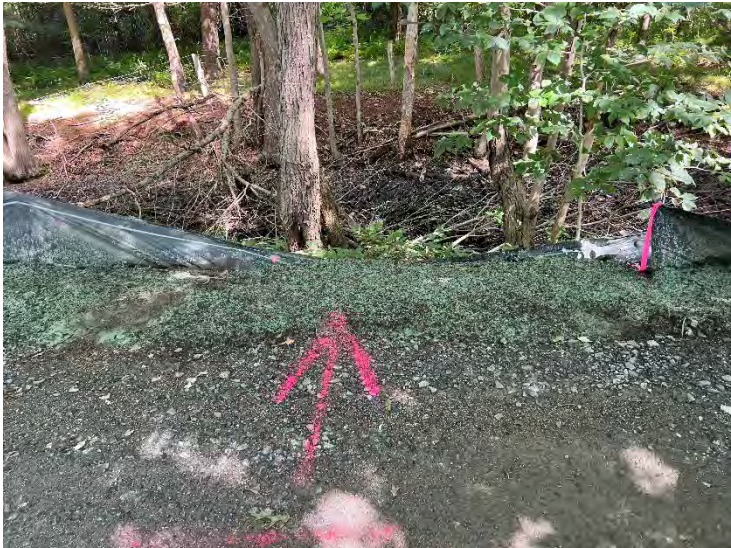
-Silt fencing at approximately Sta. #746+00 in segment 14 needs repairing. Loam operations has pushed back fencing with installed loam greater than half the height of the fencing.

Description: View of silt fencing in need of repairs in segment 14 at approximately Sta. #746+00. Facing north.

- Silt fencing at approximately Sta. #746+00 in segment 14 needs repairing. Loam operations has pushed back fencing with installed loam greater than half the height of the fencing. Contractors are aware of the issue and will be addressing.
