Client: Town of Sudbury
 Project Name: Sudbury-Hudson Transmission Reliability
 Inspector: Jeffrey Polidor
 Project No: 22012F
 Inspection Date: 8/09/24 Arrival Time: 11:00 AM
 Weather: Light Rain, 75°F Departure Time: 2:00 PM

Sudbury to Hudson
 115kV Underground Transmission Line
 Sudbury - Hudson, MA
 Date: November 16, 2018

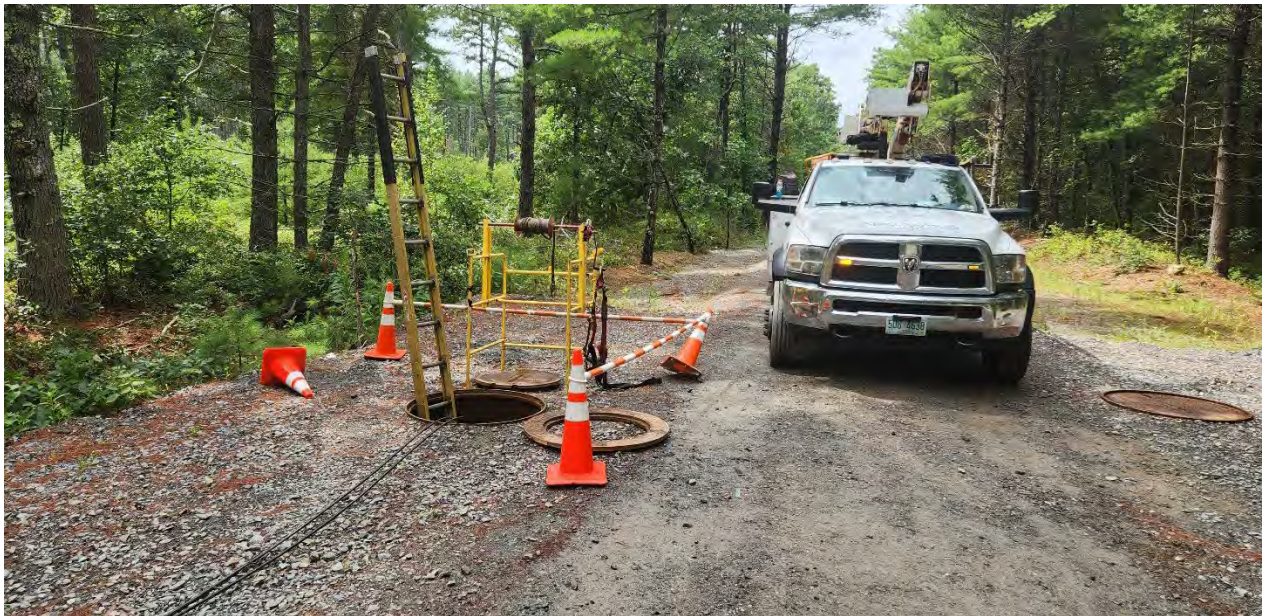
Photo 1: Cable pulling along segment 7.
Photo taken on 8/09/24

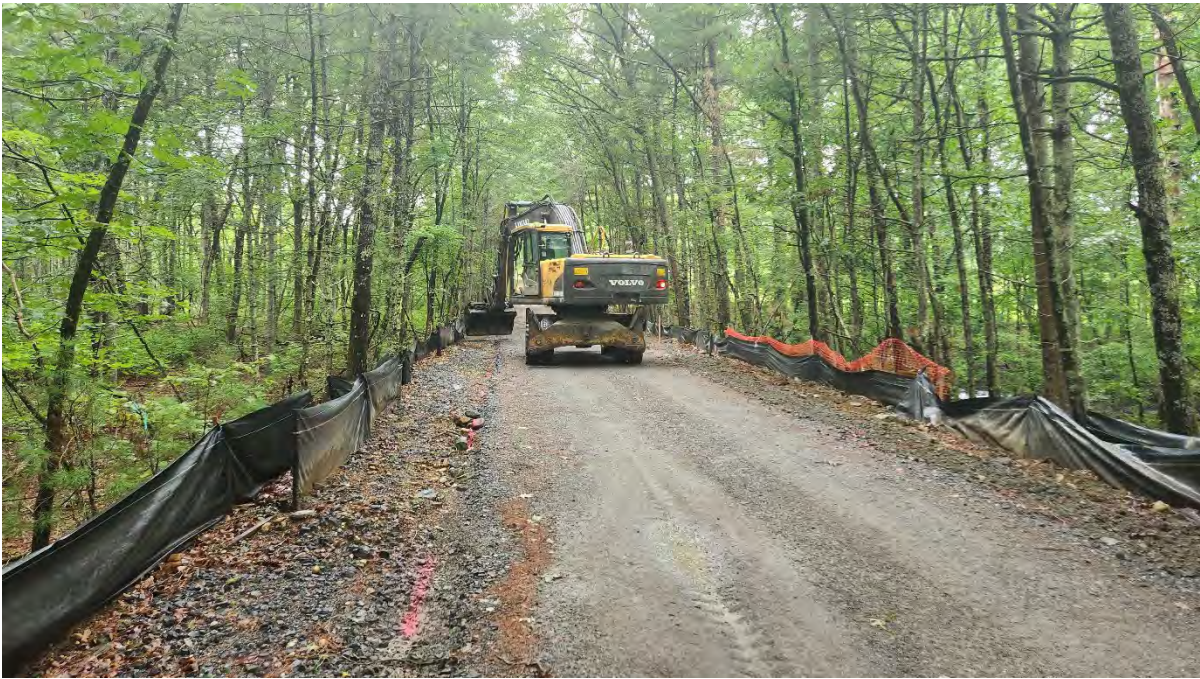
Photo 2: Grading conducted along segment 8.
Photo taken on 8/09/24

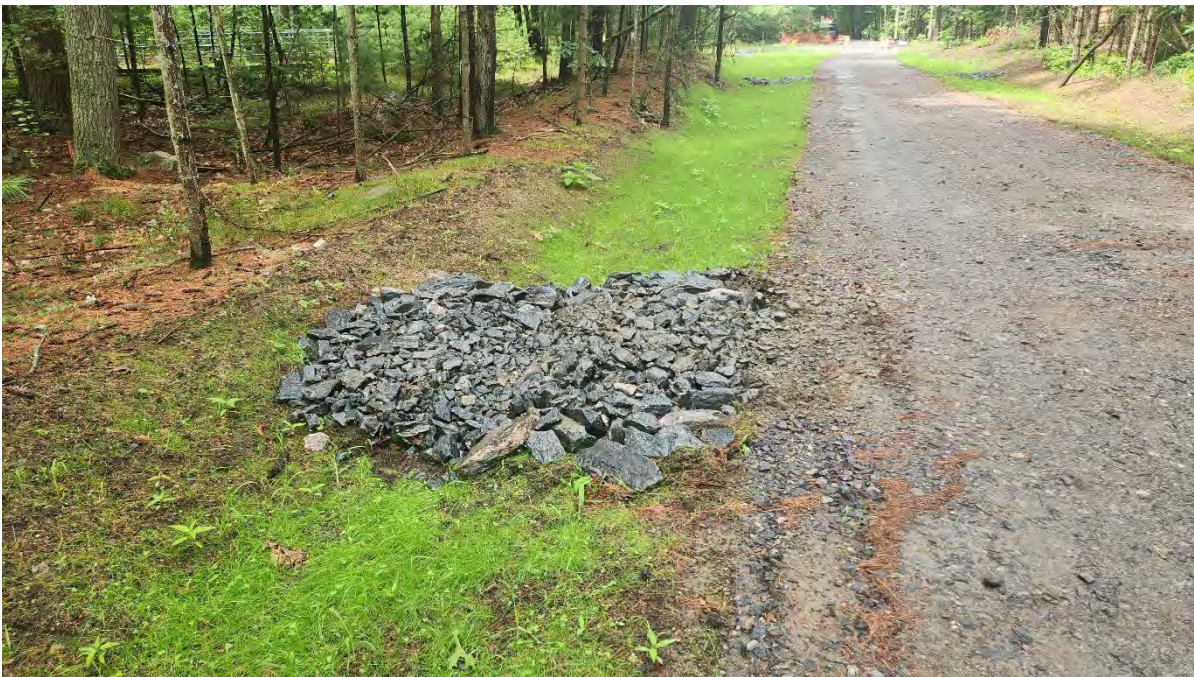
Photo 3: Gravel check dams installed along segment 9.
Photo taken on 8/09/24

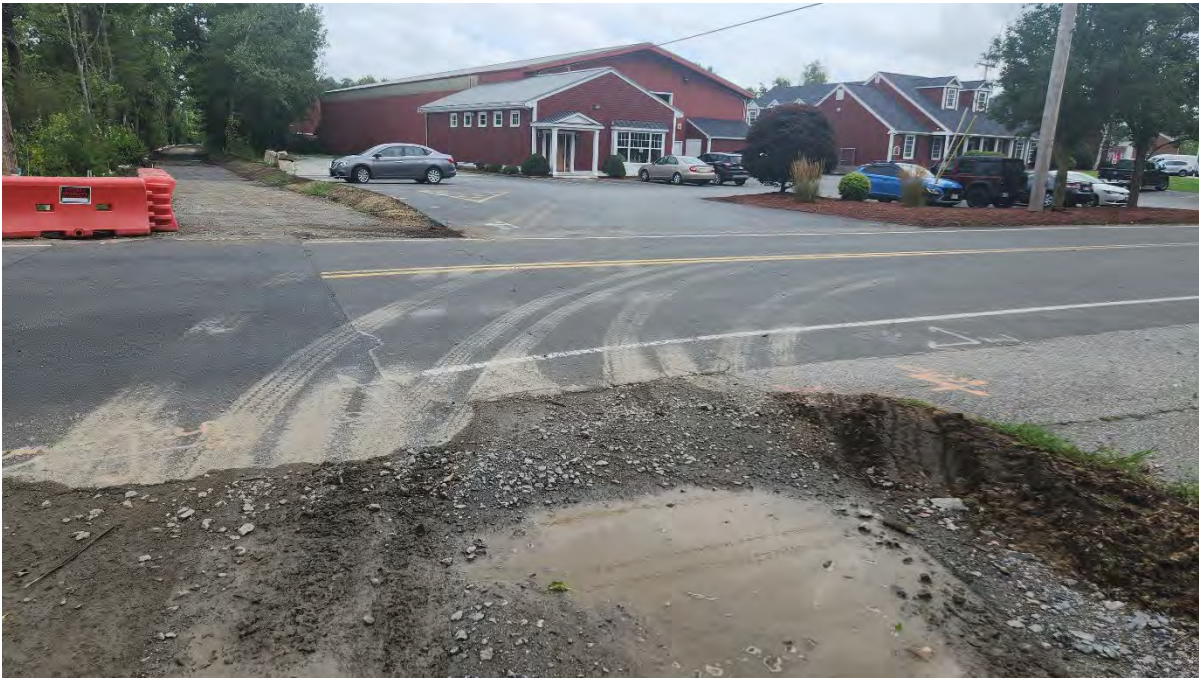
Photo 4: Sediment tracked into the road at construction entrance STA 407+50.
Photo taken on 8/09/24

1. Repair silt fence and filter tube as noted above.
2. Clear sediment from the street at construction entrance STA 407+50 and refresh gravel if necessary

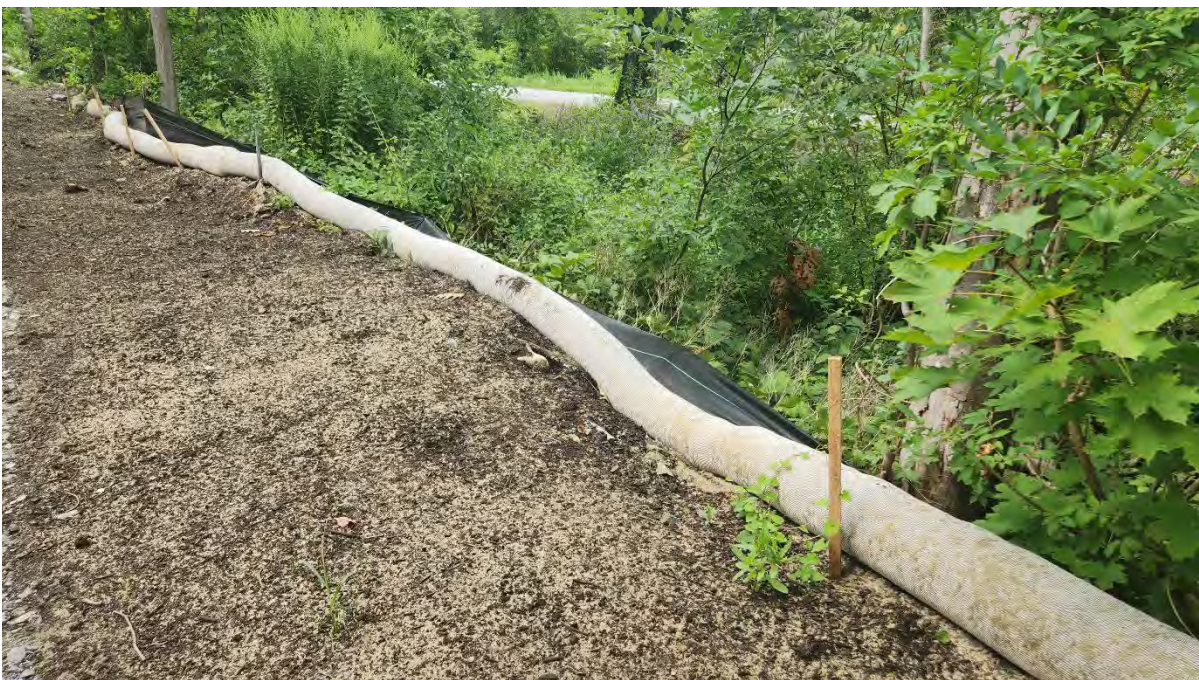
Photo 5: Broken stakes found in the silt fence along segment 12.
Photo taken on 8/09/24.

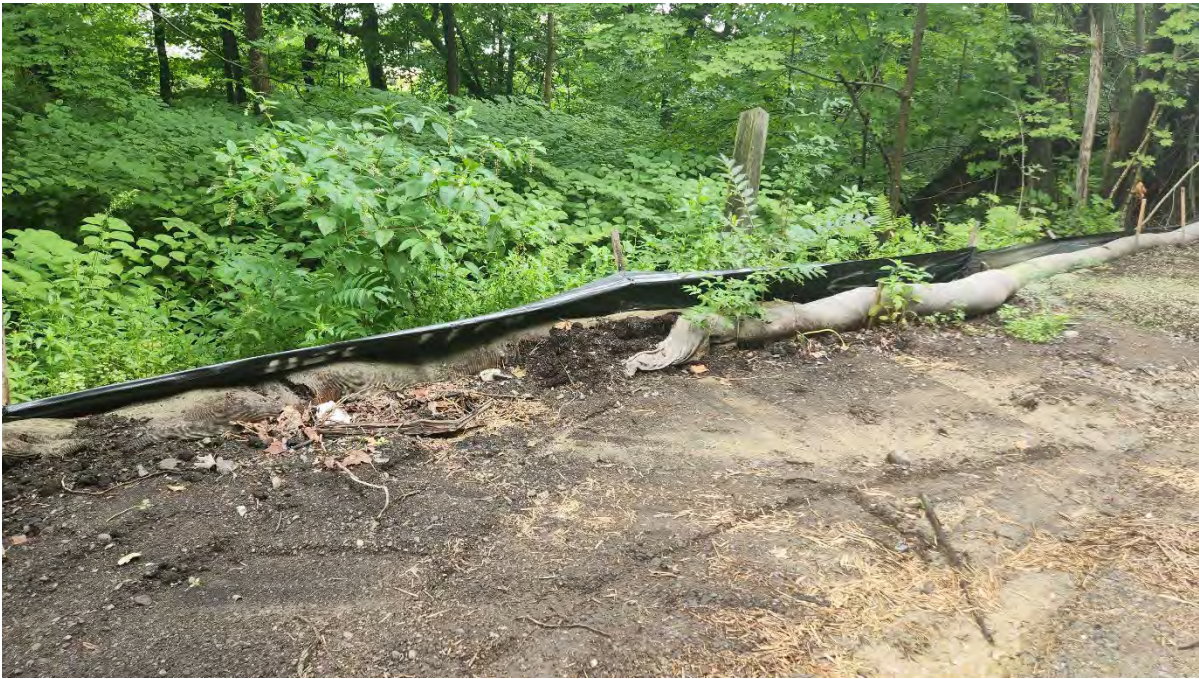
Photo 6: Filter tube is damaged and needs to be replaced along segment 13.
Photo taken on 8/09/24.

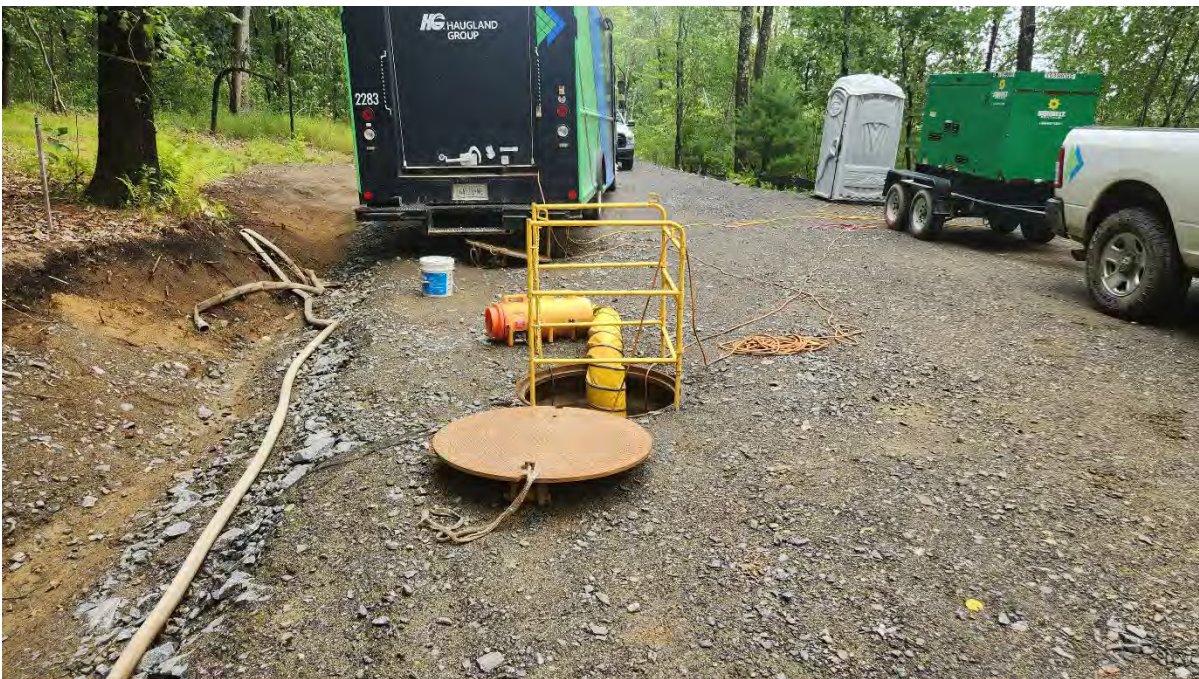
Photo 7: Cable splicing conducted along segment 14.
Photo taken on 8/09/24.
