**Environmental Monitor Construction Site Inspection Report
MassDOT Project #608164 Construction Contract # 119678
EM Report #10**

Project Description: Bruce Freeman Rail Trail Right-of-Way
Permit Description(s): Order of Conditions (MGL Chapter 131, Section 40 and 310 CMR 10.00, Mass DEP File No. 301-1362); 2022 EPA NPDES General Permit for Discharges from Construction Areas; U.S. Army Corps of Engineers Permit No NAE-2021-01975.

Project Name: Bruce Freeman Rail Trail - Phase 2d - Sudbury
Date of Inspections: 6/27/2024
Bi Weekly/ Monthly Period Covered: June Weekly Inspection #5
Inspector's Name(s): Douglas Beach
Inspectors' Contact Information: dbeach@beta-inc.com

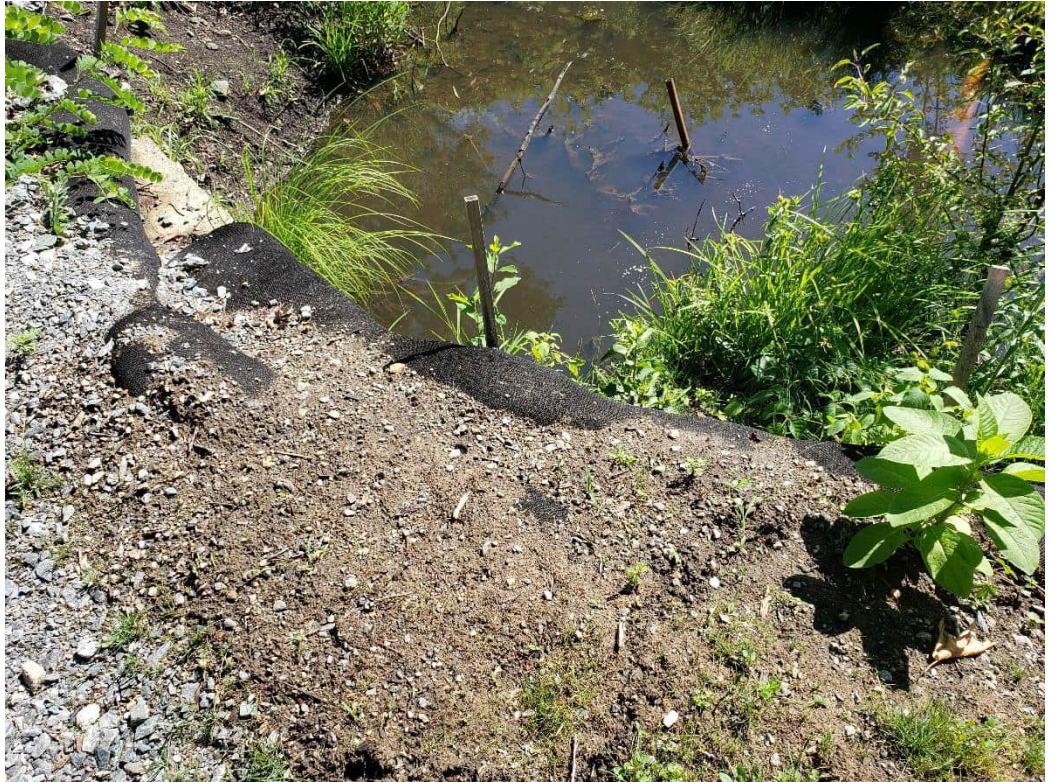
Photo No. 1 **Date:**
6/24/2024

View of slopes requiring stabilization and gravel/sediment accumulation along compost filter tubes at Station 105+00 to 106+00 per Compliance Action Items 43 and 44.

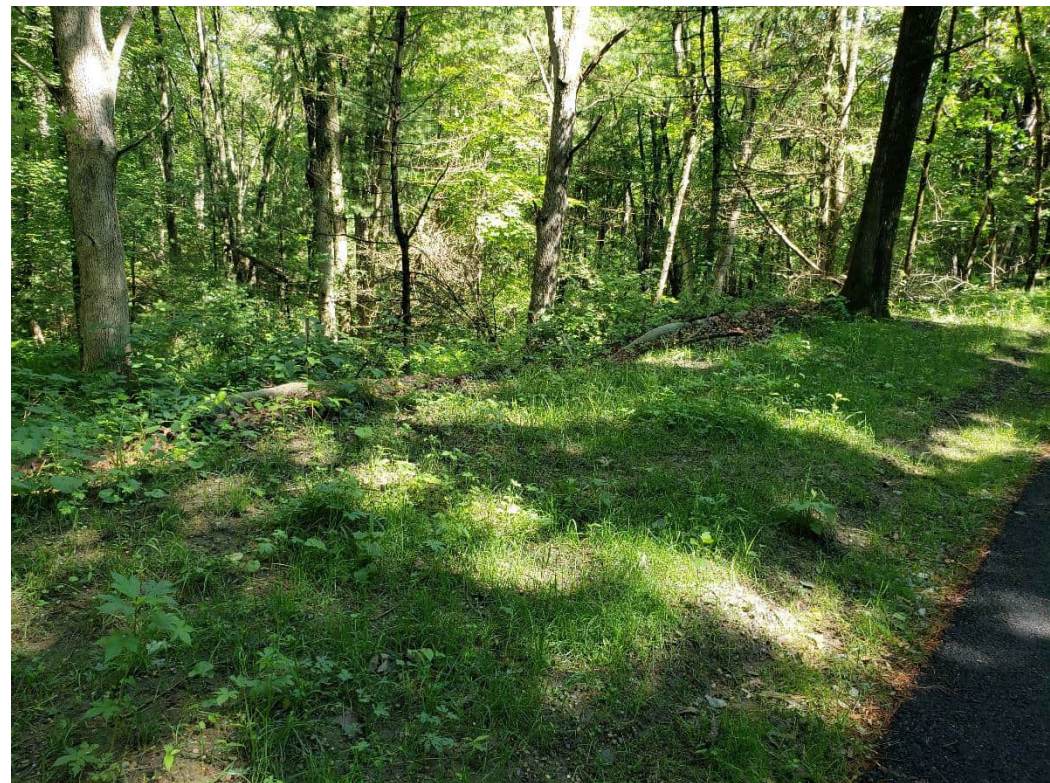
Photo No. 2 **Date:**
6/24/2024

3	Sediment washout over the slope and existing erosion controls at Stations 155+00 to 162+50 Priority: Low	5/8/2024	5/15/2024	Resolved: 6/27/2024 Replace decomposed and damaged compost filter tubes in the areas necessary to contain sediment washout until stabilization measures are completed.	5/16/2024 - Observation remains. 5/21/2024 - Observation remains. 5/28/2024 - Grass and other vegetation has temporarily stabilized the area between Stations 155+00 and Station 160+00. Stations from 160+00 to 162+50 have not yet achieved temporary stabilization. 5/31/2024 - Observation remains. 6/7/2024 - Observation remains. 6/14/2024 - Observation remains. 6/17/2024 - Observation remains. 6/24/2024 - Observation remains. 6/27/2024 - Vegetation has become established in the area.
49	Concrete pile improperly disposed of at Station 307+00 Priority: Medium	6/14/2024	6/21/2024	Resolved: 6/24/2024 Remove concrete pile from site and dispose of properly.	6/17/2024 - Observation remains. 6/24/2024 - Concrete pile has been removed and properly disposed of.

View of the location where stabilization and sediment removal is required near Station 162+00 per Compliance Action Item 3.

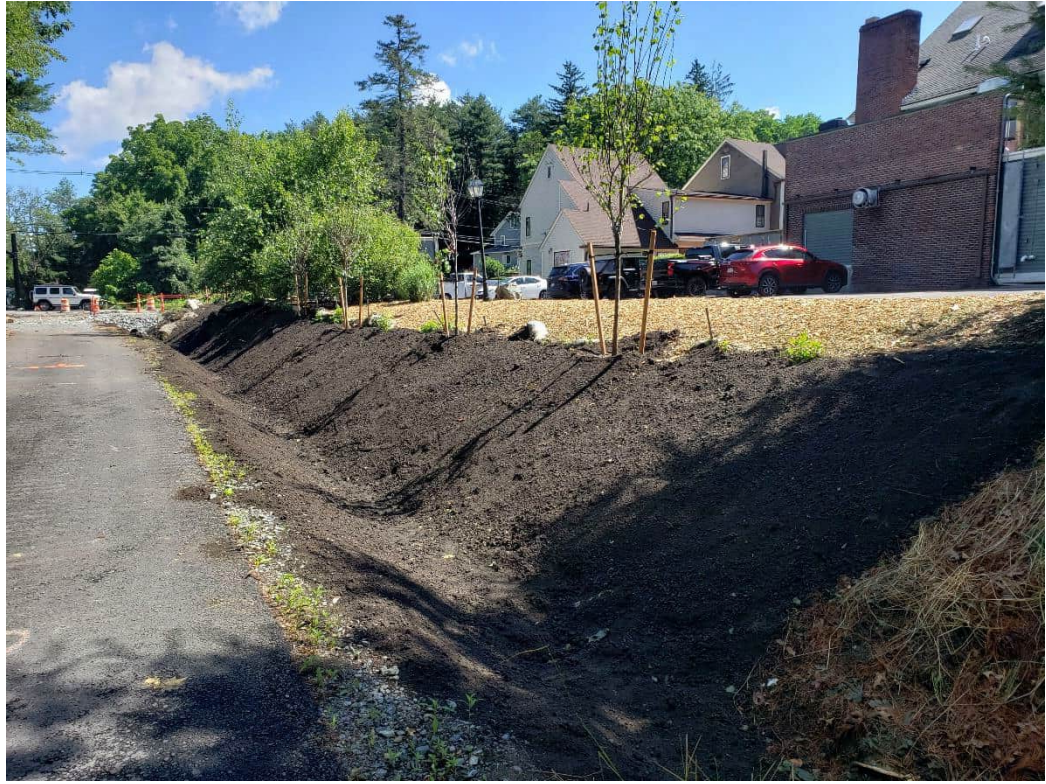
Photo No. 3 **Date:** 6/24/2024

6	Exposed sediment slope at Station 172+00 to 175+00 Priority: High	5/8/2024	5/15/2024	Install temporary sediment controls along the slope such as jute netting and/or straw following the application of seed.	5/16/2024 - Observation remains. 5/21/2024 - Observation remains. 5/28/2024 - Partial germination was observed. 5/31/2024 - See previous update. 6/7/2024 - Further earthwork has occurred and soils require stabilization. 6/14/2024 - Observation remains. 6/17/2024 - Observation remains. 6/24/2024 - Observation remains. 6/27/2024 - The area has been regraded and loamed. New trees have been planted upland of the swale. Stabilization still required.
14	Sediment-laden runoff is being discharged into a stream from the new parking lot at Station 216+50 Priority: High	5/8/2024	5/15/2024	Replace compost filter tubes around the stream and develop a method of redirecting runoff from the parking lot at the source.	5/16/2024 - New compost filter tubes have been installed but were observed to be undermined. In addition, a new earthen slope was observed to be constructed in this area and requires stabilization. 5/21/2024 - No turbidity was observed due to no rain preceding this inspection. However, additional erosion controls should be explored at this location to prevent future discharges. 5/28/2024 - Untreated runoff being discharged from the parking area has not been addressed, and work is occurring along the stream beyond the compost filter tubes. 5/31/2024 - Observation remains. 6/7/2024 - Observation remains. 6/14/2024 - Observation remains. 6/17/2024 - Observation remains. 6/24/2024 - Observation remains. 6/27/2024 - Observation remains.

View of construction and exposed soils near Station 174+00 per Compliance Action Item 6.

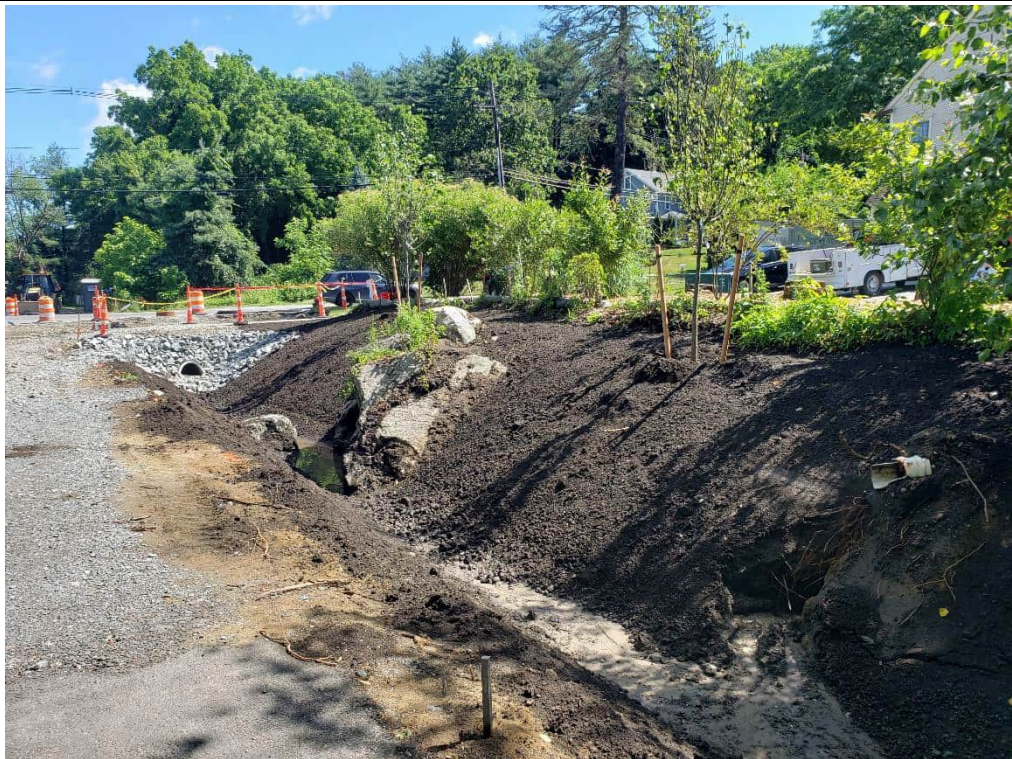
Photo No. 4 **Date:** 6/24/2024

Another view of active construction and exposed soils near Station 174+00 per Compliance Action Item 6.

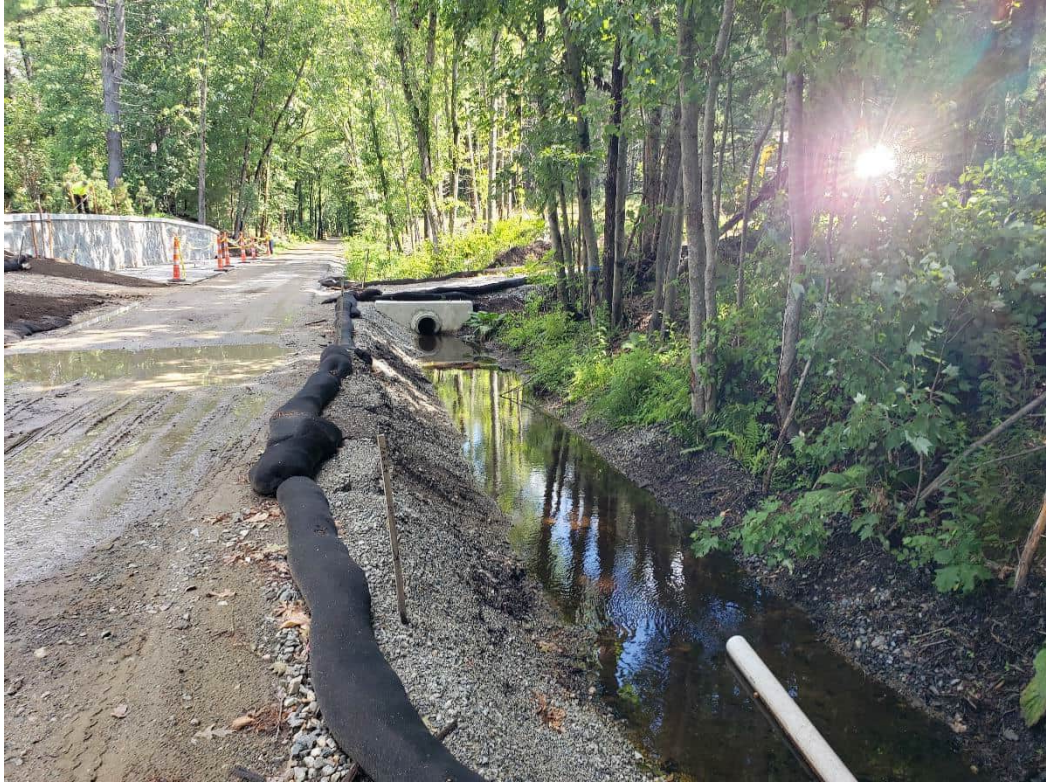
Photo No. 7 **Date:** 6/24/2024

41	Stream Bank has been regraded beyond the limit of work at Station 216+00 Priority: High	5/28/2024	6/4/2024	The Contractor should confirm if this work was permitted by the Conservation Commission, as it does not appear to be a part of the approved plans/impacts. MassDOT should be consulted on next steps regarding notification and potential restoration.	5/31/2024 - Observation remains. 6/7/2024 - Observation remains. 6/14/2024 - Observation remains. 6/17/2024 - Observation remains. 6/24/2024 - Observation remains. 6/27/2024 - Observation remains.

View of grading of the stream Bank beyond the limits of work at Station 216+00 per Compliance Action Item 41.

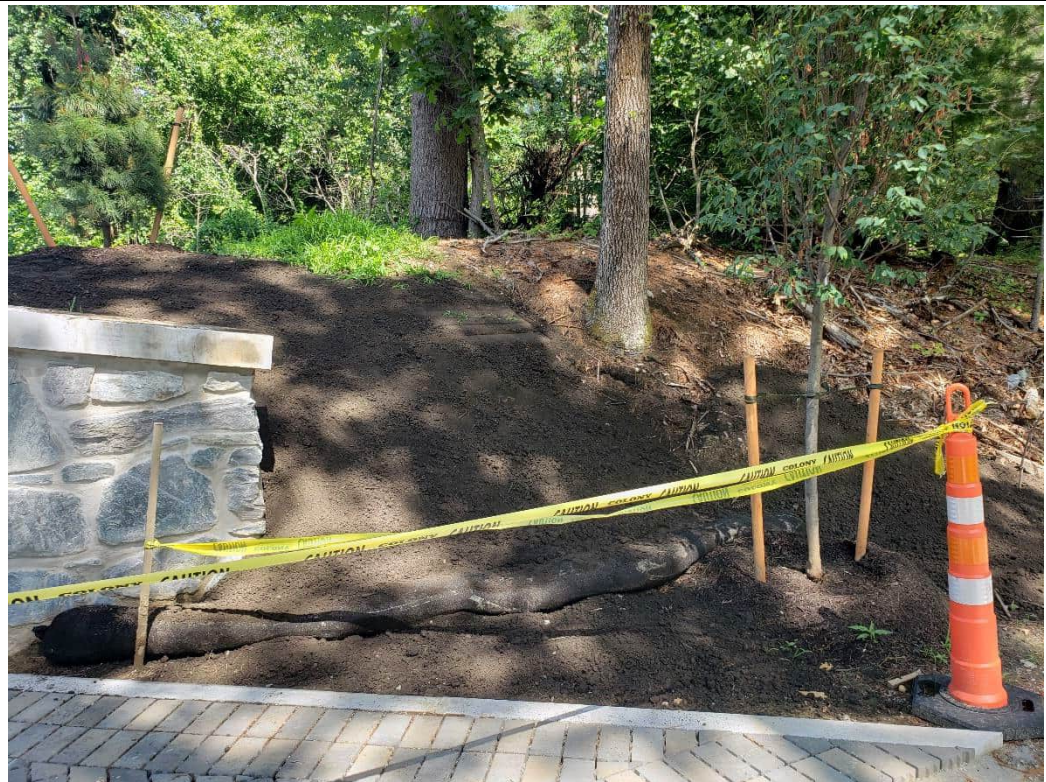
Photo No. 8 **Date:** 6/24/2024

View of new loam and hydroseed along a newly constructed masonry wall that require stabilization at Station 217+45 per Compliance Action Item 34.

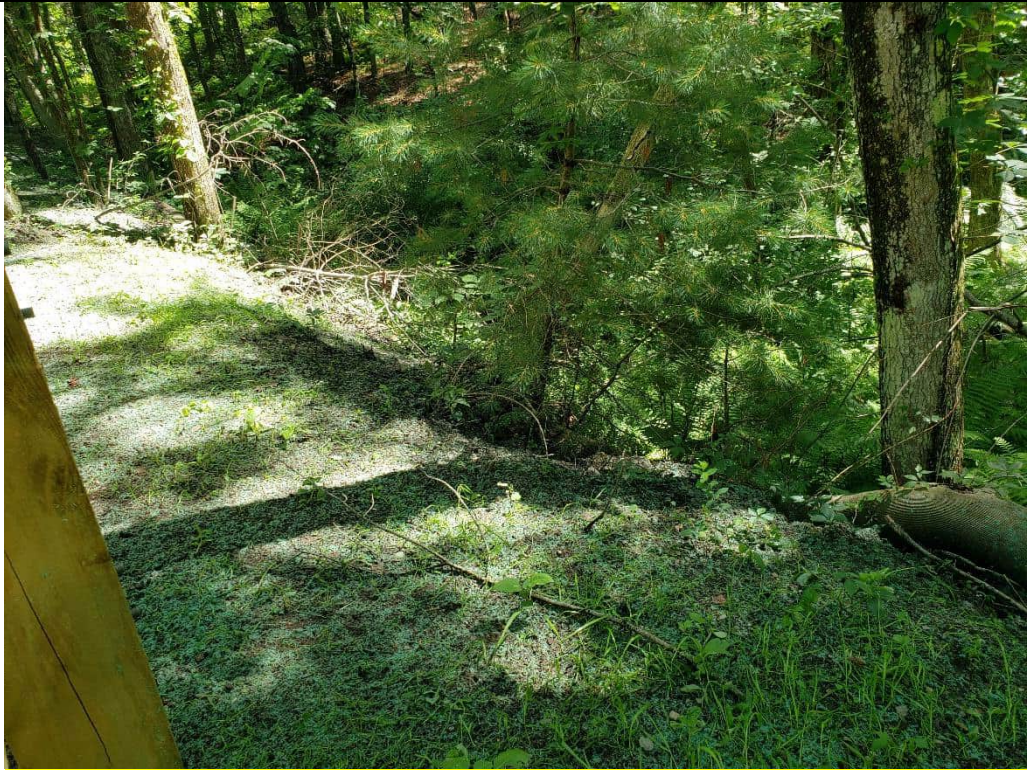
Photo No. 11	Date: 6/24/2024
---------------------	---------------------------

45	Erosion observed along east side of trail at Station 225+50 Priority: Medium	6/7/2024	6/14/2024	Stabilize the slope with the approved seed mixture and provide interim stabilization such as straw mulch.	6/14/2024 - Observation remains. 6/17/2024 - Observation remains. 6/24/2024 - Observation remains. 6/27/2024 - Vegetation has become established; however, migrated maerial requires removal.
47	Slope stabilization required due to condition of compost filter tubes at Station 265+50 and 273+00 Priority: High	6/7/2024	6/14/2024	Stabilize the slope with the approved seed mixture and provide interim stabilization such as straw mulch.	6/14/2024 - Observation remains. 6/17/2024 - Observation remains. 6/24/2024 - Observation remains. 6/27/2024 - Observation remains.

Description: View of erosion observed along east side of trail at Station 225+50 per Compliance Action Item 45.

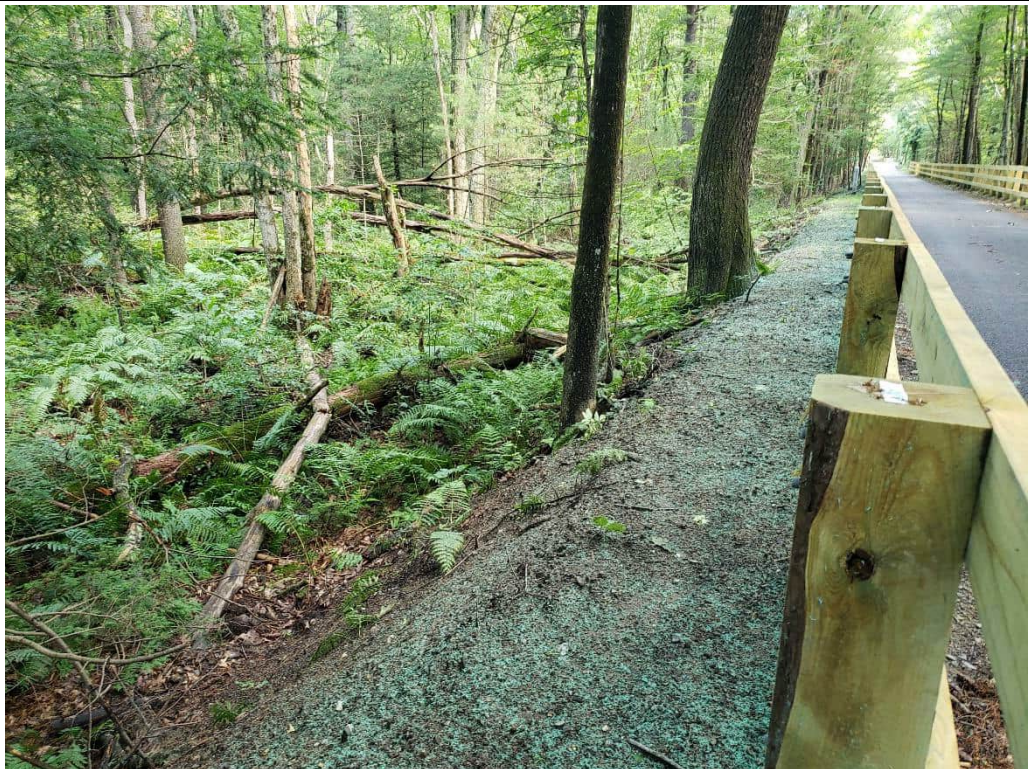
Photo No. 12	Date: 6/24/2024
---------------------	---------------------------

Description: View of washout overtopping compost filter tubes at Station 231+00 per Compliance Action Item 16.
--
