**Environmental Monitor Construction Site Inspection Report
MassDOT Project #608164 Construction Contract # 119678
EM Report #11**

Project Name:	Bruce Freeman Rail Trail - Phase 2d - Sudbury
Date of Inspections:	7/8/2024
Bi Weekly/ Monthly Period Covered:	July Weekly Inspection #1
Inspector's Name(s):	Anna Haznar
Inspectors' Contact Information:	ahaznar@beta-inc.com

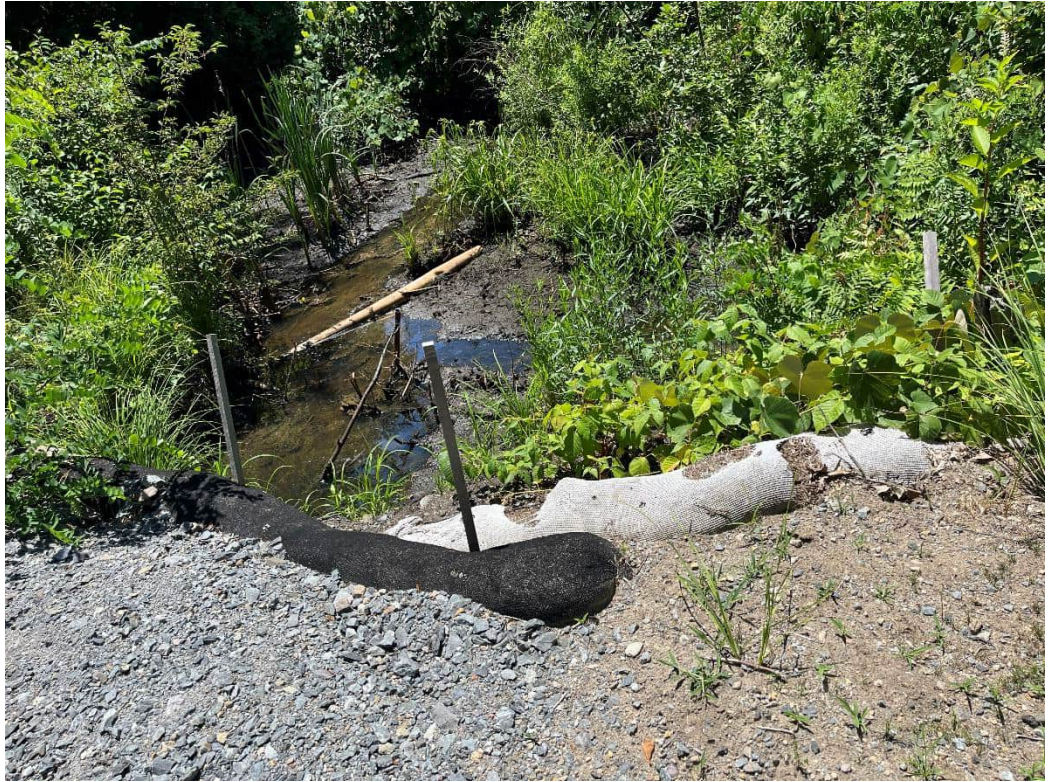
Photo No. 1 **Date:**
7/8/2024

Item	Location/ Description	Observation Date	Resolution Due Date	Recommended Resolution / Resolution Date	Comments/Updates
43	Overtopped compost filter tubes and exposed soils beyond the limits of work at Station 105+00 Priority: High	6/7/2024	6/14/2024	Stabilize the area with the approved seed mixture and provide interim stabilization such as straw mulch.	6/14/2024 - Observation remains. 6/17/2024 - Observation remains. 6/24/2024 - Observation remains. 6/27/2024 - Observation remains. 7/8/2024 - Observation remains.
44	Slopes require stabilization/ additional seed due to lack of compost filter tubes at 105+00 and 106+00 Priority: High	6/7/2024	6/14/2024	Stabilize the slope with the approved seed mixture and provide interim stabilization such as straw mulch.	6/14/2024 - Observation remains. 6/17/2024 - Observation remains. 6/24/2024 - Observation remains. 6/27/2024 - Observation remains. 7/8/2024 - Observation remains.

View of slopes requiring stabilization and gravel/sediment accumulation along compost filter tubes at Station 105+00 to 106+00 per Compliance Action Items 43 and 44.

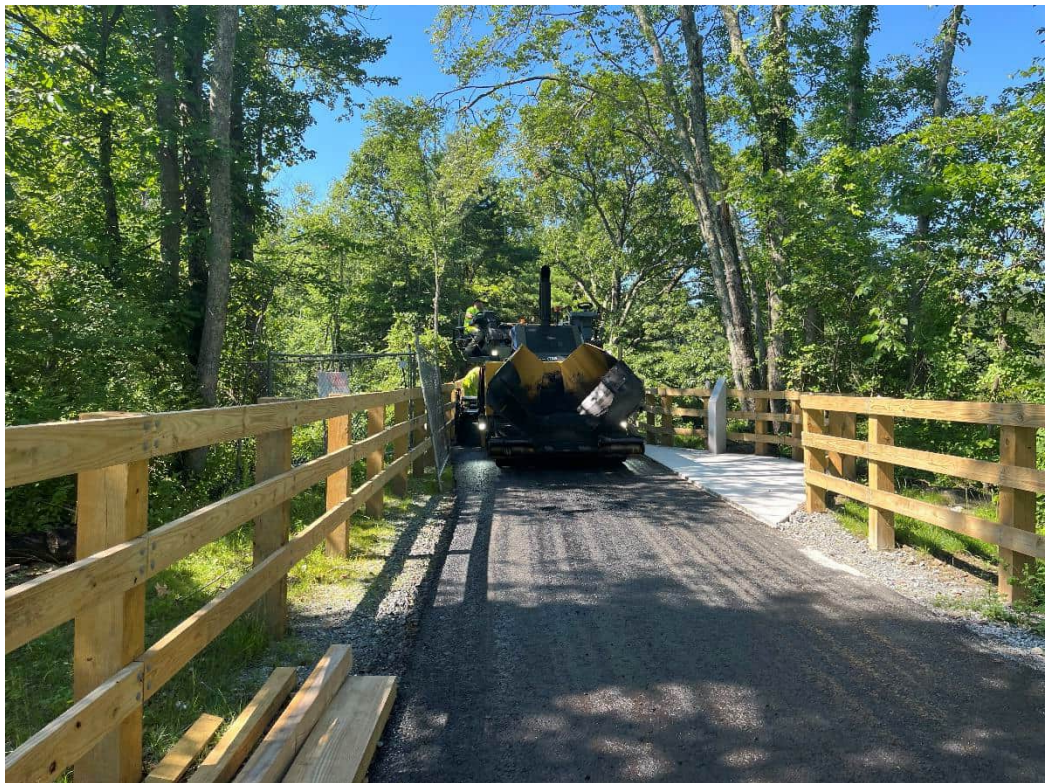
Photo No. 2 **Date:**
7/8/2024

View of active paving over Hop Brook near Station 118+00.

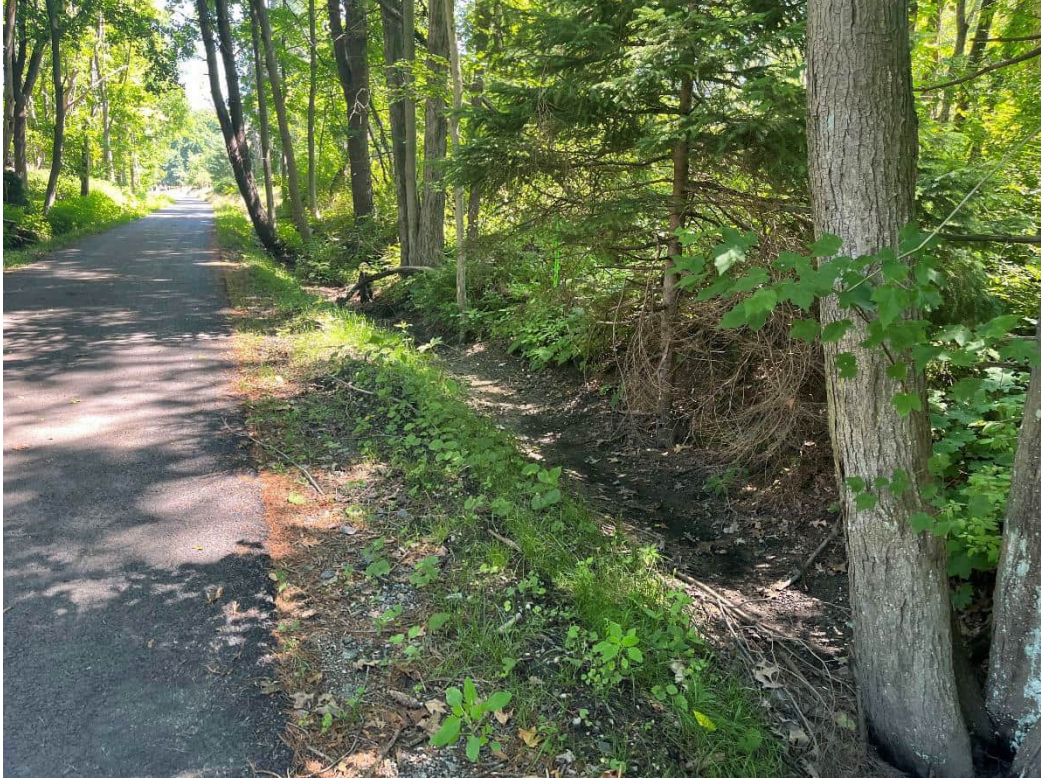
Photo No. 3 **Date:**
7/8/2024

View of established vegetation near Station 162+00.

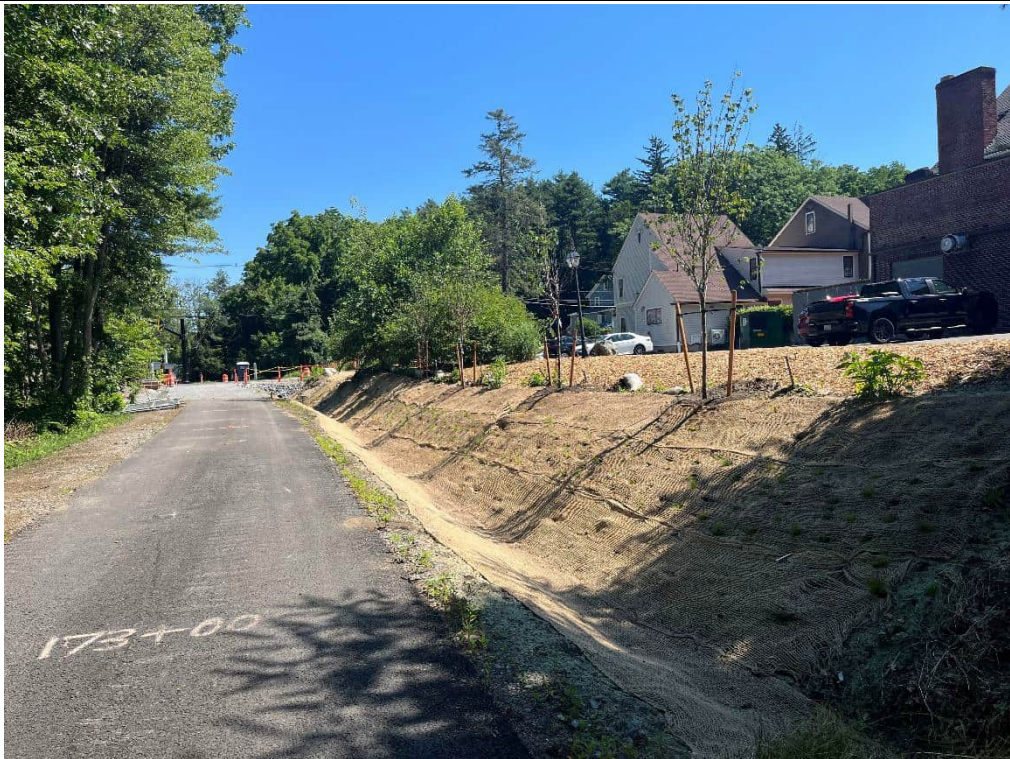
Photo No. 4 **Date:**
7/8/2024

6	Exposed sediment slope at Station 172+00 to 175+00 Priority: High	5/8/2024	5/15/2024	Install temporary sediment controls along the slope such as jute netting and/or straw following the application of seed.	5/16/2024 - Observation remains. 5/21/2024 - Observation remains. 5/28/2024 - Partial germination was observed. 5/31/2024 - See previous update. 6/7/2024 - Further earthwork has occurred and soils require stabilization. 6/14/2024 - Observation remains. 6/17/2024 - Observation remains. 6/24/2024 - Observation remains. 6/27/2024 - The area has been regraded and loam has been spread. New trees have been planted upgradient of the swale. Stabilization is still required. 7/8/2024 - Jute netting has been installed over the applied seed, and the area will be monitored for germination.
14	Sediment-laden runoff is being discharged into a stream from the new parking lot at Station 216+50 Priority: High	5/8/2024	5/15/2024	Replace compost filter tubes around the stream and develop a method of redirecting runoff from the parking lot at the source.	5/16/2024 - New compost filter tubes have been installed but were observed to be undermined. In addition, a new earthen slope was observed to be constructed in this area and requires stabilization. 5/21/2024 - No turbidity was observed due to no rain preceding this inspection. However, additional erosion controls should be explored at this location to prevent future discharges. 5/28/2024 - Untreated runoff being discharged from the parking area has not been addressed, and work is occurring along the stream beyond the compost filter tubes. 5/31/2024 - Observation remains. 6/7/2024 - Observation remains. 6/14/2024 - Observation remains. 6/17/2024 - Observation remains. 6/24/2024 - Observation remains. 6/27/2024 - Observation remains. 7/8/2024 - Observation remains.

Another view of the stabilized slopes near Station 173+00 per Compliance Action Item 6.

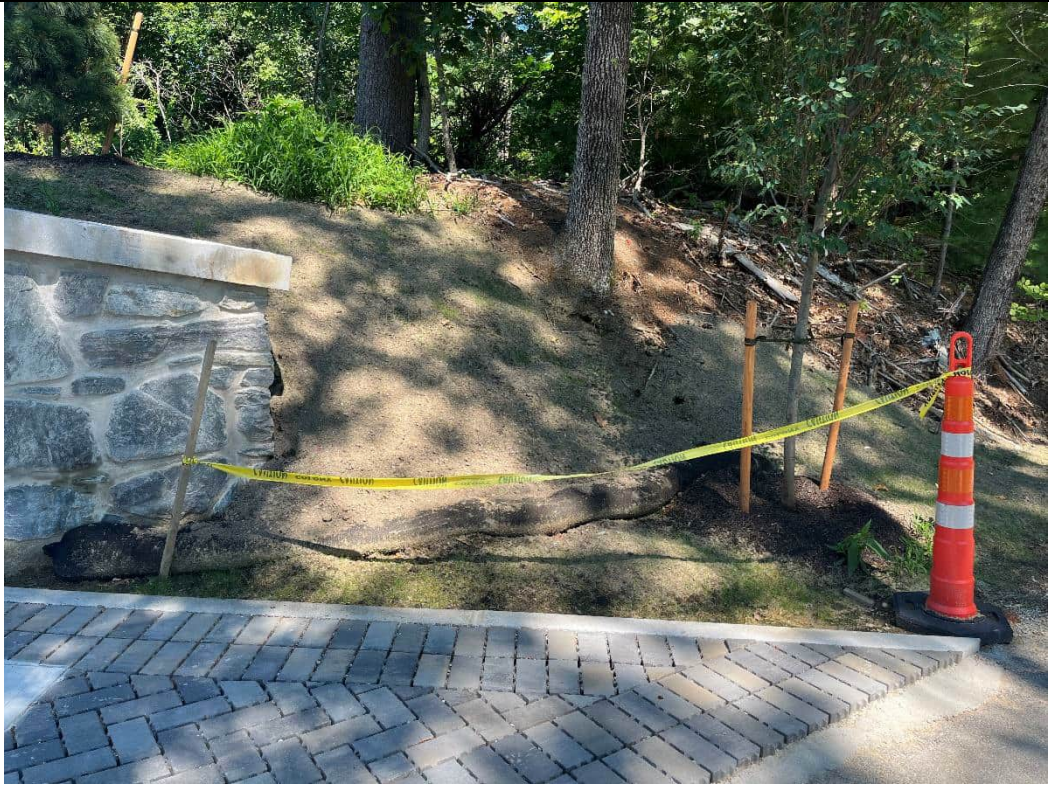
Photo No. 7 **Date:**
7/8/2024

View of germination along the slope adjacent to the constructed masonry wall at Station 217+45 per Compliance Action Item 34.

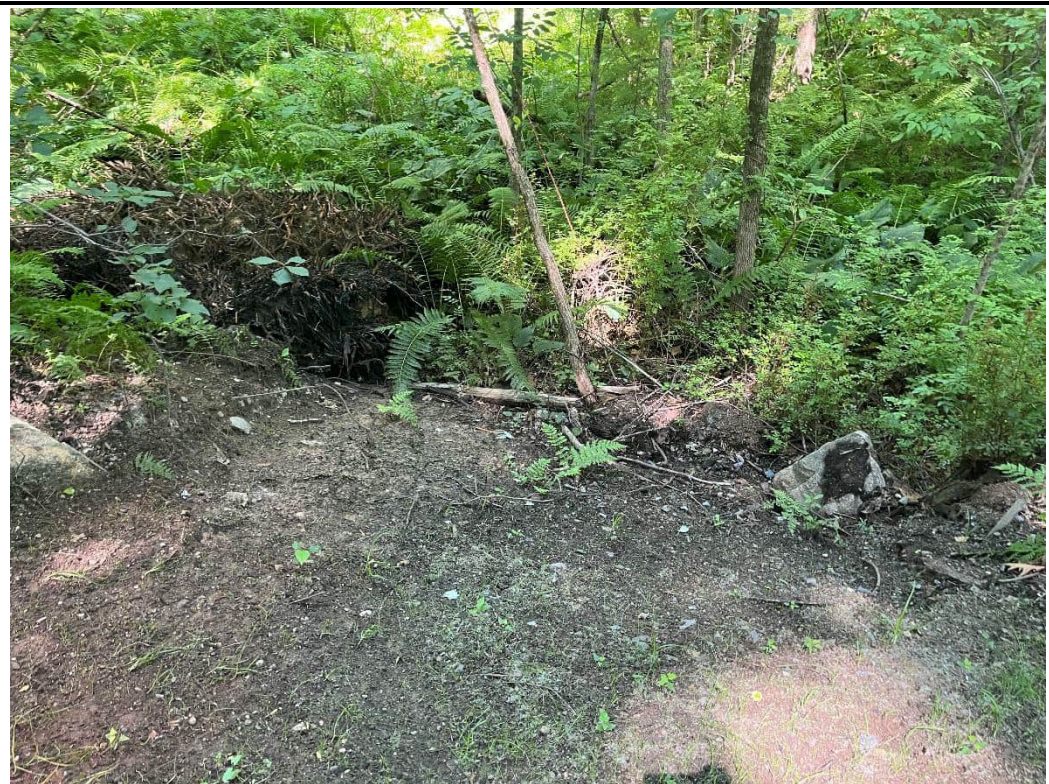
Photo No. 8 **Date:**
7/8/2024

15	Sediment migration off of the trail and into wetlands at Station 221+50 Priority: High	5/8/2024	5/15/2024	Replace damaged compost filter tubes and remove accumulated sediment from areas beyond the limits of work. Once any grading work is completed, apply seed to the slope and stabilize it with jute netting, straw, etc.	5/16/2024 - Observation remains. 5/21/2024 - Observation remains. 5/28/2024 - The area has been hydroseeded. 5/31/2024 - No additional sediment migration was observed. See previous update. 6/7/2024 - Hydroseed is present but sediment beyond the compost filter tubes requires removal. 6/14/2024 - Observation remains. 6/17/2024 - Observation remains. 6/24/2024 - Observation remains. 6/27/2024 - This area has been hydroseeded again. 7/8/2024 - Germination was observed and the area will be monitored for stabilization.
16	Sediment migration beyond the limits of work at Stations 231+00 to 232+00 Priority: Medium	5/8/2024	5/15/2024	Remove accumulated sediment from areas beyond the limits of work and replace compost filter tubes. Once any grading work is completed, apply seed to the slope and stabilize it with jute netting, straw, etc.	5/16/2024 - Observation remains. 5/21/2024 - Observation remains. 5/28/2024 - The area has been hydroseeded and additional sediment has not migrated since the last observation. 5/31/2024 - Observation remains. 6/7/2024 - Hydroseed is present but sediment beyond the compost filter tubes requires removal. 6/14/2024 - Observation remains. 6/17/2024 - Observation remains. 6/24/2024 - Observation remains. 6/27/2024 - This area was hydroseeded and germination was observed. 7/8/2024 - Germination continues and the area will be monitored for stabilization. The contractor should confirm that all soils over the compost filter tubes are confined to the limits of work.

View of washout overtopping compost filter tubes at Station 221+50 per Compliance Action Item 15.

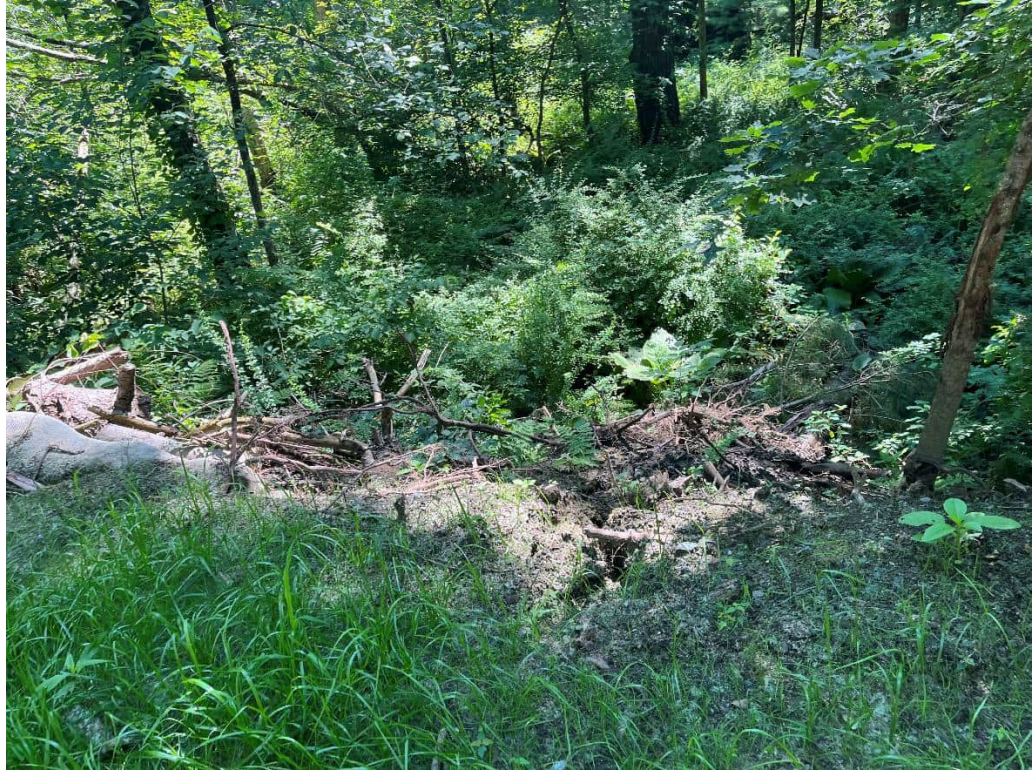
Photo No. 9 **Date:**
7/8/2024

View of soil and organic debris placed within the wetland between flags WF#23-119 and WF#23-118 at Station 224+00 per Compliance Action Item 32.

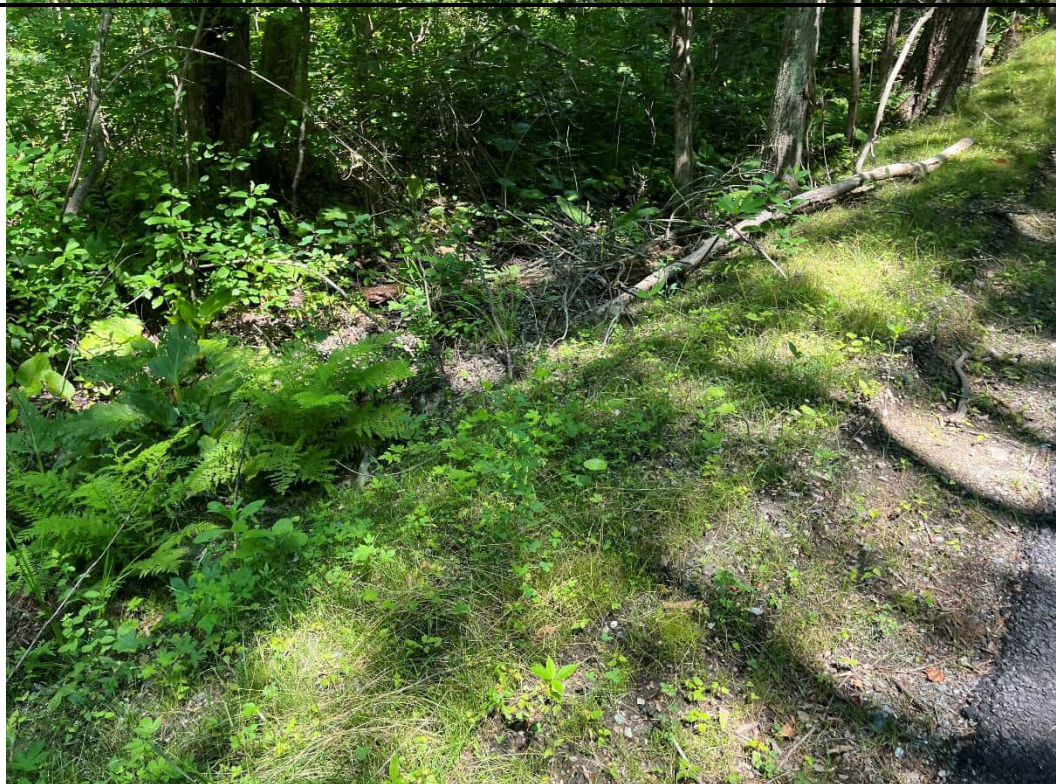
Photo No. 10 **Date:**
7/8/2024

45	Erosion observed along east side of trail at Station 225+50 Priority: Medium	6/7/2024	6/14/2024	Stabilize the slope with the approved seed mixture and provide interim stabilization such as straw mulch.	6/14/2024 - Observation remains. 6/17/2024 - Observation remains. 6/24/2024 - Observation remains. 6/27/2024 - Vegetation has become established; however, migrated material requires removal. 7/8/2024 - Observation remains.
47	Slope stabilization required due to condition of compost filter tubes at Station 265+50 and 273+00 Priority: High	6/7/2024	6/14/2024	Stabilize the slope with the approved seed mixture and provide interim stabilization such as straw mulch.	6/14/2024 - Observation remains. 6/17/2024 - Observation remains. 6/24/2024 - Observation remains. 6/27/2024 - Observation remains. 7/8/2024 - Observation remains.

View of an area of previously observed erosion along the east side of the trail at Station 225+50 per Compliance Action Item 45.
