**Environmental Monitor Construction Site Inspection Report
MassDOT Project #608164 Construction Contract # 119678
EM Report #12**

Project Description: Bruce Freeman Rail Trail Right-of-Way
Permit Description(s): Order of Conditions (MGL Chapter 131, Section 40 and 310 CMR 10.00, Mass DEP File No. 301-1362); 2022 EPA NPDES General Permit for Discharges from Construction Areas; U.S. Army Corps of Engineers Permit No NAE-2021-01975.

Project Name:	Bruce Freeman Rail Trail - Phase 2d - Sudbury
Date of Inspections:	7/15/2024
Bi Weekly/ Monthly Period Covered:	July Weekly Inspection #2
Inspector's Name(s):	Jonathan Niro
Inspectors' Contact Information:	jniro@beta-inc.com

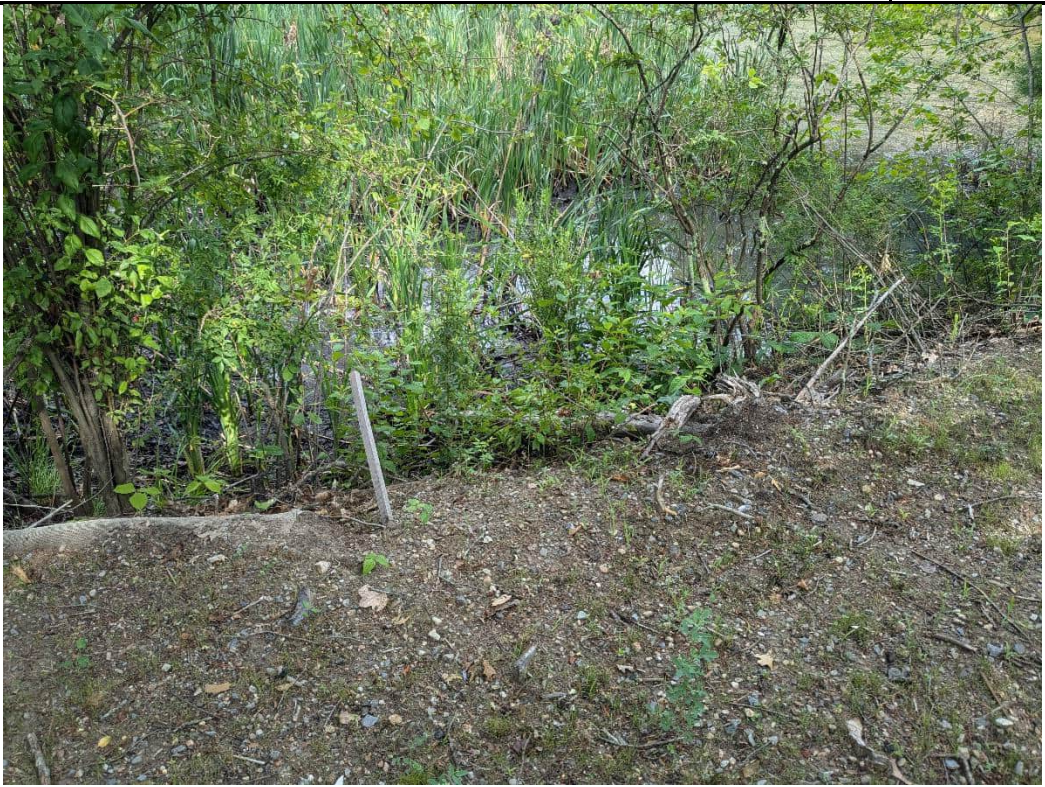
Photo No. 1 **Date:**
7/15/2024

Typical view of slopes requiring stabilization and removal of gravel/sediment accumulation along compost filter tubes at Station 105+00 to 106+00 per Compliance Action Items 43 and 44.

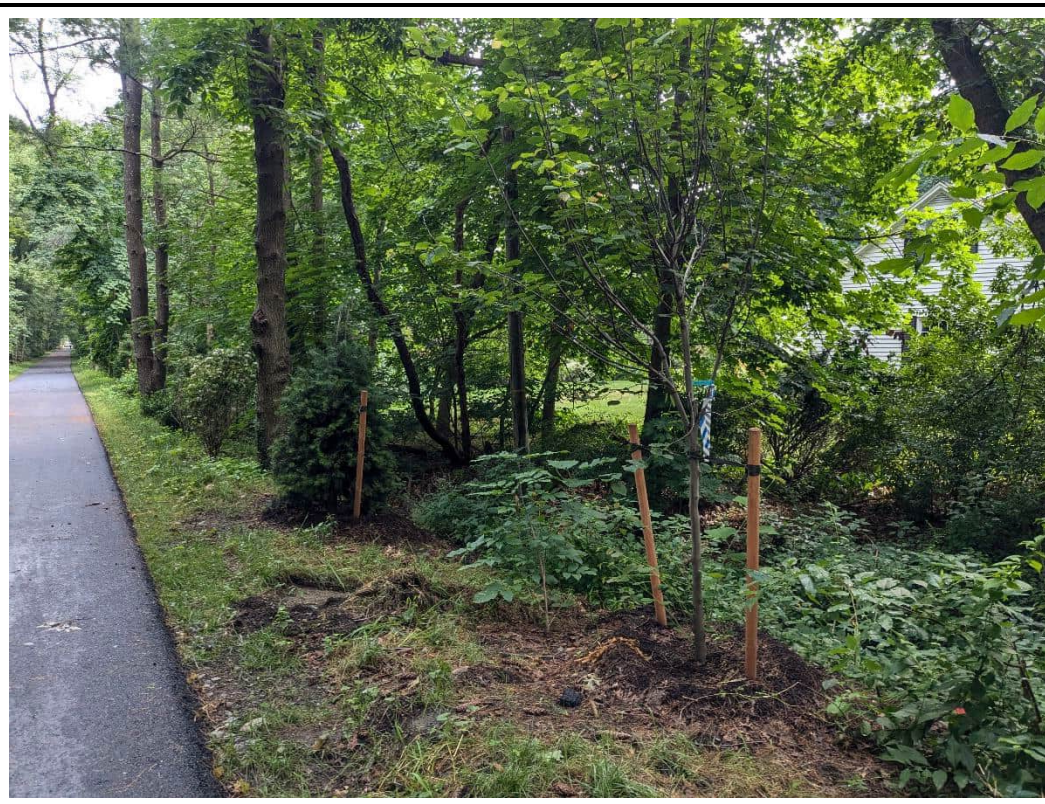
Photo No. 2 **Date:**
7/15/2024

View of plantings installed south of Old Lancaster Road.

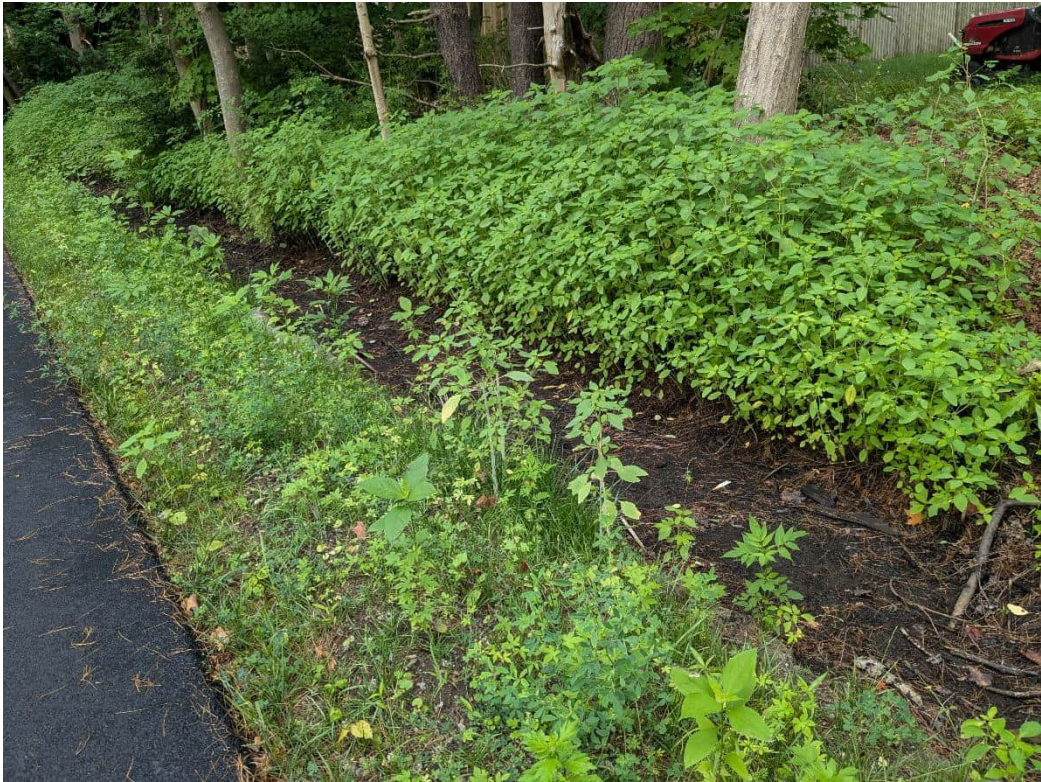
Photo No. 3 **Date:** 7/15/2024

View of established vegetation near Station 167+00 to 172+00 per Compliance Action Item 5.

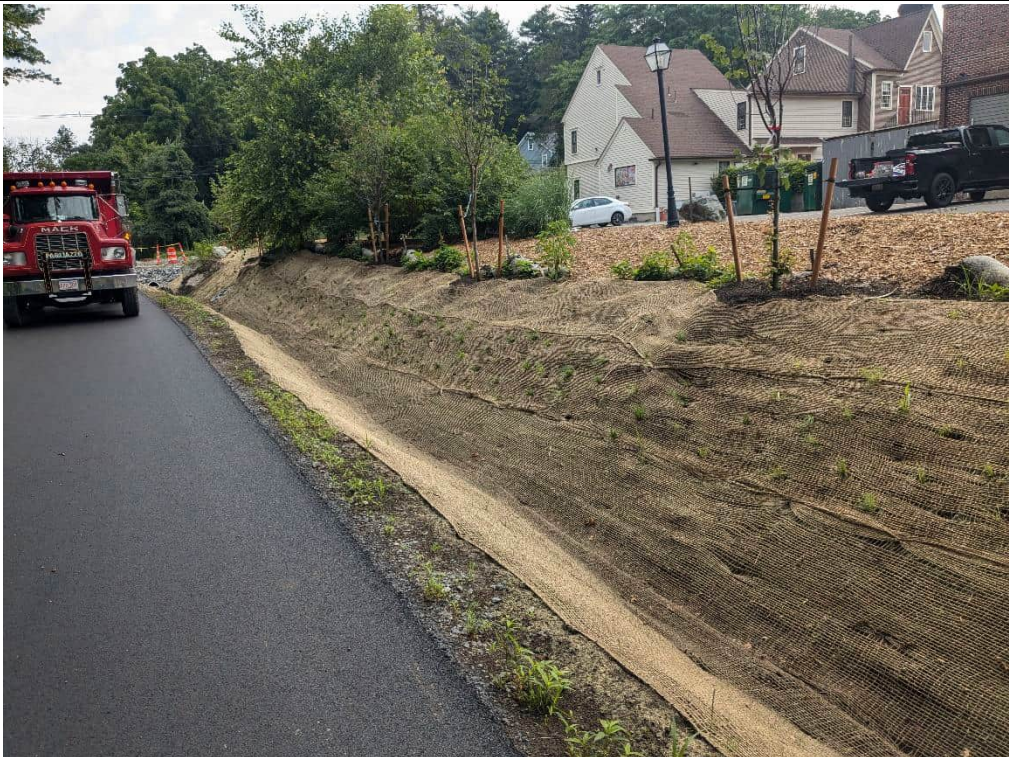
Photo No. 4 **Date:** 7/15/2024

View of the slopes near Station 173+00 per Compliance Action Item 6.

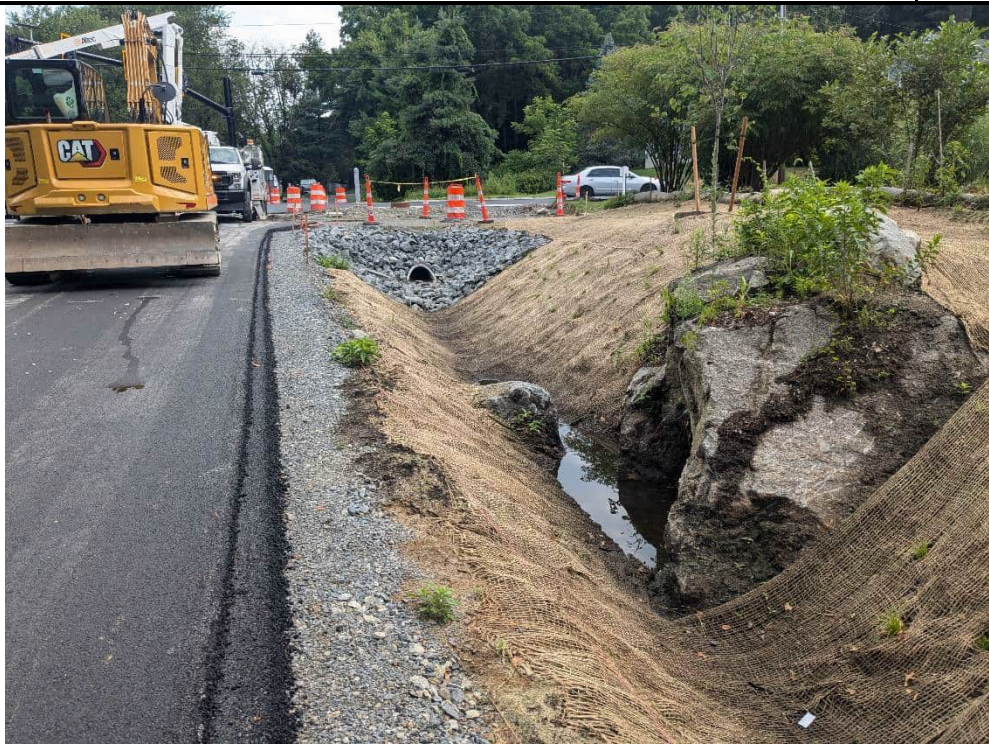
Photo No. 5 **Date:**
7/15/2024

Another view of the slopes near Station 173+00 per Compliance Action Item 6.

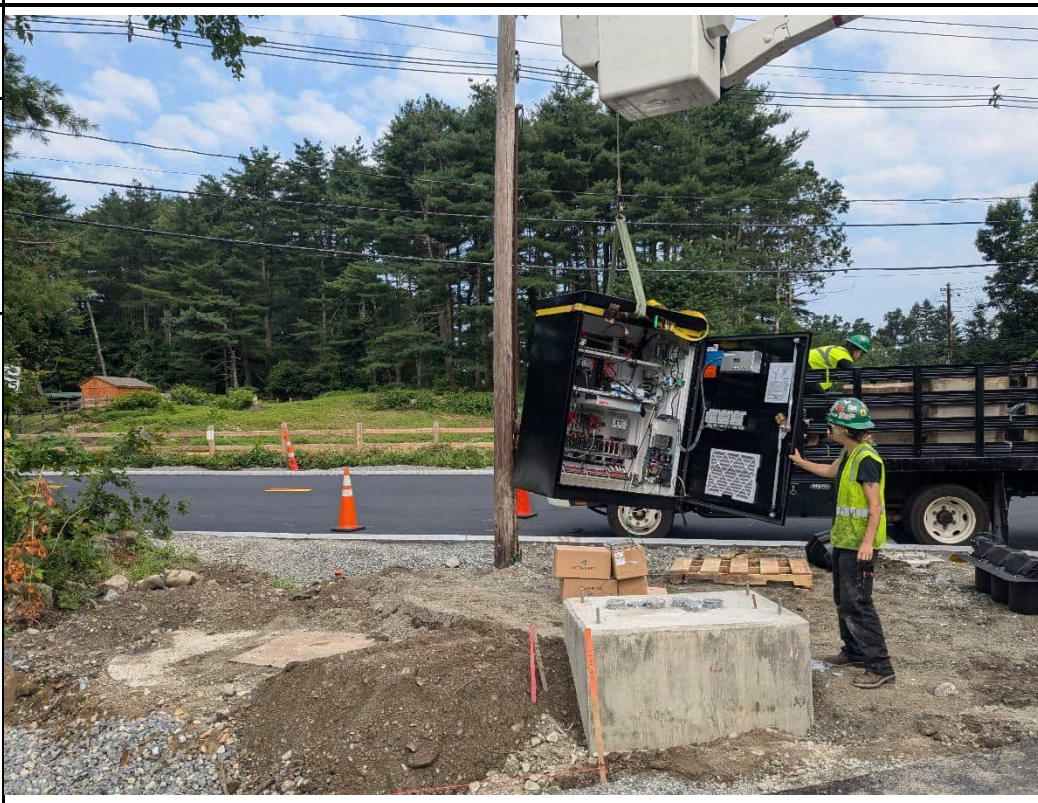
Photo No. 6 **Date:**
7/15/2024

View of ongoing utility work at the Hudson Road intersection.

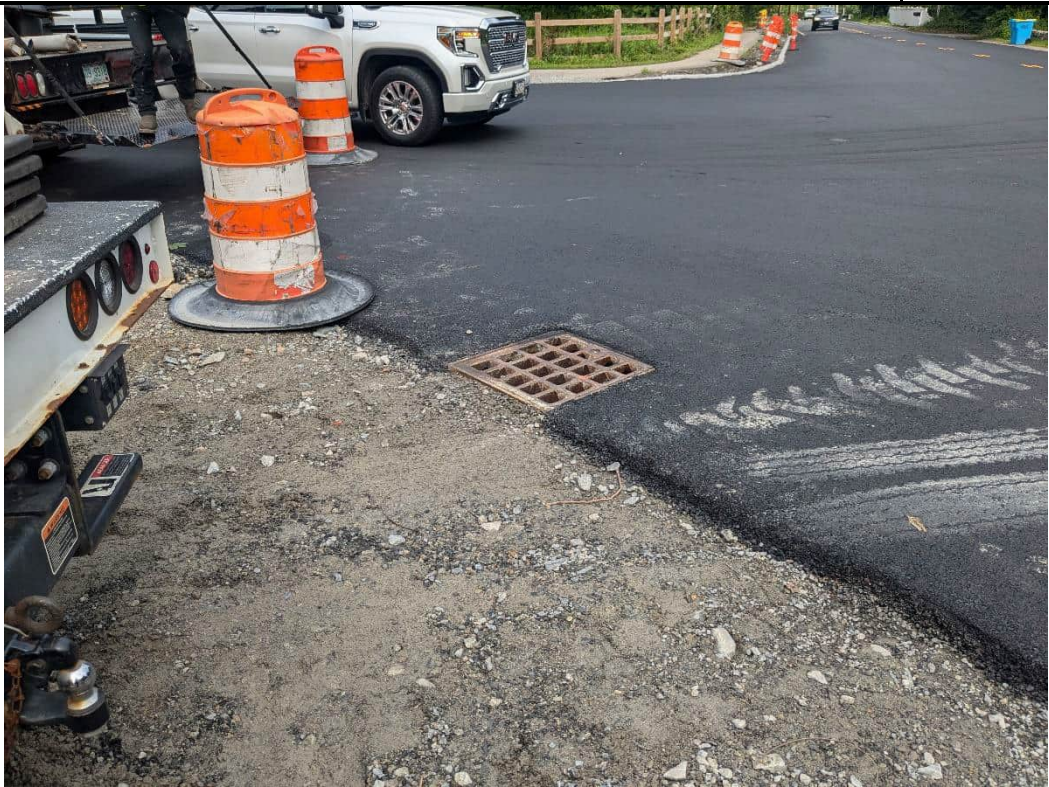
Photo No. 7 **Date:** 7/15/2024

Inlet Protection Measures	Yes	Catch basins in the vicinity of active work at the Hudson Road intersection require the installation of inlet protection.
Stabilized Construction Entrances	No	
Stockpile Protections	No	
Dust Control	No	
Street Sweeping	No	
Dewatering Controls	No	
Construction Equipment and Material Storage	No	
Construction and Domestic Waste Storage and Collection	No	
Location of Sanitary Waste Facilities	No	
Washout Areas	No	
Fertilizers, Herbicides, and Landscape Material	N/A	
Stabilization of Exposed Soil	Yes	Varying degrees of stabilization are present within areas that were constructed/graded as part of the Project. Stabilization efforts are required at Station 201+50 to 204+00, Station 221+50, Station 225+50, Station 222+00 to 241+00, Station 247+00, Station 265+50 to 273+00, Station 310+00, and Stations 313+00 to 316+00. Stabilization has commenced via application of hydroseed at the majority of these locations and should be monitored for successful establishment.

View of a catch basin requiring inlet protection at the Hudson Road intersection per Compliance Action Item 50.

Item	Location/ Description	Observation Date	Resolution Due Date	Recommended Resolution / Resolution Date	Comments/Updates
50	Catch basin requiring inlet protection at the Hudson Road intersection Priority: Medium	7/15/2024	7/22/2024	Install inlet protection within the catch basin.	
43	Overtopped compost filter tubes and exposed soils beyond the limits of work at Station 105+00 Priority: High	6/7/2024	6/14/2024	Stabilize the area with the approved seed mixture and provide interim stabilization such as straw mulch.	6/14/2024 - Observation remains. 6/17/2024 - Observation remains. 6/24/2024 - Observation remains. 6/27/2024 - Observation remains. 7/8/2024 - Observation remains. 7/15/2024 - Observation remains.
44	Slopes require stabilization / additional seed due to lack of compost filter tubes at 105+00 and 106+00 Priority: High	6/7/2024	6/14/2024	Stabilize the slope with the approved seed mixture and provide interim stabilization such as straw mulch.	6/14/2024 - Observation remains. 6/17/2024 - Observation remains. 6/24/2024 - Observation remains. 6/27/2024 - Observation remains. 7/8/2024 - Observation remains. 7/15/2024 - Observation remains.

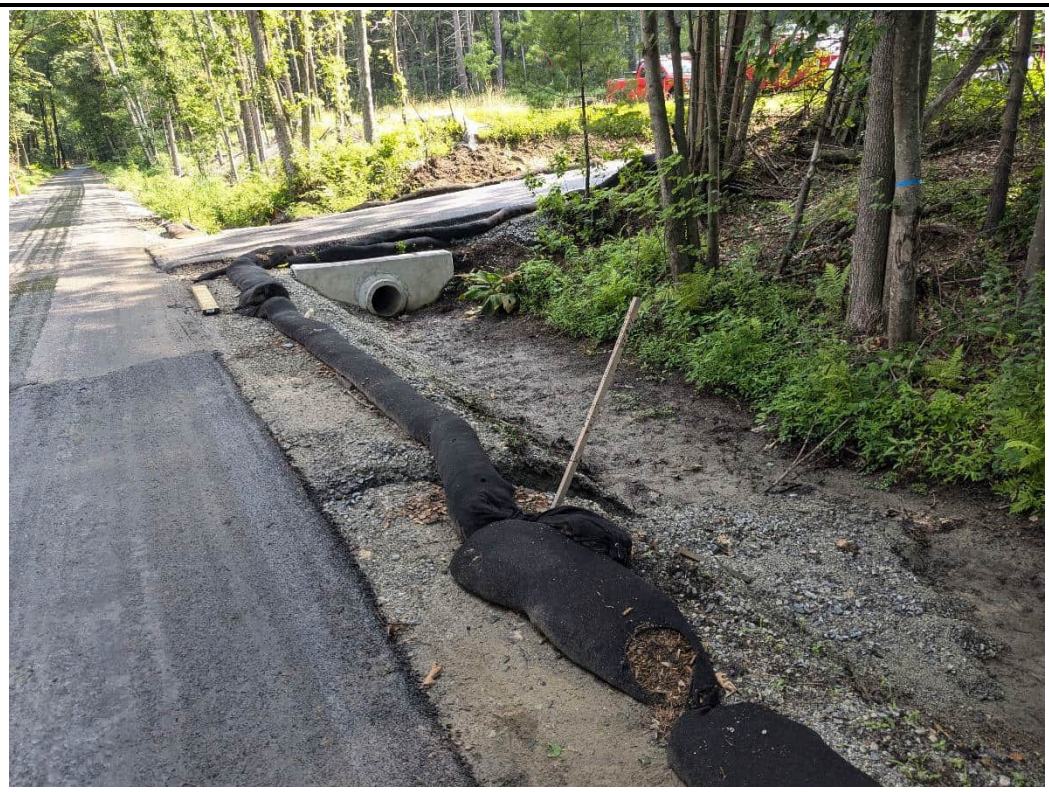
Photo No. 8 **Date:** 7/15/2024

14	Sediment-laden runoff is being discharged into a stream from the new parking lot at Station 216+50 Priority: High	5/8/2024	5/15/2024	Replace compost filter tubes around the stream and develop a method of redirecting runoff from the parking lot at the source.	5/16/2024 - New compost filter tubes have been installed but were observed to be undermined. In addition, a new earthen slope was observed to be constructed in this area and requires stabilization. 5/21/2024 - No turbidity was observed due to no rain preceding this inspection. However, additional erosion controls should be explored at this location to prevent future discharges. 5/28/2024 - Untreated runoff being discharged from the parking area has not been addressed, and work is occurring along the stream beyond the compost filter tubes. 5/31/2024 - Observation remains. 6/7/2024 - Observation remains. 6/14/2024 - Observation remains. 6/17/2024 - Observation remains. 6/24/2024 - Observation remains. 6/27/2024 - Observation remains. 7/8/2024 - Observation remains. 7/15/2024 - See previous update.

View of where work has occurred beyond the limits of work at Station 216+50 and upgradient construction is resulting in discharges of sediment to the stream per Compliance Action Item 14.

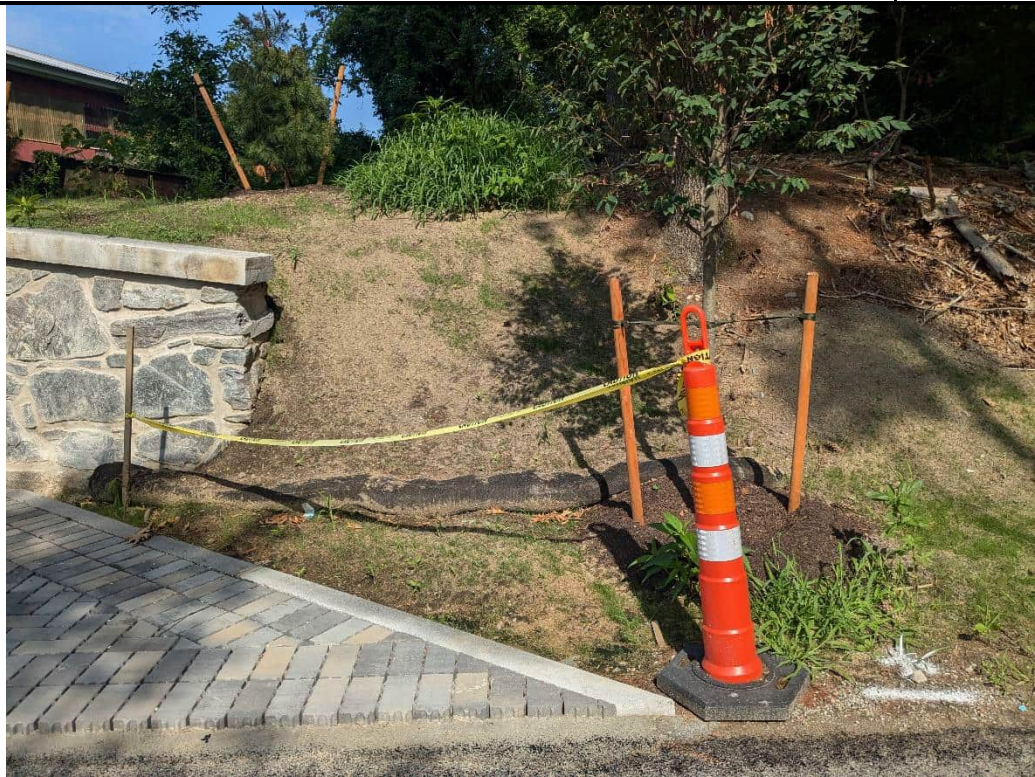
Photo No. 9 **Date:**
7/15/2024

View of an area requiring additional seed along the masonry wall at Station 217+45 per Compliance Action Item 34.

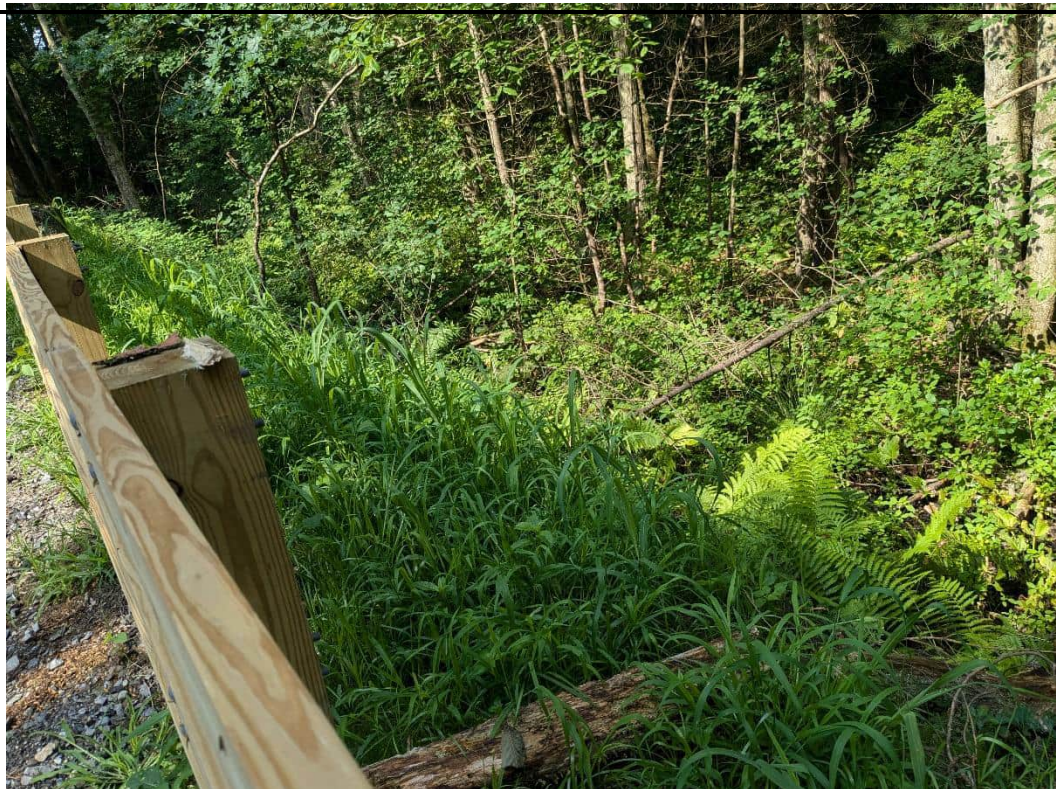
Photo No. 10 **Date:**
7/15/2024

15	Sediment migration off of the trail and into wetlands at Station 221+50 Priority: High	5/8/2024	5/15/2024	Resolved 7/15/2024 Replace damaged compost filter tubes and remove accumulated sediment from areas beyond the limits of work. Once any grading work is completed, apply seed to the slope and stabilize it with jute netting, straw, etc.	5/16/2024 - Observation remains. 5/21/2024 - Observation remains. 5/28/2024 - The area has been hydroseeded. 5/31/2024 - No additional sediment migration was observed. See previous update. 6/7/2024 - Hydroseed is present but sediment beyond the compost filter tubes requires removal. 6/14/2024 - Observation remains. 6/17/2024 - Observation remains. 6/24/2024 - Observation remains. 6/27/2024 - This area has been hydroseeded again. 7/8/2024 - Germination was observed and the area will be monitored for stabilization. 7/15/2024 - Vegetation has become established and sediment deposition is no longer discernable.

View of stabilization achieved near Station 221+50 per Compliance Action Item 15.

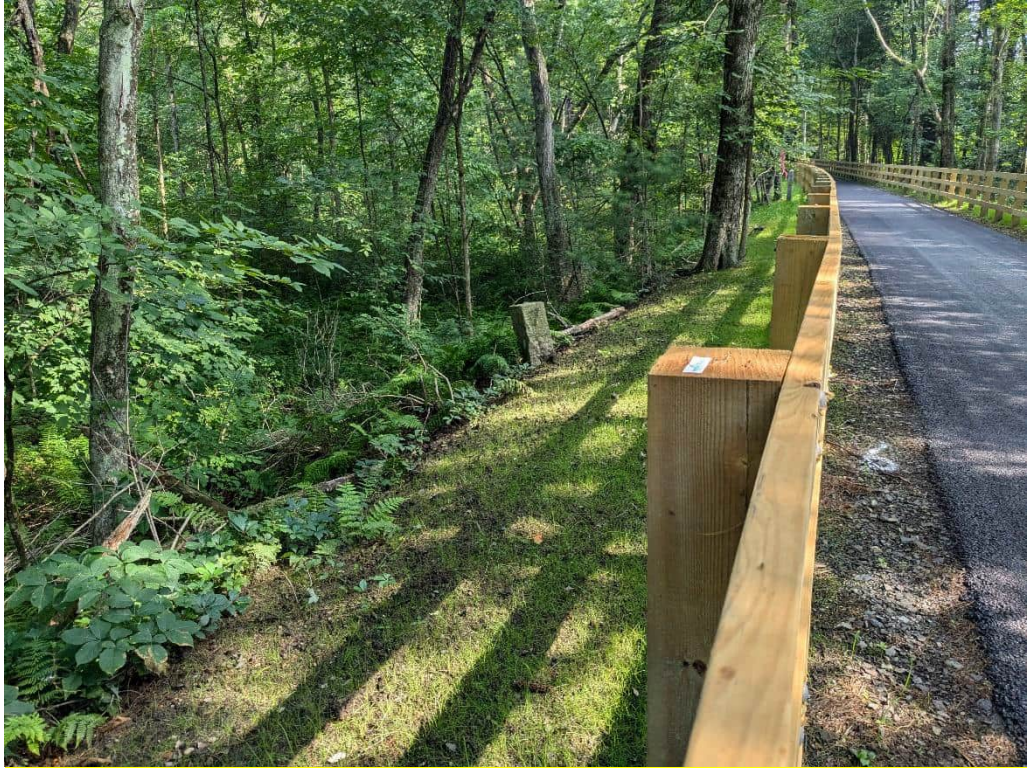
33	Sediment is eroding downhill and offsite at Station 222+00 through Station 236+00 Priority: High	5/21/2024	5/28/2024	Resolved 7/15/2024 Remove rill erosion and remove over washed material from outside limit of work.	5/28/2024 - Hydroseed has been applied and germination was observed. No new erosion was observed. 5/31/2024 - Observation remains. 6/7/2024 - Observation remains. In addition, seed is required on the west side of the trail. 6/14/2024 - Observation remains. 6/17/2024 - Observation remains. 6/24/2024 - Observation remains. 6/27/2024 - Germination of hydroseed was observed and the area will continue to be monitored for stabilization. 7/8/2024 - See previous update. 7/15/2024 - Vegetation has become established and sediment deposition is no longer discernable.
48	Multiple concrete piles left around parking lot rest stop near Station 216+00 Priority: Medium	6/14/2024	6/21/2024	Resolved 7/8/2024 Remove concrete piles from site and dispose of properly.	6/17/2024 - Observation remains. 6/24/2024 - Some of the concrete piles have been removed. One pile of the three in this area remain. 6/27/2024 - Concrete pile still remains. 7/8/2024 - Concrete piles have been removed.

Photo No. 11	Date: 7/15/2024
Direction Photo Taken: Toward the Northwest	
Description: Typical view of stabilization achieved between Station 222+00 and 236+00 per Compliance Action Item 33.

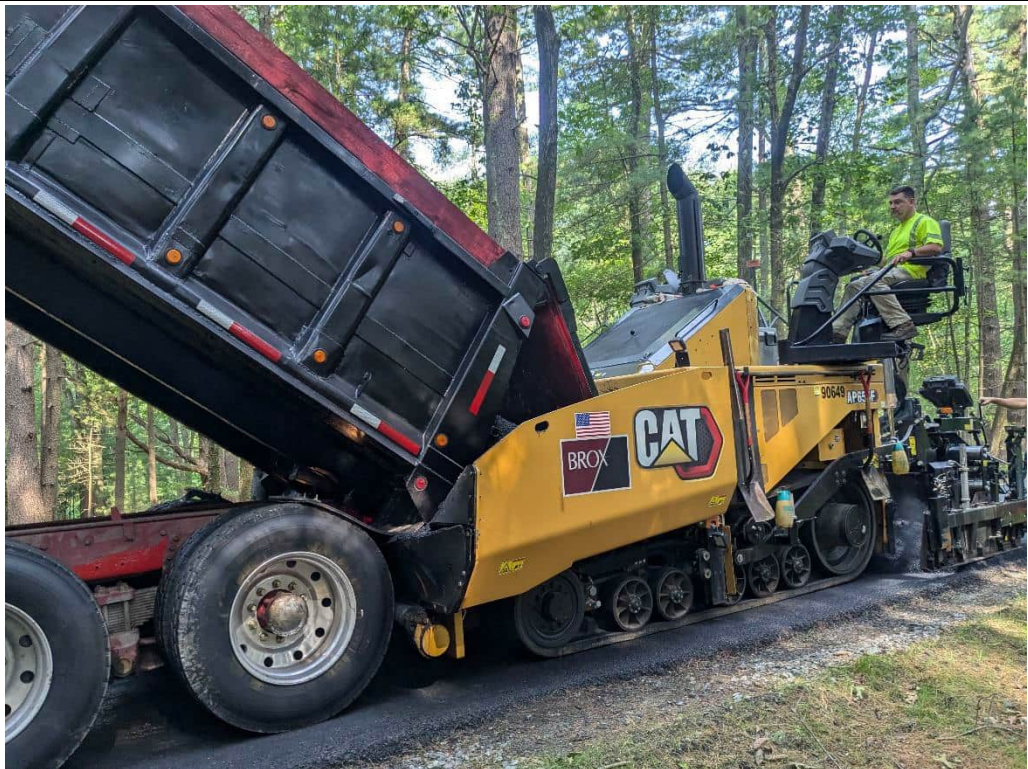
Photo No. 12	Date: 7/15/2024
Direction Photo Taken: Toward the Northwest	
Description: View of paving north of Morse Road.
